UNITED STATES ENVIRONMENTAL PROTECTION AGENCY

SUBJ: Coronet Industries Incorporated
Plant City, Florida

United States Environmental Protection Agency
 Washington, D.C. 20460
Water Compliance Inspection Report

Water Compliance Inspection Report

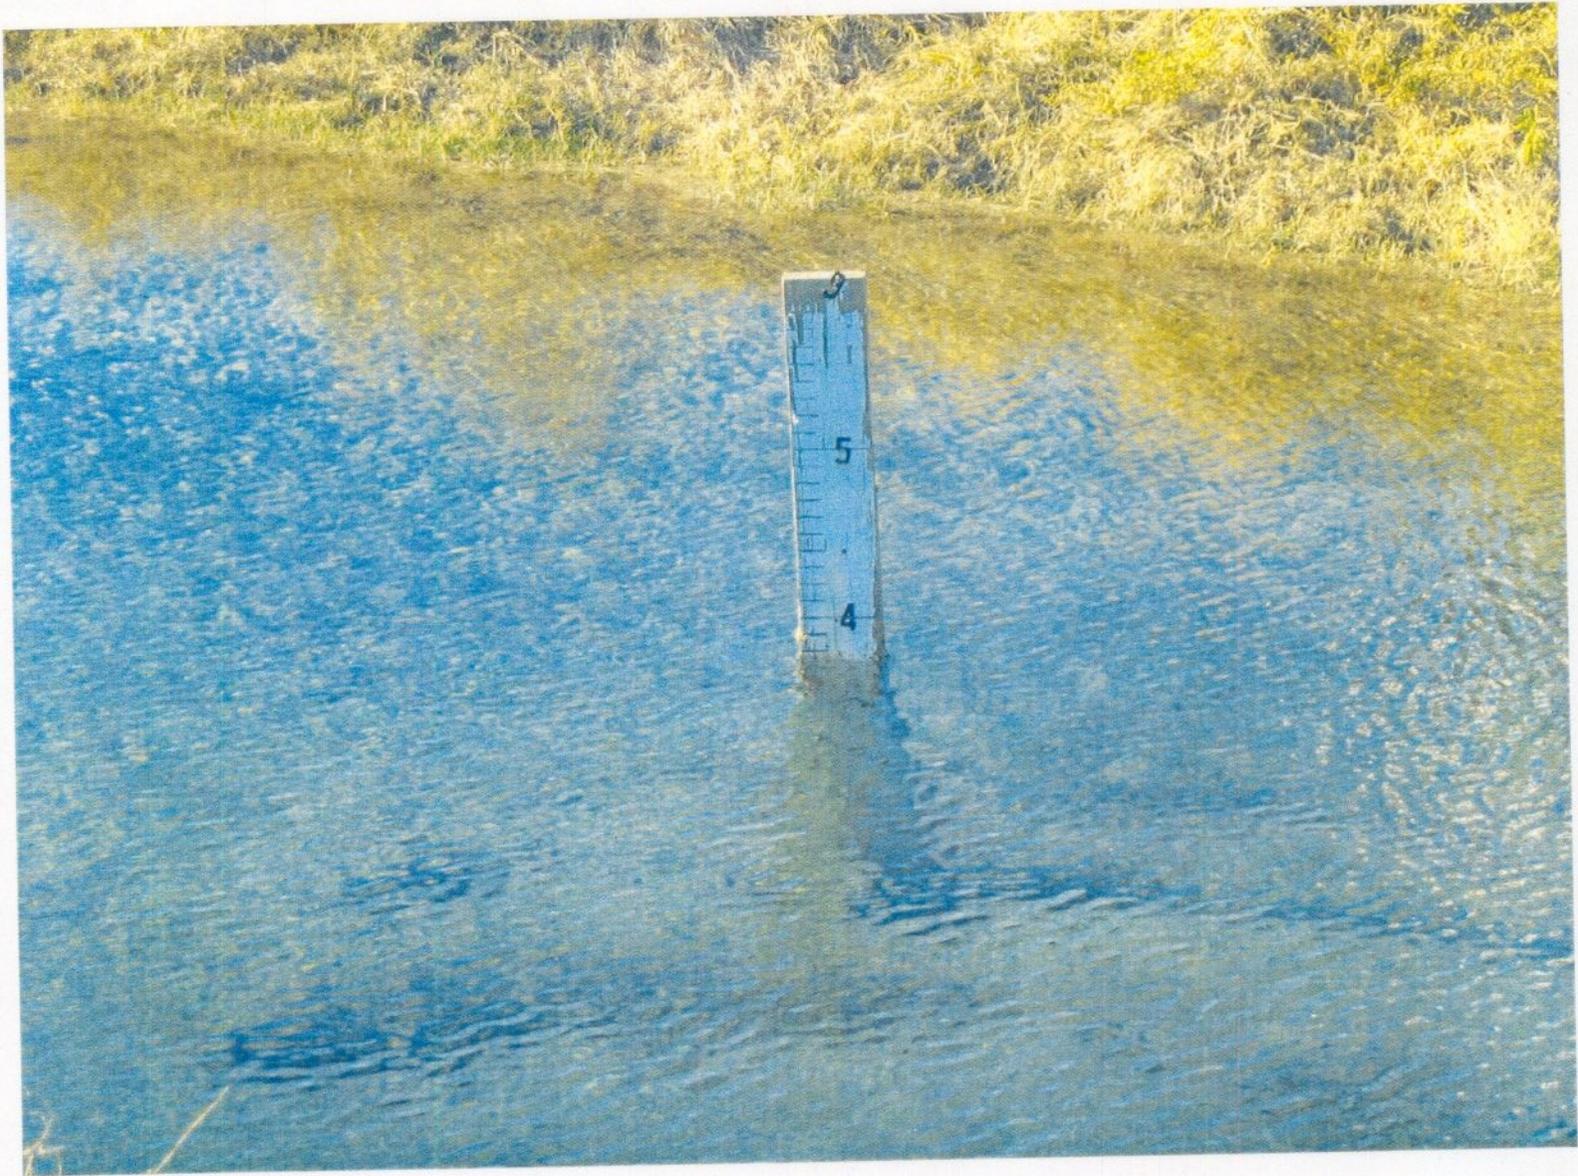
ATTACHMENT 1.

A staff gauge or a device for measuring water level in pond 4A.

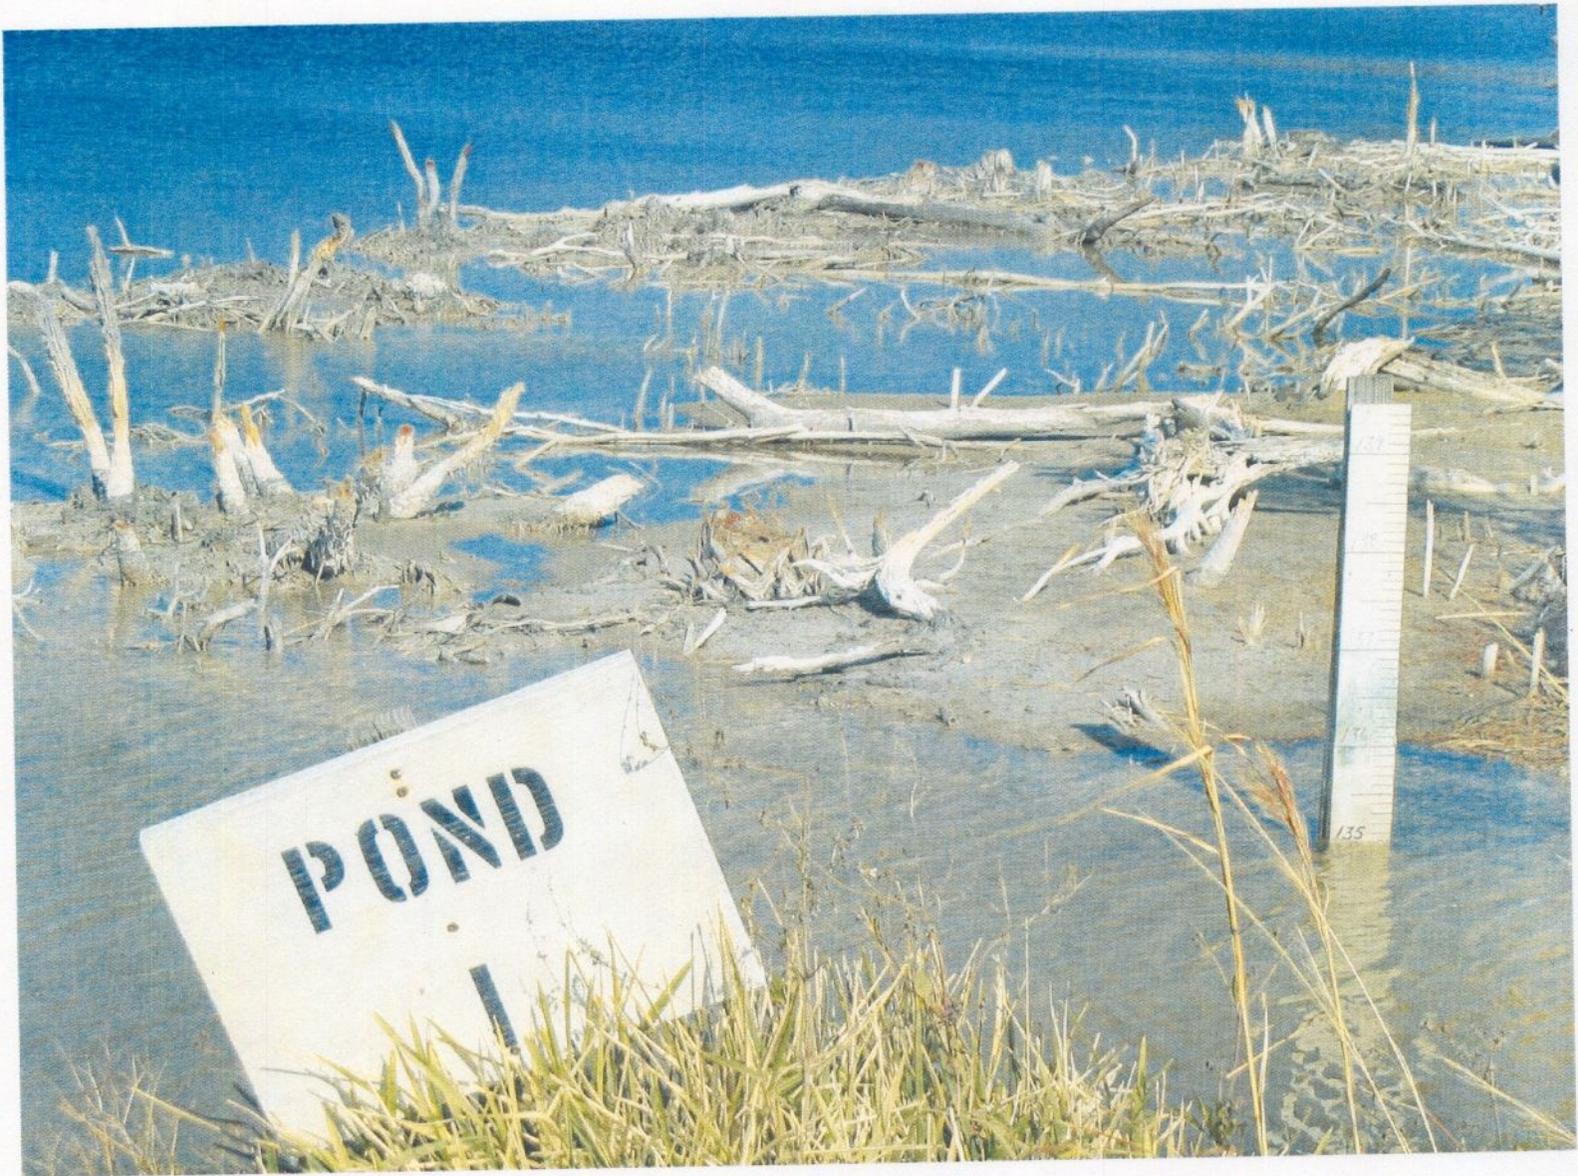
ATTACHMENT 1.

The NPDES permit (refer to Part V, Section A, item 6 on page 8 of the permit) requires the permittee to monitor the level of wastewater in its ponds so that when the wastewater level exceeds the mid-point of the surge capacity of the water recirculation system, Coronet is to treat and discharge wastewater meeting limits prescribed in the permit. However, water level measuring devices in various ponds did not clearly indicate what water level constituted the mid-point of the

A staff gauge or a device for measuring water level in pond 1.

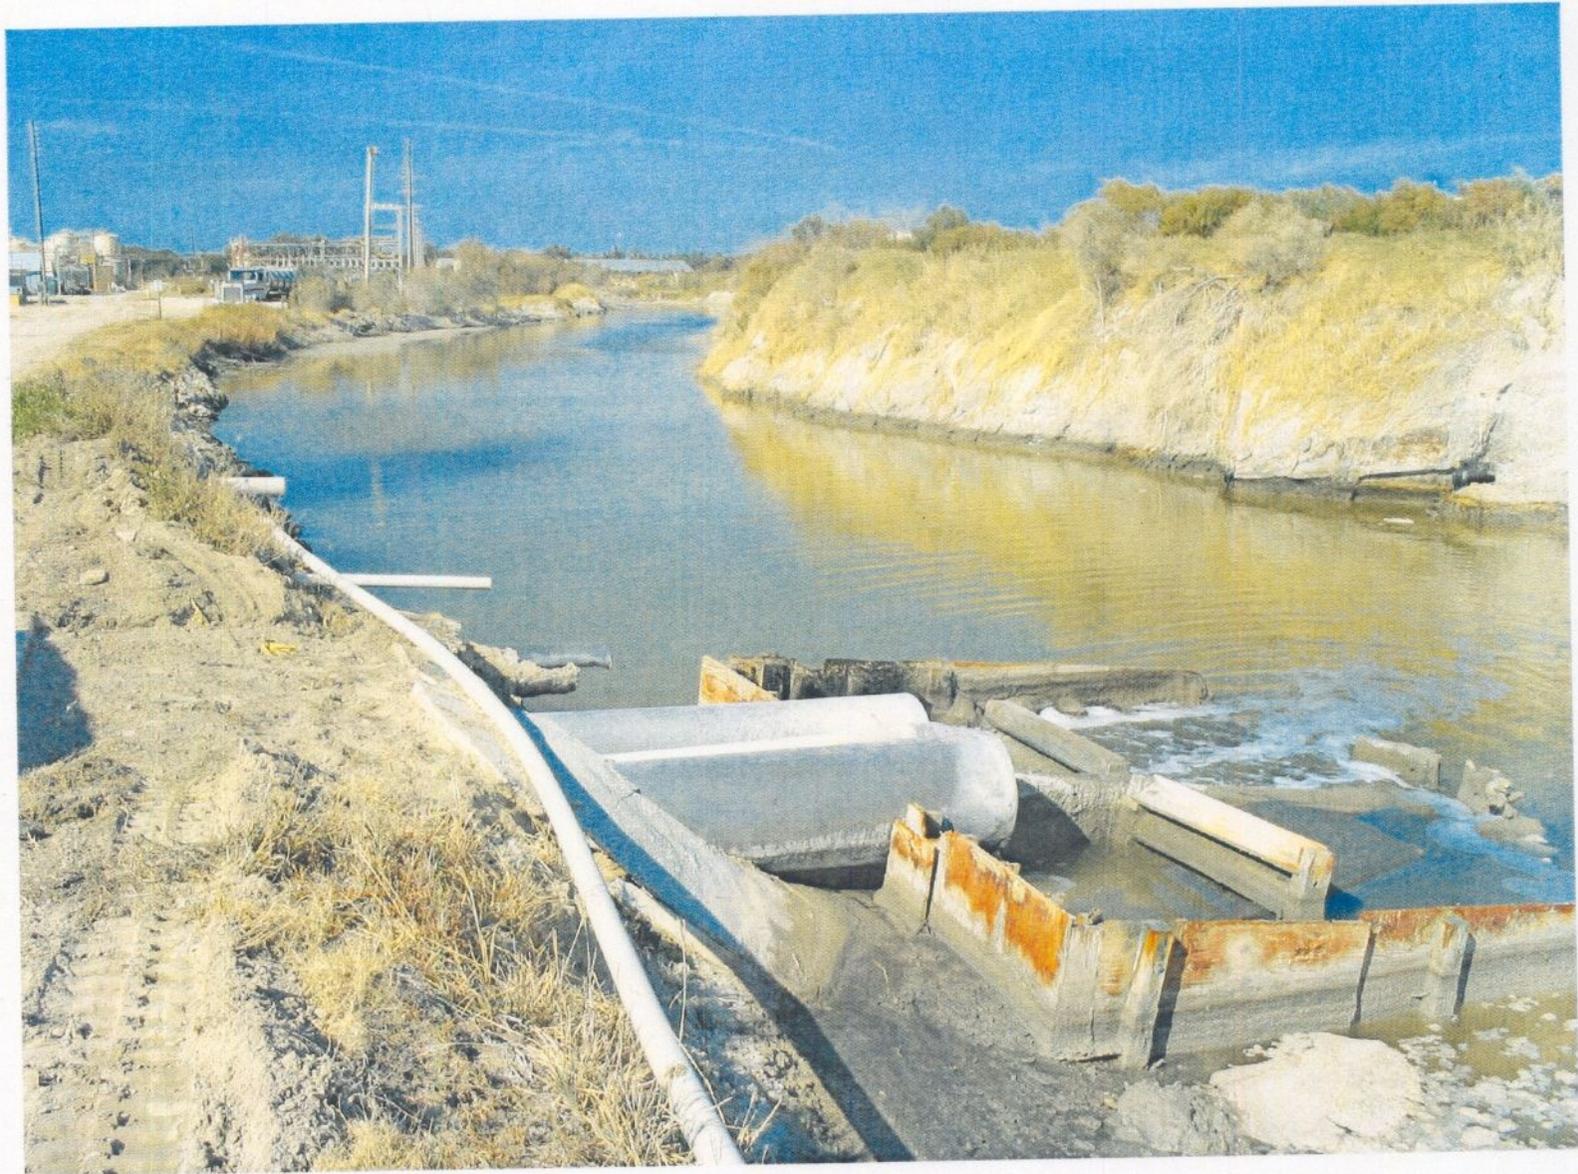
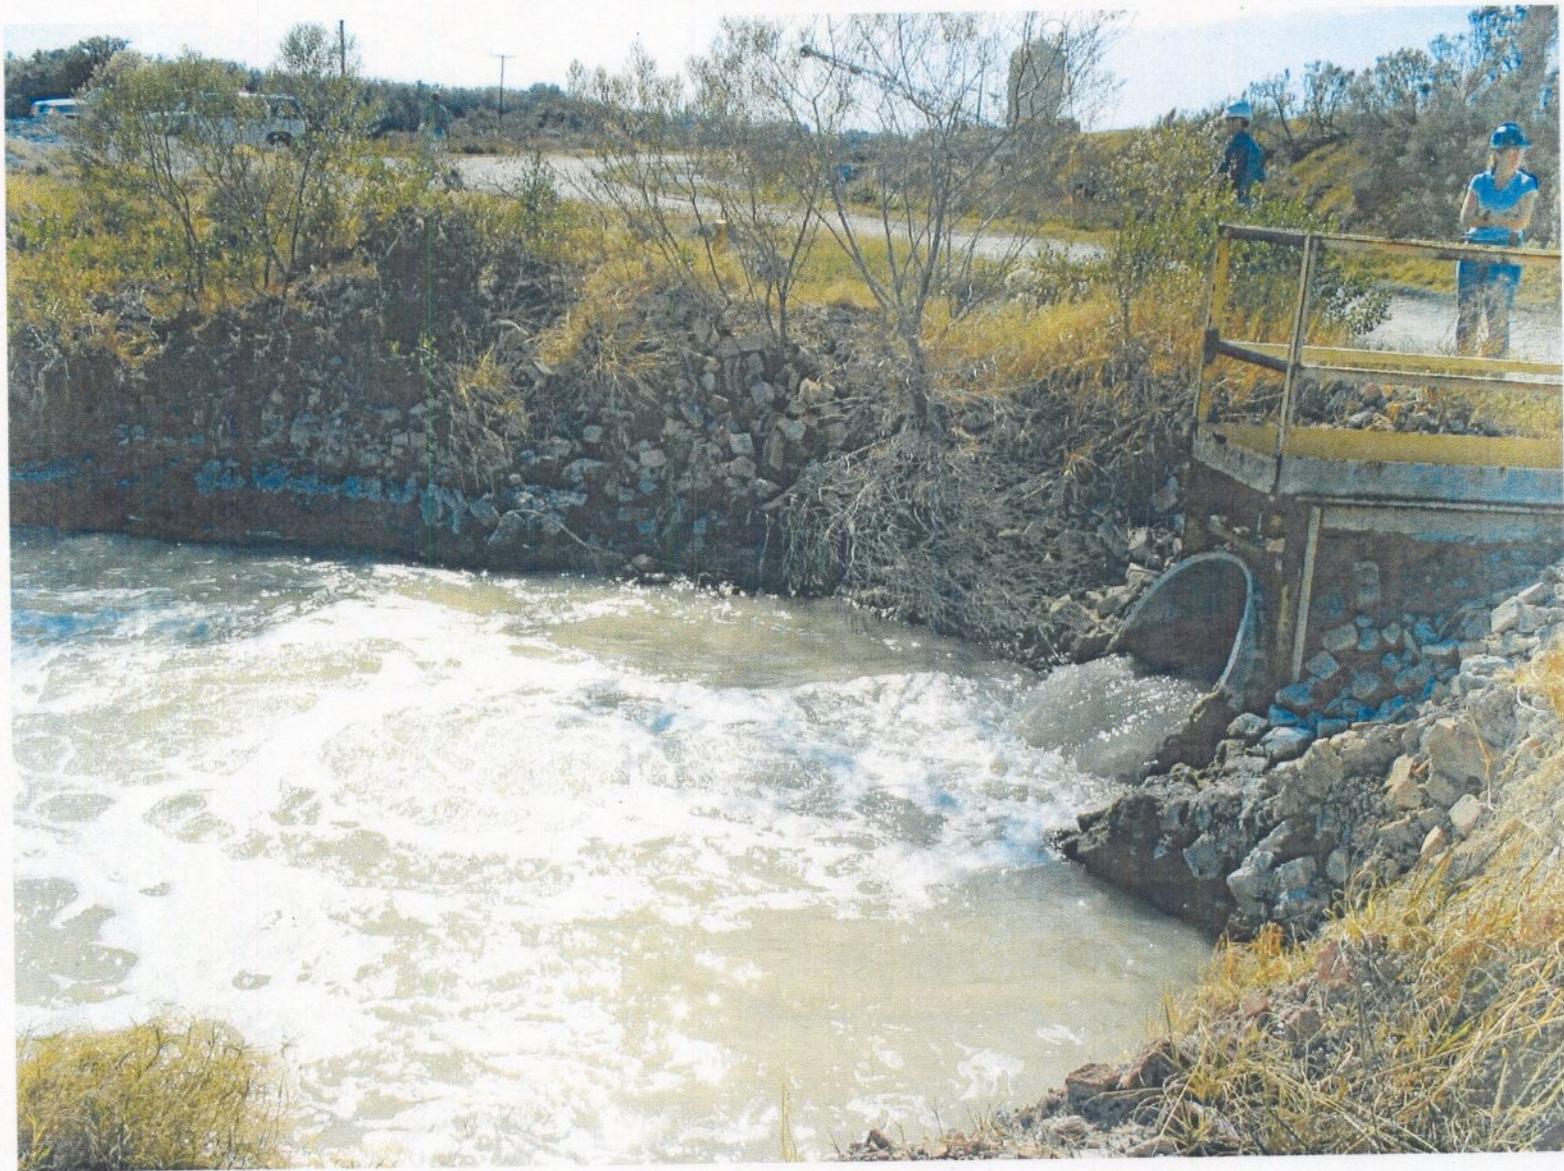
ATTACHMENT 2.

FDEP personnel guided the EPA personnel through the facility site and its wastewater system. The site review began at pond 1, followed by stop at one of the influent pipes where wastewater from the facility's industrial plant is pumped into a ditch connecting pond 6 and pond 1². Storm water runoff is collected and pumped from perimeter collection ditches located throughout the site into Pond 6 and potentially other locations within the wastewater treatment system.

Point of entry for industrial wastewater into the wastewater treatment system.

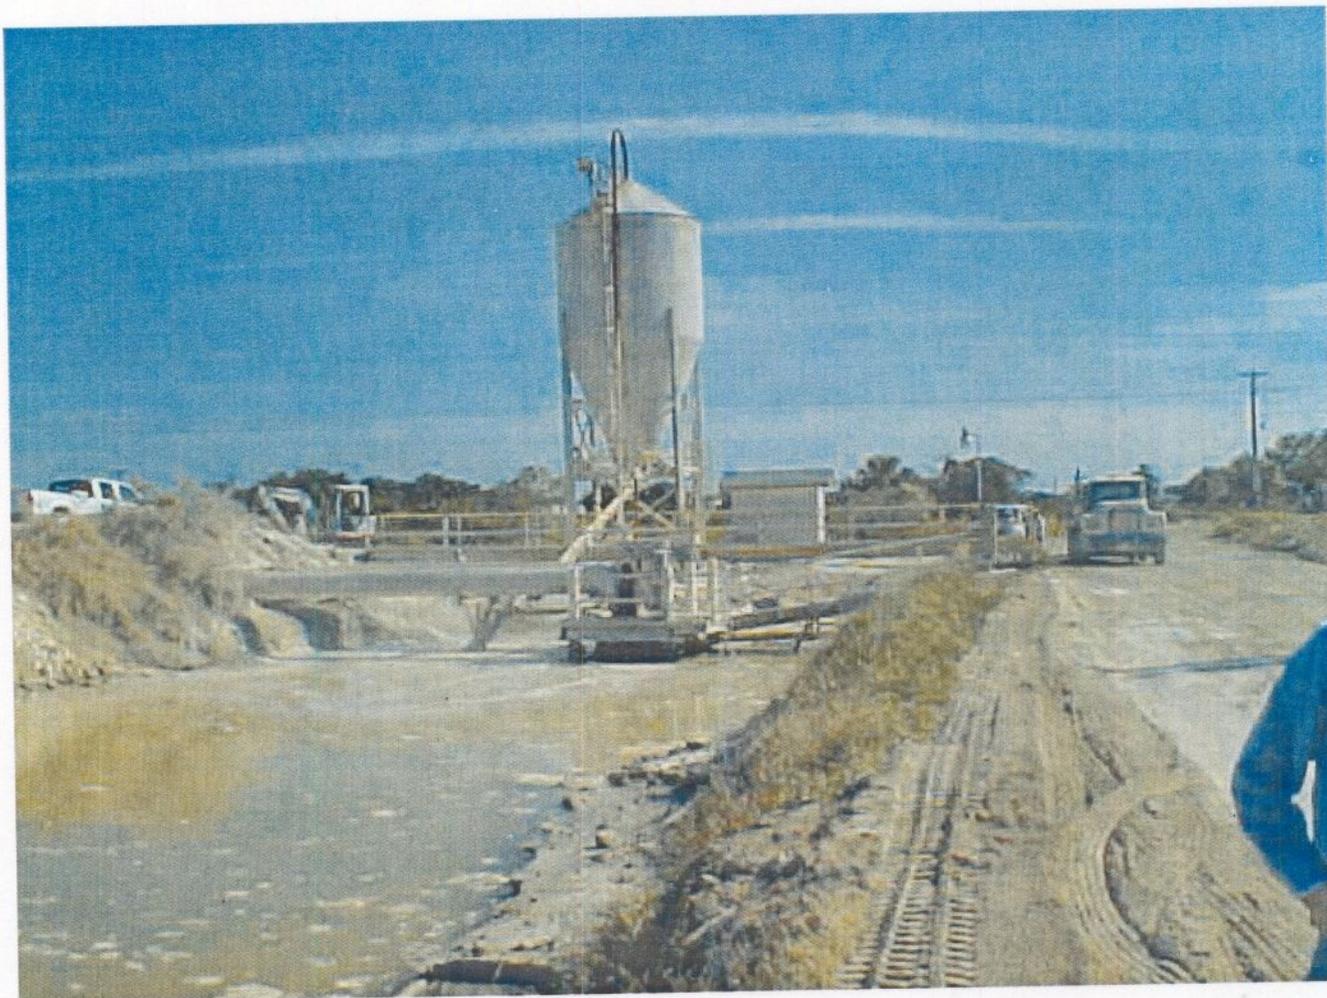
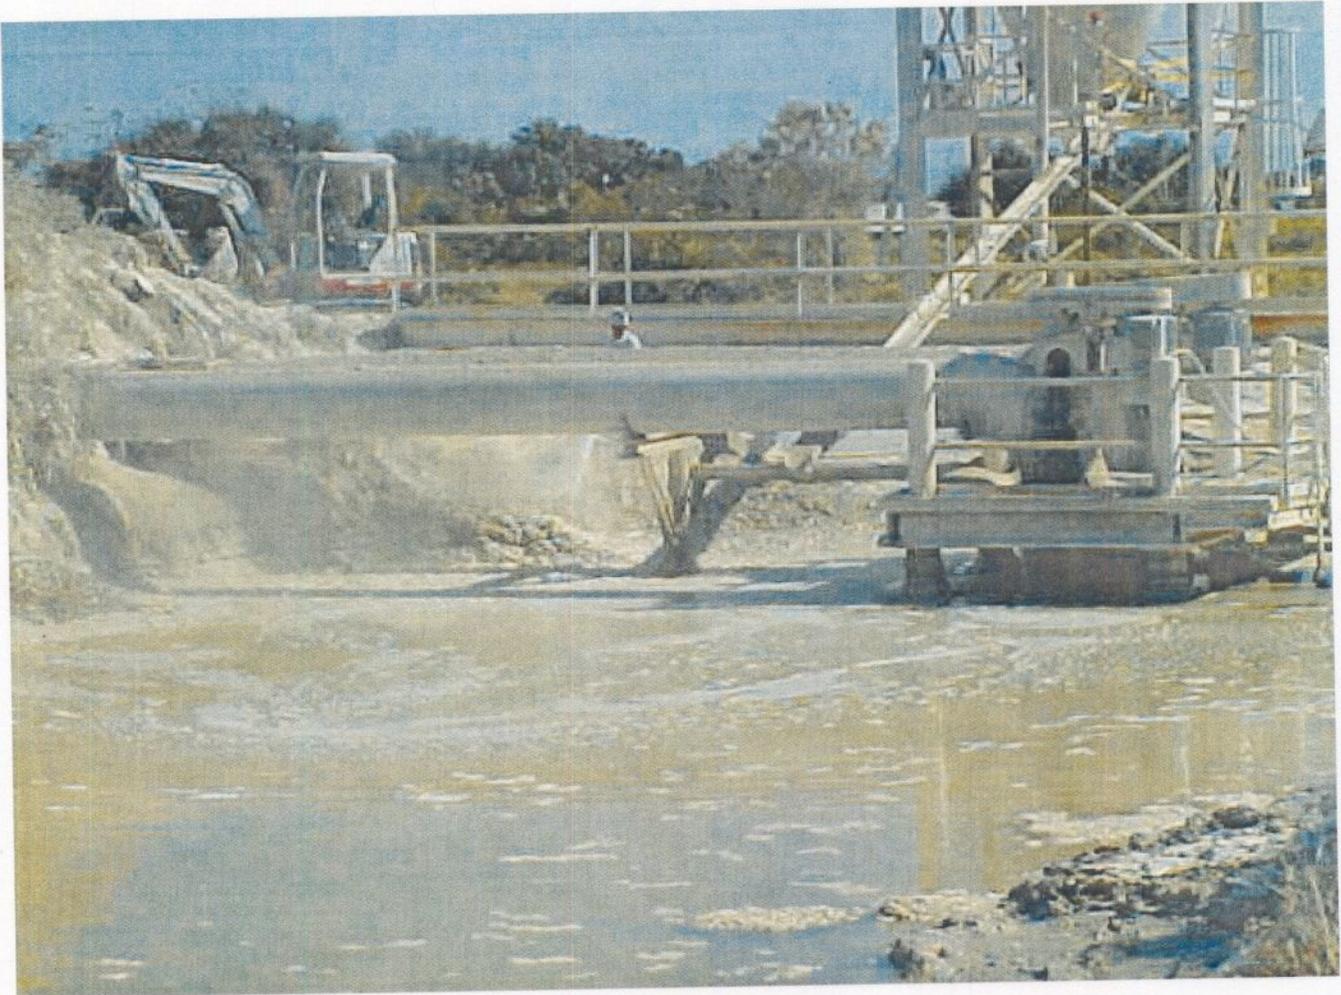
ATTACHMENT 3.

The next observation was of the initial liming station which was located in the ditch connecting pond 6 and pond 1³. The permit describes the wastewater treatment process to have primary liming stage and a secondary treatment with hydrated lime prior to discharge off-site.

Initial liming station at a ditch connecting pond 6 and pond 1.

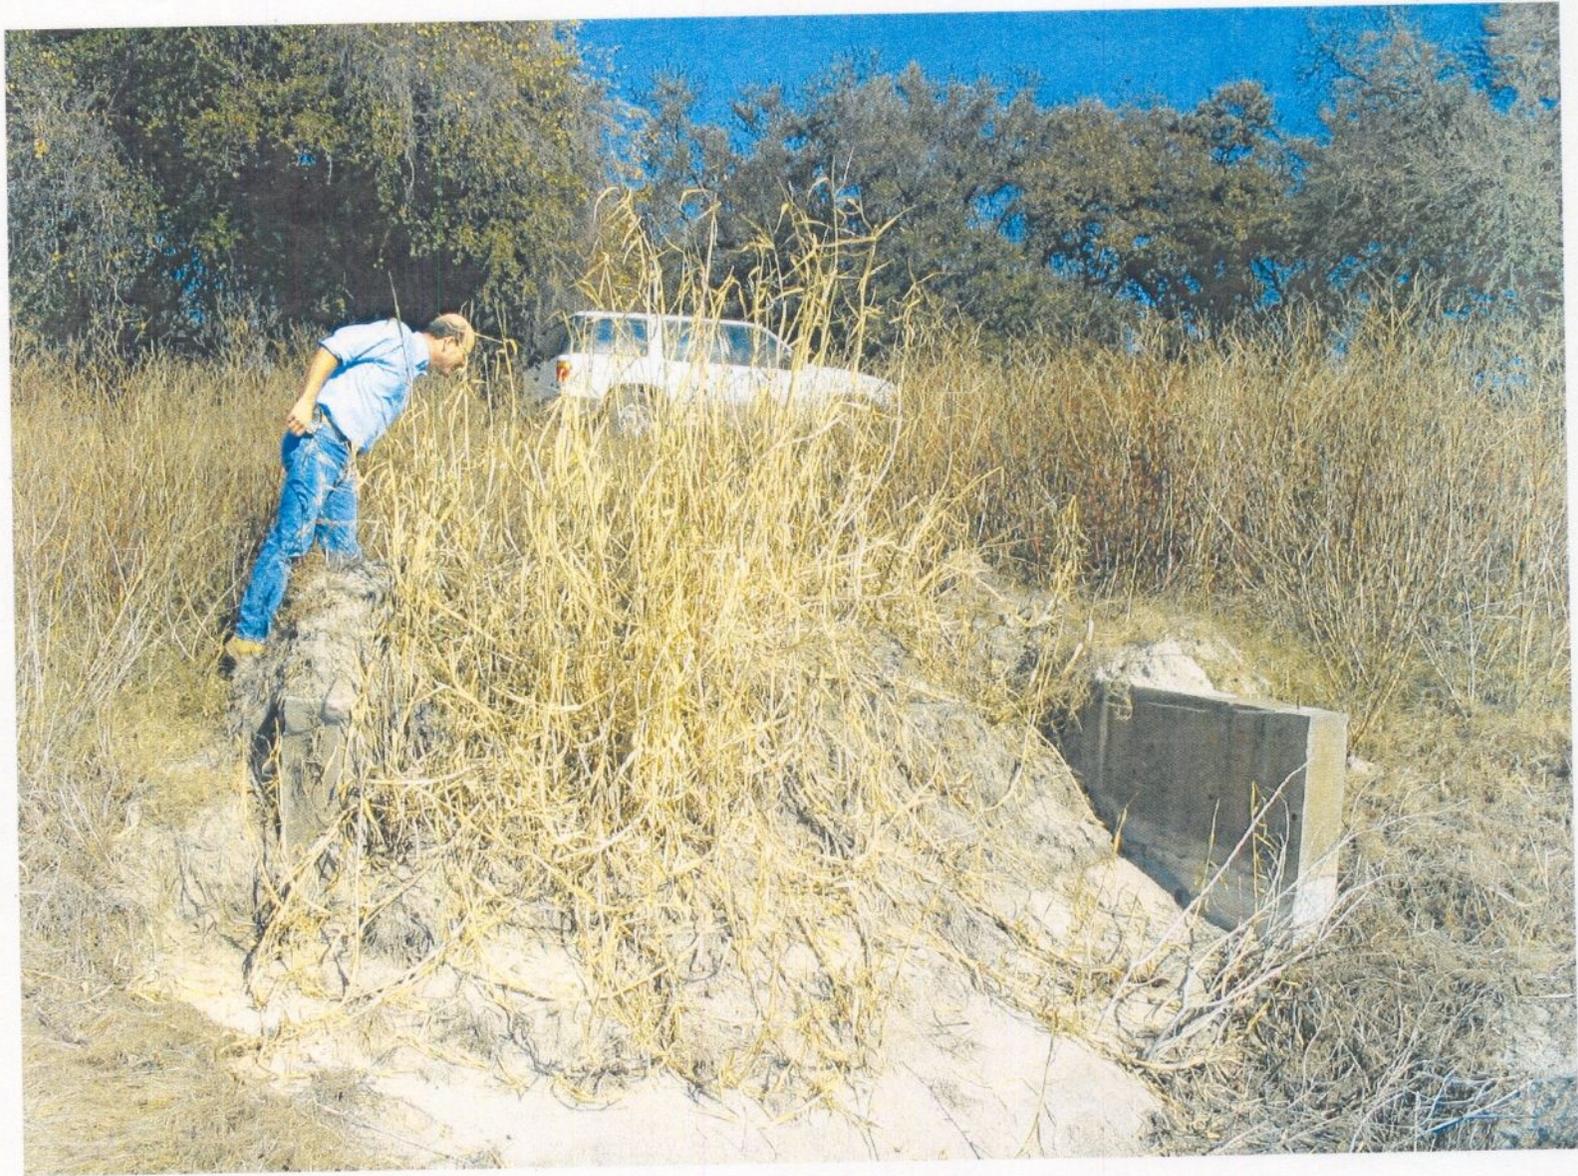
ATTACHMENT 4.

The next stops were at pond 6 where EPA and FDEP personnel tried to locate the emergency outfalls 003 and 004. An outfall structure was located on the northeast side of pond 6 that could have been outfall 003⁴. Despite our efforts during the inspection, another outfall was not located that could have been outfall 003 or 004. Coronet's consultants Mr. Douglas Grant and Mr. David Gatchel accompanying the personnel from EPA and FDEP during this inspection did not provide any information regarding these outfalls and Coronet's wastewater system operations. Coronet's personnel responsible for the wastewater system operations, although present on site at the time of inspection, were not made available during this inspection. Hence, EPA and FDEP personnel could not verify with certainty whether the outfall structure found was indeed outfall 003.

Outfall 003 at the northeast side of pond 6?

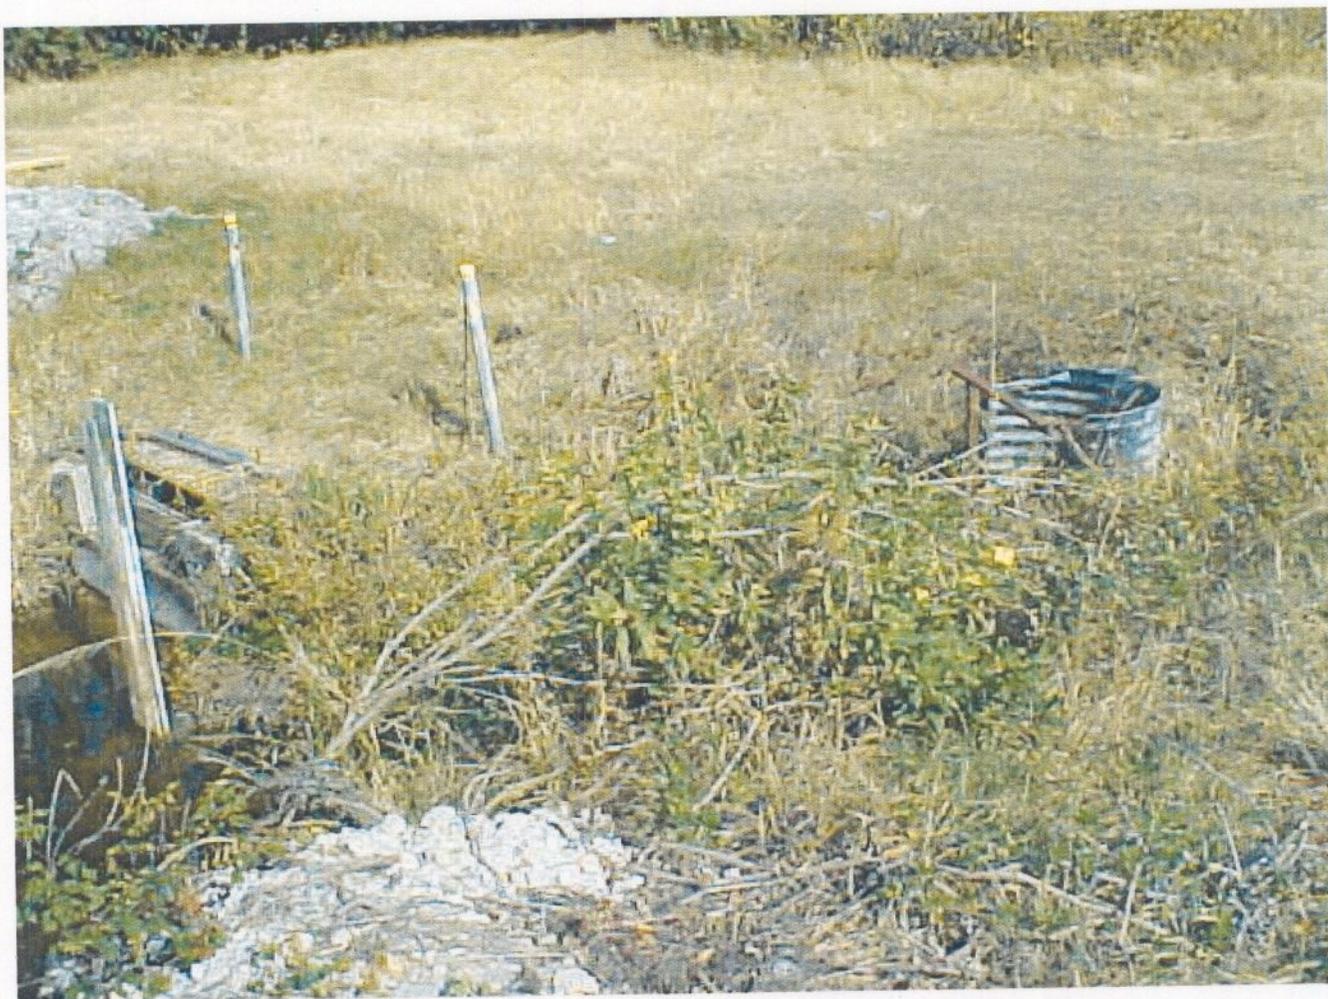
ATTACHMENT 5.

The site review then shifted northwards to pond 5, #4 ditch, and pond 7. The unauthorized outfall⁵ at pond 7 was confirmed to be in existence, however, no discharge was noted from pond 7 to English Creek at the time. In addition, a riser structure was noted in pond 7 that could discharge into English Creek through #4 ditch. Also, the unauthorized pipe with the permanent valve plate in the seepage ditch (#4 ditch) around pond 5⁶ was confirmed to be in existence, however, no discharge through this pipe was noted at the time. Because the permit does not identify a single permitted outfall at pond 7 for discharge to English Creek and it does not identify a permitted outfall to English Creek from the #4 ditch, the existence of these structures and pipes is an unauthorized deviation from the approved drawings, exhibits, specifications and/or conditions of the permit and constitutes grounds for enforcement action. Any discharges from either of these structures and pipes to English Creek would be considered unpermitted discharges. Lastly, no discharge was noted from permitted outfall 005 located at north-northeast side of pond 5.

On the left, the unpermitted outfall structure at pond 7.
On the right the riser structure at pond 7.

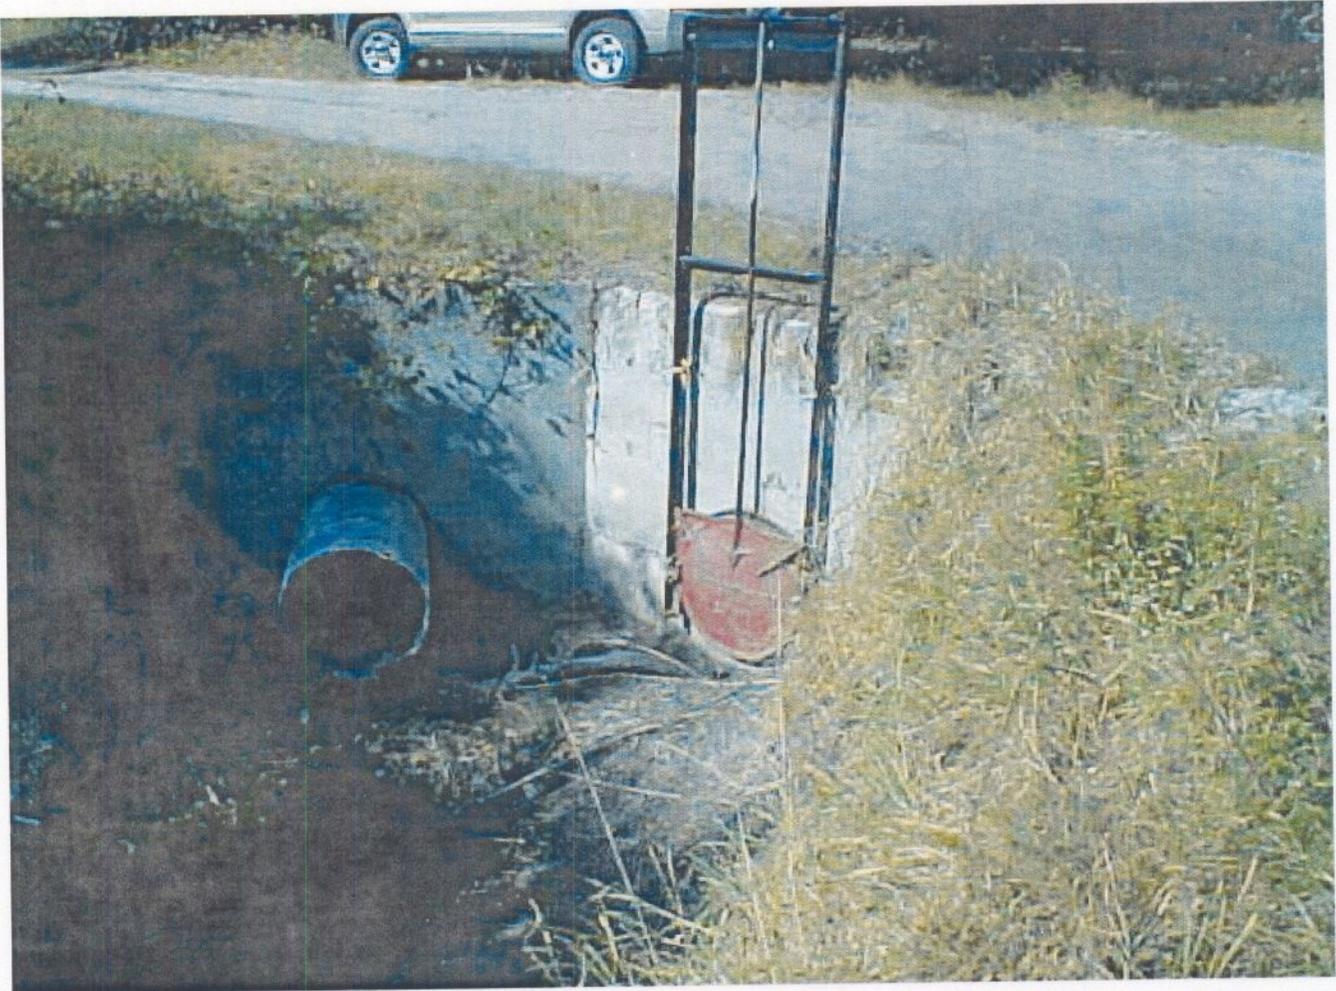
ATTACHMENT 6.

Next, the site review proceeded towards pond 3, ponds 2A and 2, pond 8, pond 4, pond 4A, and English Creek. A pipe from pond 8 into a ditch connecting to pond 7 was noted to be plugged with concrete. The interconnection between pond 8 and pond 7 via this pipe was first discovered by FDEP on February 17, 2003. Until this discovery, the water in pond 7 was thought to be storm water only and was so represented by Coronet. FDEP first confirmed the plugging of this pipe with concrete during the March 27, 2003, inspection and was reconfirmed during this inspection.

On the left is a pipe from the riser structure at pond 7.
On the right is the permanent valve in place over an unpermitted pipe in ditch #4.

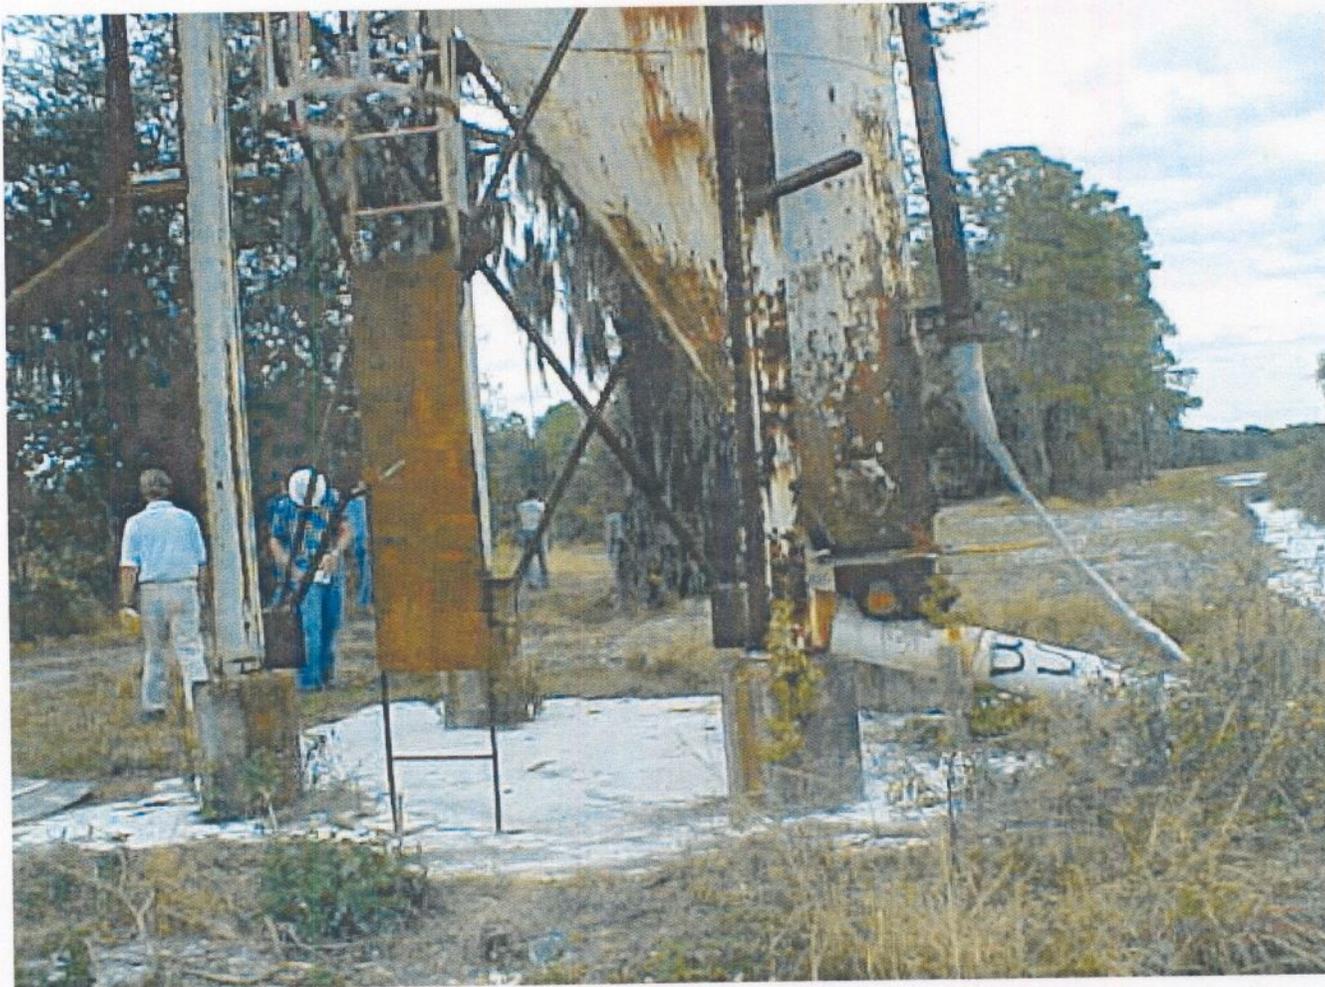
ATTACHMENT 7.

The secondary liming stage was located between pond 3 and 8 and was not in operation at the time, and appeared to be maintained in poor condition⁷. At the time of inspection, Coronet was conducting research and development using mobile reverse osmosis system at ponds 4 and 4A⁸. There was no discharge to English Creek noted from ponds 4 and 4A through permitted outfall 001.

Lime Station 2 located between ponds 3 and 8.

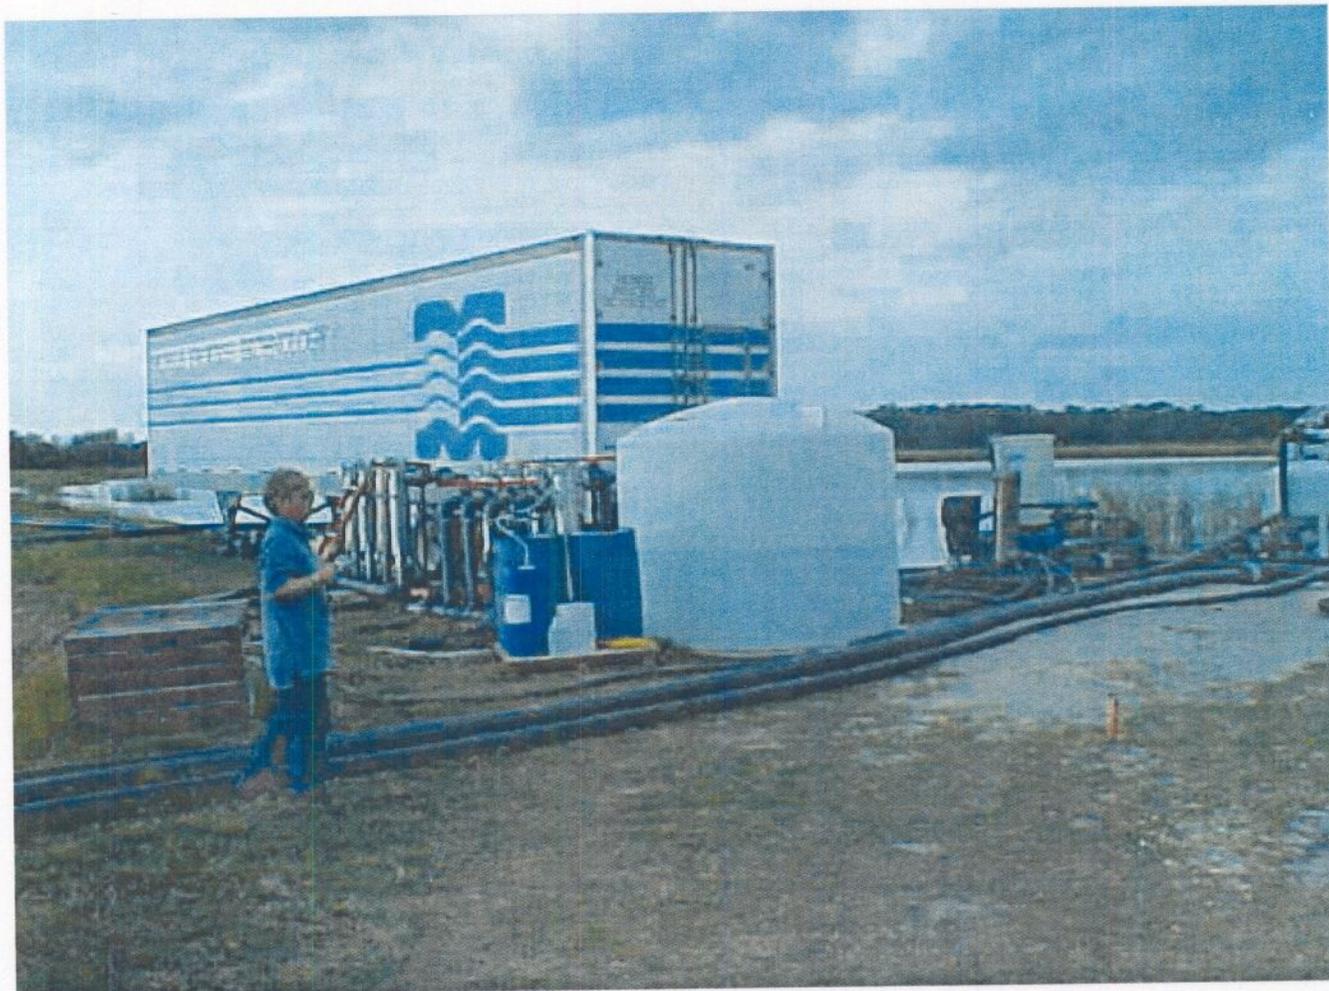
ATTACHMENT 8.

Mobile RO unit at pond 4 and/or 4A.

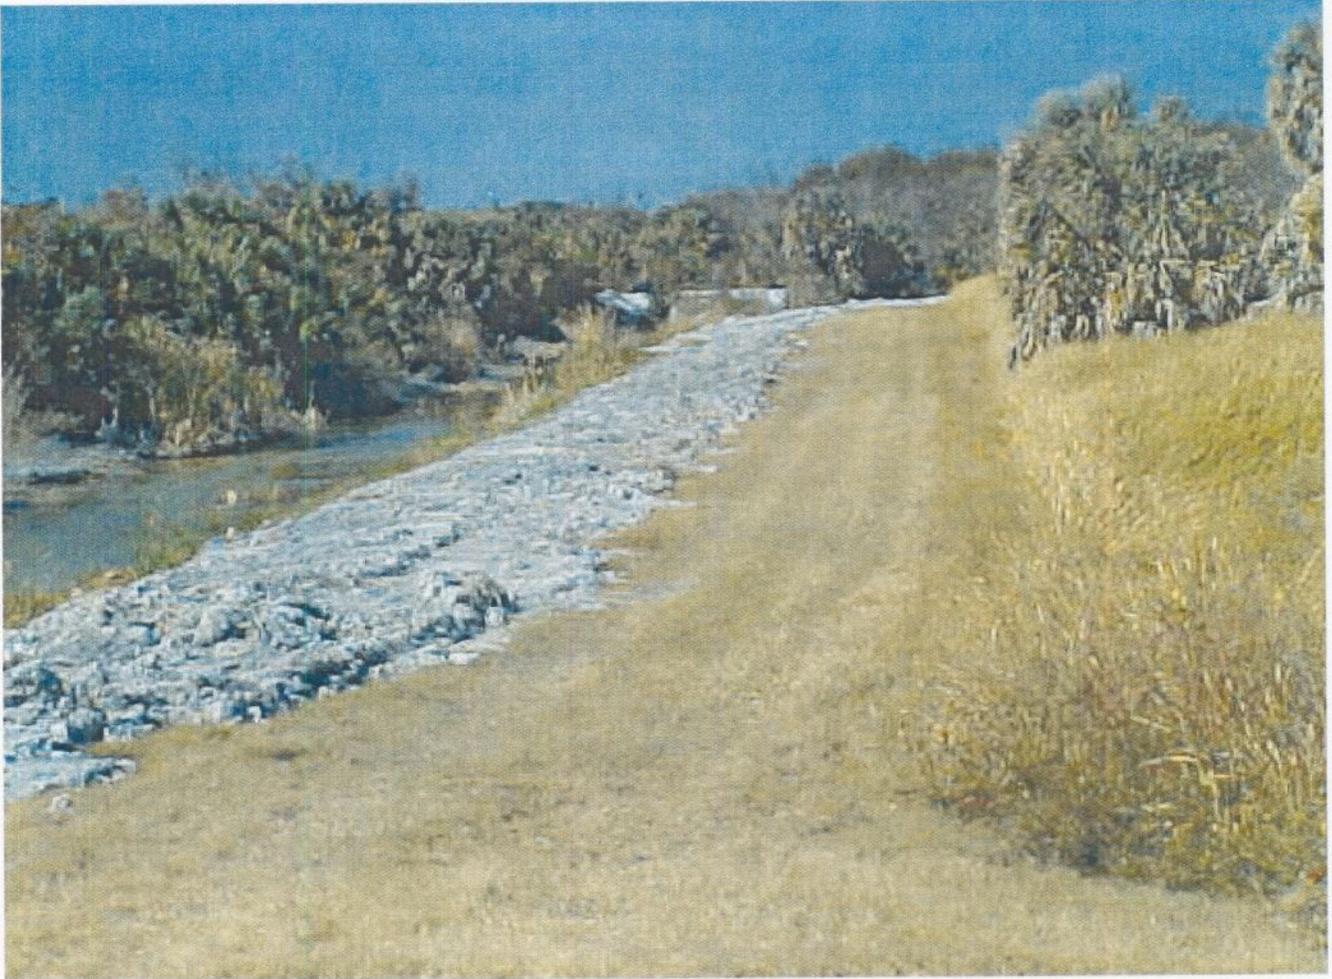
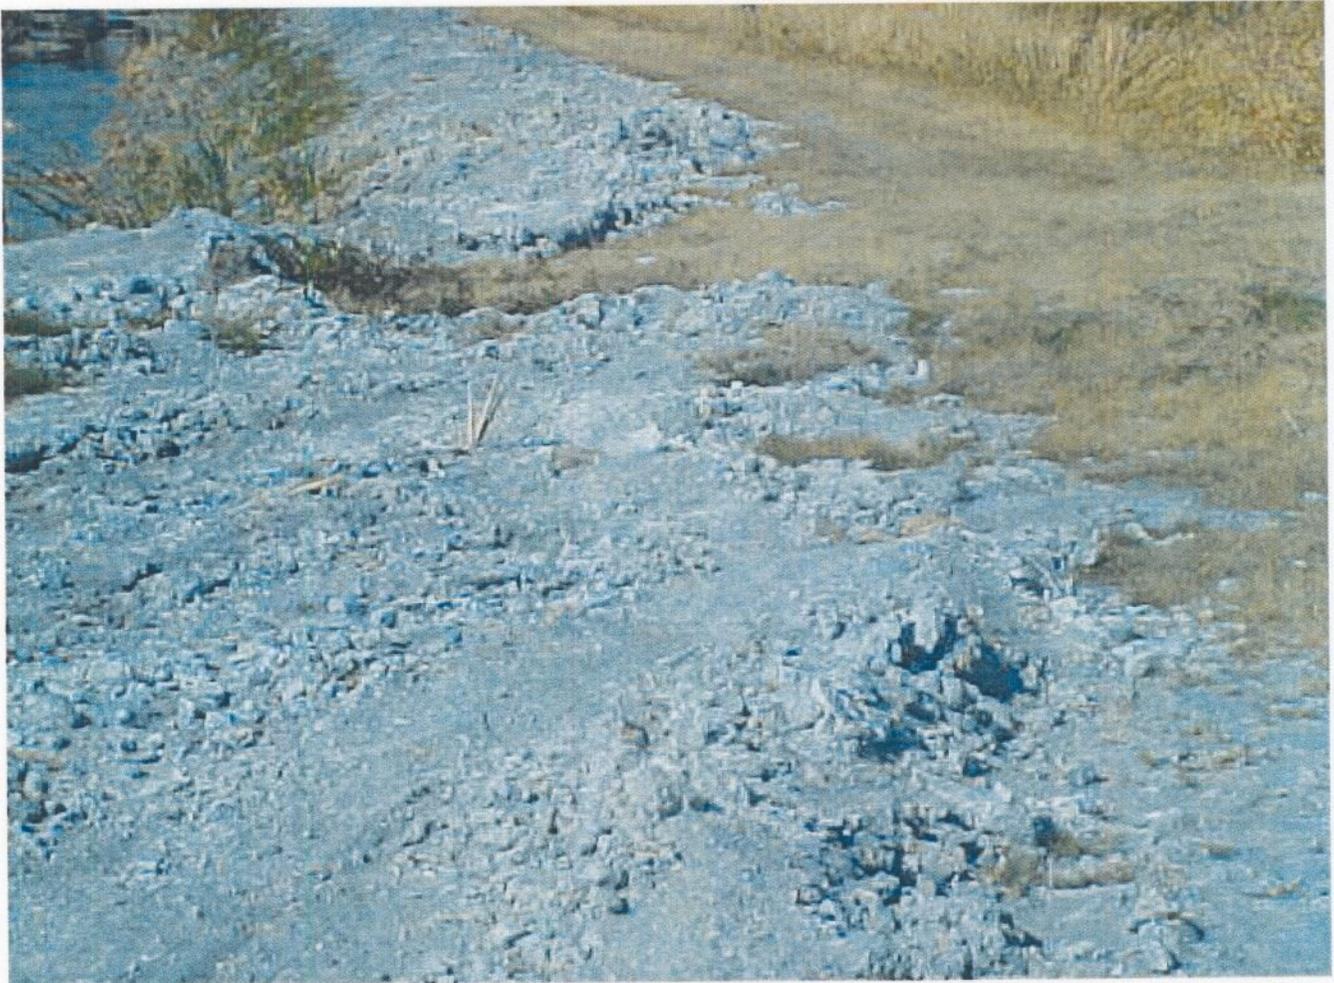
ATTACHMENT 9.

There were indications that Coronet had dredged some of the ponds and had placed some of the dredged materials on the ground⁹. Pursuant to Part V, Section A, item 2 of the permit, such placement or land application requires prior approval from FDEP, with the exception of performing dam maintenance. Coronet did not make available the personnel with intimate knowledge of wastewater system operations to ascertain whether such placement of dredged material was in compliance with the aforementioned part and section of the NPDES permit.

Dredged materials from the pond placed on the ground.
