UNITED STATES ENVIRONMENTAL PROTECTION AGENCY

SUBJ: Coronet Industries Incorporated
Plant City, Florida

United States Environmental Protection Agency
 Washington, D.C. 20460
Water Compliance Inspection Report

Water Compliance Inspection Report

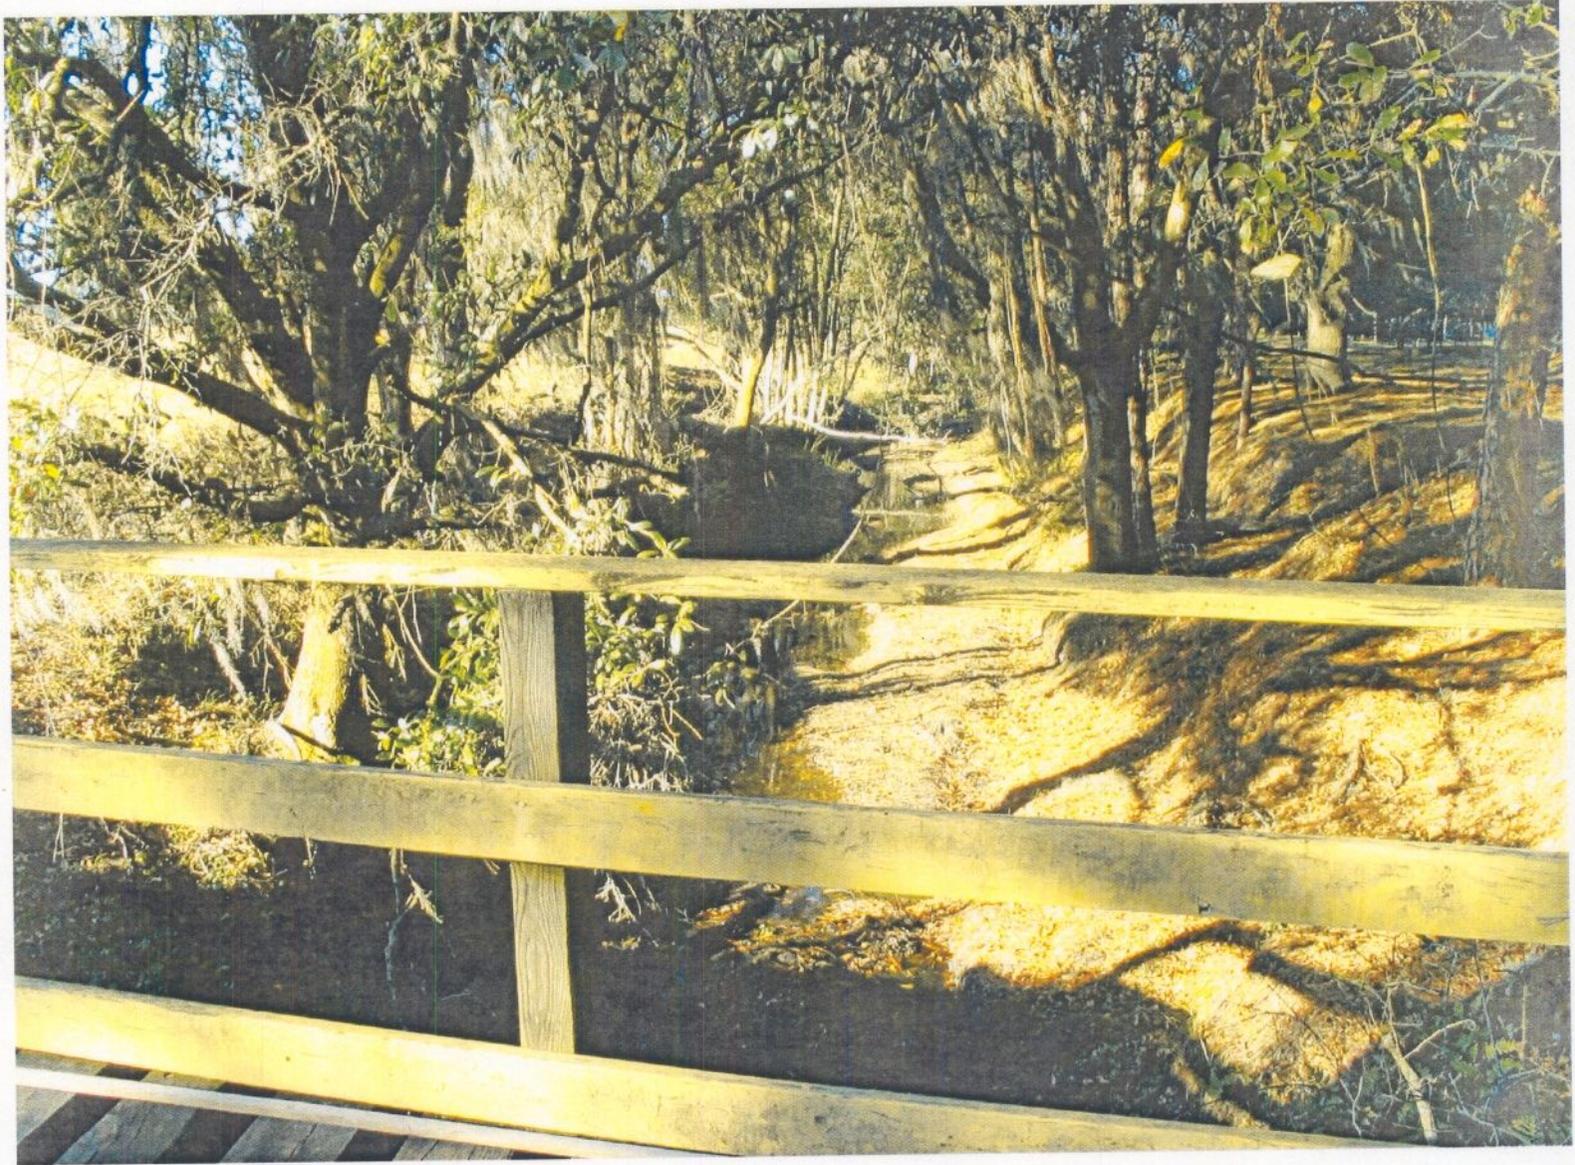
ATTACHMENT 10.

The site review then proceeded to English Creek. The site review of the English Creek was conducted from a wood bridge that was considered a sampling point at the end of 800 meter mixing zone for Fluoride and Specific Conductance established by the NPDES permit. The English Creek appeared to be dry¹⁰.

Picture of English Creek from a wood bridge at the end of the mixing zone.

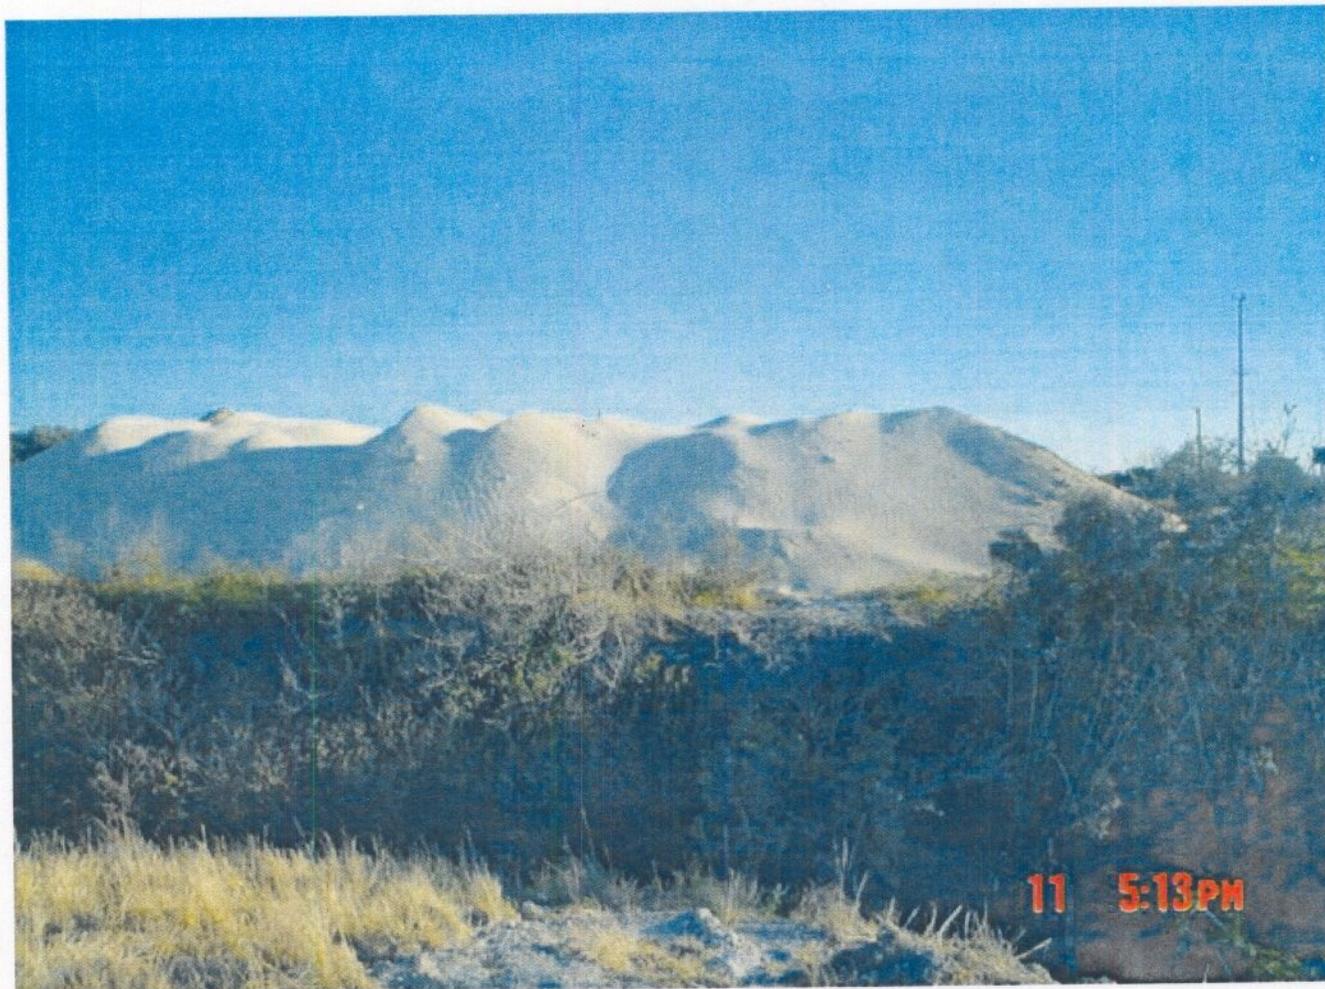
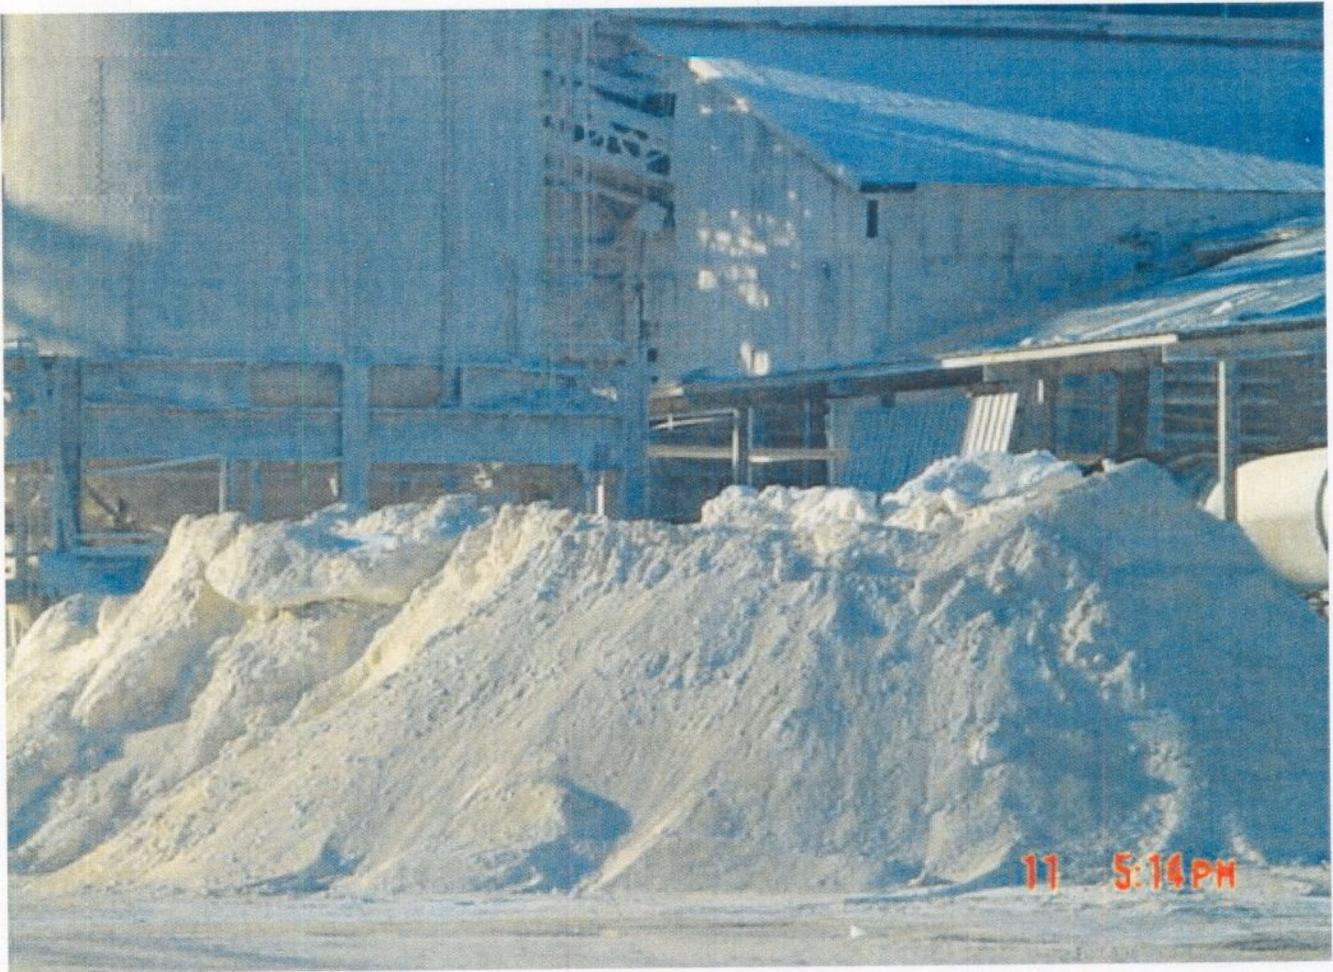
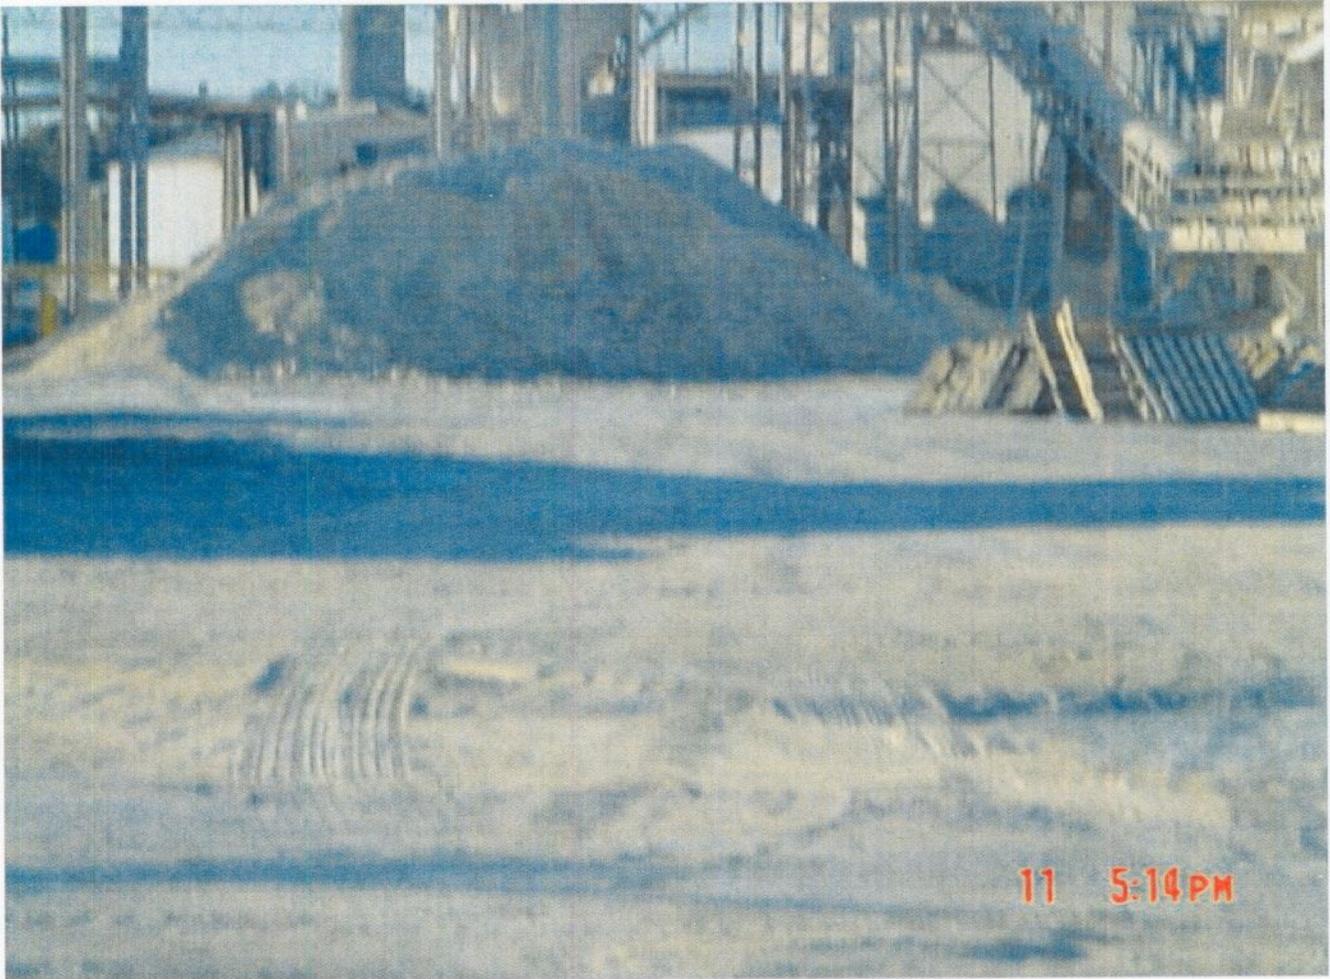
ATTACHMENT 11.

Since Coronet had gathered records which we had requested for review by end of December 9, 2003, EPA personnel decided to review the records on December 10, 2003, and suspended remaining site review until the afternoon of December 11, 2003. On December 11, 2003, EPA personnel discovered that many of the photographs taken on one of the digital camera were not available for viewing due to insufficient data memory, hence, some portion of the site were revisited and additional photographs were taken using additional data memory card, and additional cameras. During the site review conducted on December 11, 2003, we noted that on the southeast side of the facility, Coronet had some raw and/or waste materials on the ground, exposed to the nature's elements, with only a perimeter ditch to collect contaminated storm water¹¹. A BMP plan as prescribed in the permit was not available for review at the time of inspection. The permit indicates that the BMP plan was submitted to FDEP in 1997. The BMP plan implementation is required to minimize the potential for the release of pollutants from ancillary activities, including material storage areas; plant site runoff; in-plant transfer, process and material handling areas; loading and unloading locations and sludge or waste disposal areas. The extent of implementation of the BMP plan was unclear and not verified.

Raw and/or waste material on the ground at south - southeast side of the Coronet facility.

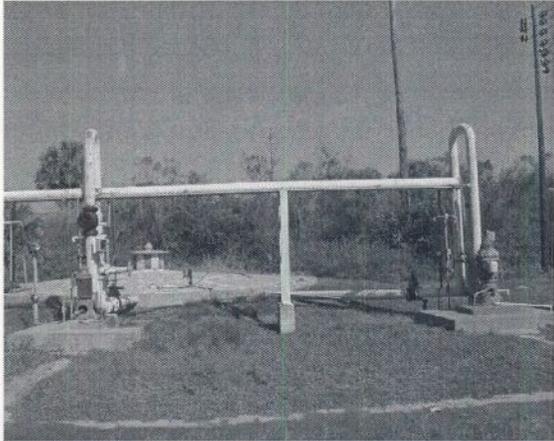
Picture 3

After calling the facility office, Mr. Brown located the drinking water well. The potable drinking water well is described as well C2 and is the subject of Picture 3. Potable water well C2 is on the left of the picture. Well C1, an industrial process water well, is visible on the right side of the picture. An underground storage reservoir, Picture 4, is located behind the wells.

Well C2 is a registered potable well with FDEP tag #AAH5977 on the well head. There is no corresponding FDEP registration tag for well C1. Well C1 and C2 are manifolded together connecting C1 to the potable water system. With the opening of a valve, water of uncertain quality from unregistered well C1 could be introduced into the potable water system. The valve appeared to be closed at the time of the inspection. The C2 well pump cycled on several times while the inspectors observed the well. Well C1 was not observed operating during the inspection. The inspection team was joined by Mr. John Broughton, Coronet's drinking water system licensed operator to explain details of the construction and operation of the water system.

Protection of the drinking water system from contamination due to cross-connection with well C1 and back-flow from the reservoir appears inadequate. Coronet should consider modifications to the manifold system, disconnecting well C1, well C2, and the reservoir to preclude the potential for contamination of the potable water system from well C1 and the reservoir.

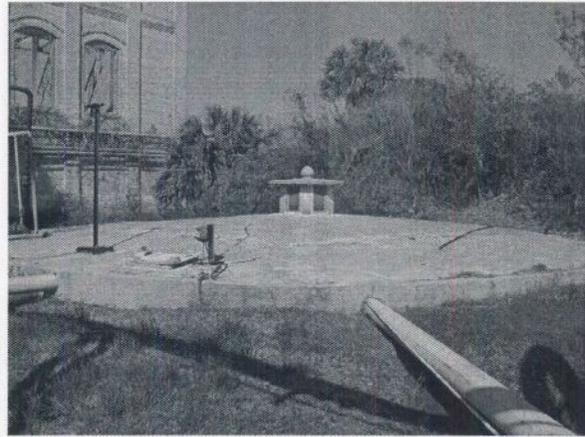
Picture 4

The underground storage reservoir is used to store industrial process water. The potable water well C2 is manifolded to the reservoir along with the industrial process water well C1. The reservoir was historically part of the drinking water system but is no longer part of the potable water system design. The reservoir had an unsecured hatch and was full of water. No ripples or waves were observed in the tank while the pump was running for well C2.

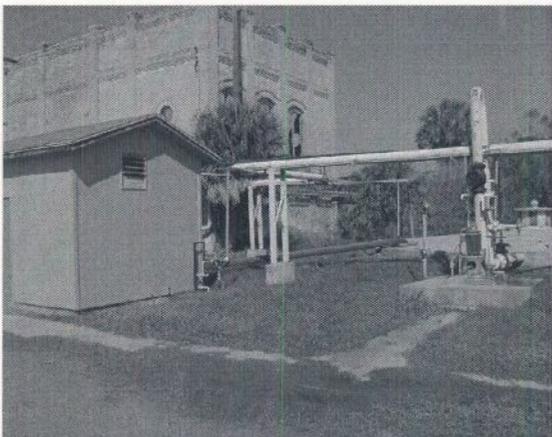
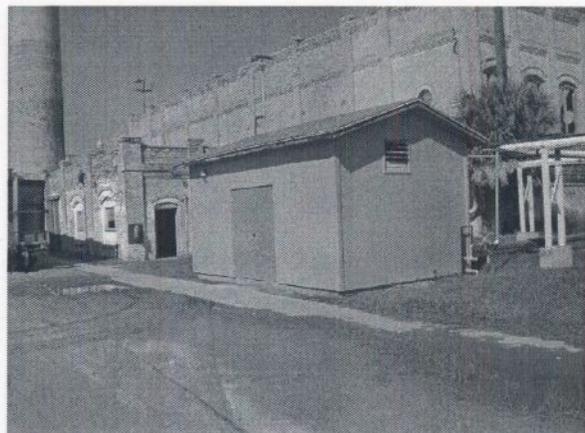
Picture 5 shows well C2 along with the water treatment shed. Picture 6 is another view of the water treatment shed where the water from well C2 is treated prior to introduction into the distribution system. While well C2 was pumping, a pressure meter was observed on the water line just prior to entering the water treatment shed which showed the well pump producing 40 pounds per square inch. The water treatment shed interior appears to be well maintained, well-lit and well organized. The treatment process in the treatment shed includes two oxidizing greensand filters in series to reduce iron levels; water is then pumped to a mixing and aeration tank for disinfection with sodium hypochlorite. The potable water is then pumped to four bladder tanks prior to introduction to the distribution system. A residual chlorine sample was taken and analyzed by Ed Watson, FDEP, in the treatment shed at a sample point prior to the distribution system. The sample showed 0.36 ppm residual chlorine. The inspection team then proceeded to the breakroom in the administration building to sample residual chlorine levels in the distribution system. John Broughton, Coronet, sampled and analyzed a breakroom tap water sample and found 0.80 ppm residual chlorine using a Hach Pocket Colorimeter. Ed Watson, sampled the tap water in the breakroom and found 1.69 ppm residual chlorine. The inspection team then broke for lunch at about 2:00 pm.
