**TECHNICAL MEMORANDUM  
BROWNFIELDS SUSTAINABILITY PILOT  
ALLEN-MORRISON SITE, LYNCHBURG, VIRGINIA**

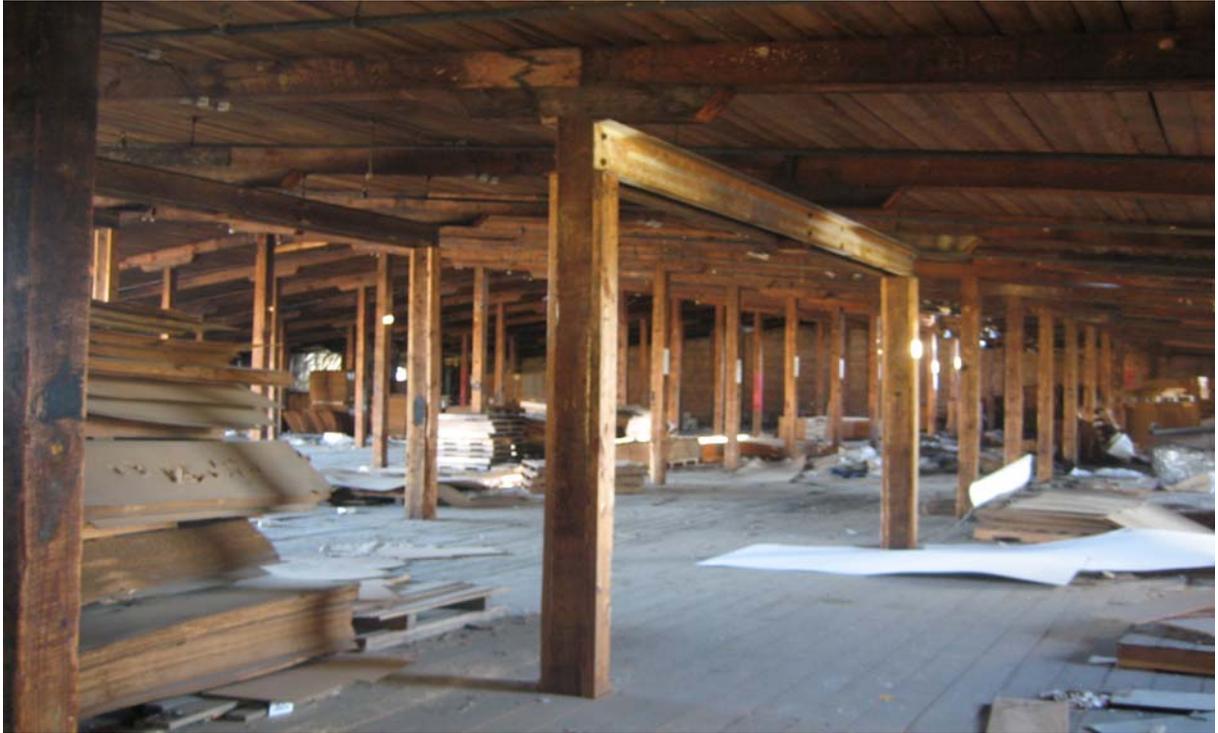
**Photograph No. 1:** Thornhill 7A (upstairs)—view of 6”x 6” timber column structure

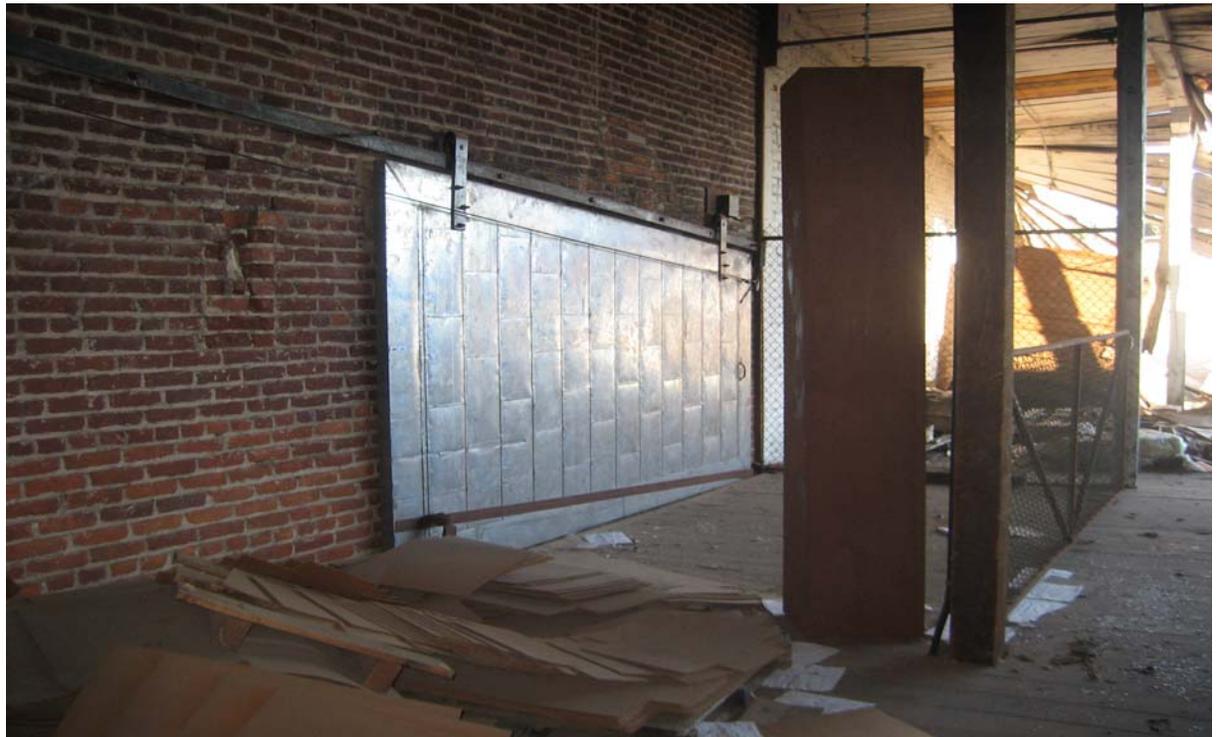
**Photograph No. 2:** Sliding door upstairs in Thornhill 7A

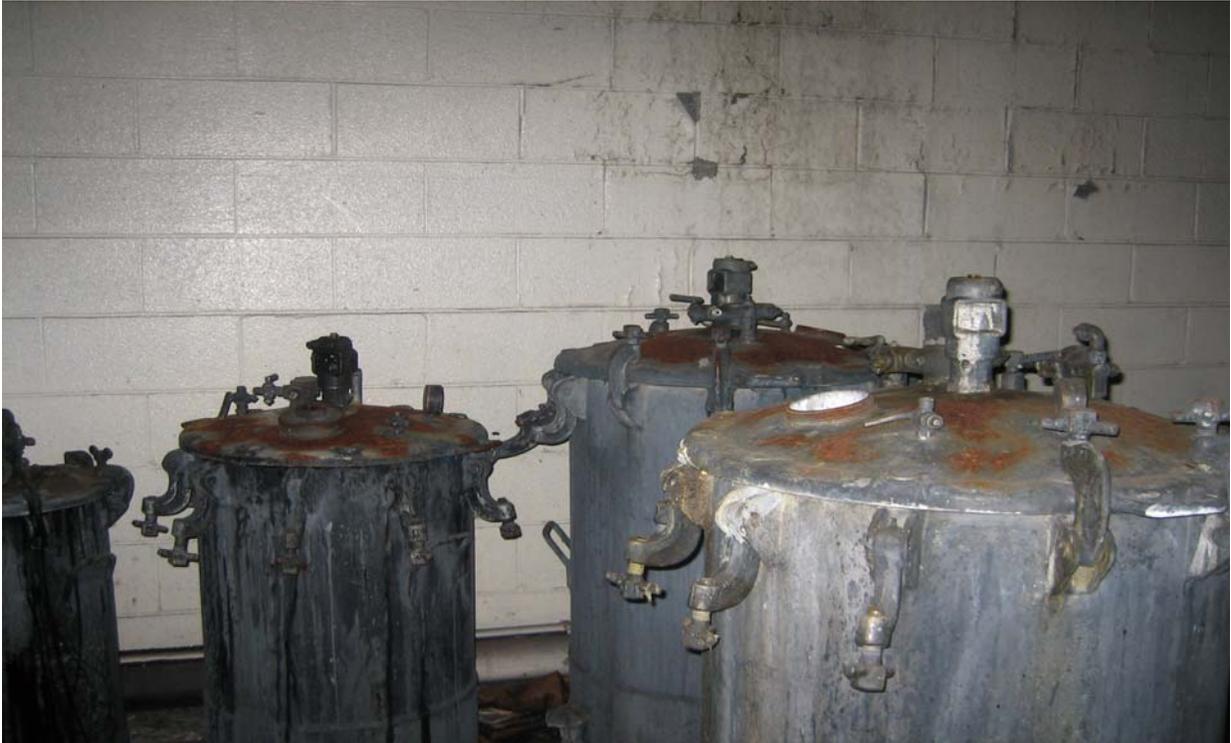
**Photograph No. 3:** Paint mixing canisters in Thornhill 7D

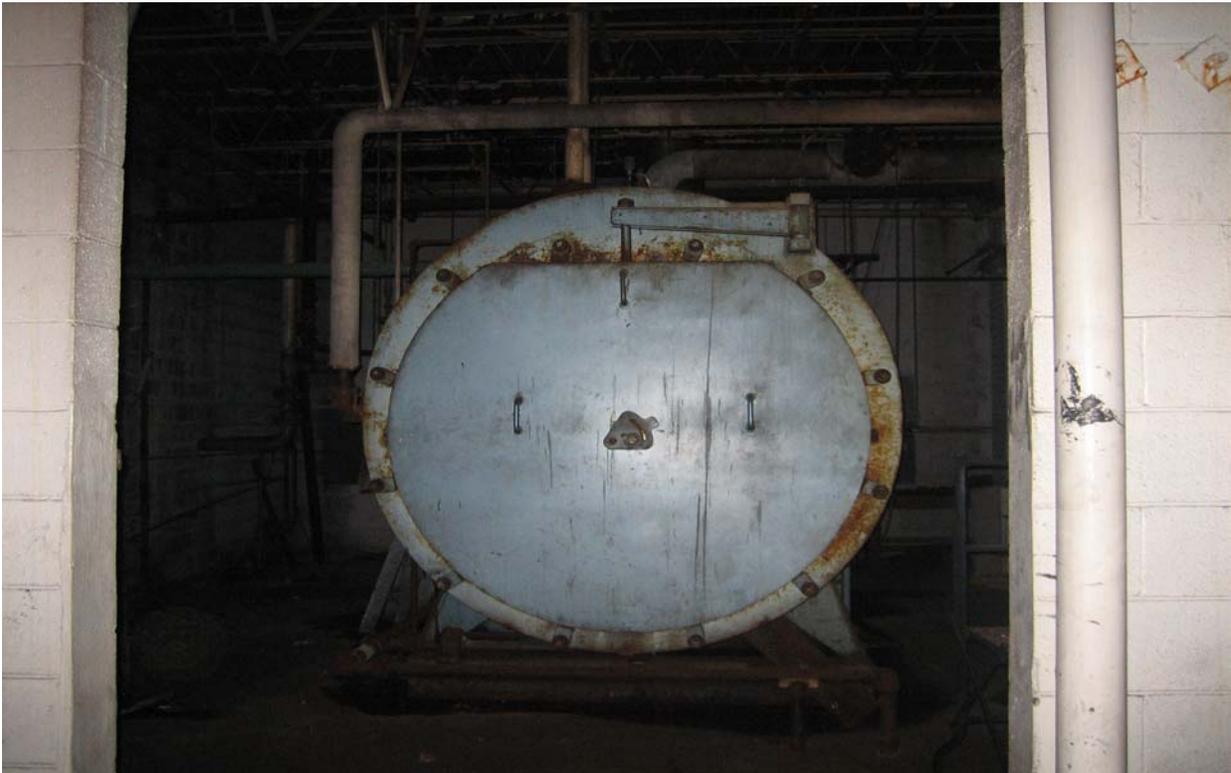
**Photograph No. 4:** Boiler tank in Thornhill 7D

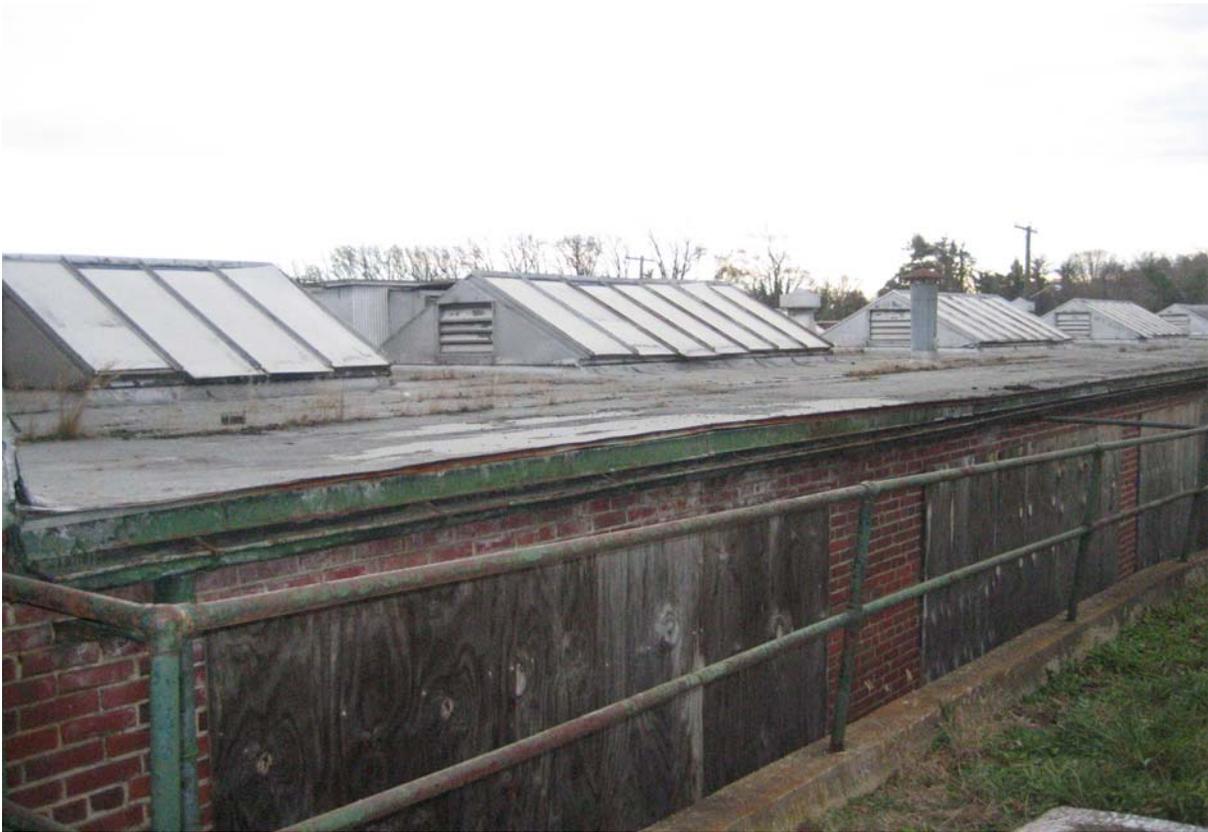
**Photograph No. 5:** Skylights on top of Allen-Morrison facility

- **Skylights:** About 12 approximately 8- by 12-ft, glass, peaked skylights are located on the roof of the Allen-Morrison facility (see Photograph No. 5). If these features can be carefully removed despite the roof damage in these buildings, they could be reused in the development to highlight the architectural and industrial heritage of the site, or possibly as part of greenhouse structures for *Lynchburg Grows*.

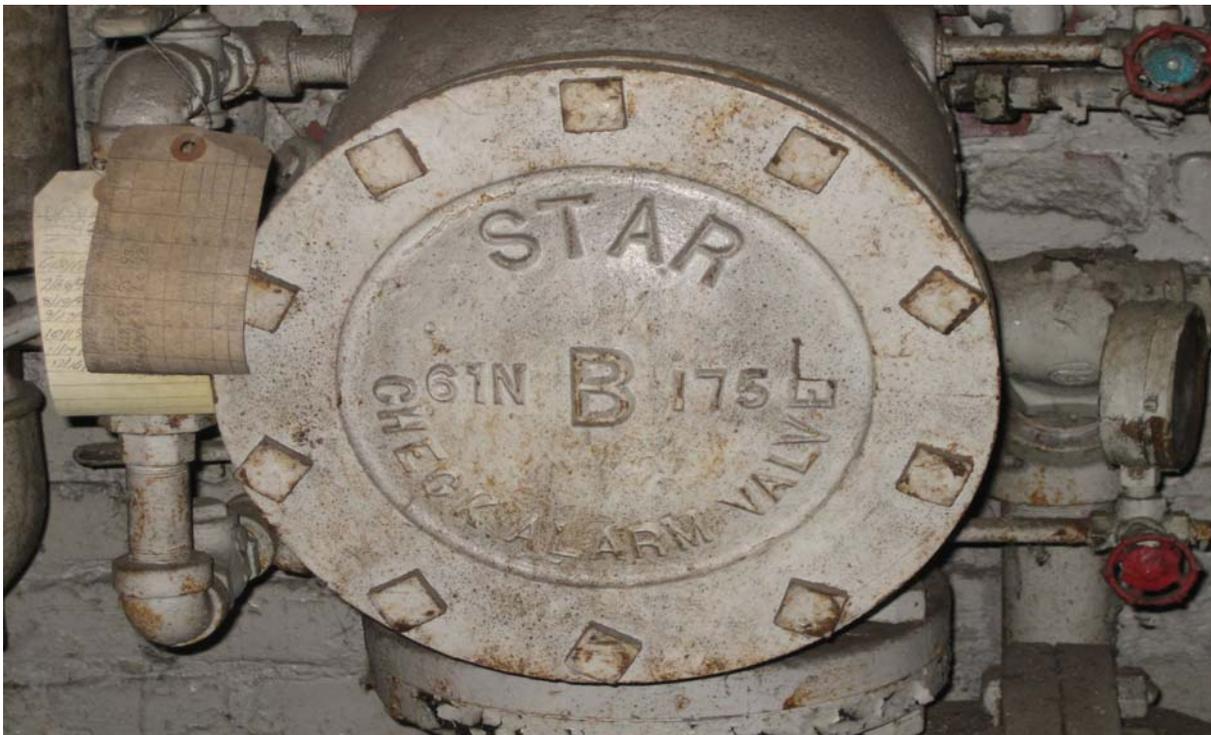
**Photograph No. 6:** Sprinkler system plating in Thornhill 7C

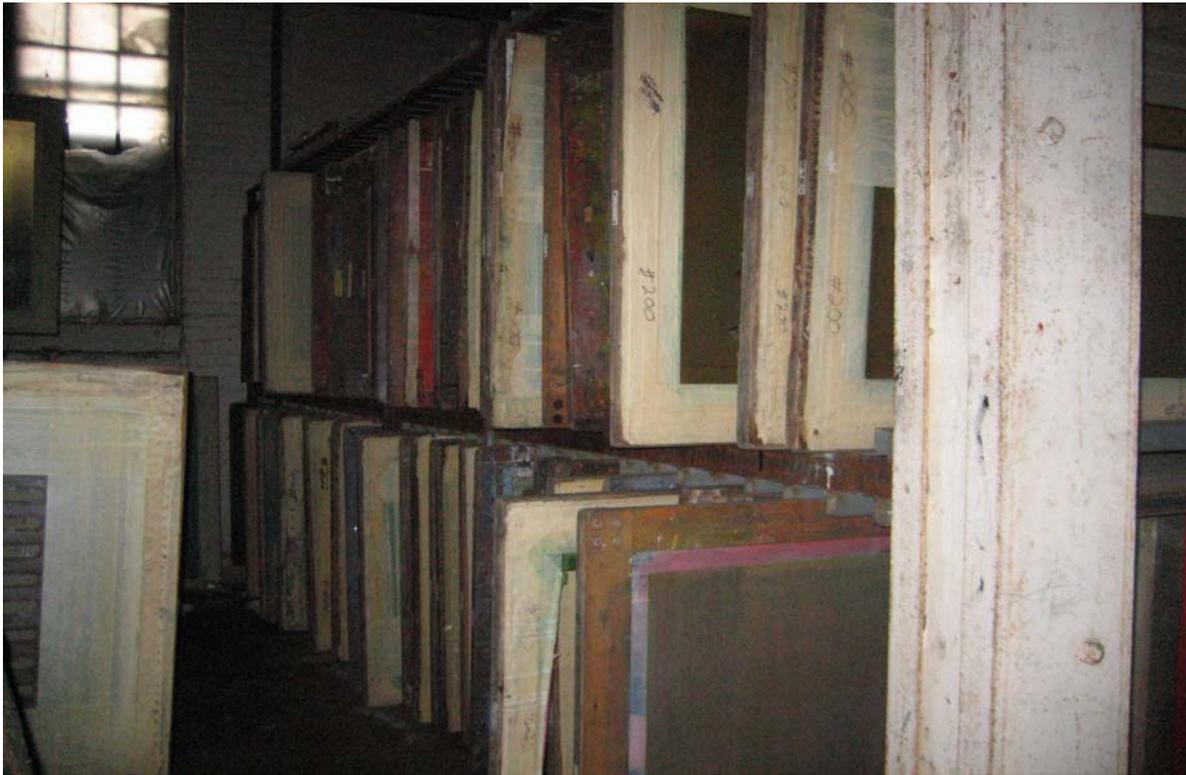
**Photograph No. 7:** Silk screens and frames in Thornhill 7D

and incorporated as artwork or other uses to highlight the industrial heritage of the site. The wooden frames could also be restored by local artists for their use. Insect- or water-damaged wooden frames that cannot be restored could be shredded for mulch.

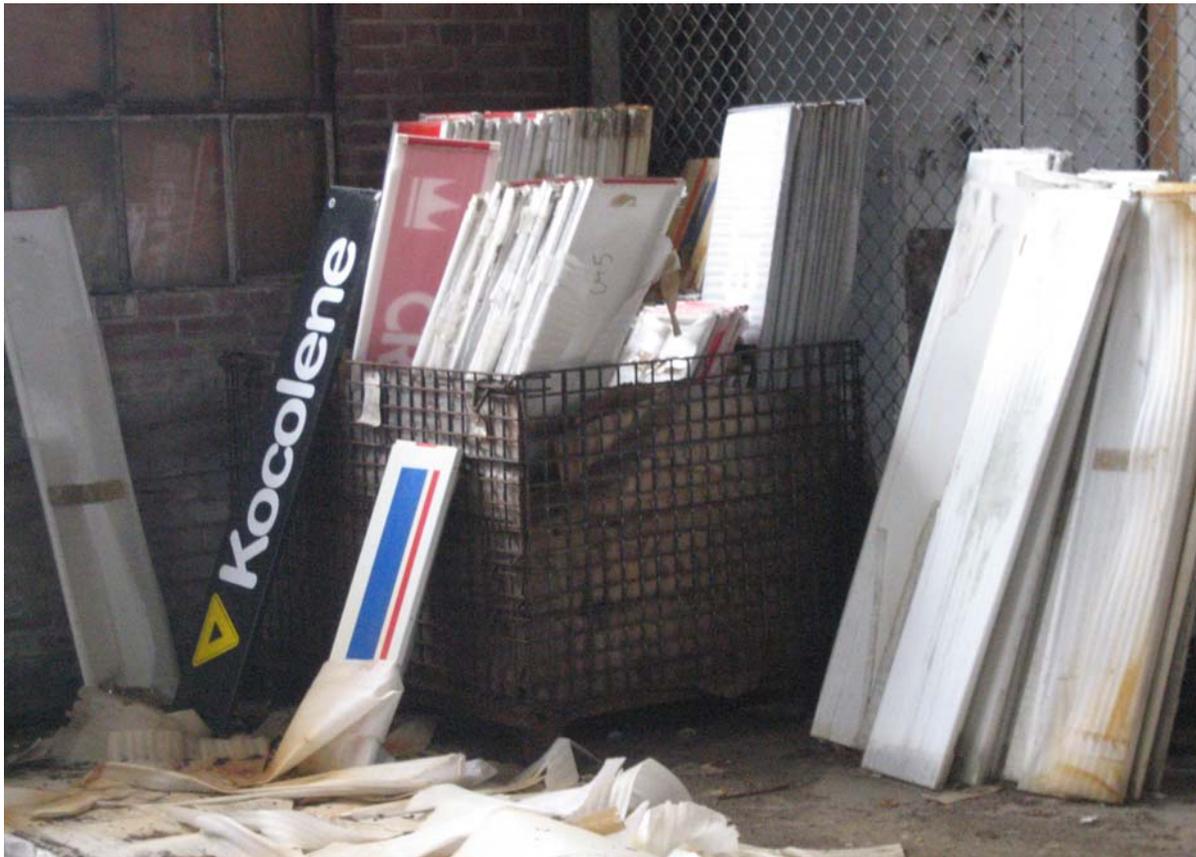
**Photograph No. 8:** Sheet metal signs in Allen-Morrison 1E

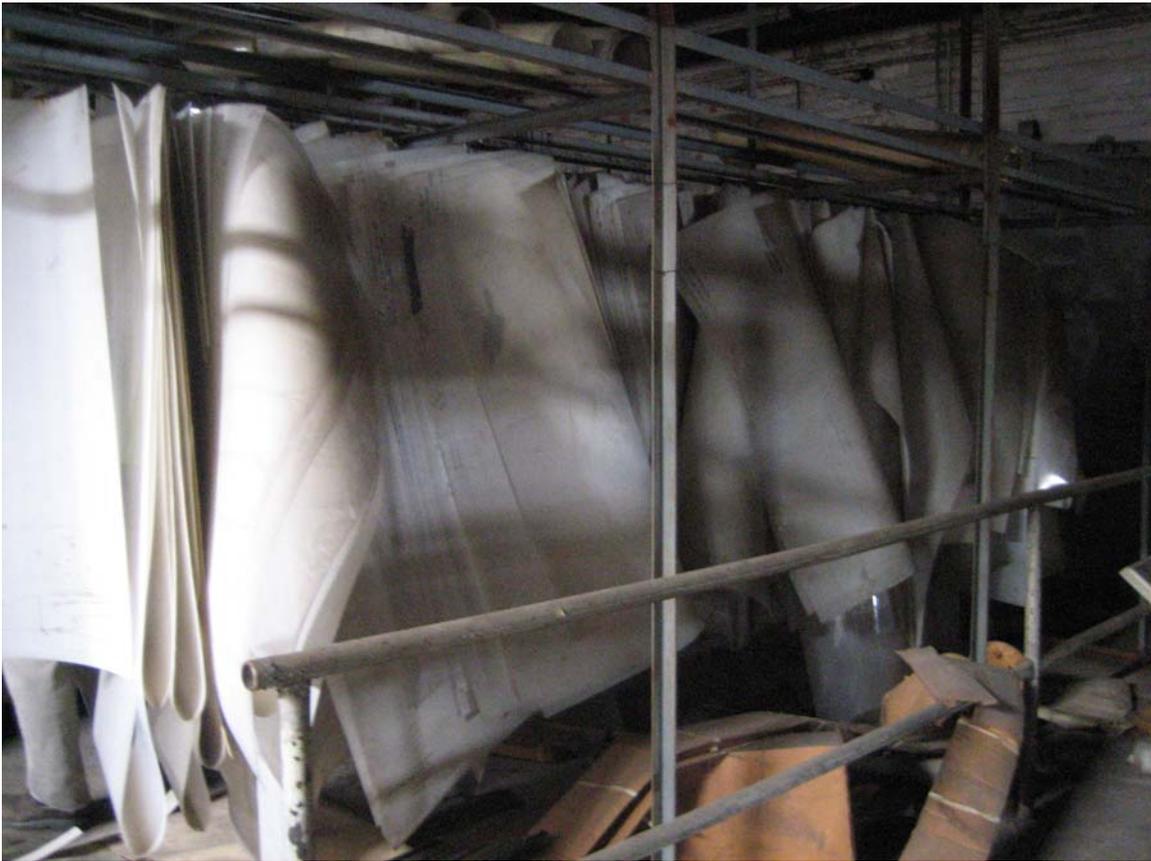
**Photograph No. 9:** Sign design drawings on rack in Allen-Morrison 1C

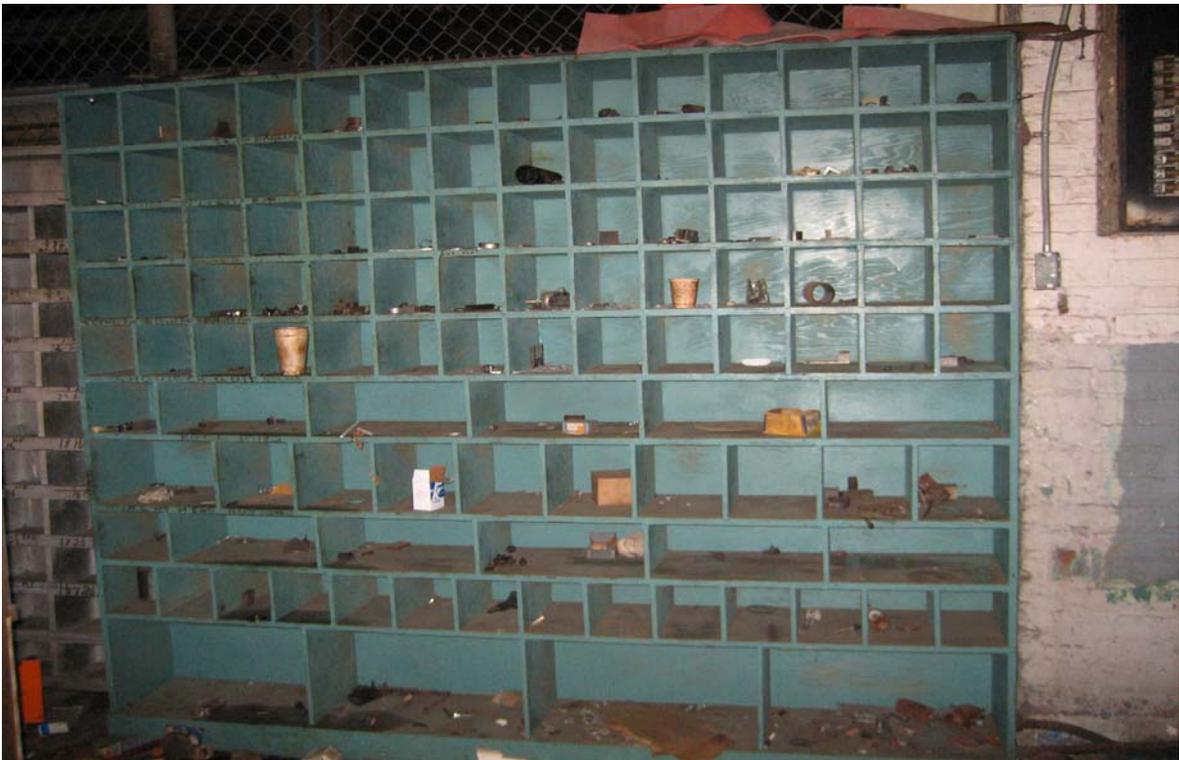
**Photograph No. 10:** Shelving unit in Allen-Morrison 1C

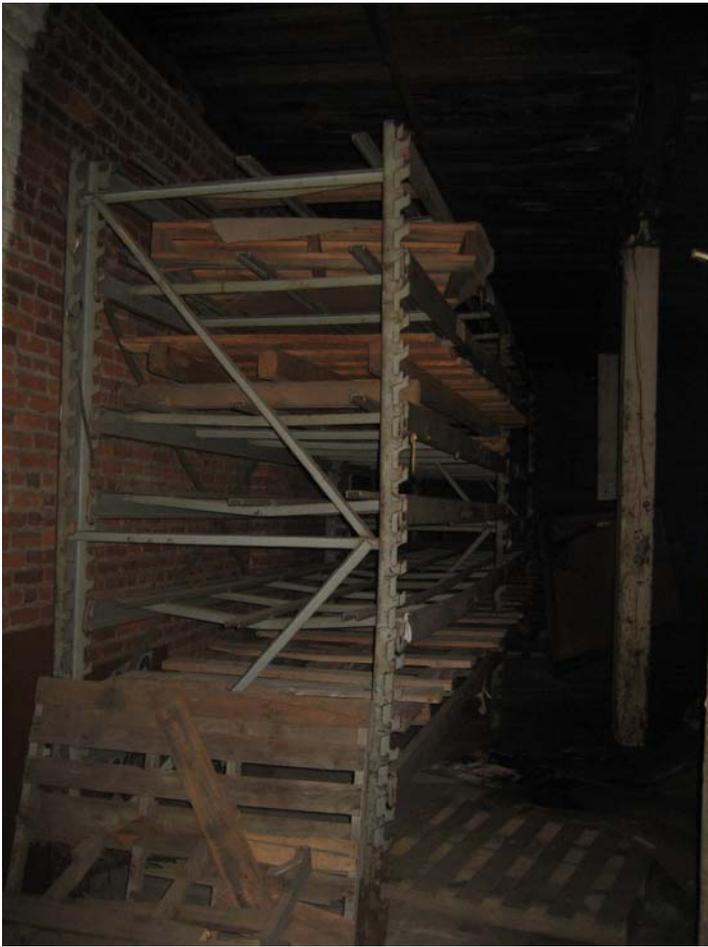
**Photograph No. 11:** Steel shelving unit in Thornhill 7A

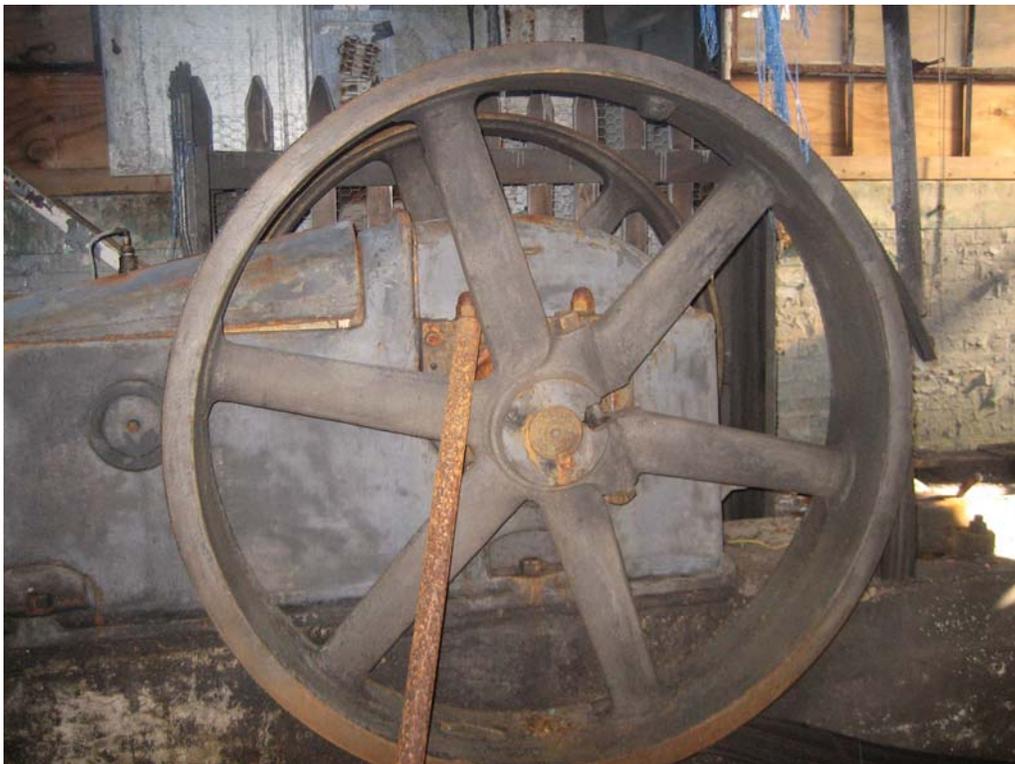
**Photograph No. 12:** Wheeled equipment in Allen-Morrison 1A

- **Wheeled Hoist System and Equipment:** An interesting wheeled hoist system and piece of wheeled equipment were located on the second floor of Thornhill Building 7A and in Allen-Morrison Building 1A, respectively (see Photograph No. 12). This hoist system could be repaired for reuse, or this system and the wheeled equipment refurbished as vintage pieces of equipment for display to highlight the industrial heritage of the site.
