**STREAMLINED**  
**REMEDIATION SYSTEM EVALUATION (RSE-LITE)**  
**BENFIELD INDUSTRIES SUPERFUND SITE**  
**WAYNESVILLE, NORTH CAROLINA**

Report of the Streamlined Remediation System Evaluation  
Conference Call Conducted August 21, 2007

Final Report  
September 2007

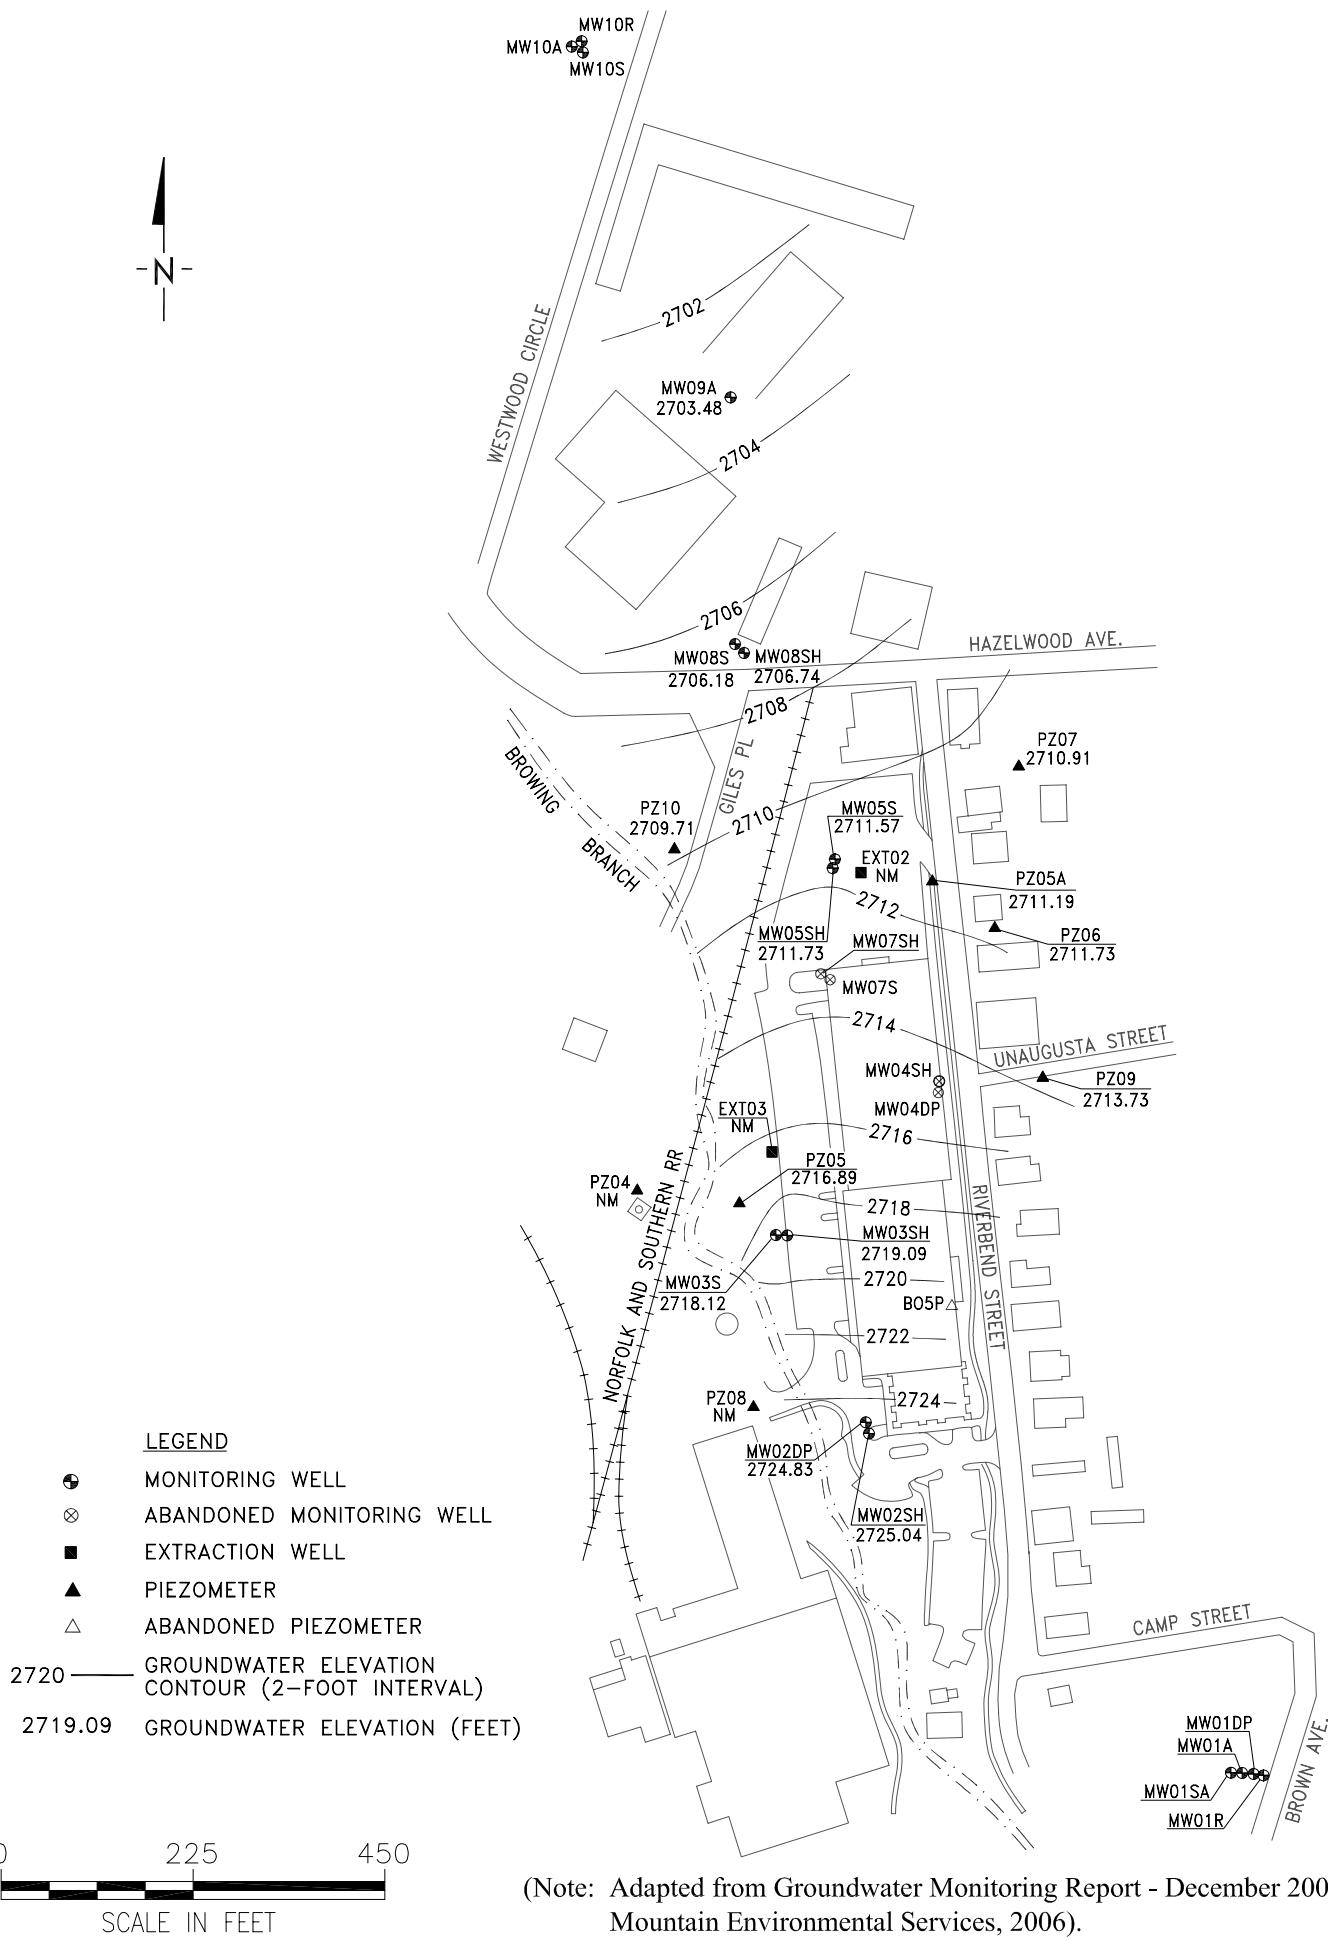
**FIGURE 1-2. SITE LAYOUT SHOWING WELL LOCATIONS AND GROUNDWATER ELEVATIONS.**

- An area in the west-central portion of the site near a former packaging building and former creosote storage tanks (near MW03SH on **Figure 1-2**).
- An area in the northern portion of the site near a former warehouse (near MW05SH).

For the last site-wide sampling event in December 2006, the only well with concentrations exceeding cleanup criteria was well MW03SH. At that well, the concentrations of five PAHs and 1,4-dichlorobenzene exceeded remediation criteria. For several COCs, the cleanup level is below the reported analytical detection limit.

The two on-site extraction wells – EXT02 and EXT03 – are shown in **Figure 1-2**. These 8-inch diameter stainless steel wells are 36 and 31.5 feet deep, respectively, with 10-foot screens in the saprolite. Based on initial pumping tests, it was determined that a maximum withdrawal rate of 4 gpm could be sustained at EXT02. The maximum withdrawal rate at EXT03 was determined to be 12 gpm. Dedicated 0.5 horsepower submersible pumps were installed in each well – a 5 gpm pump in EXT02 and a 10 gpm pump in EXT03.
