EPA 542-R-12-004

**Optimization Review**  
**Fairfield Coal Gasification Plant Superfund Site**  
**Fairfield, Iowa**

Report of the Optimization Review  
Site Visit Conducted at the Fairfield Coal Gasification Plant Superfund Site on  
February 14, 2012

Final Report  
July 30, 2012

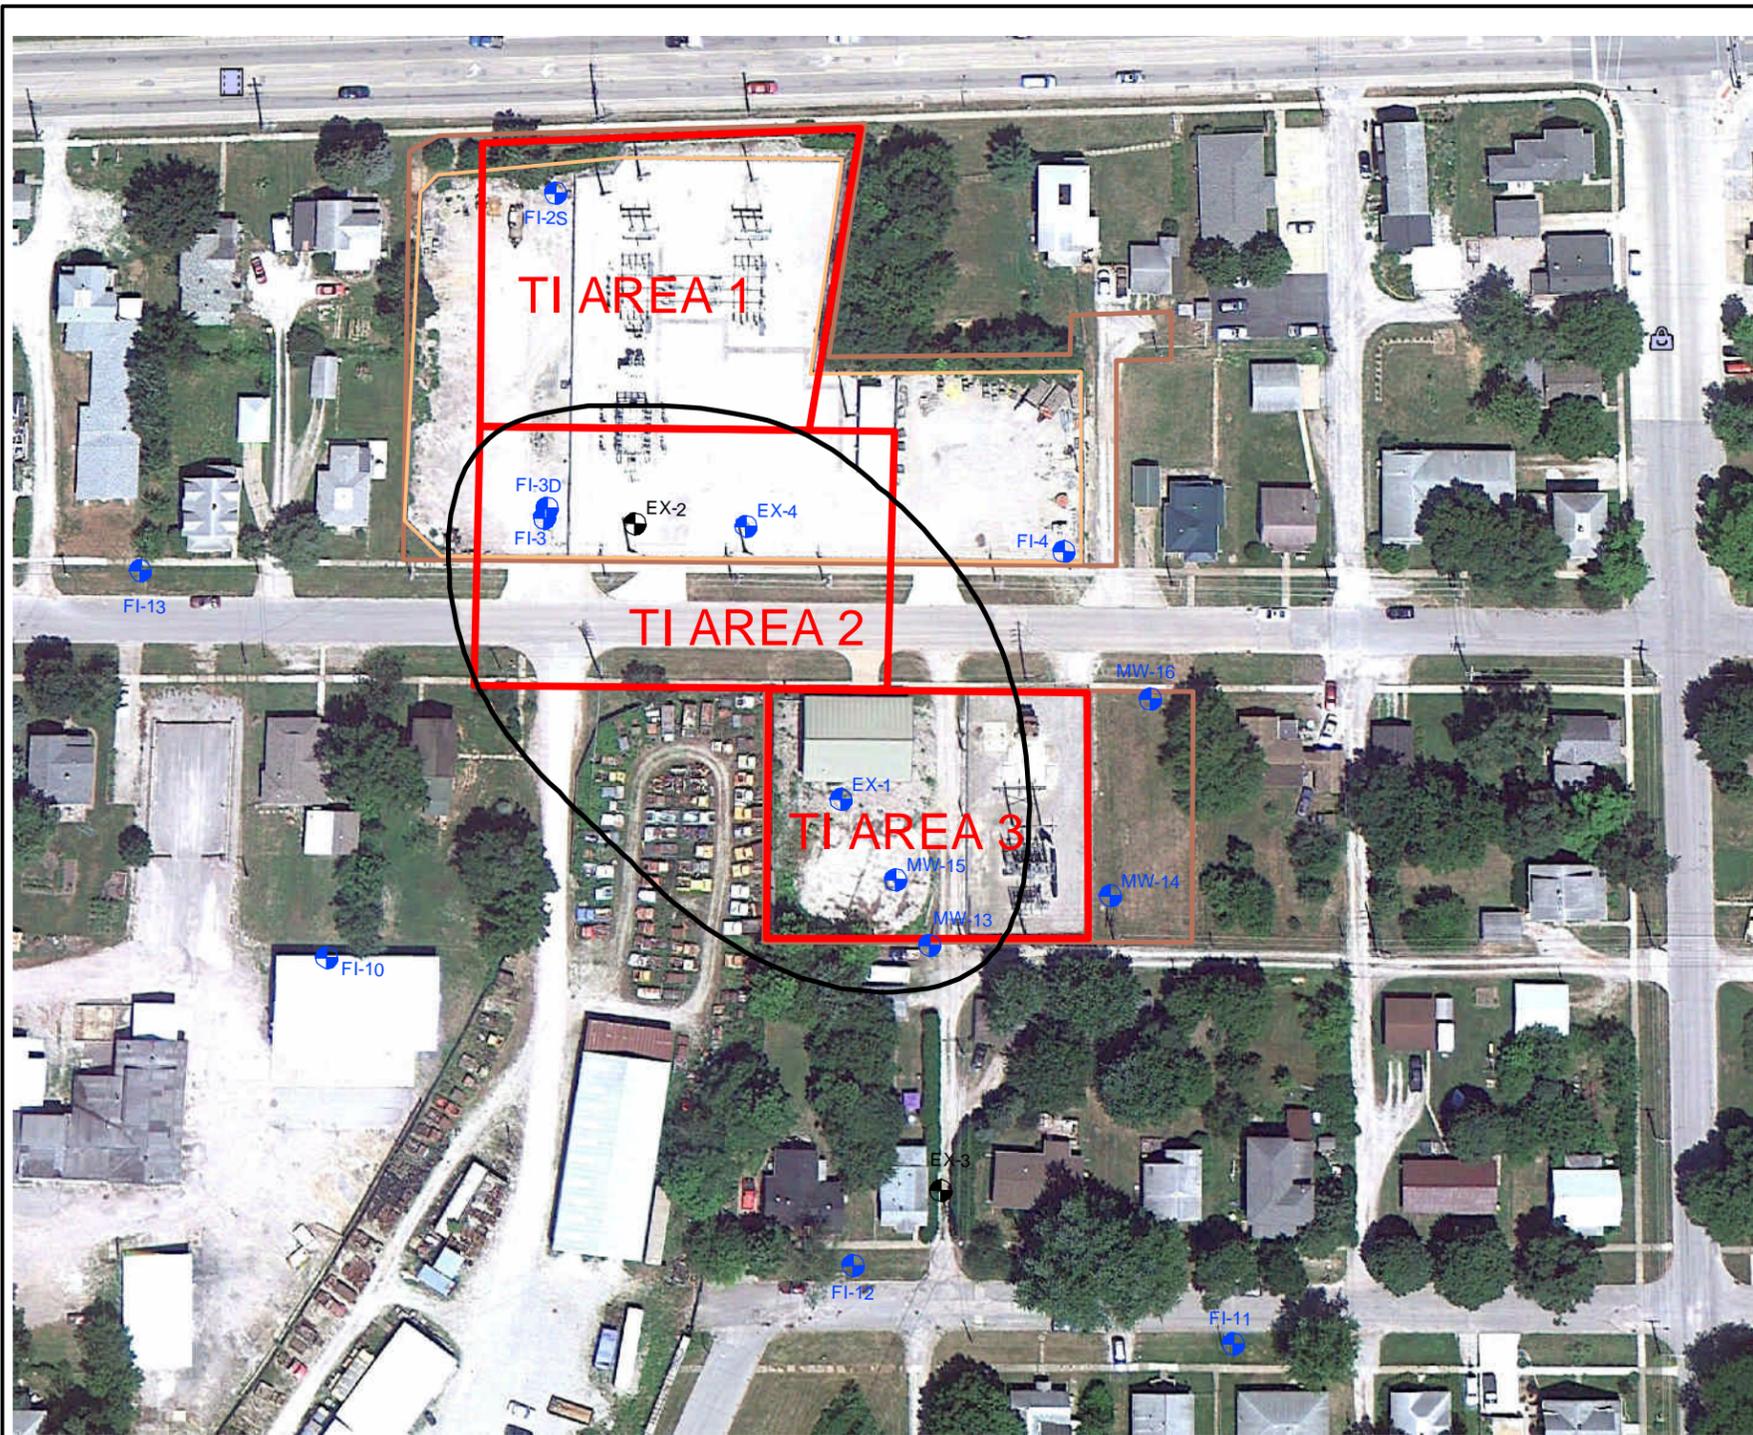
**FIGURE 1**  
**General Site Map**

Given the CSM characteristics, Black and Veatch prepared a TI Evaluation Report that suggests that no additional remediation of the site is warranted. Black and Veatch divided the site into three areas (Figure 1) based on different conditions where cleanup is impracticable and prepared the following summaries for each area:

The optimization team recommends adding an aerial photo to the existing figures to help orientate the reader to the site and providing trend charts for key monitoring wells instead of the data tables on the maps. The cost for implementing this recommendation is negligible.

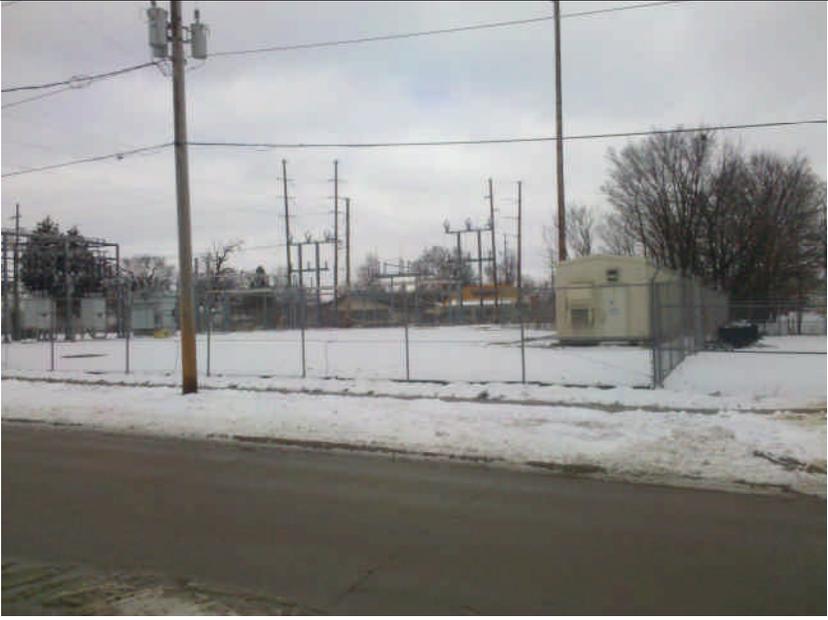
<b>Photo: 1</b>

<b>Direction:</b> Northwest	
<b>Description:</b> Electrical substation to the North Northwest of the groundwater treatment plant. Also includes TI Areas 1 and 2.	
<b>Date:</b> February 14, 2012

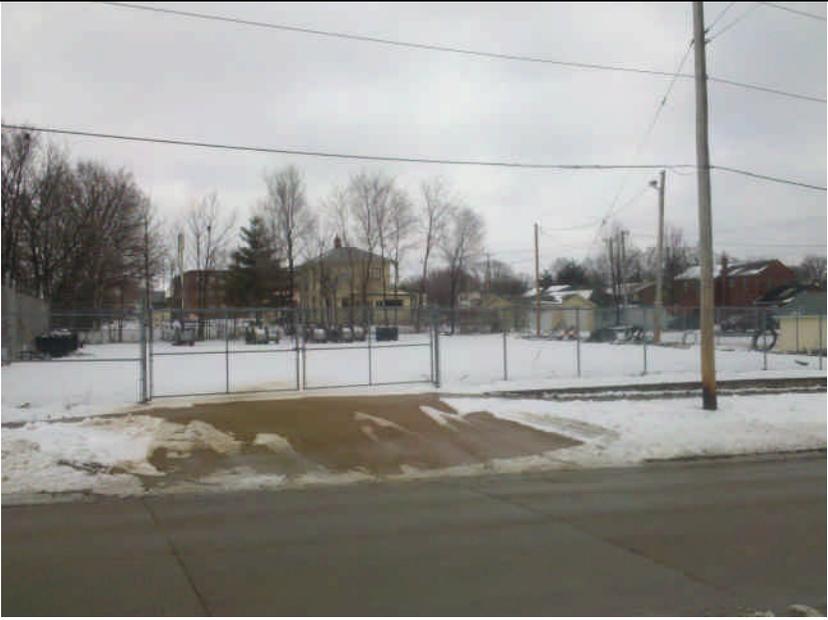
<b>Photo: 2</b>

<b>Direction:</b> North	
<b>Description:</b> Fenced area, cable storage to the north of the groundwater treatment plant	
<b>Date:</b> February 14, 2012

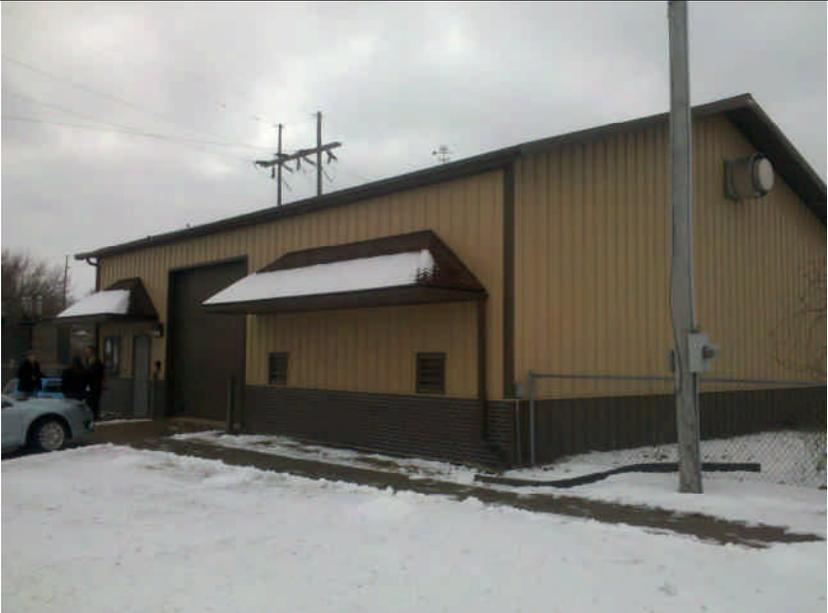
<b>Photo: 3</b>

<b>Direction:</b> Southeast	
<b>Description:</b> View of the groundwater treatment plant from Washington Street	
<b>Date:</b> February 14, 2012

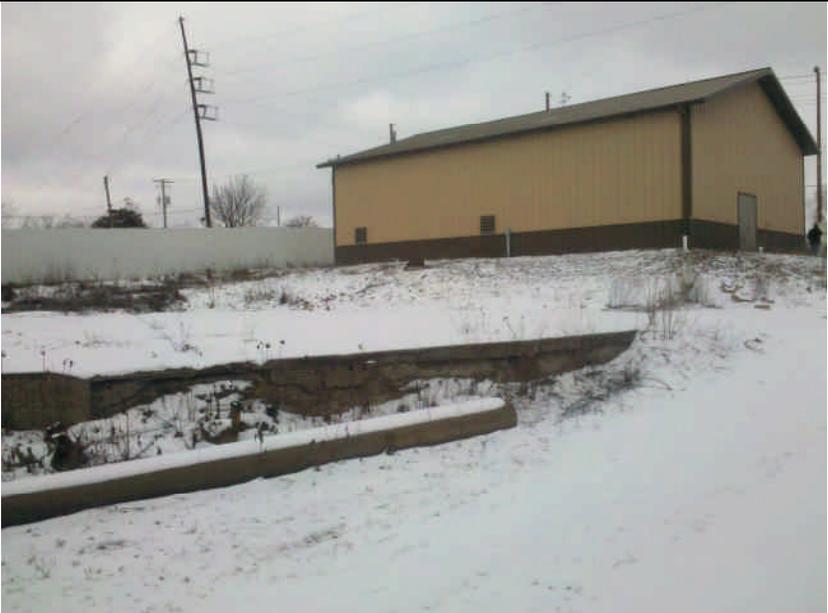
<b>Photo: 4</b>

<b>Direction:</b> Northwest	
<b>Description:</b> View of the groundwater treatment plant from Alley, includes gas holder base in foreground and includes Western portion of TI Area 3. EX-1 is located near the building along the southern berm.	
<b>Date:</b> February 14, 2012

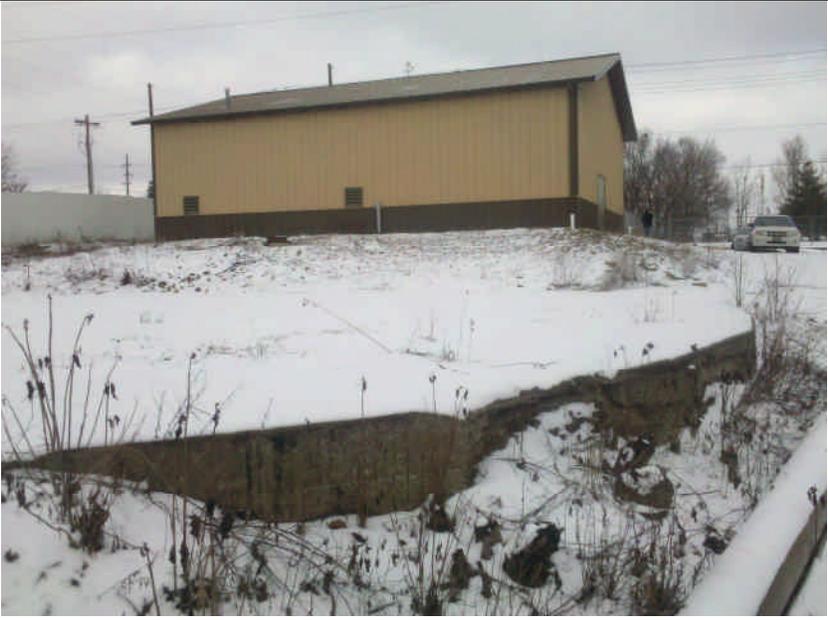
<b>Photo: 5</b>

<b>Direction:</b> North	
<b>Description:</b> View of the groundwater treatment plant from Alley, includes gas holder base in foreground and includes Western portion of TI Area 3. EX-1 is located near the building along the southern berm.	
<b>Date:</b> February 14, 2012

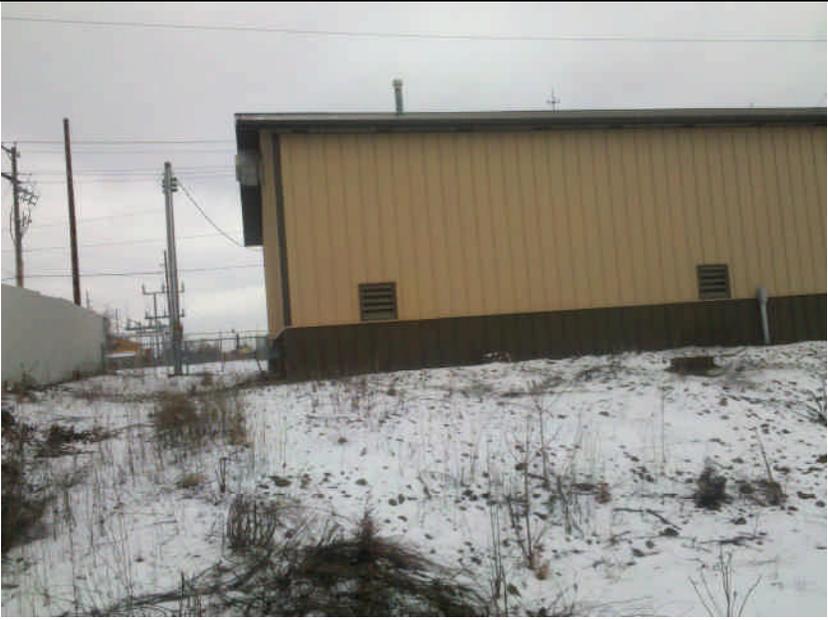
<b>Photo: 6</b>

<b>Direction:</b> North	
<b>Description:</b> Western side of the groundwater treatment plant, EW-1 is near the building on the right side of the photo.	
<b>Date:</b> February 14, 2012

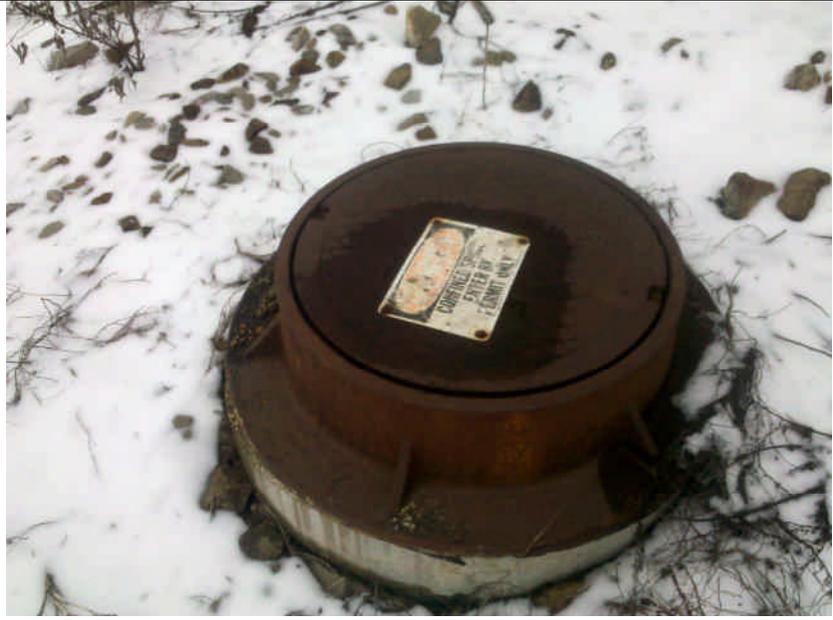
<b>Photo: 7</b>

Extraction well EX-1 was designed to capture 20 gpm of groundwater. According to the TI Evaluation Report, a pump test completed after the well was installed showed that the maximum yield of the interbedded unit was only 0.2 gpm with 15 feet of drawdown. Field observations and the results of the pump test indicate that the sand lenses present in the interbedded unit are discontinuous across the site. Wells in this formation have low yields and a minimal radius of influence was observed from the pumped well during the pump test due to the relatively low permeability across the site. In addition, the residual coal tar present below the groundwater table may restrict groundwater flow through the formation and diminished extraction well performance and limited plume capture.

<b>Direction:</b> NA	
<b>Description:</b> EX-1	
<b>Date:</b> February 14, 2012

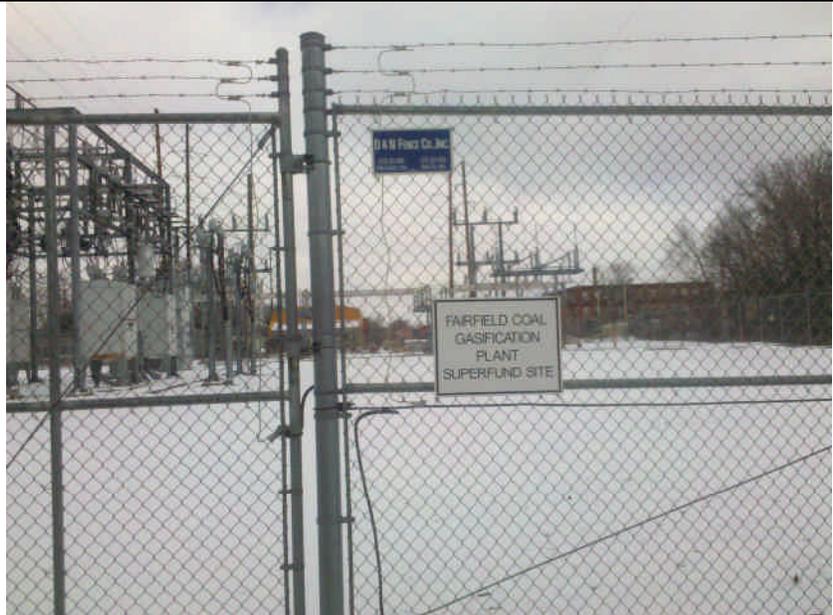
<b>Photo: 8</b>

<b>Direction:</b> North	
<b>Description:</b> Electrical substation, TI Areas 1 and 2. Former Rail line ran through this area, currently serves as a utility corridor.	
<b>Date:</b> February 14, 2012

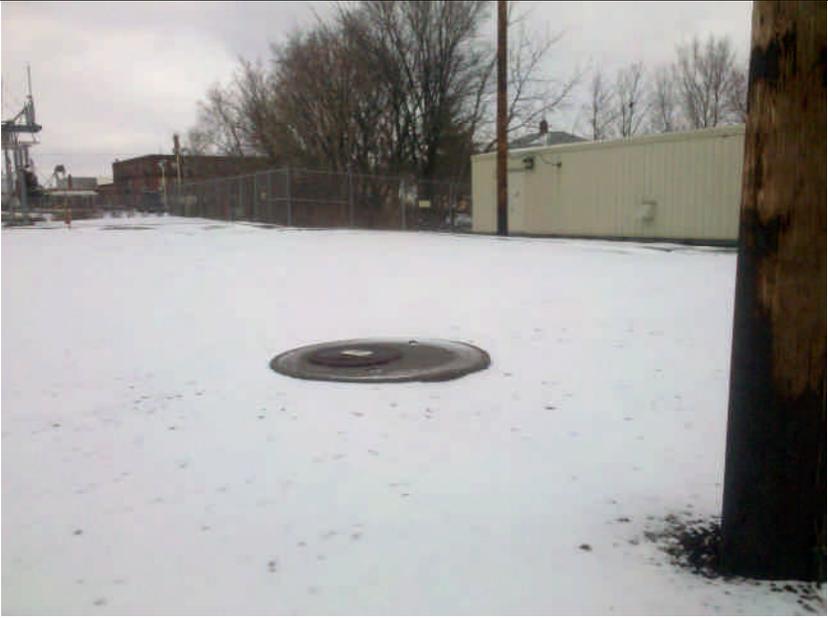
<b>Photo: 9</b>

The amounts of DNAPL historically detected have been highly variable and generally not measurable. If present in a well, the DNAPL has generally been observed as intermittent staining along the measurement device. A sheen and strong tar odor have been observed on groundwater removed from well MW-15, located south of Washington Avenue. DNAPL appears in lower portions of the base of the interbedded unit near extraction wells EX-3 and EX-4. The maximum thickness of DNAPL impacts were observed

during the installation of extraction well EX-4 when coal tar was observed in various intervals from 25 to 44.5 feet bgs.

<b>Direction:</b> Northeast	
<b>Description:</b> EX-4 in the eastern central portion of TI Area 2.	
<b>Date:</b> February 14, 2012

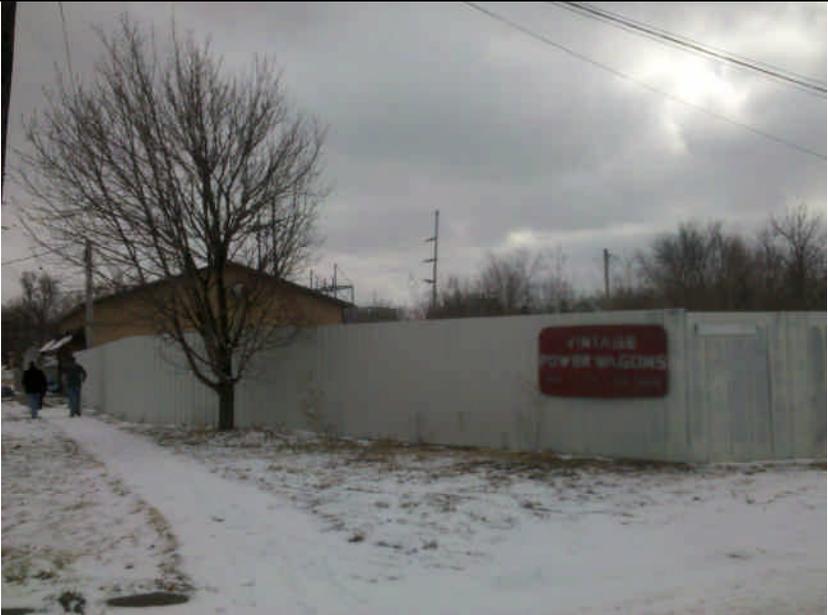
<b>Photo: 10</b>

<b>Direction:</b> Southeast	
<b>Description:</b> Adjacent property to the west is used as salvage yard for vintage Dodge power wagons, parts, service and storage.	
<b>Date:</b> February 14, 2012

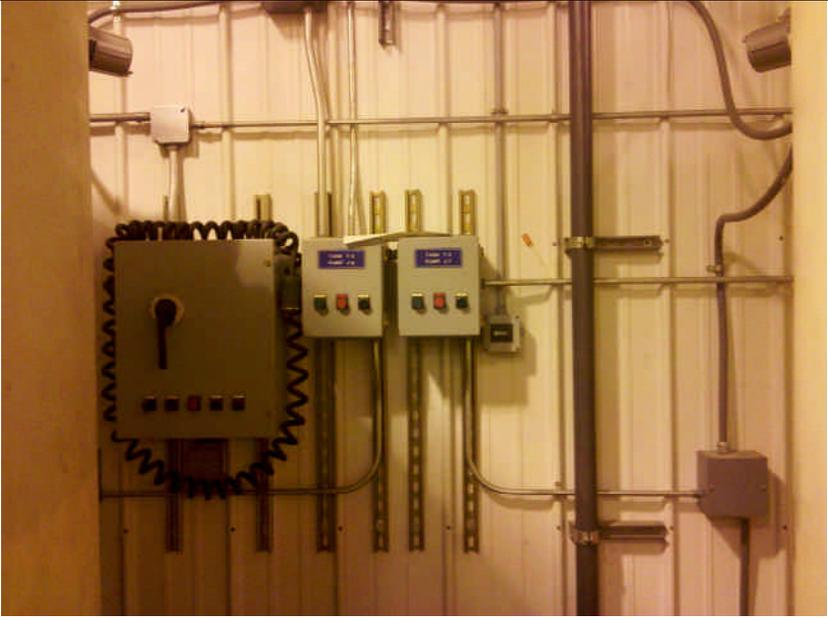
<b>Photo: 11</b>

<b>Direction:</b> NA	
<b>Description:</b> Extraction well electric starters and general controls	
<b>Date:</b> February 14, 2012

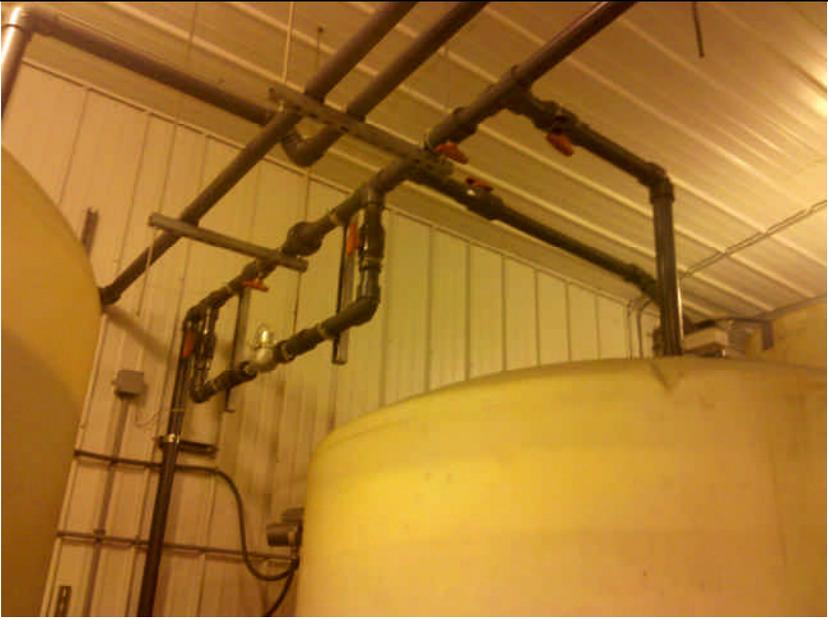
<b>Photo: 12</b>

<b>Direction:</b> East	
<b>Description:</b> Typical piping	
<b>Date:</b> February 14, 2012

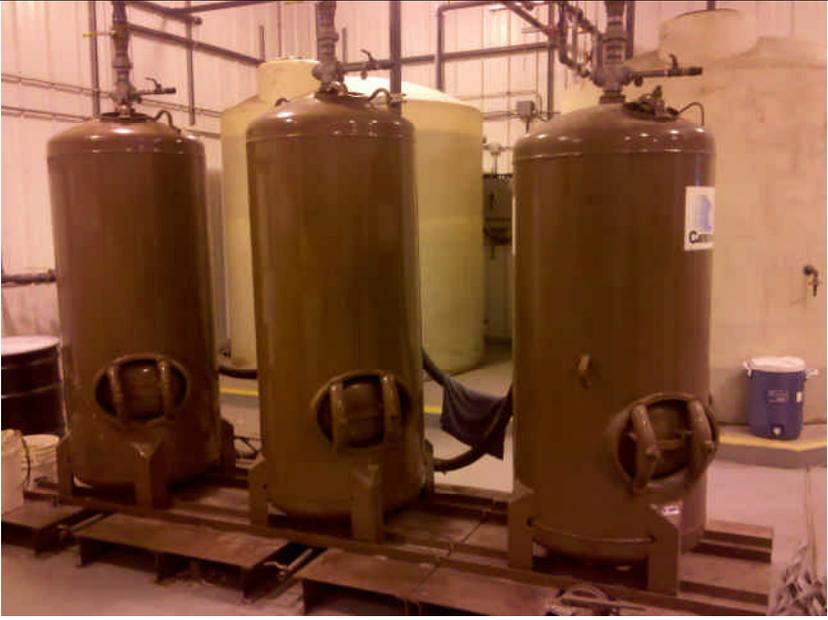
<b>Photo: 13</b>

<b>Direction: NA</b>	
<b>Description:</b> Carbon vessels	
<b>Date:</b> February 14, 2012

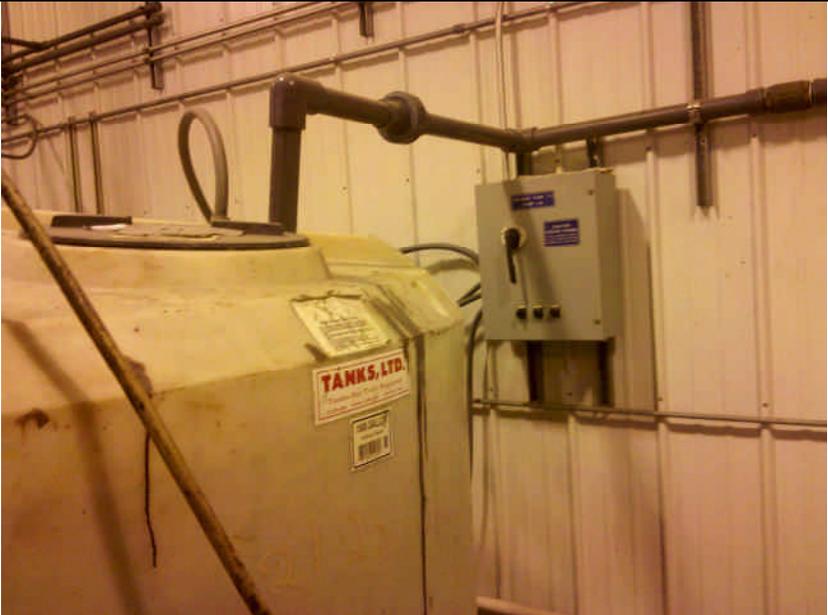
<b>Photo: 14</b>

<b>Direction: East</b>	
<b>Description:</b> Equalization tank used to collect DNAPL	
<b>Date:</b> February 14, 2012

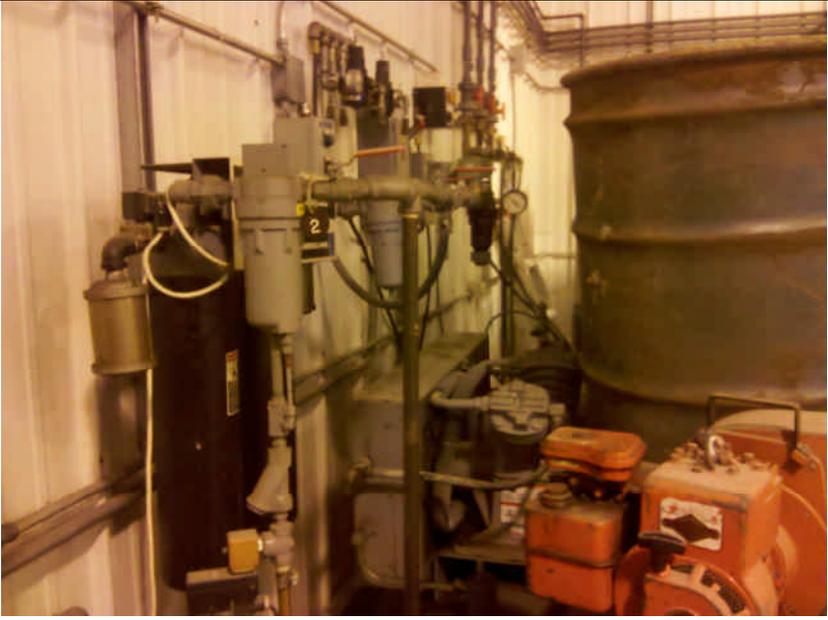
<b>Photo: 15</b>

<b>Direction:</b> NA	
<b>Description:</b> System compressor and associated filter and controls	
<b>Date:</b> February 14, 2012

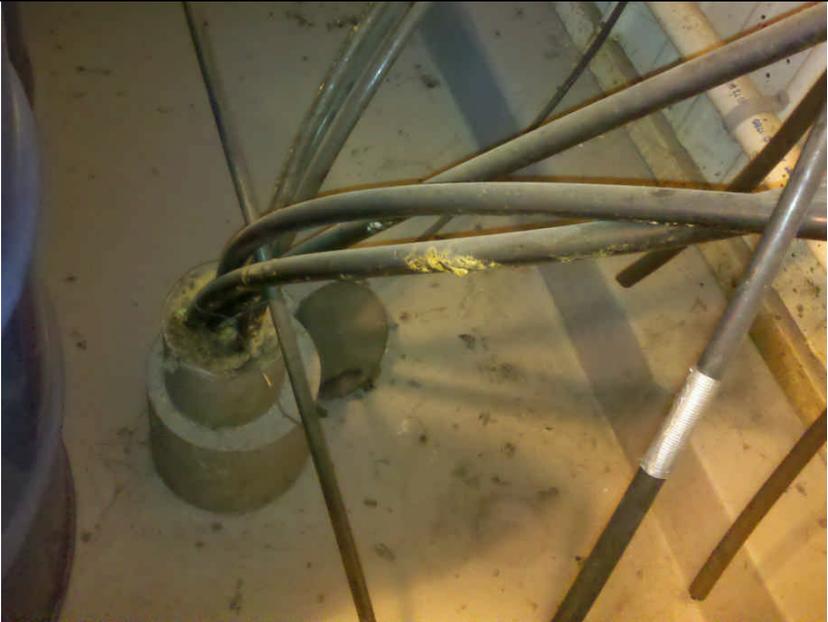
<b>Photo: 16</b>

<b>Direction:</b> East	
<b>Description:</b> Compressed air lines to extraction wells and return groundwater extraction lines from extraction wells.	
<b>Date:</b> February 14, 2012

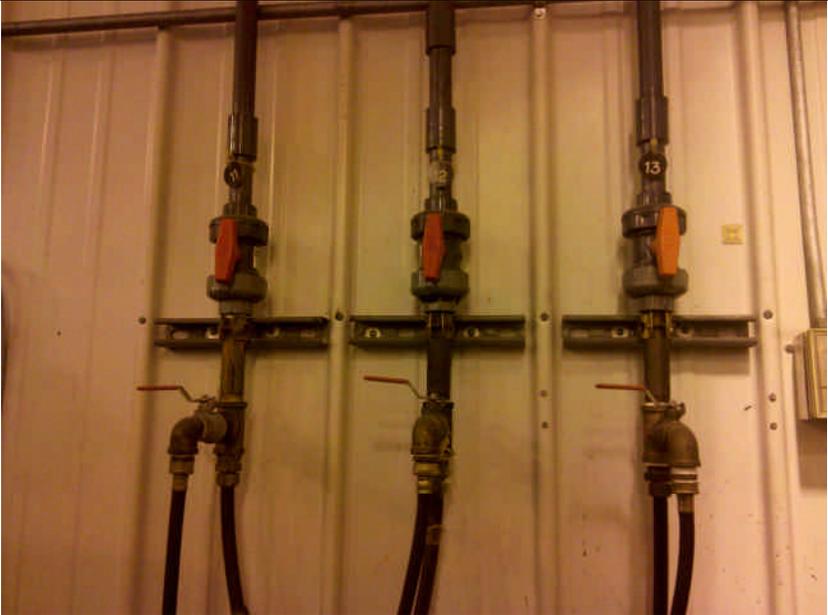
<b>Photo: 17</b>

<b>Direction: NA</b>	
<b>Description:</b> Main extraction well lines	
<b>Date:</b> February 14, 2012

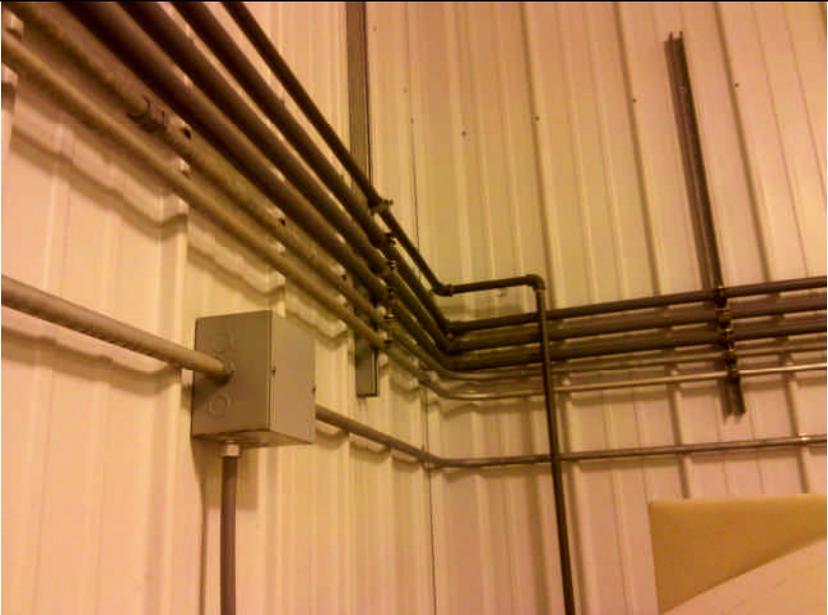
<b>Photo: 18</b>

<b>Direction: East</b>	
<b>Description:</b> Additional conveyance lines	
<b>Date:</b> February 14, 2012

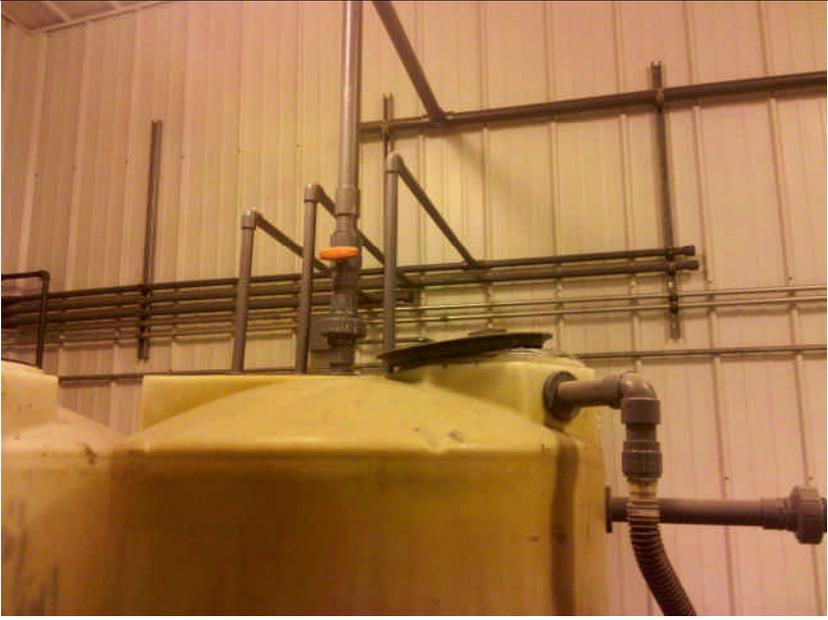
<b>Photo: 19</b>

<b>Direction: NA</b>	
<b>Description:</b> Main pre-carbon equalization tanks	
<b>Date:</b> February 14, 2012

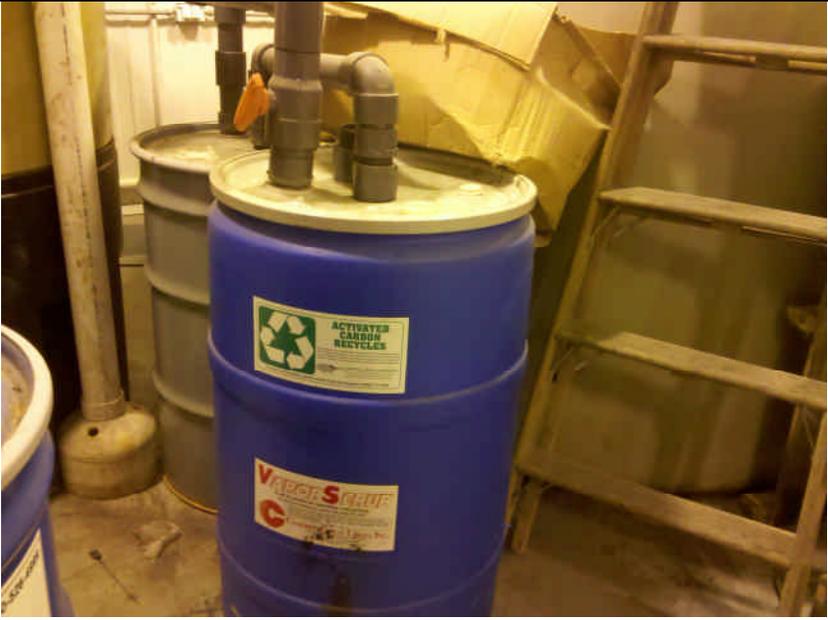
<b>Photo: 20</b>

<b>Direction: East</b>	
<b>Description:</b> Vapor phase carbon connected to pre-water treatment equalization tanks	
<b>Date:</b> February 14, 2012

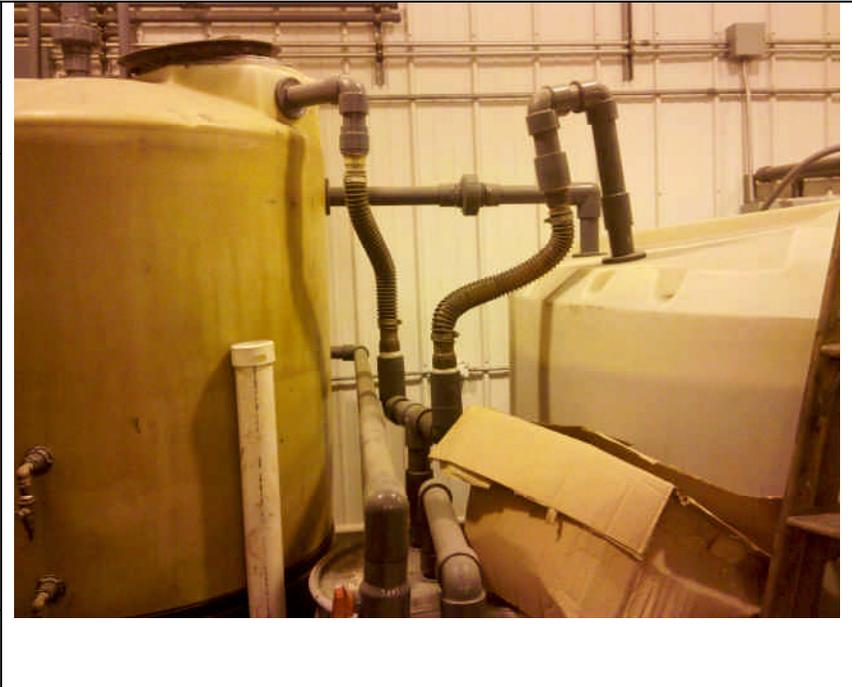
<b>Photo: 21</b>

<b>Direction:</b> NA	
<b>Description:</b> Equalization tanks with vapor phase carbon connected at the bottom of the photo.	
<b>Date:</b> February 14, 2012

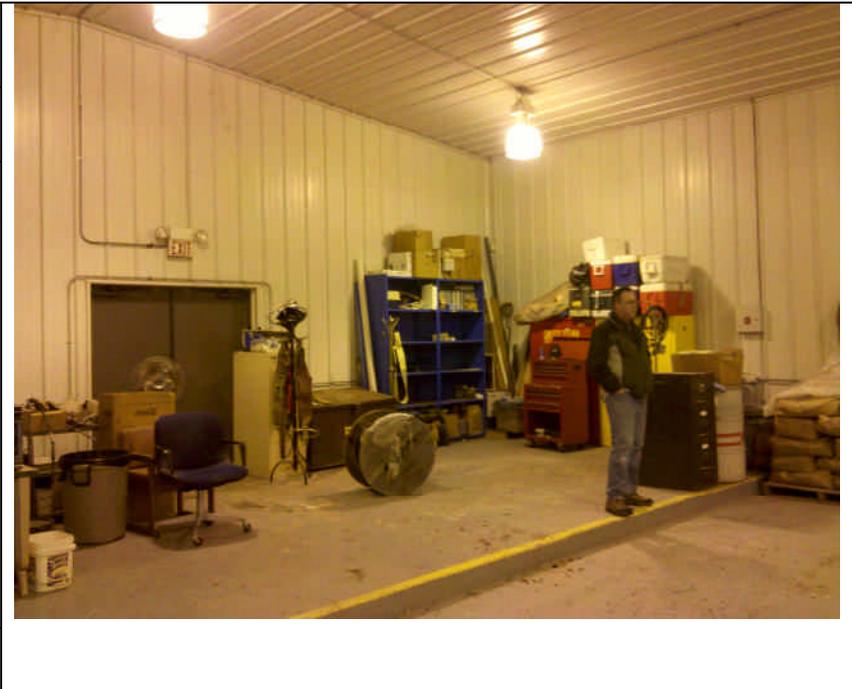
<b>Photo: 22</b>

<b>Direction:</b> East	
<b>Description:</b> Main storage and service area northwest corner of the building.	
<b>Date:</b> February 14, 2012
