# **Report of Structural Geologic Investigation**

# **Red & Bonita Mine**

## San Juan County County, Colorado

August, 2007

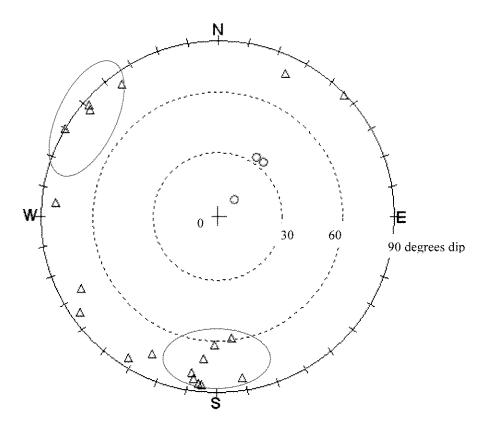
Figure 3. Pole plot of surface planar discontinuities measured around the Red & Bonita Workings. Triangles indicate poles of minor joints; circles indicate poles of flow laminations in andesite rock. The plot shows a cluster of poles to the south and a weaker set in the northwest sector, indicating two trends of anisotropy in the surface bedrock.

The southern pole cluster represents a set of joints trending roughly east-west, with dips of 60 to 89 degrees to the north. The northwest pole cluster represents joints striking roughly northeastsouthwest, dipping steeply southeast. These orientations are similar to the dominant northeastsouthwest anisotropy noted in the Simon Hydrosearch report prepared for the Sunnyside Mine (Stock, et. al, 1992,1993). They reported permeability greater in a northeast-southwest direction due to the dominant fracture orientation within this section of the Eureka Graben. The structural discontinuities measured in this study tend to agree with the direction of structural anisotropy as shown on published geologic maps and reports for this area near the Eureka Graben. Flow structure (crude bedding) in the andesite strikes south-east and dips gently southwest.

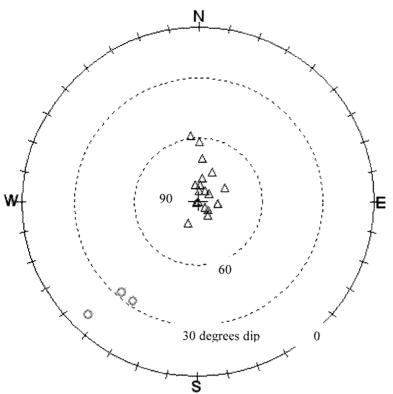
Figure 4. Dip vector plot for planar discontinuities measured on surface around the Red & Bonita workings. Triangles indicate dip of minor joints; circles indicate dips of flow laminations in andesite rock. Most joints are steeply dipping, while flow structure has shallow dips.

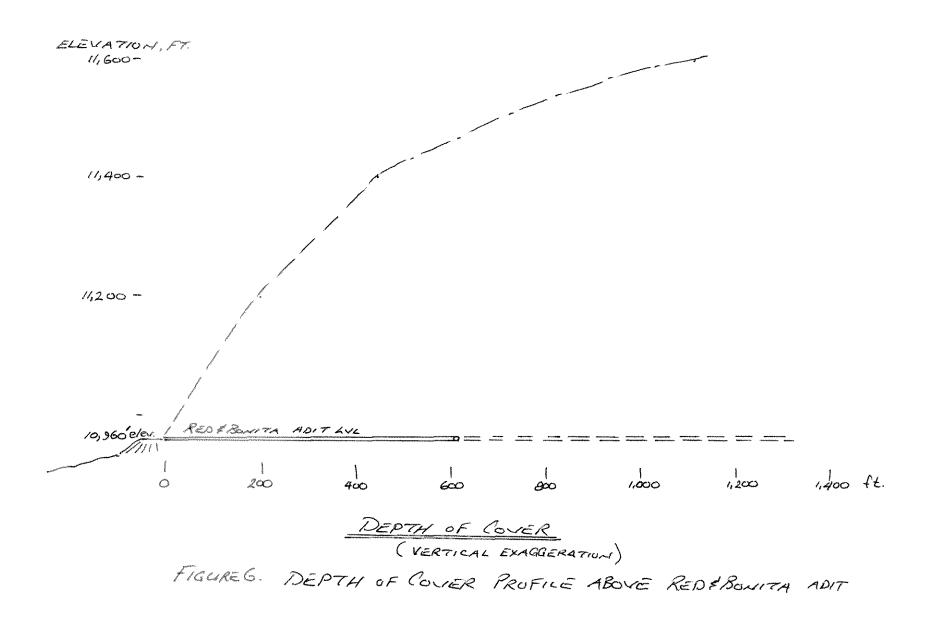
A preliminary cross section along the R&B workings was constructed as part of the bulkhead feasibility consideration (Figure 6). Due to the extremely steep valley walls along Cement Creek there are 400 feet of overburden at 400 feet in from the portal, and 600 feet of depth at 1,000 feet from the portal. A final bulkhead design must take into account the expected pressure head and depth of overburden available to prevent hydro-fracturing of the rock around the bulkhead. In the case of the R&B workings, it appears that sufficient cover exits to continue consideration of a bulkhead if this approach is chosen.
