UNITED STATES ENVIRONMENTAL PROTECTION AGENCY REGION 8

Subject: POLREP #1 (Initial Pollution Report) – Removal Assessment
Gold King Mine Site
Site #085M
Silverton, CO
Latitude: 37.8945 Longitude: -107.6384

To: (b) (6), Response Unit Chief
(b) (6), Program Director
From: (b) (6), On-Scene Coordinator
Date: September 25, 2014
Reporting Period: August to September 2014

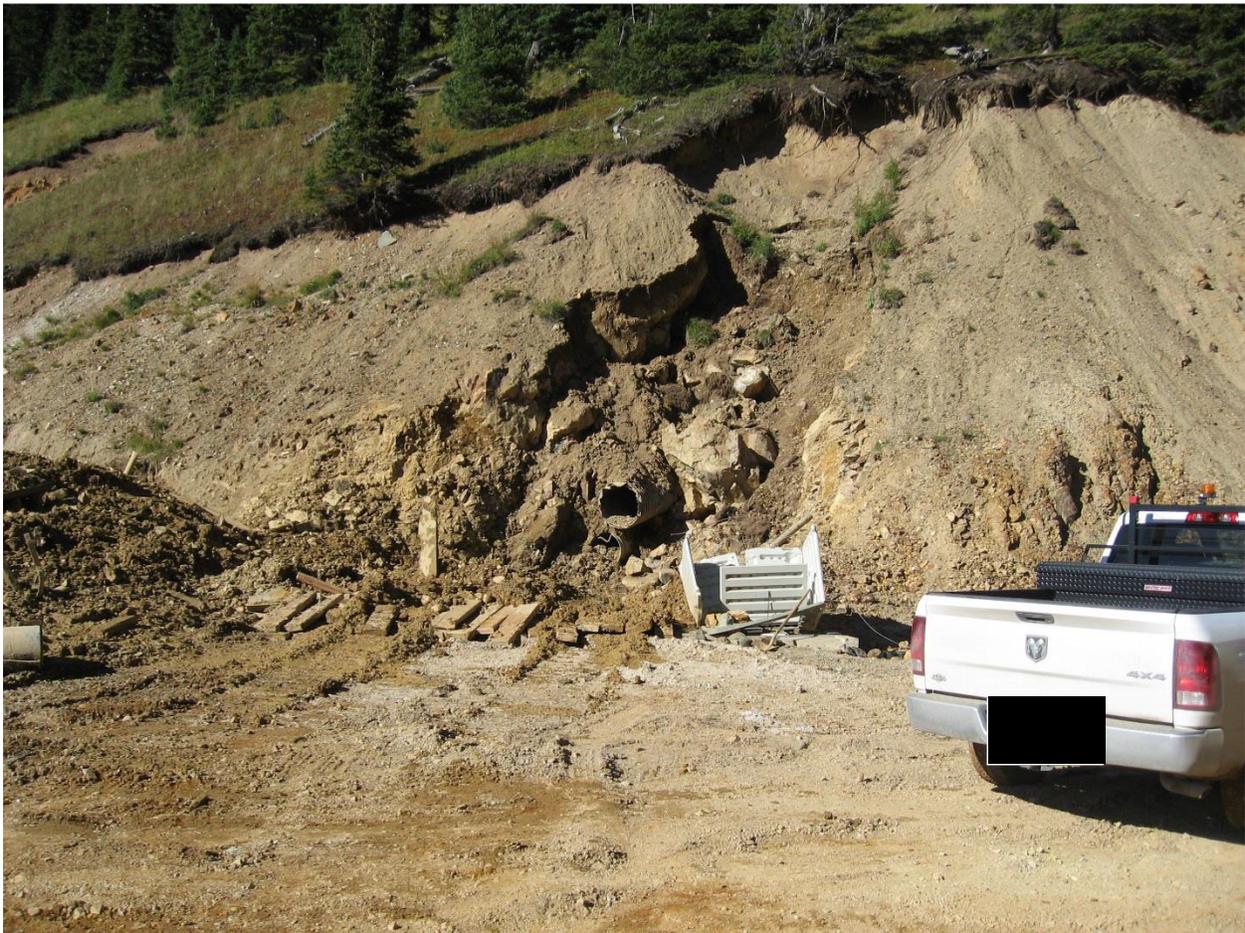
- The condition that was exposed revealed that two 24 inch pipe were in the tunnel blockage adjacent to the top (roof) of the adit. Timbers were observed on the sides and a cap timber was also observed by the contractor. The presence of the 2 – 24 inch pipe indicated the current flow of water was coming out only four feet below the roof, and then there was approximately 6 feet of impounded water below the level of the dump surface. (See Photo below)

Gold King Mine – 9/11/14: collapsed adit pipe near roof of the adit/tunnel.

- The following day, the drain pipe (2 - 12 inch) were placed at the base of the blockage to capture the on-going mine drainage and direct flow into the existing concrete flume channel previously installed at the Gold King 7th Level Mine collapsed portal. In order to do route the water into the channel, a section was removed from the concrete channel north wall (approximately 26" by 10") to allow for construction. The two 12" diameter PVC (polyvinyl chloride) pipes were installed to better direct adit drainage water from the portal into the concrete channel. Geo-fabric, crushed rock, and quick-dry concrete was used to secure the pipes in place. The portal area was backfilled and compacted with additional loads of crushed rock to maintain a stable surface at the portal for potential future work.
