PROJECT WORKSHEET

DECLARATION NO.	PW REF NO.	DATE	FIPS NO.	CATEGORY	NEMIS NO.
FEMA 1909 DR TN	NAFTA03	02/14/10	037-52004-00	E	
APPLICANT				WORK COMPLETED AS OF:	
Nashville - Davidson				DATE:	PERCENT:
				10/22/10	99%
DAMAGED FACILITY				COUNTY	
Bio Solids Admin Building 50				Davidson	
LOCATION				LATITUDE	LONGITUDE
1810 Cement Plant Road				36.18508	-86.78524

Flood water inundated the Bio Solids Admin Building (aka Bldg 50) to a depth of 40" above the finished floor (AFF). The Admin Building is a two year old, 6,400 SF, conventional office building, on slab with exterior brick veneer, that is connected to the East end of Bldg 60, the Solids Processing Building. Affected components include: 4,760 SF of VCT and 1,252 SF epoxy floors, 5,290 SF painted, drywall interior finishes, 27 solid core doors, built-in cabinetry and electrical components that include, 2-ea transformers, 2-ea service panels, inundated duplex and quadraplex receptacles and restroom and bath fixtures and accessories. The building consists of 3-offices, 2-conference rooms, 4-restrooms, 2-locker rooms, 2-janitorial rooms, several closets, 1-breakroom, storage and mechanical rooms and a reception area. The damage

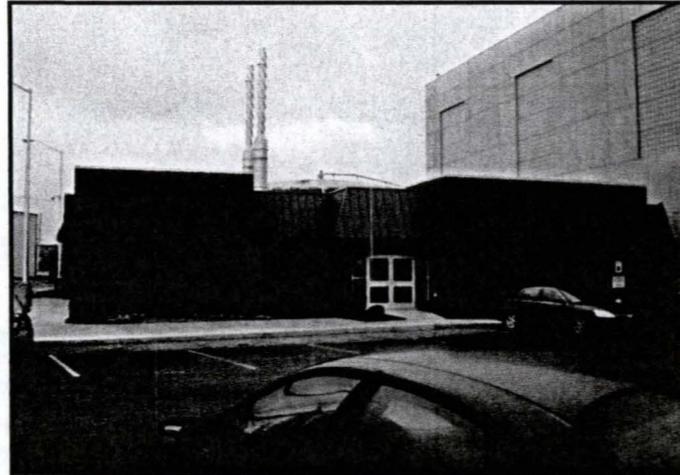
Exterior of building; main entrance.

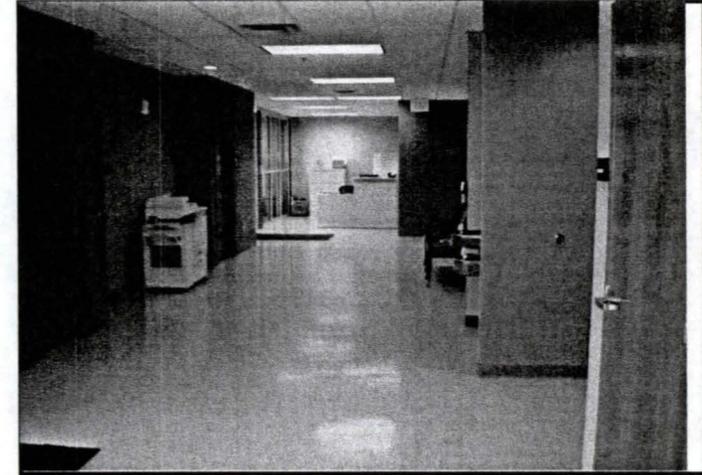
- 344 SF (86 LF x 4-ft) - 5/8" Drywall, painted was water-logged....
- 742 SF - VCT floor, 12"x12", was soiled....
- 86 LF - Vinyl Base, 4", was soiled, and is attached to water-logged drywall....
- 42 SF - Acoustical Ceiling Tile, 2'x2', tegular, was above flood line and was not damaged....
- 1-EA - 3070 Solid core wood door on metal door frame, 1.5 hour fire rated, was soiled....
- 1-SET - Bi-level Electric Water Coolers, wall-mounted, were inundated.....
- 1-EA - Aluminum and glass storefront was soiled....
- 4-EA - Duplex wall receptacle, were inundated....
- 1-EA - Ethernet connection was inundated....
- 96 SF (24 LF x 4-ft) - fiberglass wall insulation, R13, was water-logged....

Corridor 5003, looking toward the reception area; Conference rooms are on the right, restrooms and janitor's room are on the left.

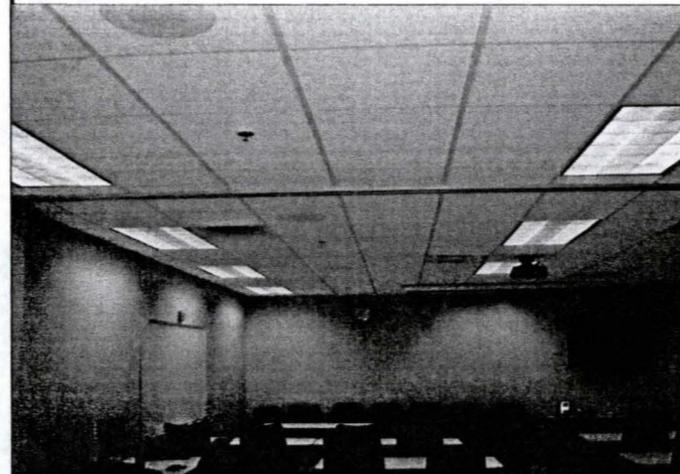
196 SF (49 LF x 4-ft) - 5/8" Drywall, painted, was water-logged....
 49 LF - Vinyl Cove Base, 4", was soiled and is attached to water-logged drywall....
 1-EA - 3070 Solid core Wood Door on metal frame, was soiled....
 1-EA - 30" x 7' metal frame, full vision panel, was soiled....
 480 SF - VCT floor, 12"x12", was soiled....
 1-EA - Marker Board, 4'x8', was inundated....
 3-EA - Duplex wall receptacle, were inundated....
 1-EA - Telephone outlet, was inundated....
 1-EA - Ethernet connection, was inundated....
 480 SF - Acoustical Ceiling Tile, 2'x2', tegular, is above flood line and was not damaged....
 1-EA - stainless sink, wet-bar type, was soiled....
 1-EA - Vanity Base cabinet, Maple, 7' L x 24" W x 34" H, was inundated and warped....
 1-EA - Moveable Partition, vinyl, folding accordion, ceiling tracked, 25'- 6" L x 8'- 10" H, was inundated....
 NOTE: Partition separates Conference Room from Training Room....

276 SF (69 LF x 4-ft) - 5/8" Drywall, painted, was water-logged....
 69 LF - Vinyl Cove Base, 4", was soiled and is attached to water-logged drywall....
 1-EA - 3070 Solid core Wood Door on metal frame, standard cyliner, was soiled....
 1-EA - 30" x 7' metal frame, full-vision panel, was soiled....
 608 SF - VCT floor, 12"x12", was soiled....
 1-EA - Marker Board, 4'x8', was inundated....
 5-EA - Duplex wall receptacle, were inundated....
 1-EA - Telephone jack, was inundated....
 2-EA - Ethernet connection, were inundated....
 2-EA - Quadraplex floor outlet, Brass, were inundated....
 608 SF - Acoustical Ceiling Tile, 2'x2', tegular, is above flood line and was not damaged....
 1-EA - stainless sink, wet-bar type, was soiled....
 1-EA - Vanity Base Cabinet, Maple, 7' L x 24" D x 34" H, was inundated and warped....

Conference and Training Rooms.

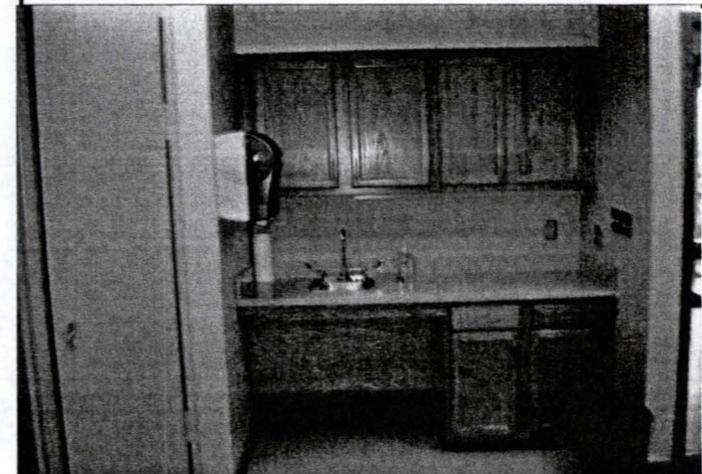
Typical vanity base cabinet with wet bar sink in Conference/Training.

- 3-EA - remove, clean & reset Stainless steel wet bar sink....
 - 1-EA - R&R shower curtain....
 - 2-EA - clean 400A service panels and bus bar, megger test prior to energizing....

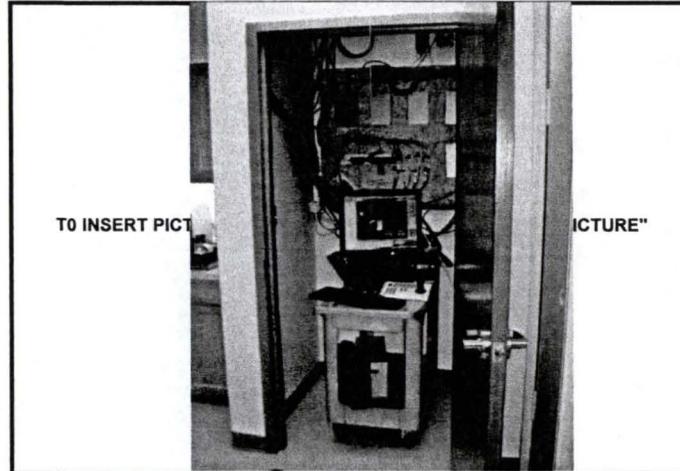
46 SF (12.5 LF x 4-ft) - 5/8" Drywall, painted, was water-logged....
 12 LF - Vinyl Cove Base, 4", was soiled and is attached to water-logged drywall....
 1-EA - 6070 set Solid core Wood Doors on double, metal frame, was soiled....
 1-EA - Duplex wall receptacle, was inundated....
 12 SF - VCT, 12"x12", was soiled....
 12 SF - Acoustical Ceiling Tile, 2'x2', tegular, is above flood line and was not damaged....
 NOTE: All security camera system equipment is captured in contents PW.

Security System in closet of Conference/Training Rooms.

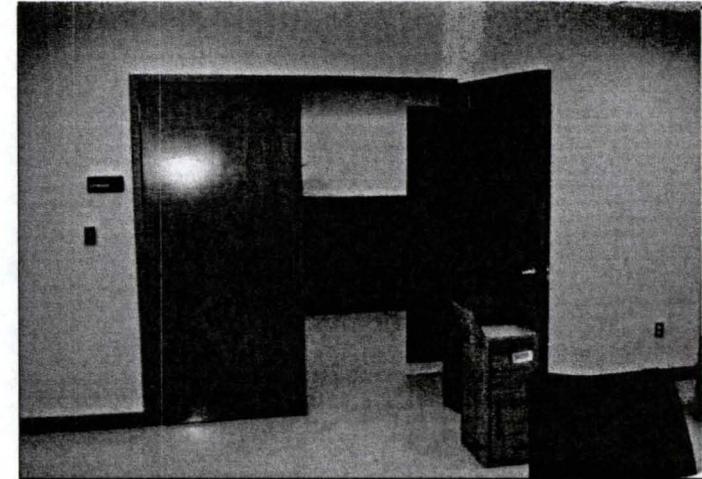
220 SF (55 LF x 4-ft) - 5/8" Drywall, painted, was water-logged....
 55 LF - Vinyl Cove Base, 4", was soiled and is attached to water-logged drywall....
 1-EA - Solid core Wood Door on metal frame, 3070, was soiled....
 216 SF - VCT, 12"x12", was soiled....
 216 SF - Acoustical Ceiling Tile, 2'x2', tegular, is above water line and was not damaged....
 1-EA - 6070 set Solid core Wood Doors, 1.5 hour rated, on double, metal frame, was soiled....
 1-EA - Duplex wall receptacle, located 48" AFF, is above flood line and was not damaged....

Double doors leading to storage room in Conference/Training rooms.

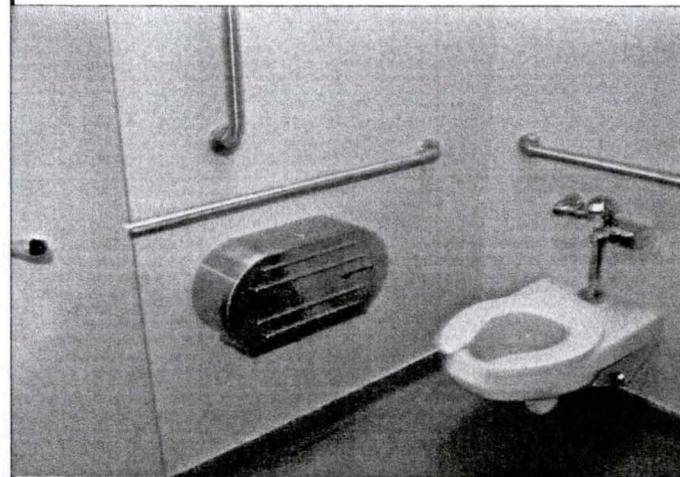
Typical toilet cubicle configuration.

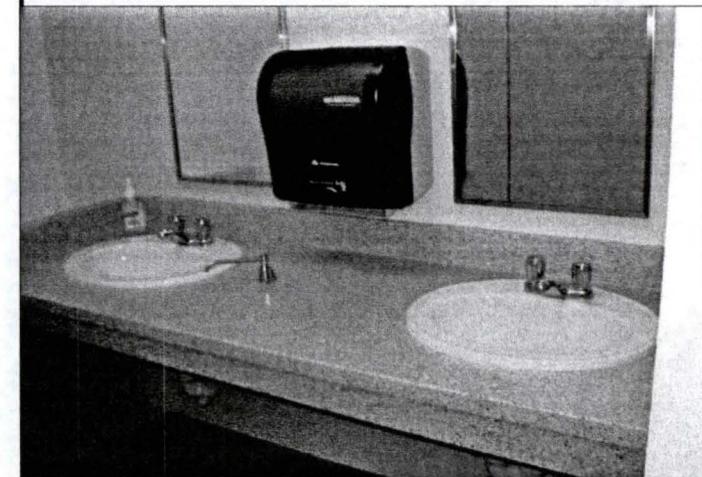
Restroom lavatory, cultured marble, with vitreous china sinks and back-splash.

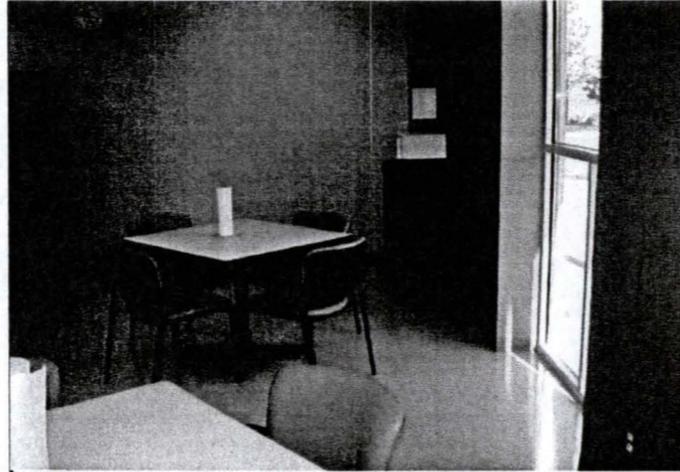
304 SF (78.5 LF x 4-ft) - 5/8" Drywall, painted, was water-logged....
 76 LF - Vinyl Cove Base, 4", was soiled....
 438 SF - VCT, 12"x12", was soiled....
 438 SF - Acoustical Ceiling Tile, 2'x2', tegular, is above the water line and was not damaged....
 1-EA - 6070 set Solid core Wood Door on double, metal frame, 1.5-hour rated, was soiled....
 1-EA - Duplex wall receptacle, located 48" AFF, is above water level and was not damaged....
 4-EA - Duplex wall receptacle, were inundated....
 2-EA - Anodized aluminum and glass storefront windows, 4'x8' area, were soiled....
 204 SF (51 LF x 4-ft H) - fiberglass wall insulation, R13, was water-logged....
 1-EA - Vanity base cabinet w/ cultured marble top (no sink), Maple, 8'-3" L x 24" D x 35" H, was inundated and warped....

Breakroom.

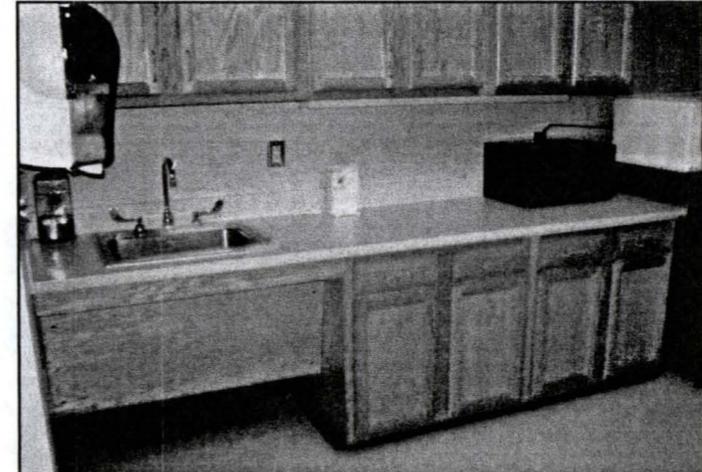
Vanity base cabinet and sink in breakroom.

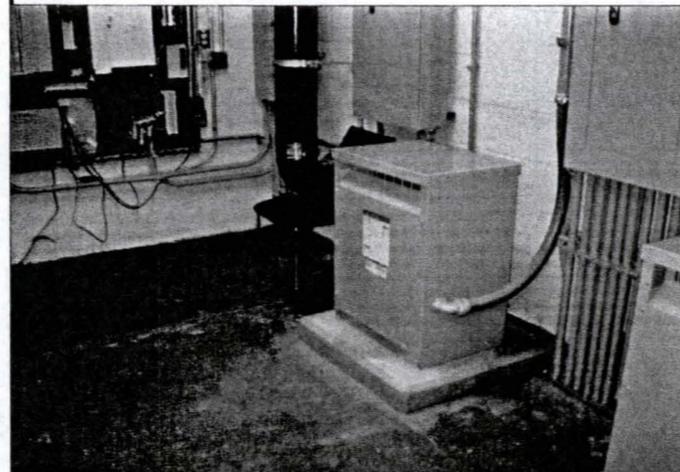
2-EA - 400 Amp Main Breaker Panels (50-BP-1 and 50-BP-2) with 42-EA 20A circuit breakers, were inundated up to the bottom row of 20A circuit breakers, per panel.....

2-EA - 45kVA Transformer, dry type, 480V primary, 208/120V secondary, were inundated....

45kV transformers in Mechanical Room; 400A panels are mounted on wall, right.

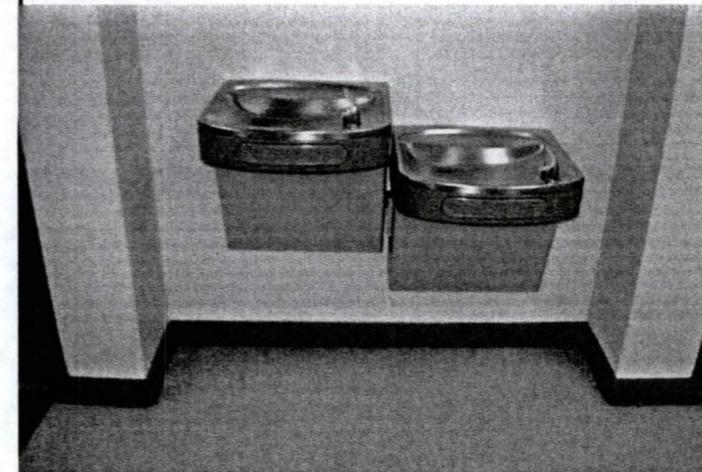
1-SET - Bi-level Electric Water Coolers, wall-mounted, were inundated.....

One of two (2) Bi-level, wall-mounted water coolers.

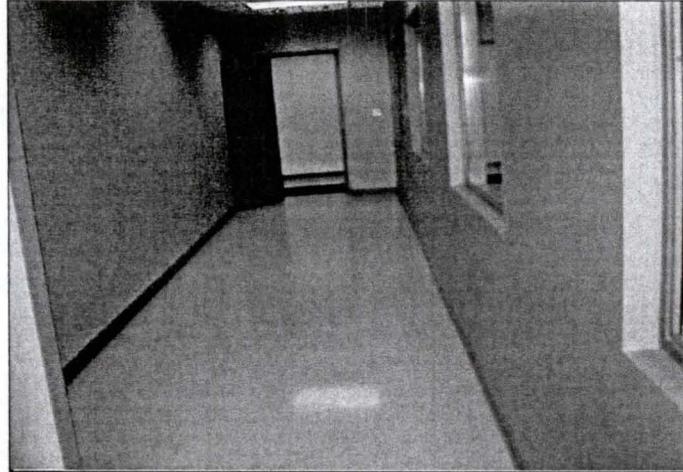
232 SF (58 LF x 4-ft) - 5/8" Drywall, painted....
 189 SF - VCT floor, 12"x12", was soiled....
 58 LF - Vinyl Cove Base, 4", was soiled and is attached to water-logged drywall....
 189 SF - Acoustical Ceiling Tile, 2'x2', is above water line and is not damaged....
 1-EA - 3070 Solid core wood door on metal frame, was soiled....
 108 SF (27 LF x 4-ft H) - fiberglass wall insulation, R13, was water-logged....

Viewing display Corridor.

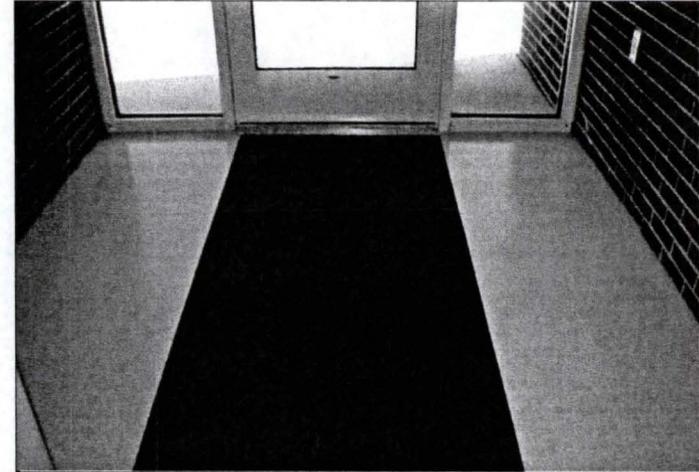
Typical flooring and doors for Entry Vestibules.

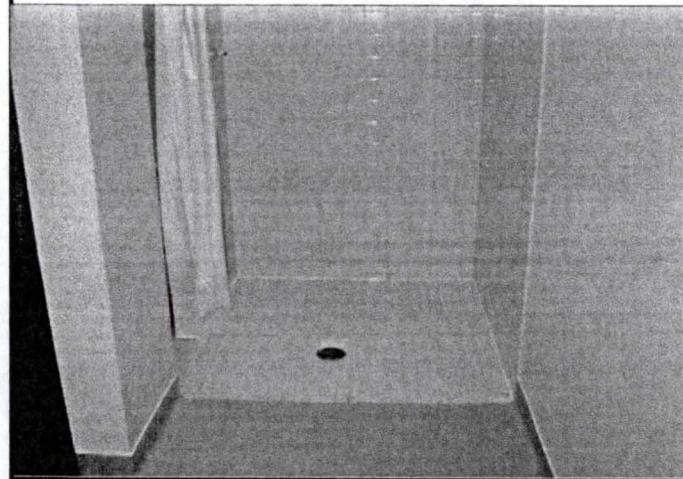
- 148 SF - Acoustical Ceiling Tile, 2'x2', tegular, is above flood line and was not damaged....
- 204 SF (51 LF x 4-ft) - ceramic wall tile (shower) , 4"x4", was soiled....

Typical shower; ceramic tile floor and walls.

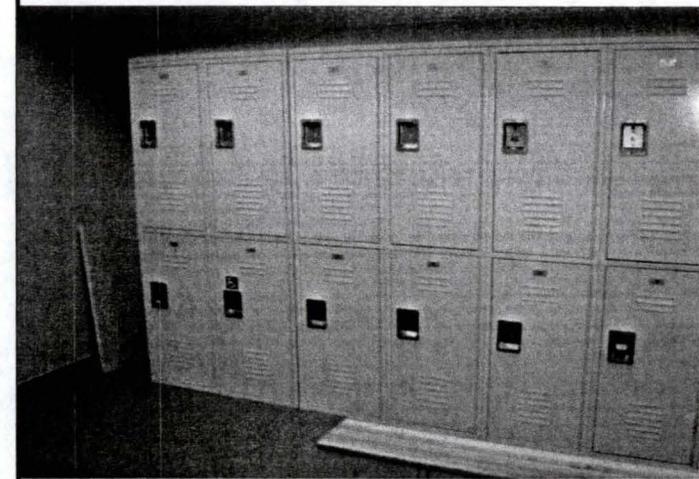
Typical duplex Lockers in Locker Rooms.
