DOCUMENTATION OF ENVIRONMENTAL INDICATOR DETERMINATION
RCRA Corrective Action
Environmental Indicator (EI) RCRIS code (CA725)
Current Human Exposures Under Control

Facility Name: Former Ametek Inc. – Specialty Filaments Division
Facility Address: 8335 Telegraph Road, Odenton, MD
Facility EPA ID #: MDD 082612110

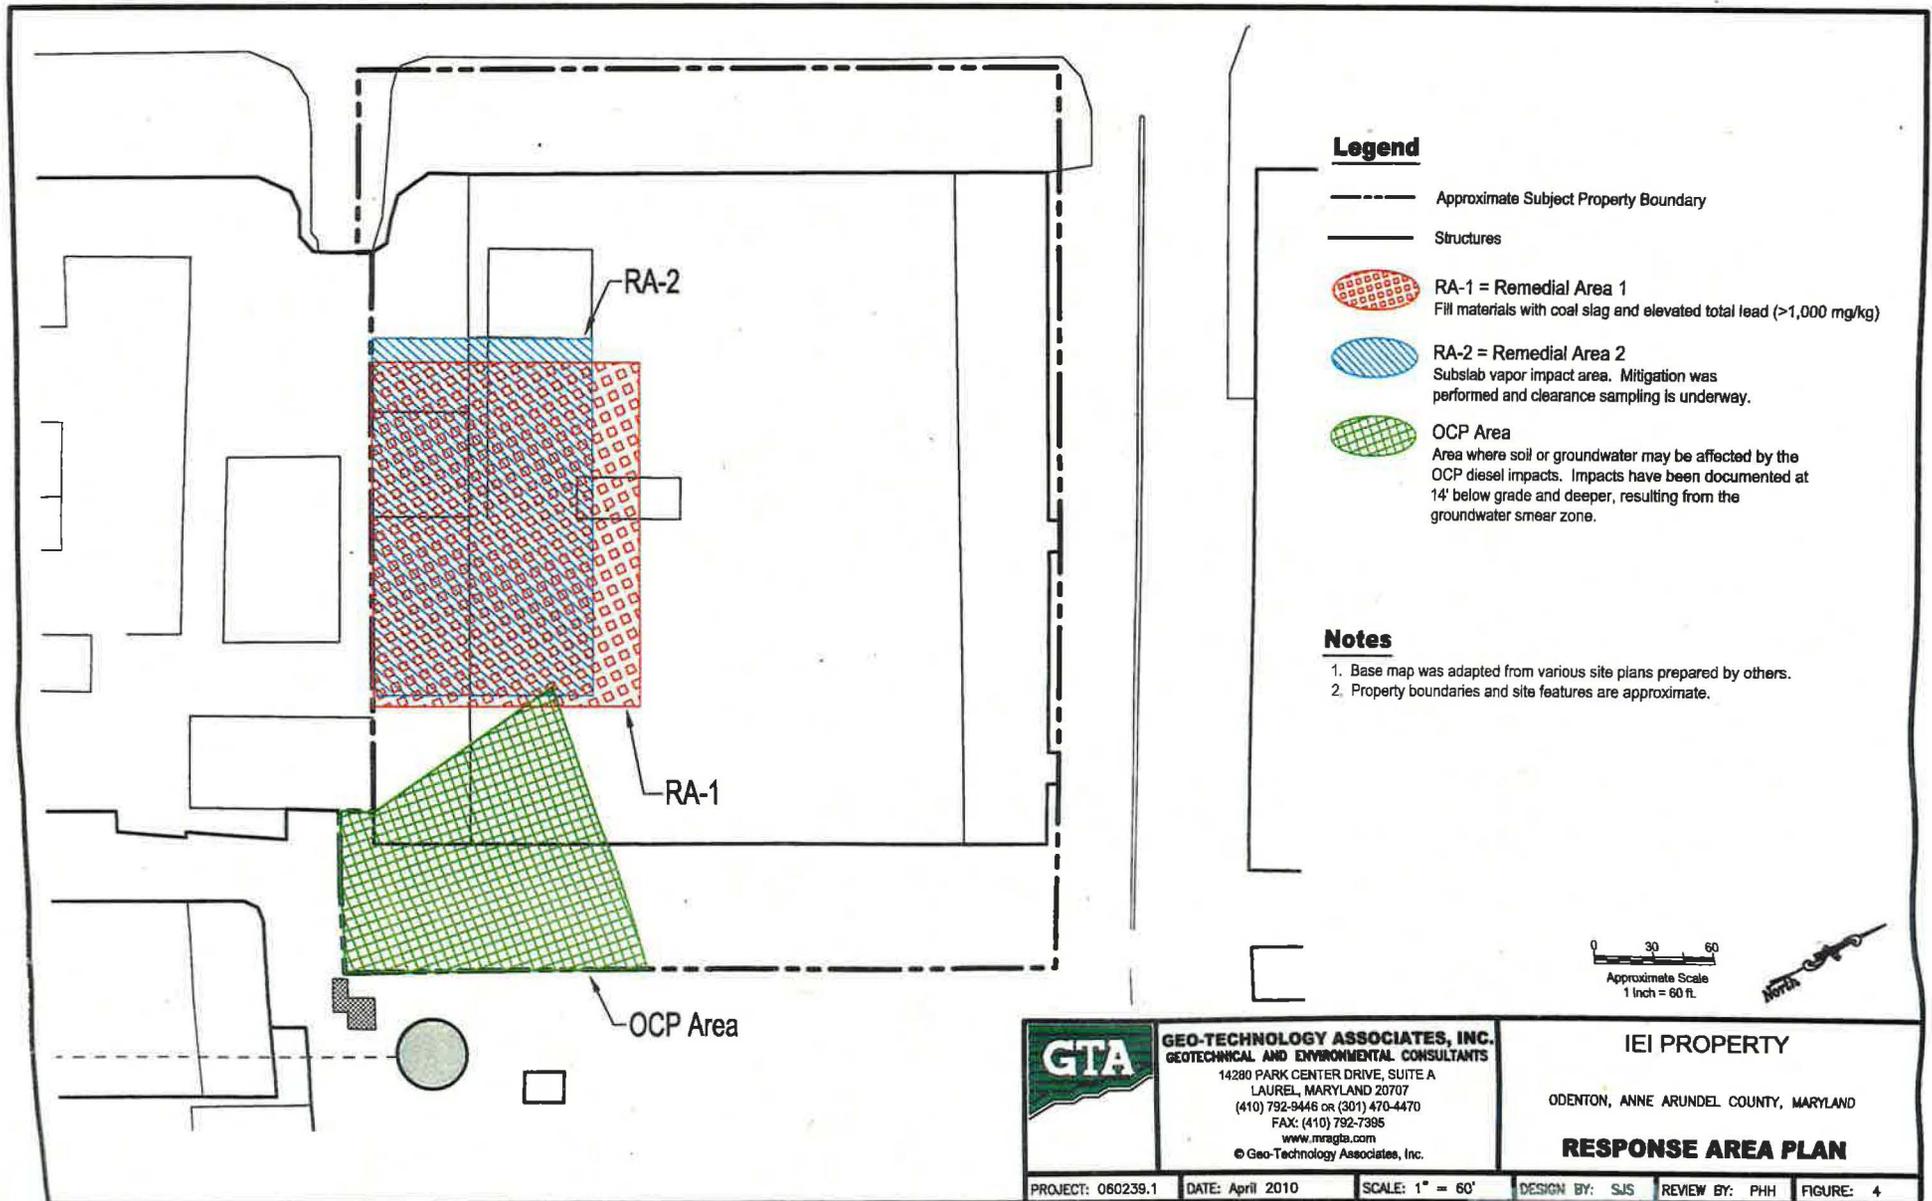
FIGURE 1

RA-1 = Remedial Area 1
Fill materials with coal slag and elevated total lead (>1,000 mg/kg)
-

RA-2 = Remedial Area 2
Subslab vapor impact area. Mitigation was performed and clearance sampling is underway.
-

OCP Area
Area where soil or groundwater may be affected by the OCP diesel impacts. Impacts have been documented at 14' below grade and deeper, resulting from the groundwater smear zone.
