**SOLID AND HAZARDOUS WASTE MANAGEMENT SECTION
LONG-TERM STEWARDSHIP INSPECTION**

FACILITY: Johnson Controls
700 N Broad St.
Middletown, DE 19709

DATE OF ASSESSMENT: June 9, 2015

REFERENCE: Johnson Controls, File Code: 70
15 0609 70 Johnson Controls LTS Report

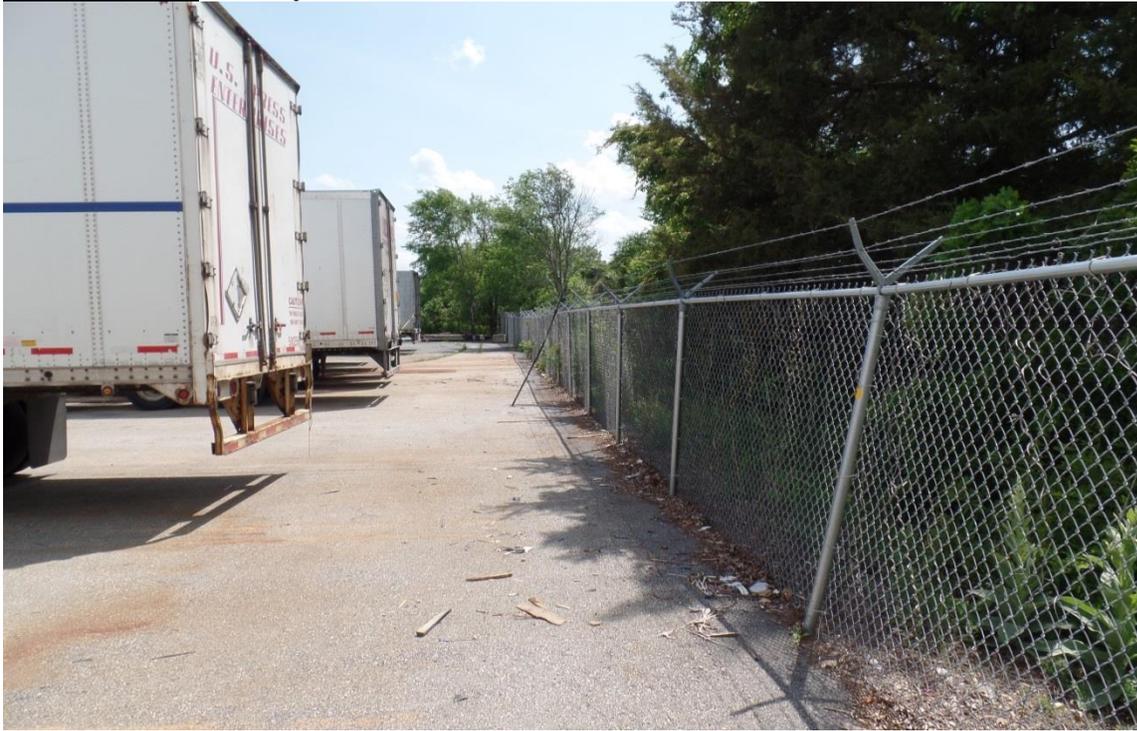
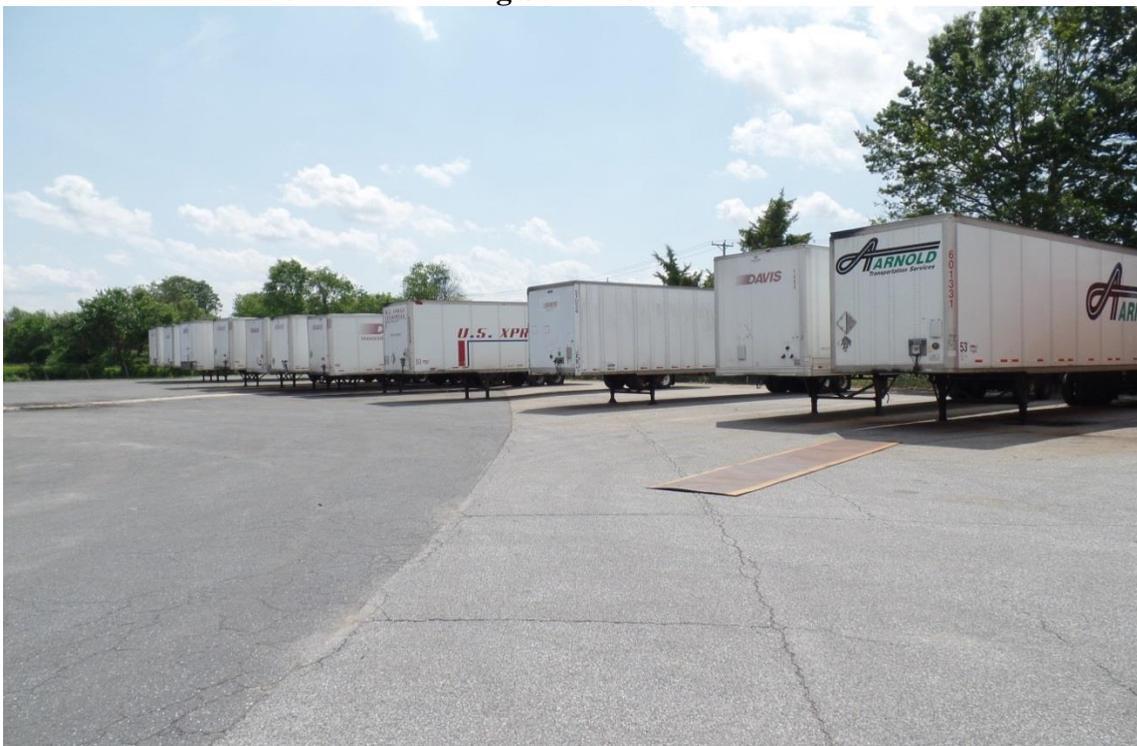
Picture 1. Remediation Area A facing South-southwest.

Remediation Area A: Area A encompasses the southwest corner of the facility and is currently used for storage of empty truck trailers (Pictures 1 and 2). Area A is a paved area that is bordered by a fence that surrounds the facility. Soil sampling, excavation, and removal occurred in this area from 1998-1999 in response to a release of 75 pounds of lead dust in a 10 hour period on March 8 and 9, 1983. After soil removal, the area was paved with asphalt to limit worker exposure to any remaining contaminated soil.

Observations: No cracks in the asphalt were observed. The facility fence also appeared to be intact and functioning properly. No evidence of digging or other earth-moving activities were observed. No violations of the Environmental Covenant or SMP were observed.

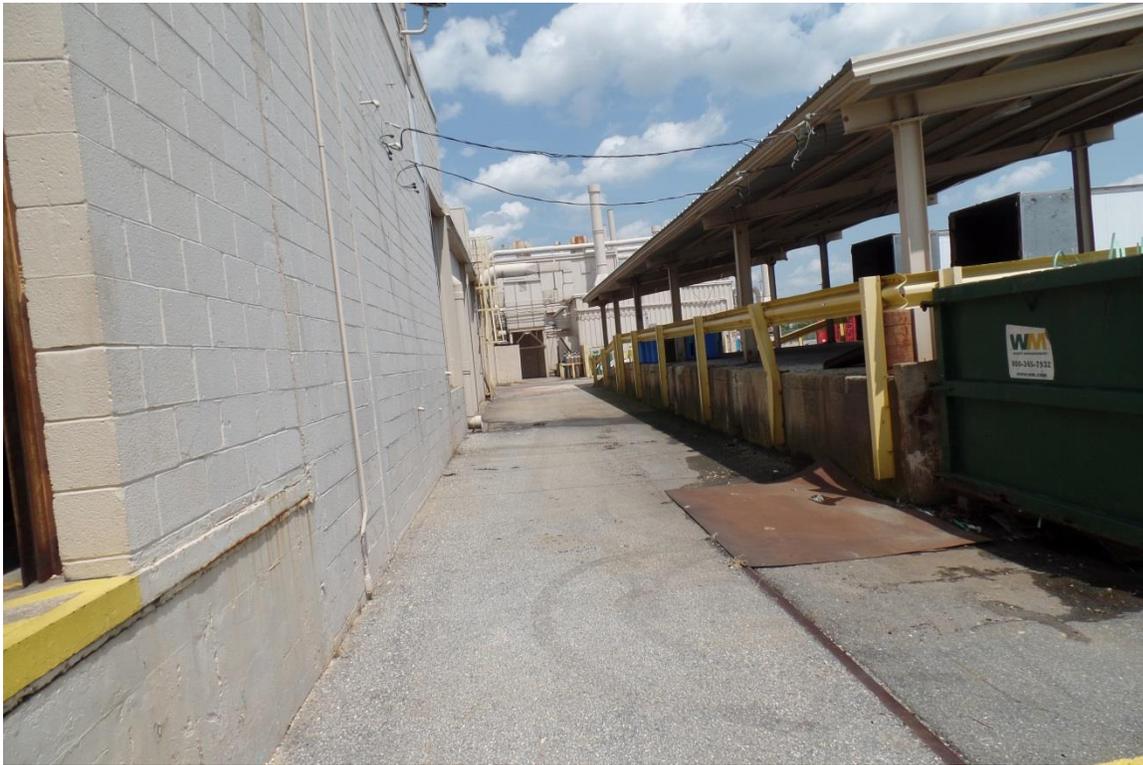
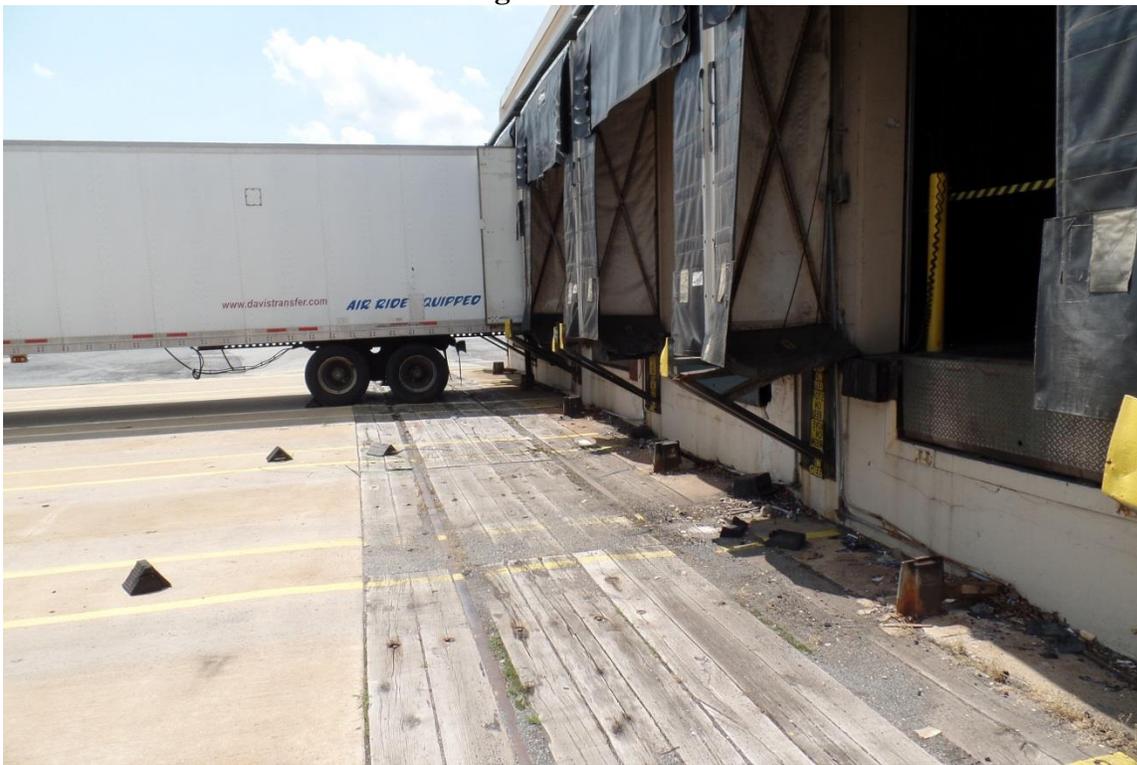
Picture 3. Remediation Area B facing east.

Remediation Area B: Area B encompasses the southwestern edge of the main facility building (Pictures 3 and 4). This area is used for receiving shipments by truck and has multiple doors for off-loading trailers. Area B is paved with asphalt. Wooden planks overlay the asphalt near the receiving doors. A set of abandoned railroad tracks were also observed.

Part of Remediation Area B was sampled and remediated in 1998-1999. The rest of this area was paved over with asphalt. As such, lead-impacted soils remain in place beneath the asphalt. There are two future projects planned in Area B which may cause the SMP to be triggered. The first project will consist of patching the asphalt within and adjacent to Area B and to pave over the abandoned railroad tracks, and the second project is to construct a new outlying building to house part of the Oxide process employed at the facility.

Observations: No cracks were observed in the asphalt cover within Area B. However, paved areas south of the main facility building are beginning to crack. The facility stated that they would be patching these areas in the early summer of 2015, as well as paving over the abandoned railroad tracks. The construction of the new outlying building will occur within the next five years. No evidence of current digging or other earth-moving activities were observed. No violations of the Environmental Covenant or SMP were observed.

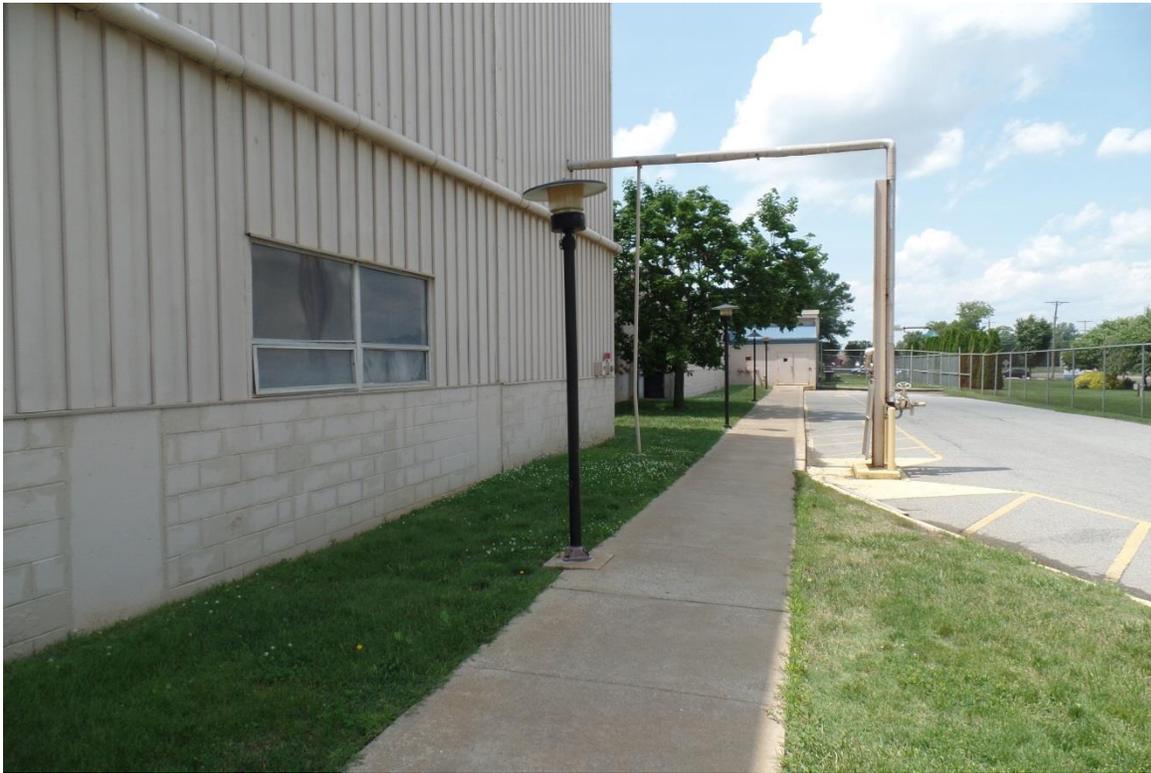
Picture 5. Remediation Area C facing north-northwest.

Remediation Area C: Area C encompasses the southeastern edge and corner of the main building up to the employee entrance and consists of a grass strip with a sidewalk in the middle of the grass (Picture 5). This area was sampled, excavated, and remediated in 1998-1999.

Observations: Vegetation appeared to be healthy and well-maintained. No visible cracks were observed in the sidewalk. No evidence of digging or other earth-moving activities were observed. No violations of the SMP or Environmental Covenant were observed.

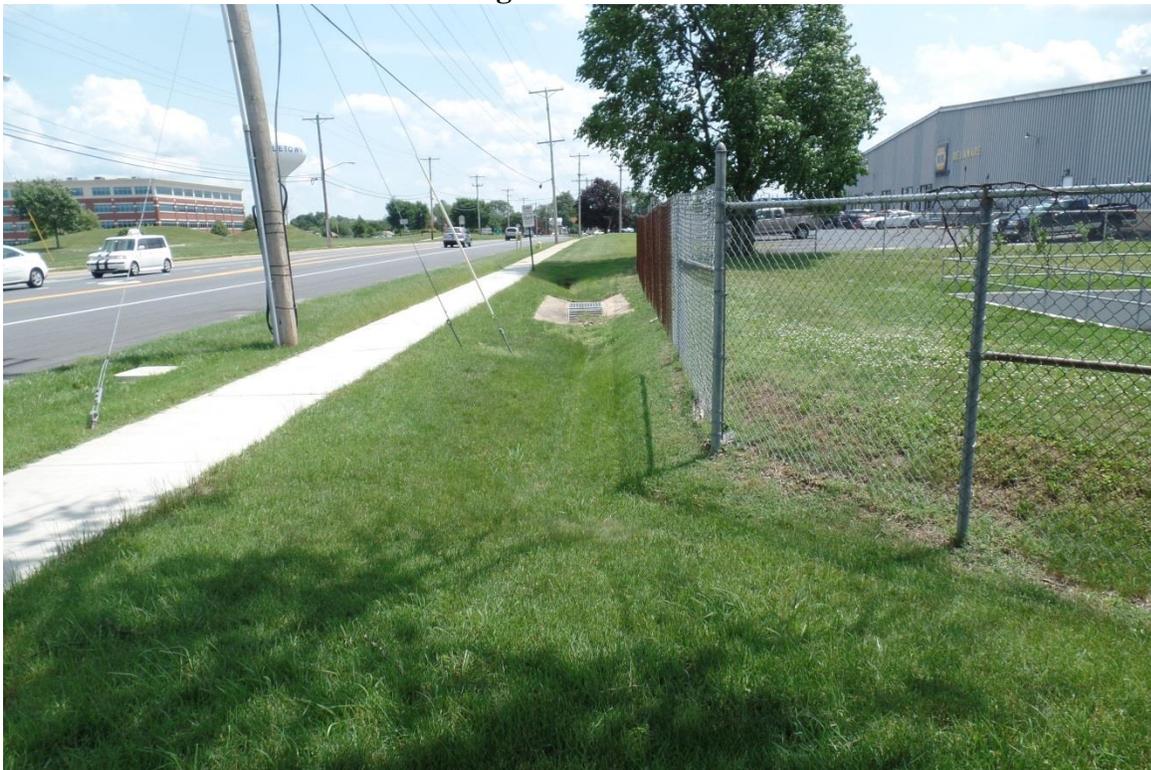
Picture 6. Remediation Area D1 facing south-southeast.

Remediation Area D1: Area D1 includes the grassy area at the northeastern edge of the southern stormwater tank (Picture 6). This area is bounded by the fence for the southern stormwater tank on the southwest, a grassy strip on the south, and the employee entrance to the facility on the north. This area was sampled, excavated, and remediated in 1998-1999.

Observations: Vegetation appeared to be healthy and well-maintained. No visible cracks were observed in either the sidewalk or the road. The security fence surrounding the stormwater tank

appeared to be intact and functioning properly. No evidence of digging or other earth-moving activities were observed. No violations of the SMP or Environmental Covenant were observed.

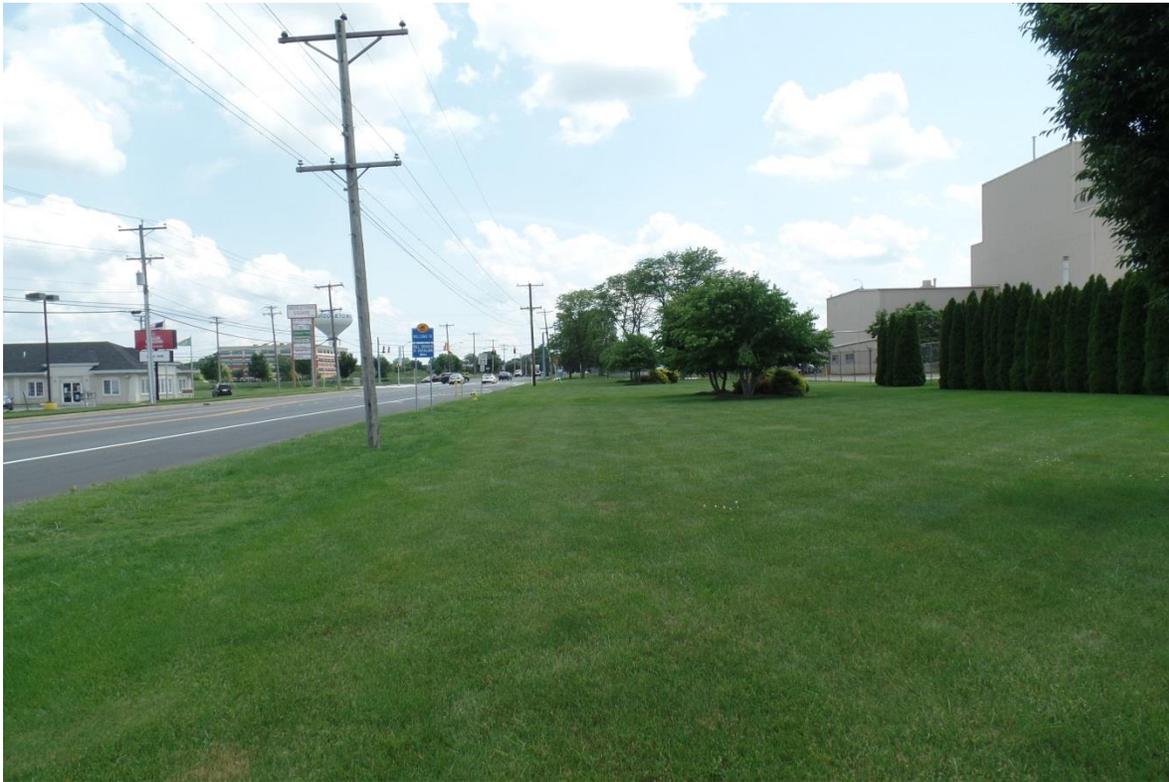
Picture 7. Remediation Area D2 facing south-southeast.

Remediation Area D2: Area D2 includes a grassy strip approximately 350 ft. x 50 ft. that borders the western side of Broad St (Picture 7). This area was sampled, excavated, and remediated in 1998-1999.

Observations: Vegetation appeared to be healthy and well-maintained. No evidence of digging or other earth-moving activities were observed. No violations of the SMP or Environmental Covenant were observed.

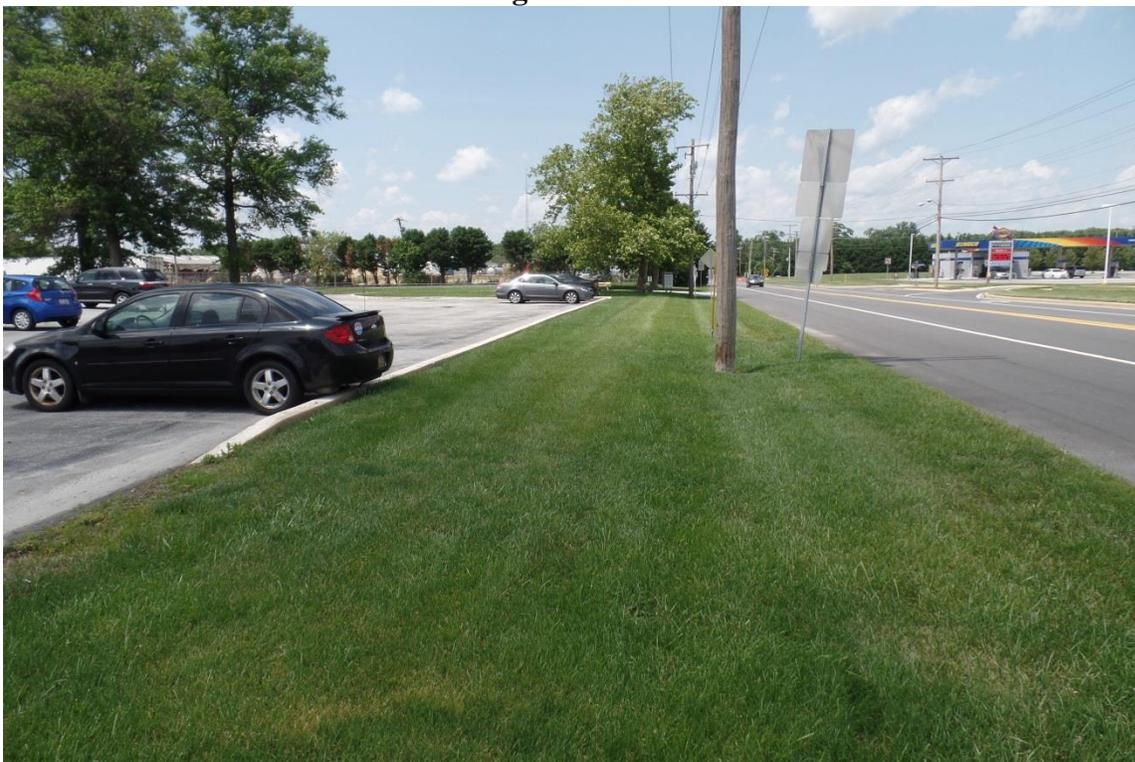
Picture 8. Remediation Area D3 facing north-northwest.

Remediation Area D3: Area D3 includes a grassy strip approximately 150 ft. x 50 ft. that is bordered by Broad St on the east and a parking lot on the west (Picture 8). This area was sampled, excavated, and remediated in 1998-1999.

Observations: Vegetation appeared to be healthy and well-maintained. No evidence of digging or other earth-moving activities were observed. No violations of the SMP or Environmental Covenant were observed.

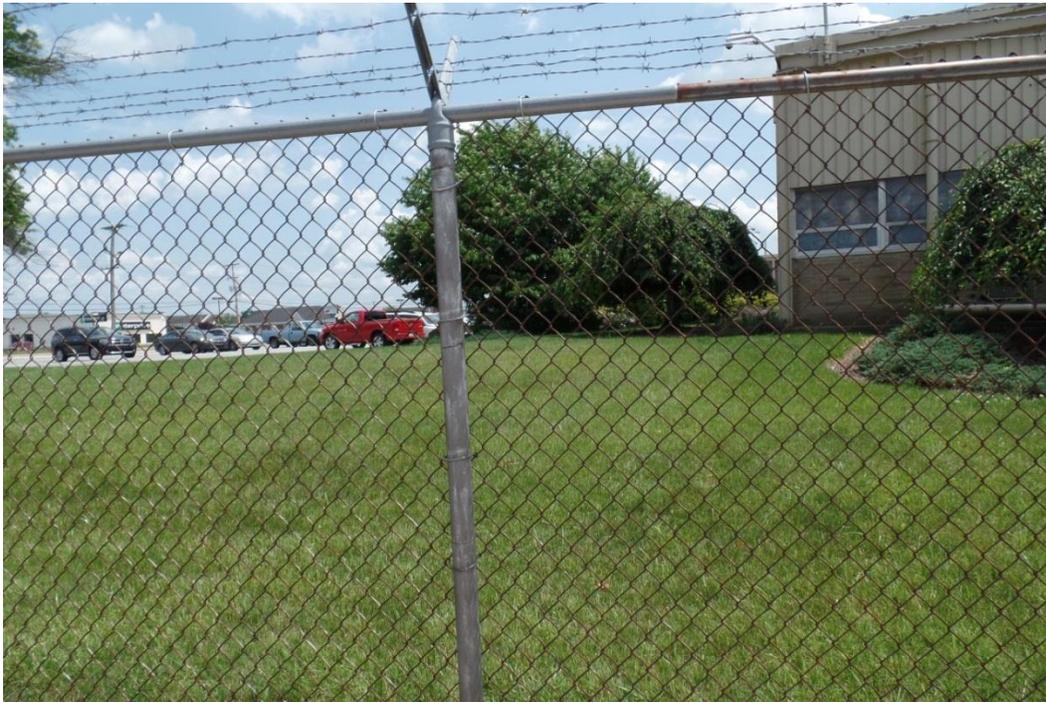
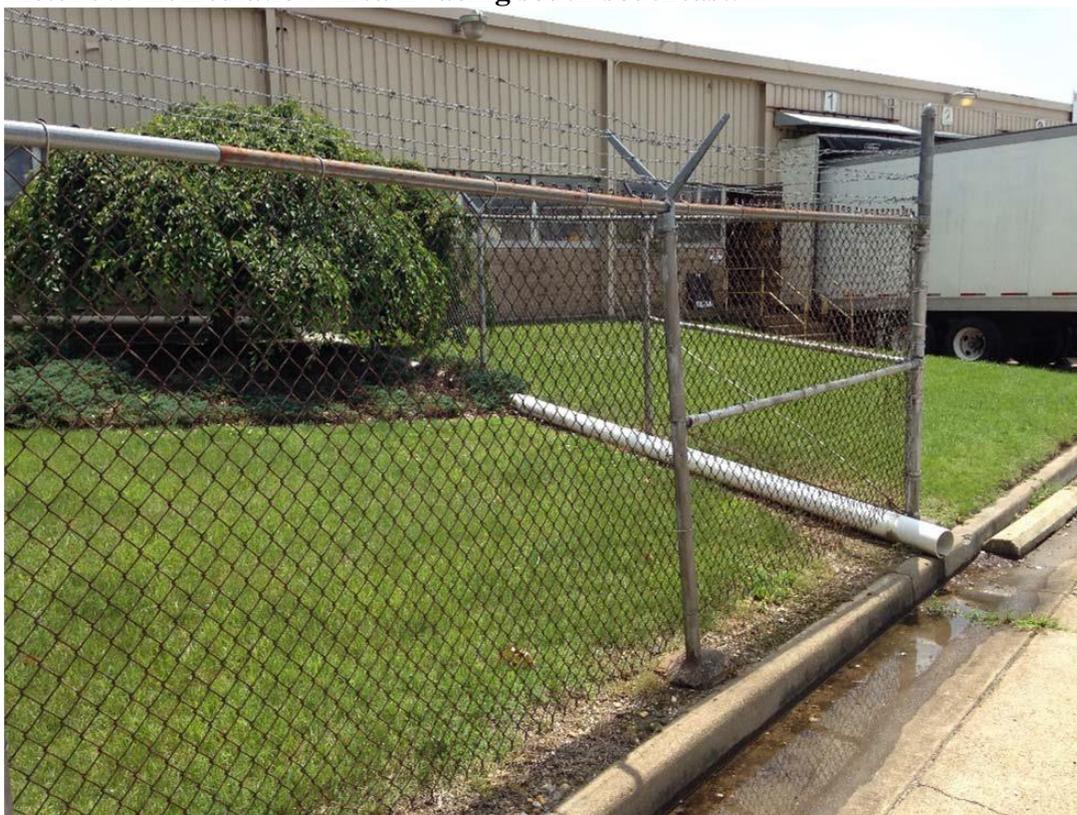
Picture 9. Remediation Area E facing south-southeast.

Remediation Area E: Area E includes a grassy area on the northeastern corner of the main facility building (Picture 9). This area was sampled, excavated, and remediated in 1998-1999.

Observations: Vegetation appeared to be healthy and well-maintained. The security fence appeared to be intact and functioning properly. No cracks were observed in the asphalt adjacent to Remediation Area E. No evidence of digging or other earth-moving activities were observed. No violations of the SMP or Environmental Covenant were observed.

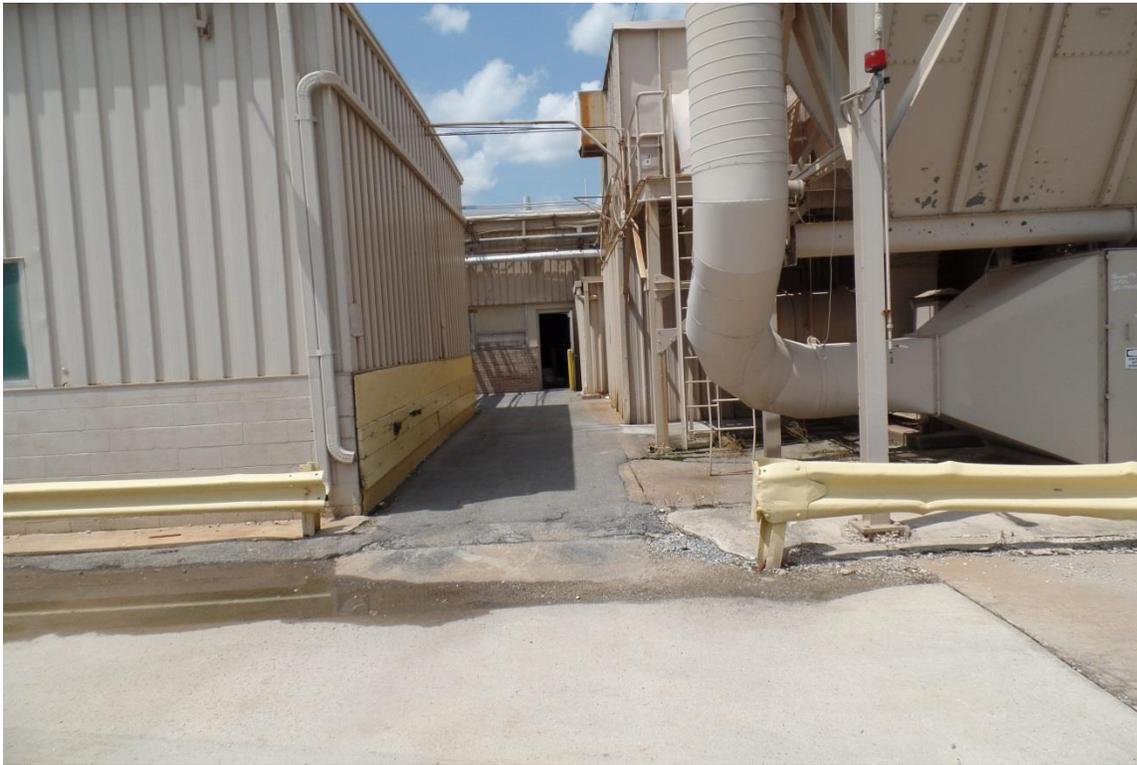
Picture 11. Remediation Area F facing north-northwest.

Remediation Area F: Area F is approximately a 25 ft. x 25 ft. area that is located near the facility's baghouses (Picture 10). This area is completely paved with asphalt. During the lead dust release in 1998, lead-contaminated sediment accumulated on top of the asphalt. However, no sampling, excavation, or other remediation activities occurred in Area F during this time because the entire region near the baghouses was paved and the lead-contaminated sediment was promptly removed.

Observations: Some cracking of the asphalt was observed. Facility representatives stated that they would be patching the asphalt in this area in the early summer of 2015. No evidence of current digging or other earth-moving activities were observed. No violations of the Environmental Covenant or SMP were observed.
