**Explosives Safety Technical Assistance Visit  
(March 9 to 11, 2015)**

**Louisiana National Guard's  
Camp Minden**

1                   **Final Report of Explosives Safety Technical Assistance Visit to Camp Minden**  
2                   **(March 9 to 11, 2015)**

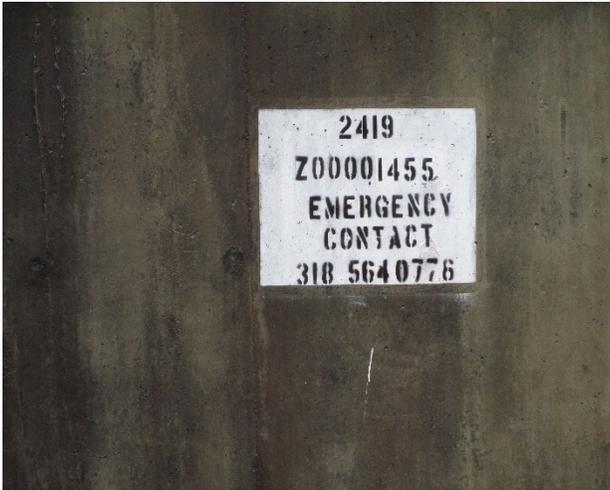
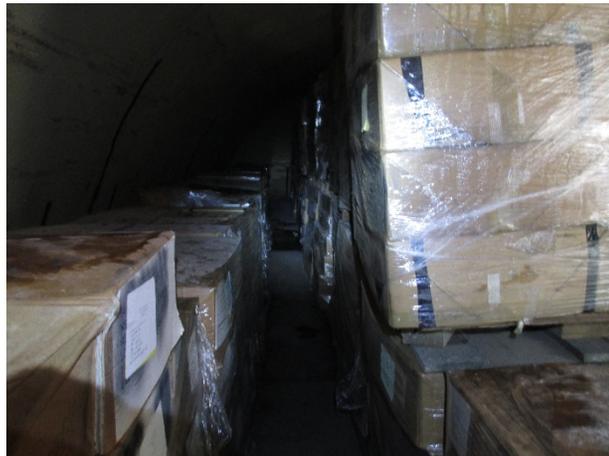
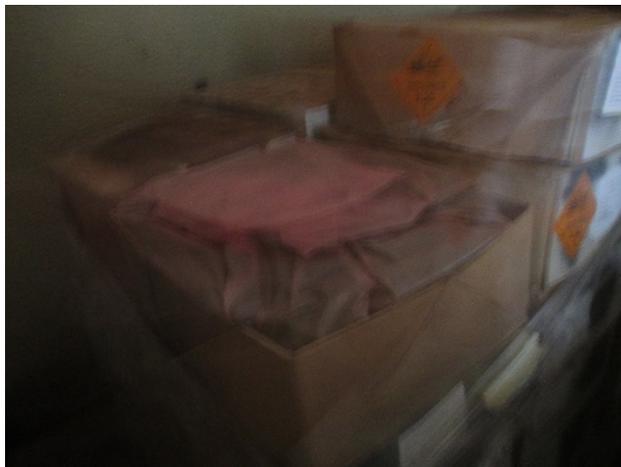
Magazine 2419

- MAG 2419:
  - Concrete arch earth-covered magazine (ECM) with front vent open, rear vent rusted closed, and support chain and fusible link missing;
  - Interior of arch treated with some type of spray-on liner material;

- Water condensation present and dripping on magazine’s contents and standing in pools on floor;
  - Contents palletized, double-stacked;
  - Boxes were wet and moldy with loose CBI on boxes; and

- Evidence of ruptured or collapsed boxes present.
  - General smell encountered was moldy cardboard, with no normal propellant (solvent) or acidic smell.

- One box was opened to determine inner packaging configuration. A pink-colored liner bag was present, but was not sealed. There was no visible moisture within liner bag. There was no LOT number or specific identification on boxes.

While verifying CBI packaging configuration today, we discovered one magazine (#2419) that has significant condensation. I thought it was leaking at first, but upon further investigation it looks like heavy condensation from inside. Water is actually dripping from the roof. As you can see from the attached photos many boxes of CBI are extremely wet and a majority of the boxes have mold growing on the outside. Some of the boxes appear to be swelling. We did not detect any unusual odor but need advice from you and your staff on what to do regarding this situation

- Repairing the rear vent on MAG 2419 to allow air flow through the magazine. Doing so may reduce or alleviate condensation.
- Covering the top of stacks in MAG 2419 with visquine or another impermeable material to prevent further wetting of boxes until dripping from condensation stops. Once the condensation stops or dries up, the cover should be removed to allow the wet material to dry out. Leaving the shroud in place will slow the drying process.

- Re-warehousing the content of the MAG 2419 to a dry magazine, if condensation and dripping cannot be stopped.
- Destroying the wet nitrocellulose in MAG 2471 as soon as possible – as an emergency destruction.

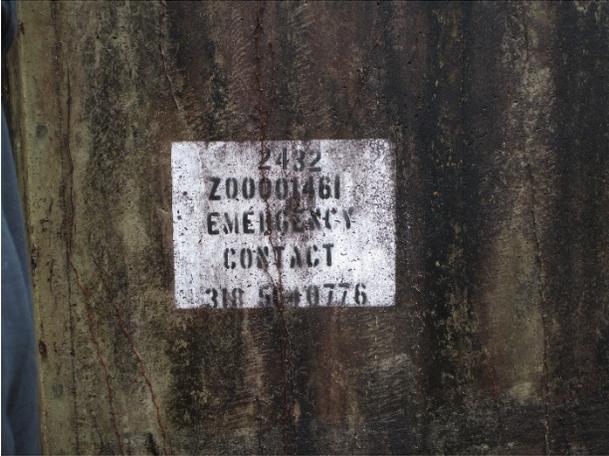
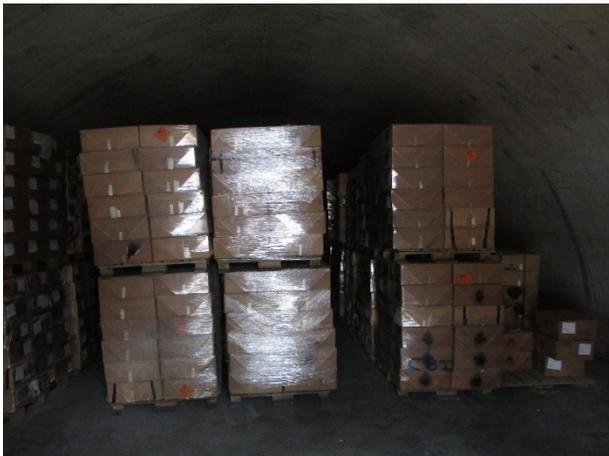
Magazine 2432

- MAG 2232:
  - Concrete arch ECM with dry interior;
  - Front and rear vent open, rear vent had been replaced with a recent design with interior flue;
  - Contents were palletized, double-stacked in good order;

- Small quantities of spilled CBI on boxes, but no evidence of collapsed or ruptured boxes; and
  - General smell encountered was normal magazine smell.

- One lid was removed from a box. A pink-colored liner bag was present and was not sealed. There was no visible moisture inside bag.

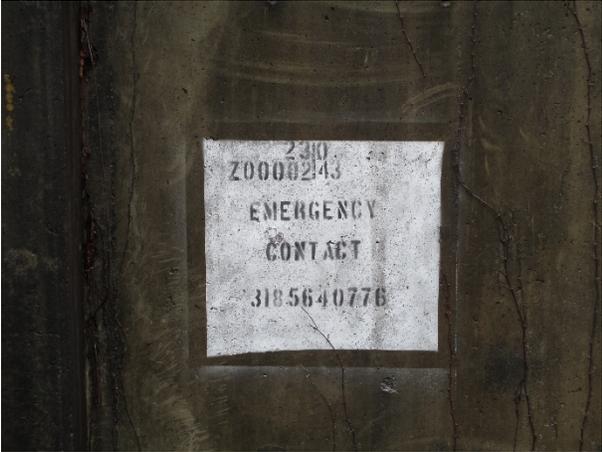
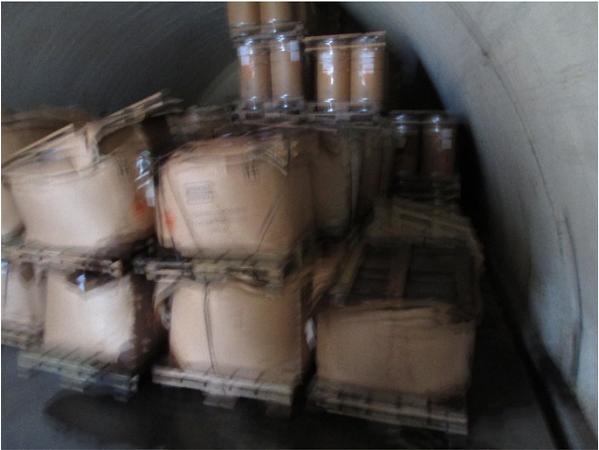
Magazine 2310

- MAG 2310:
  - Concrete arch ECM, with crack in arch reaching approximately halfway across with water dripping on content;
  - Front and rear vents open;
  - Magazine contents: M6 in triwalls and drums;
  - Approximately five triwall pallets of M6 were wet on top.
  - A triwall top was lifted to examine the 800-lb bag. The bag appeared and felt dry. General smell present was that of normal propellant.

Another magazine (#2310) that contains approx. 124,000 lbs of M6 Propellant, has a leak in the roof and water has dripped onto at least five 880 lb Super sacks. Once again is this something we should be concerned about?

- Moving the material underneath the cracked arch in magazine 2310 to a dry portion of the magazine as soon as possible. If the material cannot be moved expeditiously, shroud the material as described above.

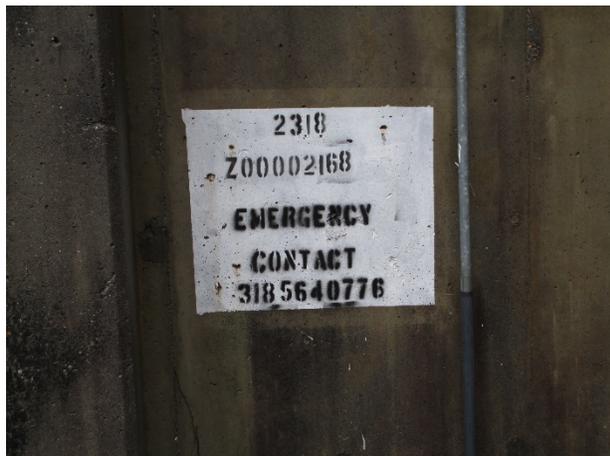
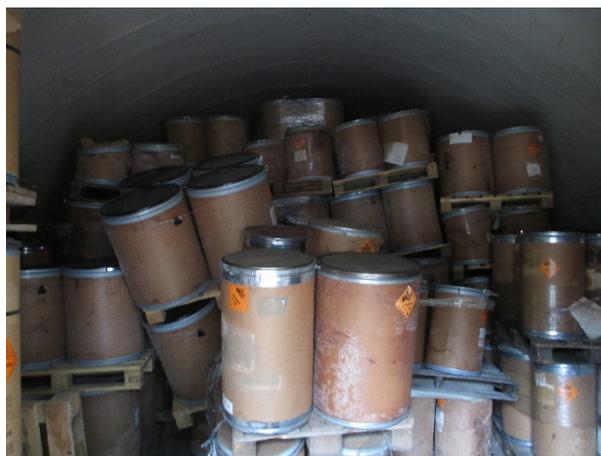
Magazine 2318

- MAG 2318:
  - Concrete arch ECM with dry interior, front and rear vents open.
  - Interior was stuffed with M6 drums and tritonal drums.
  - Interior rear and sides of magazine were not accessible.
  - Some of the tritonal drums were crushed.
  - Strong propellant odor (solvent) present.
  -
