Subject: **April 2012 Compliance Evaluation Inspection**

**CWA COMPLIANCE EVALUATION INSPECTION REPORT  
U.S. ENVIRONMENTAL PROTECTION AGENCY, REGION 5**

L'Anse Warden Electric Company  
Fuel Aggregation Facility  
17696 U.S. Highway 41  
L'Anse, Michigan 49946  
46.749590, -88.462230

MIS310000

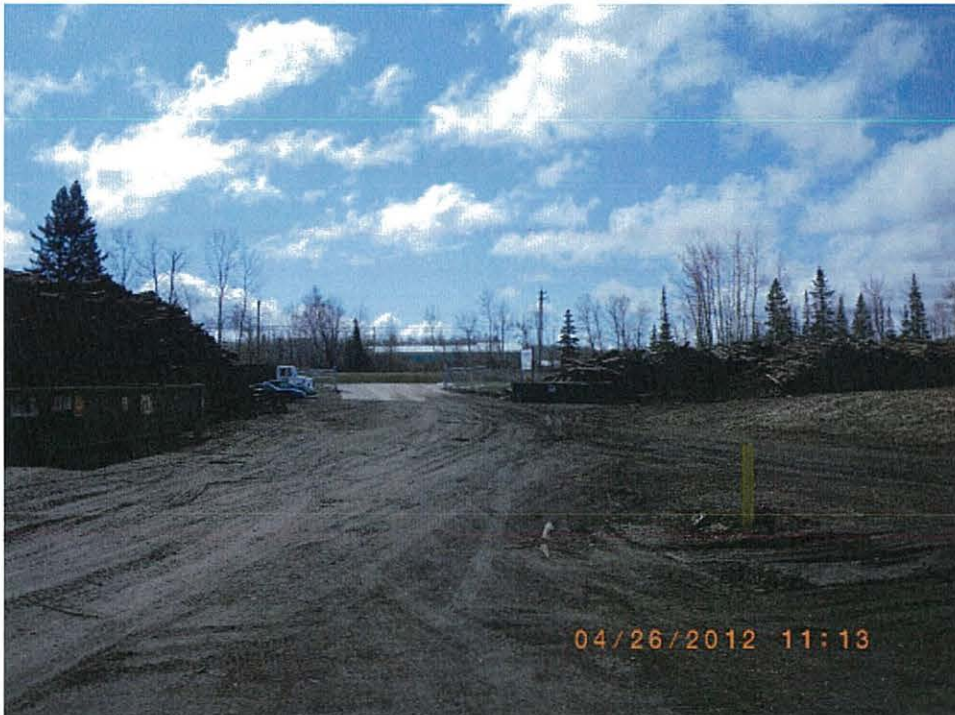
I observed that the entrance, from U.S. Highway 41, into the FAF was dirt inside of the entrance gate (IMGP9069).

Photo: IMGP9069: Entrance to the FAF with the PCP treated railroad ties on the left side of the photo. Direction: Facing south.

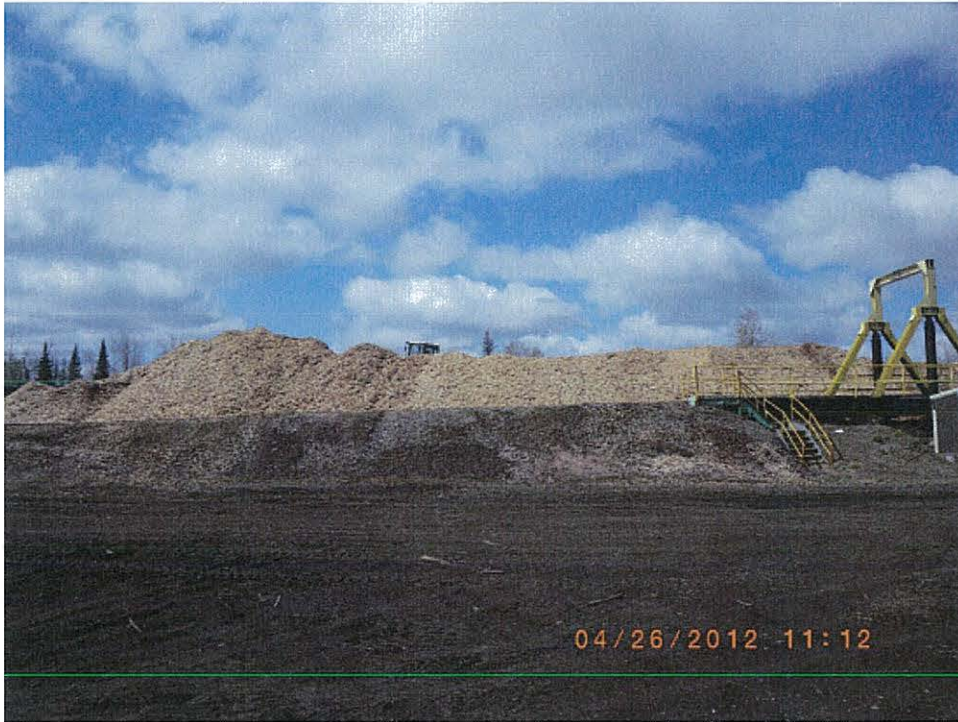
Entering the FAF I observed a large accumulation of wood chips located northwest of the entrance. On the east side of the wood chip pile was a truck scale (Photo IMGP9068).

Photo IMGP9068: Untreated wood chip pile with truck scale.  
Direction: Facing west.

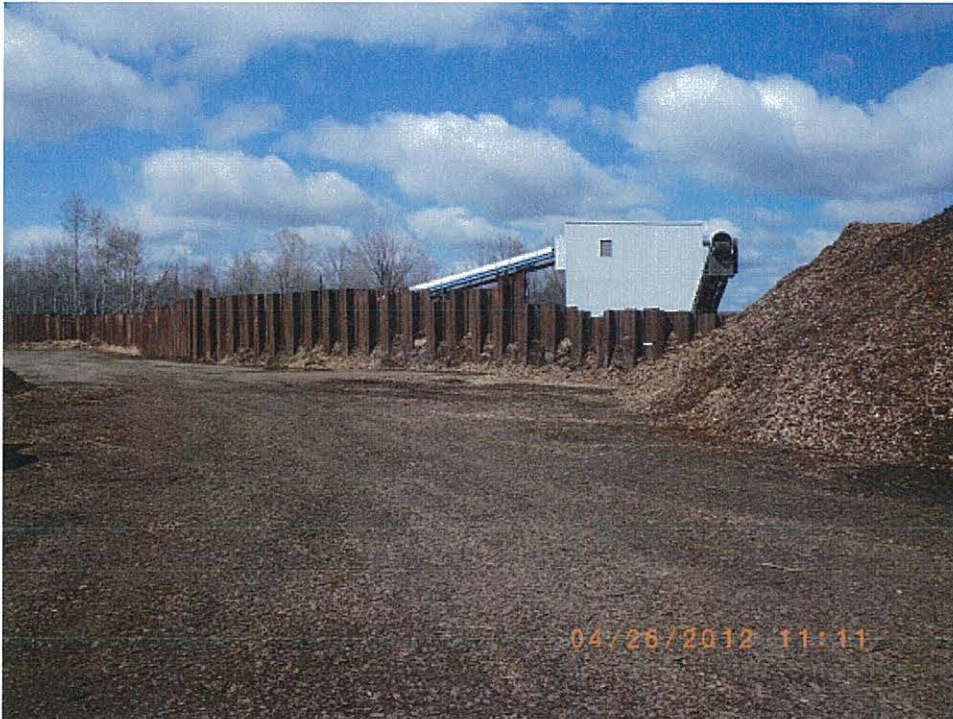
Surrounding the north and northwest sides of the wood chip pile were steel pilings which were separated from the wood chip pile by a dirt road for vehicles and equipment (Photo IMGP9066). I observed piles of wood chips that were pushed up against both sides of the pilings. Wood chips were piled to the top of the pilings in some areas. There was no runoff or water observed during the inspection around the wood chip pile, the dirt road or pilings.

Photo IMGP9066: Pilings along the north side of the access road surrounding the wood chip pile.  
Direction: Facing northwest.

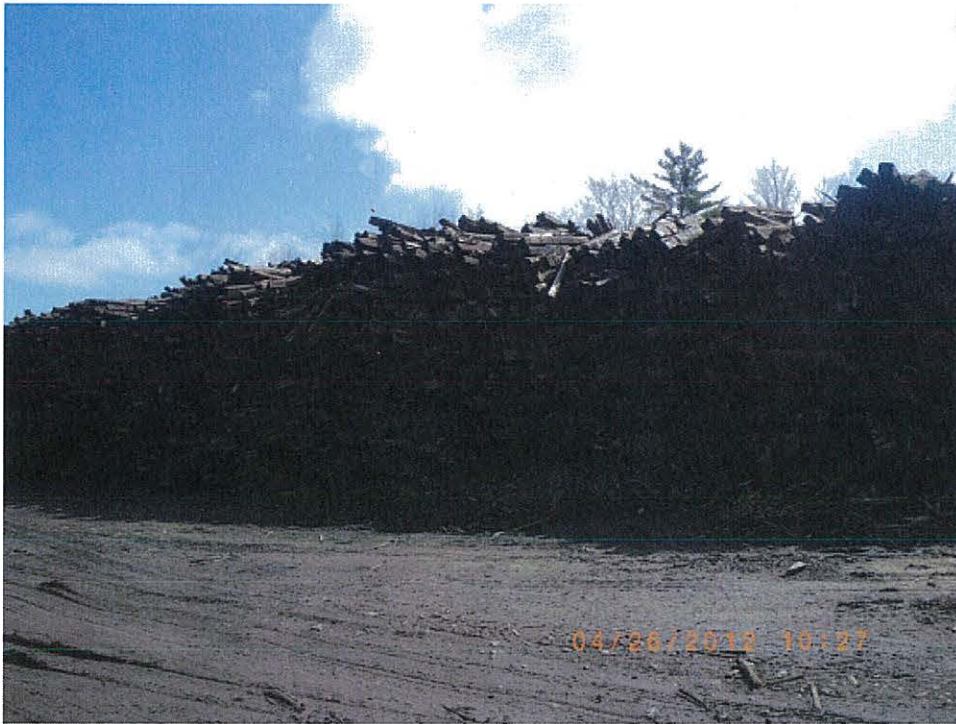
There were three separate areas where railroad ties were aggregated. Upon entry from U.S. Highway 41, I observed a large aggregate of railroad ties that ran parallel to the east side of the entry road (Photo IMGP9045, IMGP9062 and IMGP9081). This was identified by facility representatives as the PCP treated railroad tie aggregate. I observed that the ties were piled on the ground. They were not elevated. I observed that immediately to the east, and running parallel with the PCP railroad tie aggregate, was a ditch that had water during the inspection (Photo IMGP9080). The water in the ditch flowed on site from a culvert that ran under U.S. Highway 41 just east of the FAF entrance (Photo IMGP9078). The ditch had thick vegetation and water was not flowing from the north end of the ditch during the inspection (Photo IMGP9064). At the north end of the PCP railroad tie aggregate was another ditch that ran from west to east (Photo IMGP9063). This ditch received runoff from the woods between the PCP railroad ties and the overflow railroad tie pile. This ditch was full of debris. I observed water in the ditch at the time of the inspection, but it was not flowing. The only observable method of discharge from the ditch was from overflow at the west end, just north of the PCP railroad ties. Facility representatives stated that any overflow from this point would flow towards the north end of the FAF through an open dirt area and would dissipate. No structural controls were observed around the PCP railroad tie aggregate.

Photo IMGP9045: PCP treated railroad tie aggregate.  
Direction: Facing northeast.

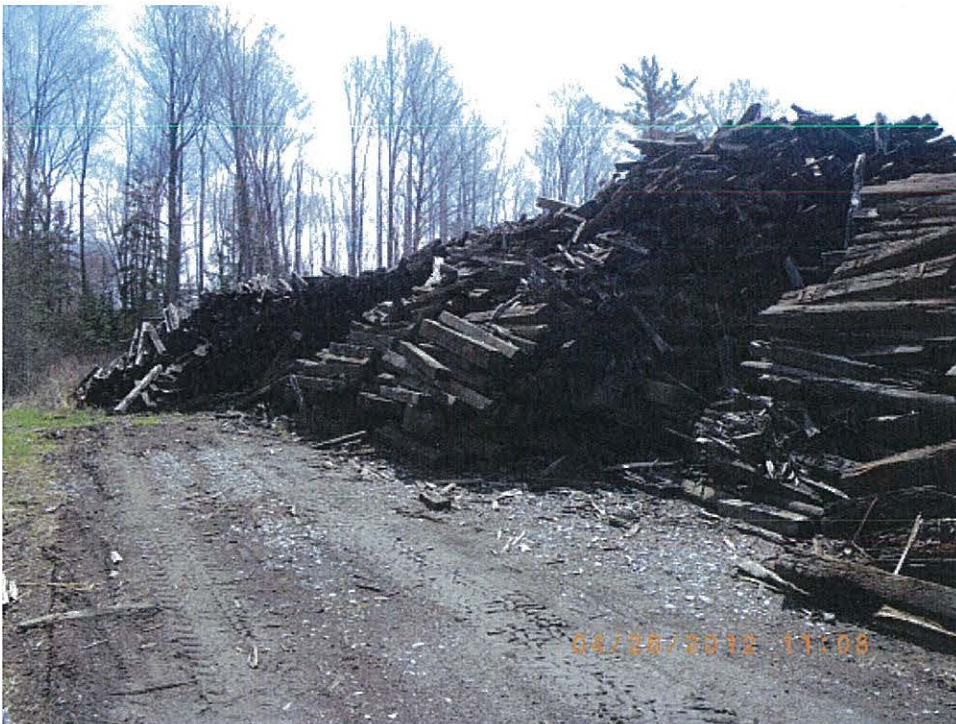
Photo IMGP9062: North end of the PCP railroad tie aggregate.  
Direction: Facing east.

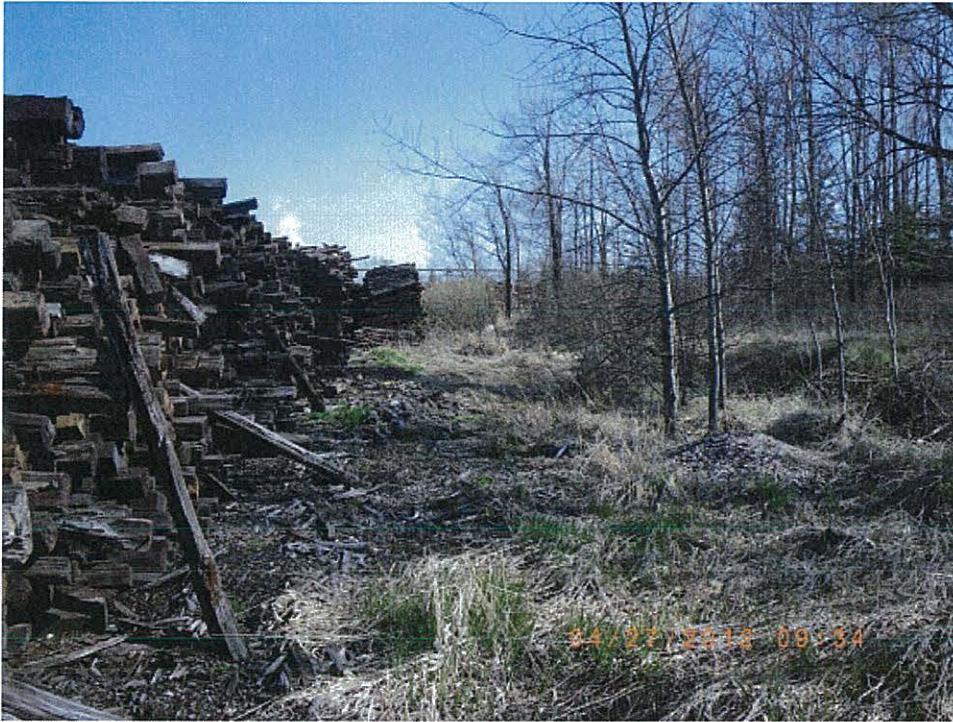
Photo IMGP9081: Eastern edge of the PCP railroad tie aggregate with the adjacent ditch containing water.  
Direction: Facing north.

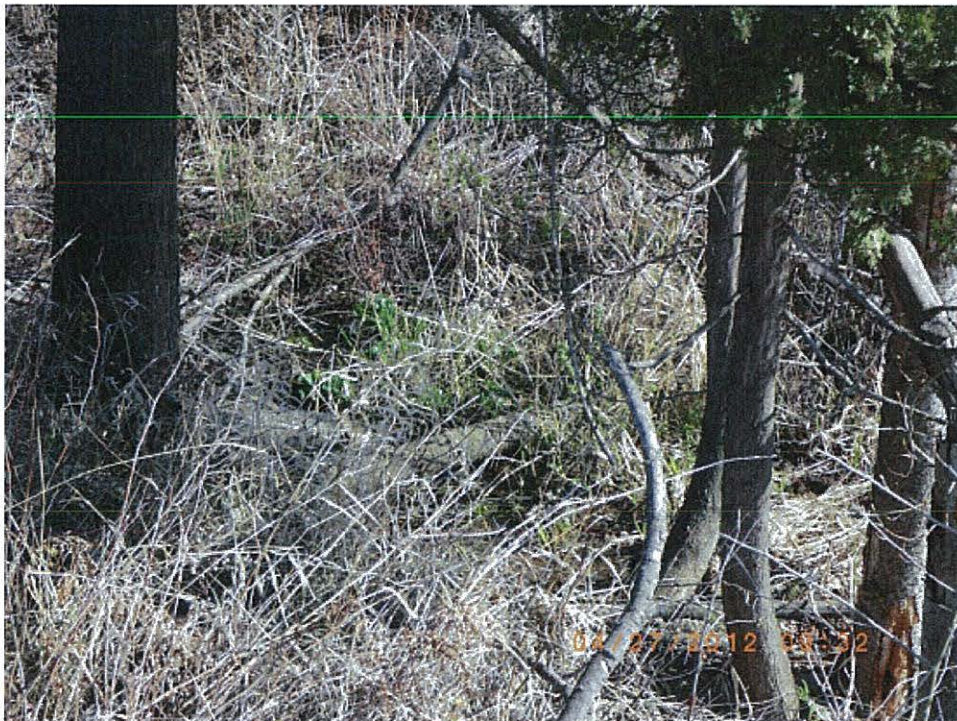
Photo IMGP9080: Water in the ditch on the eastern edge of the PCP railroad tie aggregate.  
Direction: Facing north.

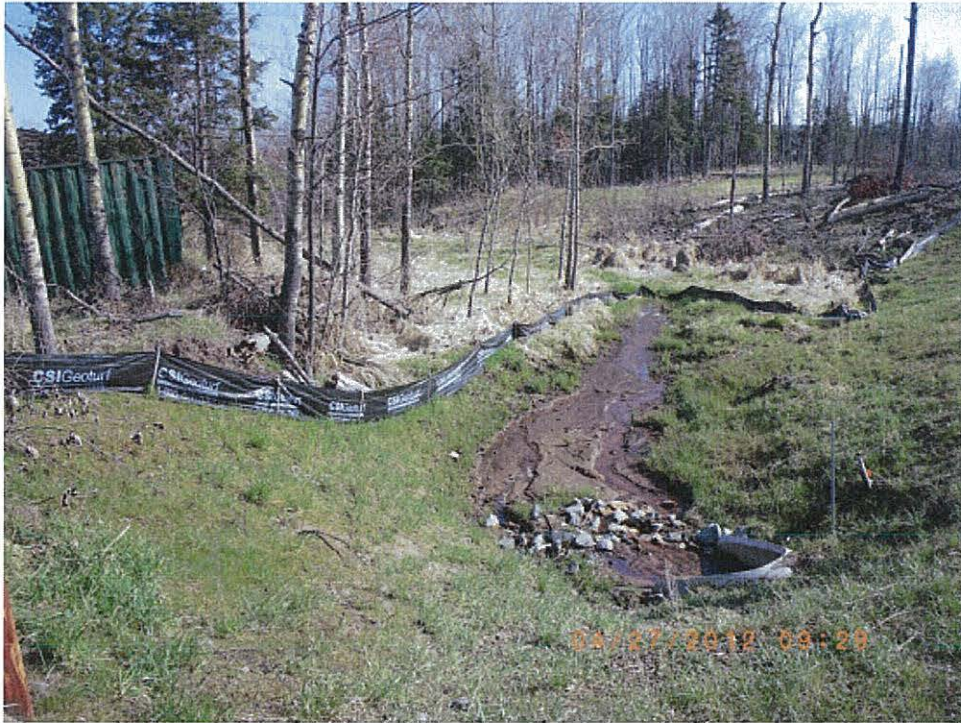
Photo IMGP9078: Culvert from under U.S. Highway 41 flowing onto the FAF.  
Direction: Facing northeast.

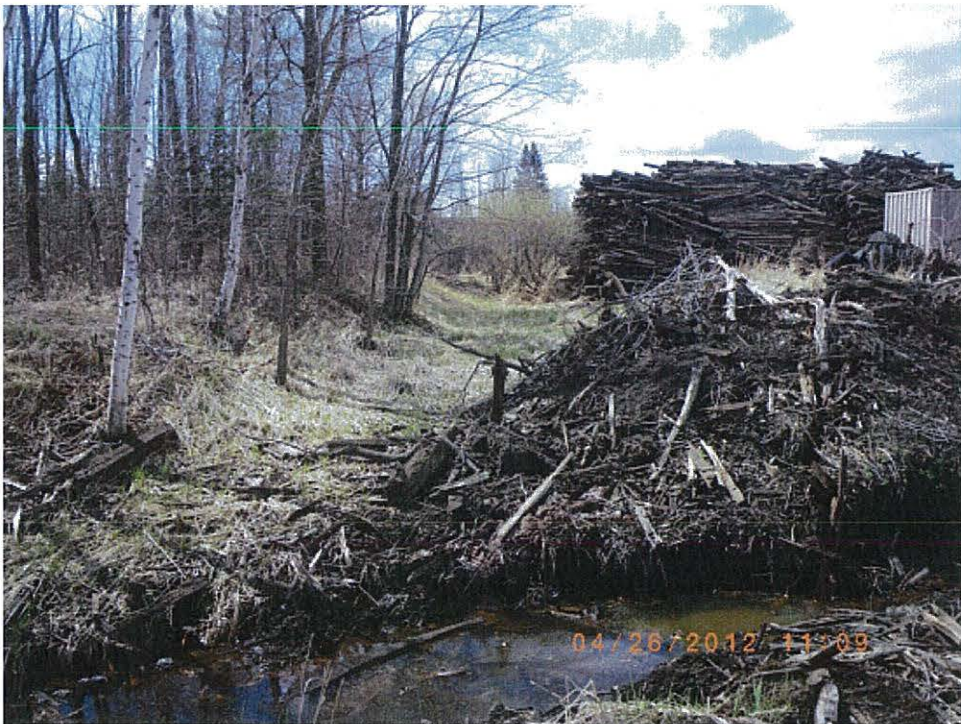
Photo IMGP9064: Ditch adjacent to the PCP railroad tie aggregate leading into a second ditch with water at the north end of the aggregate.  
Direction: Facing south.

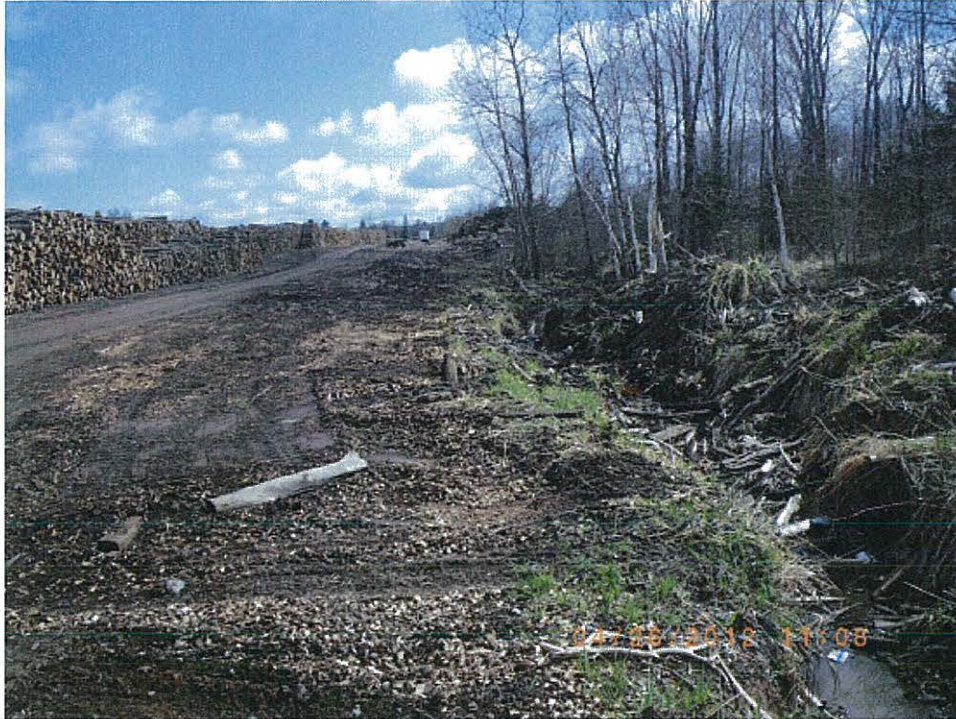
Photo IMGP9063: Ditch at the north end of the PCP aggregate with water and debris present.  
Direction: Facing east.

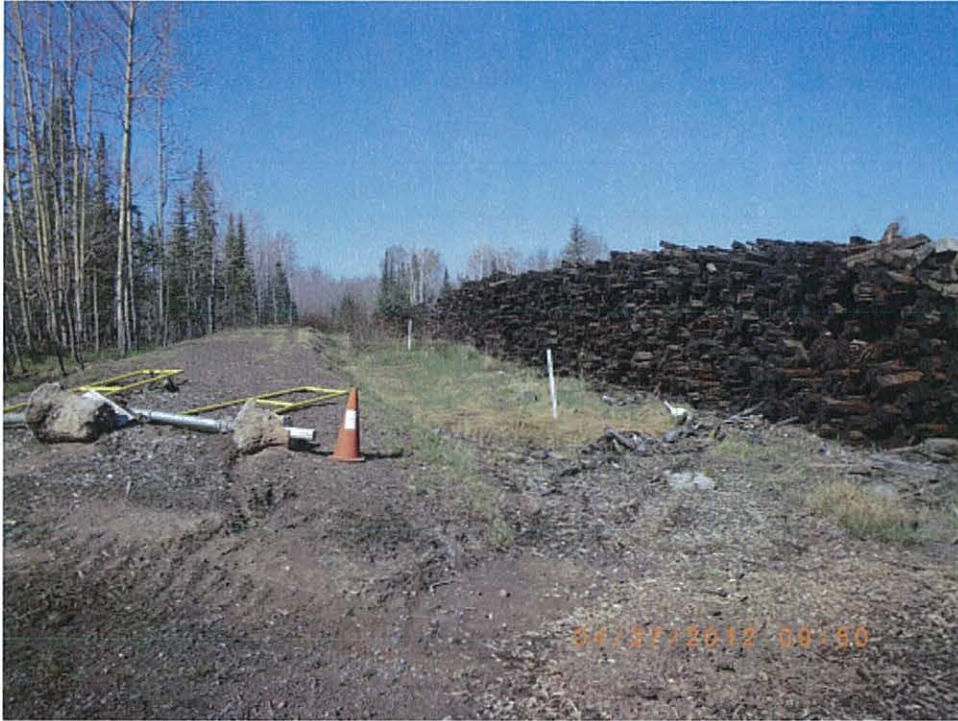
On the west side of the entry road running parallel to U.S. Highway 41 was a second railroad tie aggregate identified by facility representatives as being creosote treated railroad ties. This aggregate was not elevated off of the soil. I observed a berm along the south side of the creosote aggregate (Photo IMGP9085). The berm started at the FAF entrance and was approximately 150 feet in length. The berm did not extend the length of the aggregate. Immediately west of where the berm ended, I observed an area that showed evidence of water flowing into the creosote aggregate (Photo IMGP9086). I observed that this area had water at the time of the inspection. The west end of the creosote railroad tie aggregate was piled to the edge of the woods (Photo IMGP9087). I identified a small north flowing stream that ran along the west edge of the FAF that was approximately 30 to 40 feet from the west end of the creosote aggregate (Photo IMGP9089). The ground in the woods was vegetated between the creosote railroad ties and the stream. I observed a runoff path into the woods from the area around the creosote aggregate. I did not observe a distinct connection between the pathway and the stream. There was water in the pathway at the time of the inspection. The berm was the only structural control identified around the creosote aggregate during the inspection.

Photo IMGP9085: Creosote railroad tie aggregate with a berm running parallel on the south side.  
Direction: Facing west.

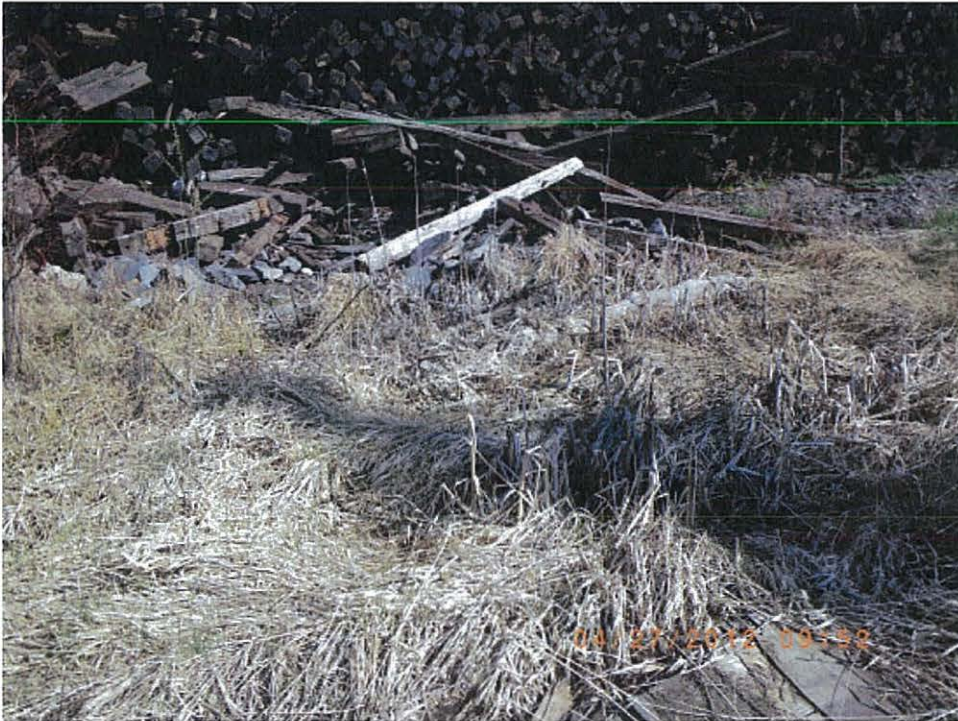
Photo IMGP9086: Wet area on the south side of the creosote railroad tie aggregate that showed evidence of flow under the aggregate.  
Direction: Facing north.

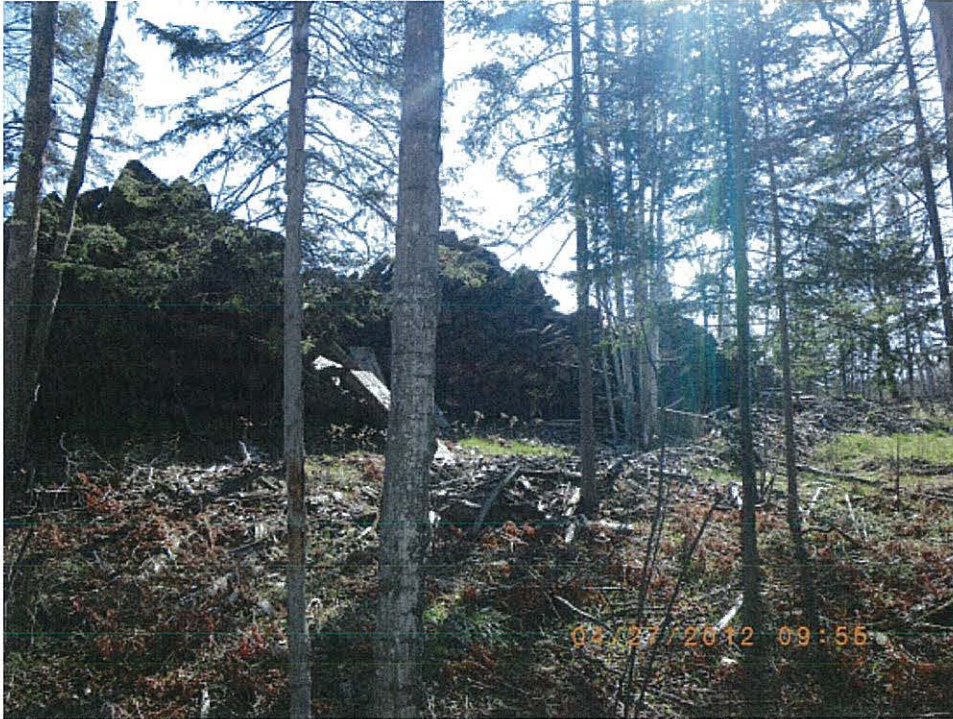
Photo IMGP9087: West end of creosote railroad aggregate adjacent to the woods.  
Direction: Facing southeast.

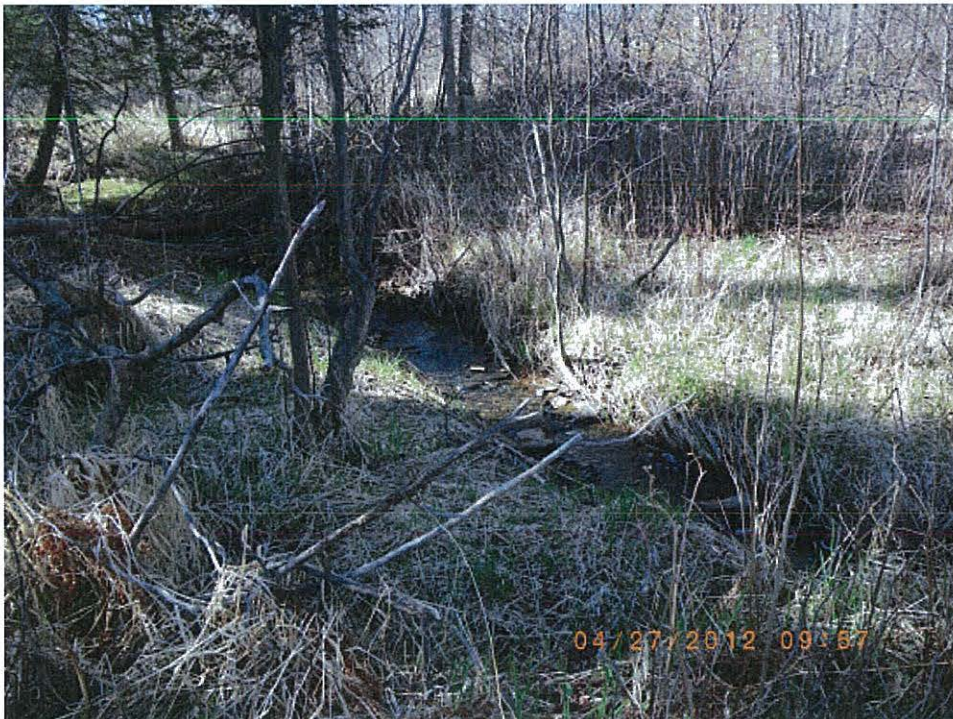
Photo IMGP9089: Stream running along the western edge of the FAF.  
Direction: Facing southwest.

In order to mitigate pollutants from entering the nearby stream, it is recommended that structural controls, such as berms and silt fencing, should be placed along the west side of the facility around railroad tie piles. BMPs should be implemented around the site to prevent storm water or run-on from off site from contacting sources of potential pollutants such as the railroad tie aggregates.

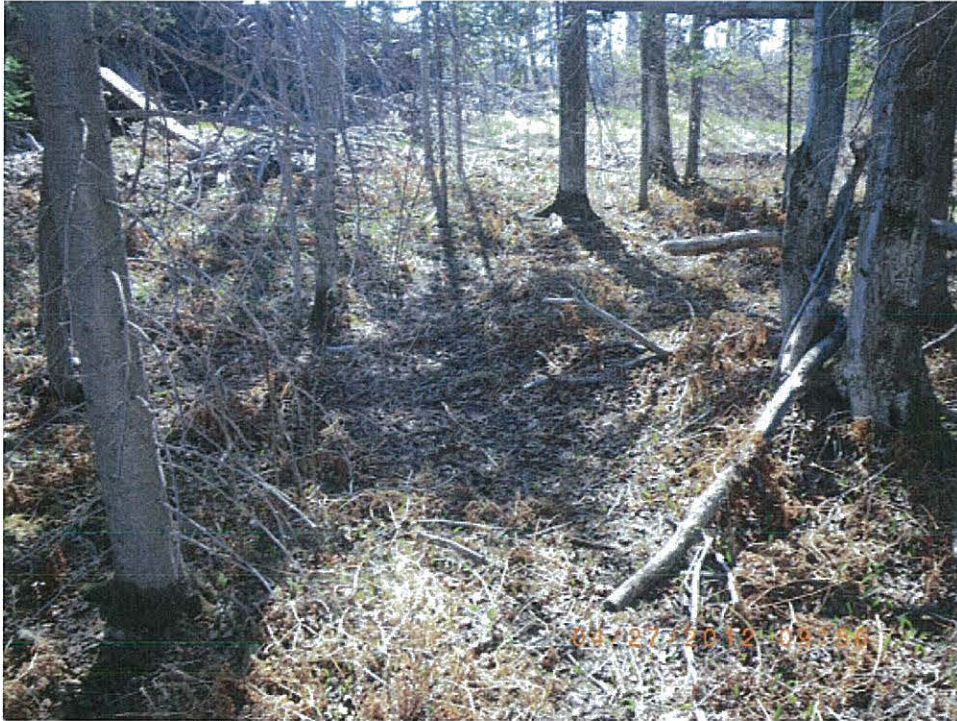
Photo IMGP9088: Runoff pathway from the area around the end of the creosote railroad tie aggregate into the woods and towards the stream along the west edge of the FAF.

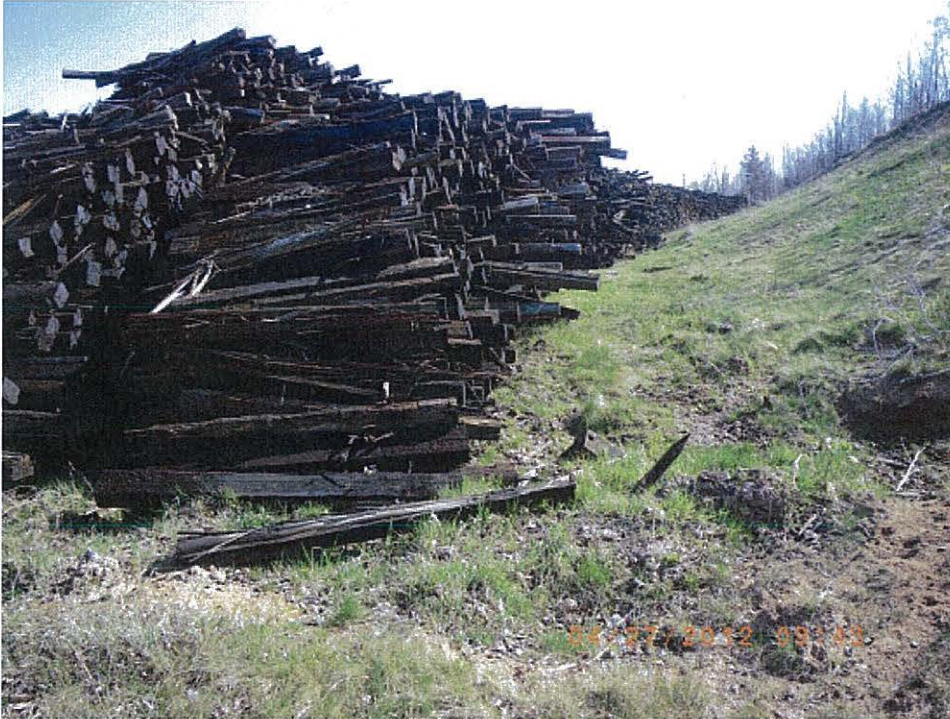
The third aggregate was termed the overflow railroad tie aggregate. All railroad ties in the overflow aggregate were creosote treated. The overflow aggregate ran parallel to U.S. Highway 41 just south of the Verso wood storage area. The aggregate was not elevated off of the soil. The overflow aggregate was situated at the base of a hill and ran parallel to U.S. Highway 41 (Photo IMGP9082). The hill was vegetated and ran the length of the overflow aggregate, turning slightly north at the east end of the overflow aggregate (Photo IMGP9061). The ground at the west end of the overflow aggregate was sloped west towards the woods. No water or pathways were observed around the overflow aggregate. There were no structural controls identified around the overflow aggregate.

Photo IMGP9082: View from the west end along the south side of the overflow railroad tie aggregate.  
Direction: Facing northeast.

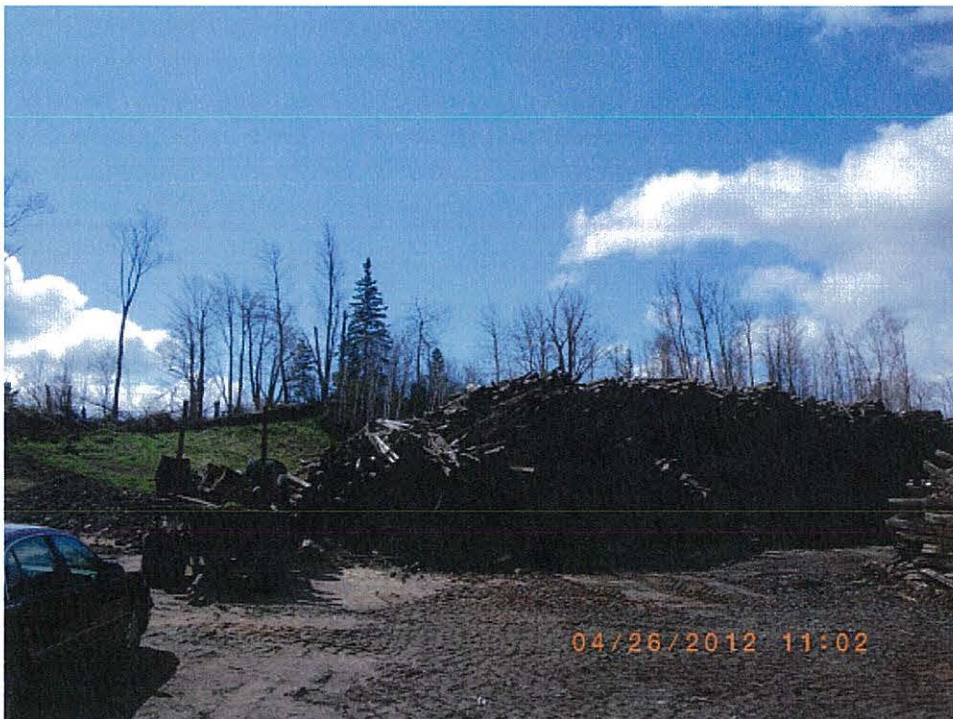
Photo IMGP9061: East end of the overflow railroad tie aggregate.  
Direction: Facing south.

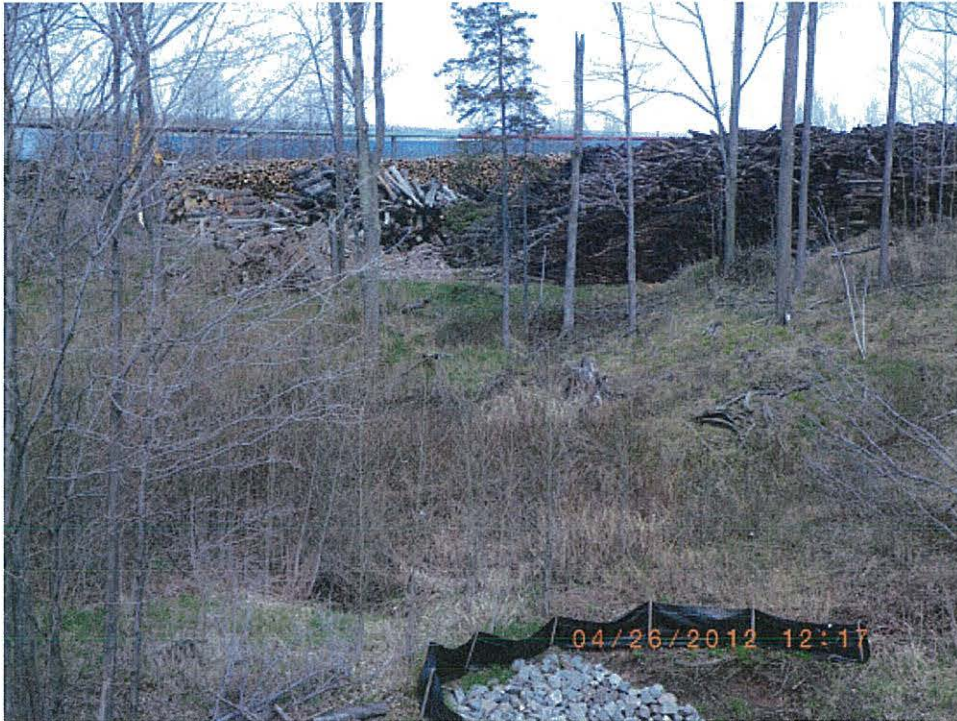
Photo IMG9077: Overflow railroad tie aggregate from U.S. Highway 41.  
Direction: Facing northeast.

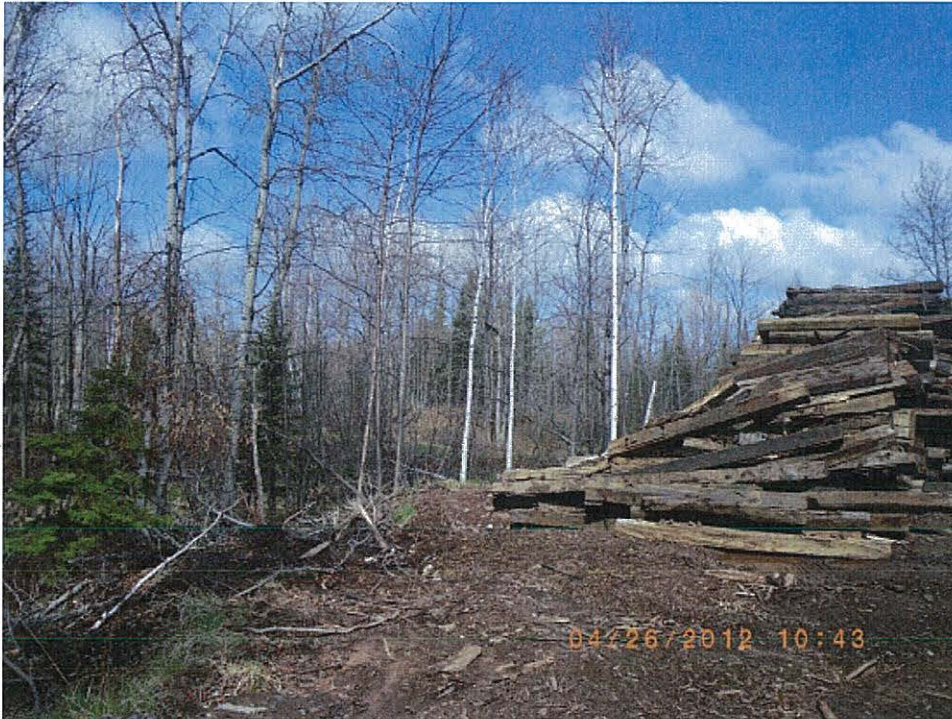
I observed an additional small pile of railroad ties at the west end of the FAF along the edge of the woods (Photo IMG9053 and IMG9052). The railroad ties were located on the west of the construction area behind the processed railroad tie storage area. Facility representatives identified the railroad ties as those that needed to have metal removed. The length of time that the railroad ties sat at this location is unknown, but appeared significant based on the dirt buildup at the base of the pile (Photo IMG9052). I observed that the railroad ties were located within 20 feet of the stream that ran along the west edge of the FAF. The area between the railroad ties and the stream was vegetated and contained debris. No structural controls were observed around the railroad ties.

Photo IMGP9053: Additional pile of railroad ties located west of the processed railroad tie storage building.  
Direction: Facing northwest.

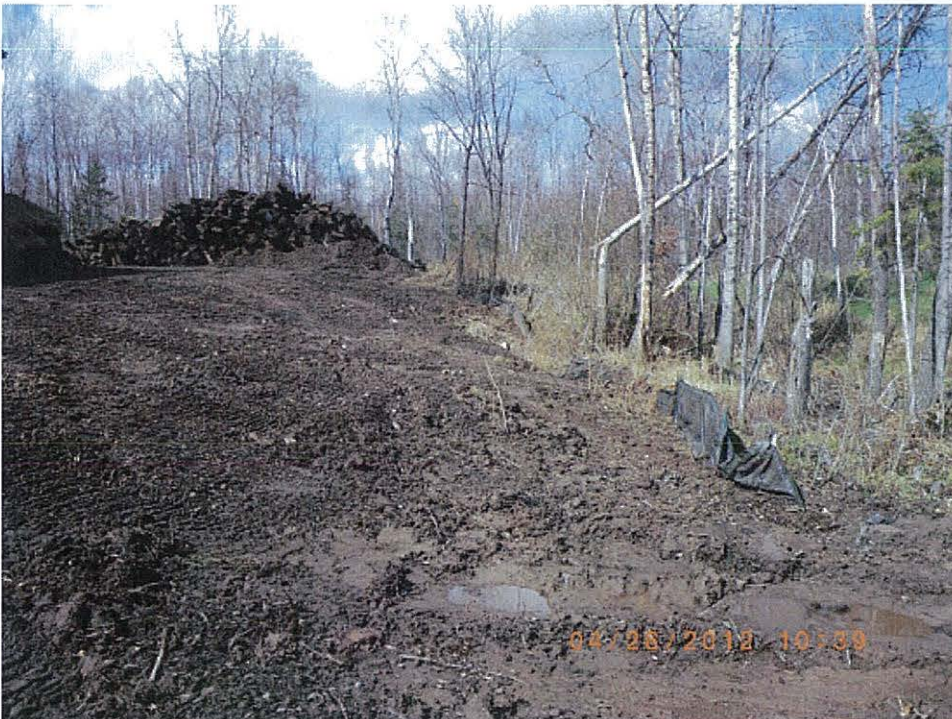
Photo IMGP9052: Loose soil located at the construction area along the west side of the processed railroad tie storage building.  
Direction: Facing west.

I observed that the construction area around the processed railroad tie storage building was not stabilized in accordance with the NPDES general permit for discharges from construction activity (Photo IMGP9052). This was most apparent on the north and west sides. The area contained loose dirt and no vegetation. Water was pooled in several areas of the uneven soil at the time of the inspection (Photo IMGP9052). Along the north edge of the construction area there was a ditch that contained water at the time of the inspection. The water in the ditch was not flowing (Photo IMGP9050 and IMGP9049). There was silt fencing on the sides of the ditch. I observed that the ditch led to the small stream that runs along the western end of the FAF. The ditch was vegetated and contained significant debris including fallen trees and branches (Photo IMGP9049). I observed silt fencing along the north side and at the northwest corner of the construction area. The silt fencing was not continuous. Facility representatives stated that the silt fencing was put up for the construction work and was never removed. The silt fencing that remained had not been properly maintained and contained areas of both torn and fallen fence (Photo IMGP9050). In some areas, there were gaps underneath the fence. I observed a pile of dirt and rock that contained eroded runoff pathways that led into the woods towards the small stream on the west side of the FAF (Photo IMGP9054). The pile was located on the west side of the processed railroad tie storage building. Large rocks and dirt from the pile were observed in the woods within 10 feet of the small stream. There were no structural controls observed around the area.

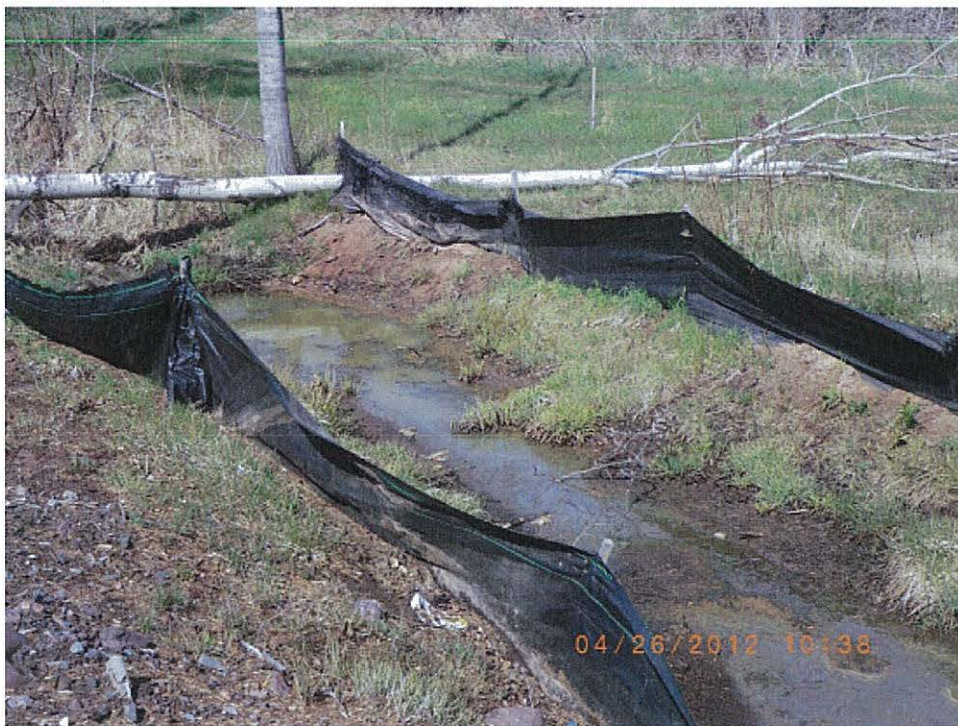
Photo IMGP9050: Silt fencing along the ditch at the north end of the construction area. Direction: Facing northwest.

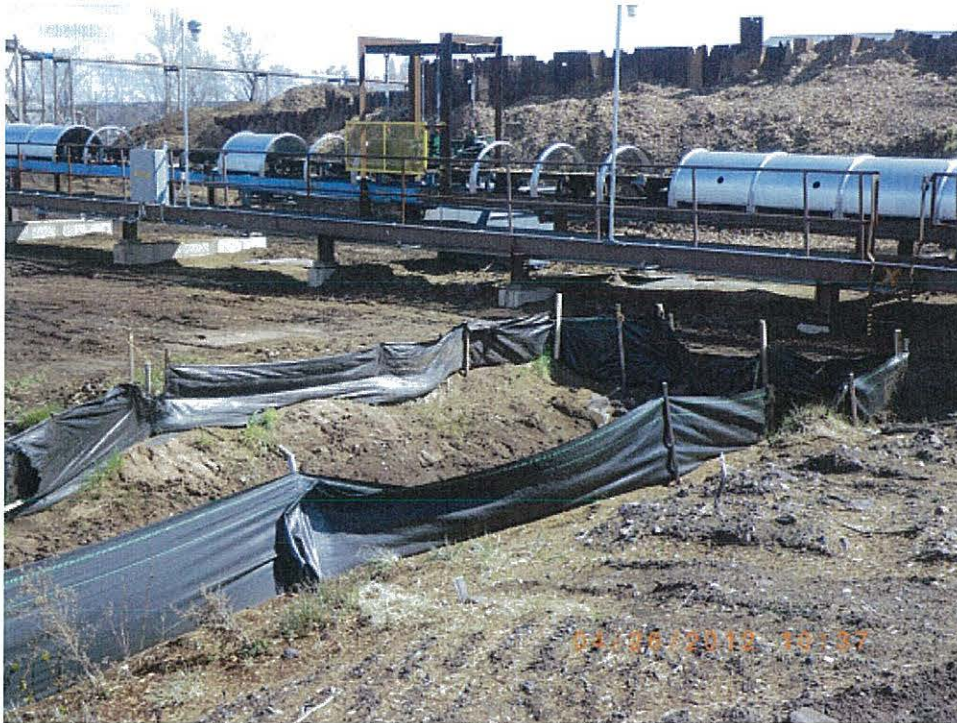
Photo IMGP9049: Silt fencing around the ditch at the north end of the construction area with identifiable rips and missing segments.  
Direction: Facing northeast.

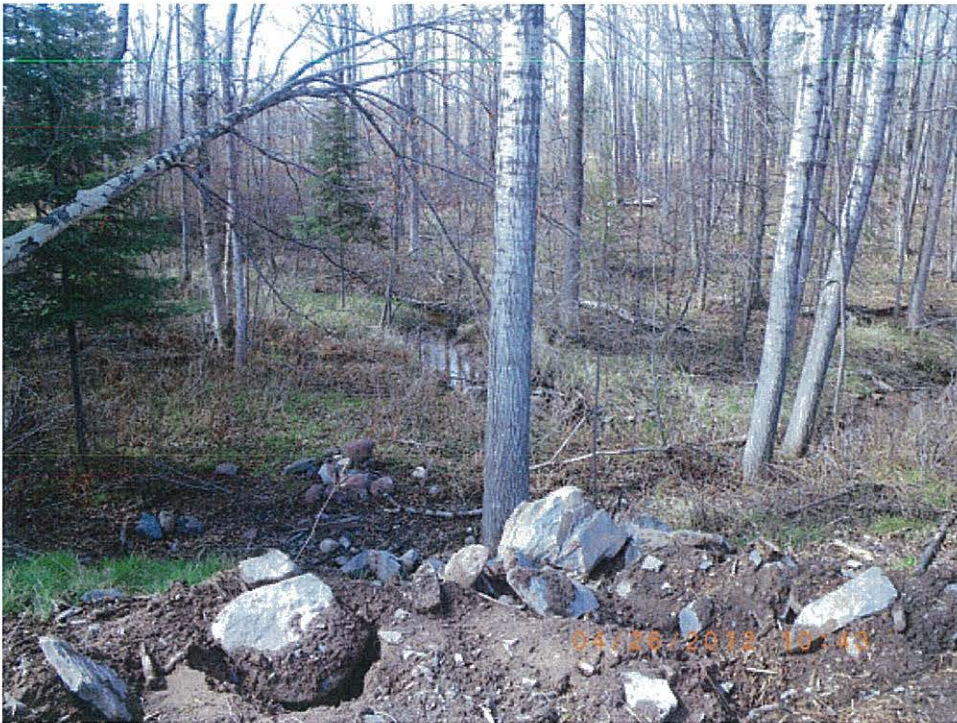
Photo IMGP9054: Soil and rock that was piled along the western side of the construction with identifiable runoff pathways leading towards the stream.  
Direction: Facing southwest.

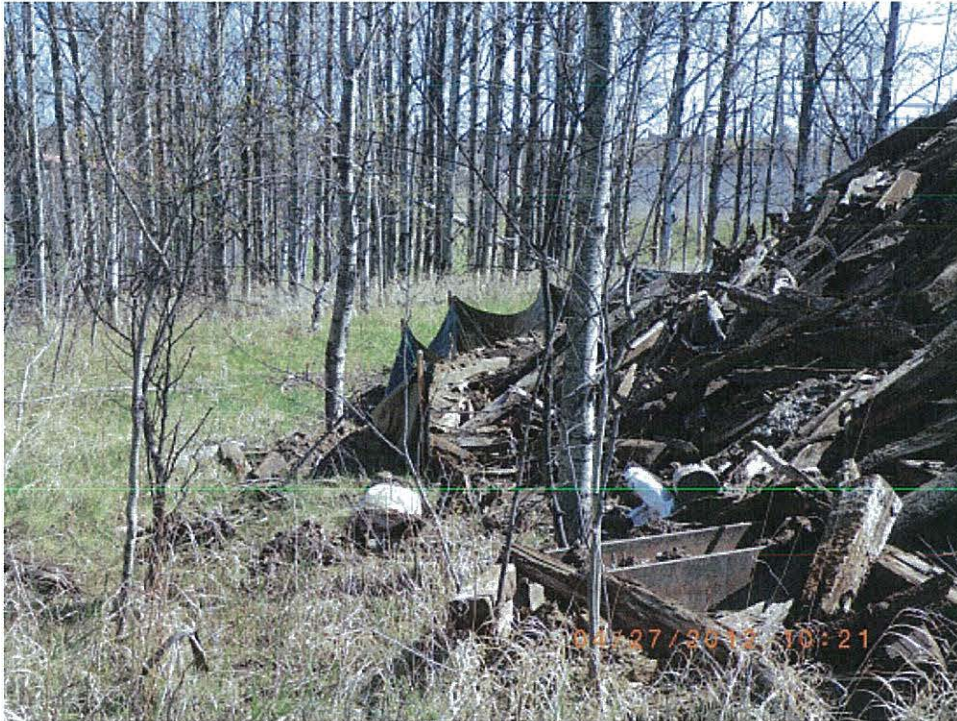
I observed a pile of railroad tie scrap wood pieces and dirt at the northeast corner of the facility where railroad ties are unloaded from the railcars (Photo IMGP9098). Facility representatives identified the pile as material removed from the bottom of railcar after railroad ties have been offloaded. Next to the pile were two uncovered dumpsters (Photo IMGP9097). Railroad tie pieces and soil are loaded into the dumpsters and shipped off site. The current pile was too large to be put into two dumpsters. Facility representatives stated that dumpsters are not picked up frequently enough to only store the material in the two dumpsters. I observed that there was silt fencing along the north side of the pile (Photo IMGP9098). Any runoff from the pile that would leave the FAF would flow through a heavily vegetated wooded area before reaching CertainTeed (Photo IMGP9098). The silt fencing was the only structural control identified.

Photo IMGP9098: Backside of the scrap railroad tie and soil pile with silt fencing around the backside. Direction: Facing northeast.

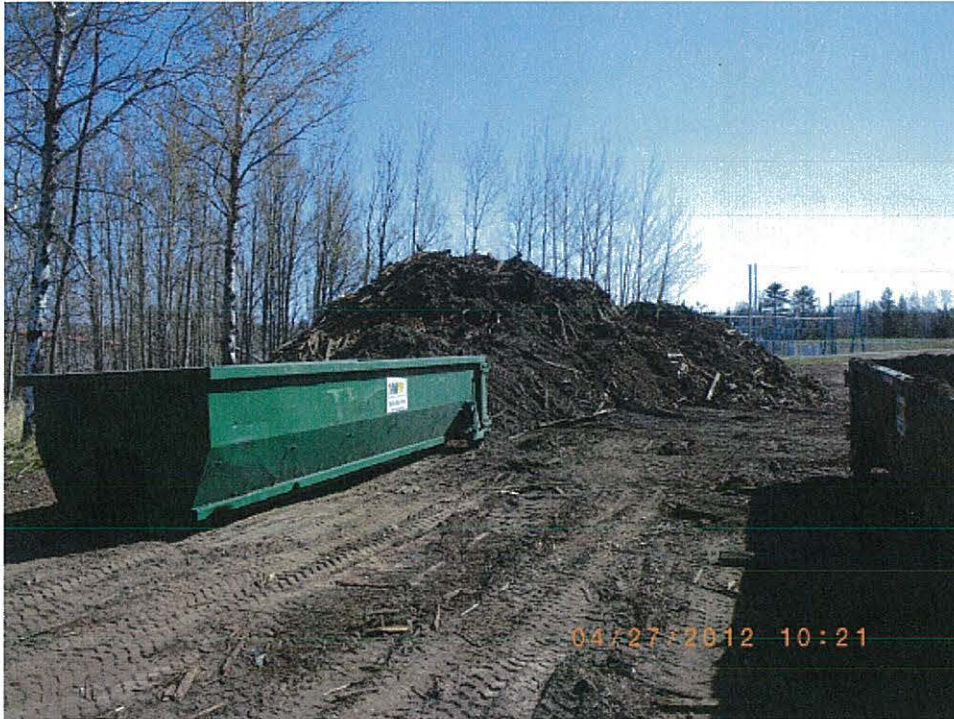
Photo IMGP9097: Dumpsters used to remove the scrap railroad tie and dirt material.  
Direction: Facing northeast.

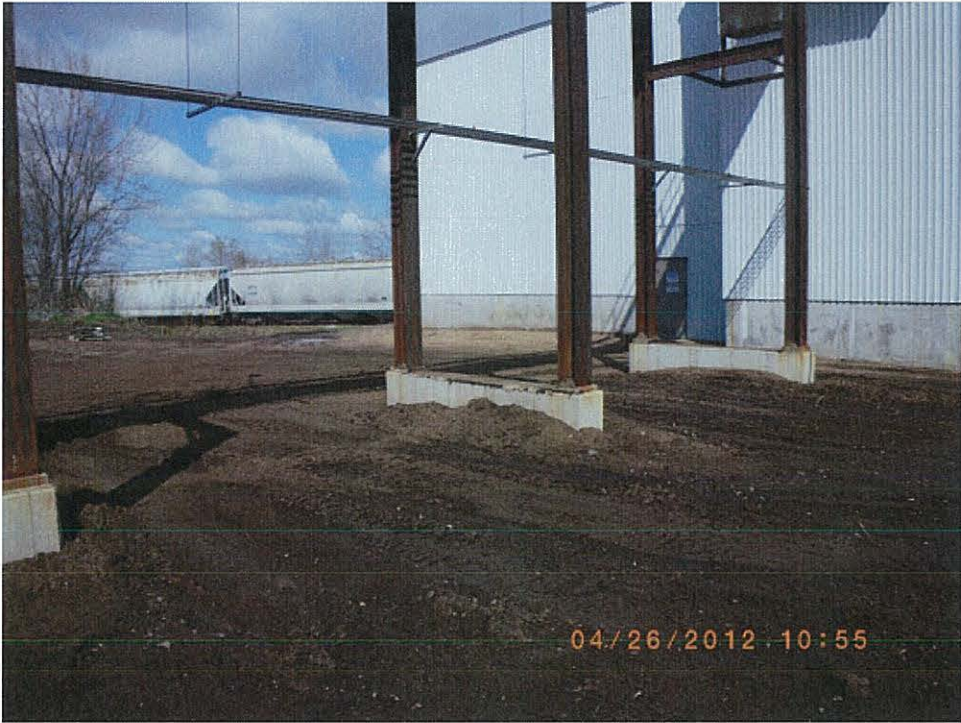
I observed that the conveyor belt to the wood room building is covered, but there was a buildup of fine wood particles underneath the conveyor (Photo IMGP9058). I observed fine wood particles falling from the conveyor. The area below the conveyor was wet. There was a section of silt fencing that remained from previous construction activity that was located next to the conveyor loading bin. There were no other structural controls observed around the wood room building or under the conveyor. I observed a ditch that entered the woods near the the northwest corner of the wood room building (Photo IMGP9094). The ditch was vegetated once it entered the woods (Photo IMGP9095). The ditch led to the stream along the west side of the FAF (Photo IMGP9096). No flow was observed in the ditch during the inspection.

Photo IMG9058: Wood fines accumulated under the conveyor leading to the wood room building.  
Direction: Facing northwest.

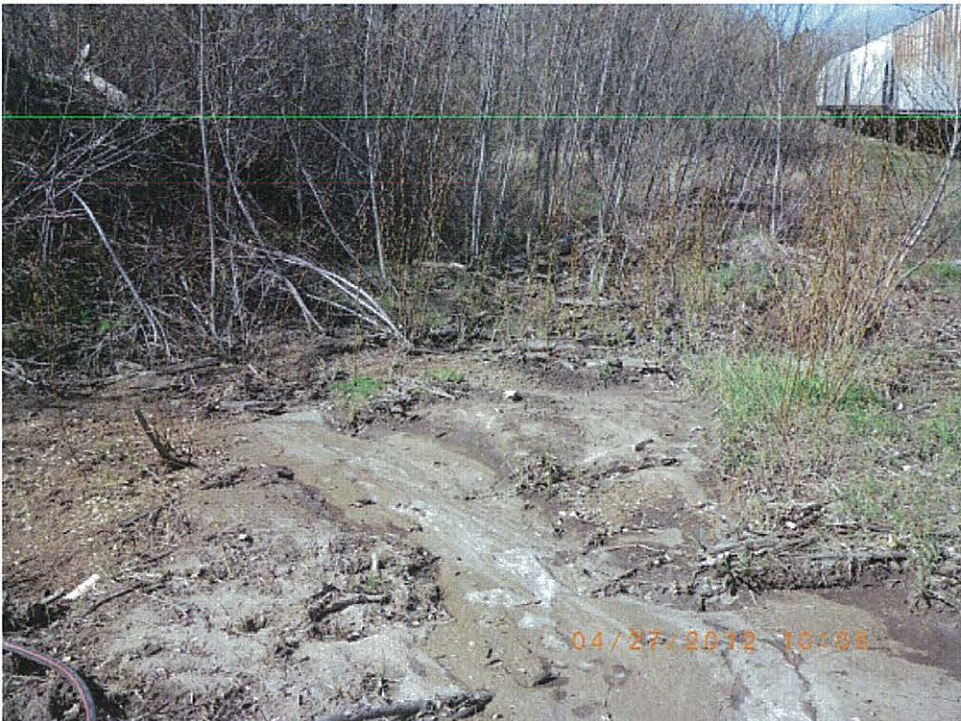
Photo IMG9094: Discharge pathway into the ditch at the northwest corner of the wood room building.  
Direction: Facing west.

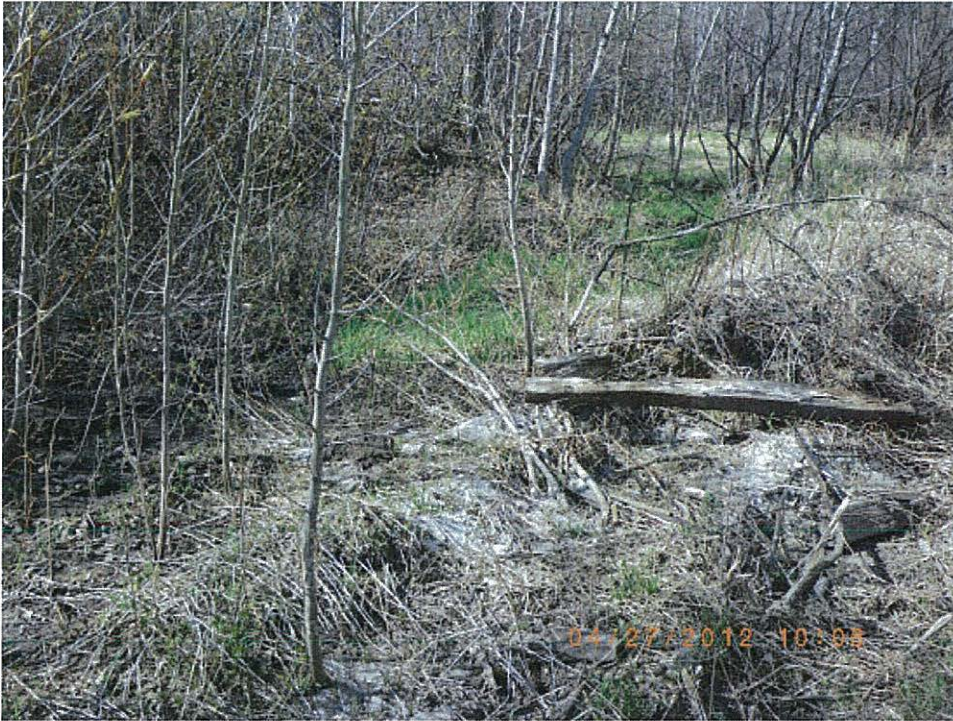
Photo IMGP9095: Vegetated area of the ditch originating at the northwest corner of the wood room building.  
Direction: Facing west.
