Subject: **April 2012 Compliance Evaluation Inspection**

**CWA COMPLIANCE EVALUATION INSPECTION REPORT  
U.S. ENVIRONMENTAL PROTECTION AGENCY, REGION 5**

L'Anse Warden Electric Company  
Fuel Aggregation Facility  
17696 U.S. Highway 41  
L'Anse, Michigan 49946  
46.749590, -88.462230

MIS310000

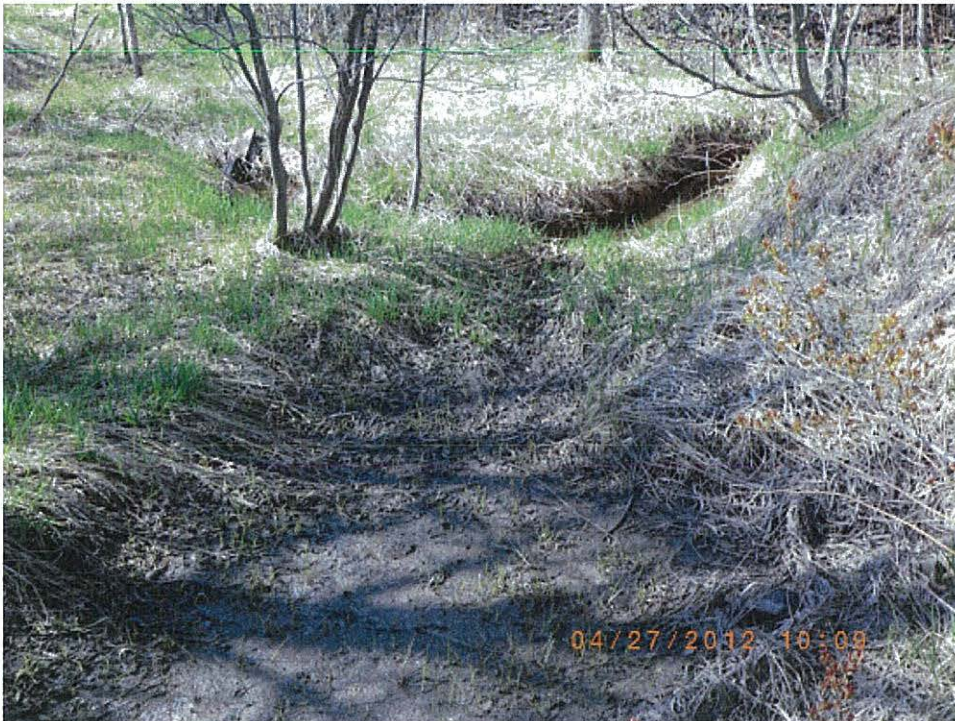
I observed that the conveyor belt to the wood room building is covered, but there was a buildup of fine wood particles underneath the conveyor (Photo IMGP9058). I observed fine wood particles falling from the conveyor. The area below the conveyor was wet. There was a section of silt fencing that remained from previous construction activity that was located next to the conveyor loading bin. There were no other structural controls observed around the wood room building or under the conveyor. I observed a ditch that entered the woods near the the northwest corner of the wood room building (Photo IMGP9094). The ditch was vegetated once it entered the woods (Photo IMGP9095). The ditch led to the stream along the west side of the FAF (Photo IMGP9096). No flow was observed in the ditch during the inspection.

Photo IMGP9096: Discharge point from the ditch into the stream along the west edge of the FAF.  
Direction: Facing southwest.

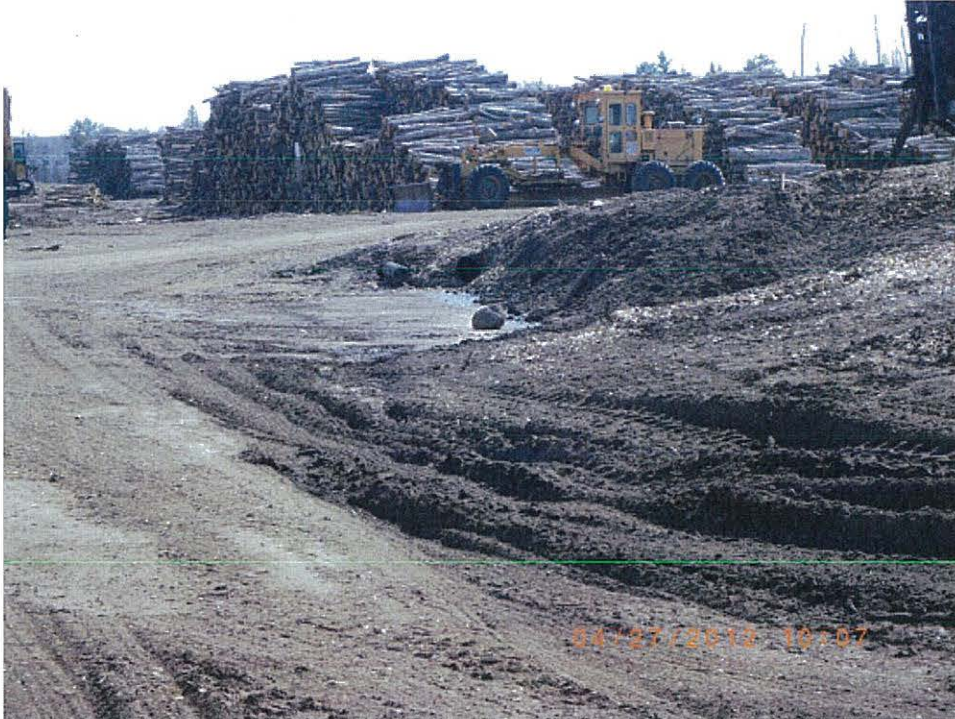
Photo IMG9092: Culvert from the Verso wood storage area.  
Direction: Facing east.

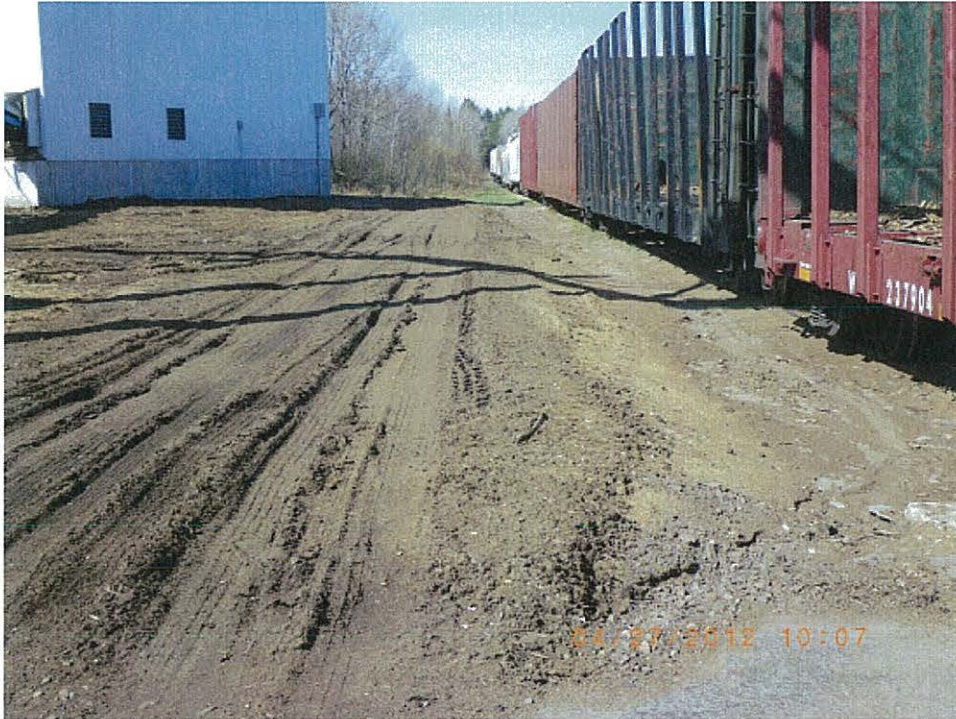
I observed a runoff pathway along the south edge of the railroad tracks that entered the ditch at the northwest corner of the wood room building. A facility representative identified the sources of storm water that contributed to the pathway as the runoff from the central dirt area in the FAF and from a Verso wood storage area culvert (Photo IMG9092). I observed that the re-chipping pile was upslope of the runoff pathway. The pathway was well defined until it entered the woods at which time it became vegetated (Photo IMG9094, IMG9095, IMG9096 and IMG9093). The ditch connected with the stream that runs along the west side of the FAF. There were no structural controls around the pathway at the time of the inspection.

Photo IMGP9093: Runoff pathway along the south side of the railroad tracks leading to the ditch at the northwest corner of the wood room building.  
Direction: Facing west.
