# Corsica River Watershed Restoration Action Strategy: Final Report

## **Excerpt Showing an Example of Stream Sampling Documentation**

**September 2004**

**CORSICA RIVER WATERSHED  
SCA SURVEY RESULTS**

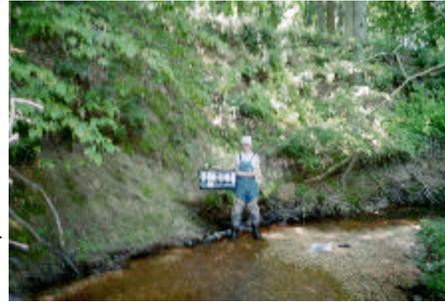
Problem	Site	Date	Type	Possible Cause	Length(ft)	Height(ft)	Landuseight	Landuseleft	Infrastructure Threatened?	Describe	Severity	Correctability	Access
Erosion Site	021103	06/25/2003	Widening	Natural	1037	4	Forest	Forest	No		1	2	2
Erosion Site	138202	06/09/2003	Widening	Below Channelization	7230	4	Forest	Forest	No		1	5	4
Erosion Site	160102	06/03/2003	Widening	Below Road Crossing	3430	4	Crop Field	Forest	No		1	4	2
Erosion Site	061101	06/24/2003	Widening	Bend at Steep Slope	4380	1	Forest	Forest	No		2	2	4
Erosion Site	066203	07/07/2003	Downcutting	Bend at Steep Slope	1000	1.5	Forest	Forest	No		2	2	4
Erosion Site	091203	06/24/2003	Downcutting	Bend at Steep Slope	3200	1	Forest	Forest	No		2	2	2
Erosion Site	098104	05/12/2003	Widening	Bend at Steep Slope	1720	2	Forest	Forest	No		2	3	4
Erosion Site	109102	05/27/2003	Widening	Land Use Change Upstream	1720	3	Forest	Forest	No		2	4	3
Erosion Site	109203	06/03/2003	Widening	Bend at Steep Slope	1480	2	Forest	Forest	No		2	3	2

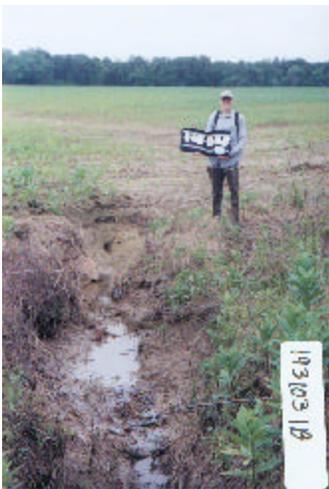
Inadequate Buffer	193103	06/17/2003	Both	Both	0	0	1575	1575	Crop Field	Crop Field	No	No		1	3	2	2

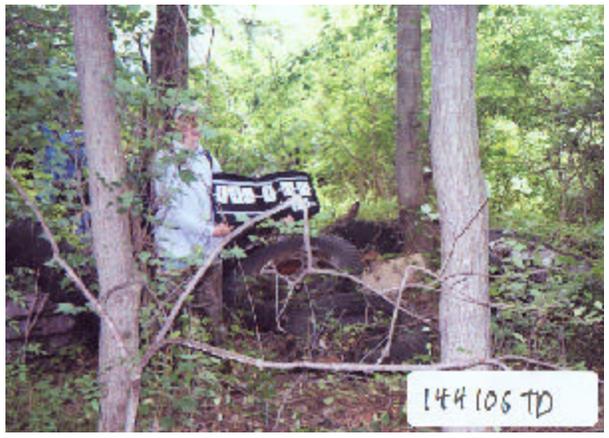
Problem	Site	Date	Type	Truckloads	Other measure	Extent	Volunteer Project?	Owner Type	Owner Name	Severity	Correctability	Access
Trash Dumping	144106	06/17/2003	Cars/Buses	30	40-50 Cars, junkyard	Large Area	No	Private		3	4	2
Trash Dumping	105203	06/24/2003	Residential	1		Single Site	Yes	Private		4	1	2
Trash Dumping	105205	06/24/2003	Industrial	2		Single Site	No	Unknown		4	2	2
Trash Dumping	118102	06/24/2003	Residential	1		Single Site	Yes	Private		4	2	2
Trash Dumping	144205	06/12/2003	Tires	3		Single Site	No	Unknown		4	4	3
Trash Dumping	096202	06/03/2003	Construction	3		Large Area	Yes	Unknown		5	2	2
Trash Dumping	099102	06/09/2003	Lumber/Building Materials	1		Single Site	Yes	Private		5	1	3
Trash Dumping	147103	06/03/2003	Lumber	1		Single Site	Yes	Private		5	3	3

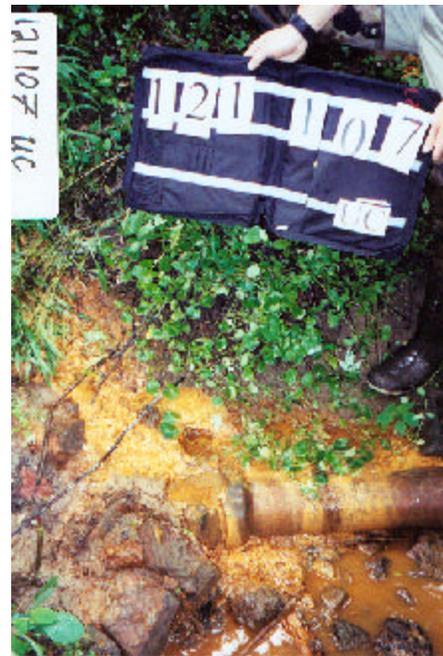
Problem	Site	Date	Type	Description	Potential Cause	Severity	Correctability	Access
Unusual Condition	121107	05/28/2003	Abnormal Seep From Bank	Musky Smelling Seep 3ft long, 10 inches side	Land Use Change Upstream	2	2	2
Unusual Condition	085102	05/12/2003	Red Flock	Red Flock In Stream below instream pond	eutrophication in pond	3	3	2
Unusual Condition	134106	06/03/2003	Red Flock	Excessive Red Flock Present	Iron Oxides	3	3	2
Unusual Condition	139106	06/11/2003	Channel Discharging into Stream	Dark Brown Discharge in Channel entering stream	Unknown	3	3	2
Unusual Condition	143206	06/17/2003	Orange Substance Leaking from Bank	Orange Substance leaking from bank in many different places along section of bank	Runoff from field	3	4	3
Unusual Condition	098105	05/12/2003	Black Organic Material	Stream has large amount of black organic material present		4	3	3
Unusual Condition	109101	05/27/2003	Excessive Sediment	Whole Tributary w/excessive sediment from upstream construction	Upstream Construction	4	4	3
