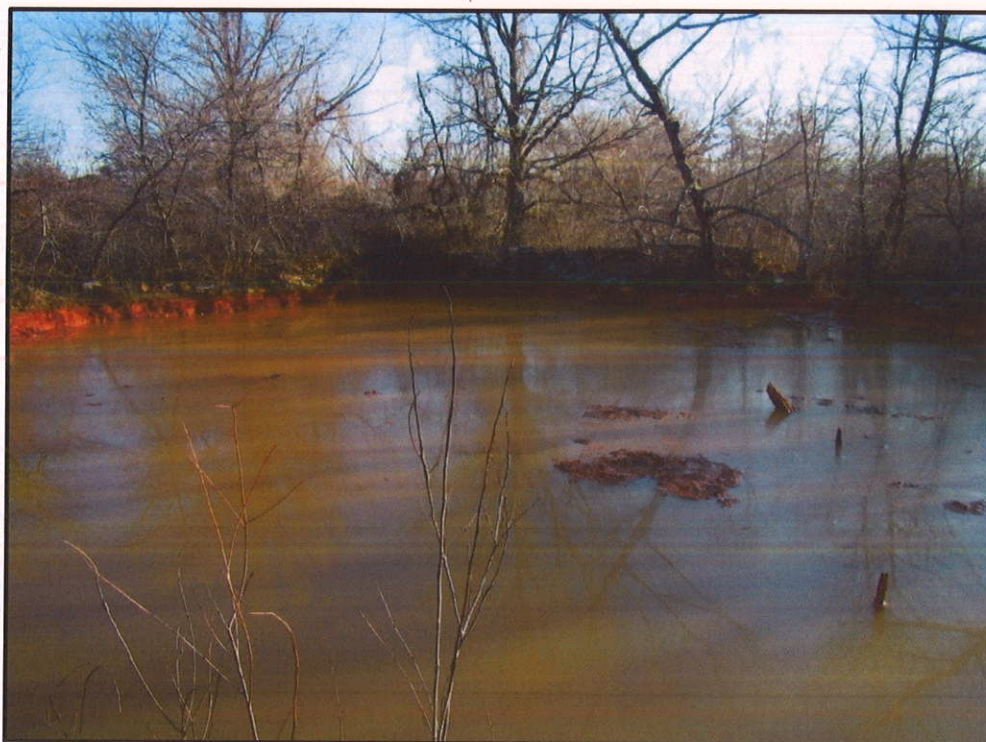
Photo 25: Flooded Collapsed Mine Feature at Admiralty Mine Site

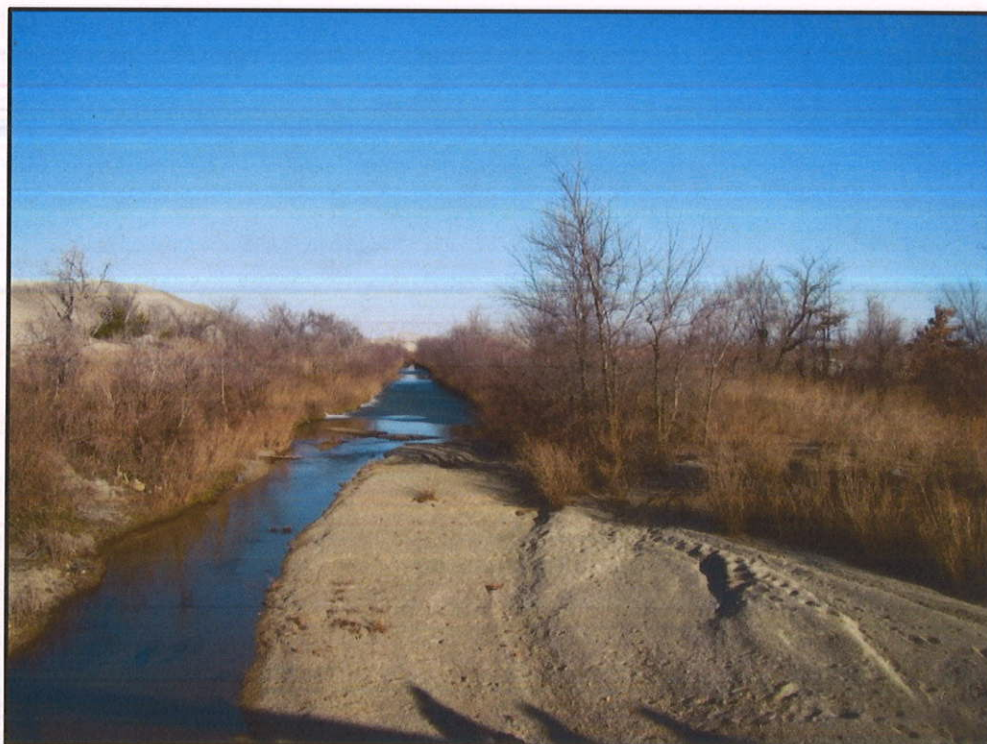
Photo 26: Tar Creek at Douthat Bridge (photo taken facing upstream)

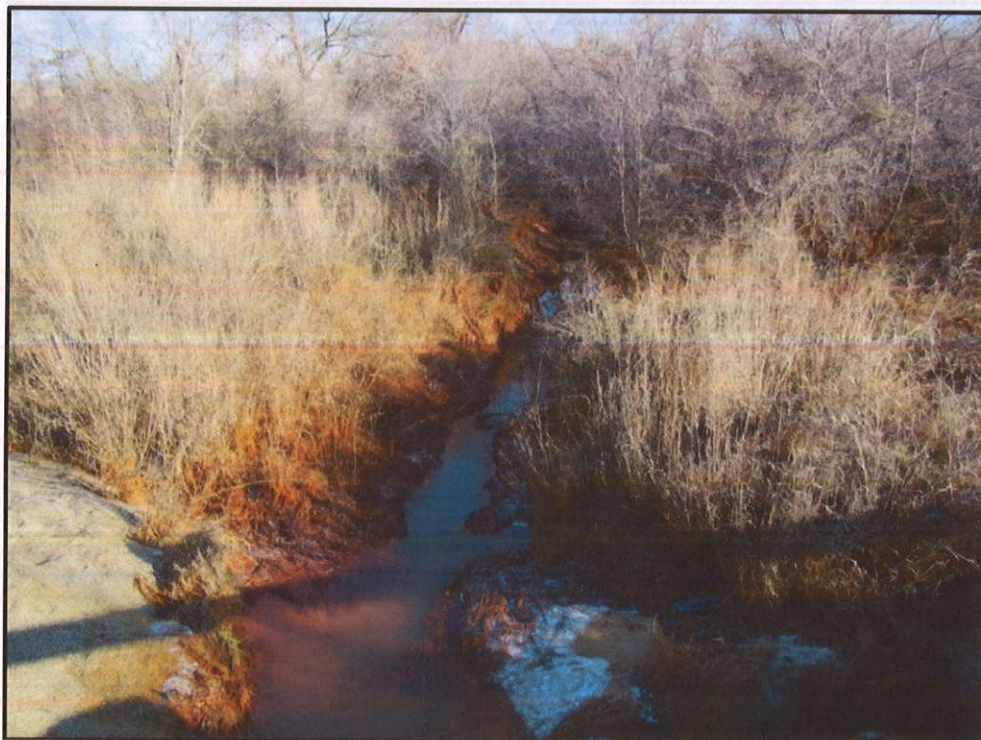
Photo 27: Former Lytle Creek at Douthat Bridge (photo taken facing upstream)

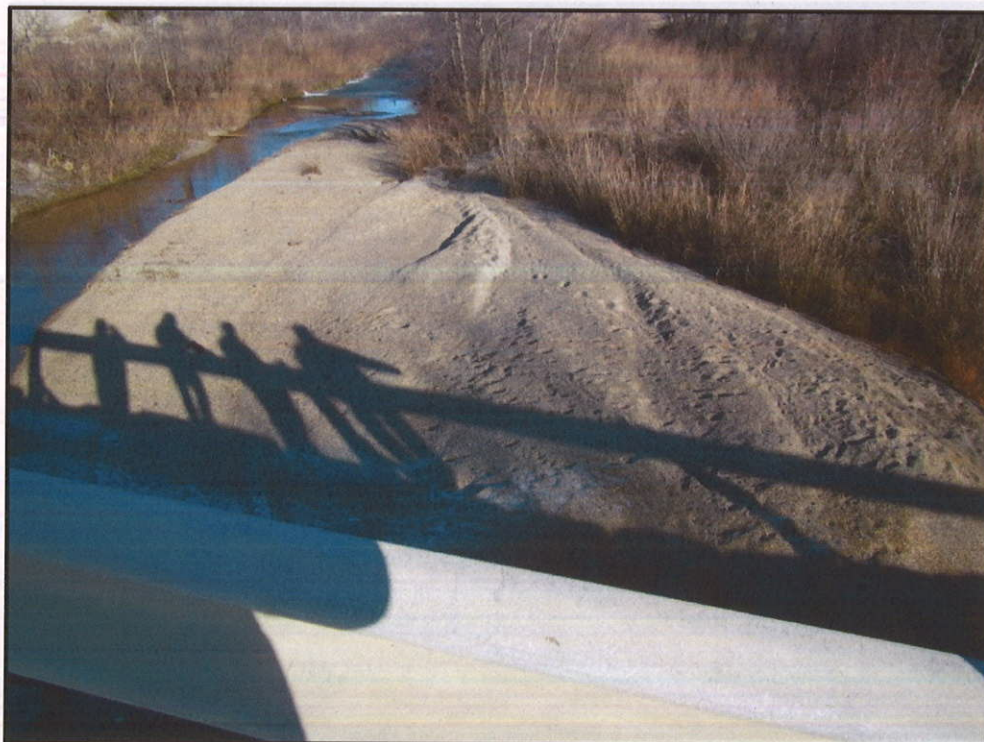
Photo 28: Chat in Tar Creek at Douthat Bridge (photo taken facing upstream)

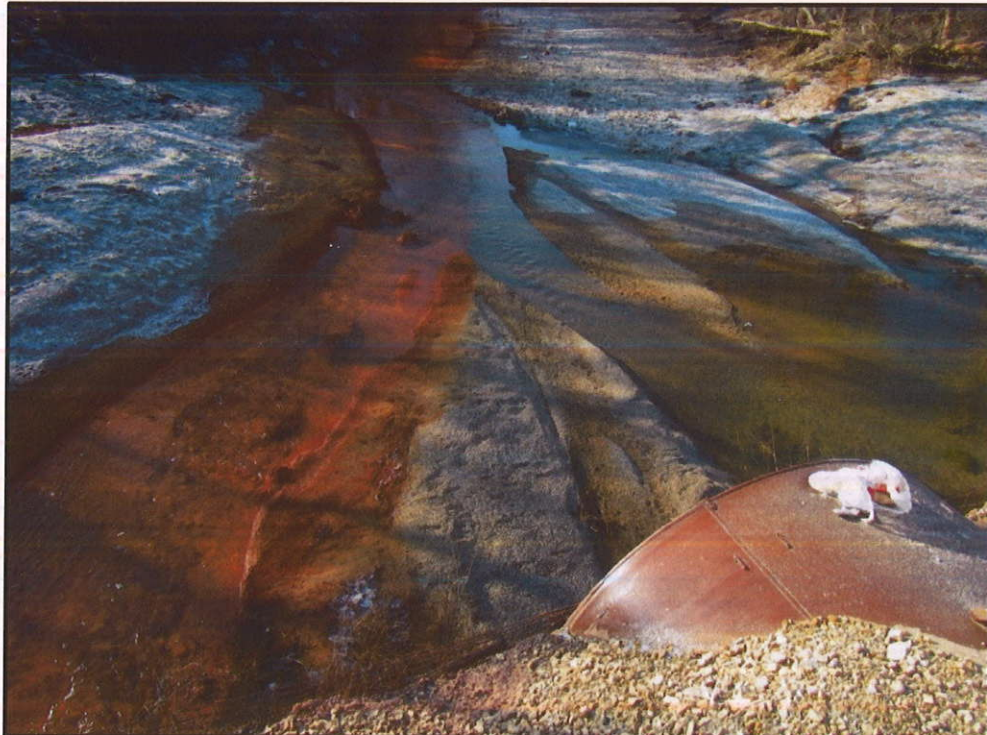
Photo 29: Tar Creek at Douthat Bridge (photo taken facing downstream)

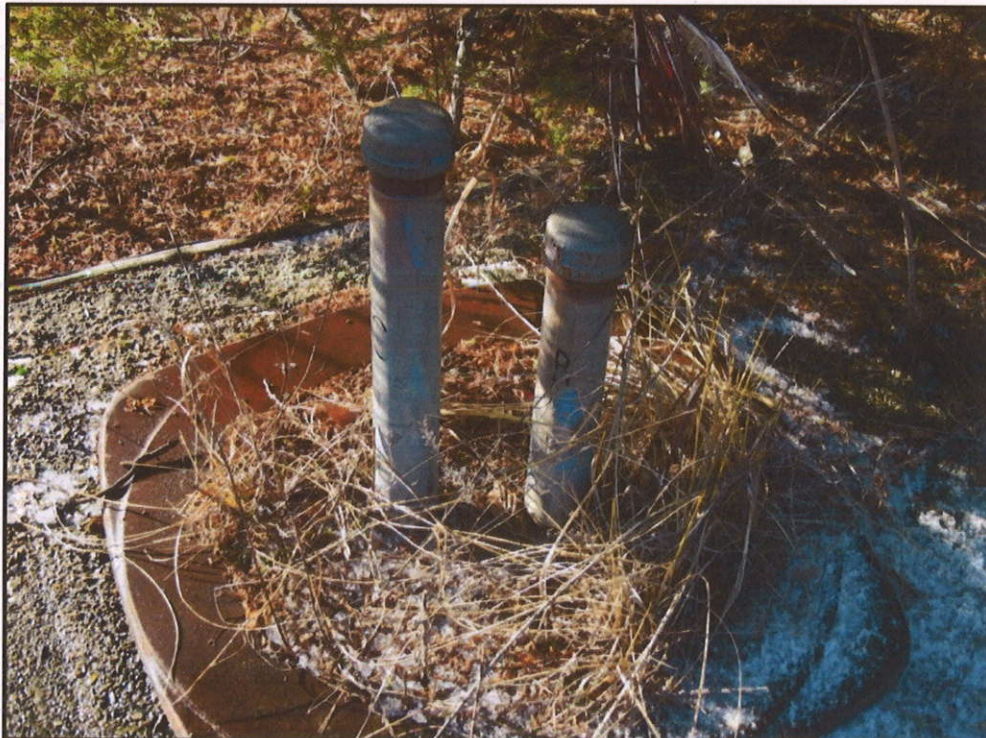
Photo 30: Powerhouse Well in January 2015 (well plugged in February 2015)

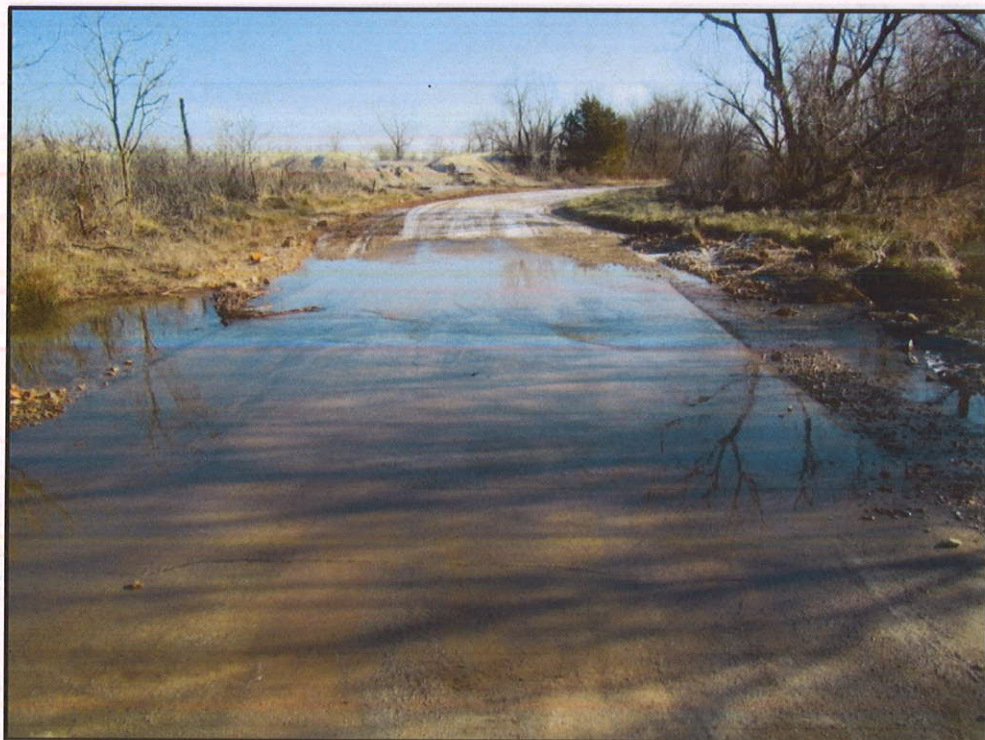
Photo 31: Tar Creek at Stateline Road between Oklahoma and Kansas

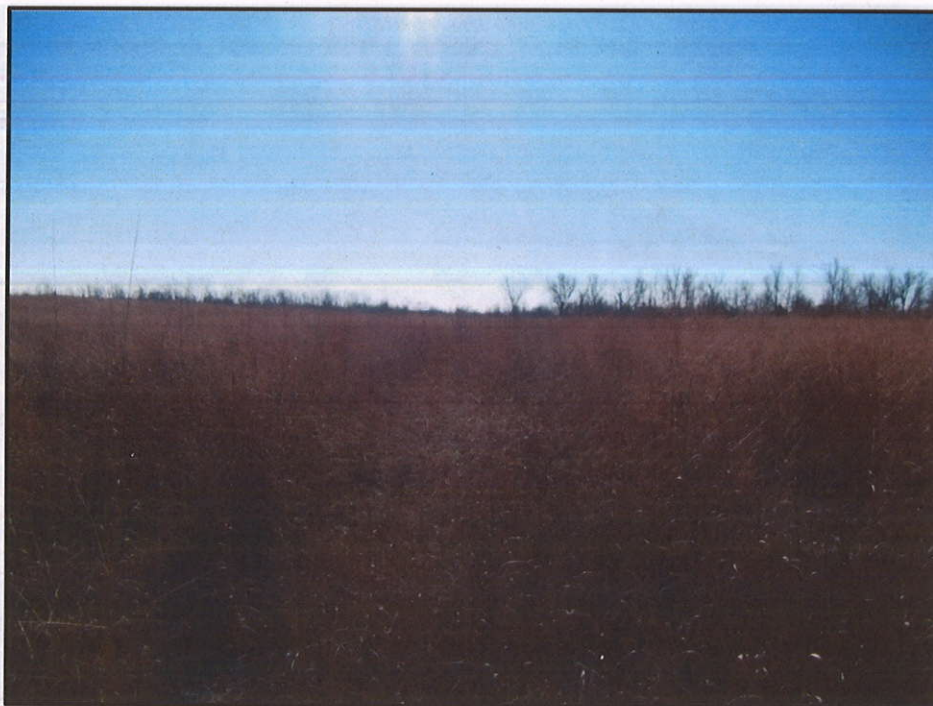
Photo 32: OU2 Repository Formerly Owned by Picher Development Authority; Property Currently Owned by Quapaw Tribe

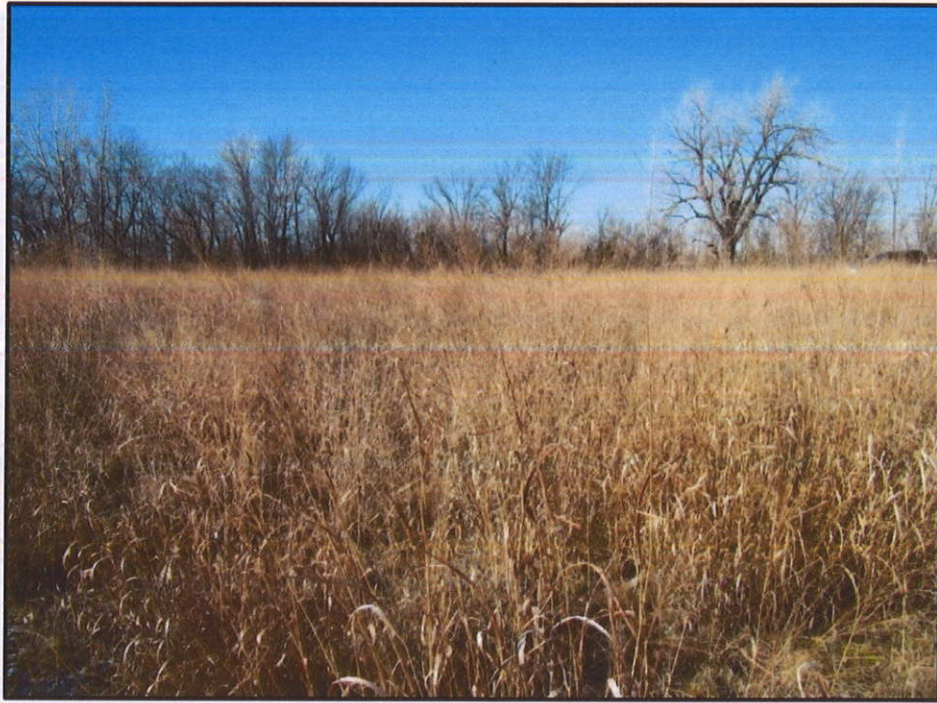
Photo 33: OU2 Repository Formerly Owned by Picher Development Authority; Property Currently Owned by Quapaw Tribe

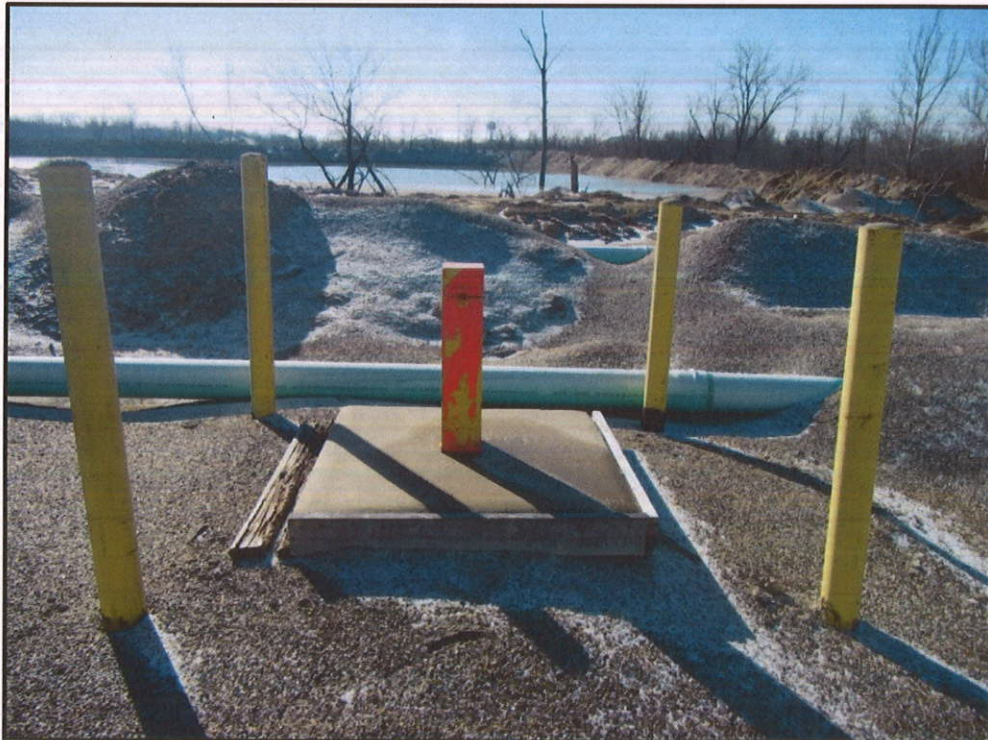
Photo 34: MW-1 at Sooner Pile, Location of Chat Injection Pilot Study

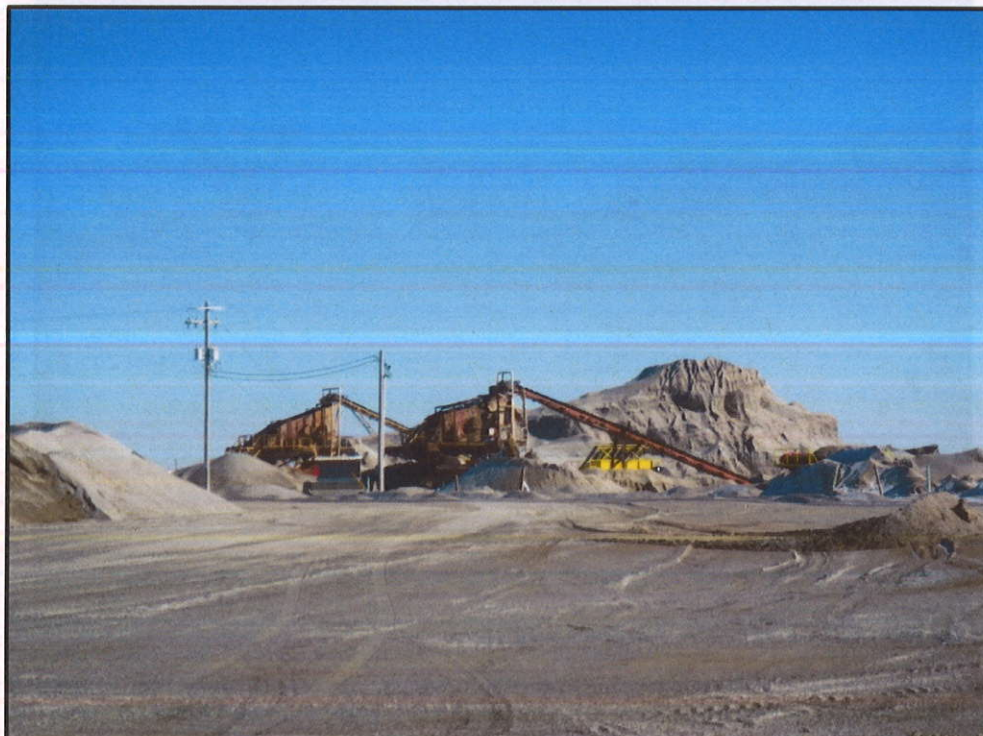
Photo 35: Chat Washing Operation at Sooner Pile

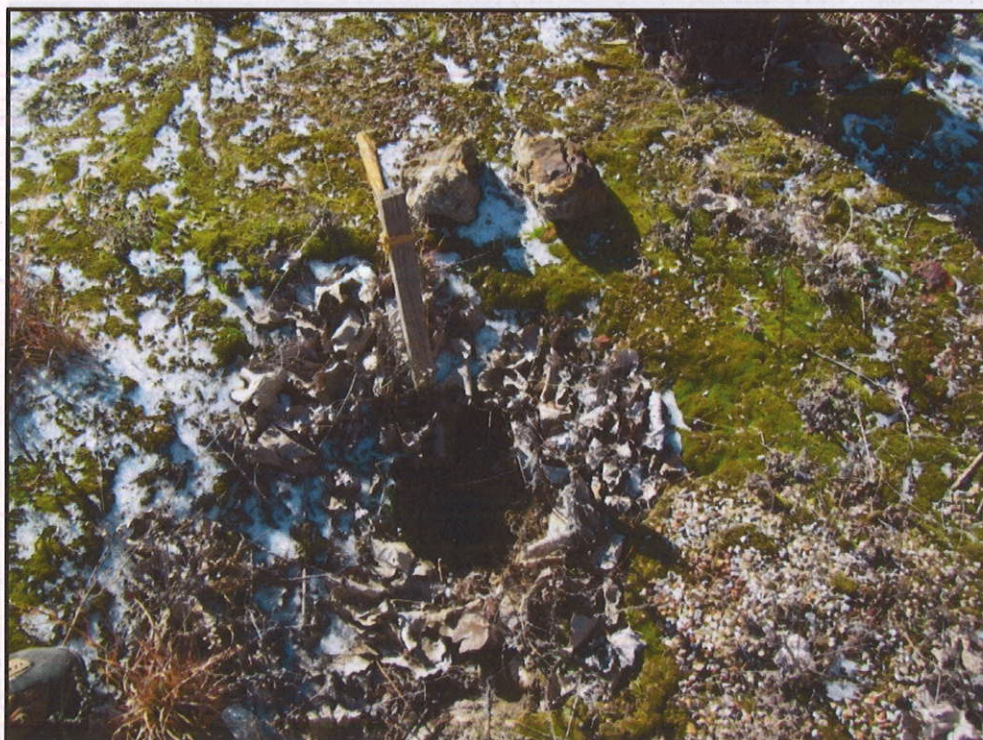
Photo 36: Tulsa Mine Well at Atlas Chat Pile
(well was plugged in February 2015)

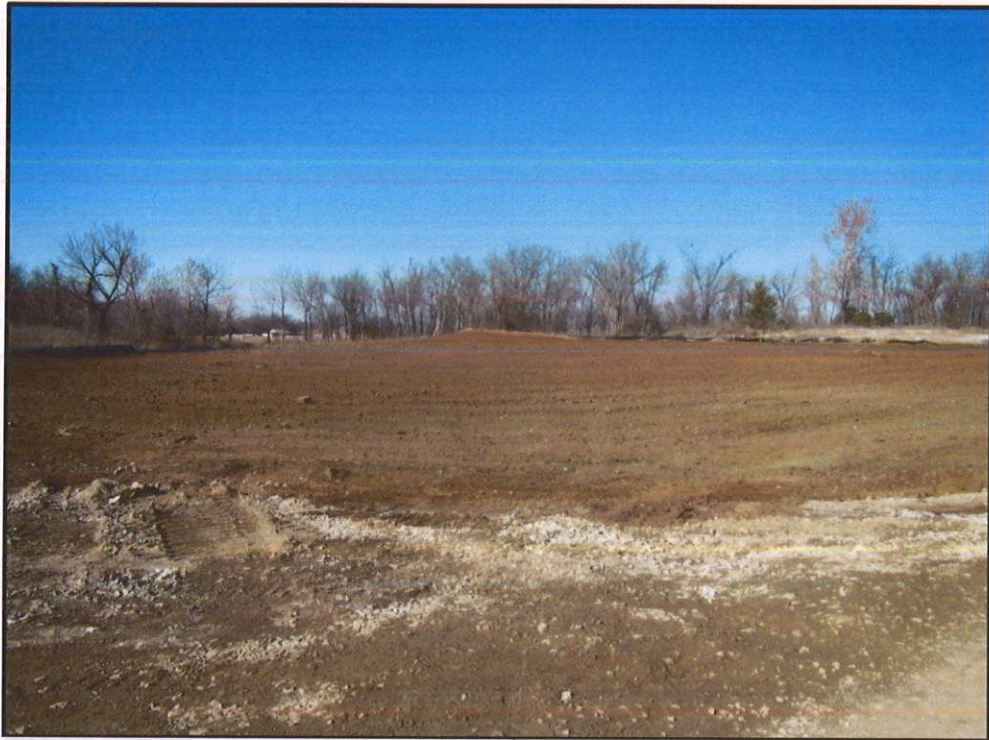
Photo 37: Distal 8 Remediation (Catholic 40)

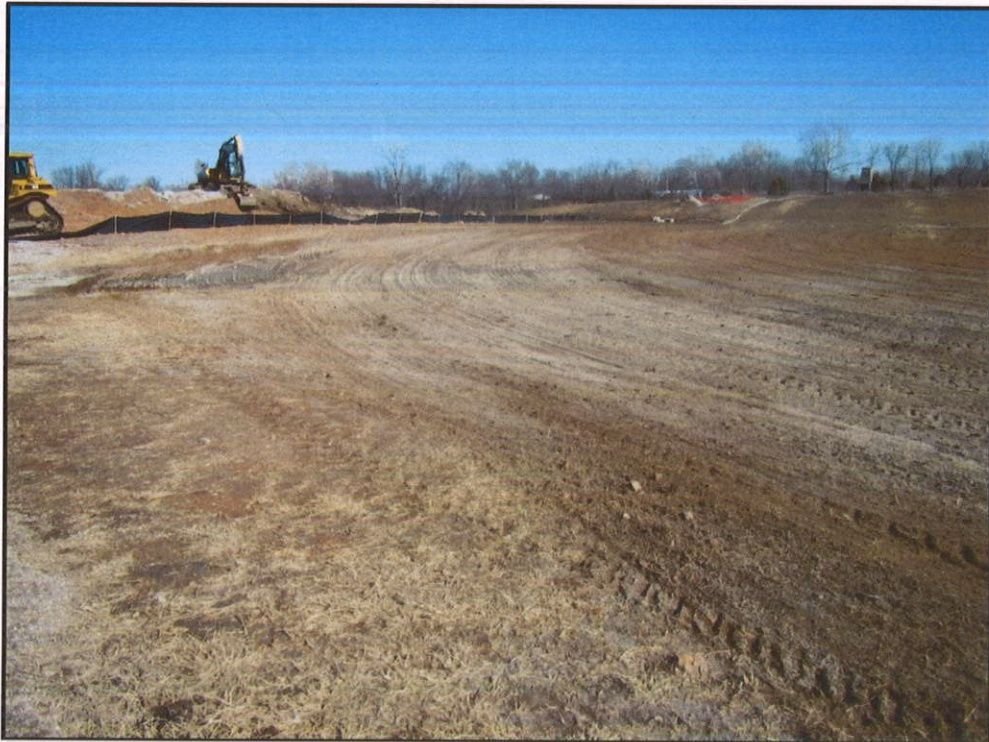
Photo 38: Soil Amendments Placed on Catholic 40 Site

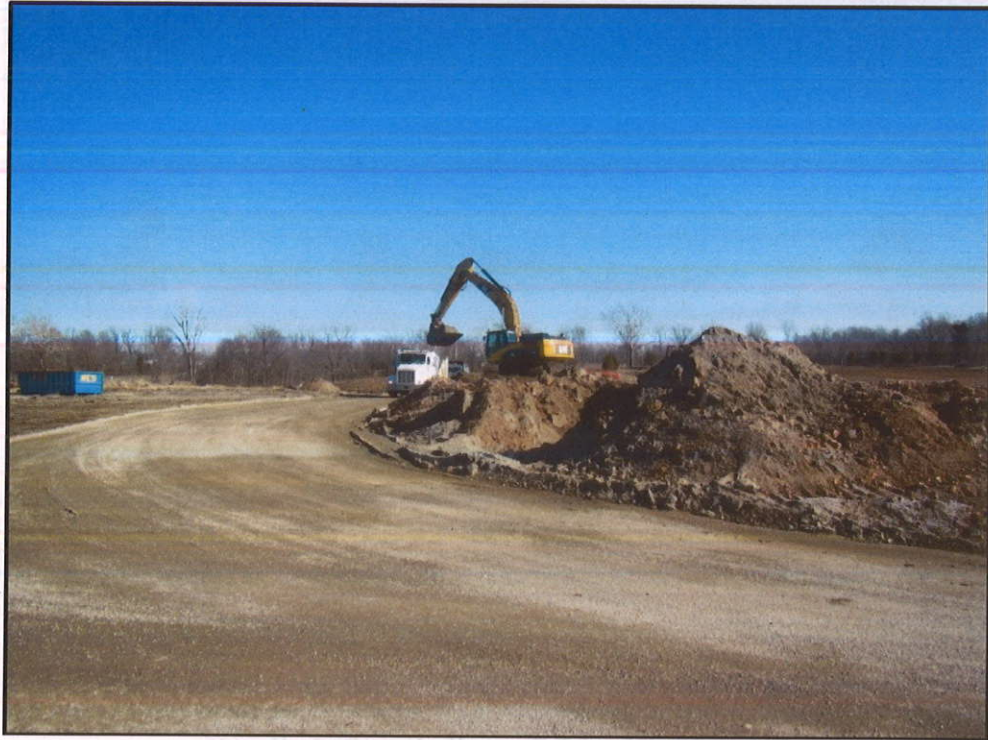
Photo 39: Chat Hauling from Distal 6A

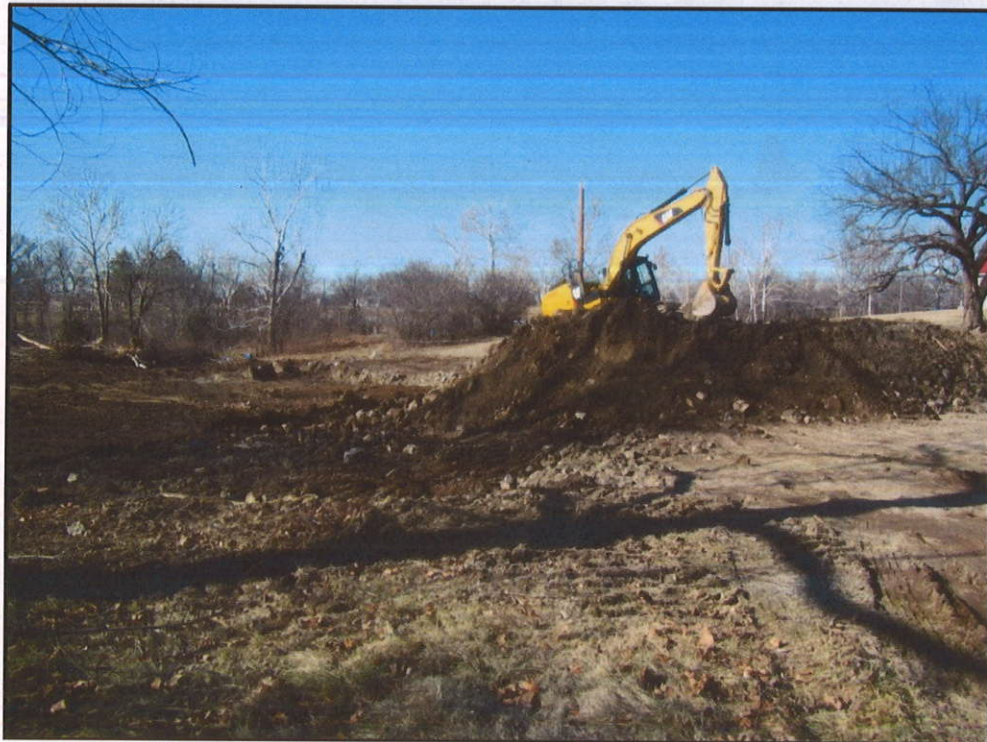
Photo 40: Excavation of Chat from Distal 6A

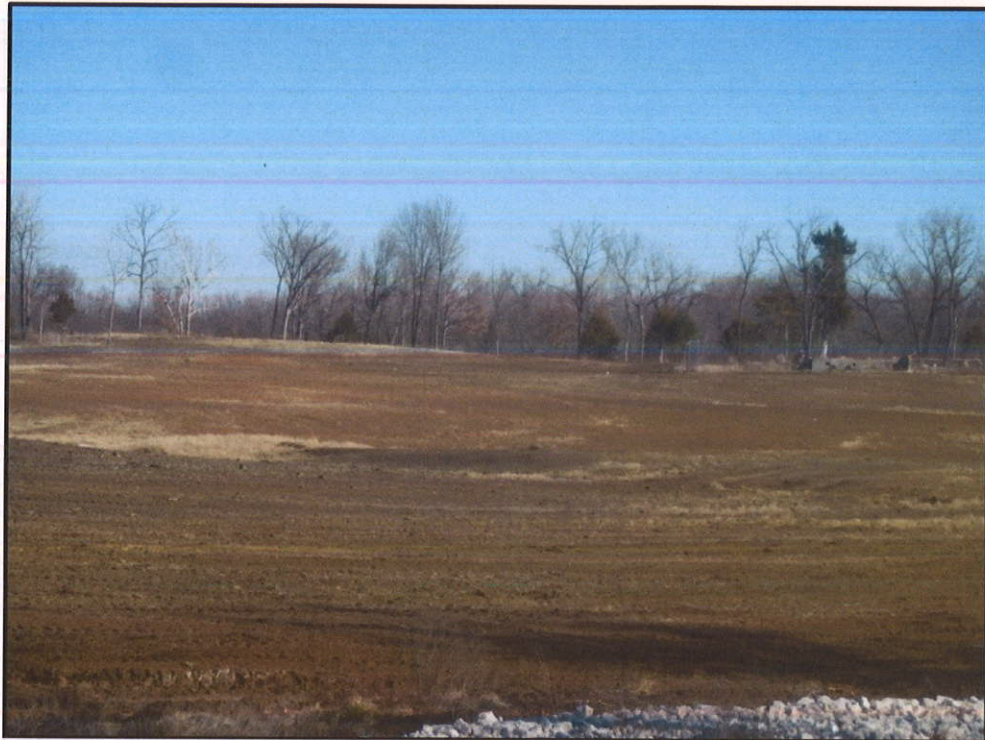
Photo 41: Catholic 40 Remediation

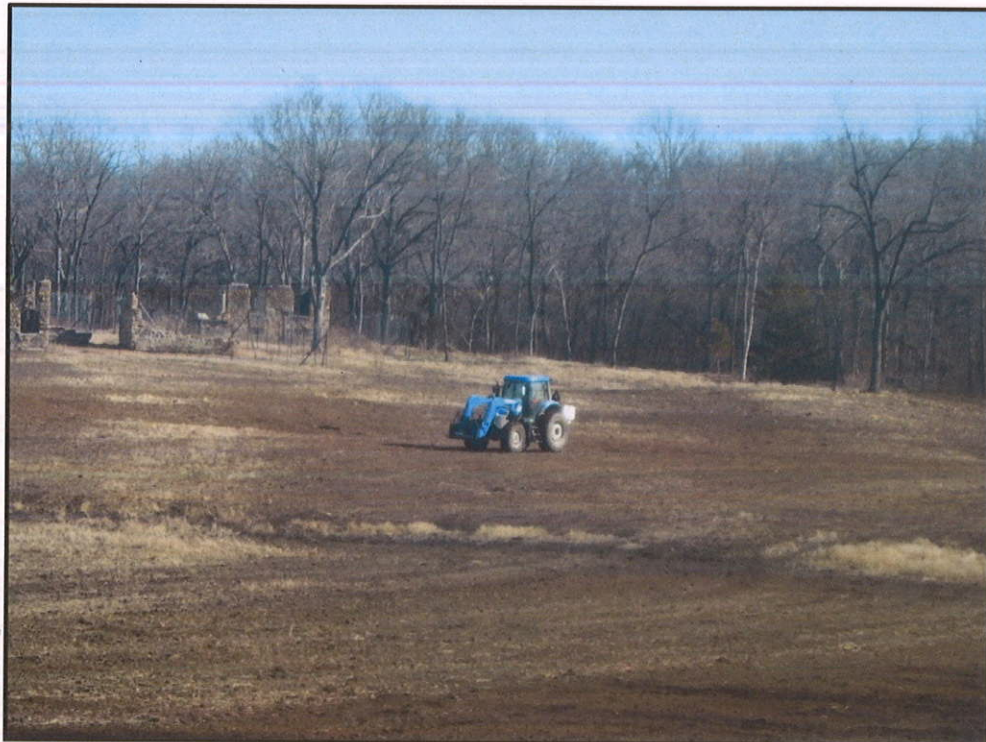
Photo 42: Soil Amendment Placement on Catholic 40

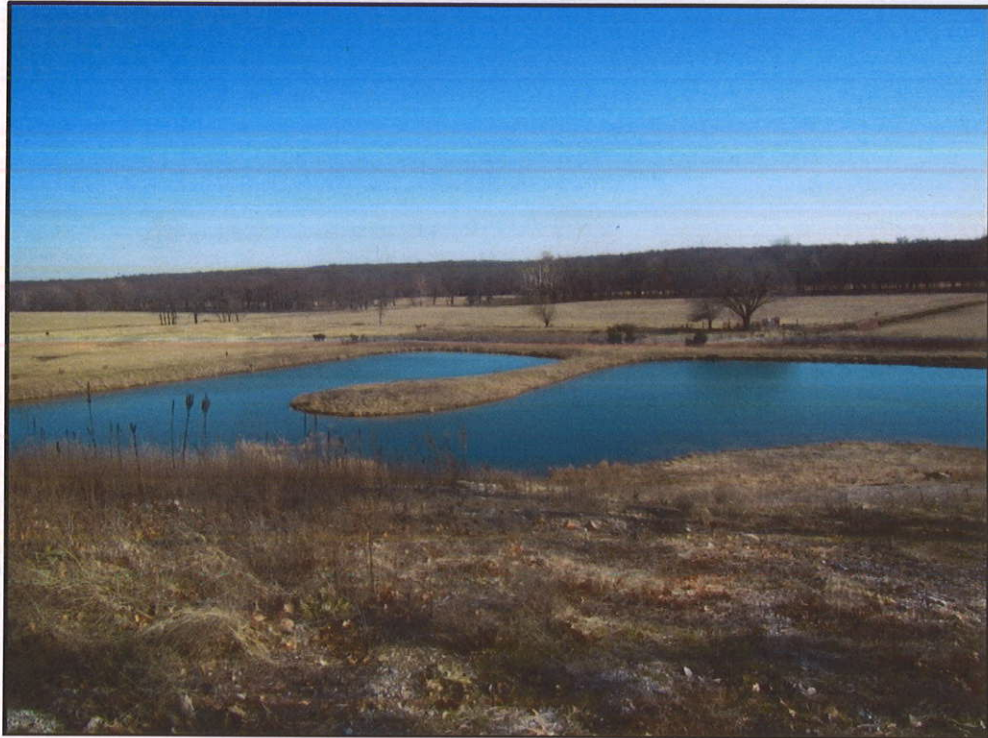
Photo 43: Distal 6 (CP104) Final Remediation

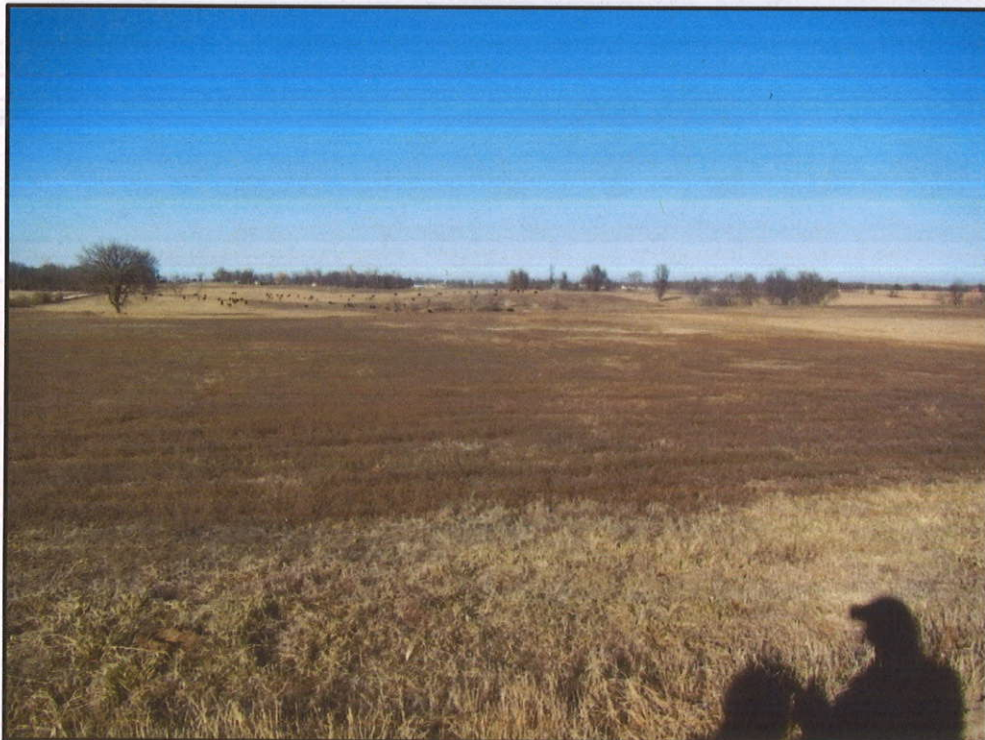
Photo 44: Distal 7 North; Vegetation Has Yet to Become Established

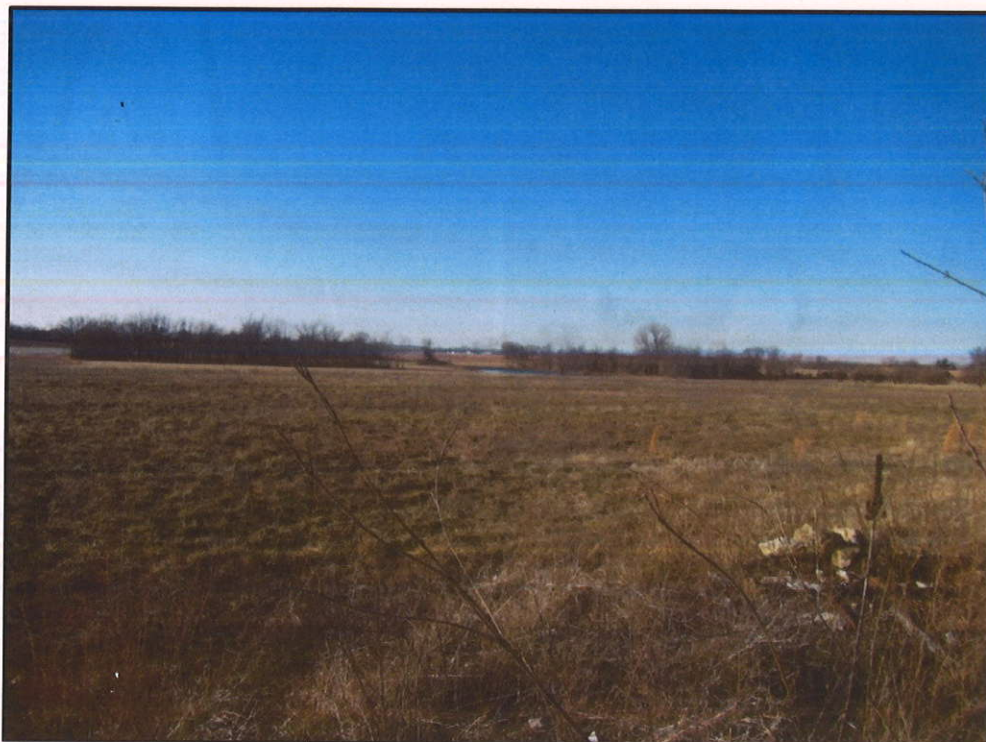
Photo 45: Distal 1 Final Remediation

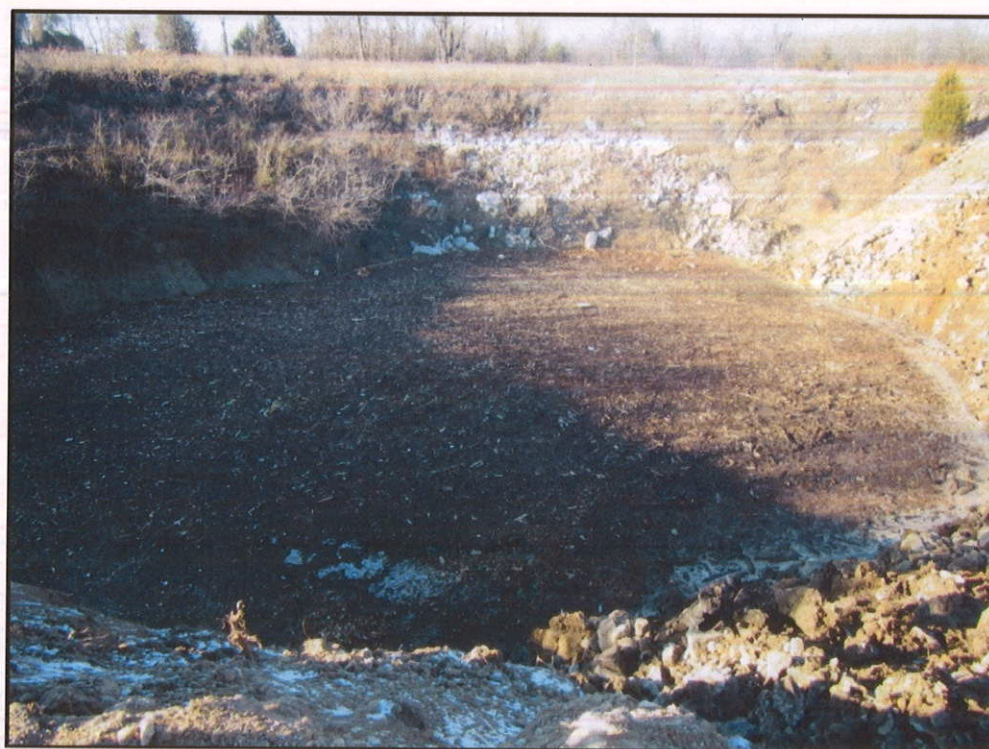
Photo 46: "605" Hole

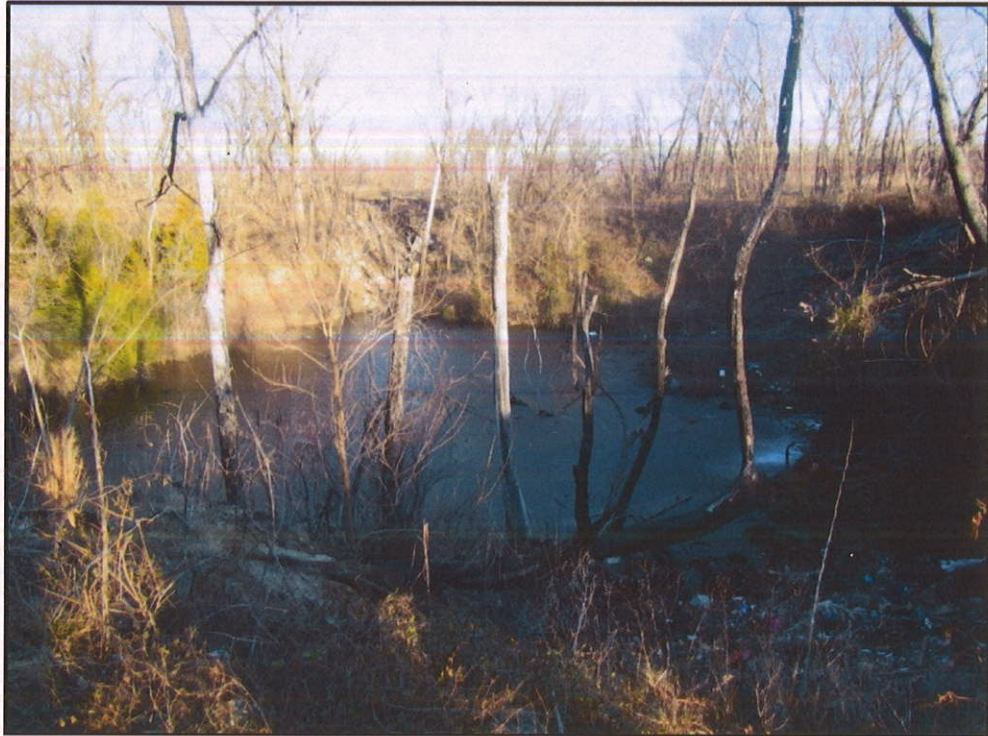
Photo 47: County Subsidence Near 605 Road

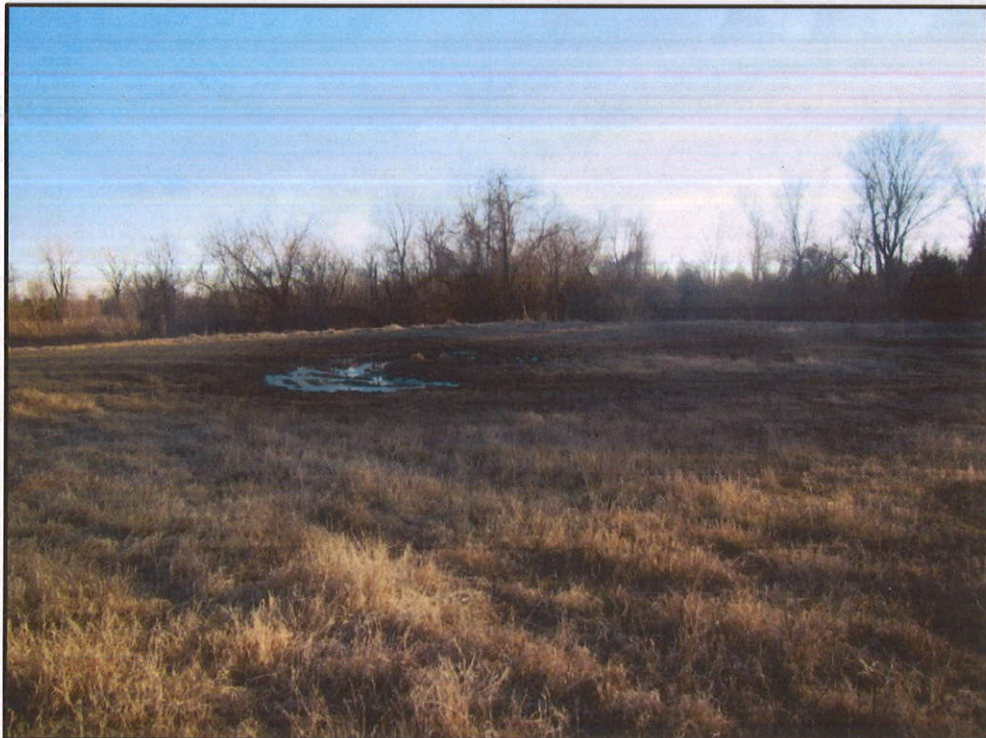
Photo 48: Hockerville Subsidence; Settling and Vandalism Present

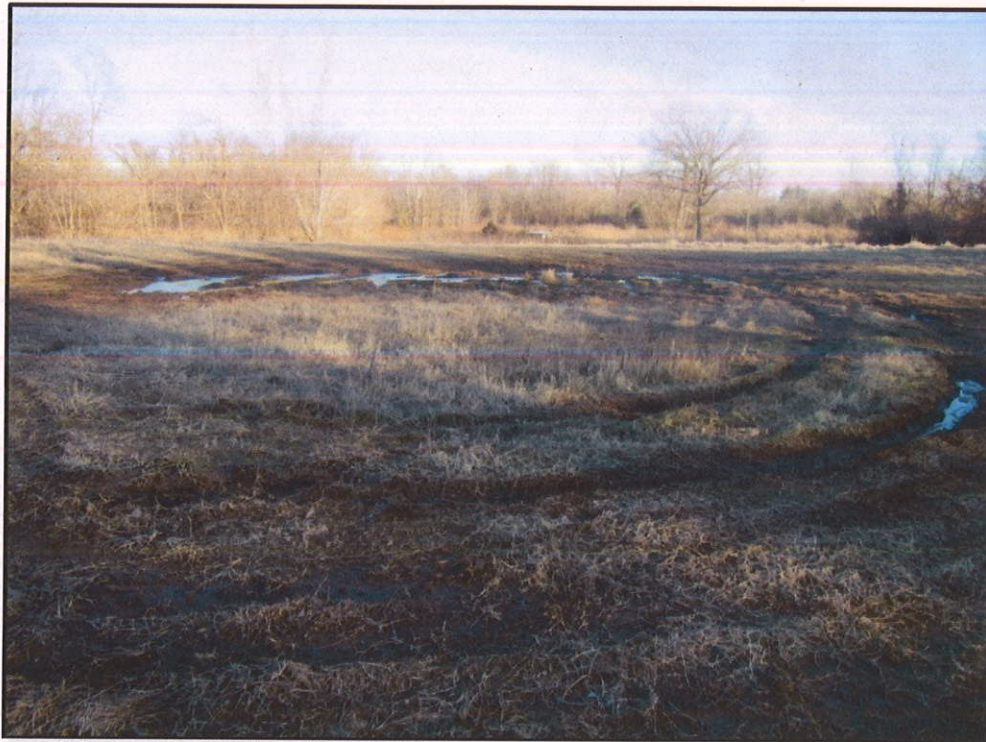
Photo 49: Hockerville Subsidence; Settling and Vandalism Present

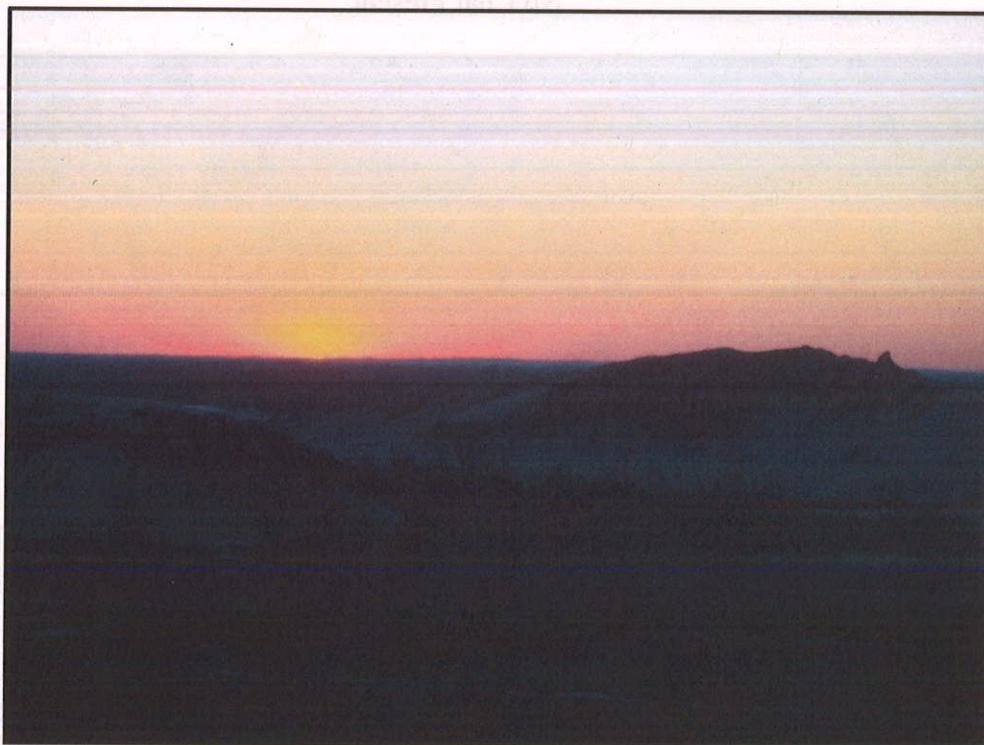
Photo 50: Overview of Picher from Sample Pile

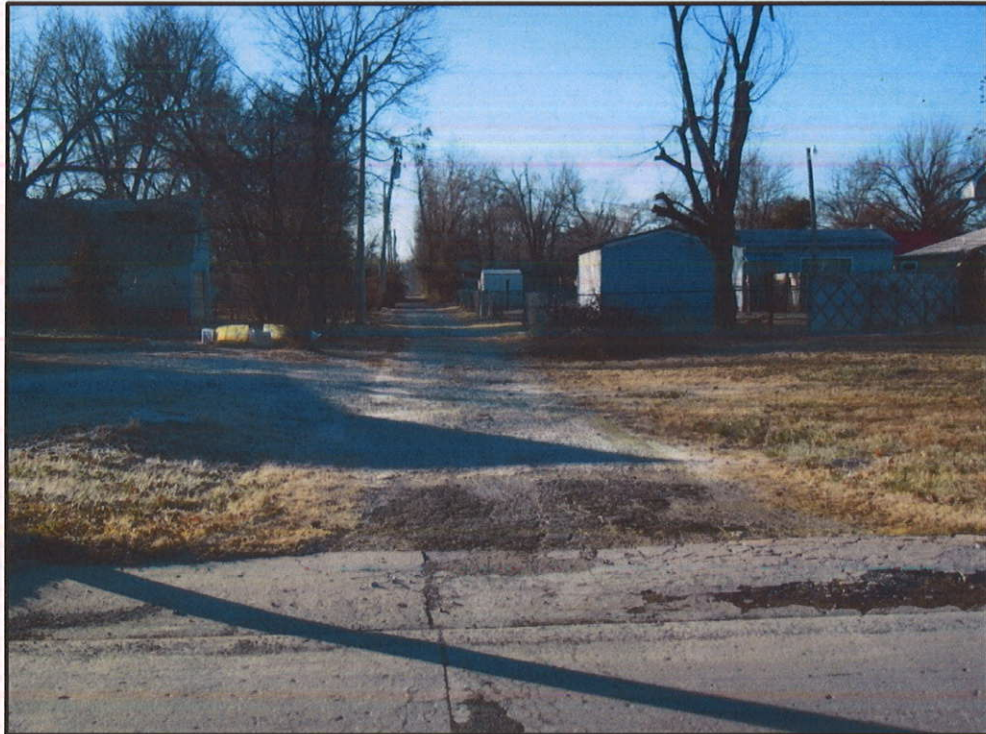
Photo 51: Alleyway Adjacent to Washington Elementary School;
No Chat Present

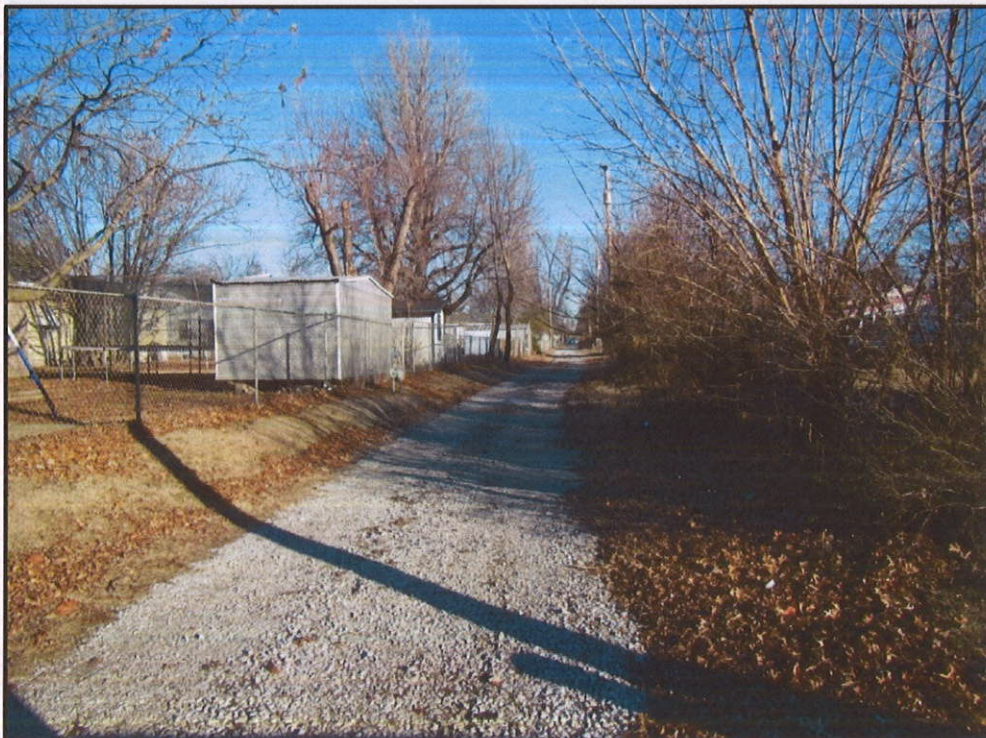
Photo 52: Limestone Alleyway Adjacent to Washington Elementary School

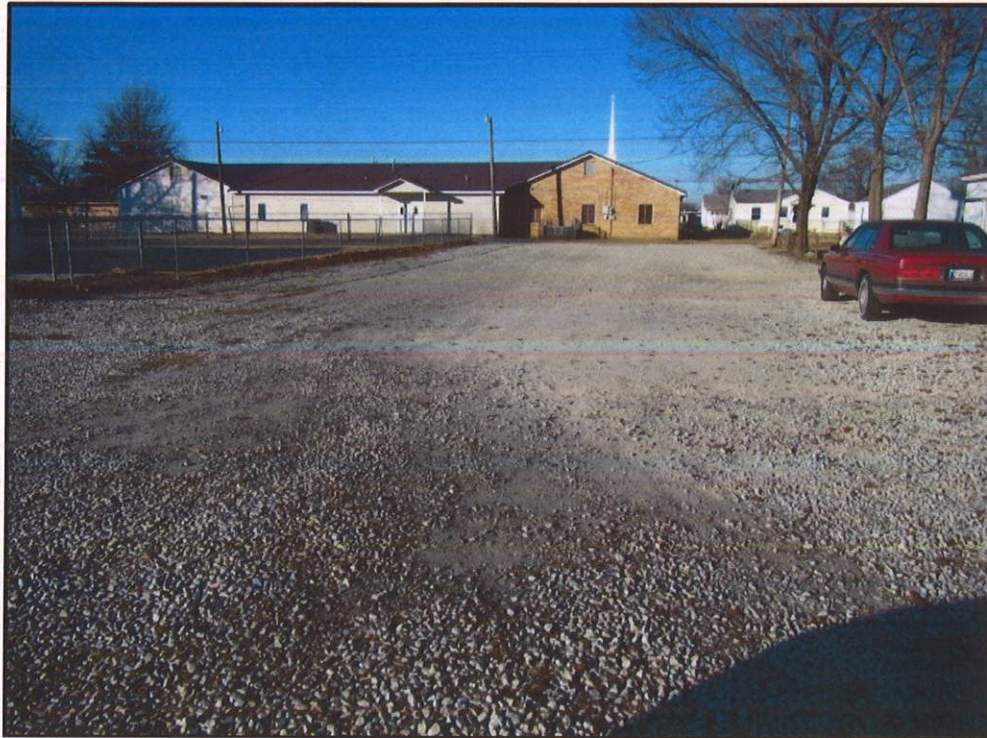
Photo 53: High-access Area, Limestone Church Parking Lot

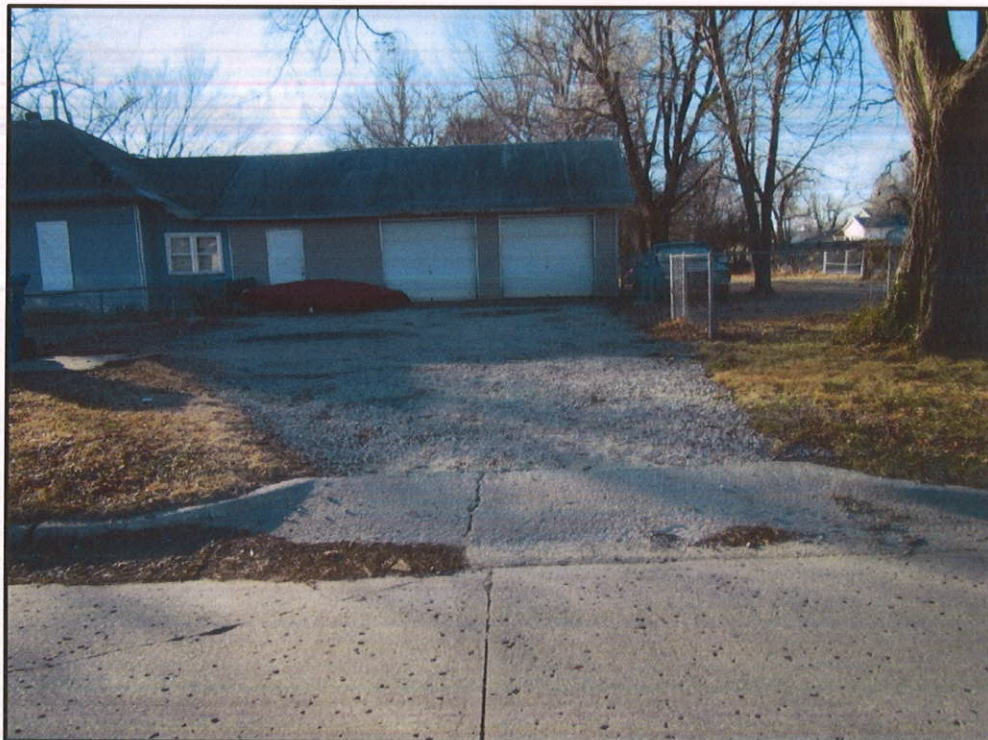
Photo 54: Driveway Replacement Near Washington Elementary School

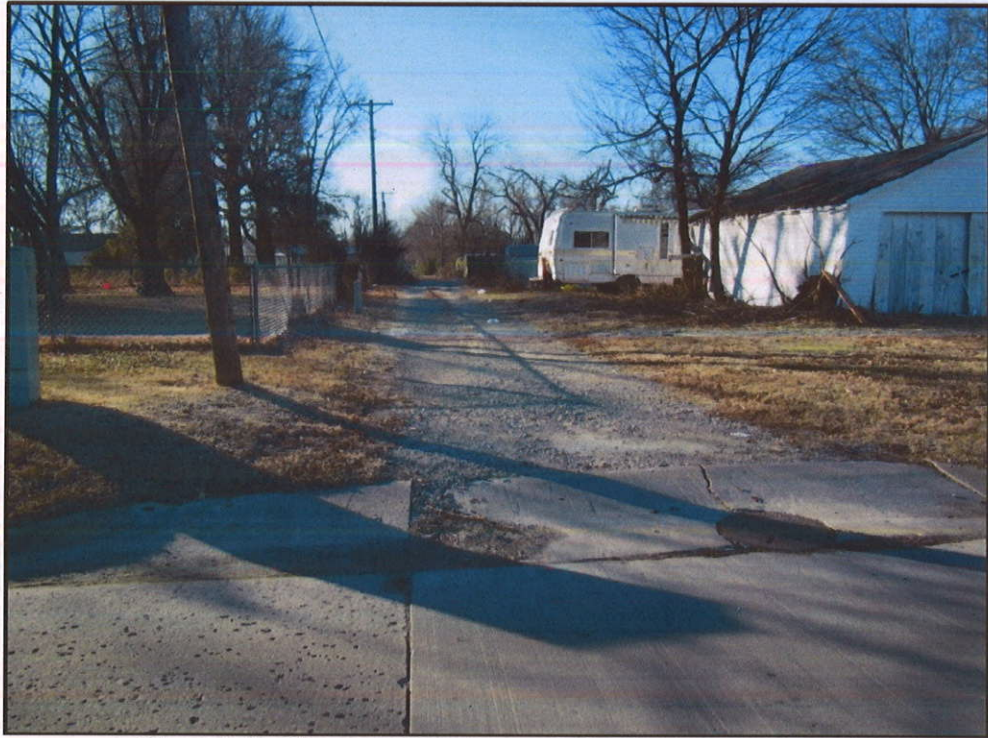
Photo 55: Alleyway Near Roosevelt Elementary School
