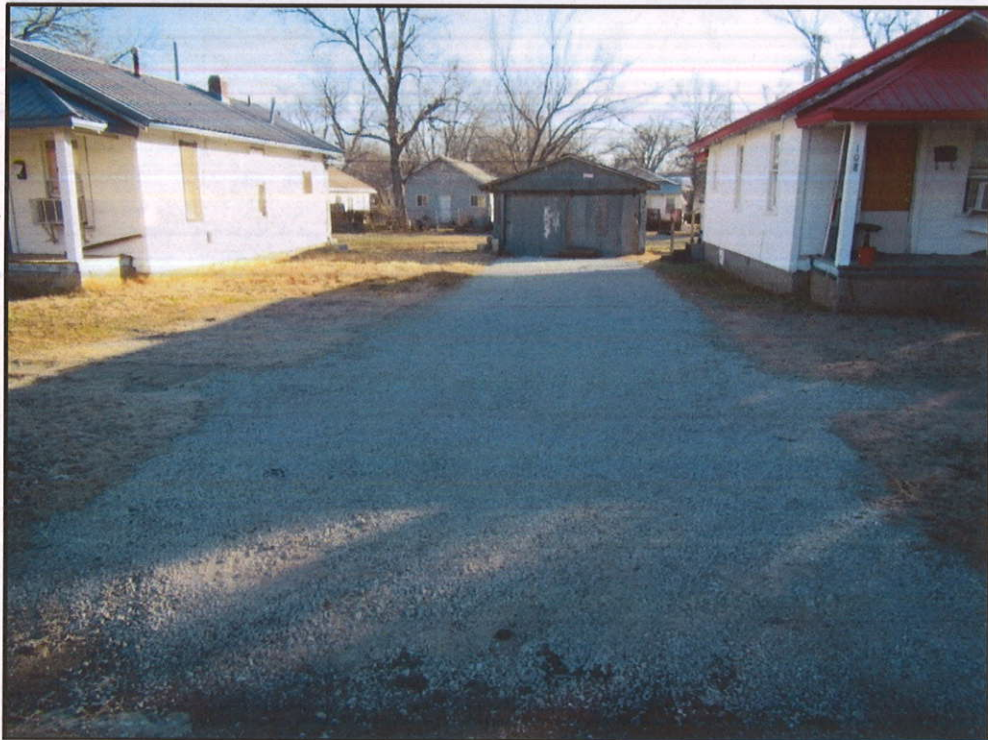
Photo 56: Driveway Near Roosevelt Elementary School

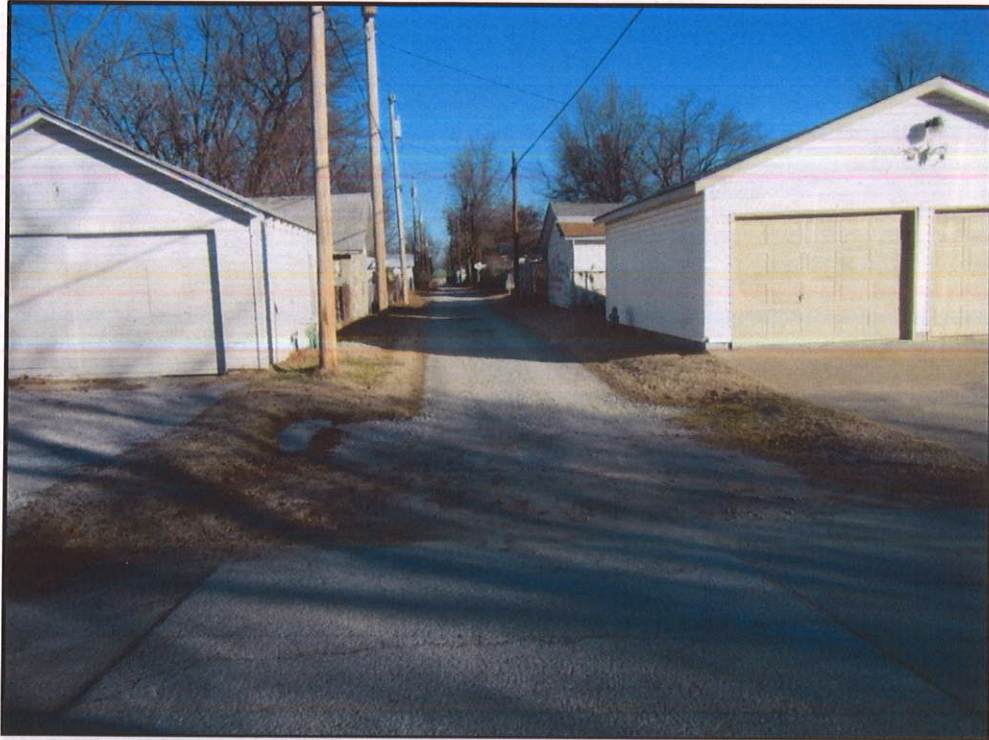
Photo 57: Alleyway Near Roosevelt Elementary School

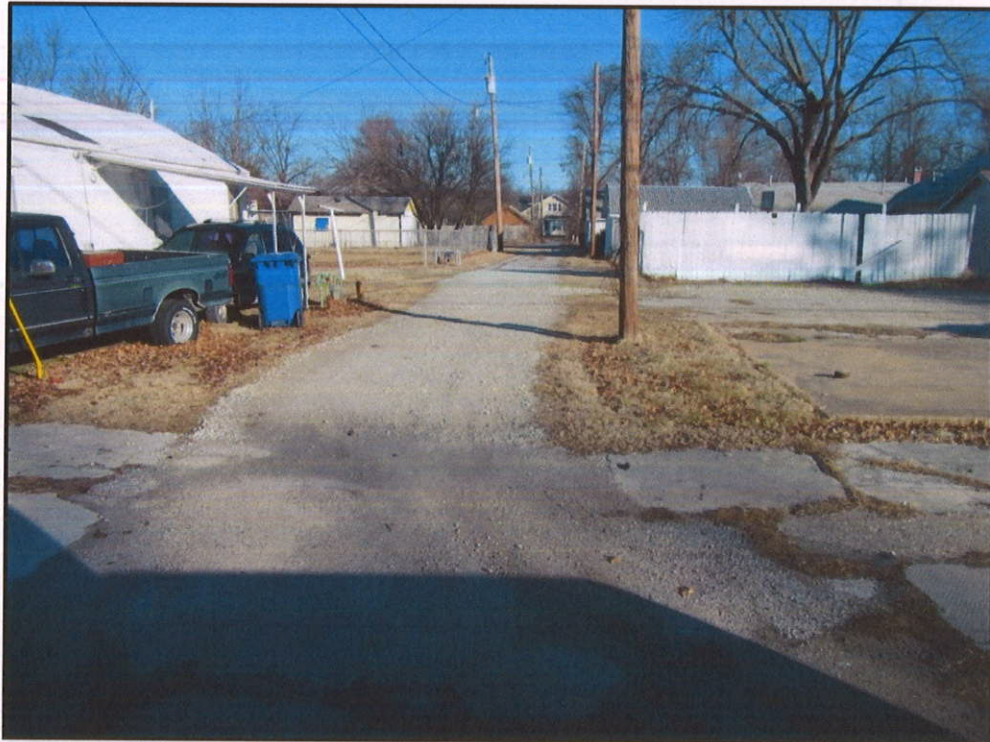
Photo 58: Alleyway Near Roosevelt Elementary School

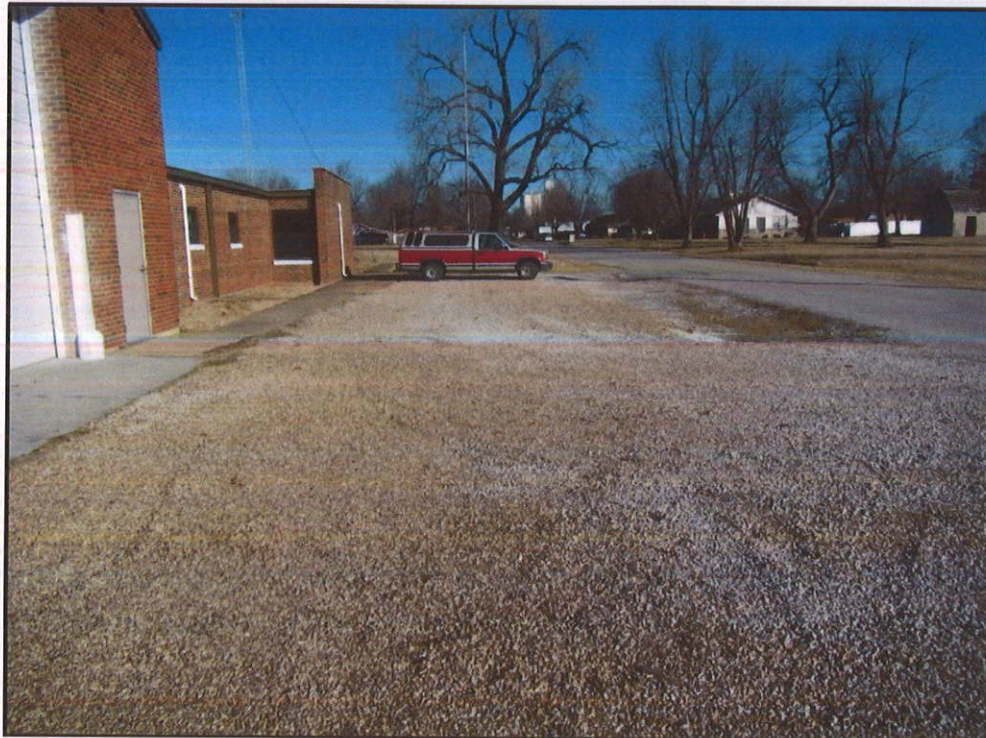
Photo 59: Armory Near Riverview Park; Chat Parking Lot has been Replaced with Limestone

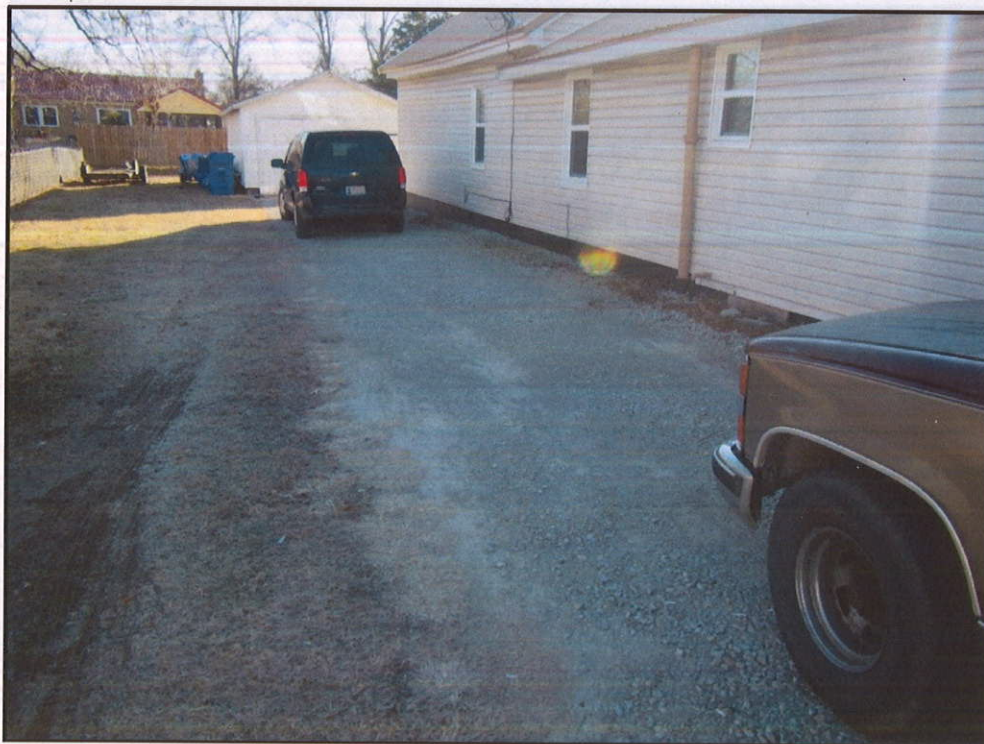
Photo 60: Driveway Replacement at 504 5th NE Road

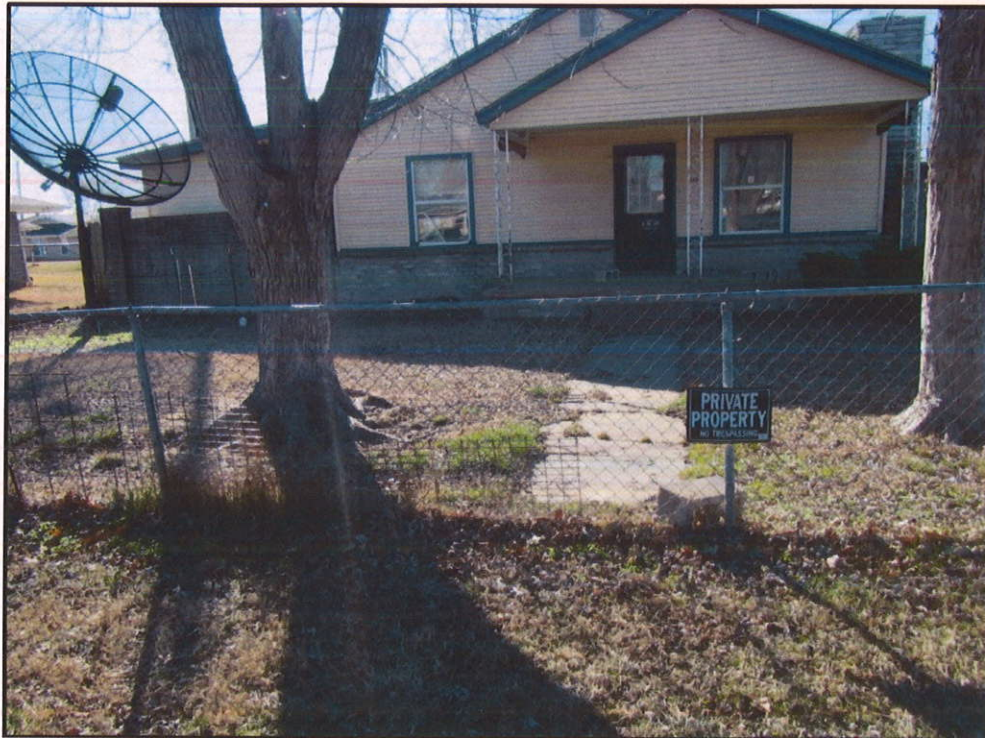
Photo 61: Yard Replacement in Commerce Under OU2

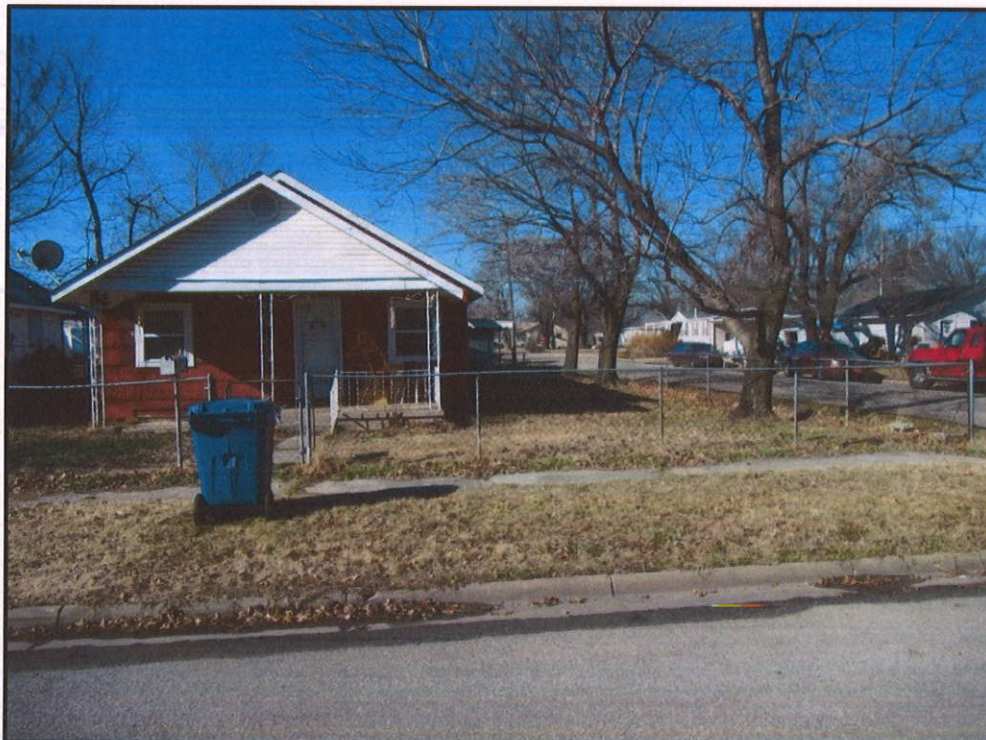
Photo 62: Yard Replacement in Commerce Under OU2

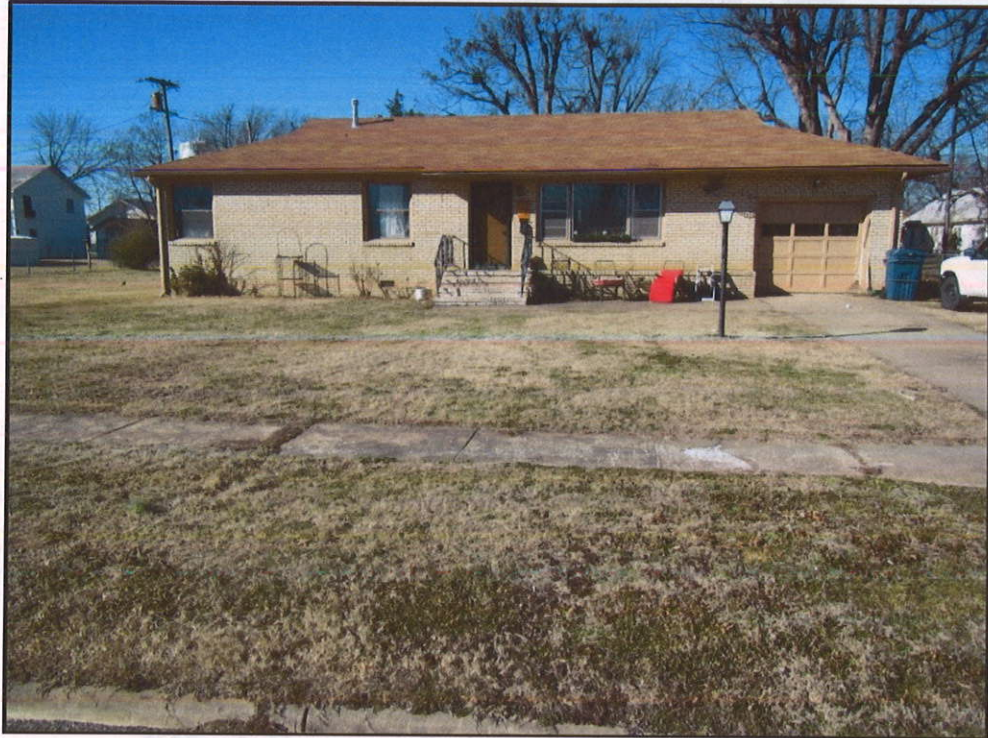
Photo 63: Yard Replacement in Commerce Under OU2

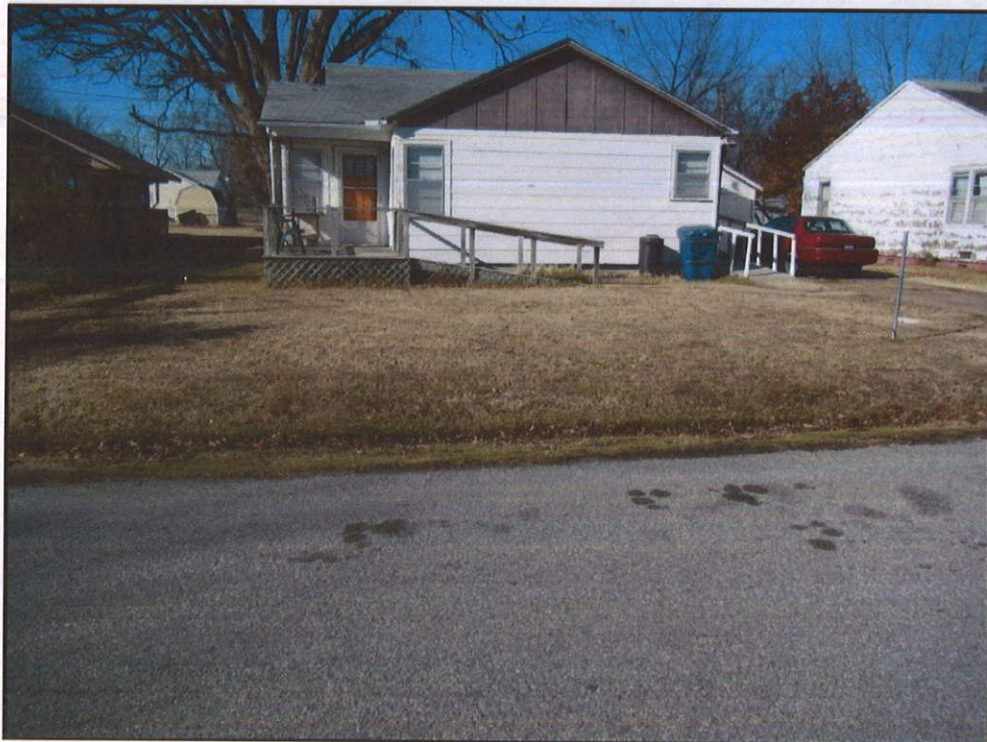
Photo 64: Yard Replacement in Commerce Under OU2

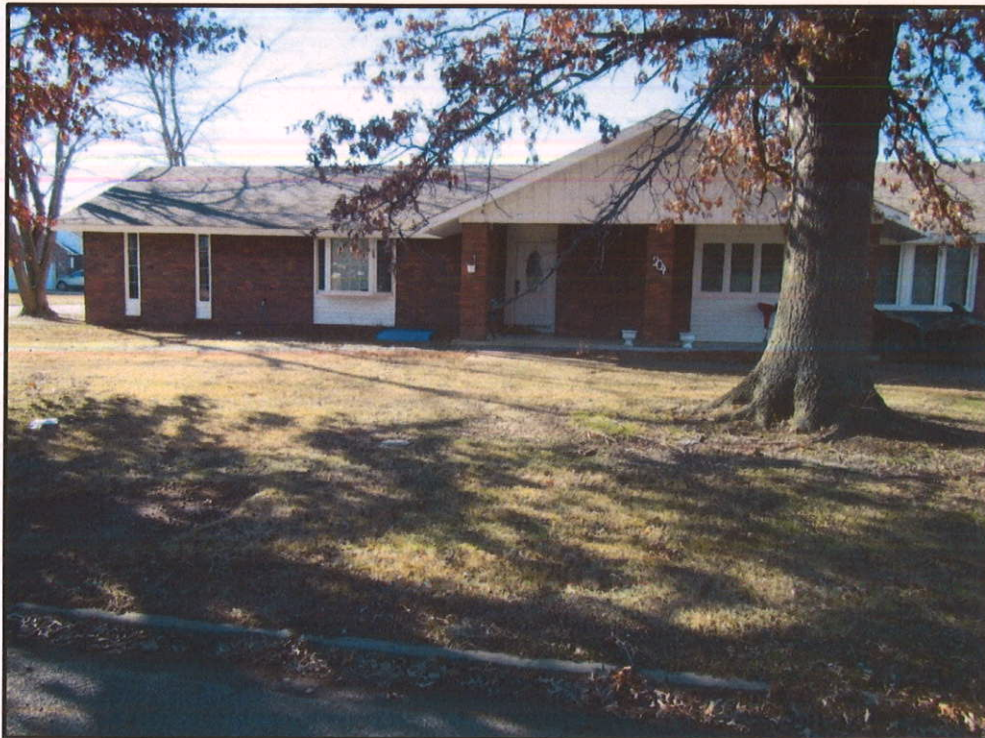
Photo 65: Yard Replacement in Commerce Under OU2
