**Enbridge Line 5
Straits of Mackinac, MI**

**Supplement to the Biota Investigation Work Plan dated September
27, 2016**

Enbridge Energy, Limited Partnership

Submitted: March 23, 2017

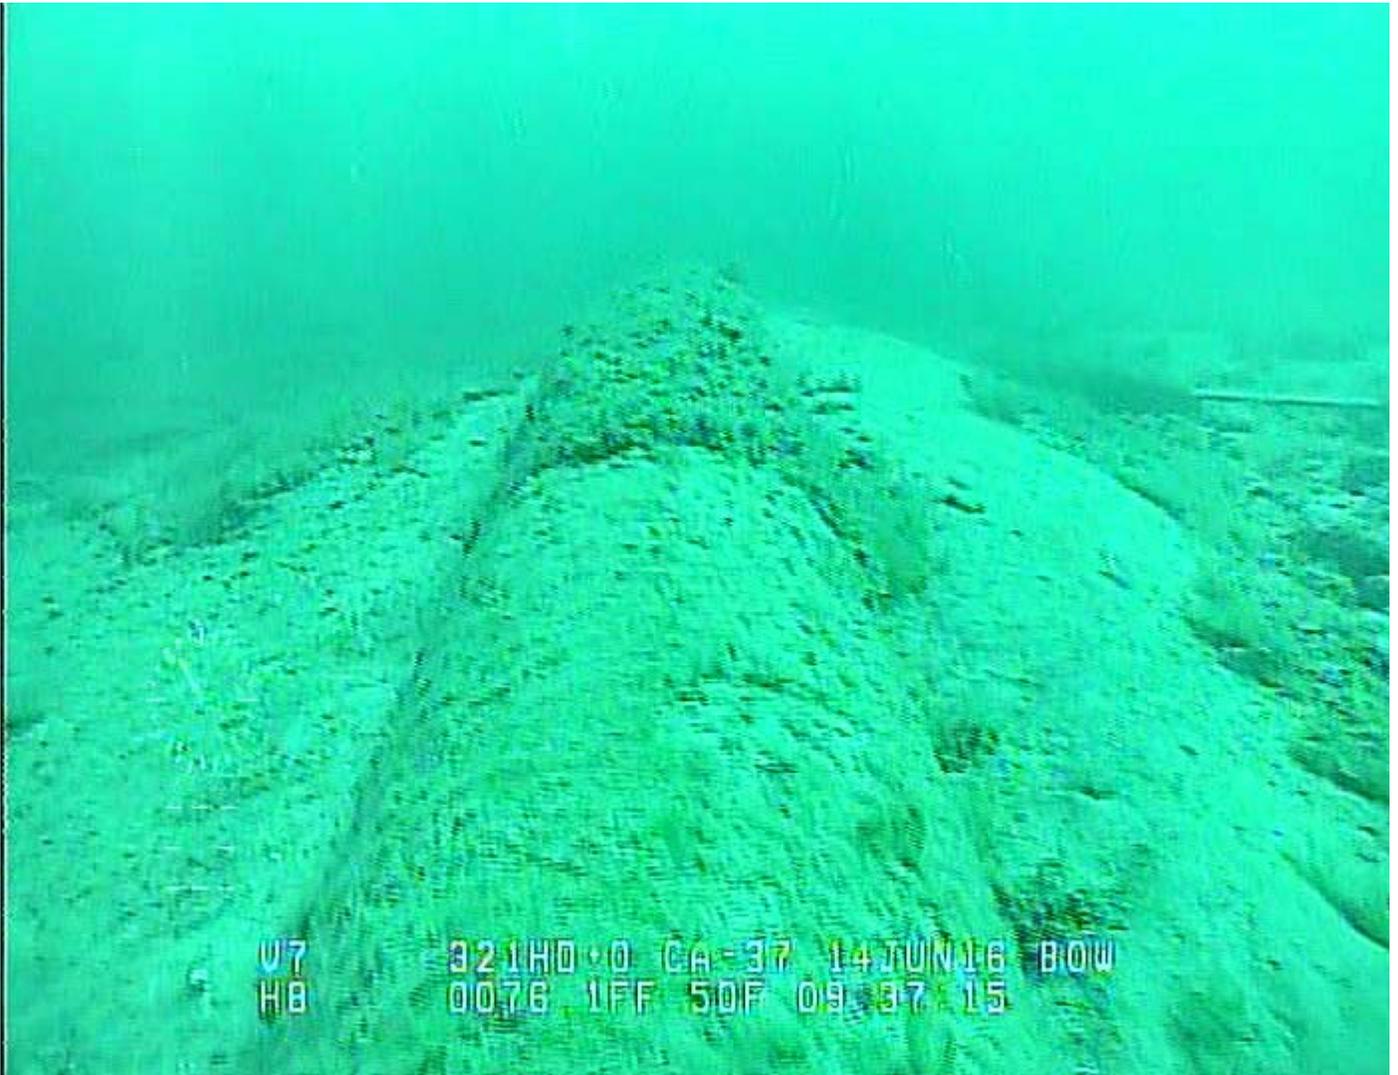
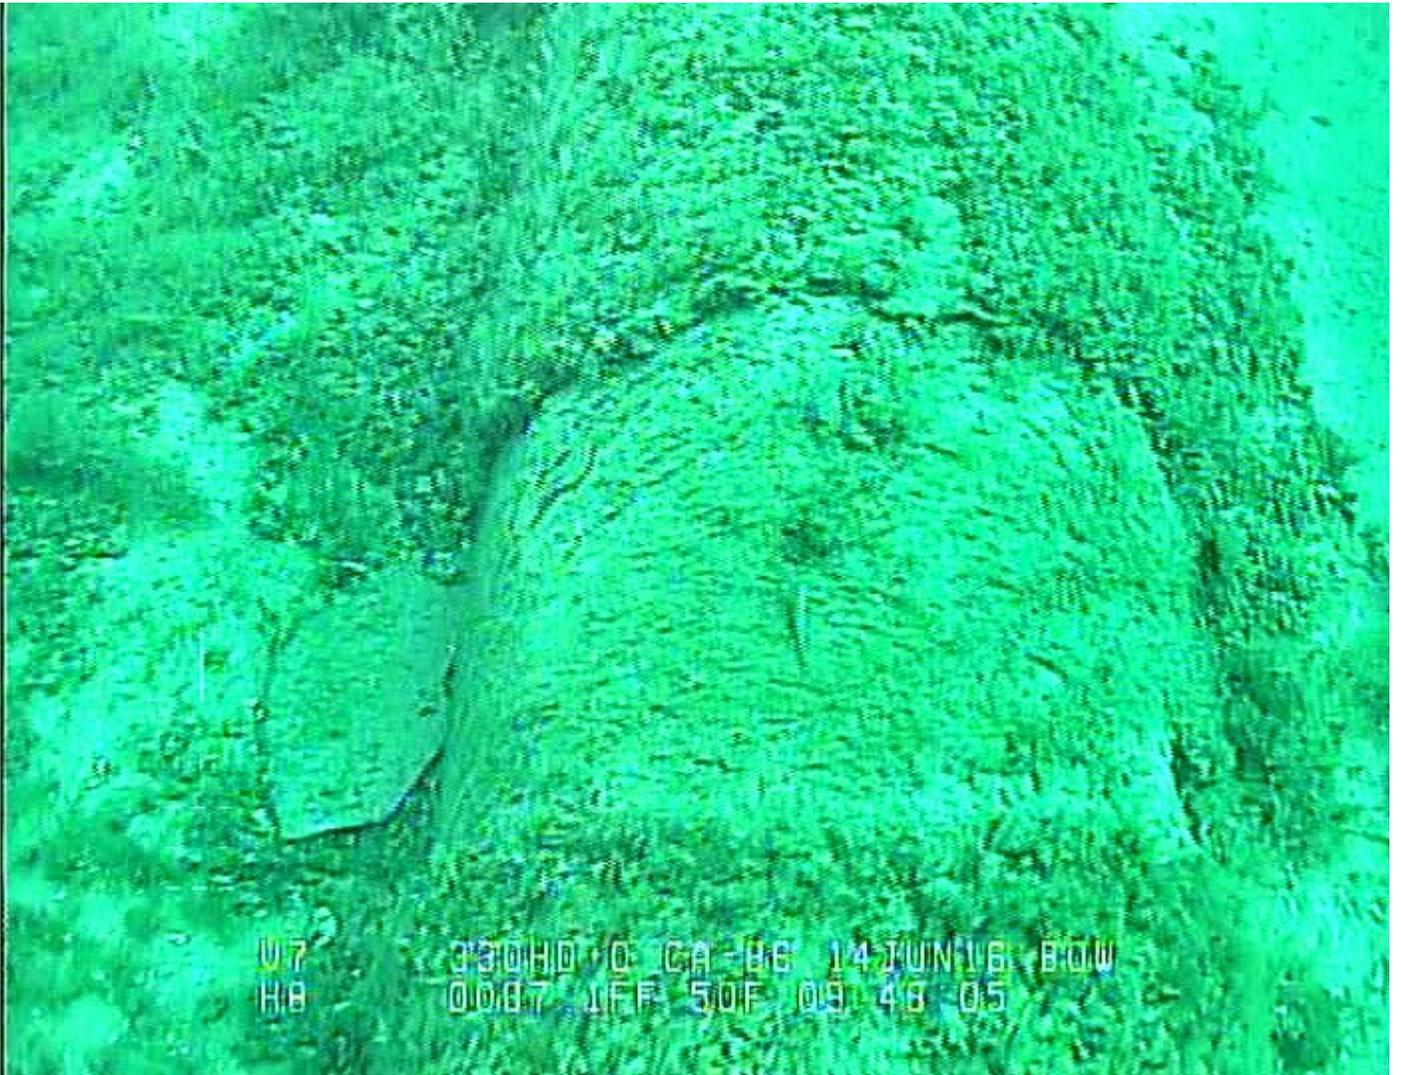
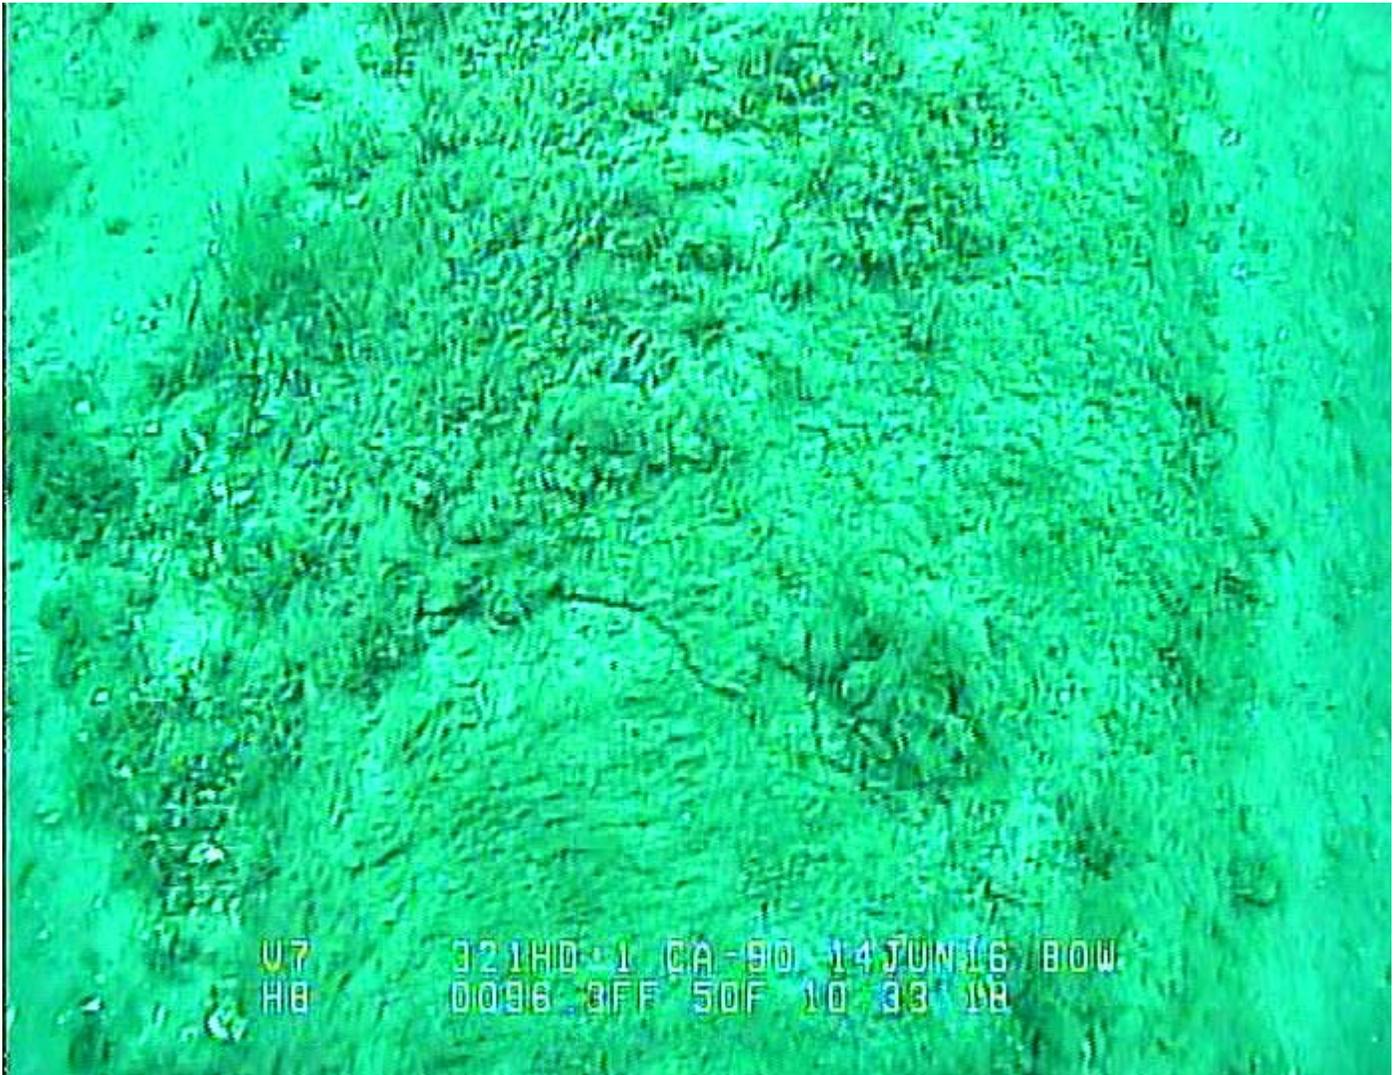
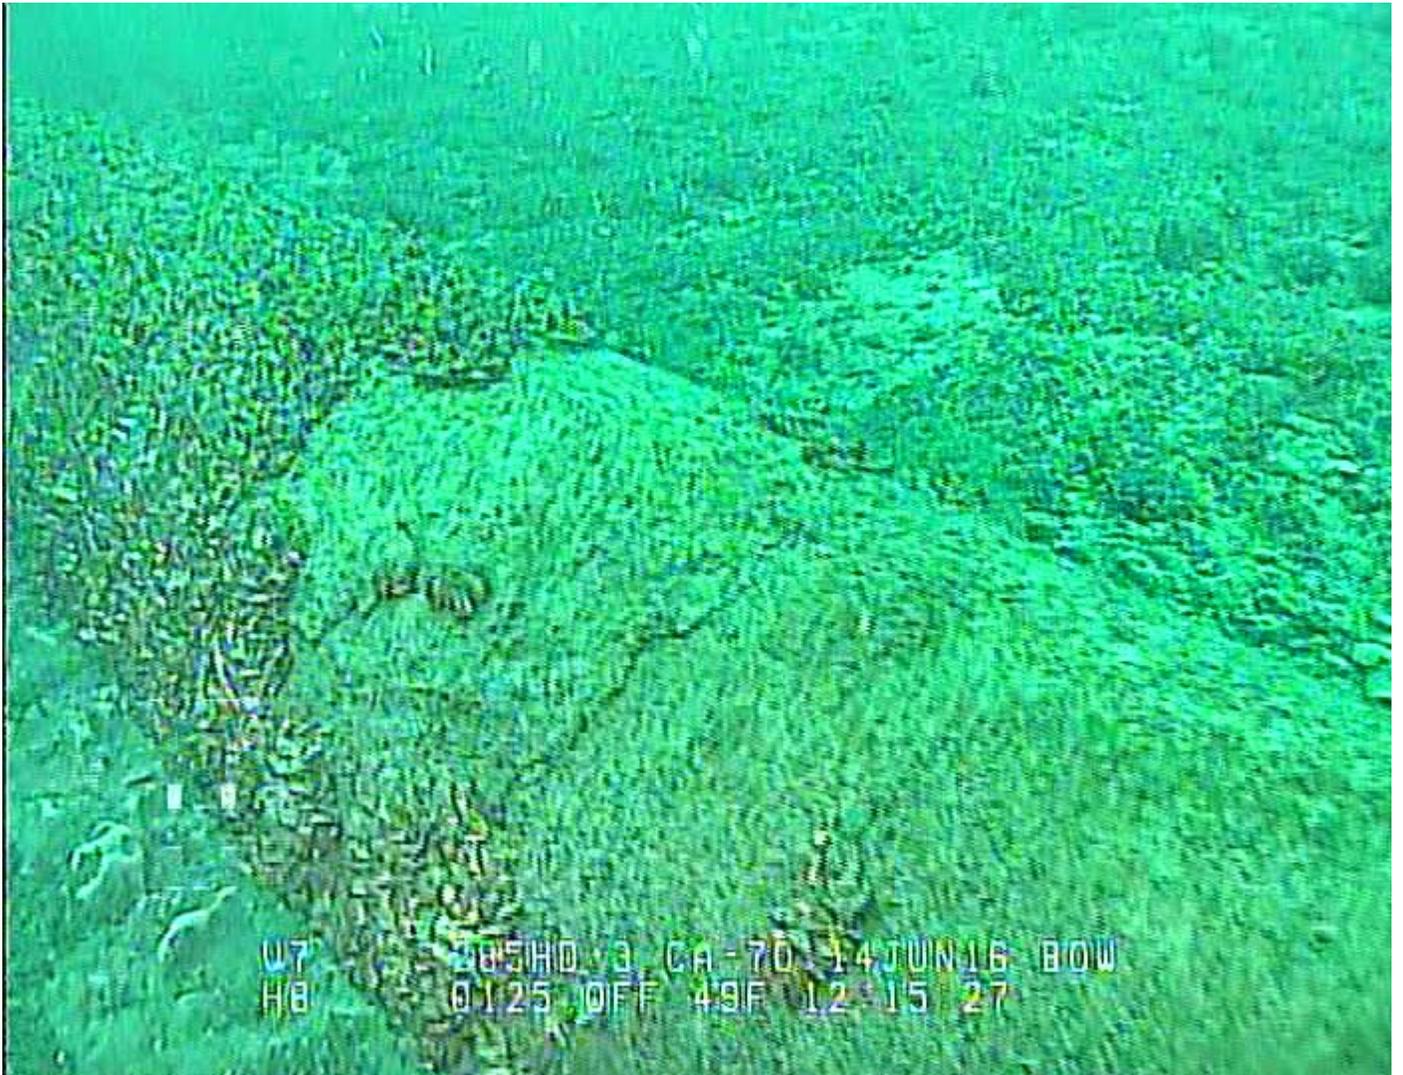
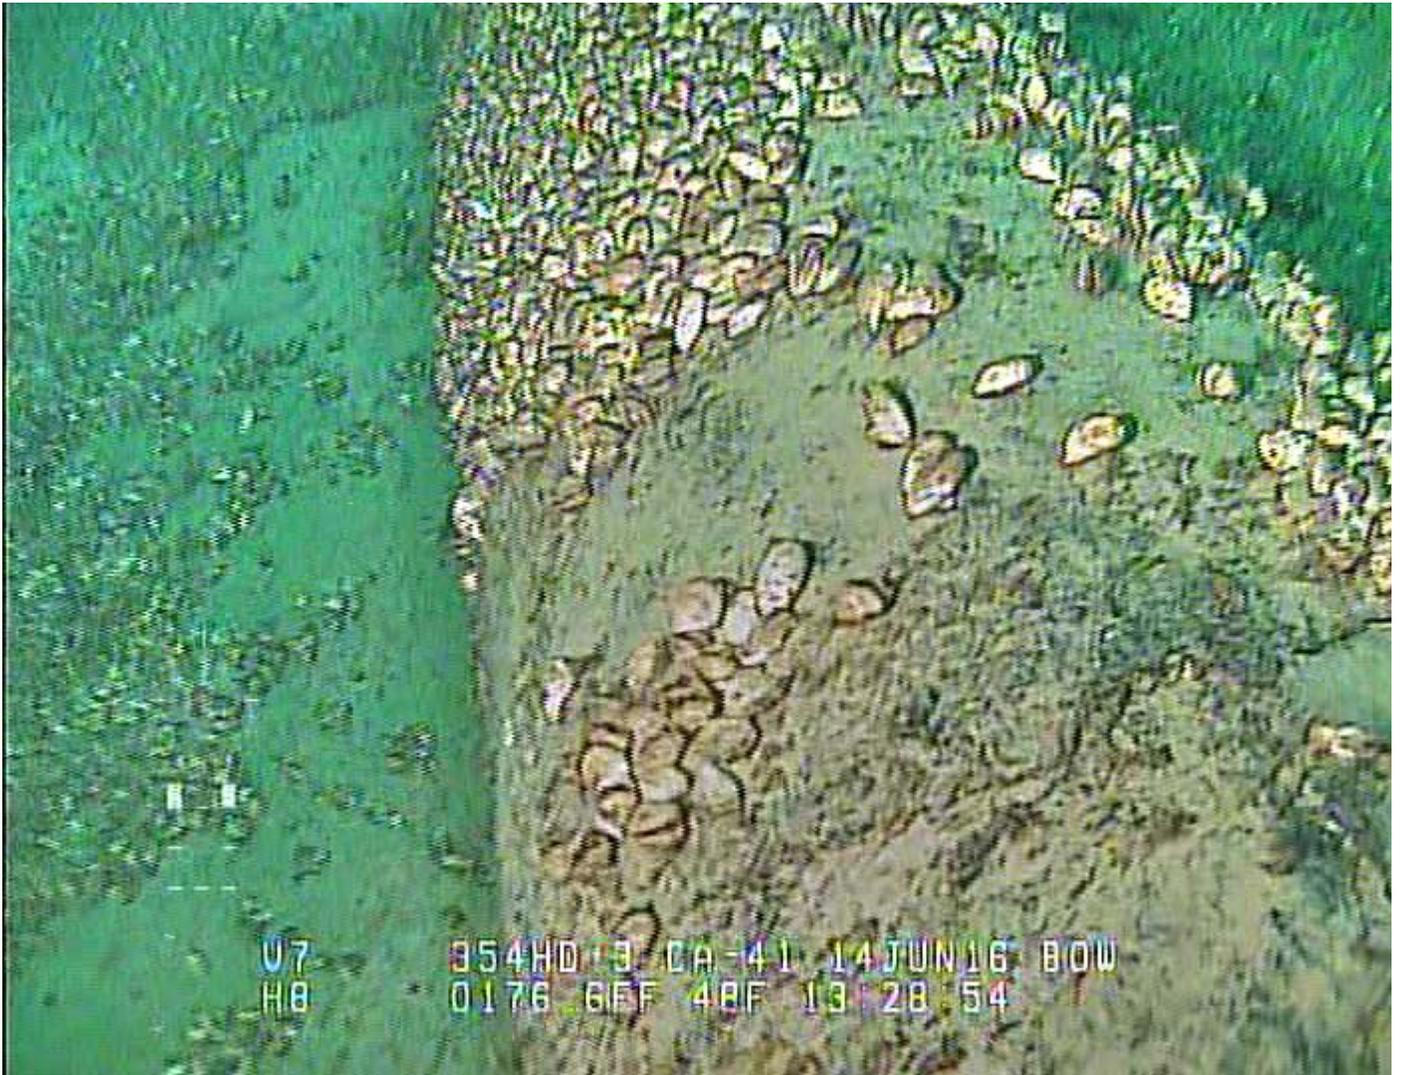
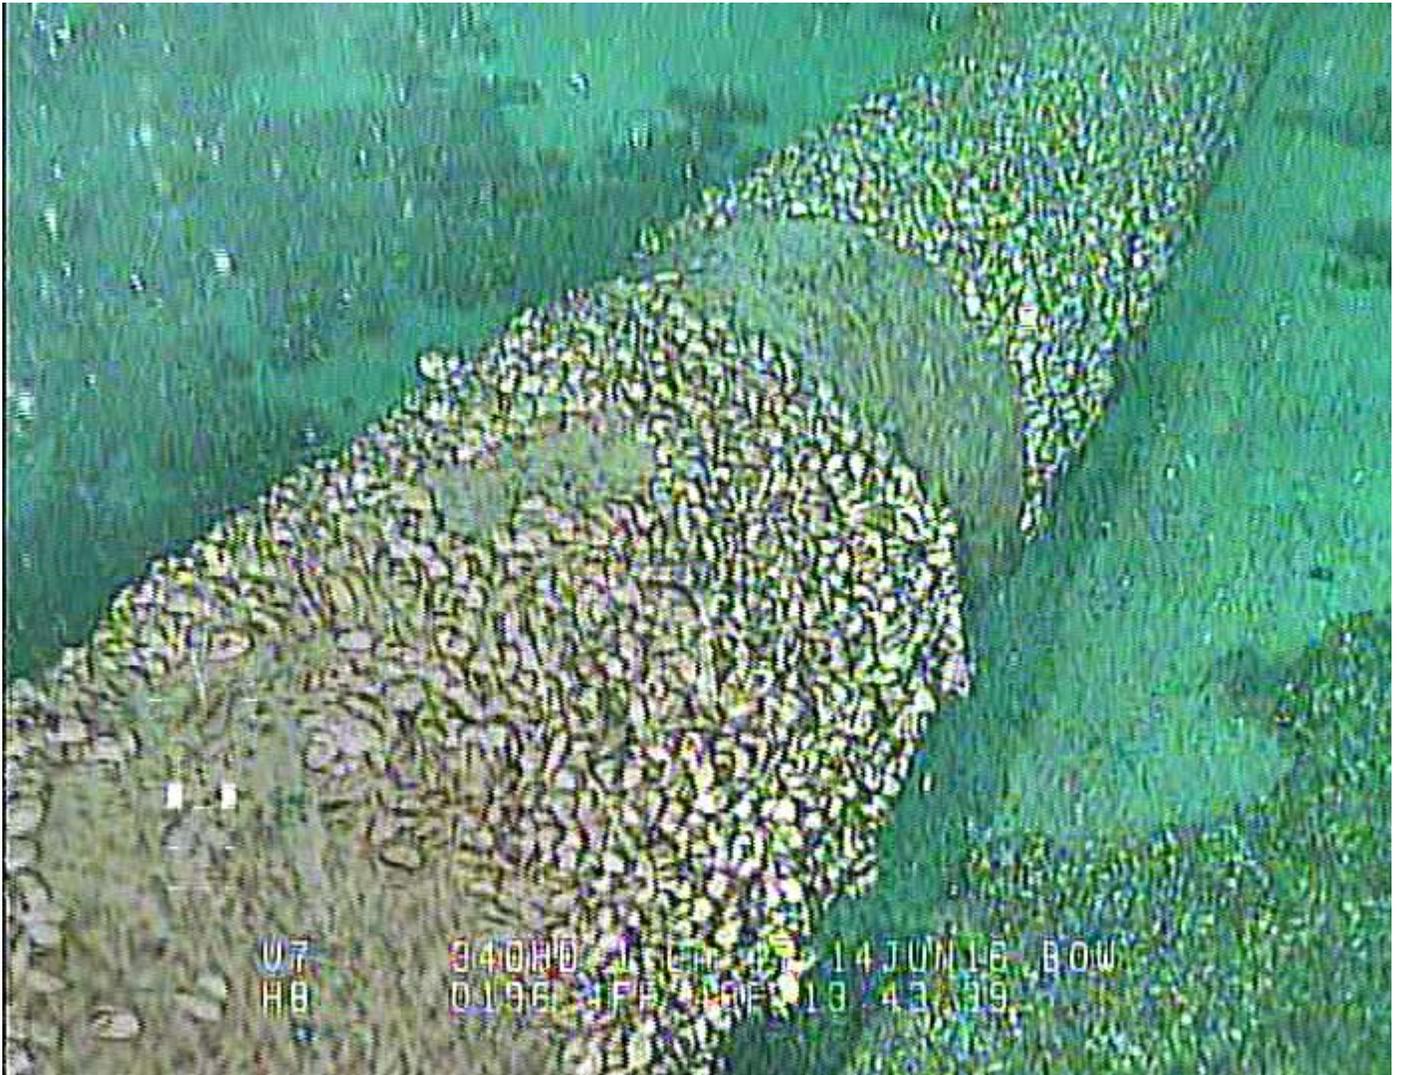
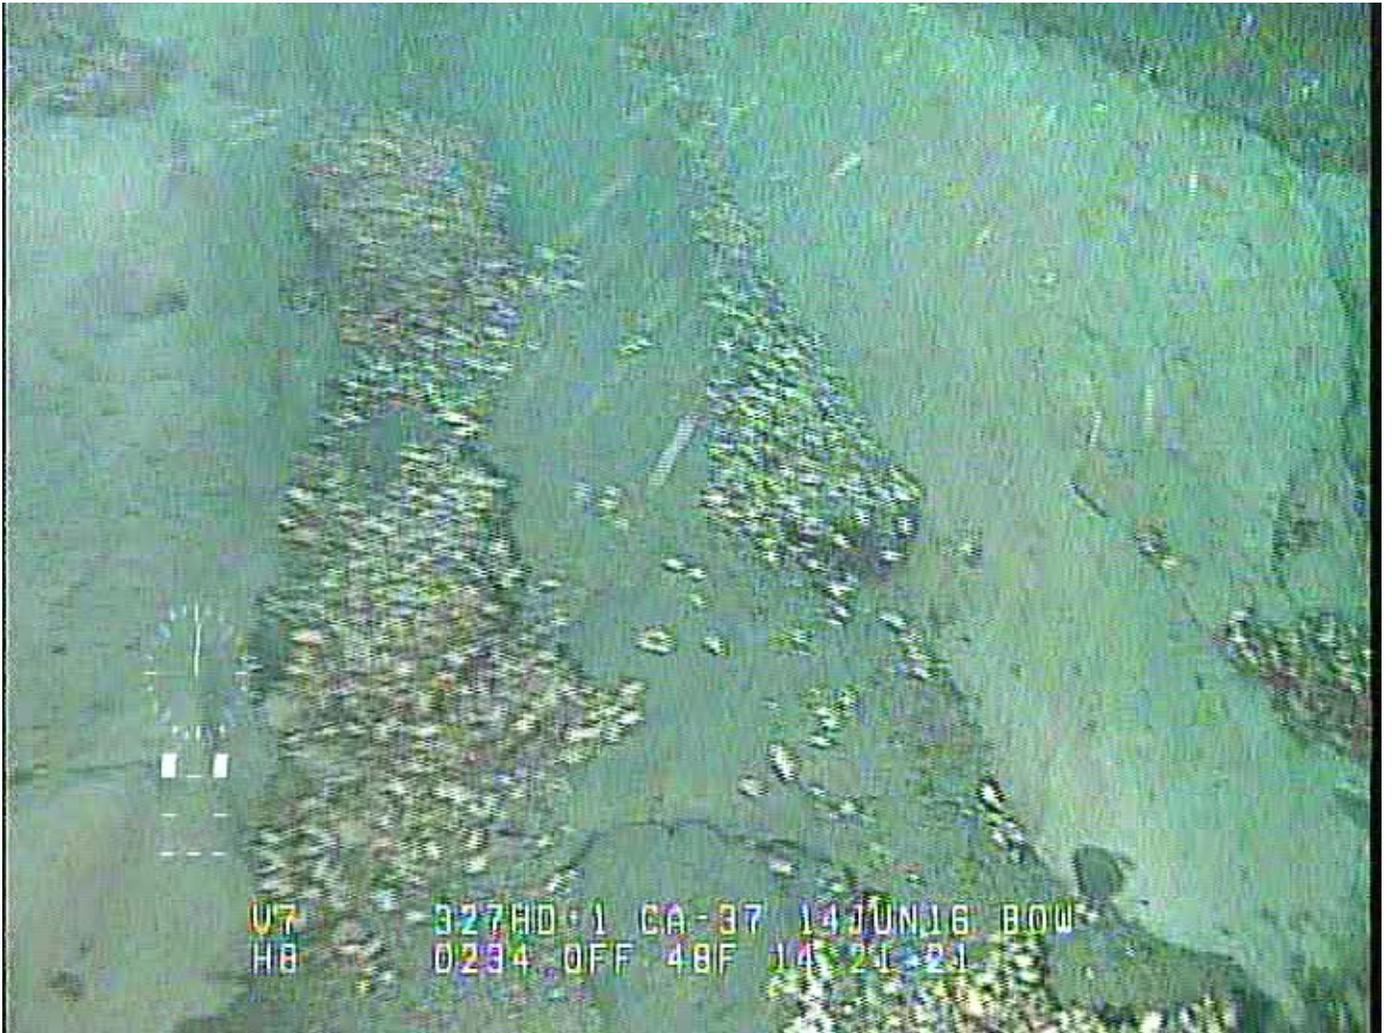
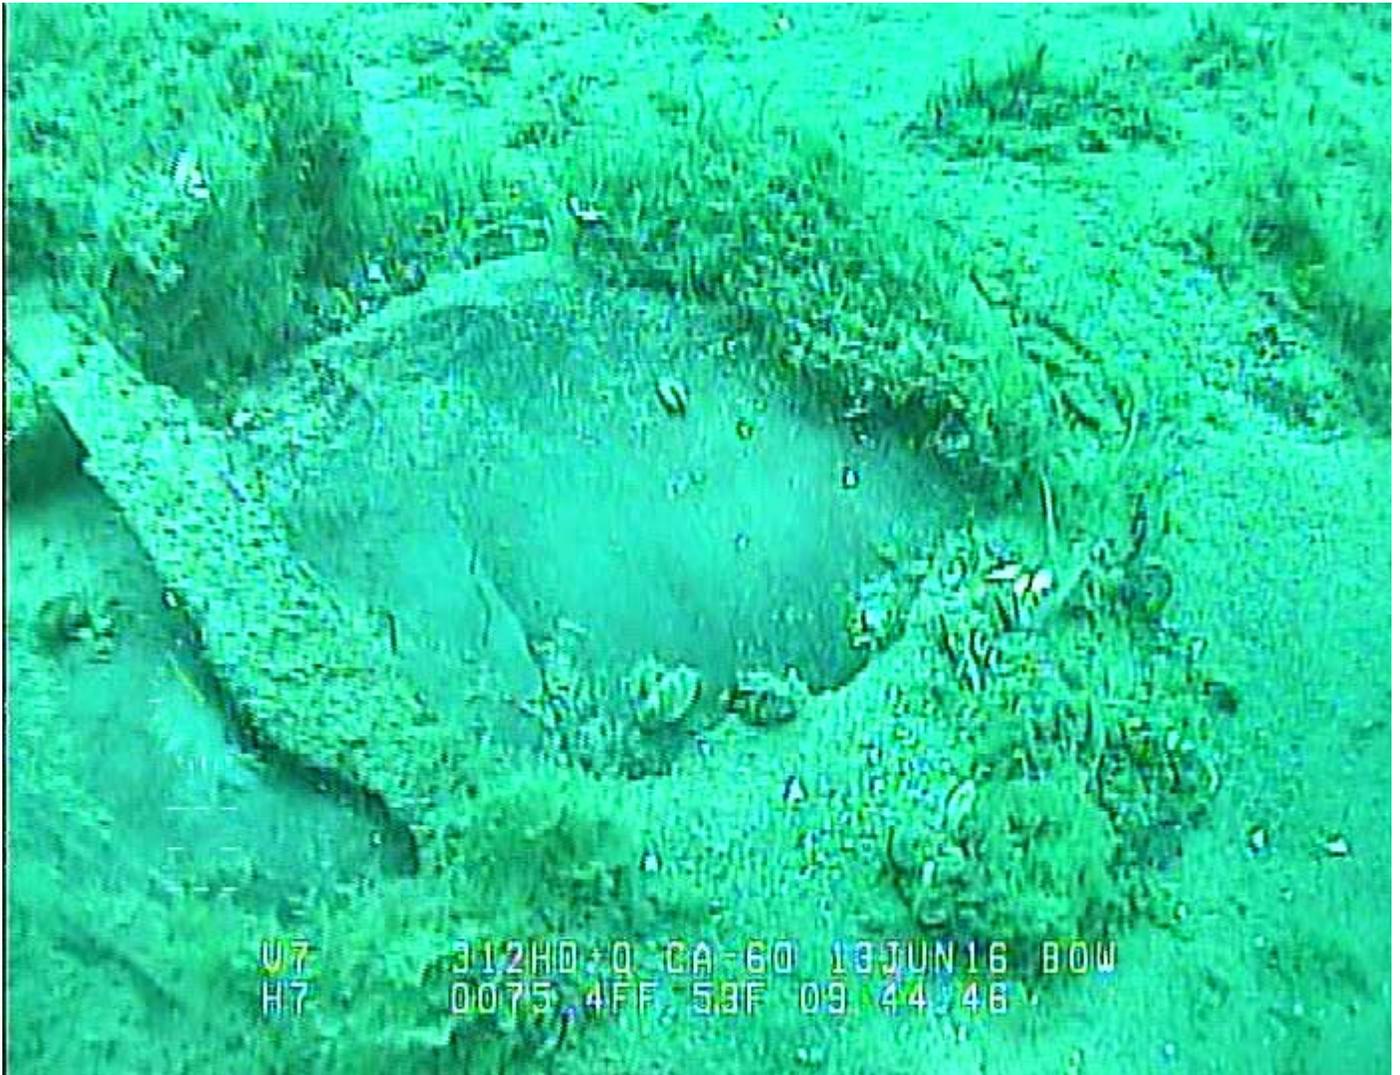
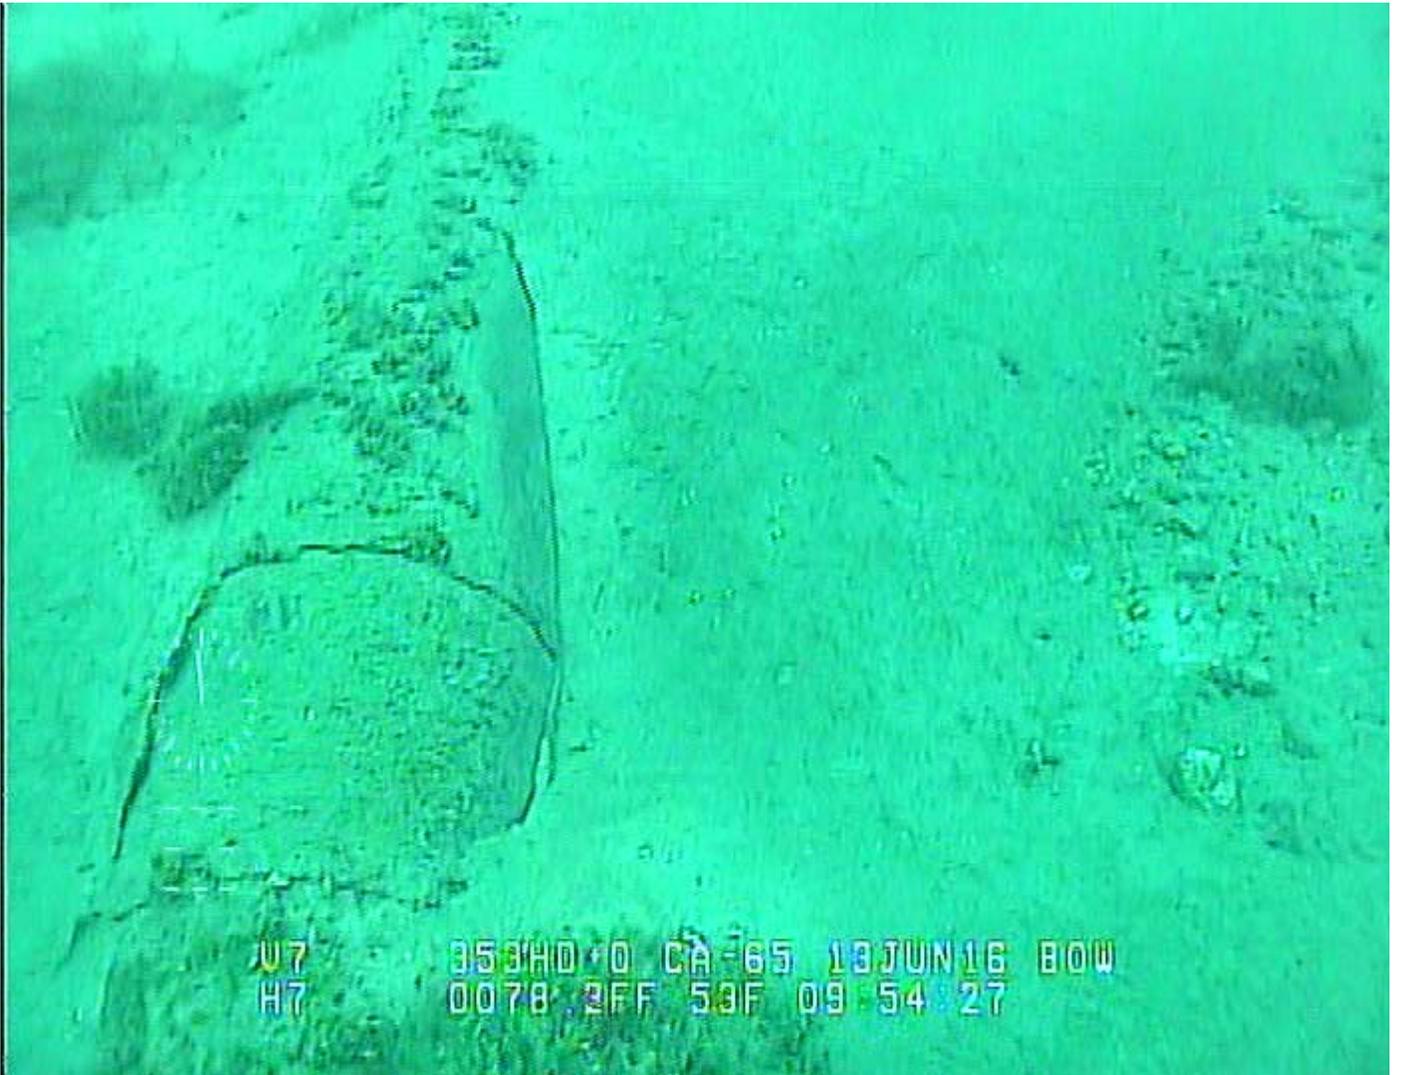
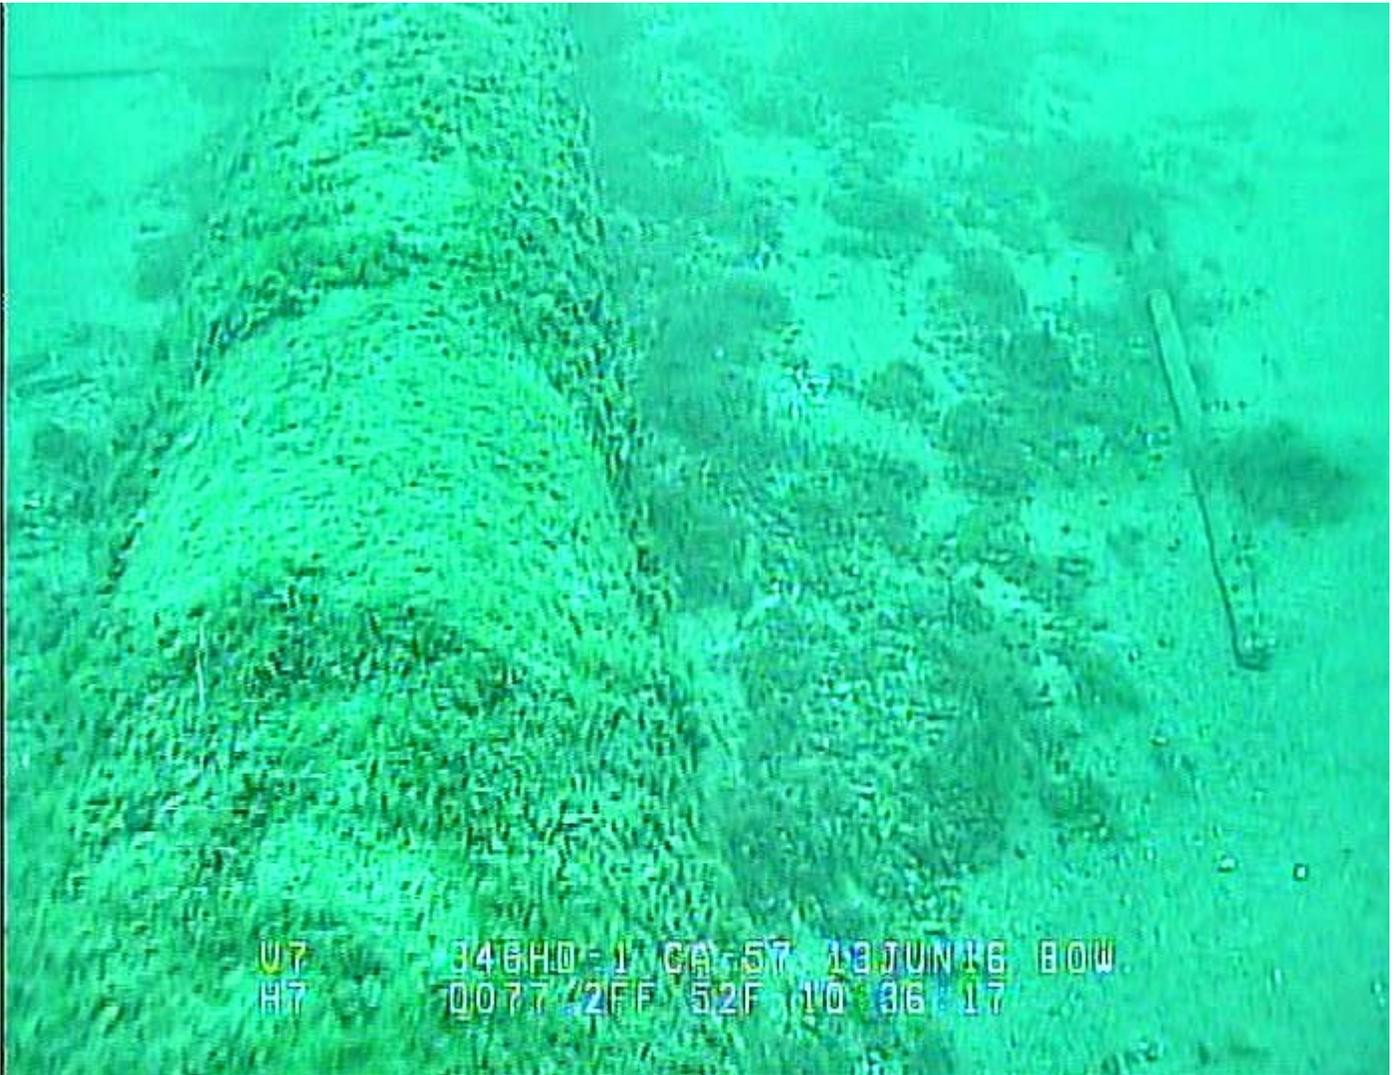
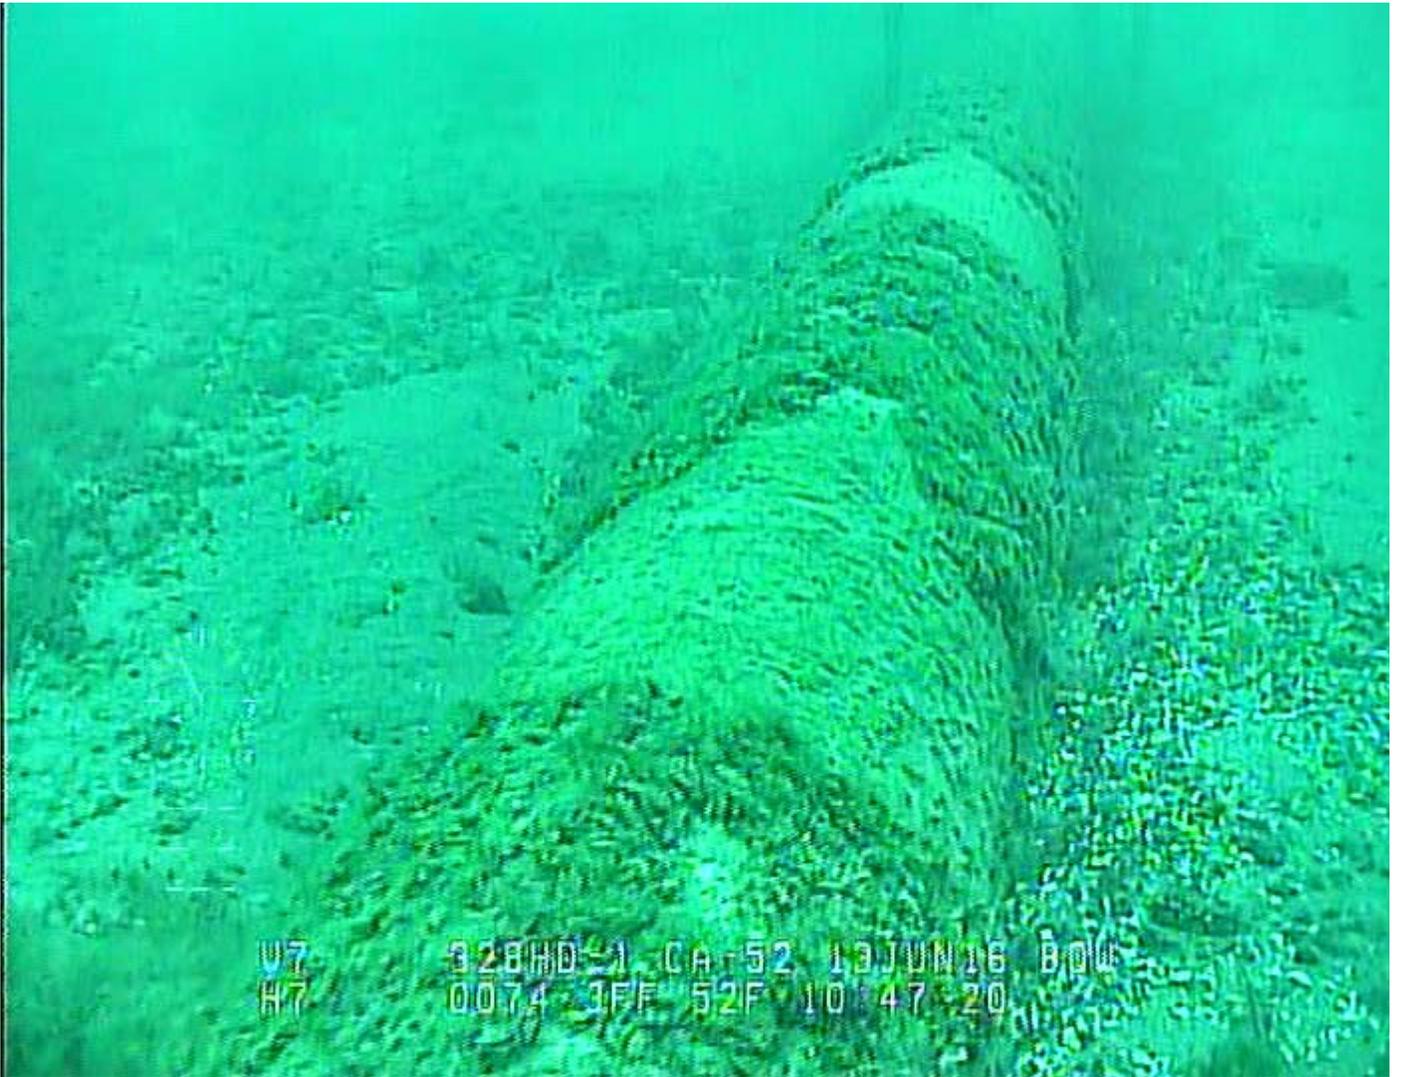
The attached photographs generally show areas of the pipelines in which biota are not present or are only minimally present and in some cases the outer wrap of the coating appears loose or dislodged. As discussed above, it is not clear at this time whether all of these locations reflect areas where the outer wrap of the coating is no longer in place or whether these locations reflect areas that simply are lacking biota. Enbridge provided EPA on March 20, 2017, a copy of the video recording of the 2016 visual inspection, from which the attached photographs were obtained. The purpose of implementing the Work Plan is to obtain further information about these or similar areas on the Dual Lines.

As noted, the portion of the coating system that protects against corrosion after installation of a pipeline is the enamel layer below the inner and outer wraps. Photographs from the 2016 inspection of the dual pipelines do not show any loss of the underlying enamel coating. These observations will be subject to further review as part of the Biota Investigation Work Plan. Section 3.3.4.1 of the Work Plan (Cathodic Protection Evaluation) as submitted can be read to suggest that there may be holiday areas of exposed metal.² However, as noted, subsequent review of the visual data from 2016 has not shown any areas of bare metal. Implementation of the Work Plan will determine whether the current conclusion that no bare metal is exposed can be confirmed. The cathodic protection evaluation described in § 3.3.4.1 would be employed if any bare metal areas were identified.
