Navajo Abandoned Uranium Mine Site Screen Report

Largo AUM Site

Navajo AUM Eastern Region

May 2009

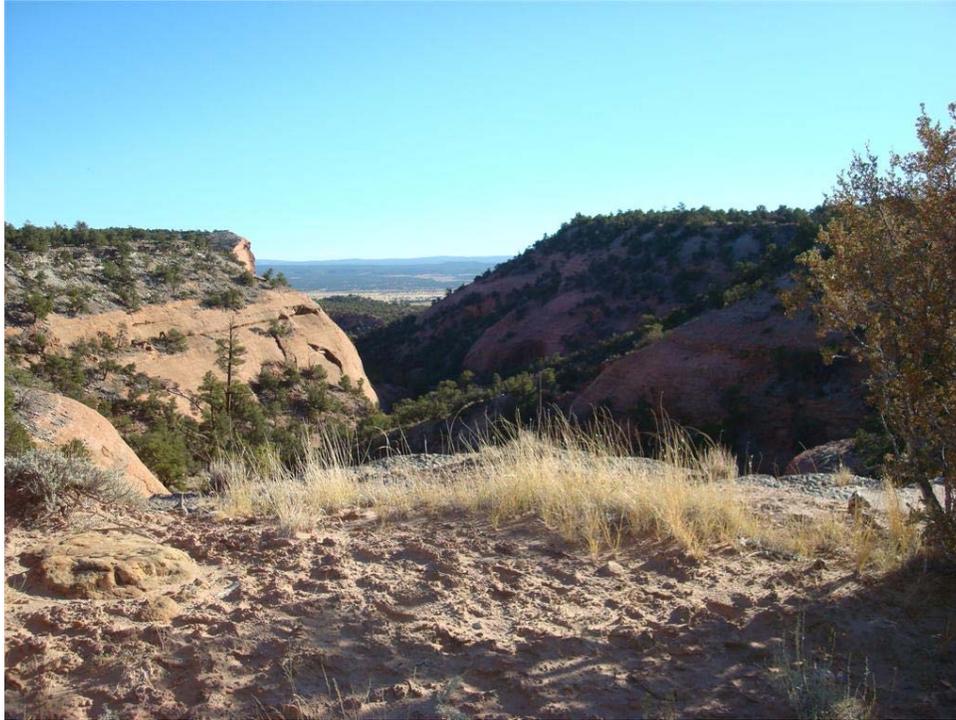
Reclamation status of the mine site is currently unknown. No visible signs of reclamation of mine workings were observed. The mine is located above a box canyon with drainage towards the south with residences located one mile down stream. No waste piles, adits, or other mine features were observed during the site visit.

Photo 1. Largo Mine site, towards the south

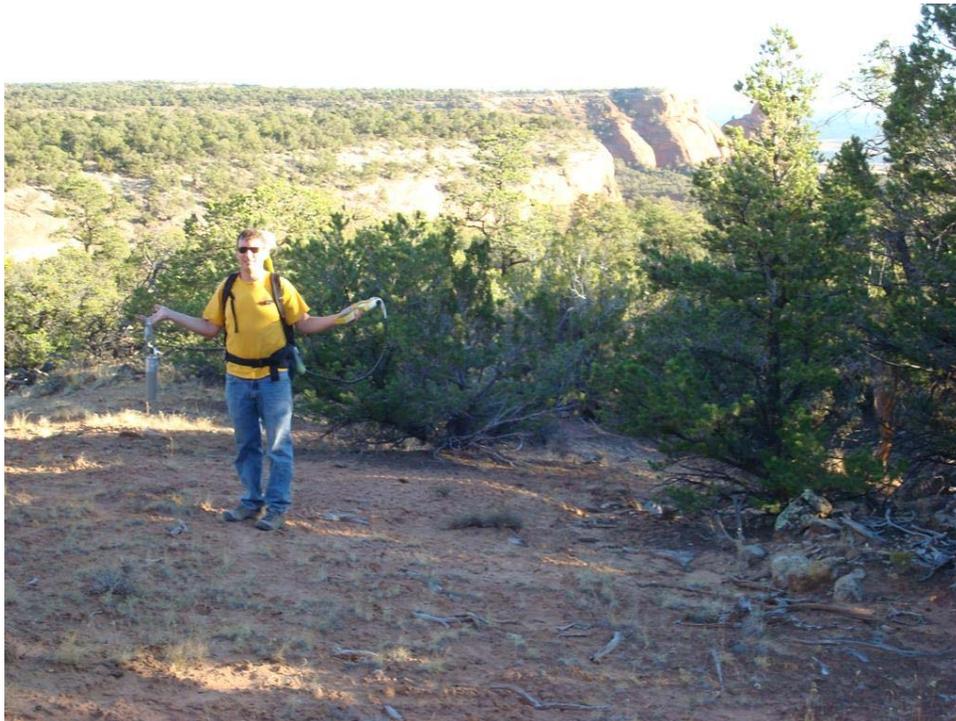
Photo 2. Largo Mine site, towards the east

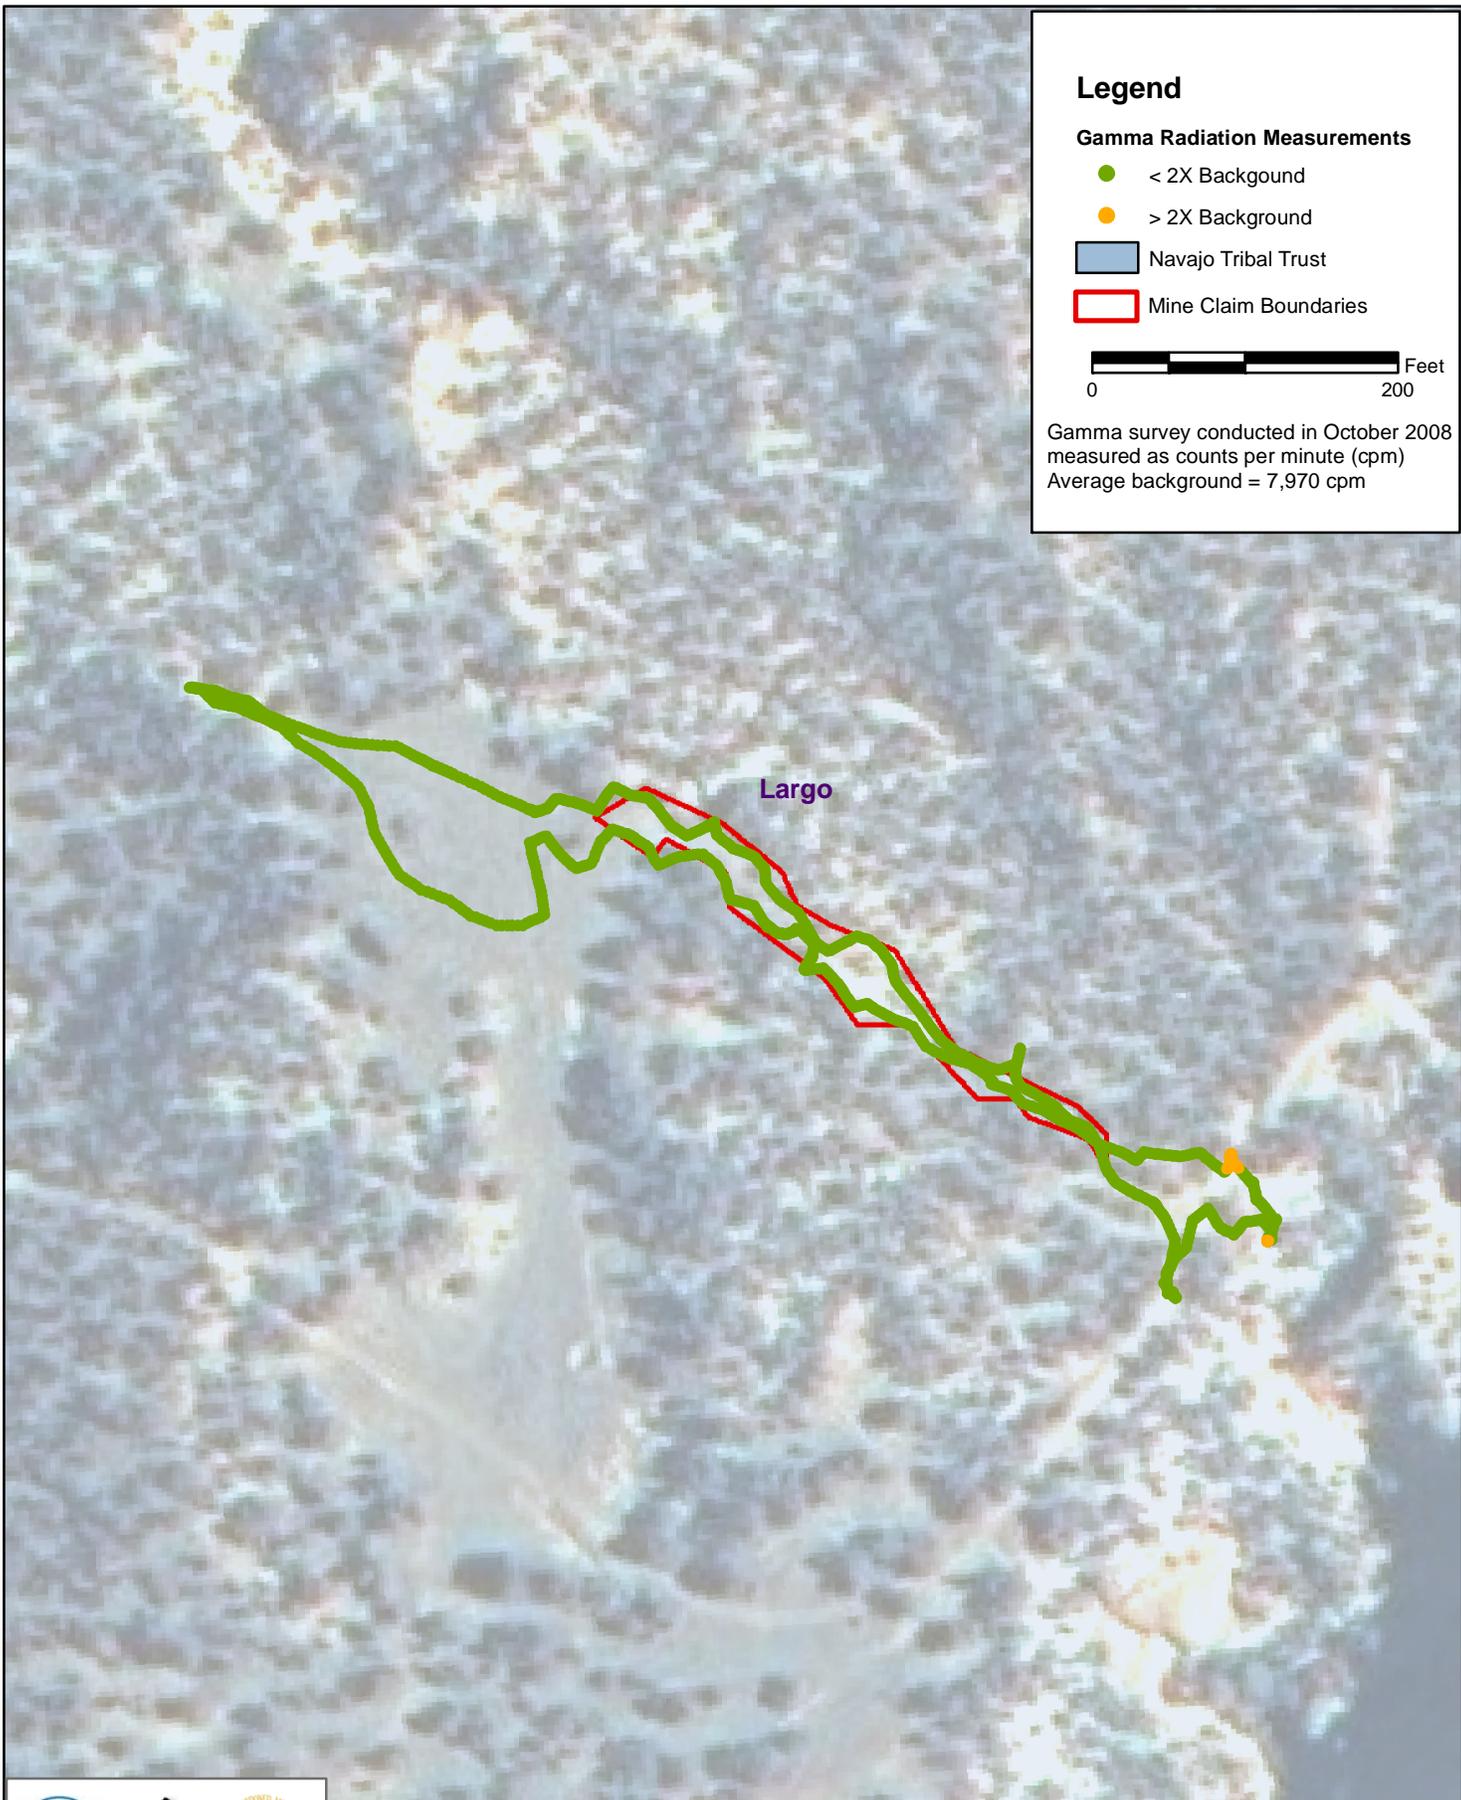
Gamma Radiation Measurements Above Two Times Background Largo
 Smith Lake Chapter
 Navajo Nation, New Mexico Figure 1

A total of 1,105 gamma radiation measurements were collected from mine sites, ranging from 5,722 cpm to 91,911 cpm. The measurements are represented in Figures 1 and 2.

Gamma survey conducted in October 2008
 measured as counts per minute (cpm)
 Average background = 7,970 cpm

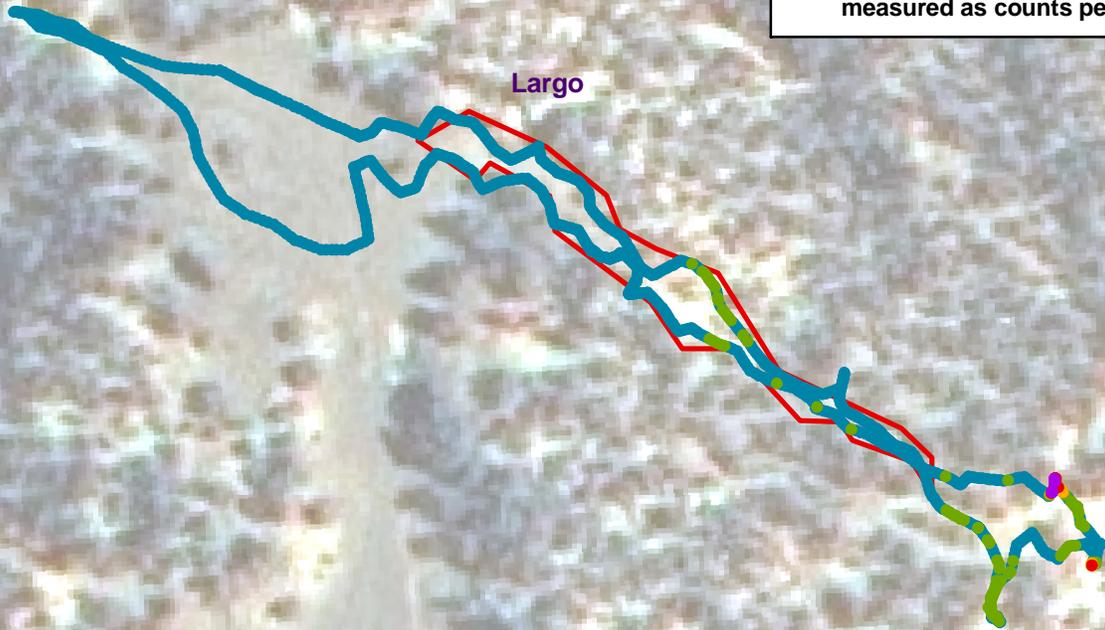
Gamma Radiation Measurements
Largo
Smith Lake Chapter
Navajo Nation, New Mexico
Figure 2

Gamma survey conducted in October 2008
measured as counts per minute
