Navajo Abandoned Uranium Mine Site Screen Report

Crownpoint ISL Site

Navajo AUM Eastern Region

May 2009

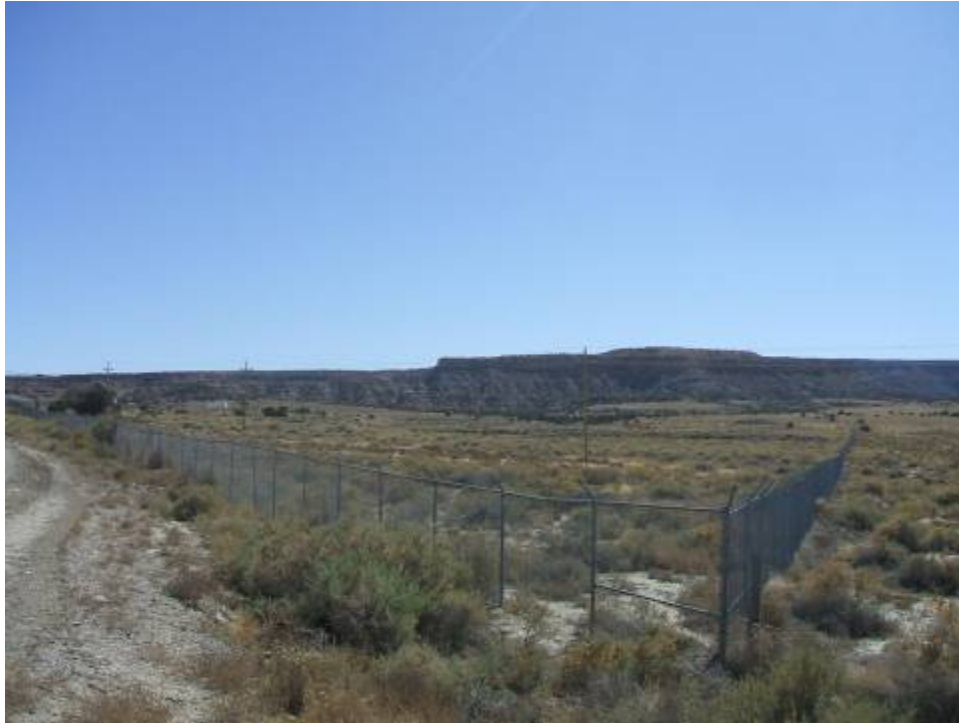
No ownership was identified. The mine site property is classified as Indian Allotment, and Private land. Currently, Hydro Resources, Inc, occupies the property, although the facility is not presently active. The site was fenced in, and field personnel were unable to access the interior of the property (Photo 1, 2).

Photo 1. Crownpoint ISL mine site, towards the southeast

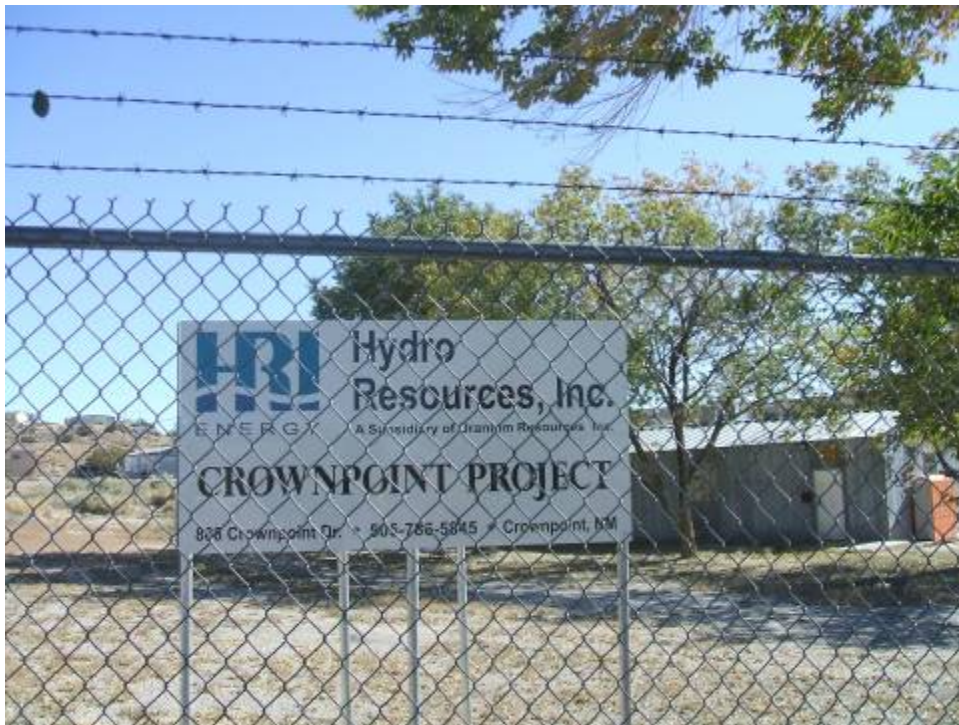
Photo 2. Crownpoint ISL mine site, current business operating onsite – “Hydro Resources, Inc”, towards the south

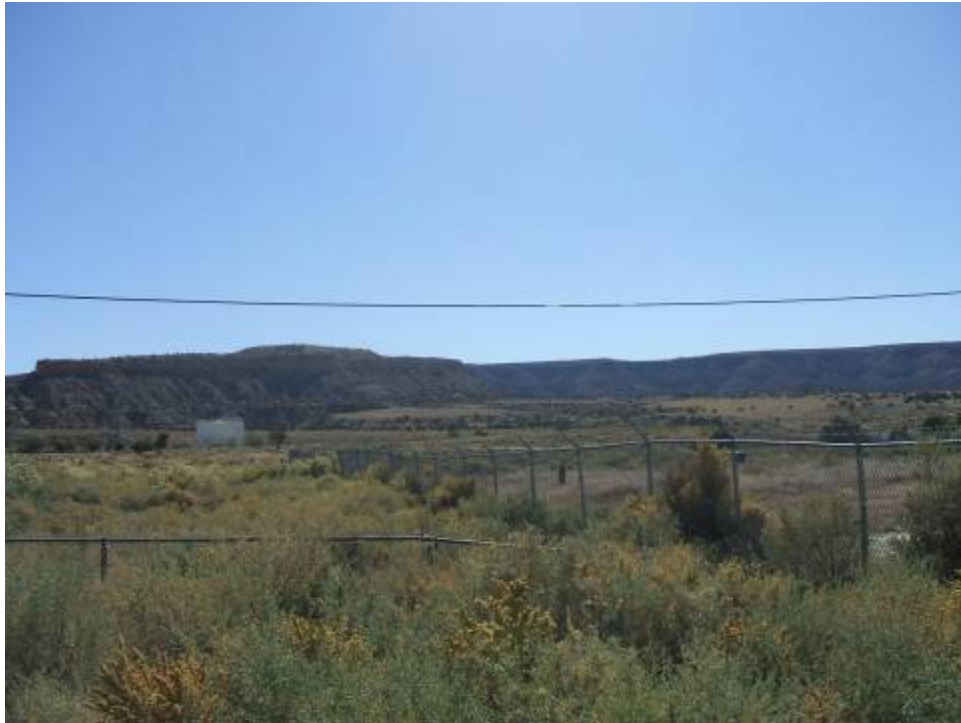
Photo 3. Crownpoint ISL mine site, towards the south

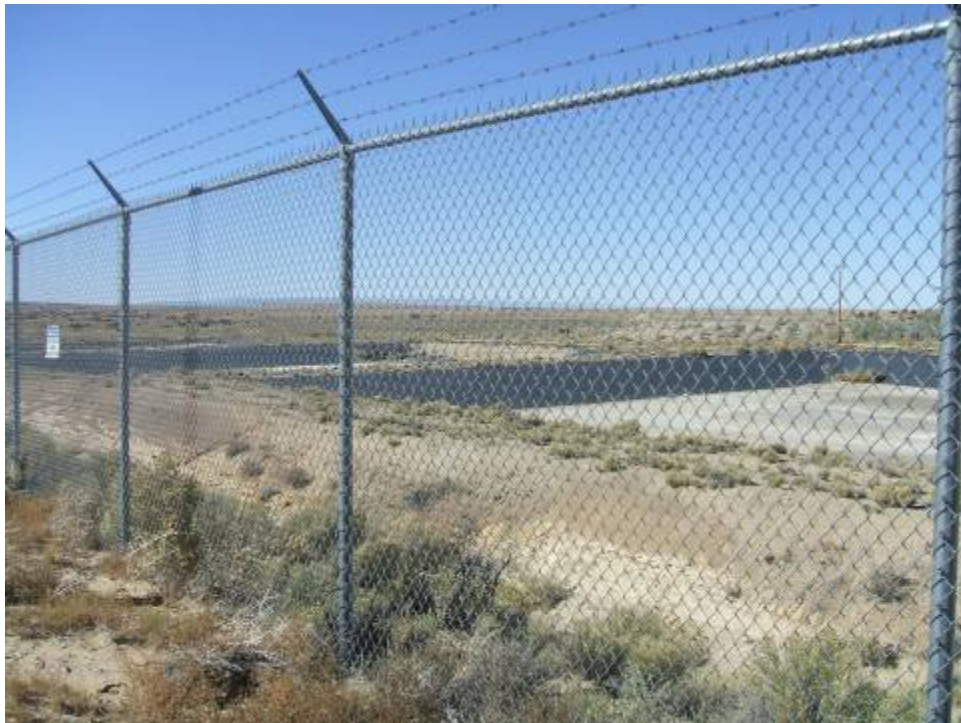
Photo 4. Crownpoint ISL mine site lined ponds, towards the northwest

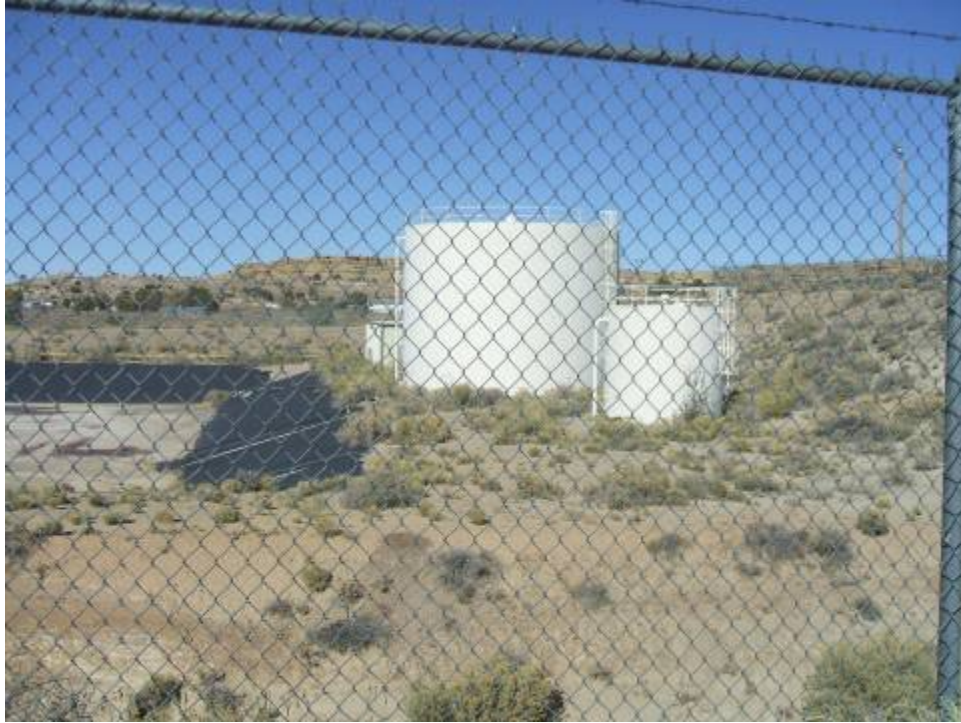
Photo 5. Crownpoint ISL mine site lined ponds and tanks, towards the northwest

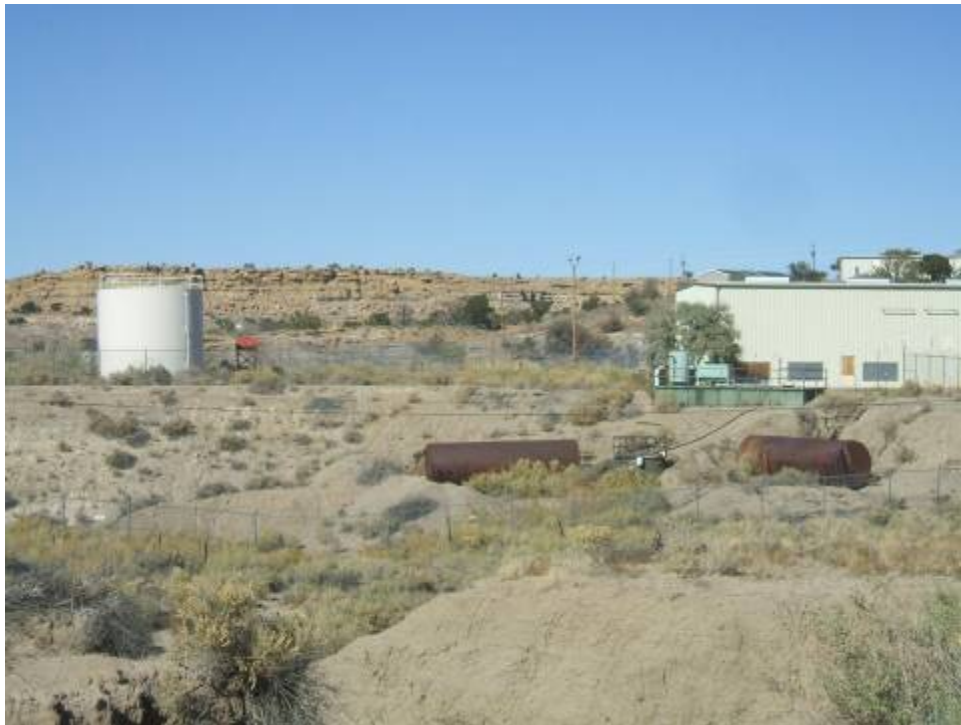
Photo 6. Crownpoint ISL mine site tanks and Hydro Resources building, towards the north

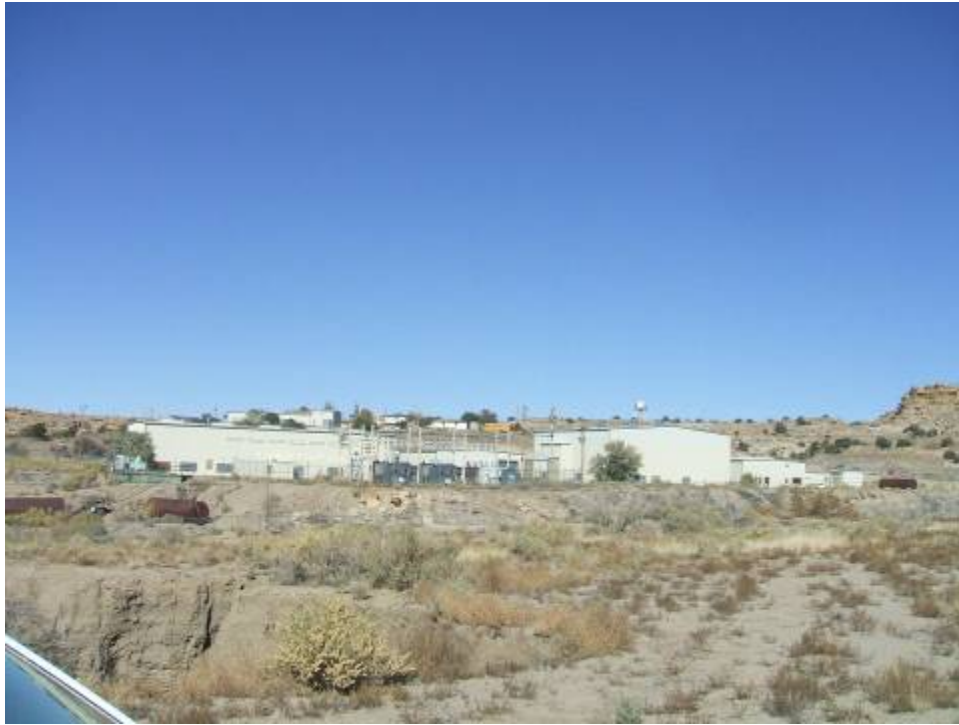
Photo 7. Crownpoint ISL mine site and Hydro Resources building, towards the north

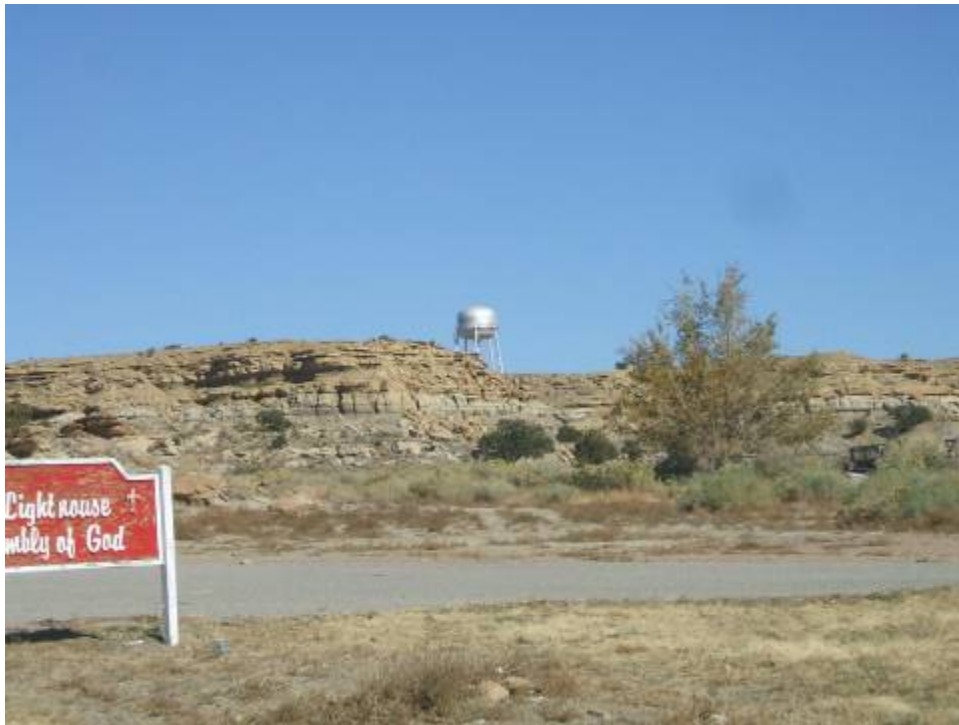
0.25 miles to 4 miles: A water tower was observed approximately 0.5 miles north of the site, field personnel were unable to access the tower, and were not able to identify the source of the water.

Photo 8. Water tower approximately 0.5 miles north/northeast of site, towards the northeast

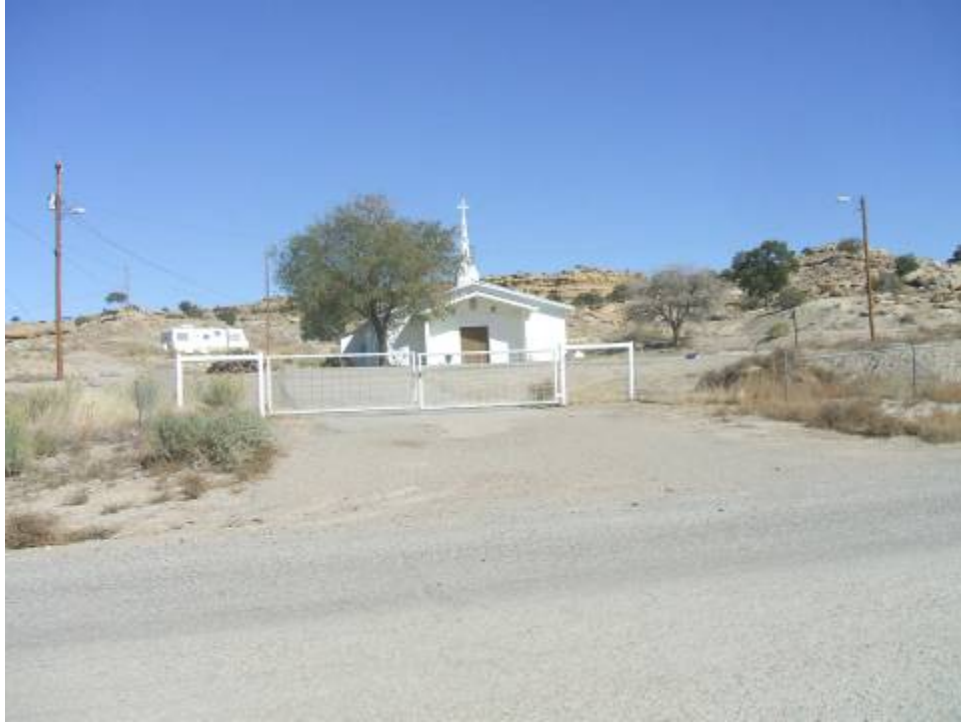
0 to 200 feet: 3 churches were observed within 200 feet of the site property, to the north, along Church Drive (Photo 9, 10). Gamma radiation levels at the churches were found at less than 2 times background levels.

Photo 9. New Life Fellowship Church, approximately 200 feet north of site, towards the north

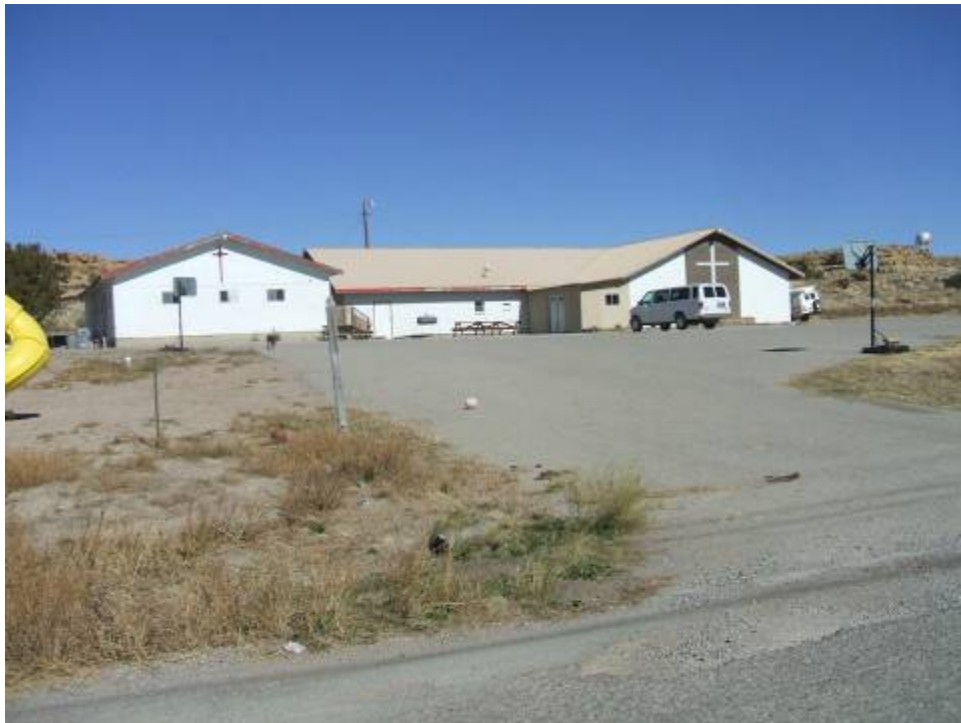
Photo 10. Church at northeast corner of site, towards the northeast

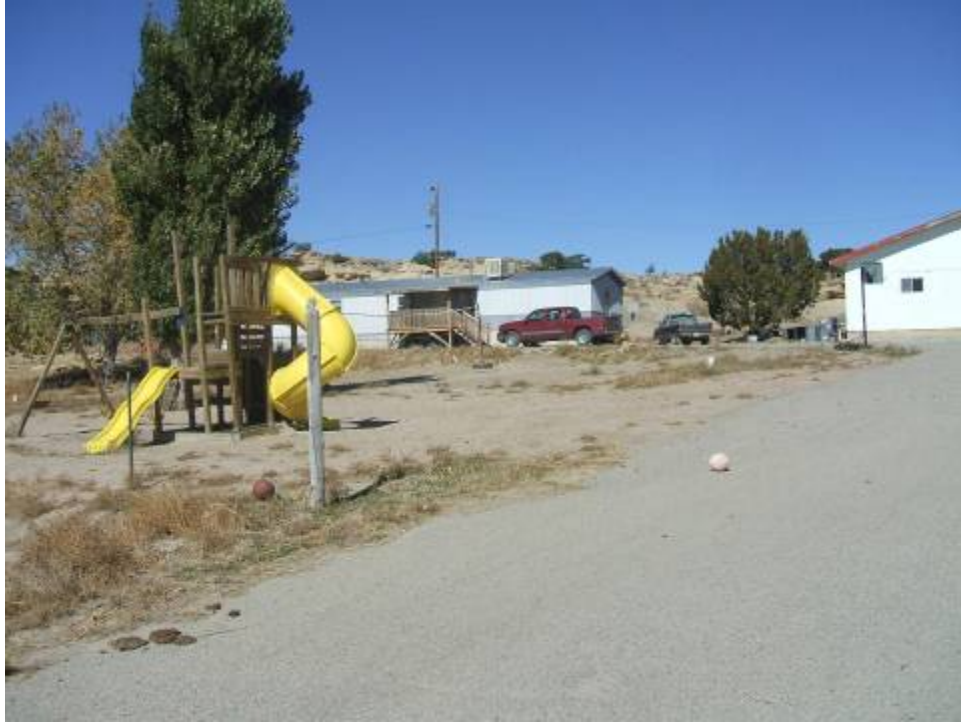
0 to 200 feet: Approximately 6 houses were observed within 200 feet of the site property, to the north, along Church Drive (Photo 11, 12. Gamma radiation levels at the houses were found at less than 2 times background levels.

Photo 11. Trailer and church at northeast corner of site, towards the northeast

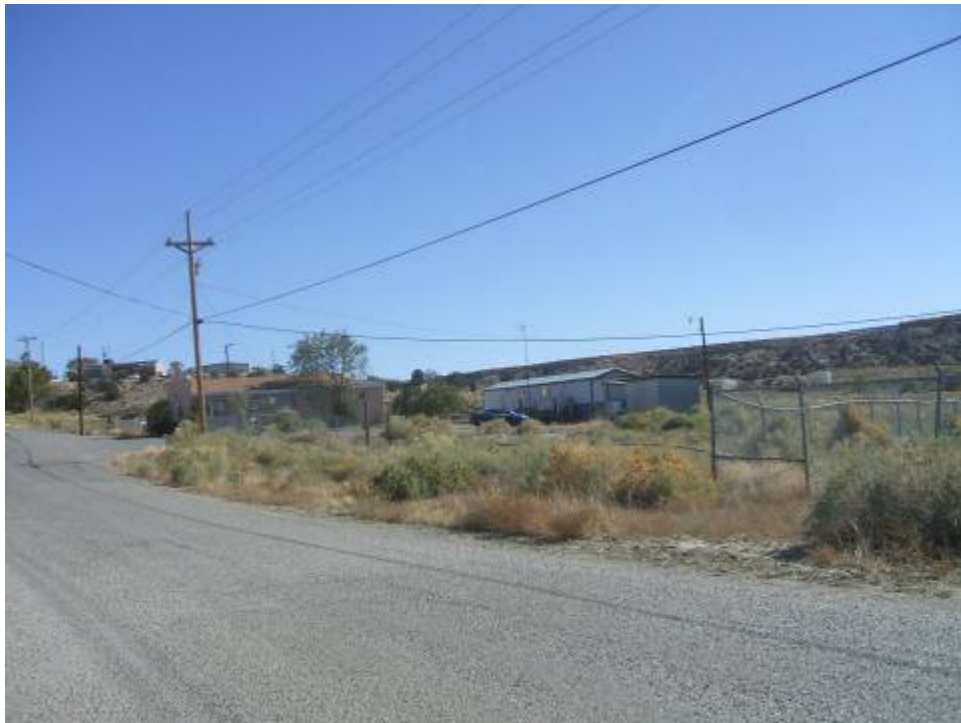
Photo 12. Trailers and houses at northeast corner of site, towards the southeast

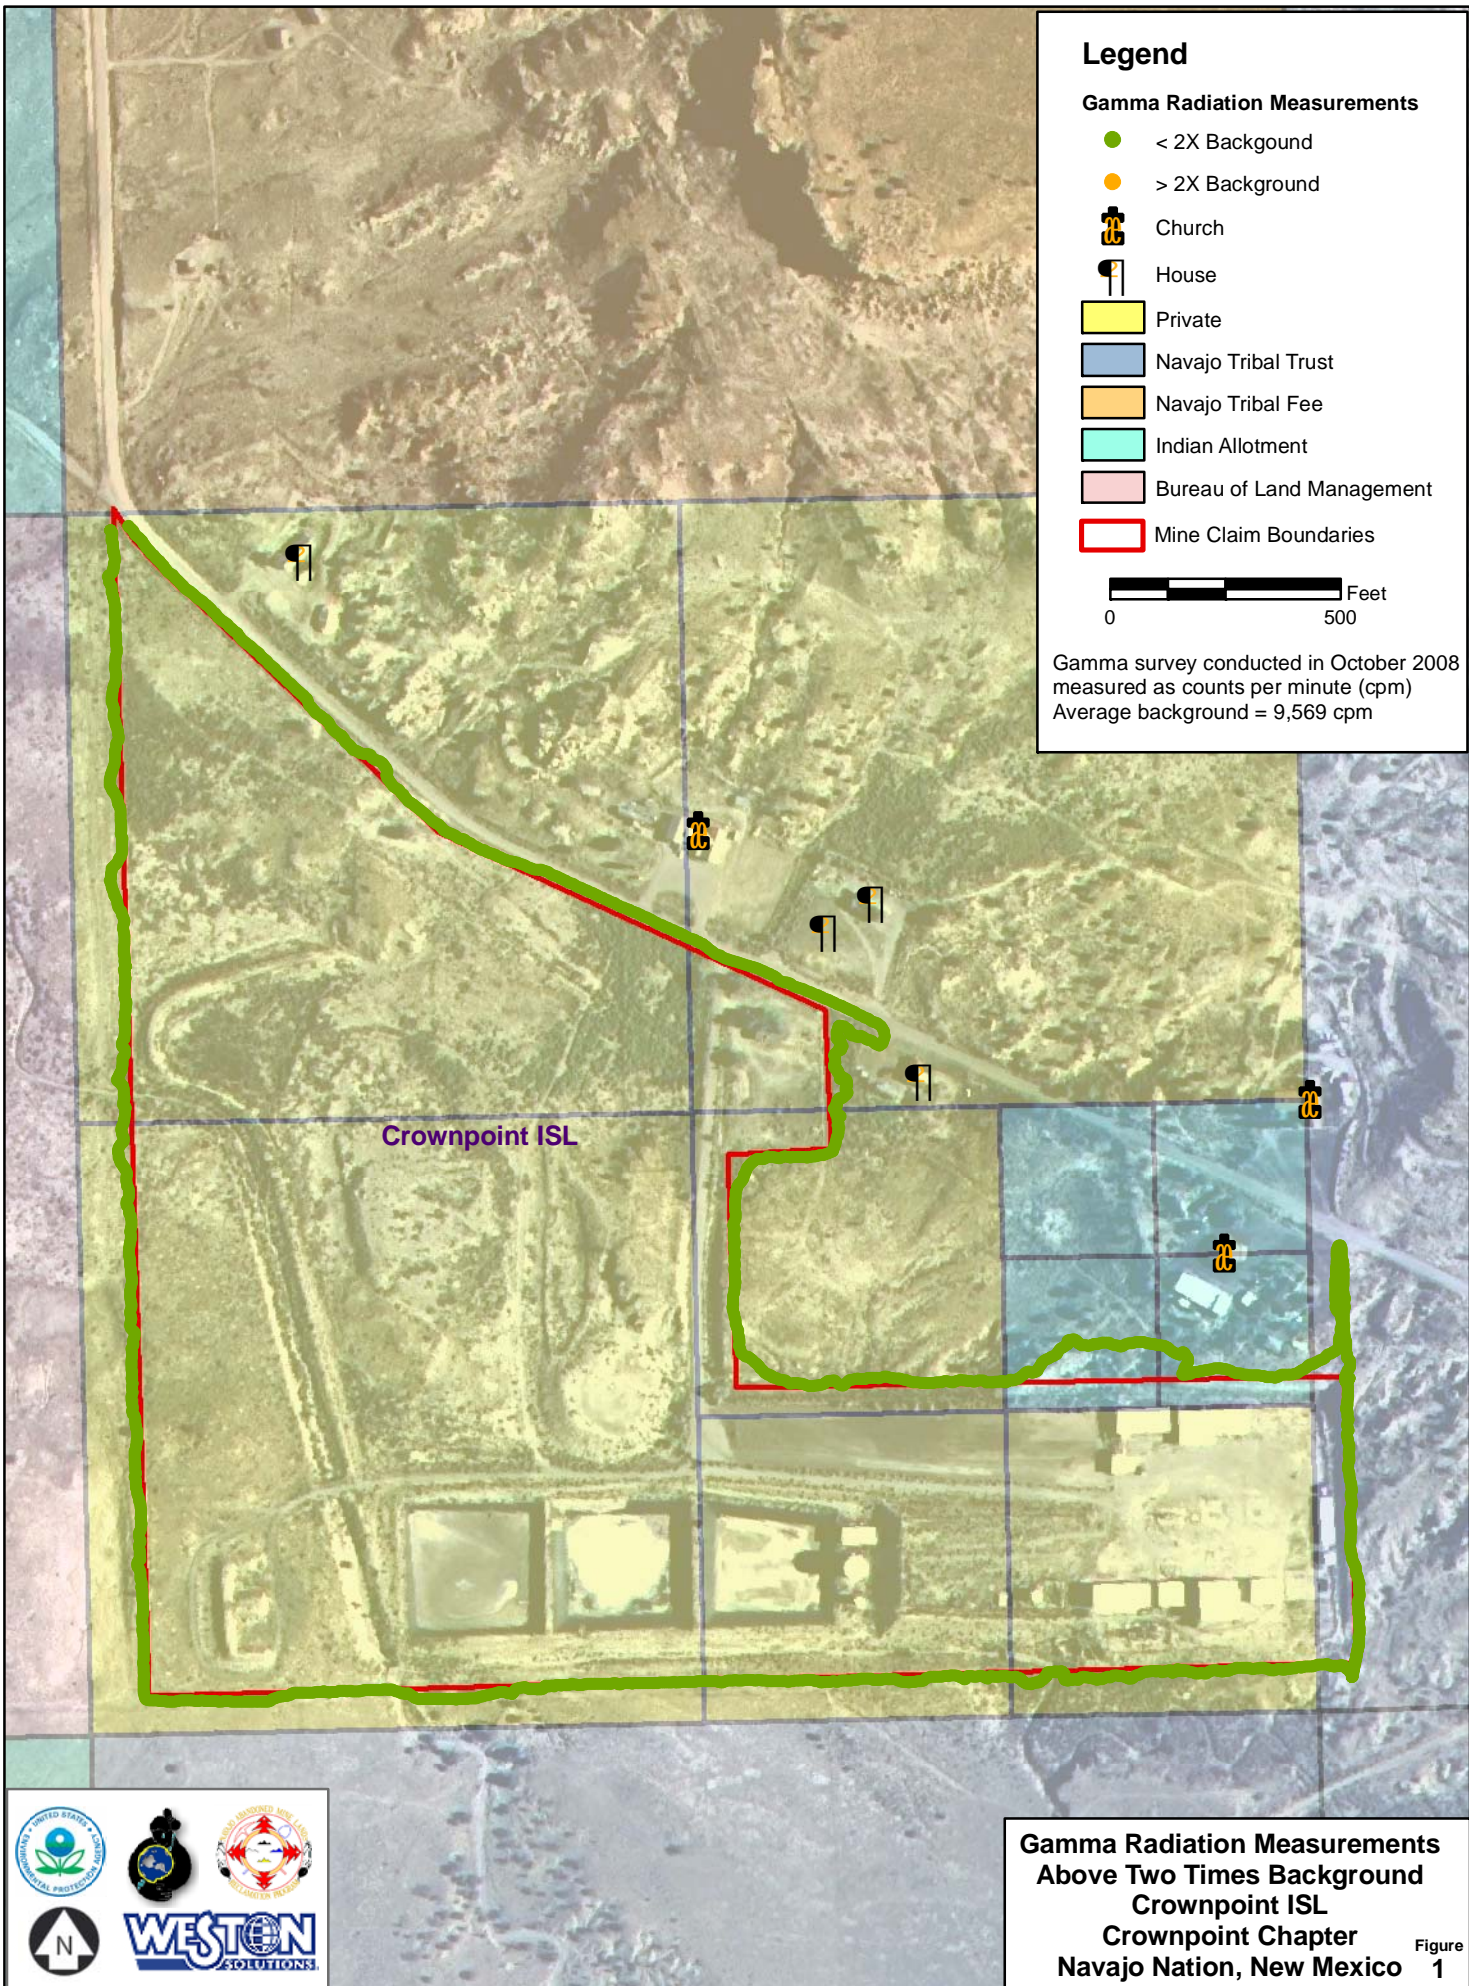
**Gamma Radiation Measurements
Above Two Times Background
Crownpoint ISL
Crownpoint Chapter
Navajo Nation, New Mexico** Figure 1

A total of 3,344 gamma radiation measurements were collected from mine sites, ranging from 6,248 cpm to 15,680 cpm. The measurements are represented in Figures 1 and 2.

Gamma survey conducted in October 2008
measured as counts per minute (cpm)
Average background = 9,569 cpm
