# **Navajo Abandoned Uranium Mine Site Screen Report**

## **Reynolds AUM Site**

### **Navajo AUM Eastern Region**

**May 2009**

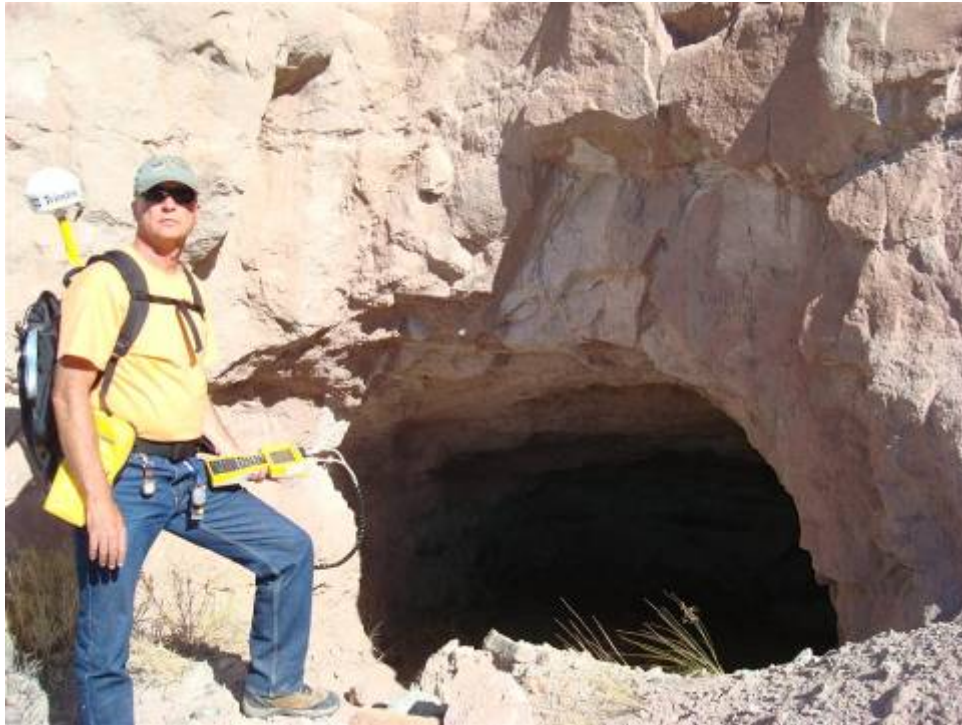
Photo 3. Reynolds Mine site, possible sealed adit

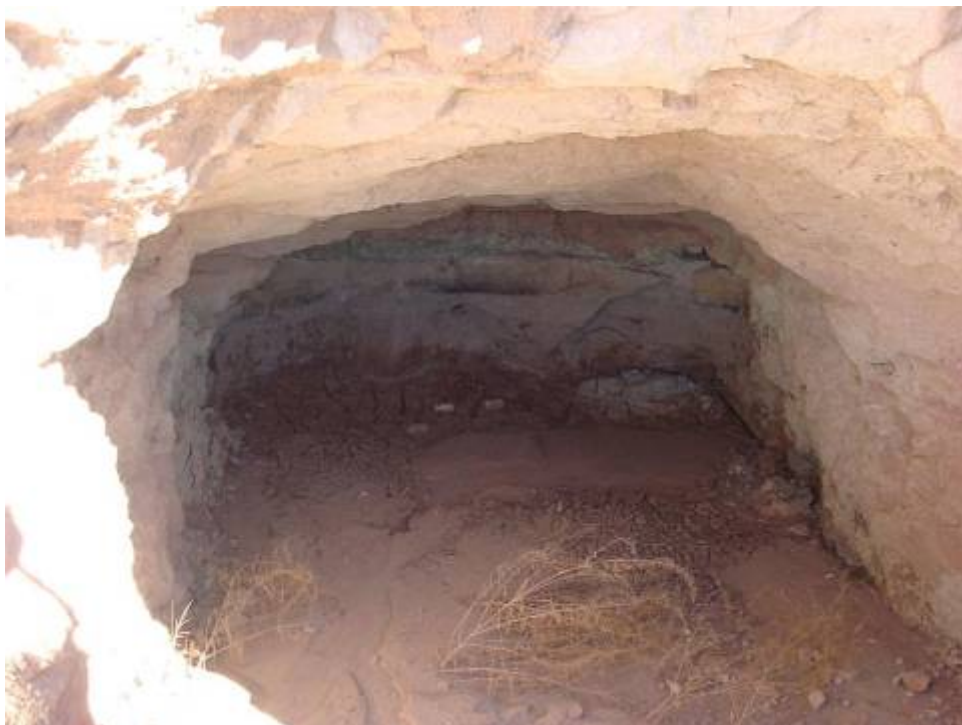
Photo 4. Reynolds Mine site, possible sealed adit

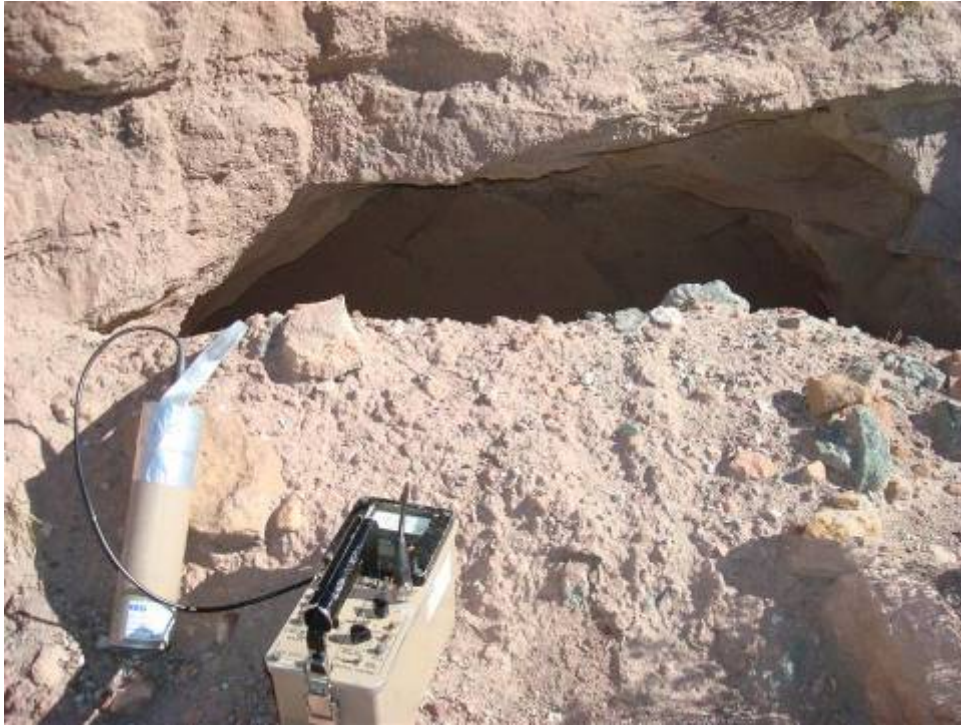
Photo 5. Reynolds Mine site, partially buried adit

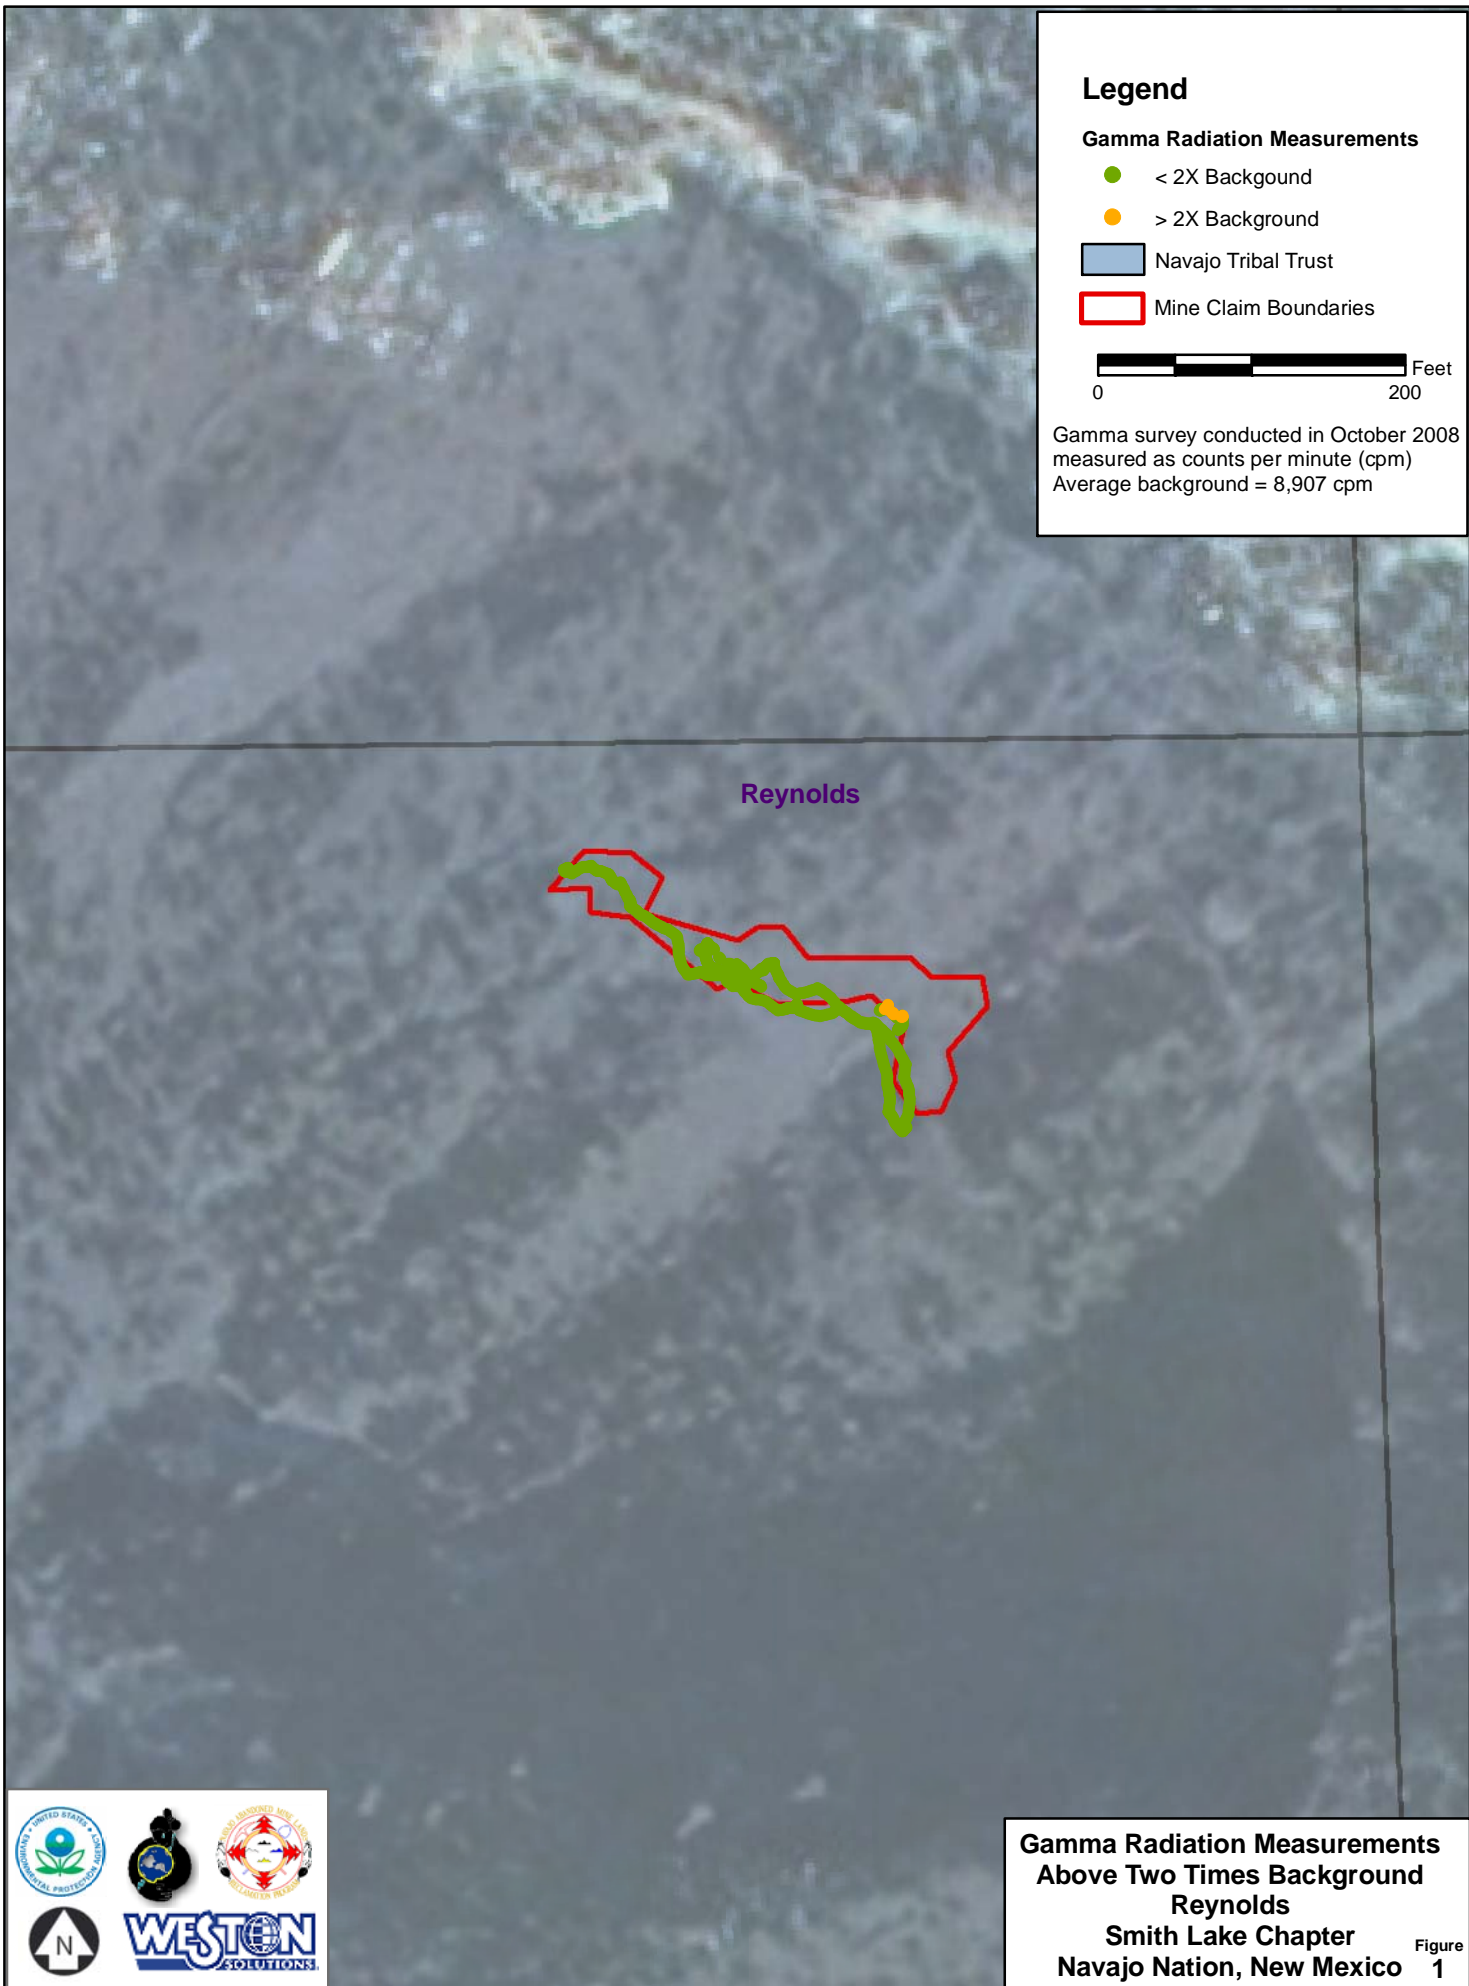
**Gamma Radiation Measurements  
 Above Two Times Background  
 Reynolds  
 Smith Lake Chapter  
 Navajo Nation, New Mexico** Figure 1

A total of 1,082 gamma radiation measurements were collected from mine sites, ranging from 5,634 cpm to 22,329 cpm. The measurements are represented in Figures 1 and 2.

Gamma survey conducted in October 2008  
 measured as counts per minute (cpm)  
 Average background = 8,907 cpm
