# Navajo Abandoned Uranium Mine Site Screen Report

## **Section 18 SEQ AUM Site**

### **Navajo AUM Eastern Region**

**May 2009**

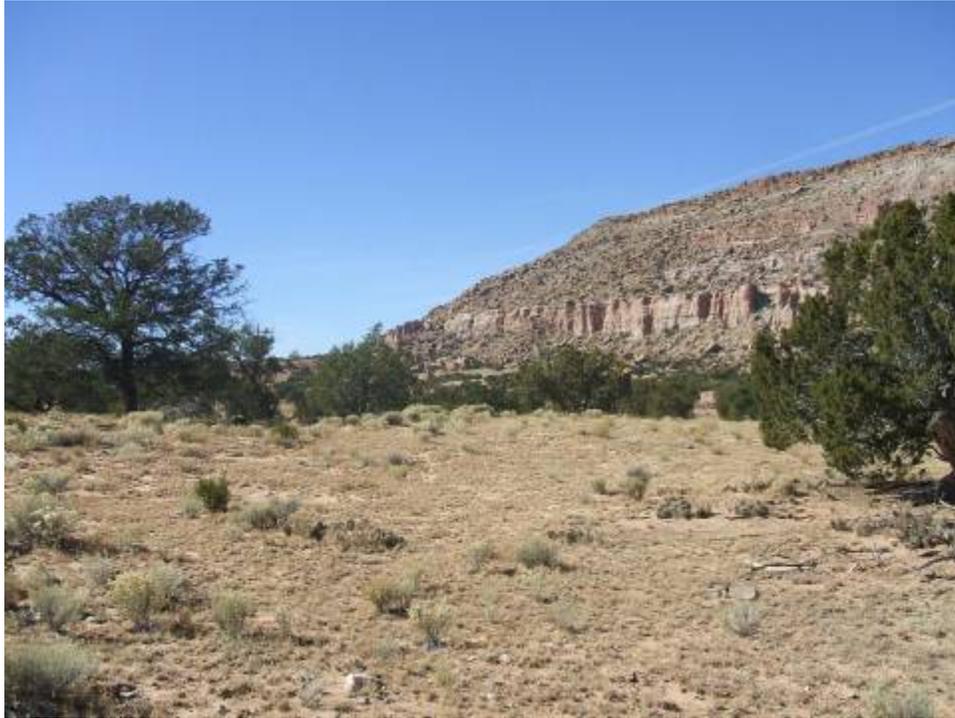
Reclamation status of the mine site is currently unknown. No waste pile, pits, adits or other mine features were observed during the site visit.

Photo 1. Section 18 SEQ mine site, towards the southwest

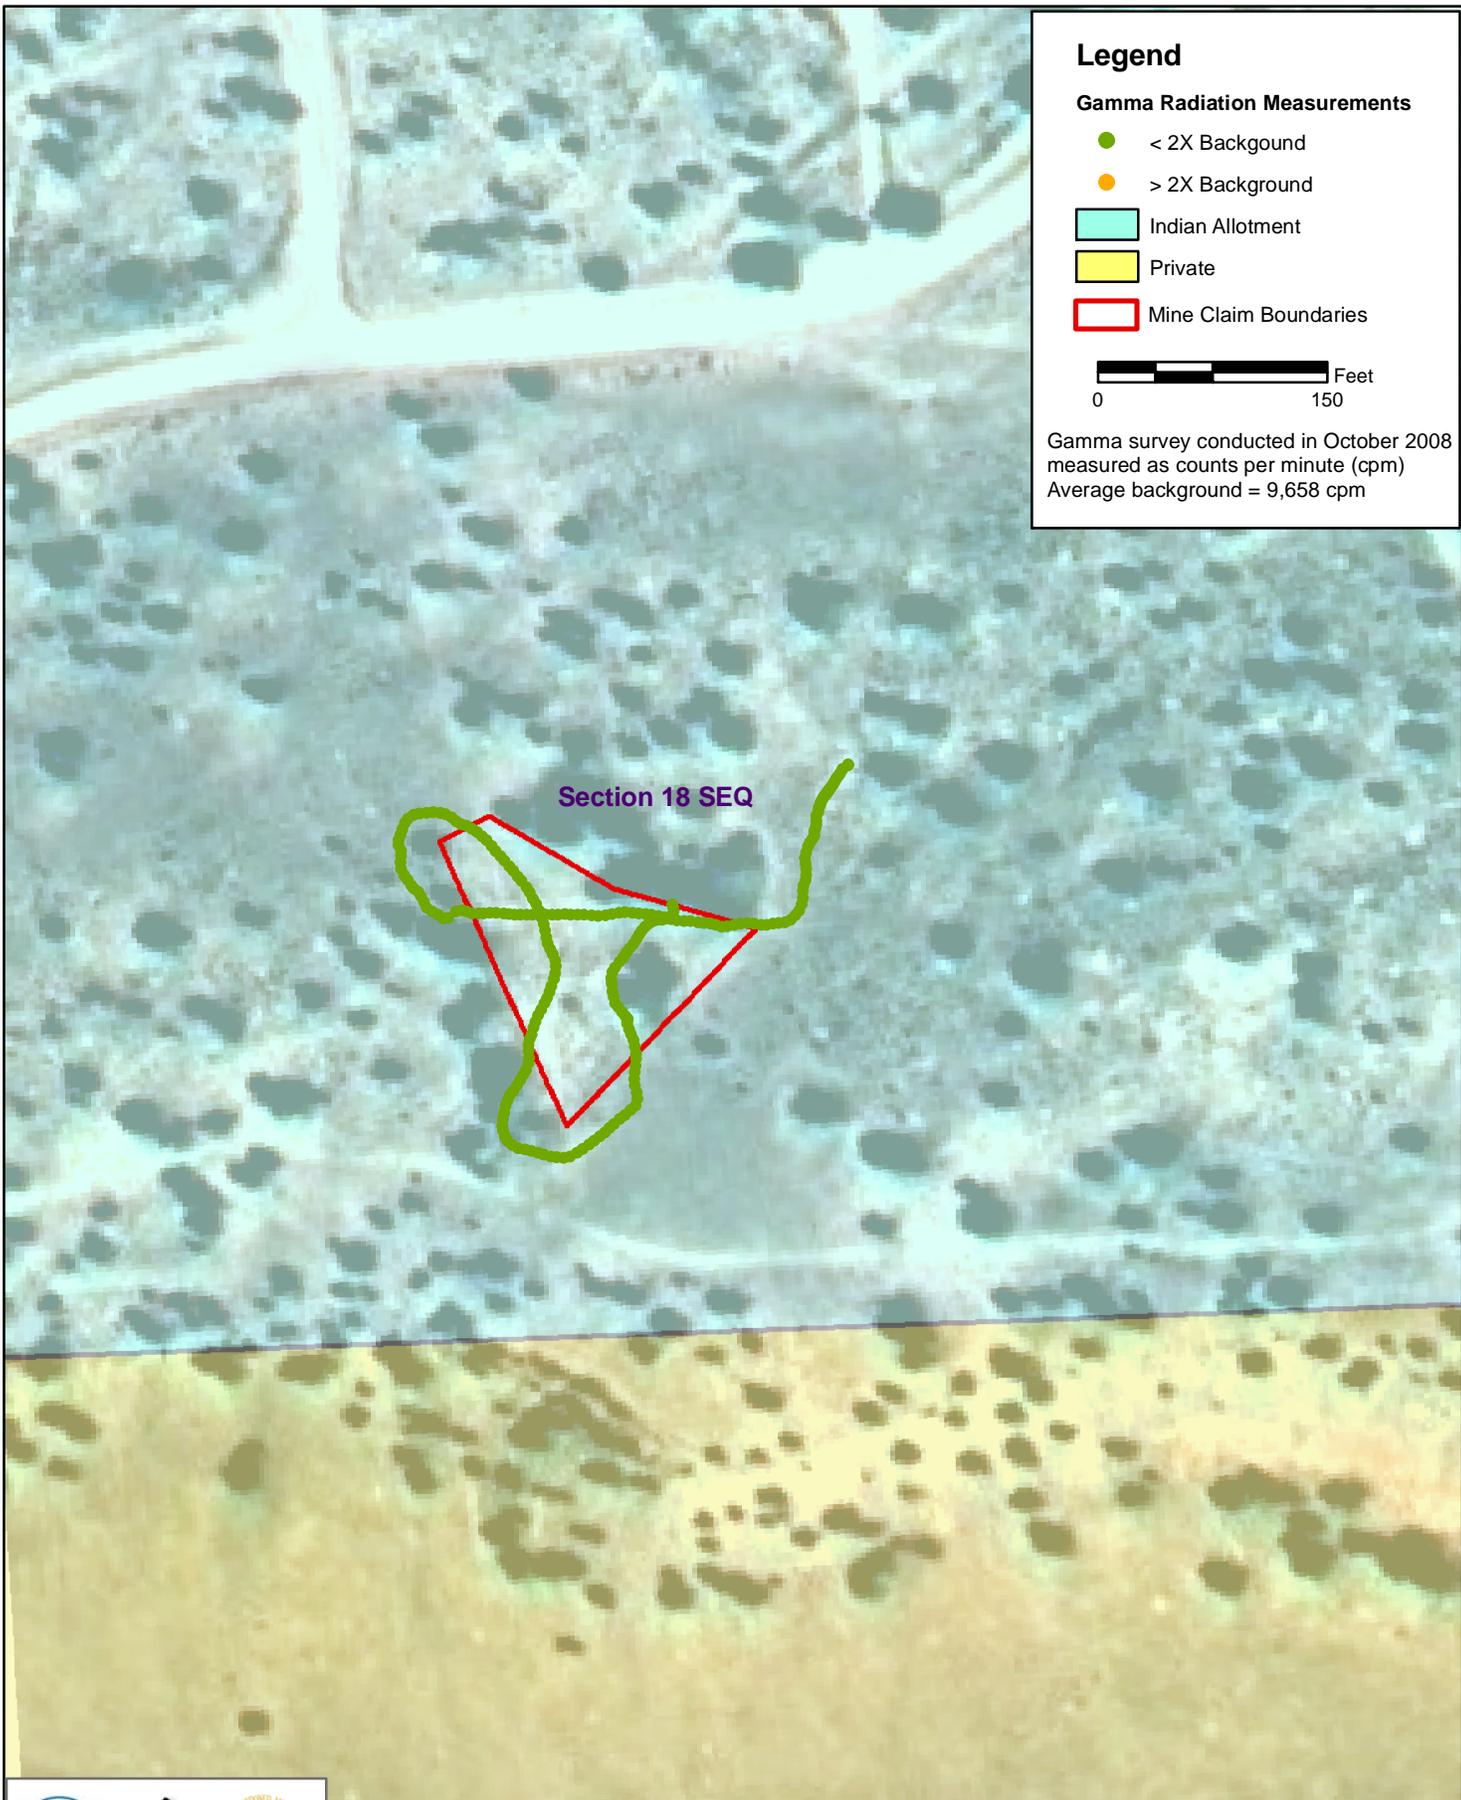
**Gamma Radiation Measurements  
 Above Two Times Background  
 Section 18 SEQ  
 Baca/Haystack Chapter  
 Navajo Nation, New Mexico** Figure 1

A total of 253 gamma radiation measurements were collected from mine sites, ranging from 6,469 cpm to 8,775 cpm. The measurements are represented in Figures 1 and 2.

5 houses approximately 0.2 miles west of site. Gamma radiation levels were less than 2 time background levels.
