Navajo Abandoned Uranium Mine Site Screen Report

Section 16 Deposit AUM Site

Navajo AUM Eastern Region

May 2009

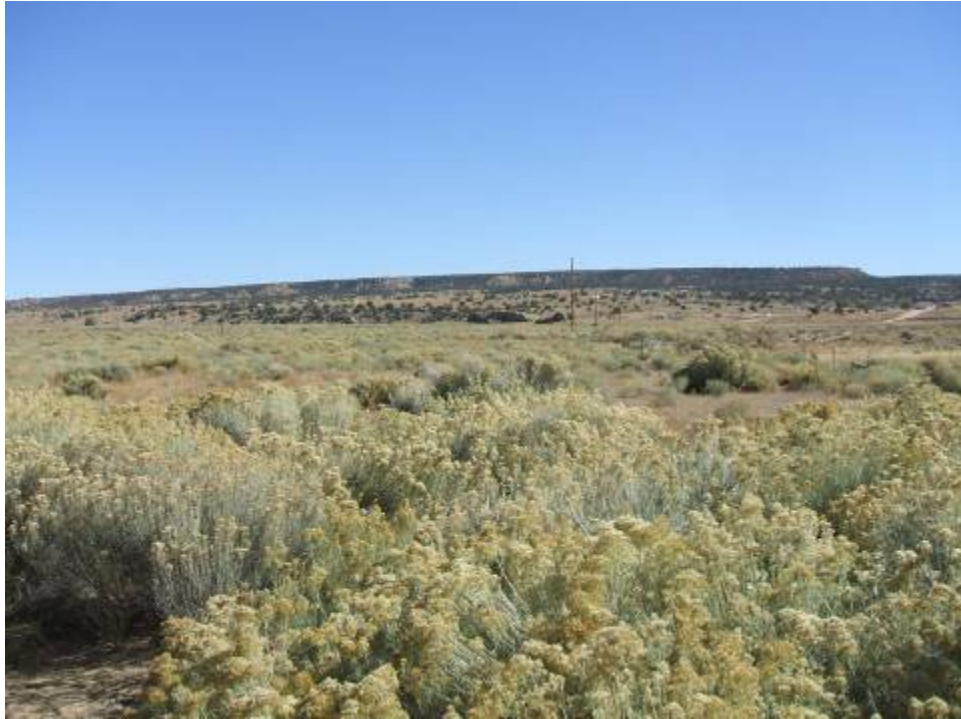
Photo 1. Section 16 Deposit site, towards the east

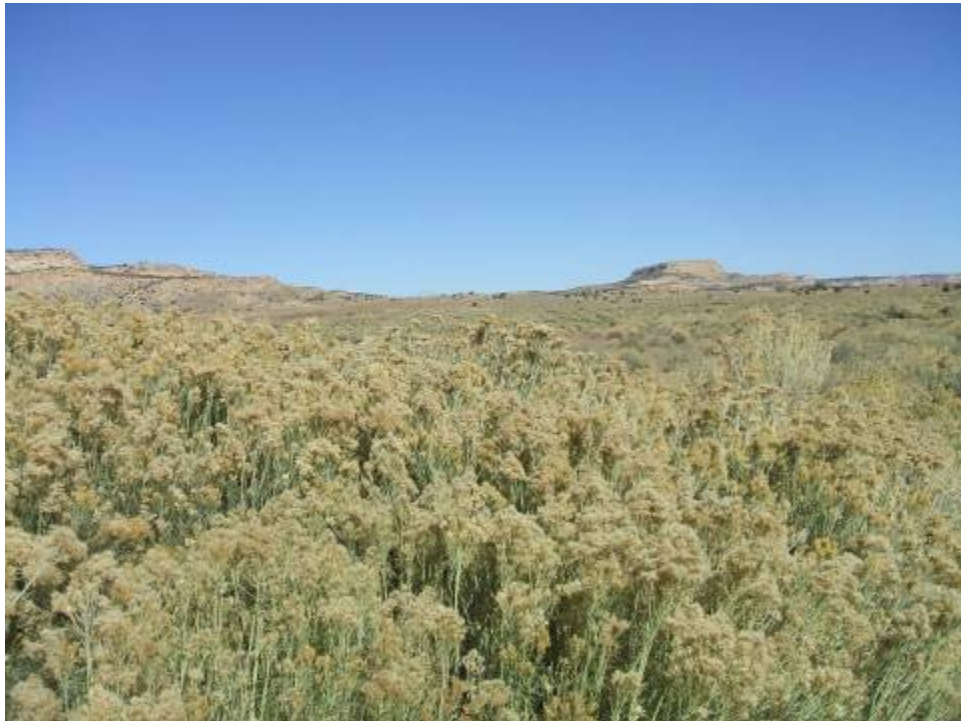
Photo 2. Section 16 Deposit site, towards the north

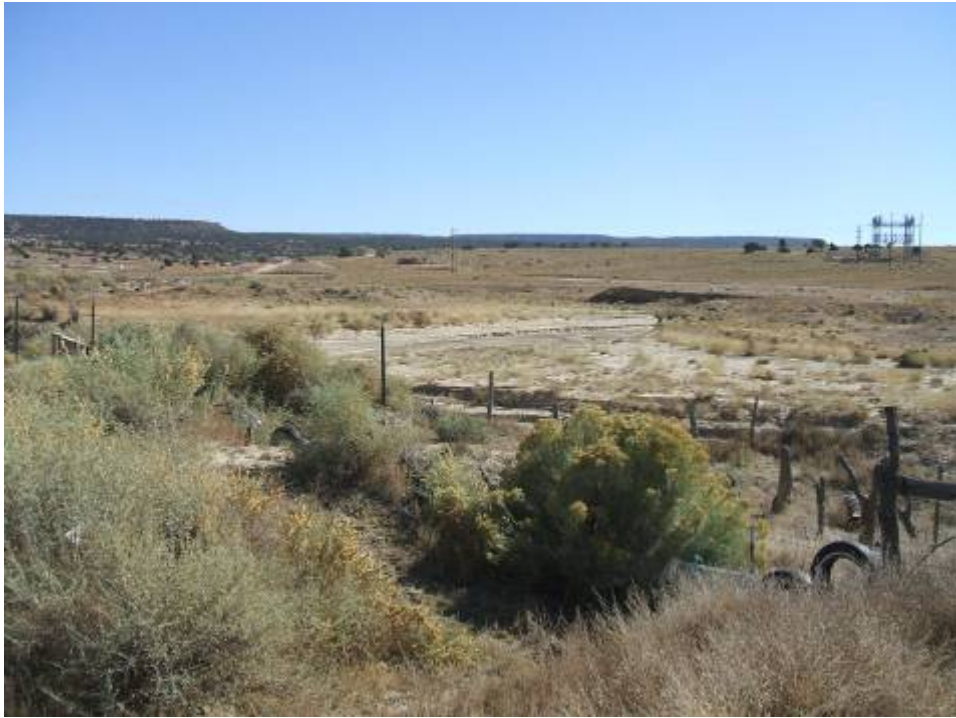
Section 16 Deposit mine consists of an area of 911,757.33 square meters. Any historical information pertaining to mining operations and historical ownership of the mine site appeared to be unclear. Two riverbeds/washes were found along the eastern and southern edges of the site (Photo 3, 5).

Photo 3. River bed / wash area along the southern edge of the site, towards the southeast

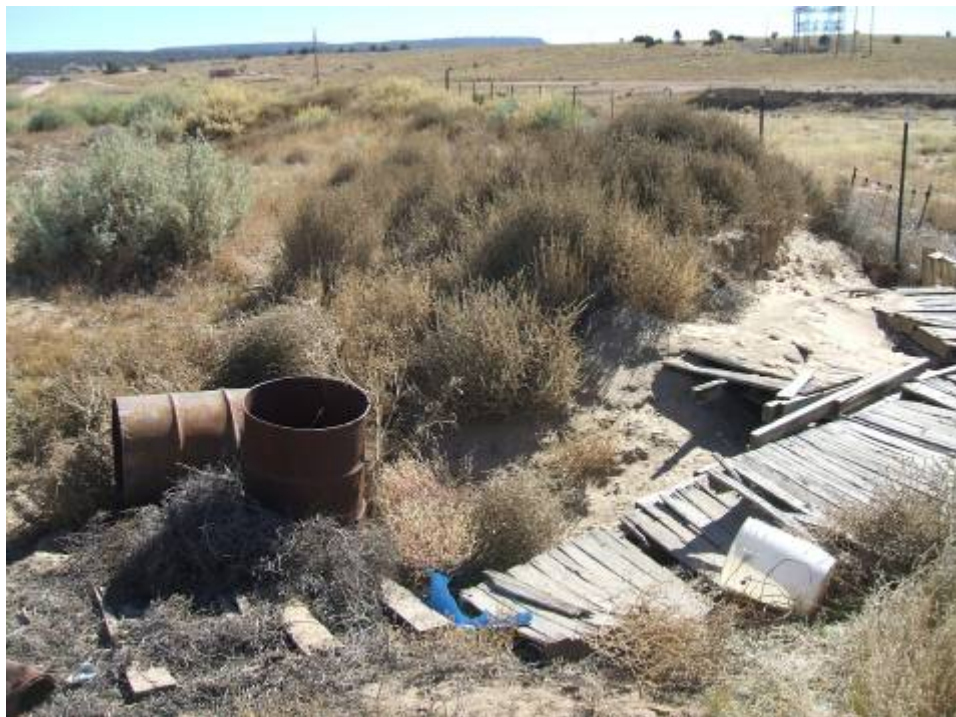
0 to 200 feet: 1 home located along the northwestern edge of the site (Photo 6). Gamma radiation levels near the house were found less than 2 times background levels. Home also includes a small livestock stable and 2 small wood structures. Field personnel was unable to contact the occupants. Several other wooden structures were found throughout the site (Photo 9, 10). Empty drums and other waste was found along the southern portion of the site (Photo 4).

Photo 4. Empty drums and wooden boards found along the southern edge of the site, towards the south

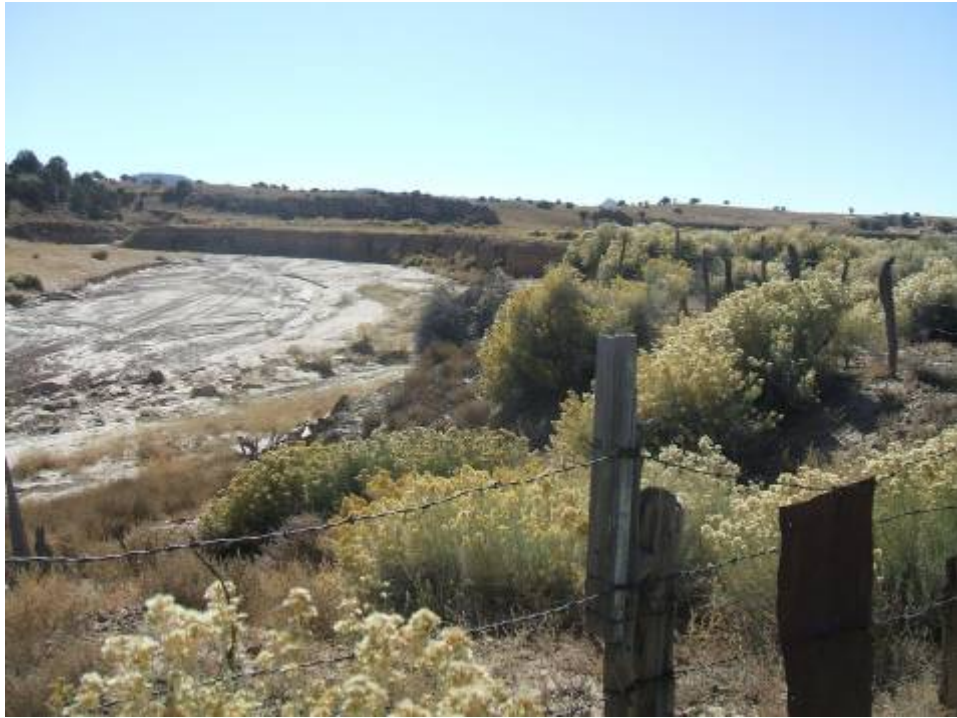
Photo 5. River bed / wash area along the eastern edge of the site, towards the southeast

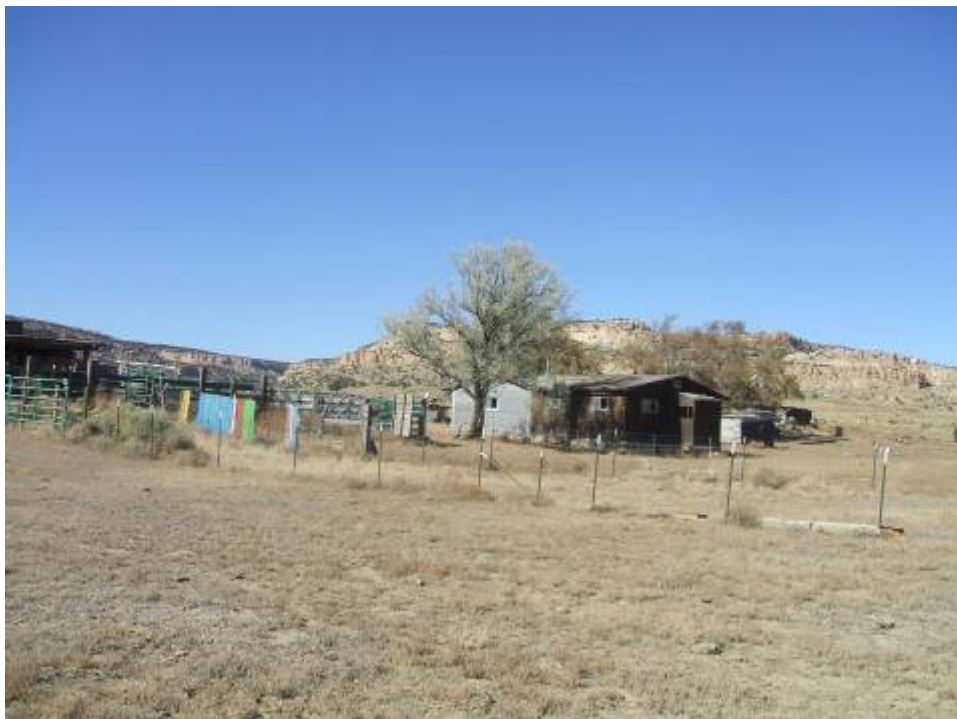
Photo 6. Housing complex located along the western edge of the property, towards the west

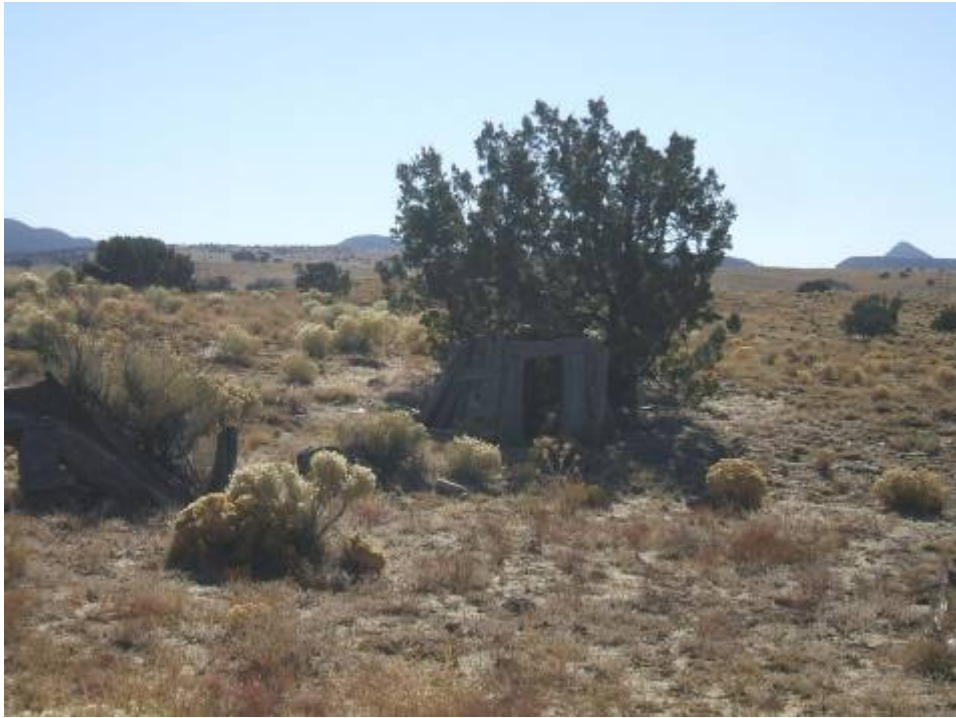
Photo 7. Small wooden structure found within the central western area of the mine site, towards the east

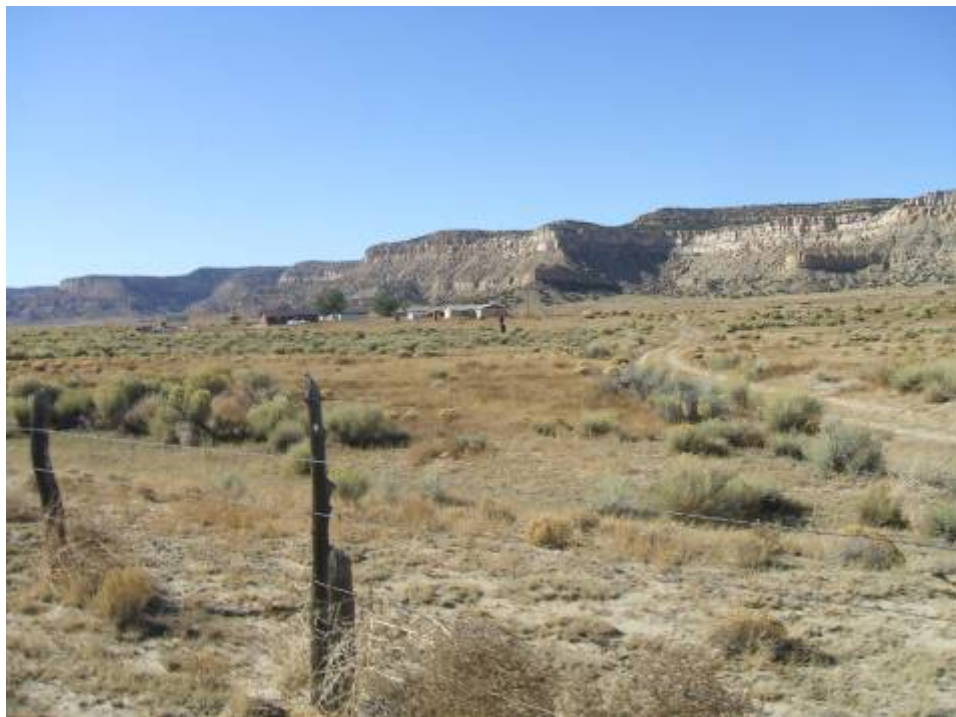
200 feet to 0.25 mile: 1 home located approximately 300 feet west of the site (Photo 8). Home also includes 3 small structures and a water tank. The source of water for the tank is unknown. Field personnel was unable to contact the occupants.

Photo 8. Housing complex located approximately 200 feet west-northwest of the mine site, towards the west

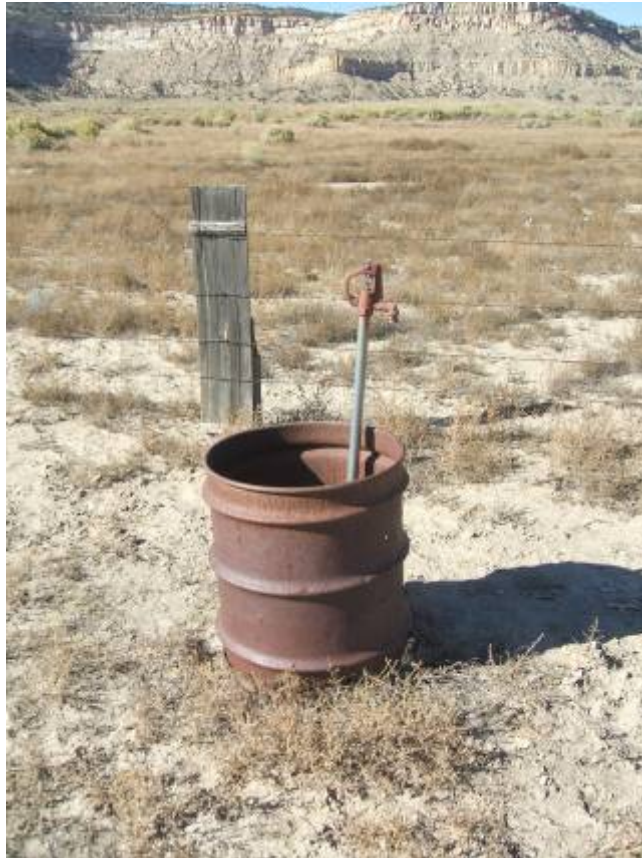
0 to 0.25 miles: Water pump observed in the western area of the site (Photo 9), likely used for livestock. A water tank associated with the home to the west of the site was observed. Field personnel were unable to determine the source or use of the tank.

Photo 9. Water pump found along the western edge of the site, towards the west

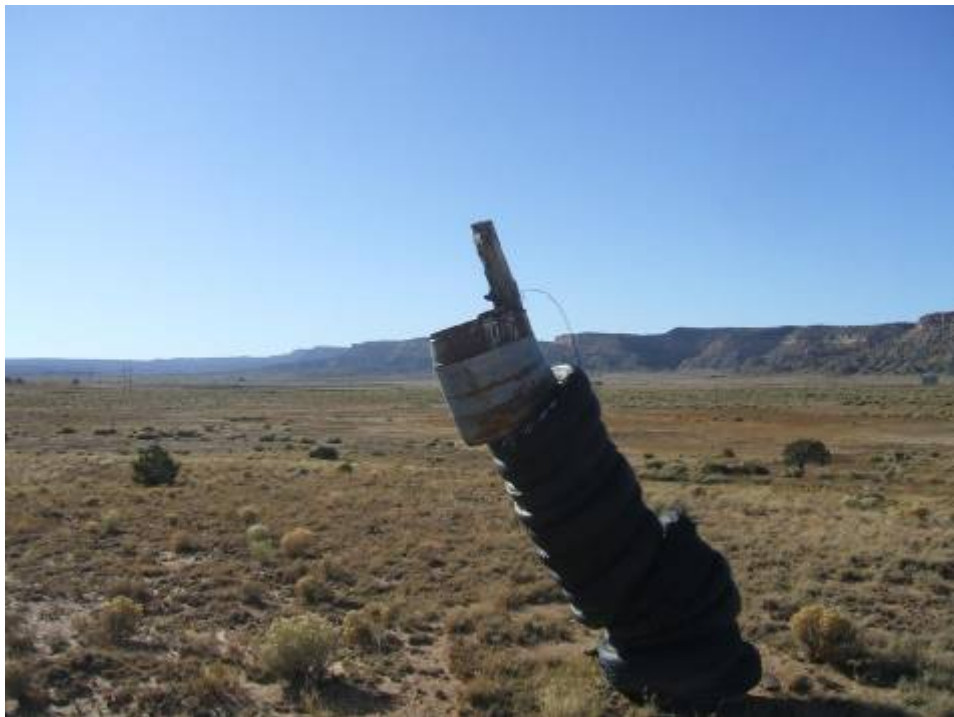
Photo 10. Wooden pole with tires and metal sheeting found in the center of the site, towards the south

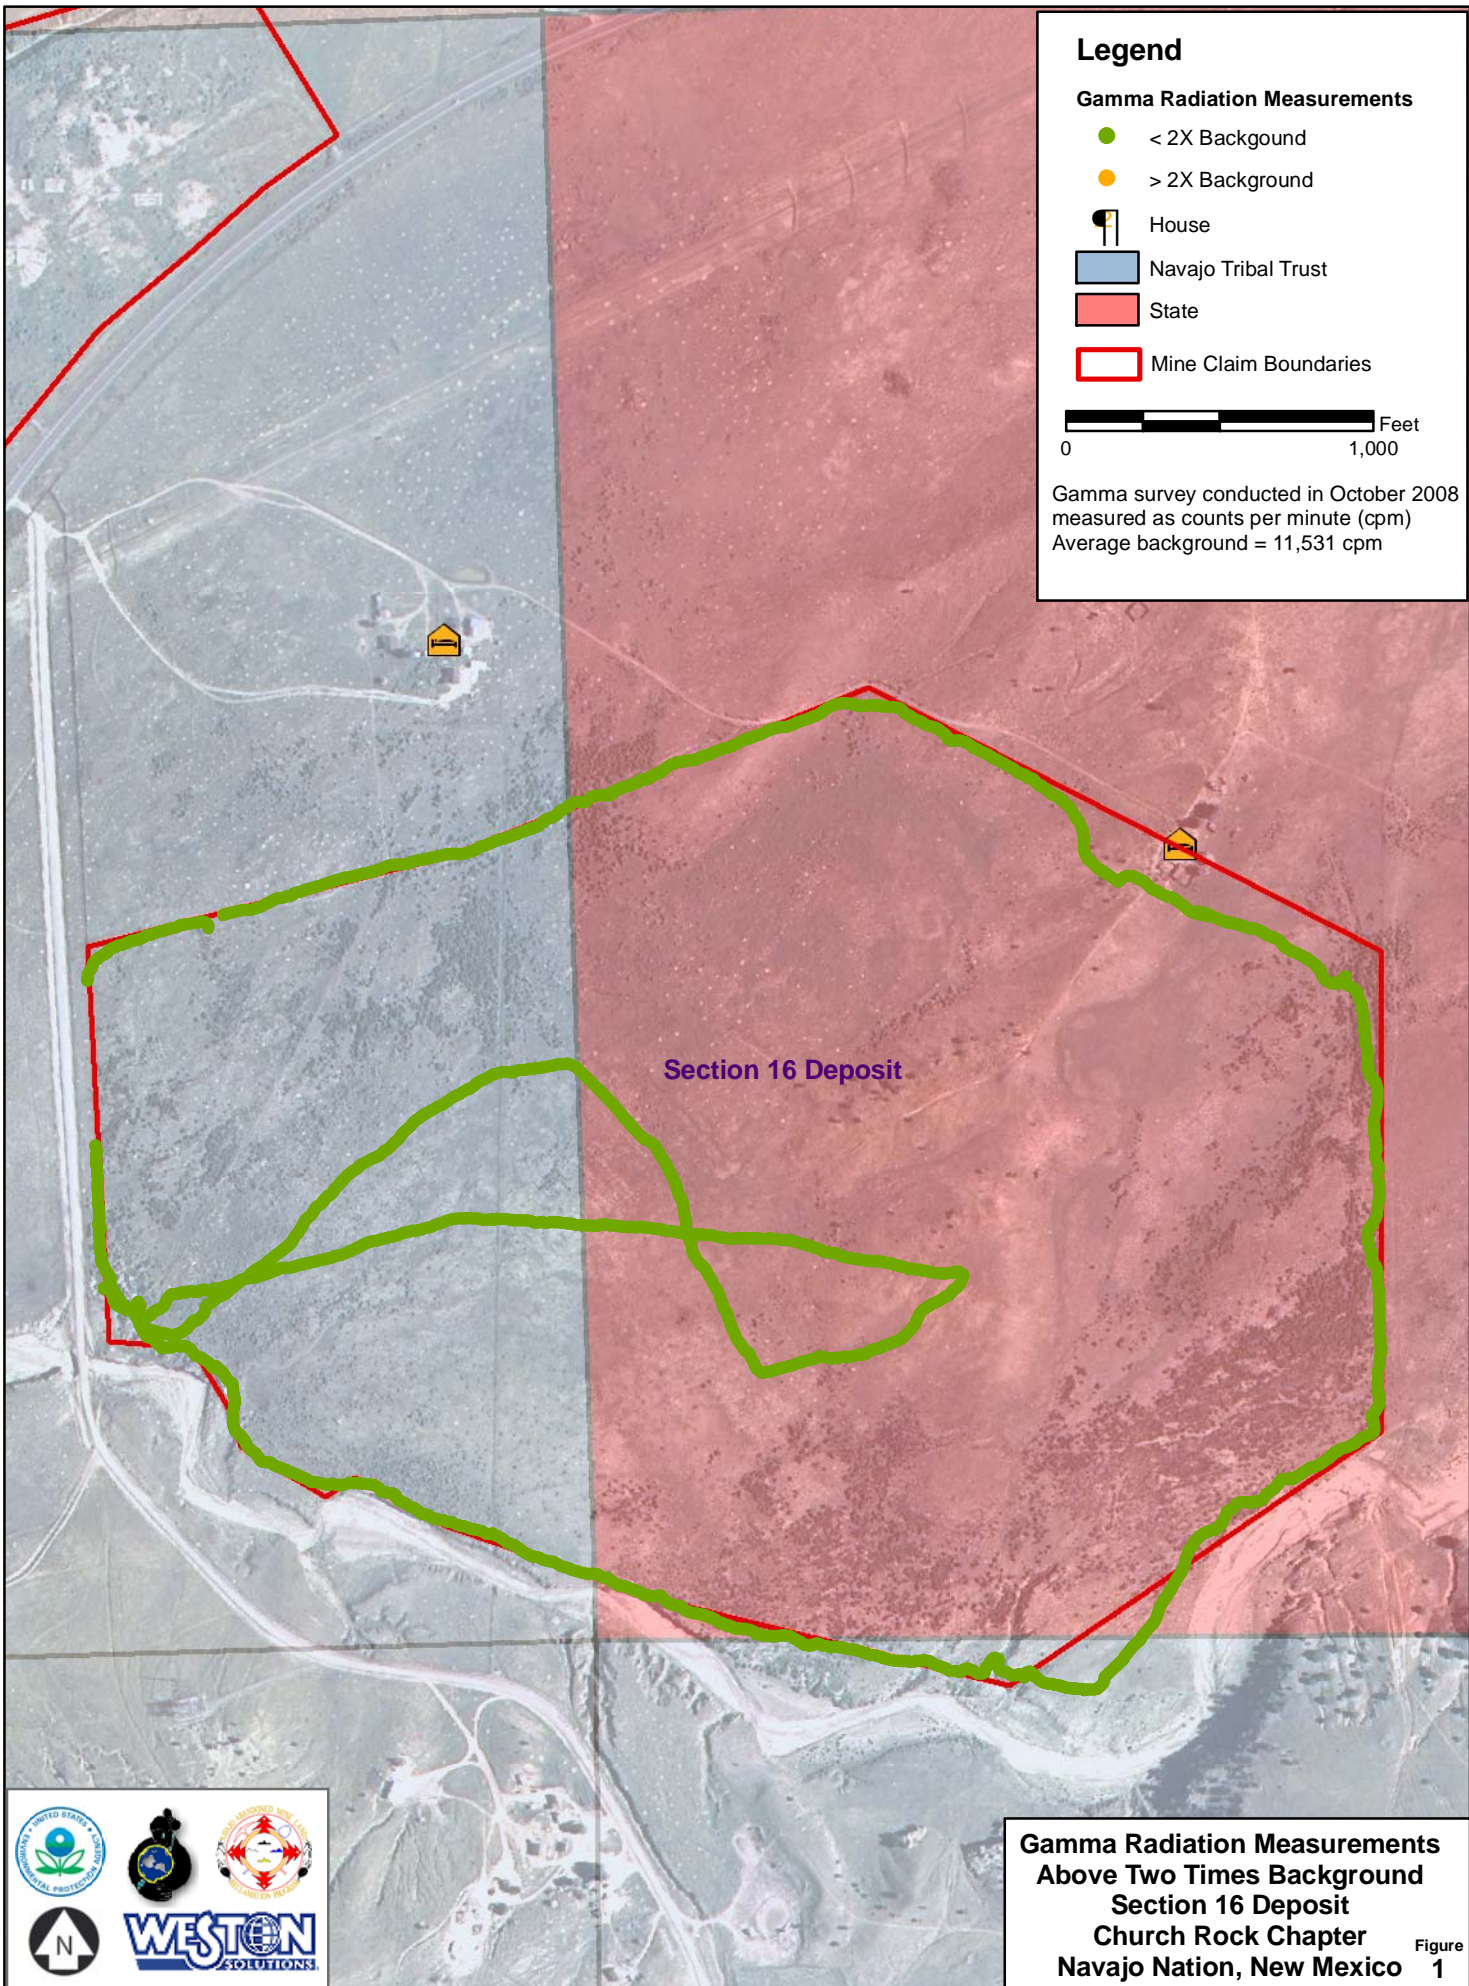
**Gamma Radiation Measurements
Above Two Times Background
Section 16 Deposit
Church Rock Chapter
Navajo Nation, New Mexico** Figure 1

A total of 5,600 gamma radiation measurements were collected from mine sites, ranging from 7,130 cpm to 18,483 cpm. The measurements are represented in Figures 1 and 2.

Gamma survey conducted in October 2008
measured as counts per minute (cpm)
Average background = 11,531 cpm
