# **Navajo Abandoned Uranium Mine Site Screen Report**

## **Foutz No. 3 AUM Site**

### **Navajo AUM Eastern Region**

**May 2009**

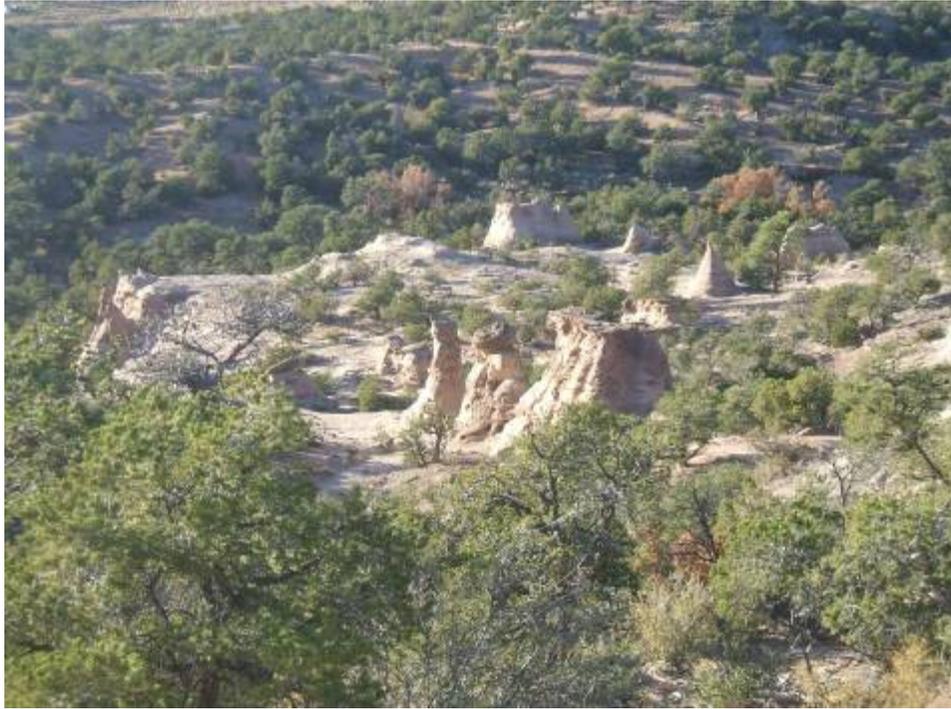
The site has been identified as reclaimed by the NAML RP, with a reclaimed reference ID of NA-0551, and reclaimed status source of S06220502. No visual signs of reclamation were identified during the site visit. No waste piles, adits or other mine features were observed during the site visit.

Photo 1. Mine site, towards the north/northwest

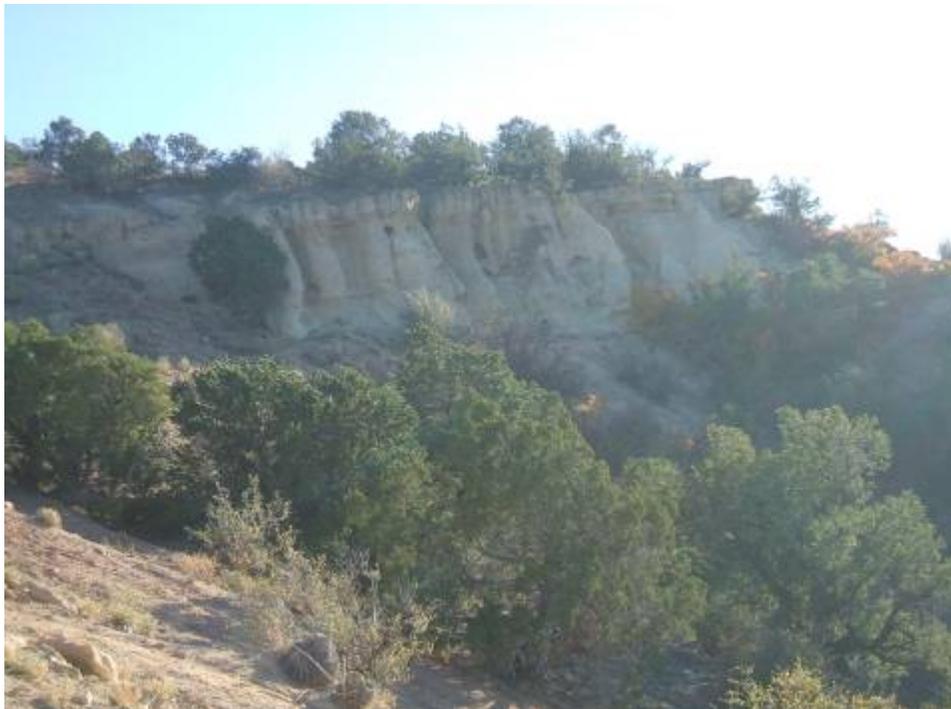
Photo 2. Mine site, towards the south/southwest

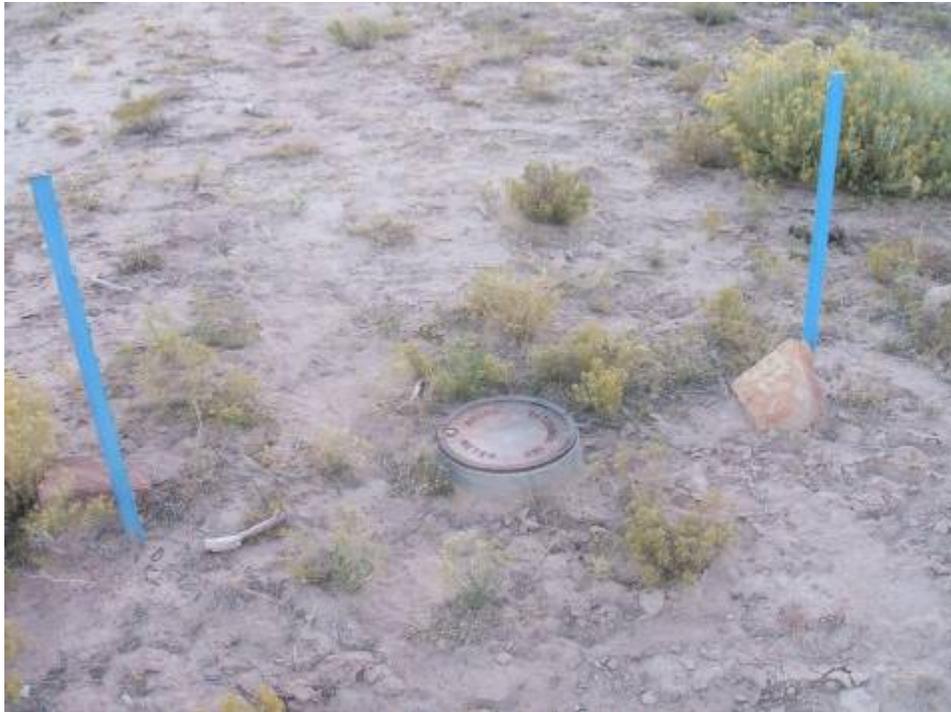
**0 to 0.25 miles:** None                      **0.25 miles to 4 miles:** A well was observed approximately 1 mile west of the site, gamma radiation levels at the well location were found at 15,523 cpm (Photo 3).

A well was observed approximately 1 mile west of the site, gamma radiation levels at the well location were found at 15,523 cpm (Photo 3). The levels at the well are less than 2 times the background levels.

Photo 3. Well, located approximately 1 mile west of the mine site

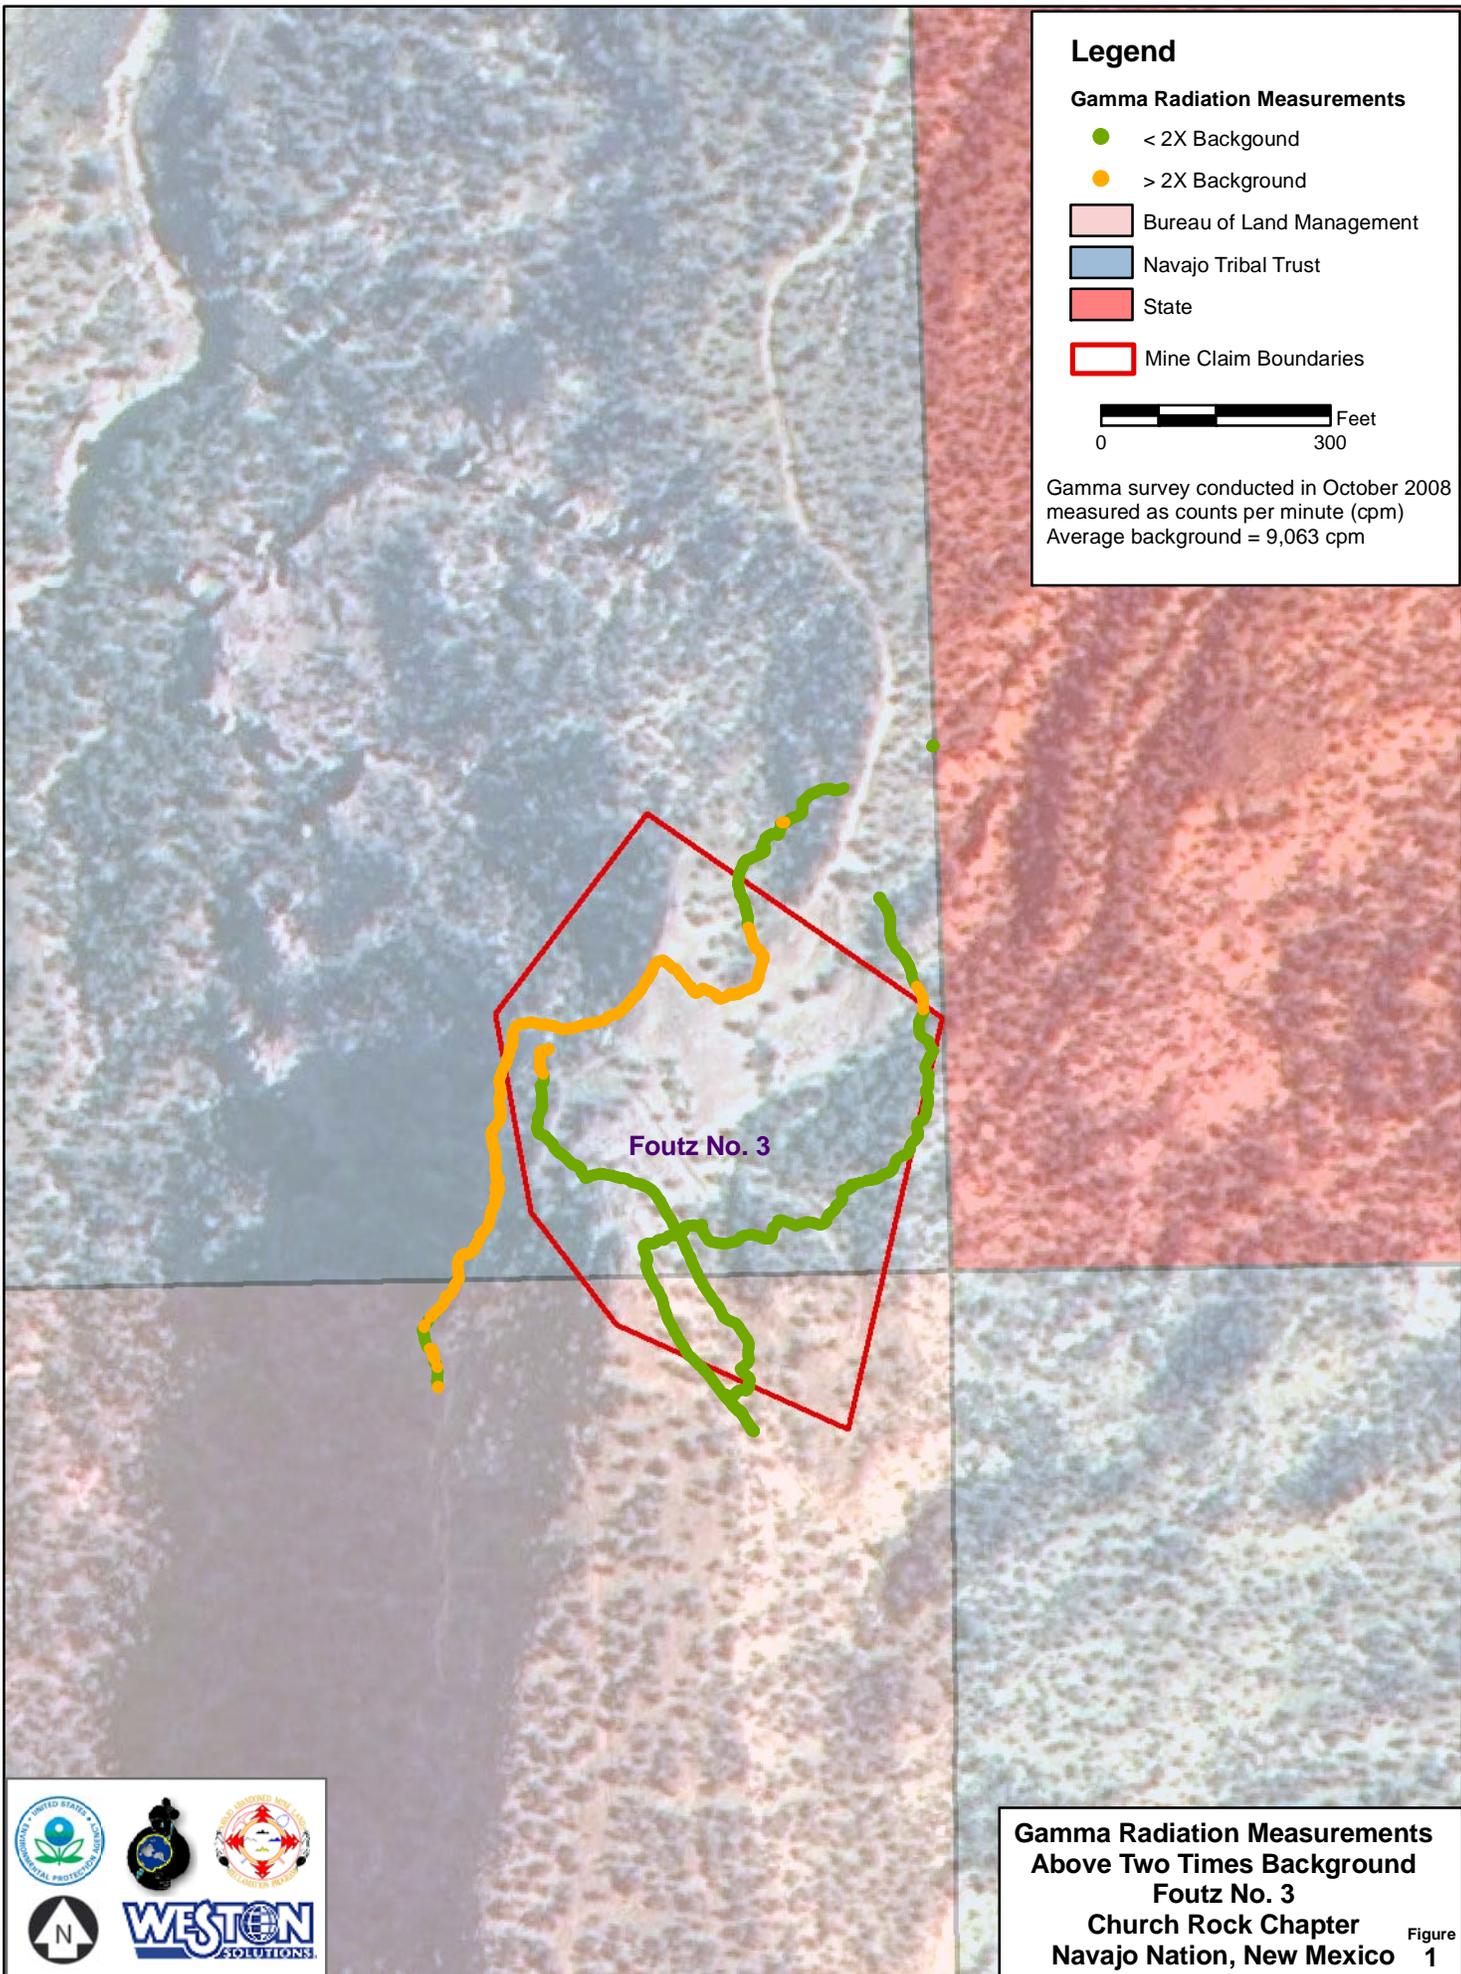
**Gamma Radiation Measurements  
 Above Two Times Background  
 Foutz No. 3  
 Church Rock Chapter  
 Navajo Nation, New Mexico** Figure 1

A total of 1,198 gamma radiation measurements were collected from mine sites, ranging from 7,633 cpm to 71,131 cpm. The measurements are represented in Figures 1 and 2.

Gamma survey conducted in October 2008  
 measured as counts per minute (cpm)  
 Average background = 9,063 cpm
