# Navajo Abandoned Uranium Mine Site Screen Report

CD&S AUM site

Navajo AUM Eastern Region

May 2009

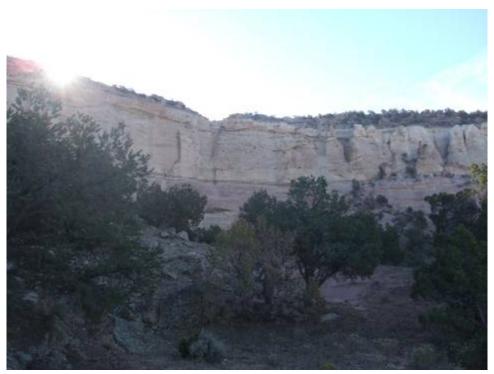
Photo 1. C D & S mine site, towards the south

Reclamation status of the mine site is currently unknown. No visible signs of reclamation were observed. No waste piles, adits, or other mine features were observed during the site visit. The site was found alongside a large cliff-face, making much of the site inaccessible.

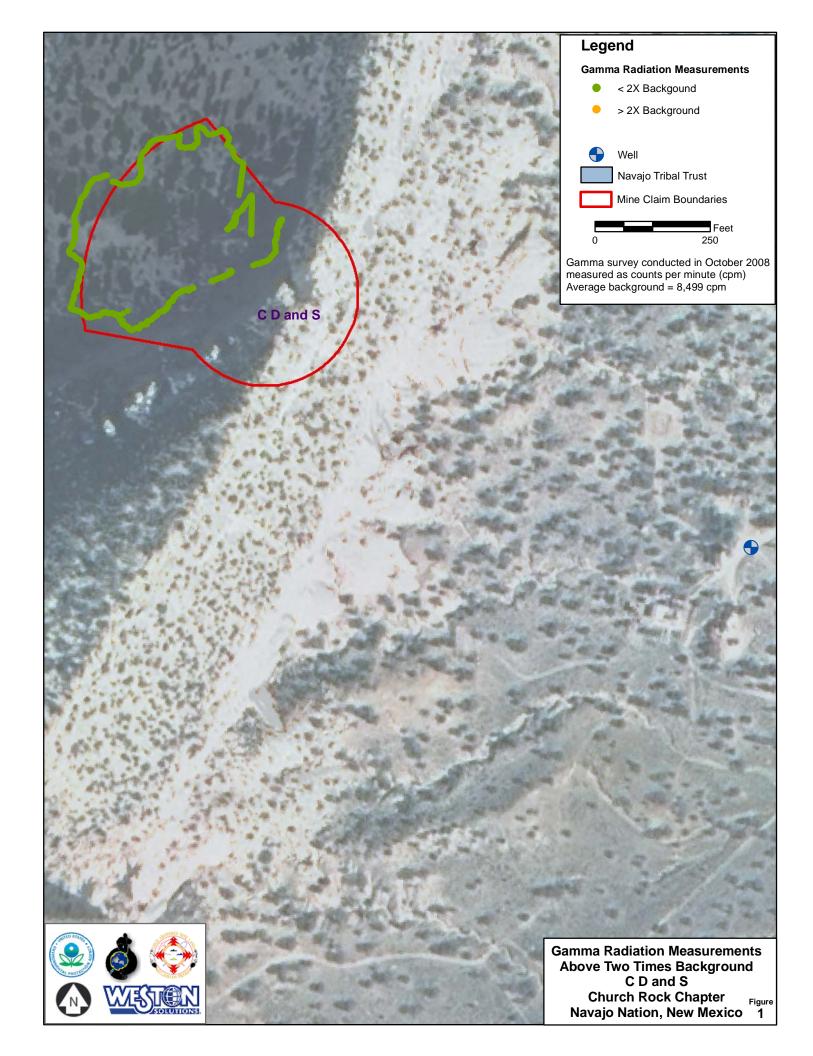
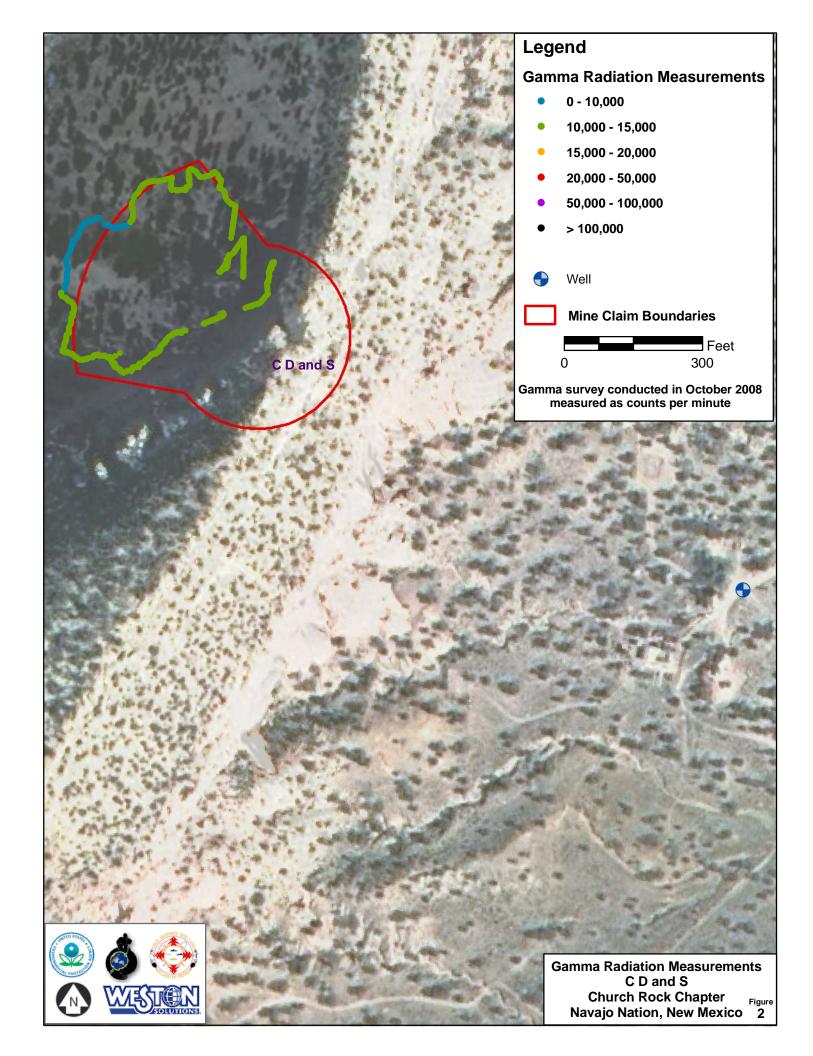
A total of 951 gamma radiation measurements were collected from mine sites, ranging from 7,198 cpm to 14,948 cpm. The measurements are represented in Figures 1 and 2.

5 residential houses and 2 water wells were located approximately 0.25 miles from the site. Gamma reading at the site did not exceed two-times background, and readings collected at the houses/wells were found to be consistent with the background levels.
