# **Navajo Abandoned Uranium Mine Site Screen Report**

## **Mac No. 1 AUM Site**

### **Navajo AUM Eastern Region**

**May 2009**

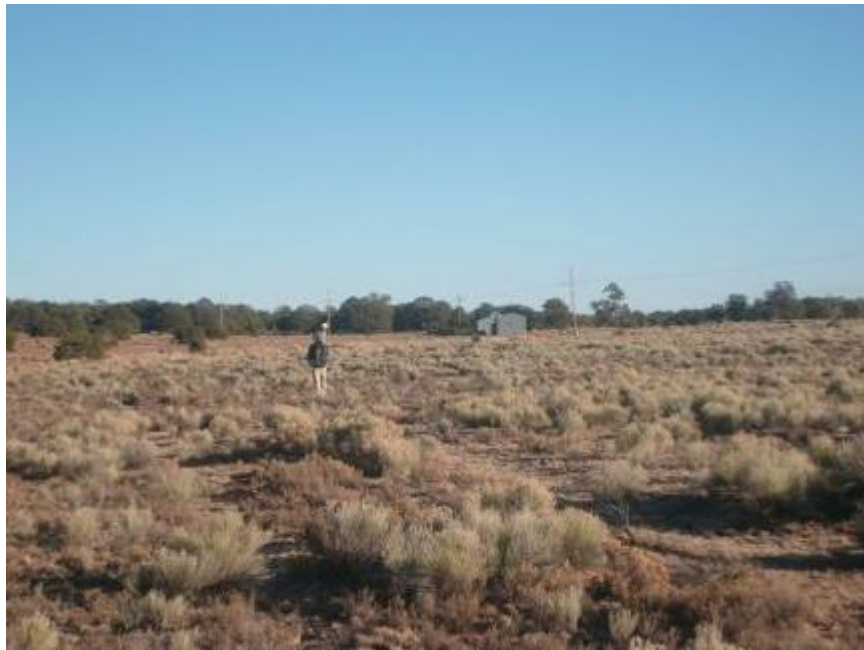
Photo 1. Mac No. 1 mine site, looking east towards grey buildings

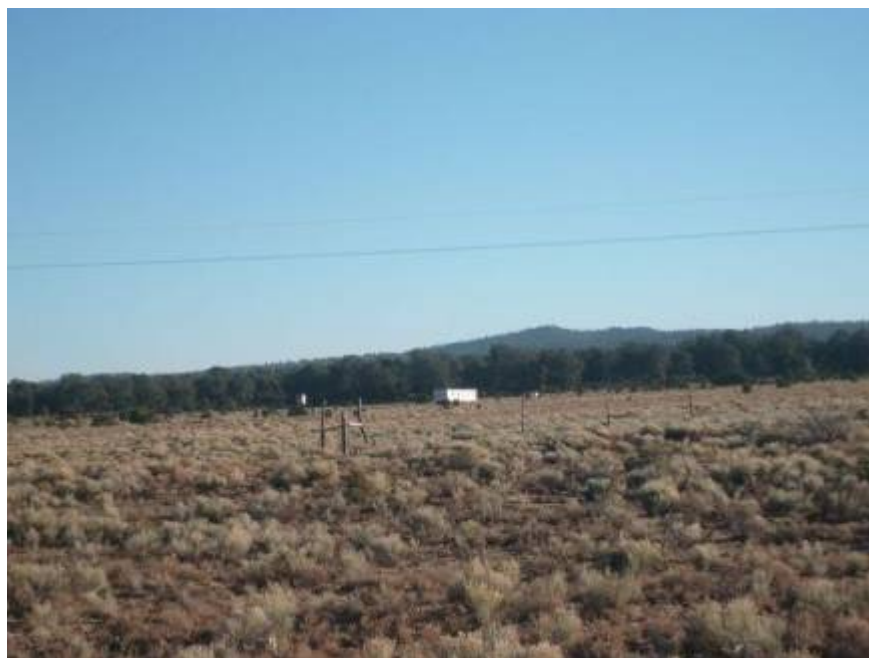
Photo 2. Mac No. 1 mine site, looking south/southeast towards trailer

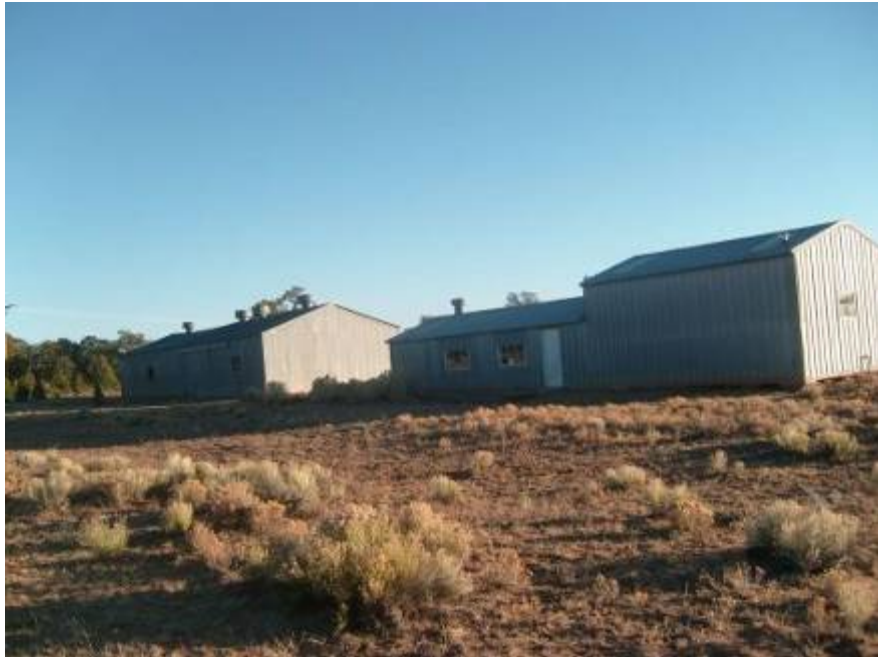
Photo 3. Grey buildings, north side

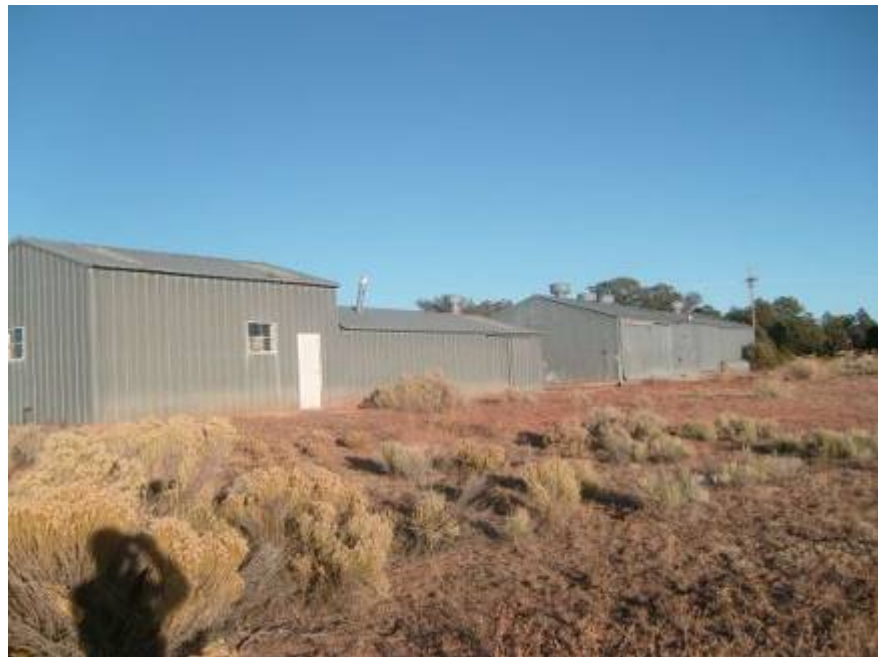
Photo 4. Grey buildings, south side

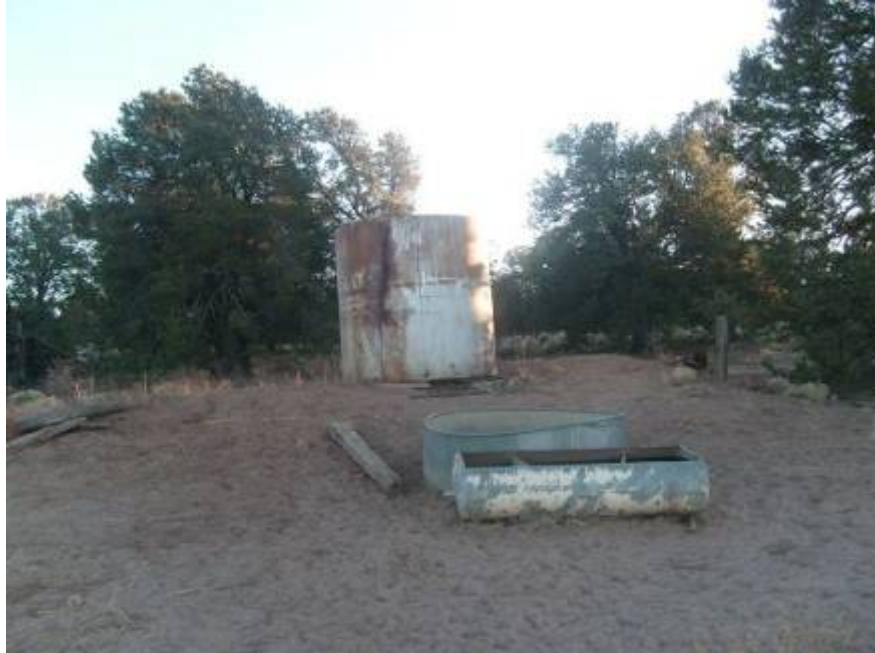
**0 to 0.25 miles:** Water tank at the south corner of the site. Water troughs directly adjacent to tank. Old fenced-in well behind grey buildings on the north side. Downed windmill behind well.

Photo 5. Water tank at south end, towards the south

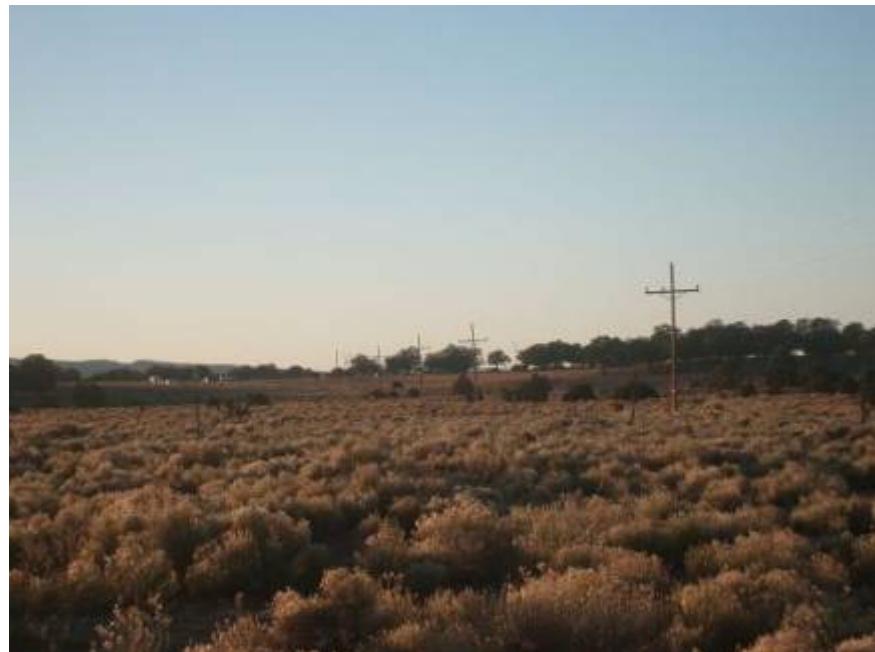
**200 feet to 0.25 mile:** Unknown number of residences to the west of the site, could not access.

Photo 6. Residences towards the west

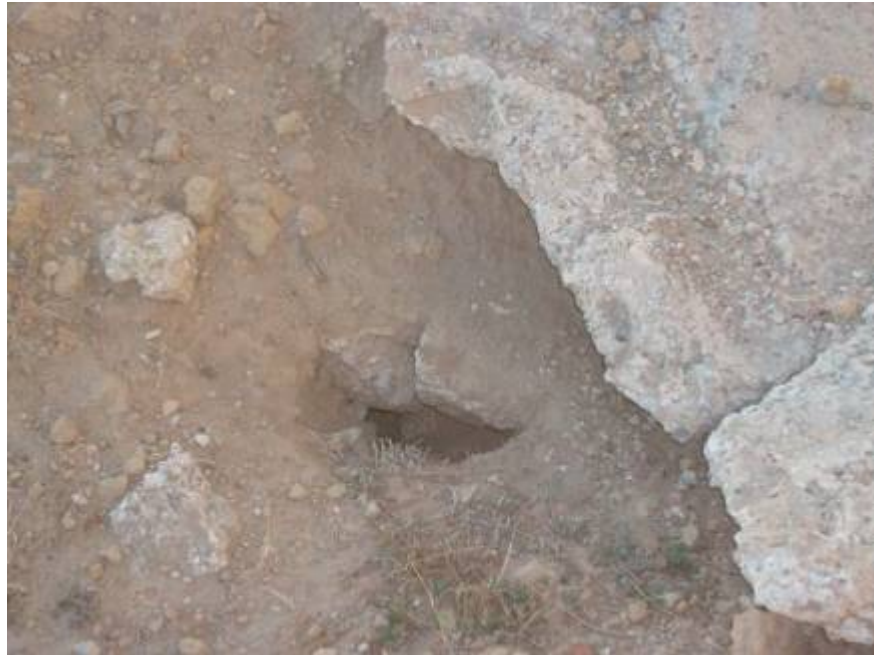
Reclamation status of the mine site is currently unknown. A small hole was observed near the concrete pad on the south side of the grey building (Photo 7). No waste piles or other features were observed during the site visit.

Photo 7. Hole on south side of grey building, at the end of concrete pad

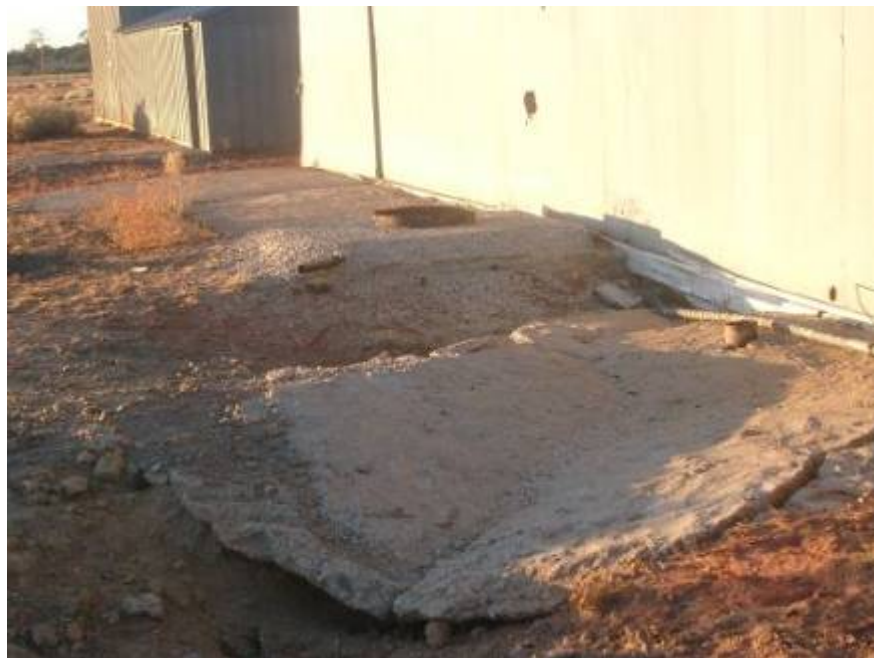
Photo 8. Concrete pads on south side of grey buildings

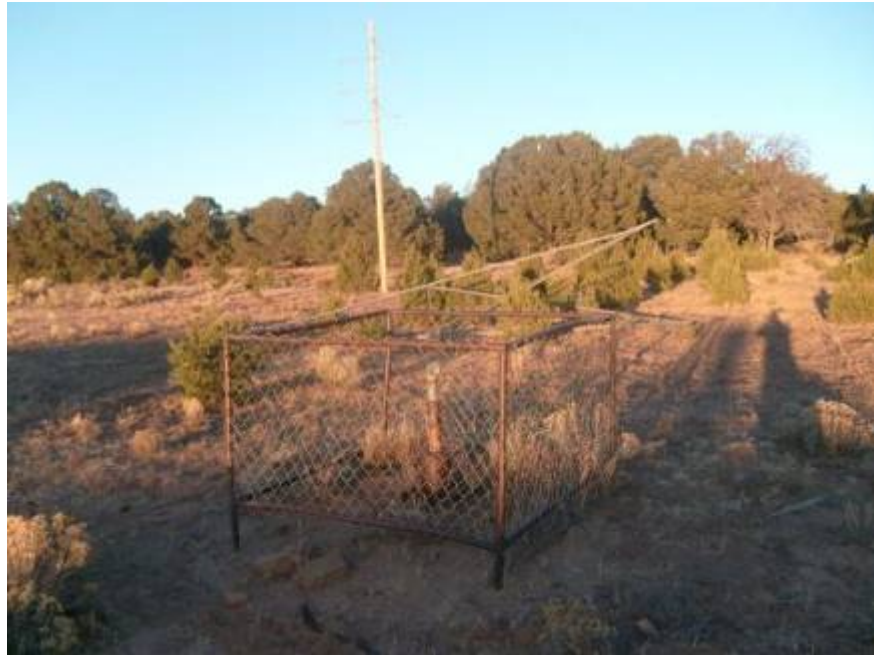
Photo 9. Old well with downed windmill behind it, towards the northeast on south side of grey buildings

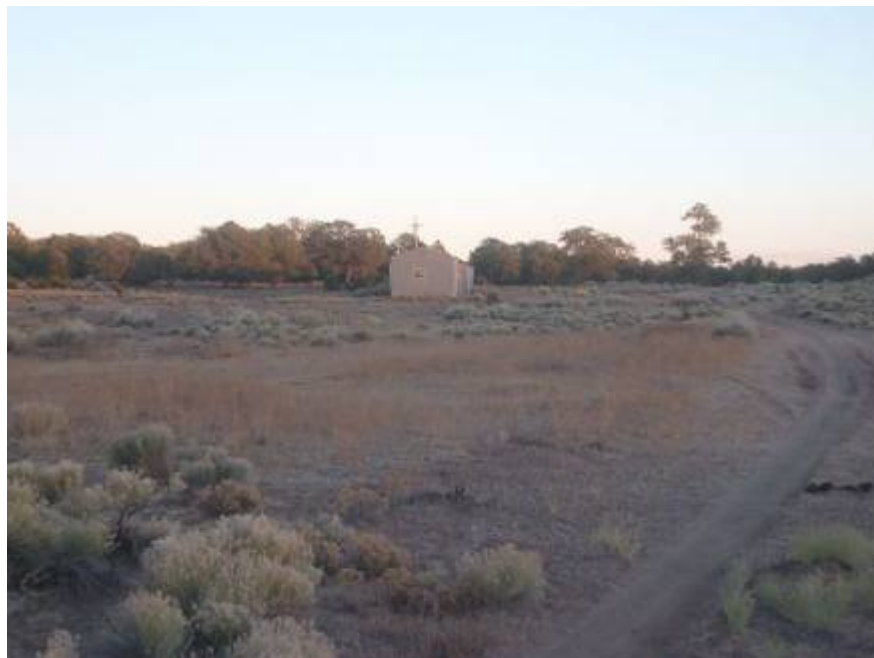
Vegetation changed approaching the grey buildings (Photo 10).

A total of 1,349 gamma radiation measurements were collected from the mine site, ranging from 10,636 cpm to 54,684 cpm. Readings were high surrounding the grey buildings (50,000 to 120,000 cpm). Readings around the water tank were approximately 7,500 cpm. Picture 10 shows a difference in vegetation, with readings ranging from 25,000 to 35,000 cpm. The readings gradually increased east towards the grey buildings. The measurements are represented in Figures 1 and 2.

Photo 10. Difference in vegetation from road to grey buildings, towards the east

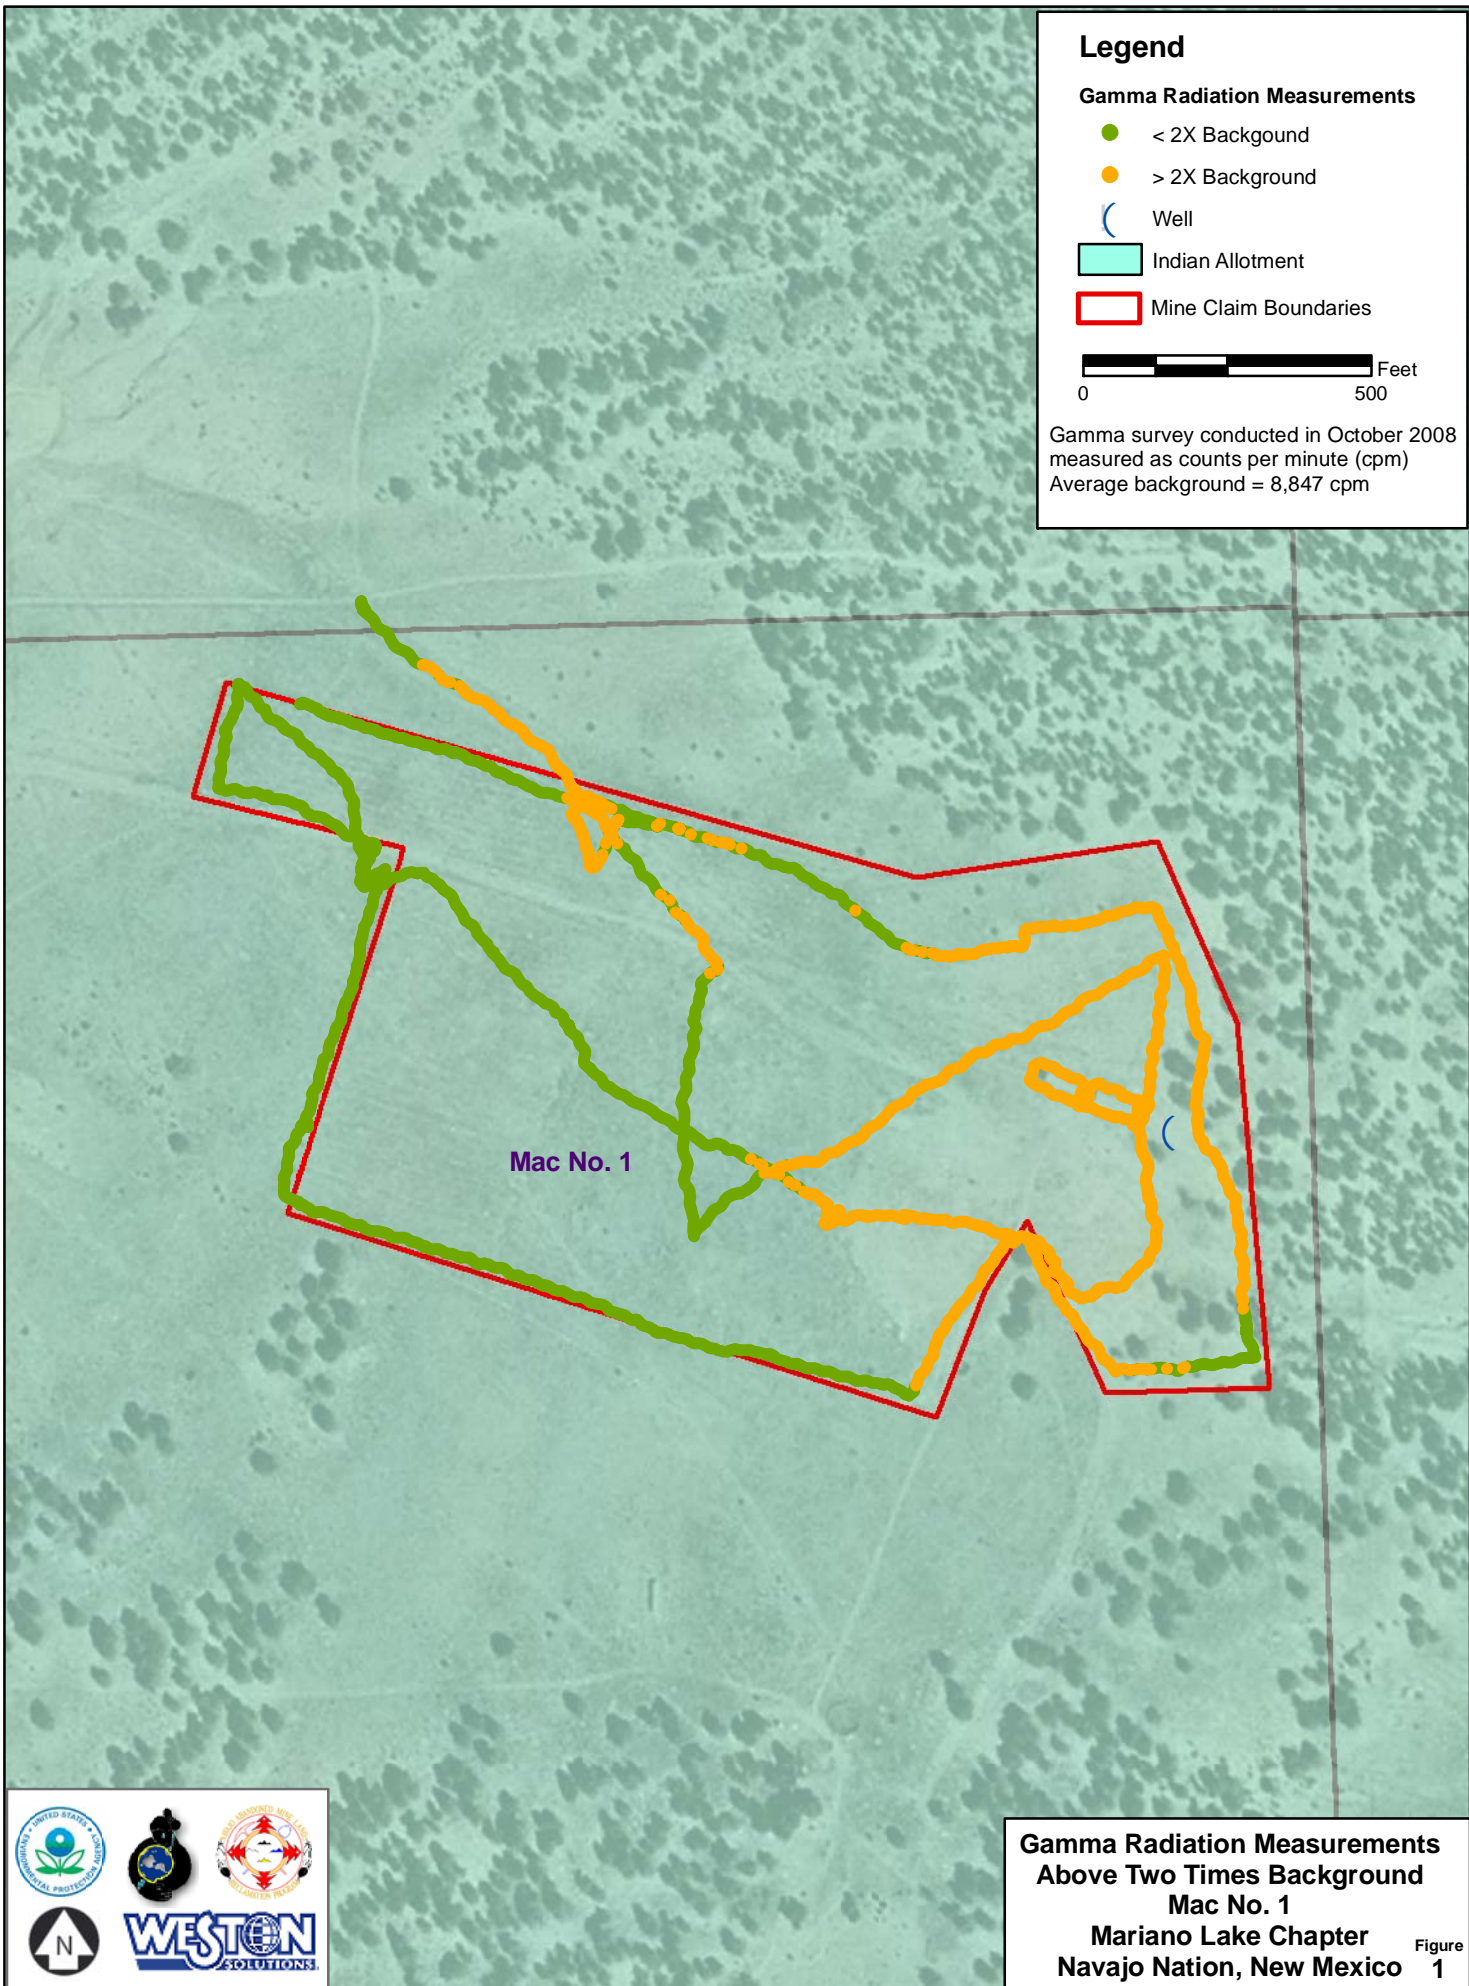
Figure 1

Residences within 0.25 miles of site, with nearby gamma radiation measurements found greater than 2 times background levels. Unable to access the residences.

Gamma survey conducted in October 2008  
 measured as counts per minute (cpm)  
 Average background = 8,847 cpm

**Gamma Radiation Measurements Above Two Times Background**  
**Mac No. 1**  
**Mariano Lake Chapter**  
**Navajo Nation, New Mexico**
