Navajo Abandoned Uranium Mine Site Screen Report

Mac No. 1 AUM Site

Navajo AUM Eastern Region

May 2009

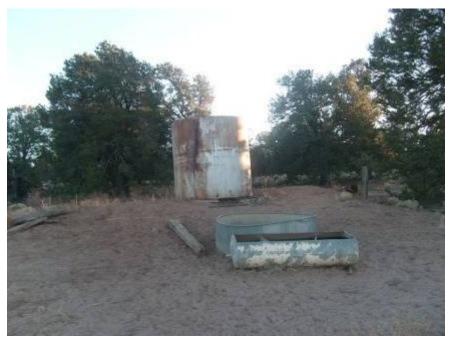
0 to 0.25 miles: Water tank at the south corner of the site. Water troughs directly adjacent to tank. Old fenced-in well behind grey buildings on the north side. Downed windmill behind well. **0.25 miles to 4 miles:** None corner of the site. Water troughs directly adjacent to tank. Old fenced-in well behind well.

Photo 5. Water tank at south end, towards the south

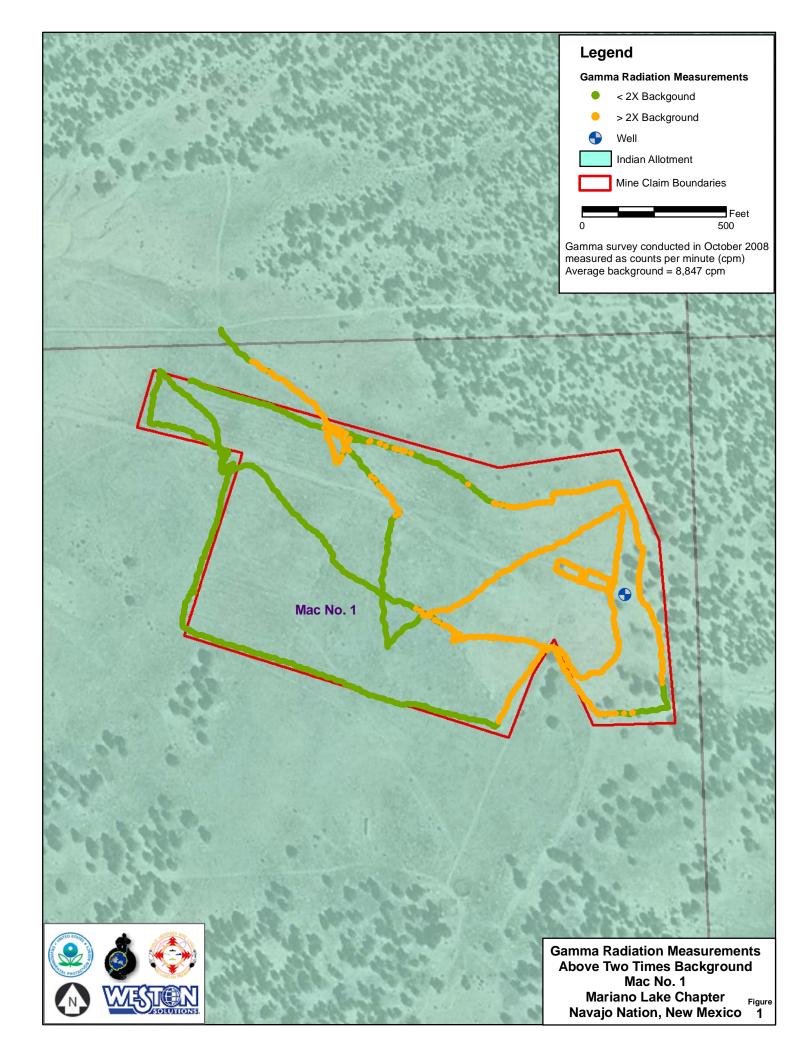
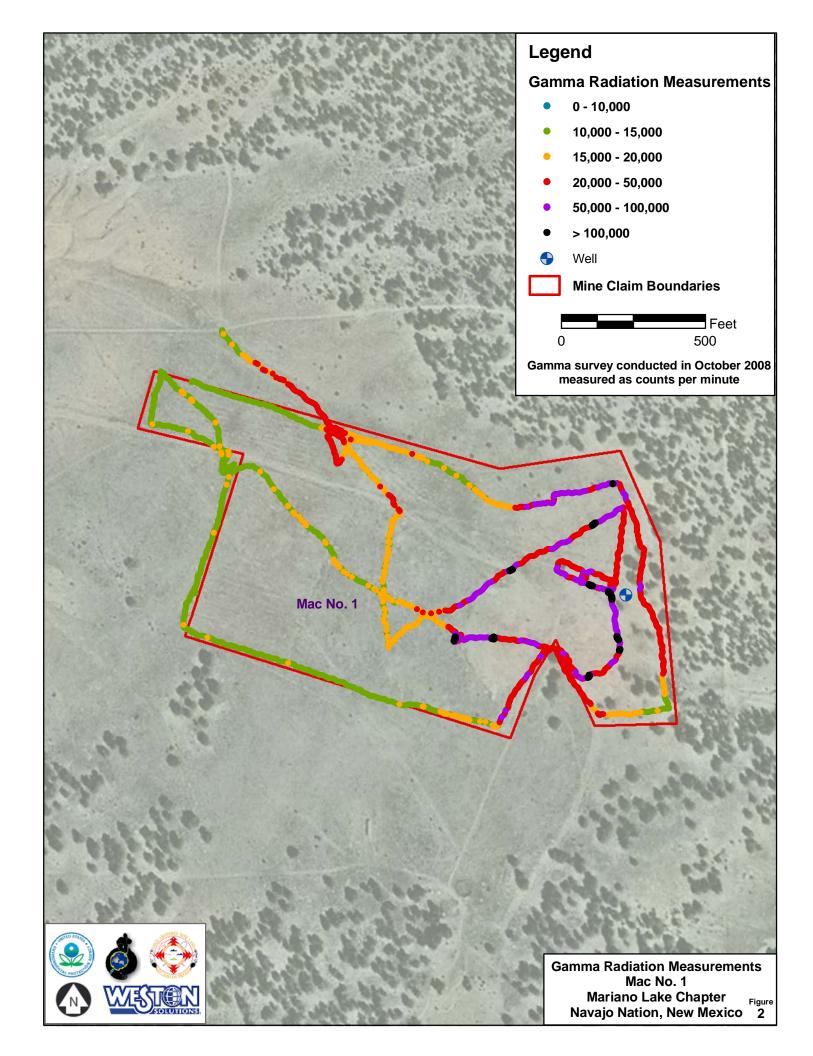
A total of 1,349 gamma radiation measurements were collected from the mine site, ranging from 10,636 cpm to 54,684 cpm. Readings were high surrounding the grey buildings (50,000 to 120,000 cpm). Readings around the water tank were approximately 7,500 cpm. Picture 10shows a difference in vegetation, with readings ranging from 25,000 to 35,000 cpm. The readings gradually increased east towards the grey buildings. The measurements are represented in Figures 1 and 2.
