Navajo Abandoned Uranium Mine Site Screen Report

Silver Bit No. 18 AUM Site

Navajo AUM Eastern Region

May 2009

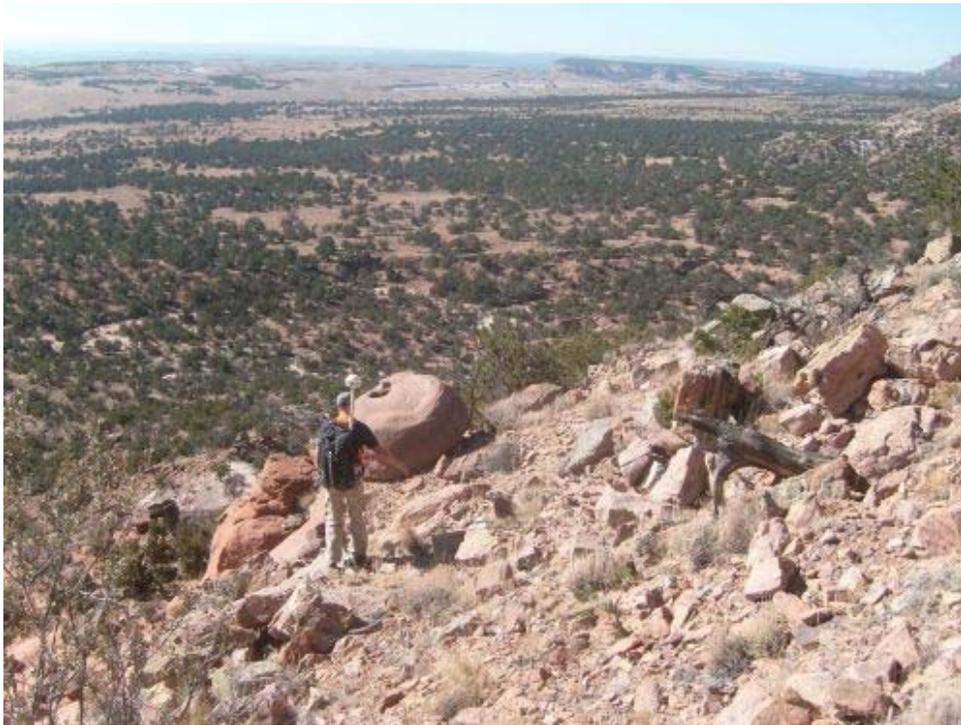
Photo 1. Silver Bit 18 mine site, towards the west on top of cliff

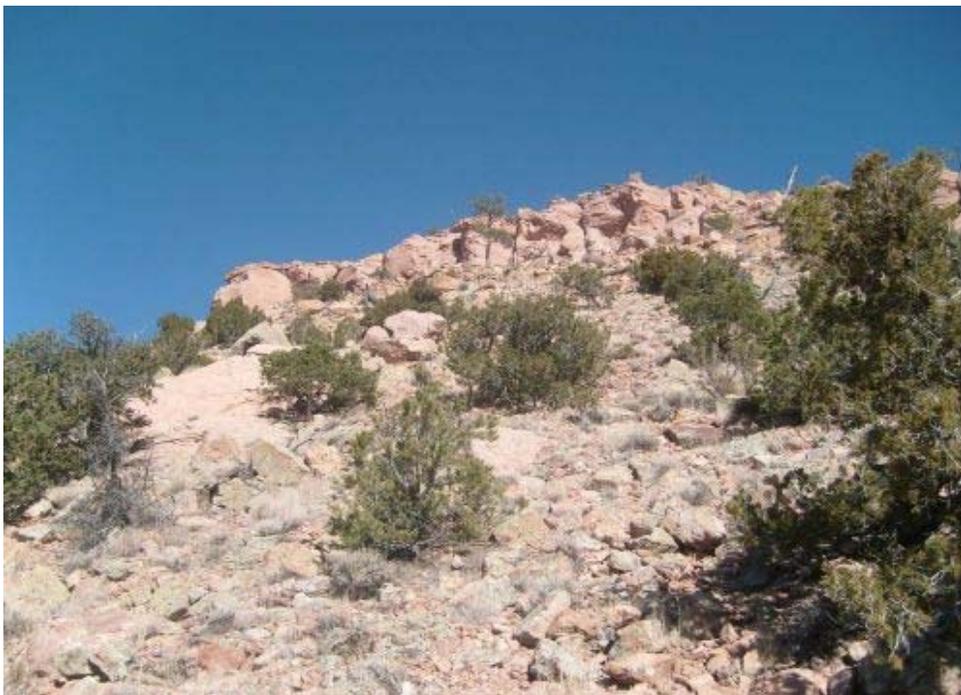
Photo 2. Silver Bit 18 mine site, looking up cliff to the north

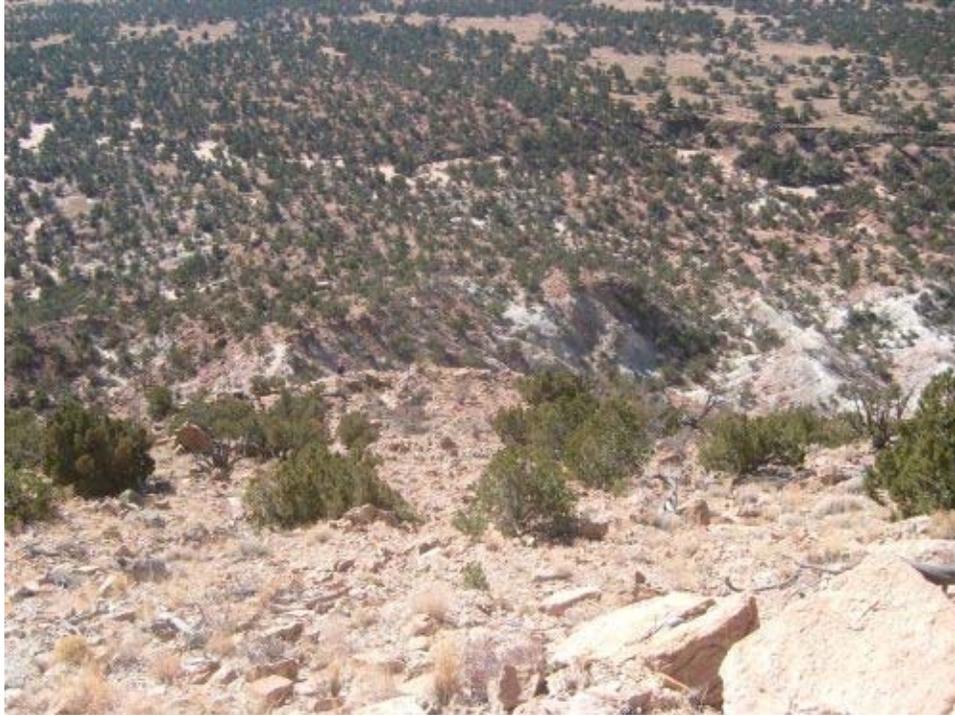
Photo 3. Silver Bit 18 mine site, looking down cliff face (top of site boundary)

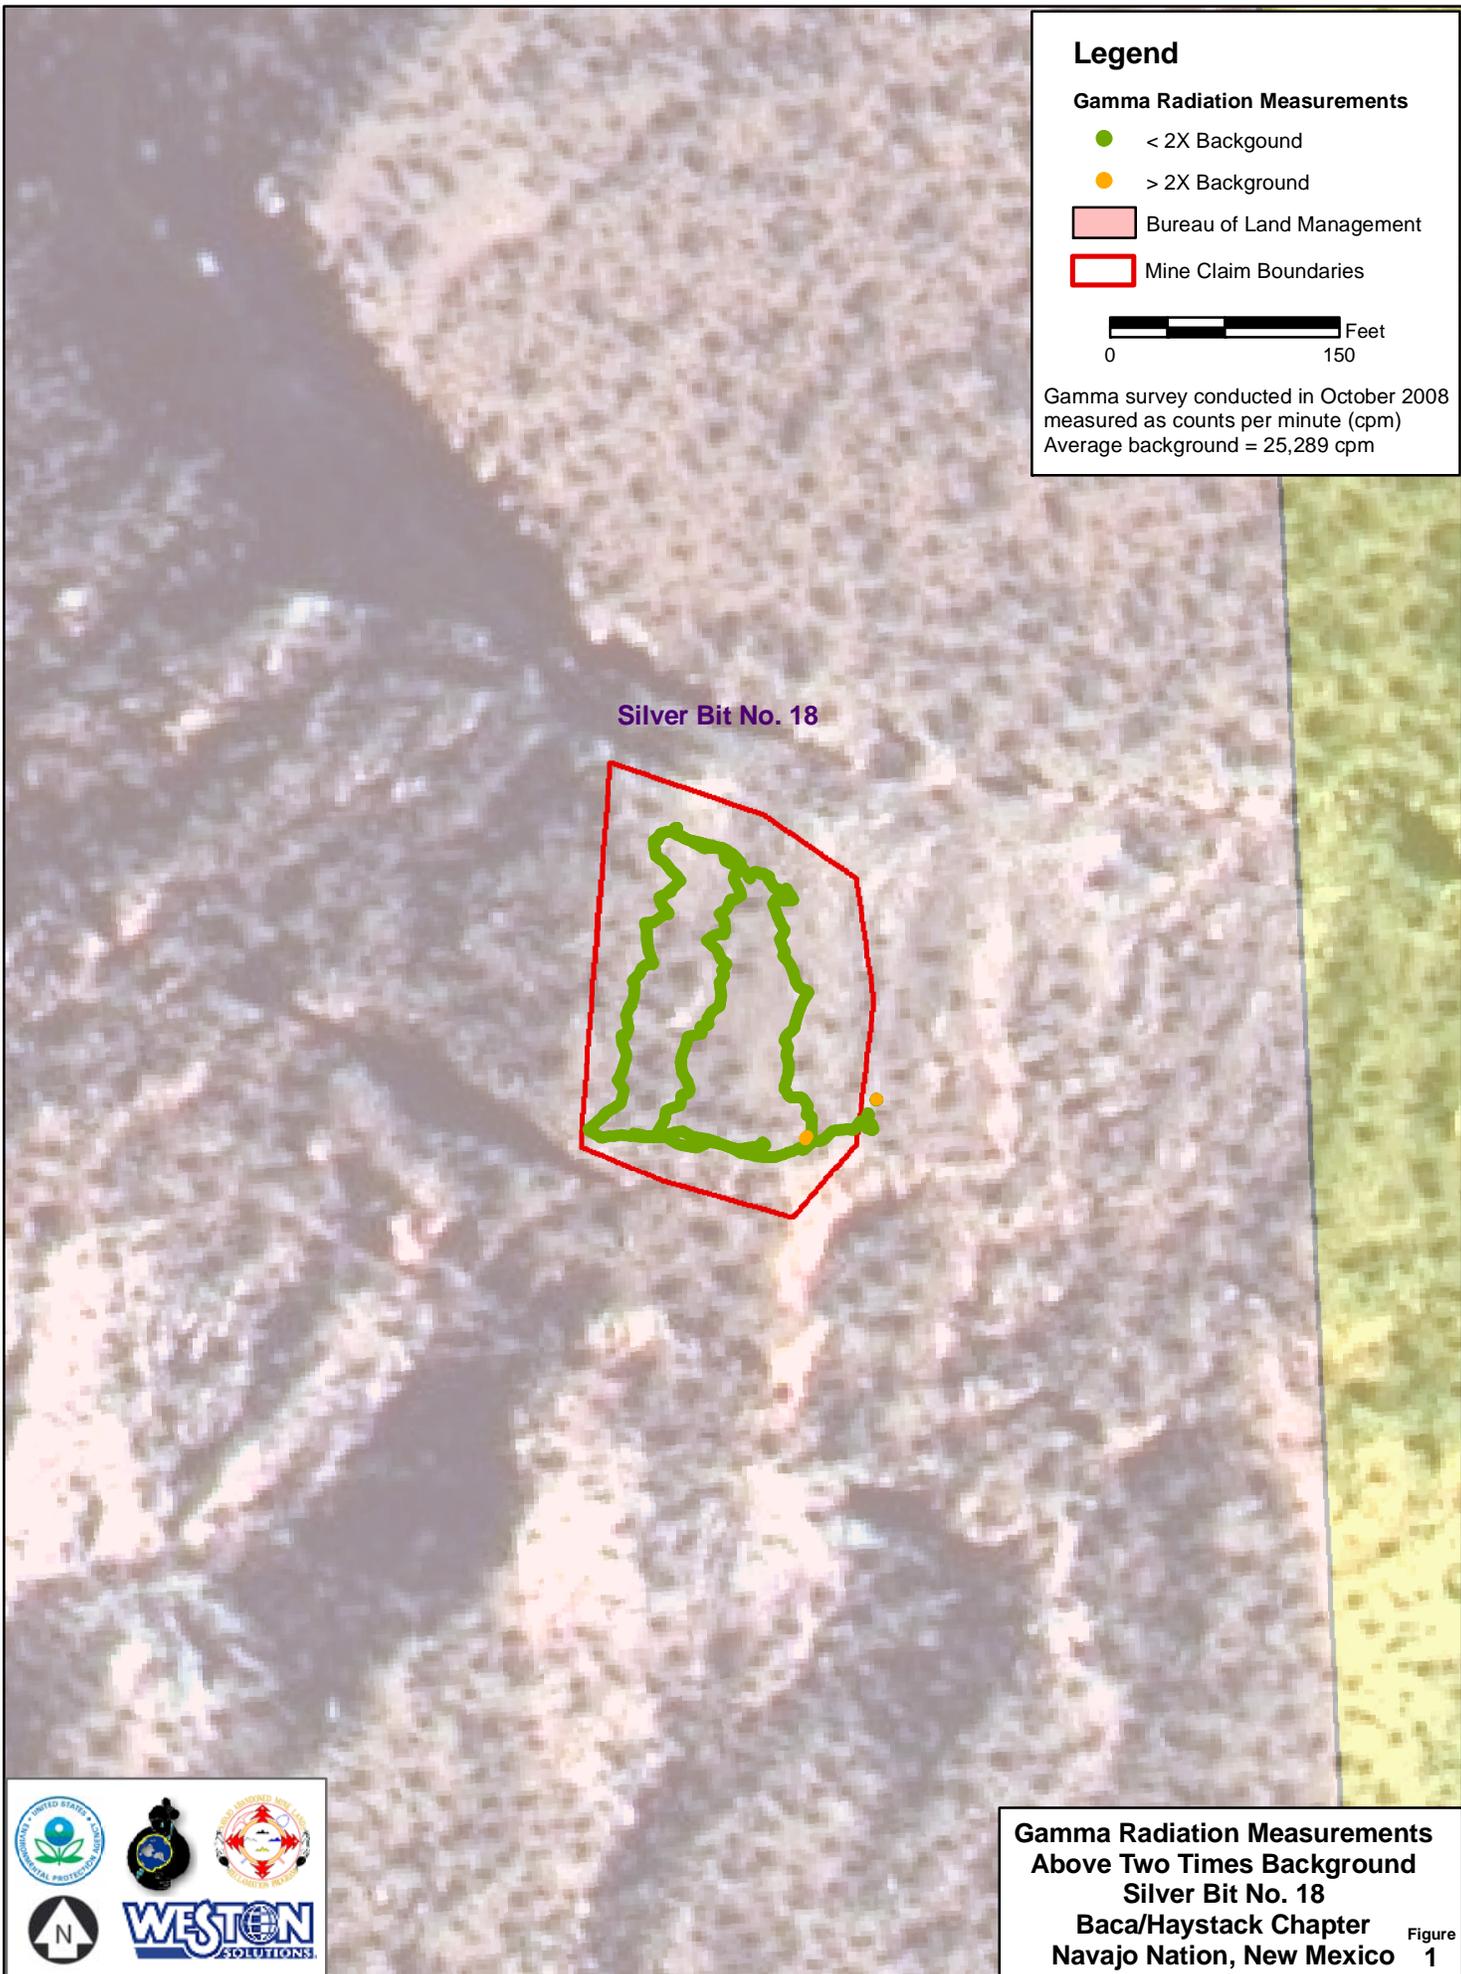
Gamma Radiation Measurements Above Two Times Background Silver Bit No. 18
 Baca/Haystack Chapter Navajo Nation, New Mexico Figure 1

A total of 1,349 gamma radiation measurements were collected from the mine site, ranging from 10,636 cpm to 54,684 cpm. The measurements are represented in Figures 1 and 2. Radiological measurements collected for the New Mexico Mining and Minerals Division during a 2008 field screening survey found gamma radiation levels near the ground surface with a maximum of 160 micro Roentgen per hour ($\mu\text{R/hr}$) and a minimum of 24 $\mu\text{R/hr}$, levels at the 4-foot elevation with a maximum of 160 $\mu\text{R/hr}$ and a minimum of 21 $\mu\text{R/hr}$, and background levels of less than 20 $\mu\text{R/hr}$.

Gamma survey conducted in October 2008
 measured as counts per minute (cpm)
 Average background = 25,289 cpm
