Navajo Abandoned Uranium Mine Site Screen Report

Haystack Mines AUM Site

Weston Solutions, Inc.

May 2009

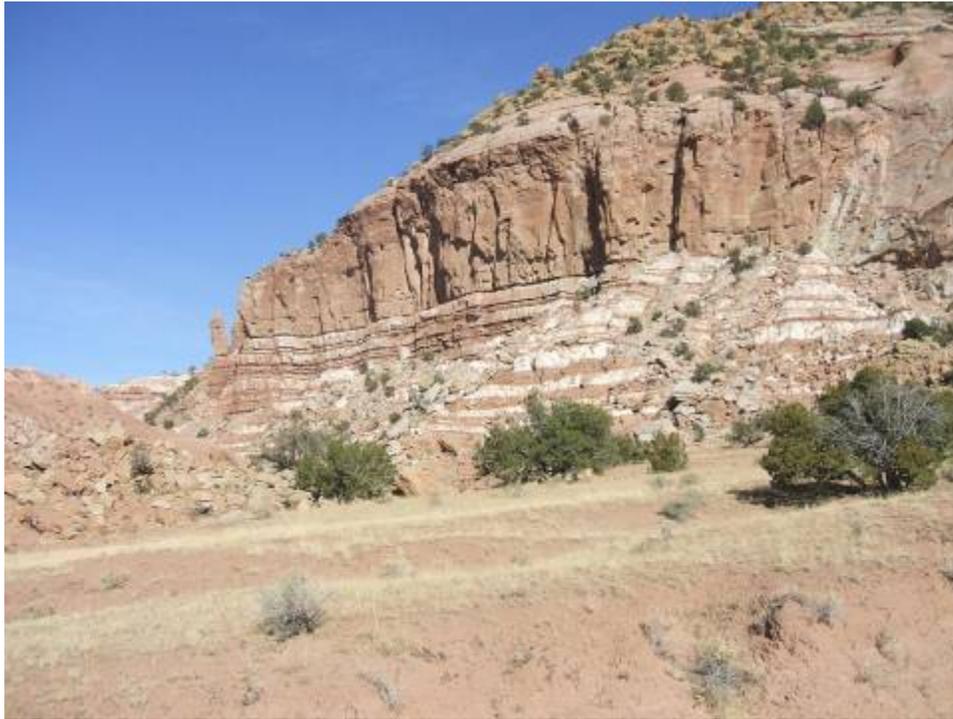
Photo 1. Haystack mine site 345, towards the north

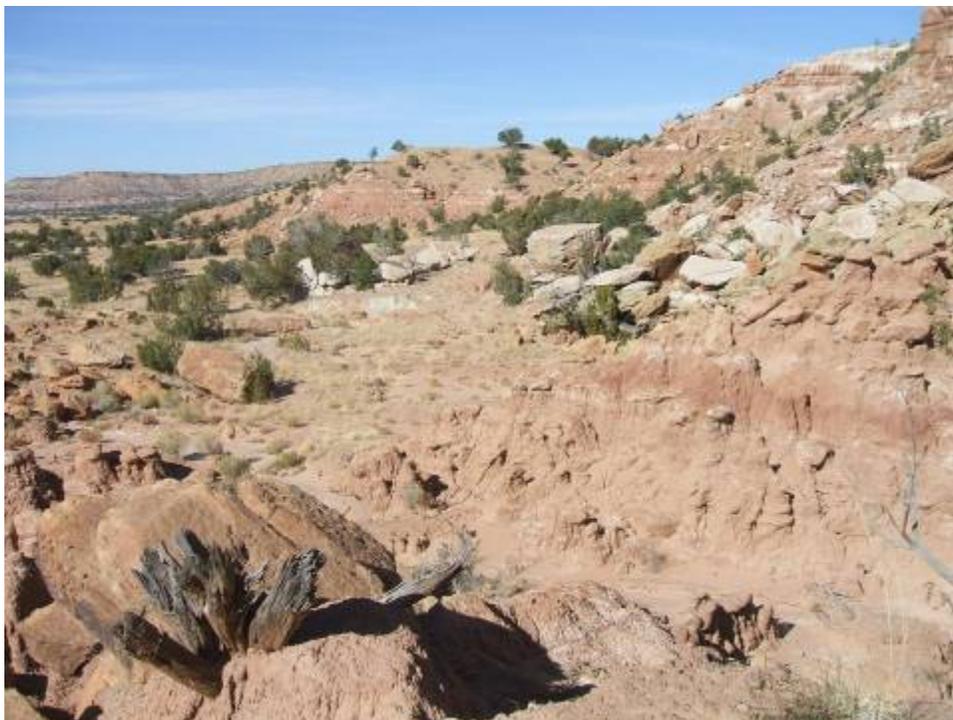
Photo 2. Haystack mine site 345, towards the north/northwest

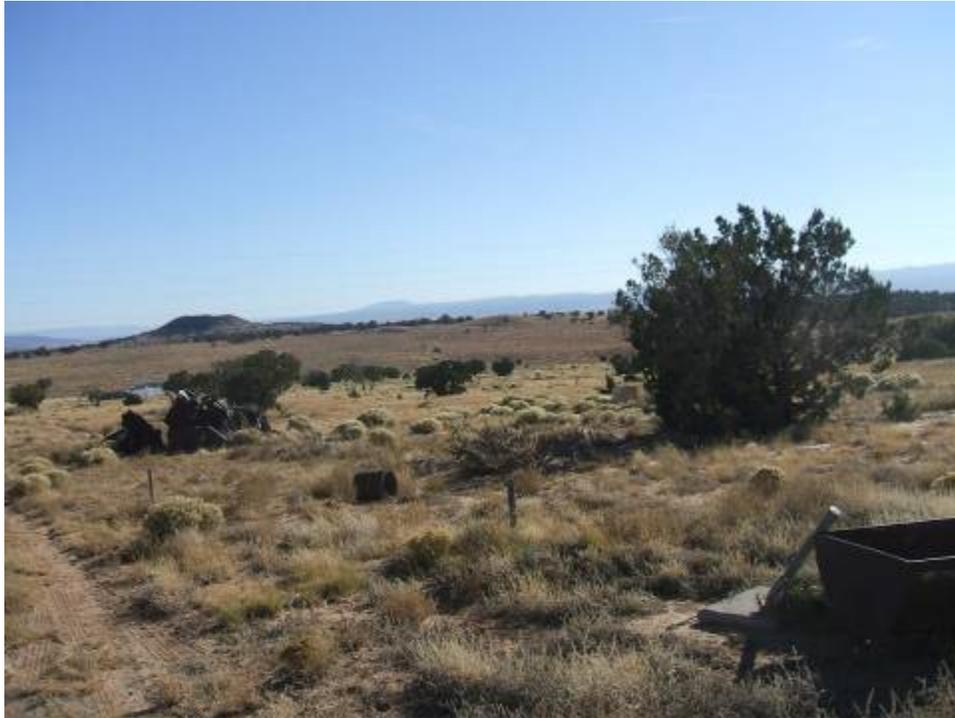
Photo 3. Haystack mine site 1039, towards the south

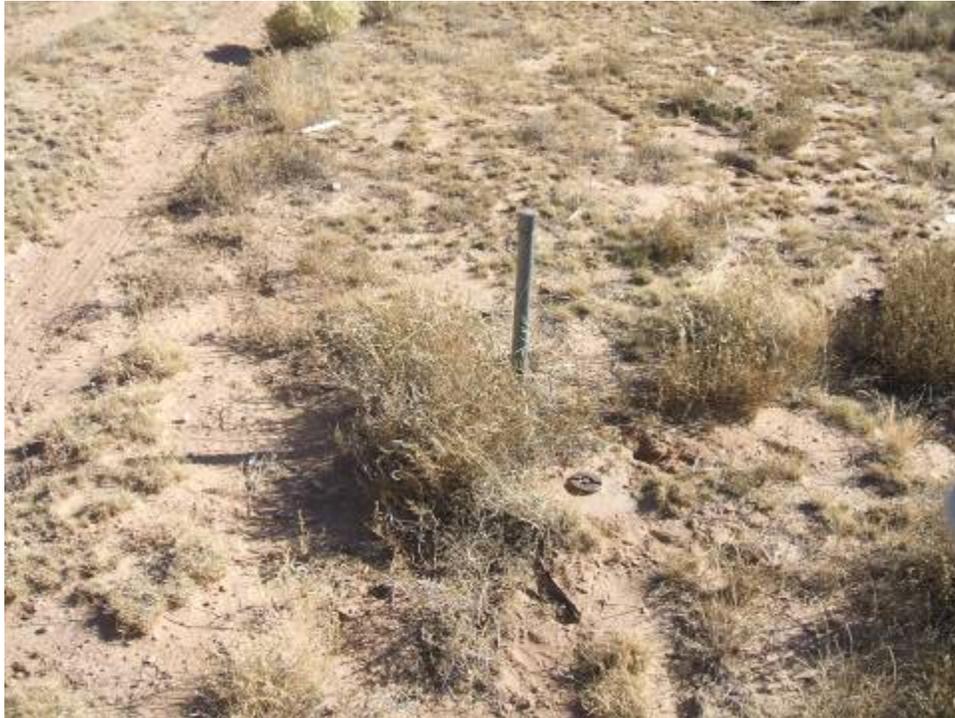
Photo 5. Haystack mine site 1039, water pipe, towards the south

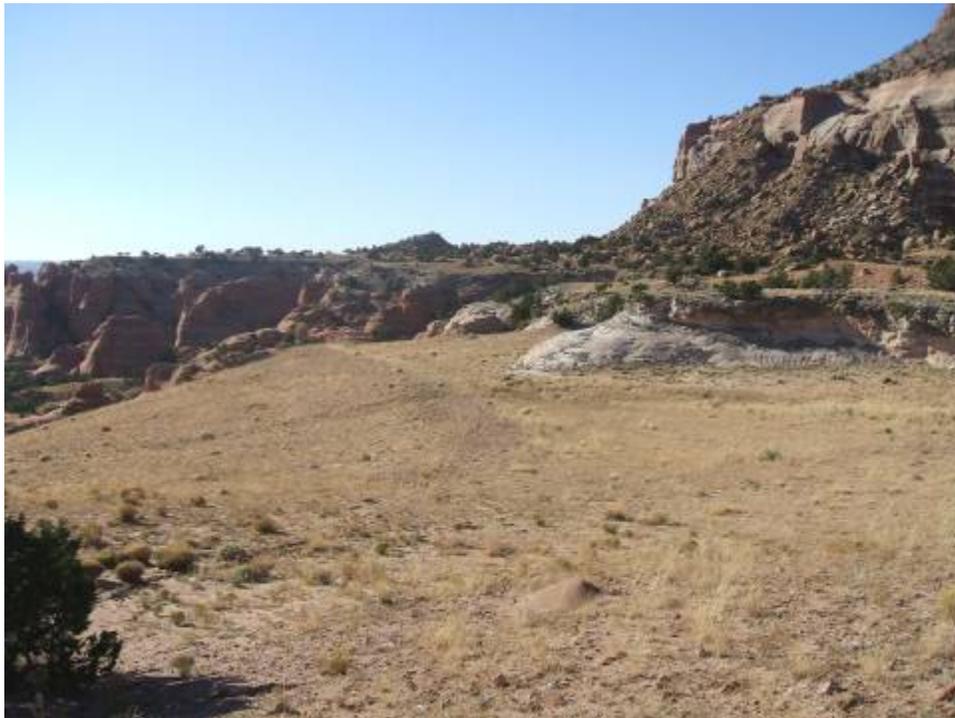
Photo 6. Haystack mine site 342, towards the northwest

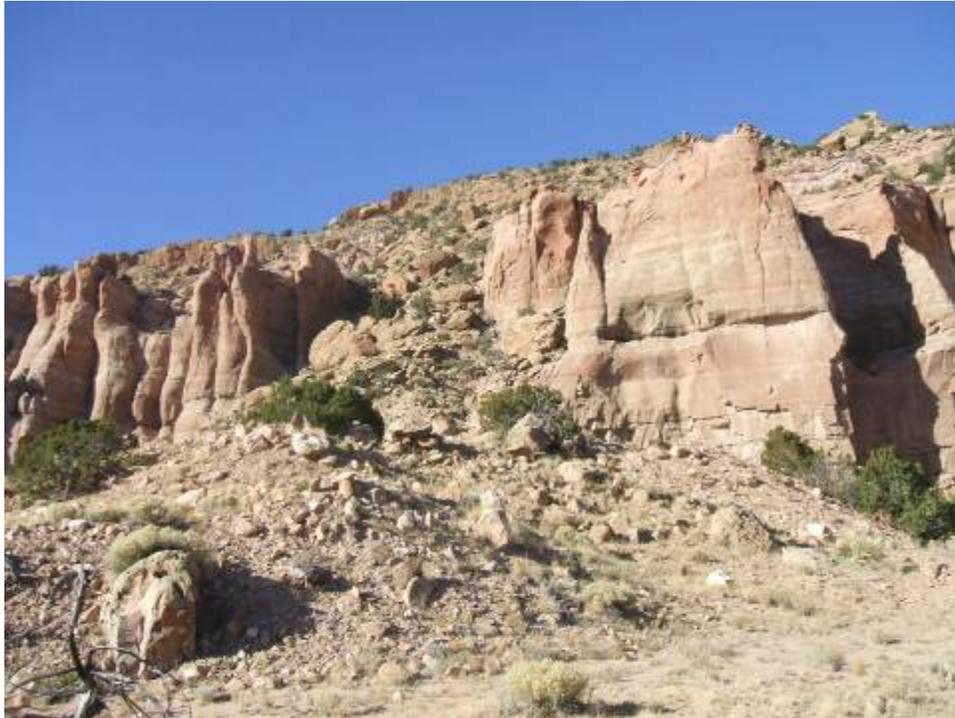
Photo 7. Haystack mine site 1038, towards the north

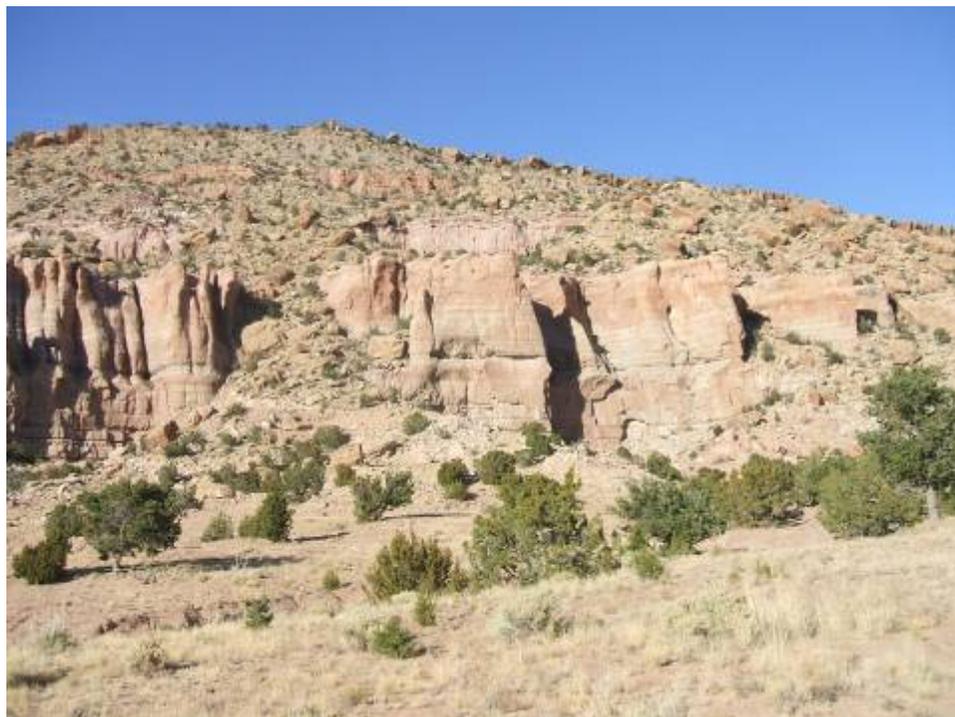
Photo 8. Haystack mine site 1038, towards the north

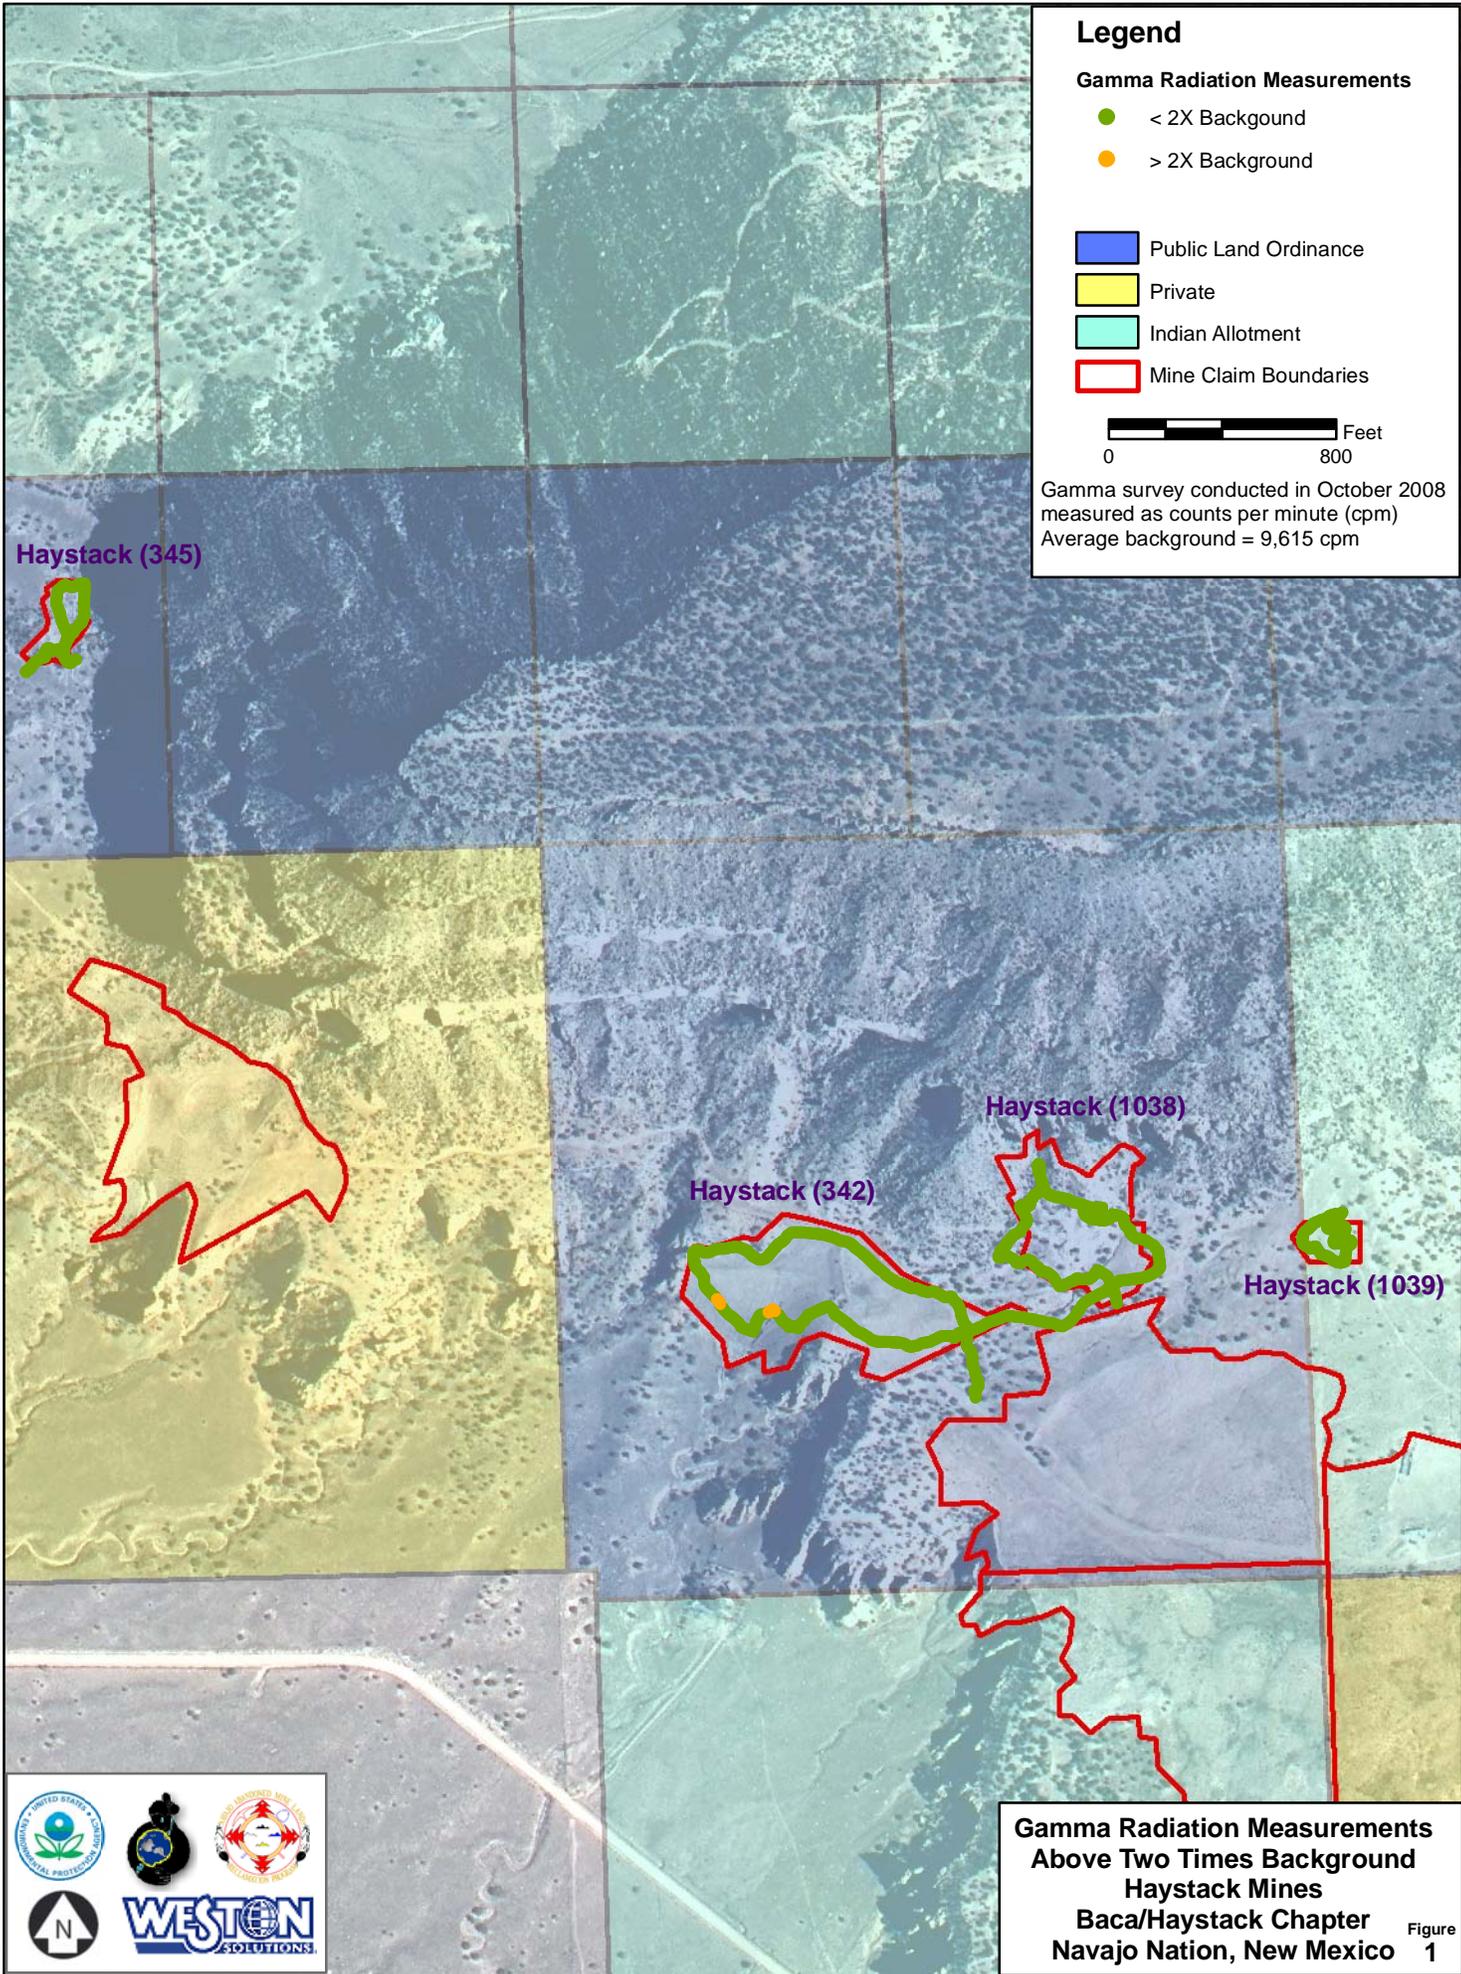
Gamma Radiation Measurements Above Two Times Background Haystack Mines
Baca/Haystack Chapter Navajo Nation, New Mexico Figure 1

A total of 2,223 gamma radiation measurements were collected from the mine sites, ranging from 6,074 cpm to 33,870 cpm. The measurements are represented in Figures 1 and 2.

Gamma survey conducted in October 2008
 measured as counts per minute (cpm)
 Average background = 9,615 cpm

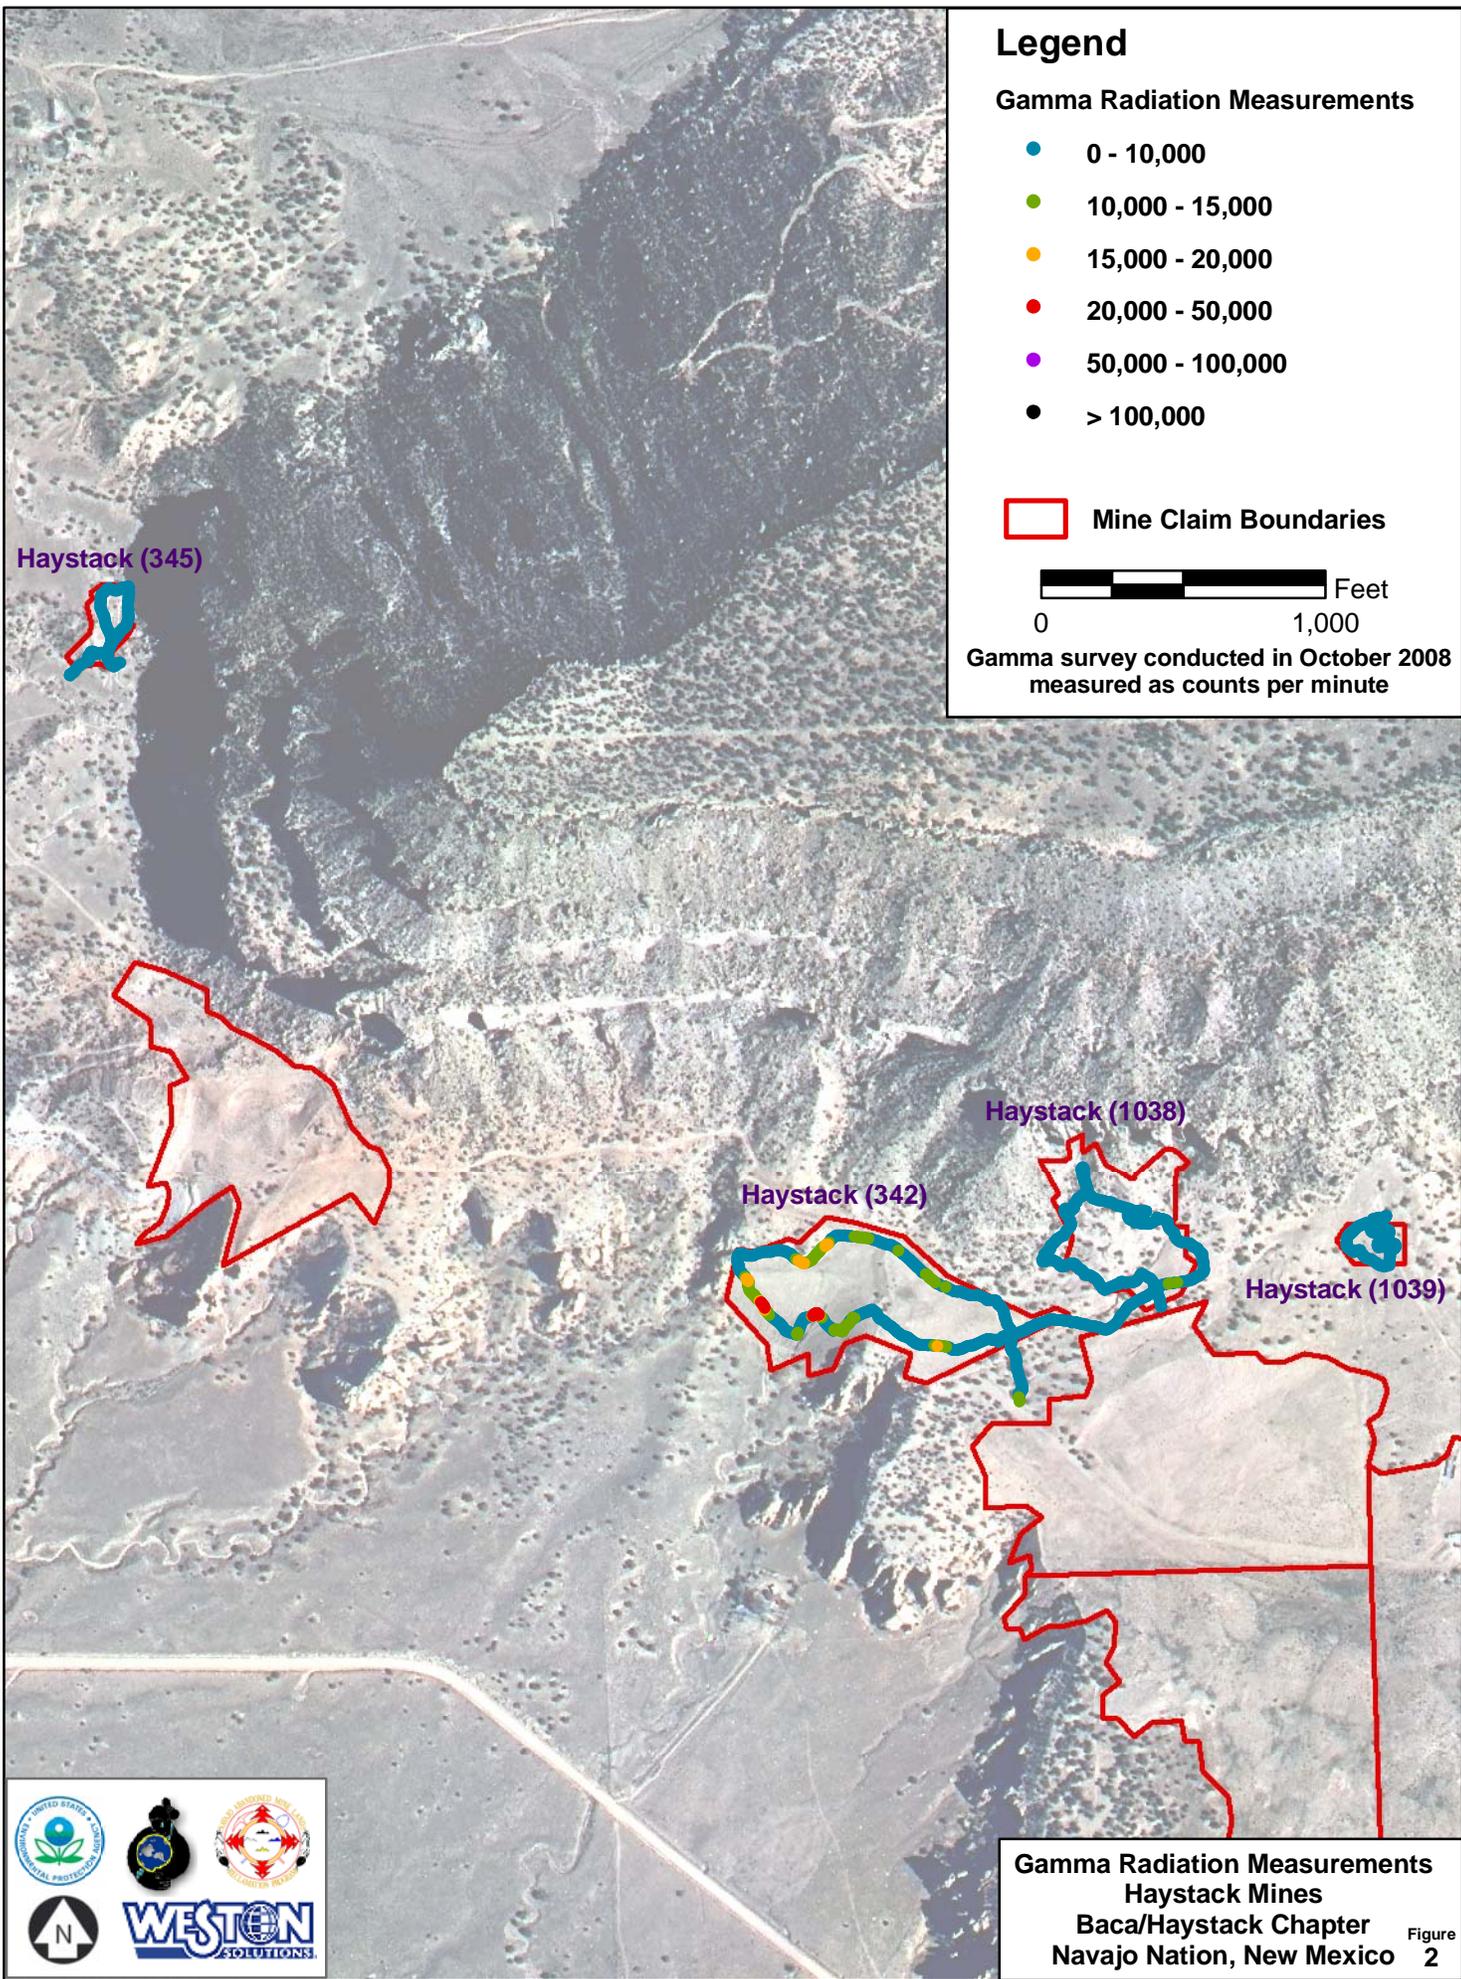
**Gamma Radiation Measurements
Haystack Mines
Baca/Haystack Chapter
Navajo Nation, New Mexico** Figure 2

Gamma survey conducted in October 2008
measured as counts per minute
