# **Navajo Abandoned Uranium Mine Site Screen Report**

## **Haystack Mines AUM Site**

### **Navajo AUM Eastern Region**

**May 2009**

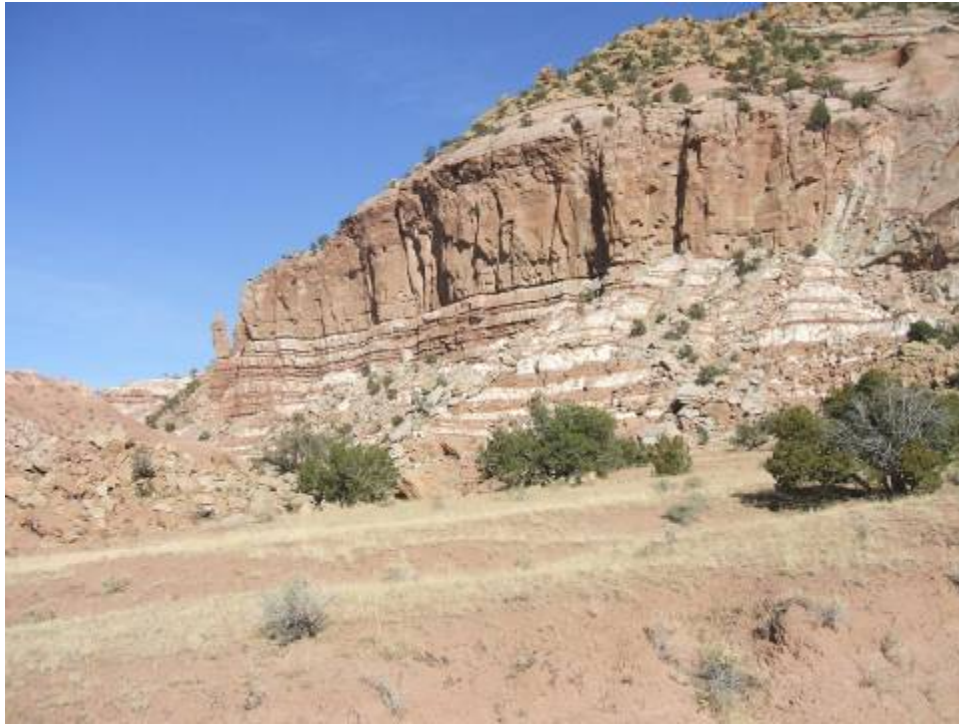
Photo 1. Haystack mine site 345, towards the north

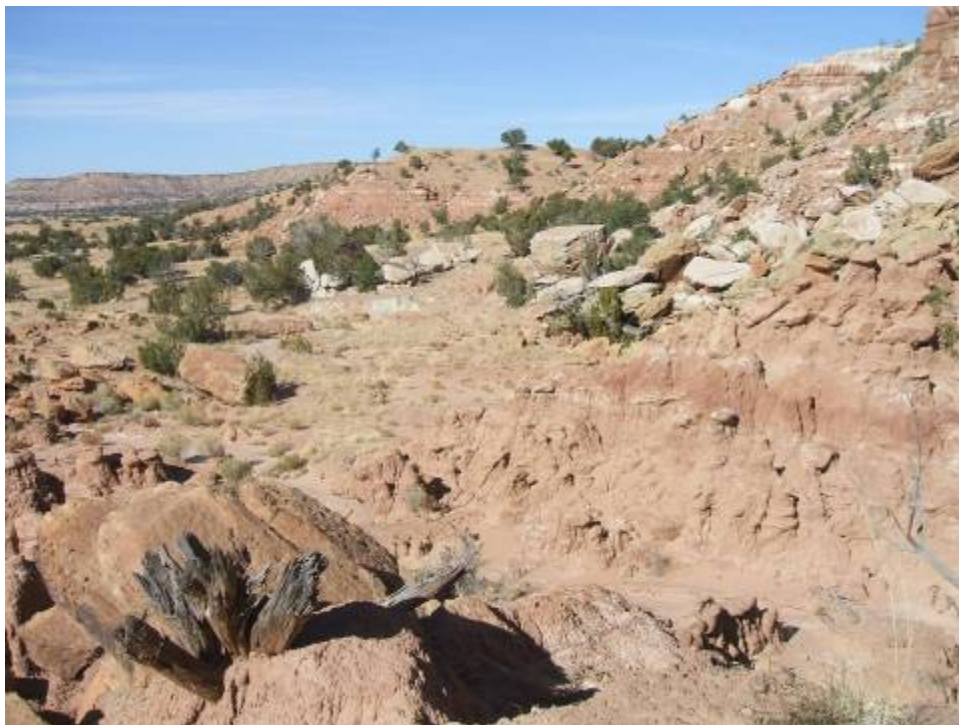
Photo 2. Haystack mine site 345, towards the north/northwest

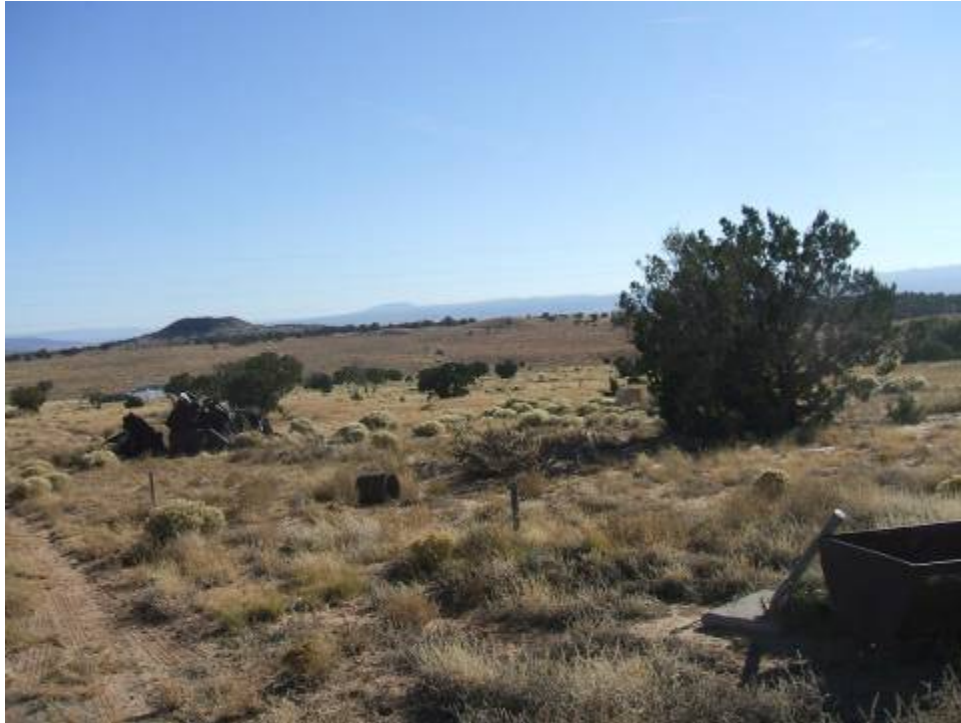
Photo 3. Haystack mine site 1039, towards the south

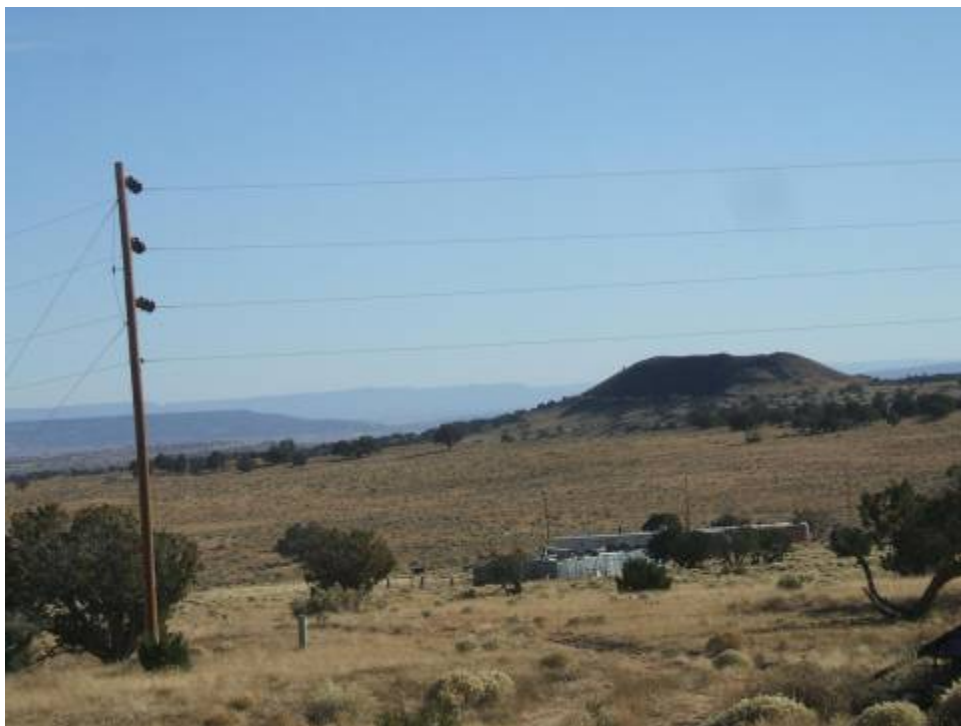
- 2 houses southeast of 1039 – measured at 11,140 counts per minute (cpm)
- House south of 342 – measured at 8,257 cpm

- #1 8,780 cpm
- #2 13,500 cpm

Photo 4. Haystack mine site 1039, houses approximately 750 feet southease of site, towards the south

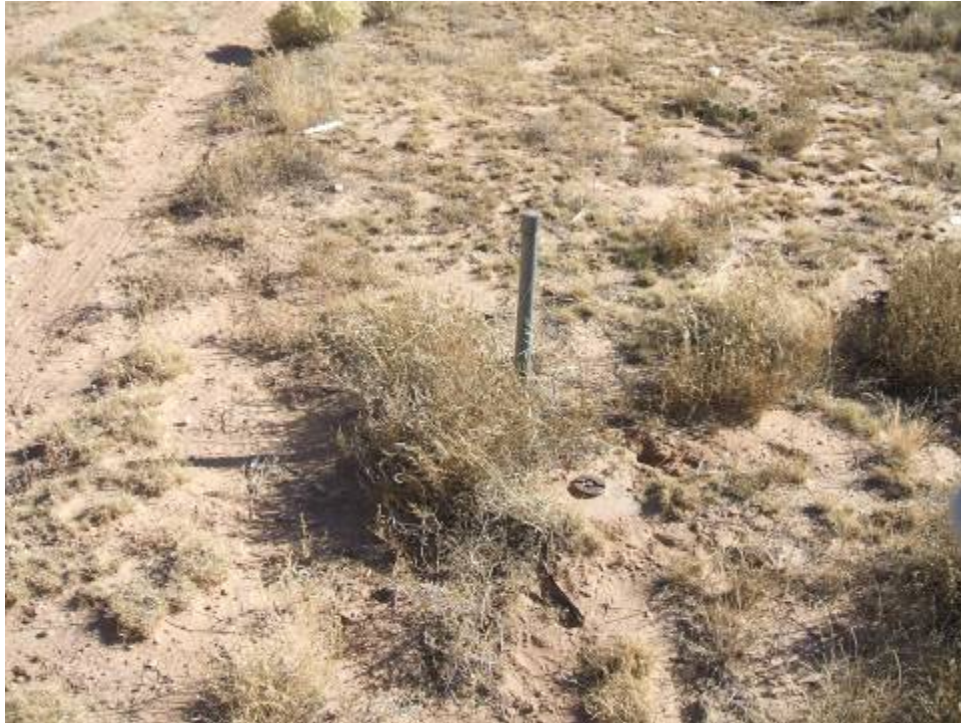
Photo 5. Haystack mine site 1039, water pipe, towards the south

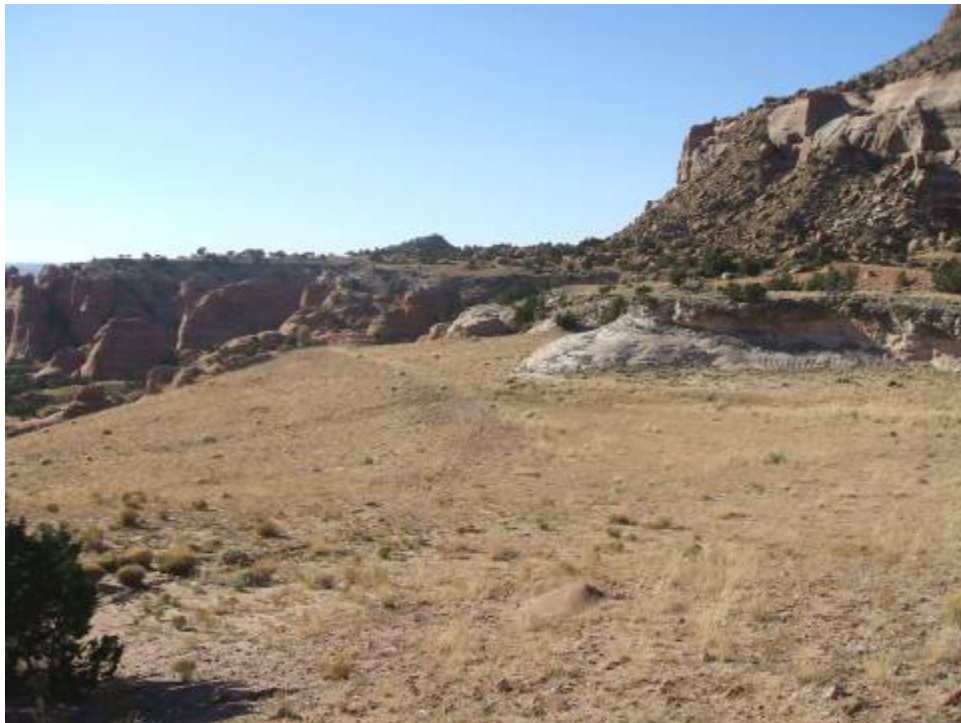
Photo 6. Haystack mine site 342, towards the northwest

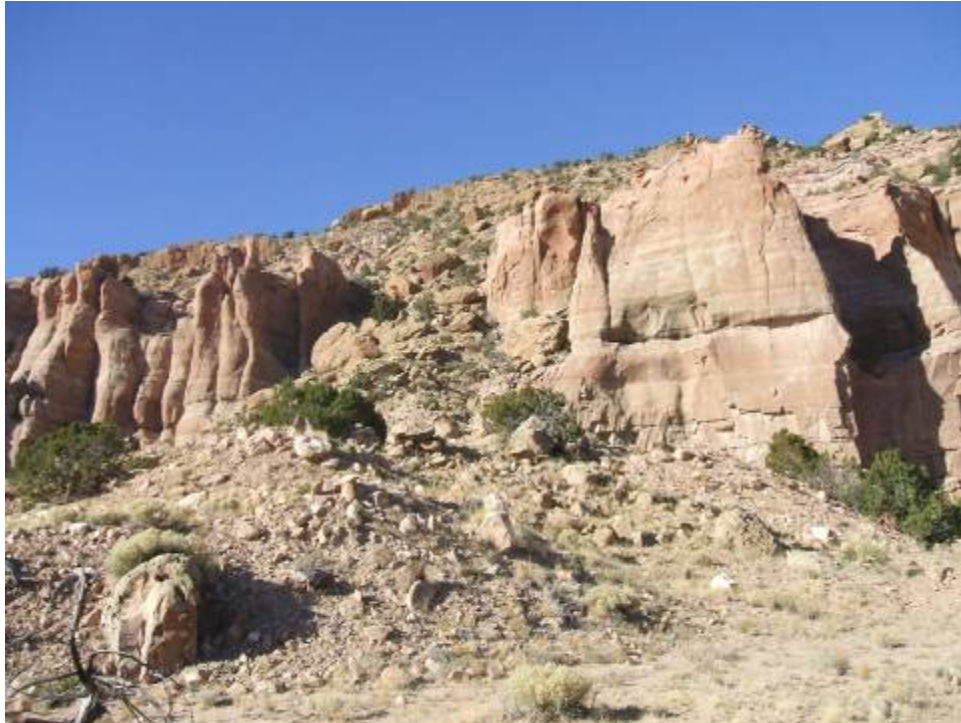
Photo 7. Haystack mine site 1038, towards the north

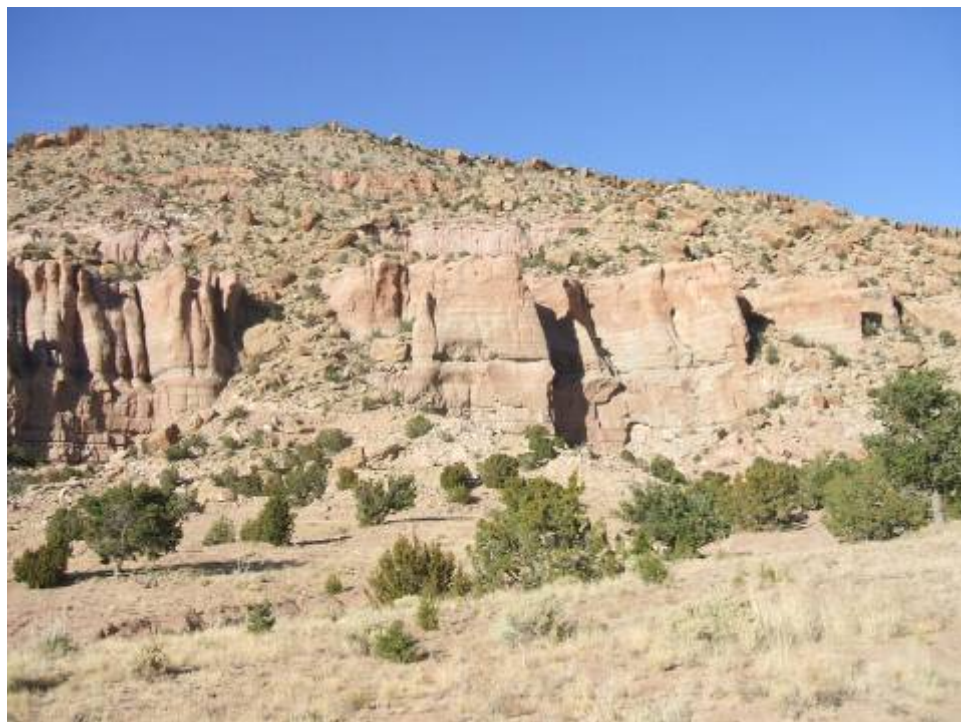
Photo 8. Haystack mine site 1038, towards the north

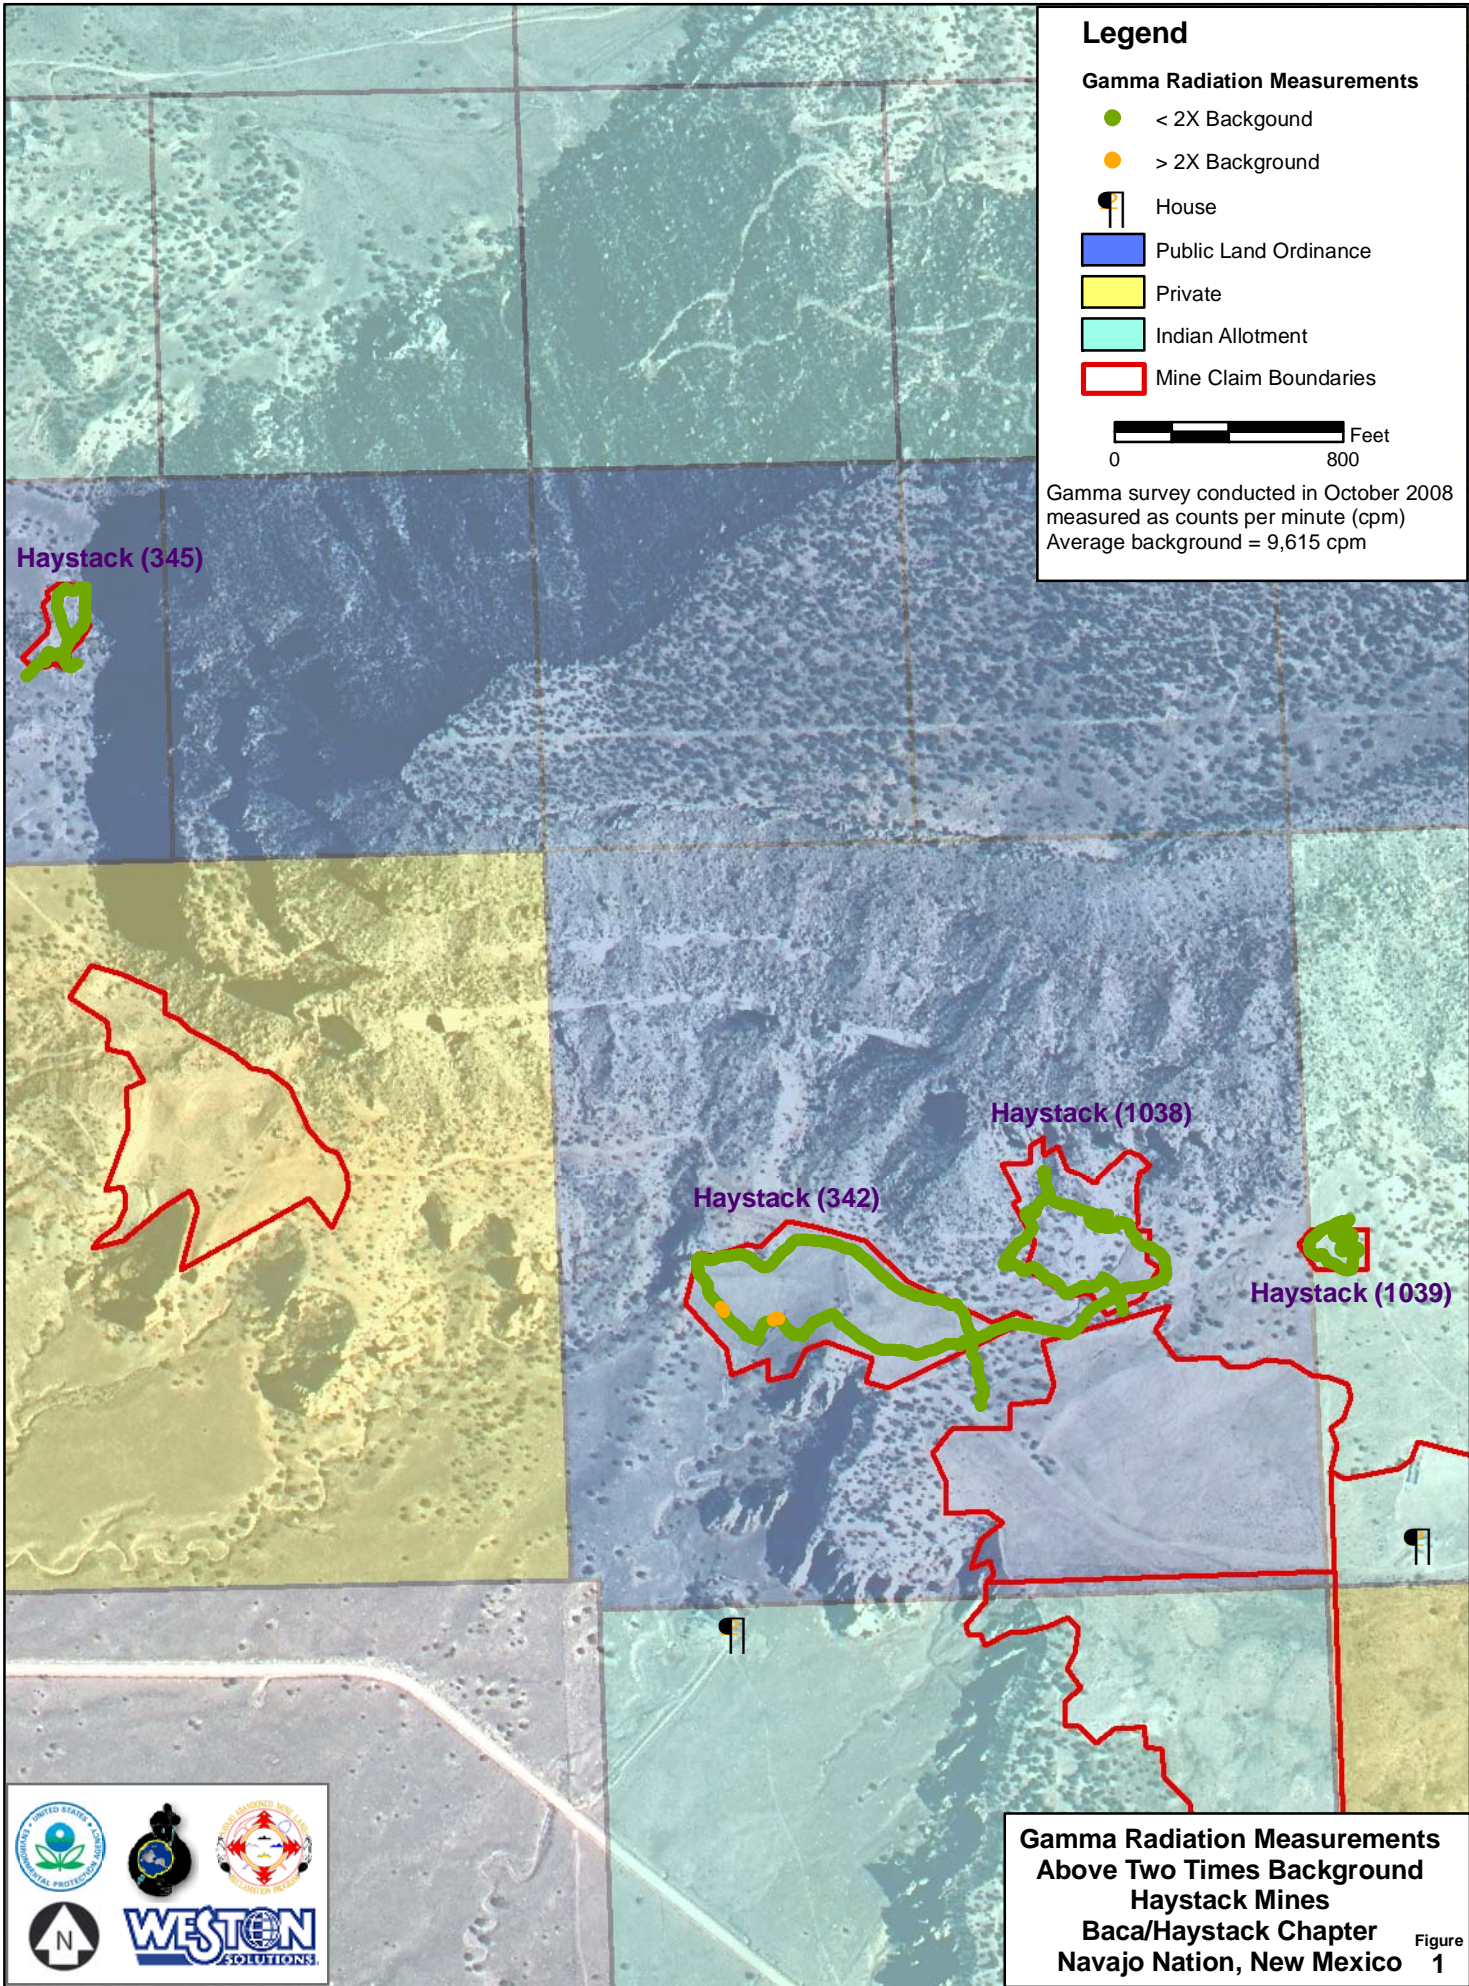
**Gamma Radiation Measurements Above Two Times Background Haystack Mines**  
Baca/Haystack Chapter Navajo Nation, New Mexico Figure 1

A total of 2,223 gamma radiation measurements were collected from the mine sites, ranging from 6,074 cpm to 33,870 cpm. The measurements are represented in Figures 1 and 2.

Gamma survey conducted in October 2008  
measured as counts per minute (cpm)  
Average background = 9,615 cpm
