Coating Repairs Work Plan Line 5 Dual Pipelines

United States v. Enbridge Energy et al Case 1:16 –cv-914

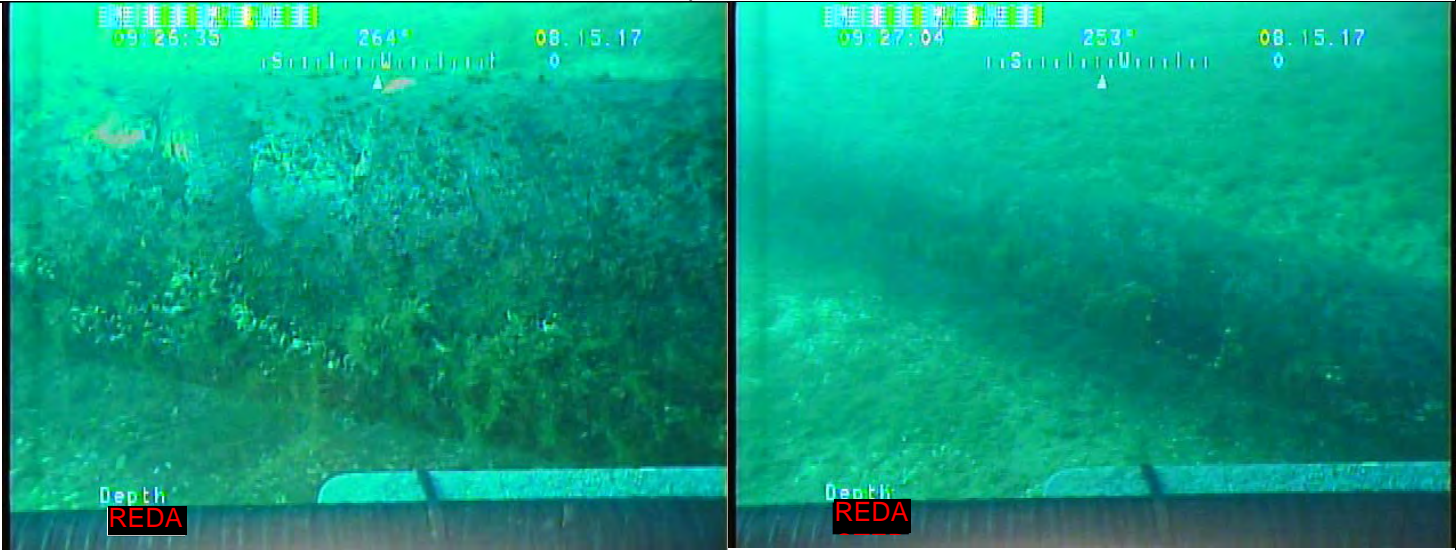
Date:	8/15/17	Frame(HH:MM:SS)	09:26:36	Date:	8/15/17	Frame(HH:MM:SS)	09:27:04
-------	---------	-----------------	----------	-------	---------	-----------------	----------

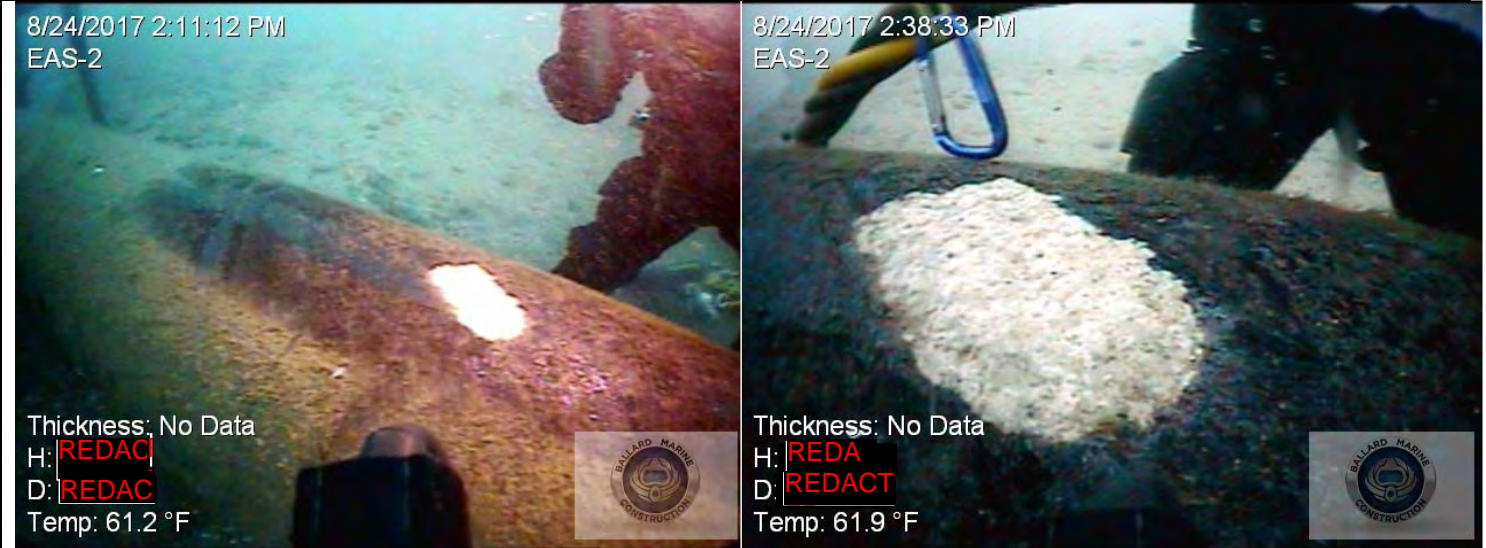
Date:	8/24/17	Frame(HH:MM:SS)	14:11:12	Date:	8/24/17	Frame(HH:MM:SS)	14:38:33
-------	---------	-----------------	----------	-------	---------	-----------------	----------

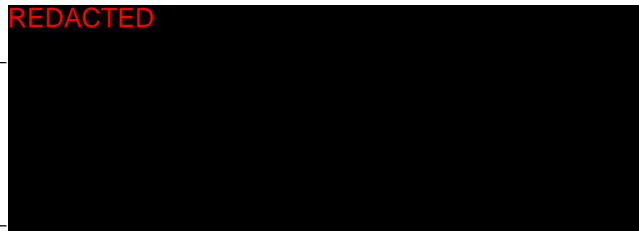
Handwritten signature

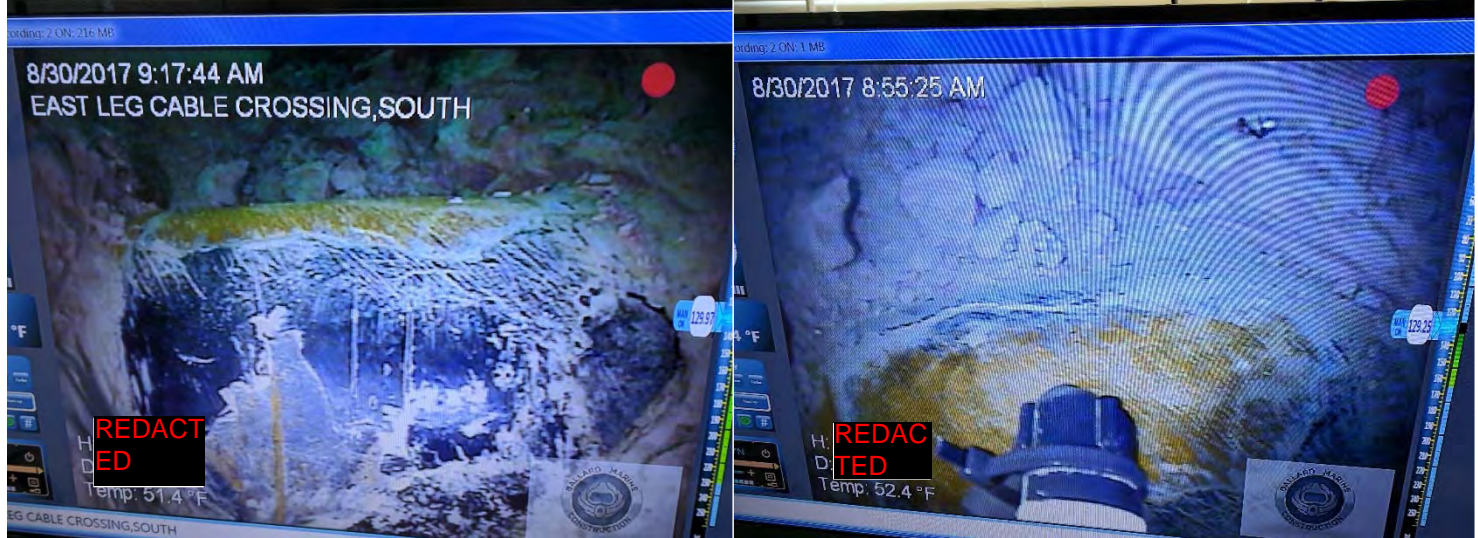
Date:	8/30/17	Frame(HH:MM:SS)	09:17:44	Date:	8/30/17	Frame(HH:MM:SS)	08:55:25
-------	---------	-----------------	----------	-------	---------	-----------------	----------

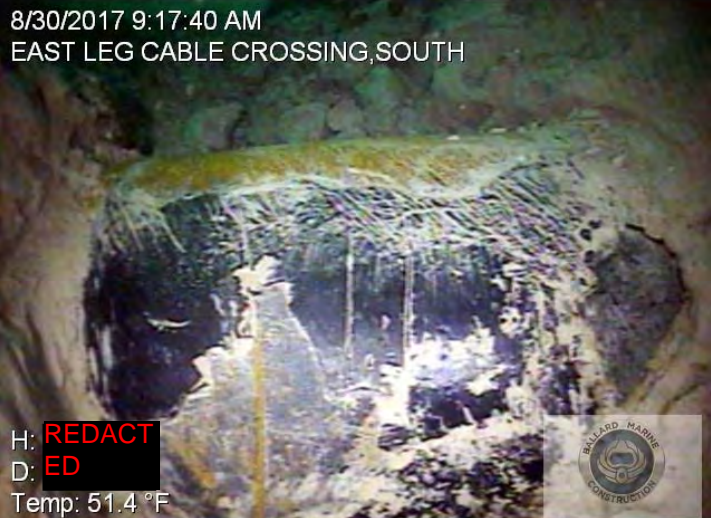
<p>H: REDACT D: ED Temp: 51.4 °F</p>				
Date: 8/30/17	Frame(HH:MM:SS)	8:58:31	Date: 8/30/17	Frame(HH:MM:SS)	9:17:40

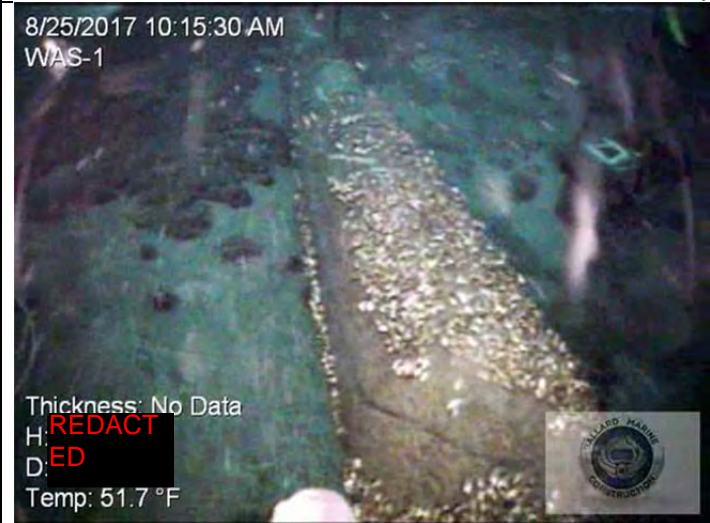
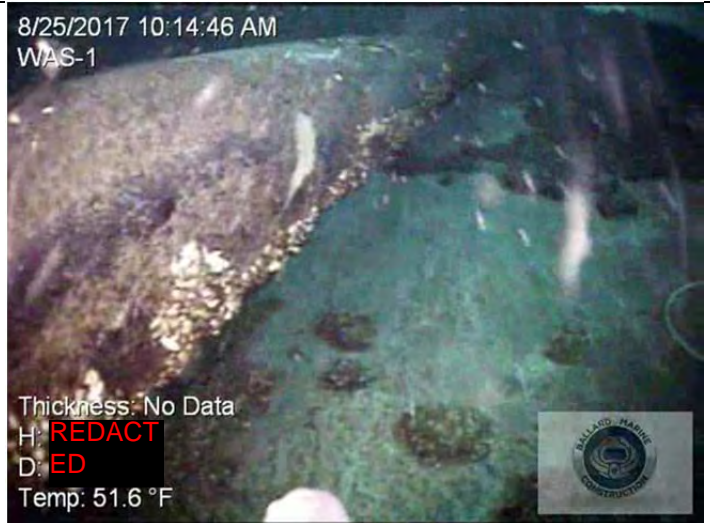
Date:	8/25/17	Frame(HH:MM:SS)	10:15:30	Date:	8/25/17	Frame(HH:MM:SS)	10:14:46
-------	---------	-----------------	----------	-------	---------	-----------------	----------

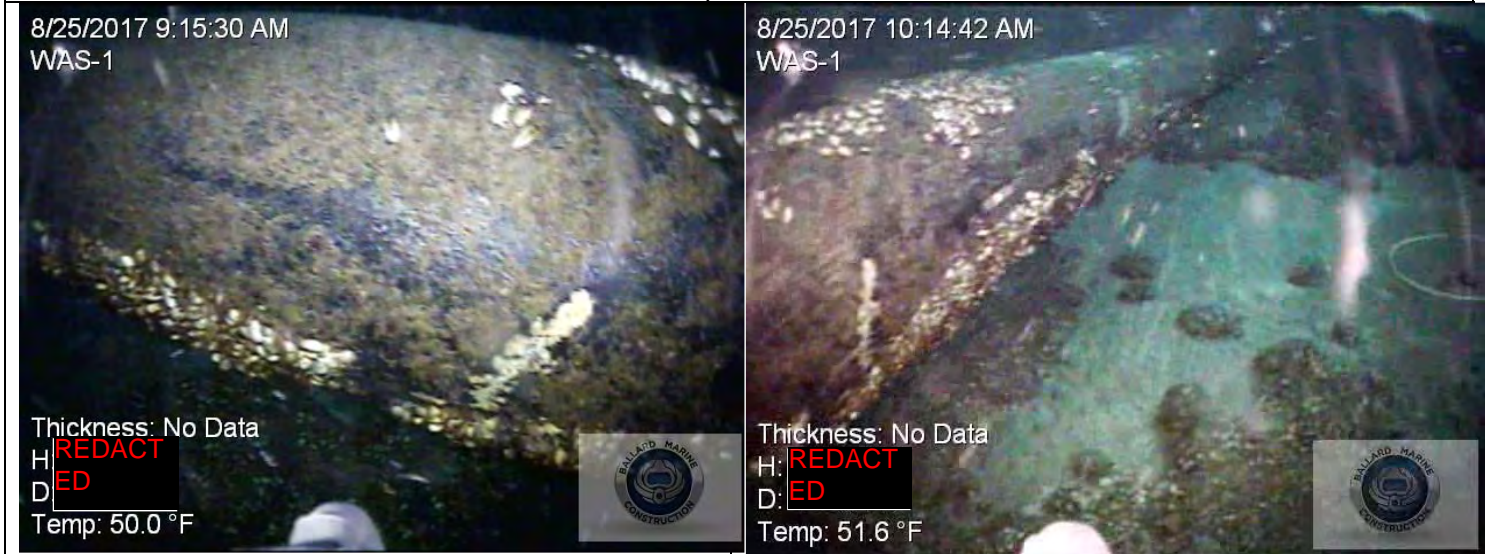
Date:	8/25/17	Frame(HH:MM:SS)	09:15:30	Date:	8/25/17	Frame(HH:MM:SS)	10:14:42
-------	---------	-----------------	----------	-------	---------	-----------------	----------

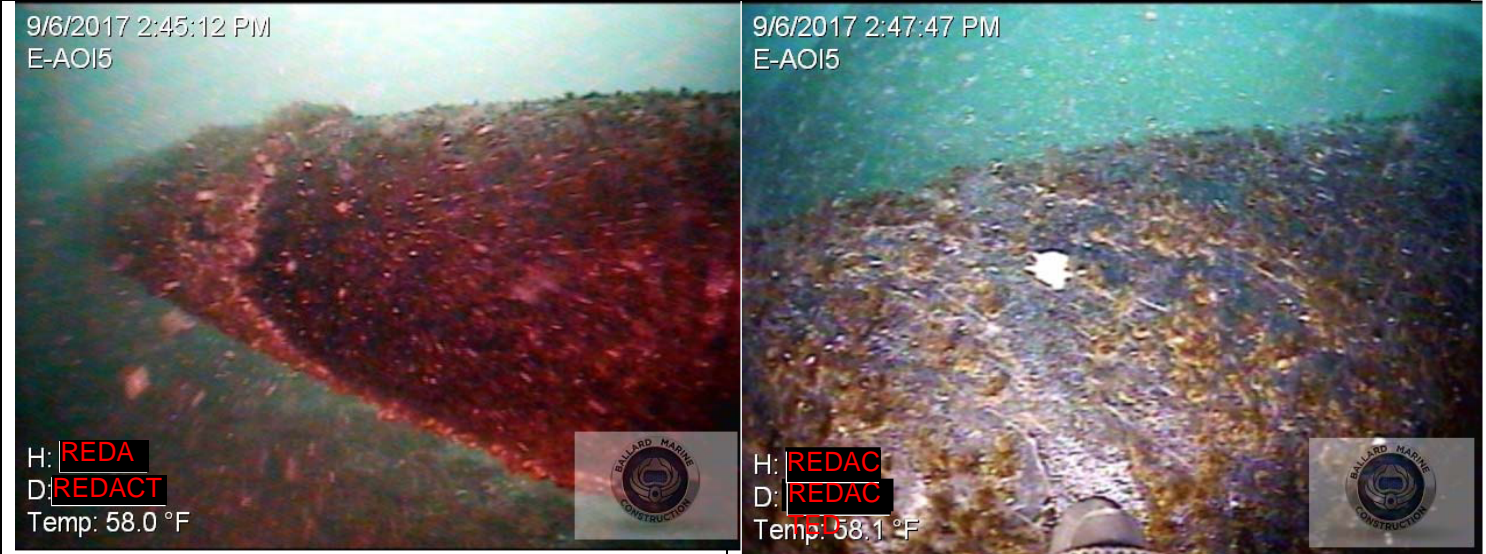
Date:	09/06/17	Frame(HH:MM:SS)	14:45:12	Date:	09/06/17	Frame(HH:MM:SS)	14:47:47
-------	----------	-----------------	----------	-------	----------	-----------------	----------

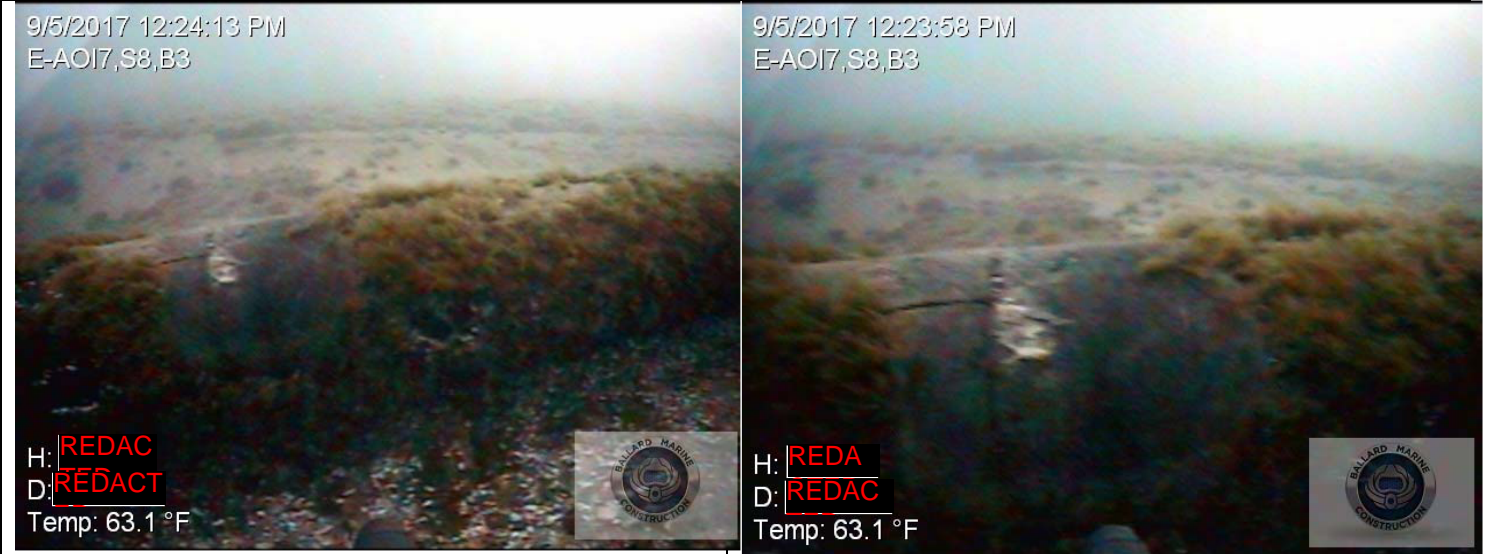
Date:	09/05/17	Frame(HH:MM:SS)	12:24:13	Date:	09/05/17	Frame(HH:MM:SS)	12:23:58
-------	----------	-----------------	----------	-------	----------	-----------------	----------

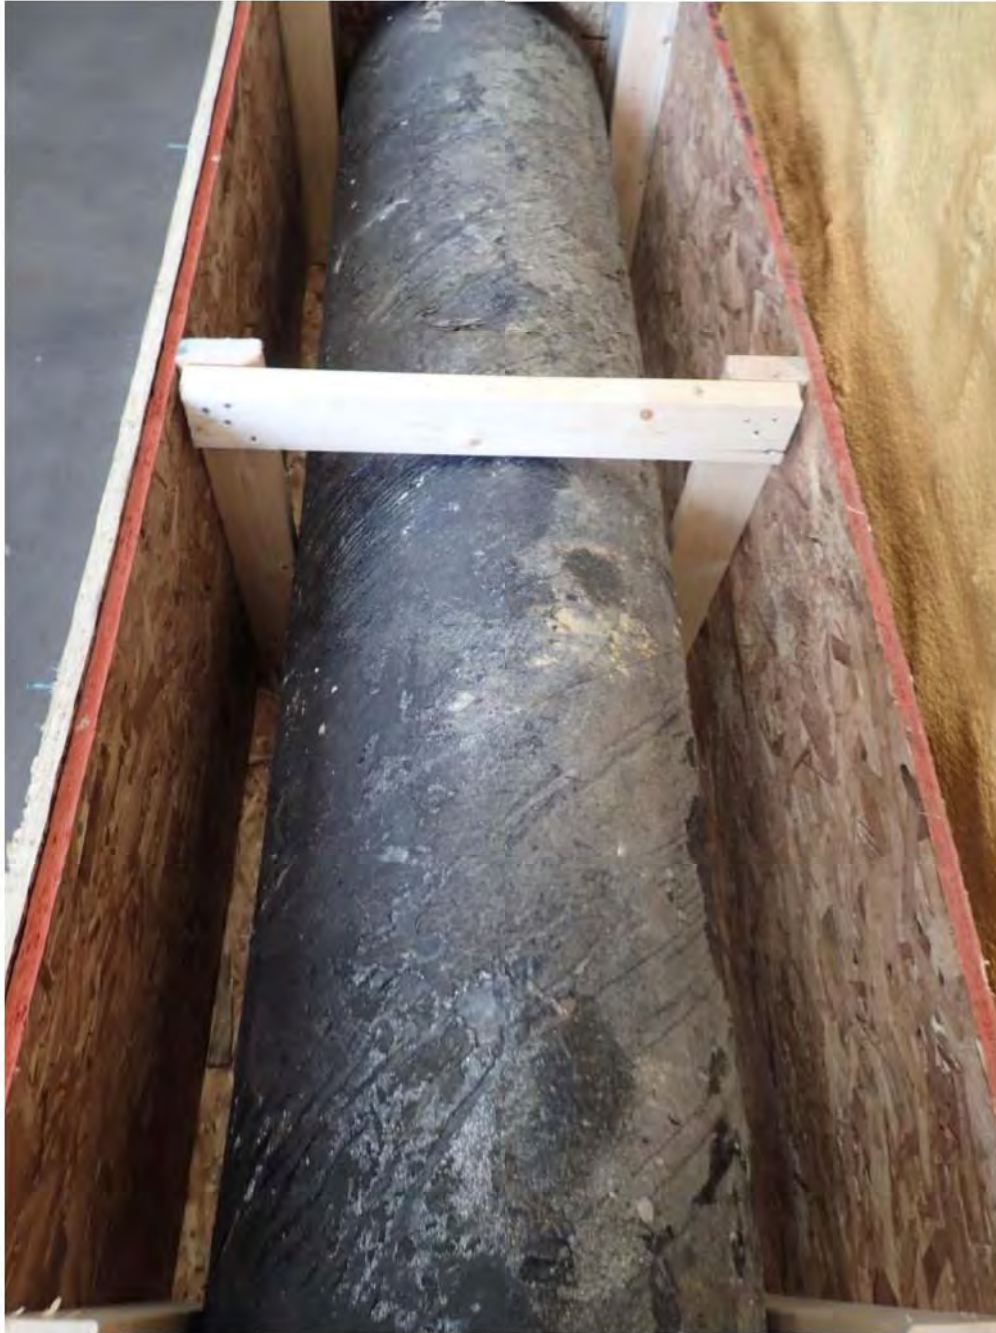
Figure 1: Photograph showing as-received 20" diameter pipe sample used for full-scale repair testing.

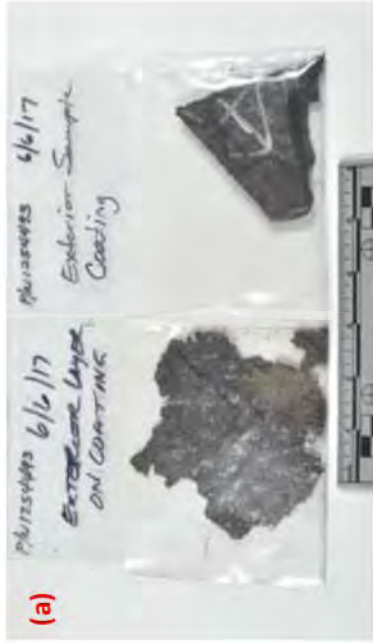
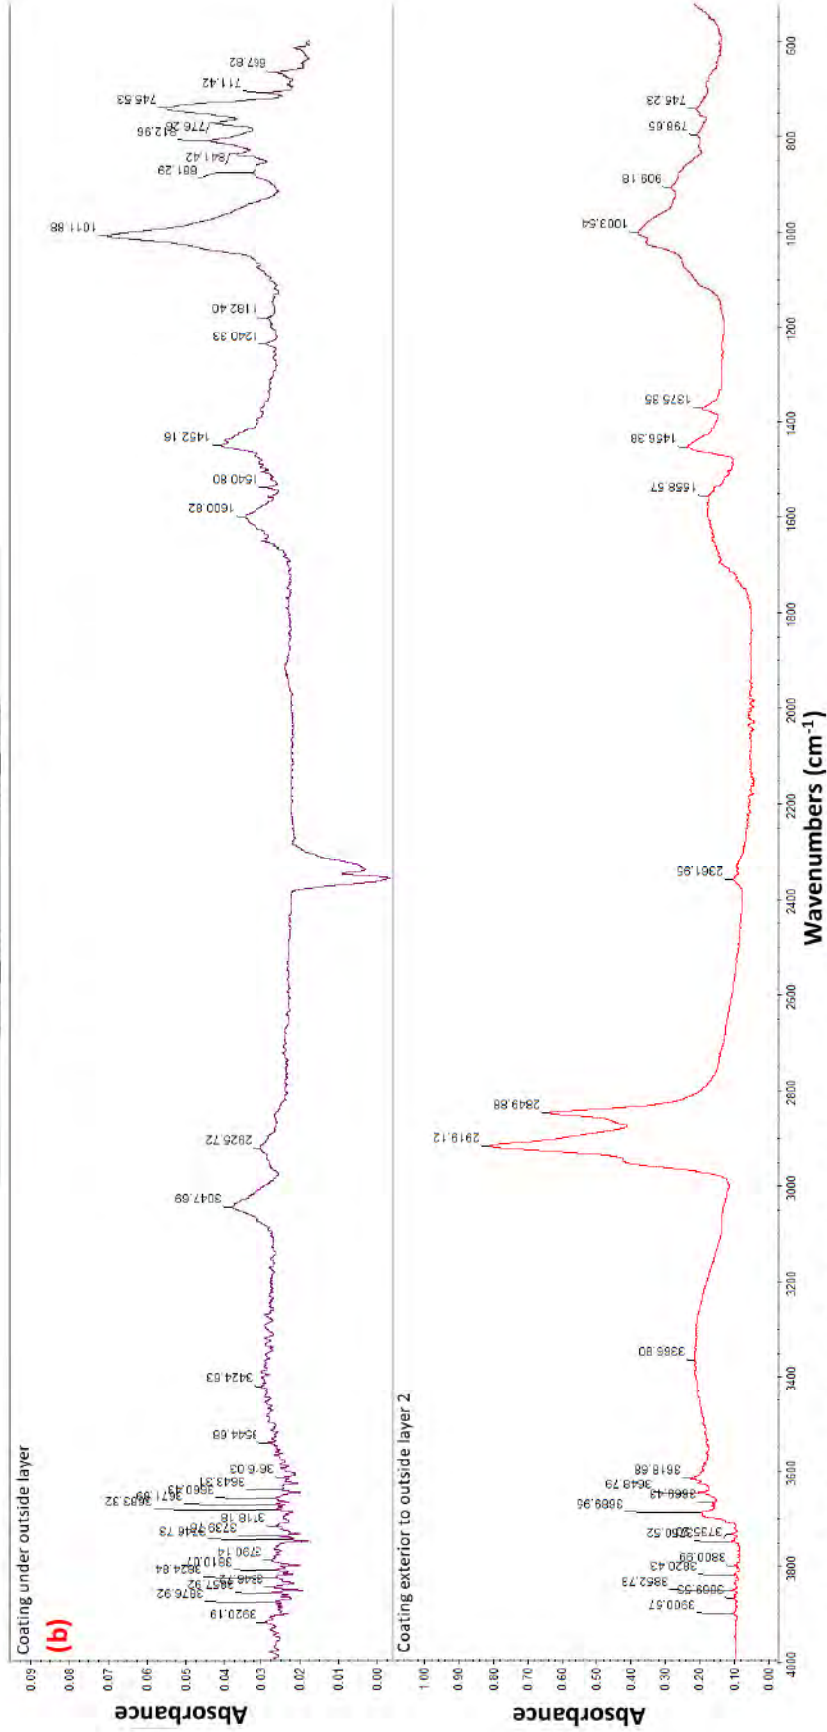
Figure 2: (a) Photograph of coating samples removed for FTIR analysis; (b) FTIR analysis results for original coating of 20" pipe sample.

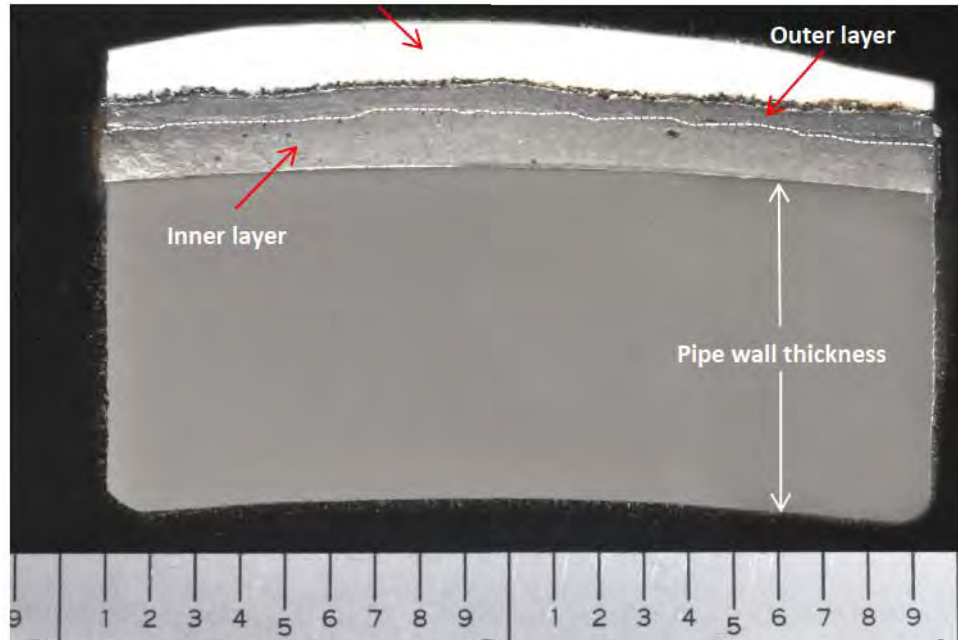
Figure 3: Metallographic cross-section through original coating. Dashed line indicates approximate boundary between inner and outer layers of coating. Numbered scale divisions are 0.1".

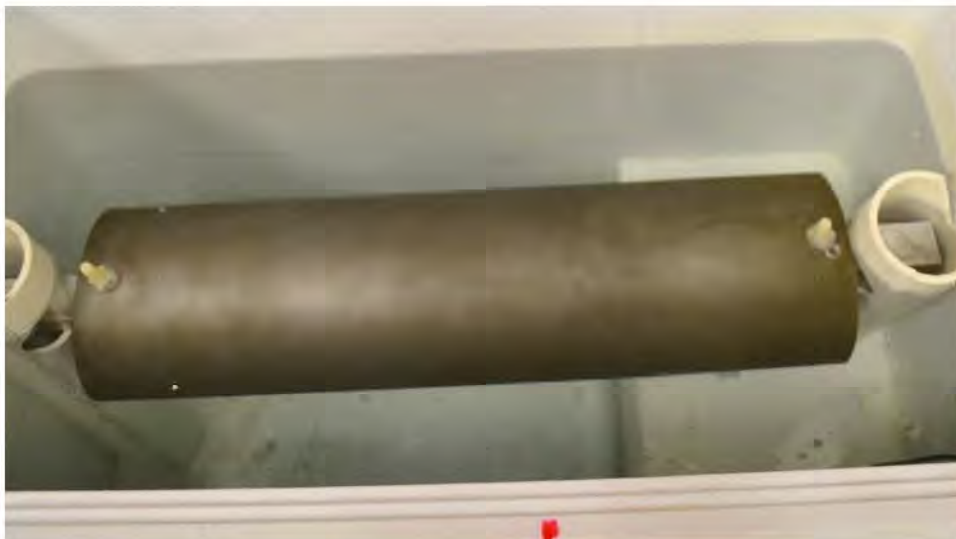
Figure 4: One of two laboratory test samples used for initial tests of repair material. A 6” pipe section is shown submerged in 40°F water prior to application of repair coating.

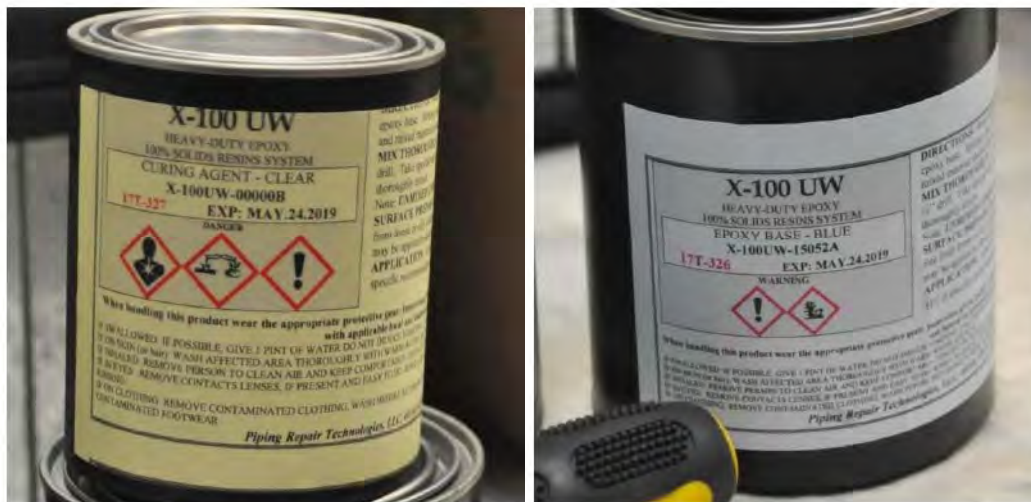
Figure 5: Two-part epoxy repair system provided by PRT Incorporated, Hempstead, Texas.

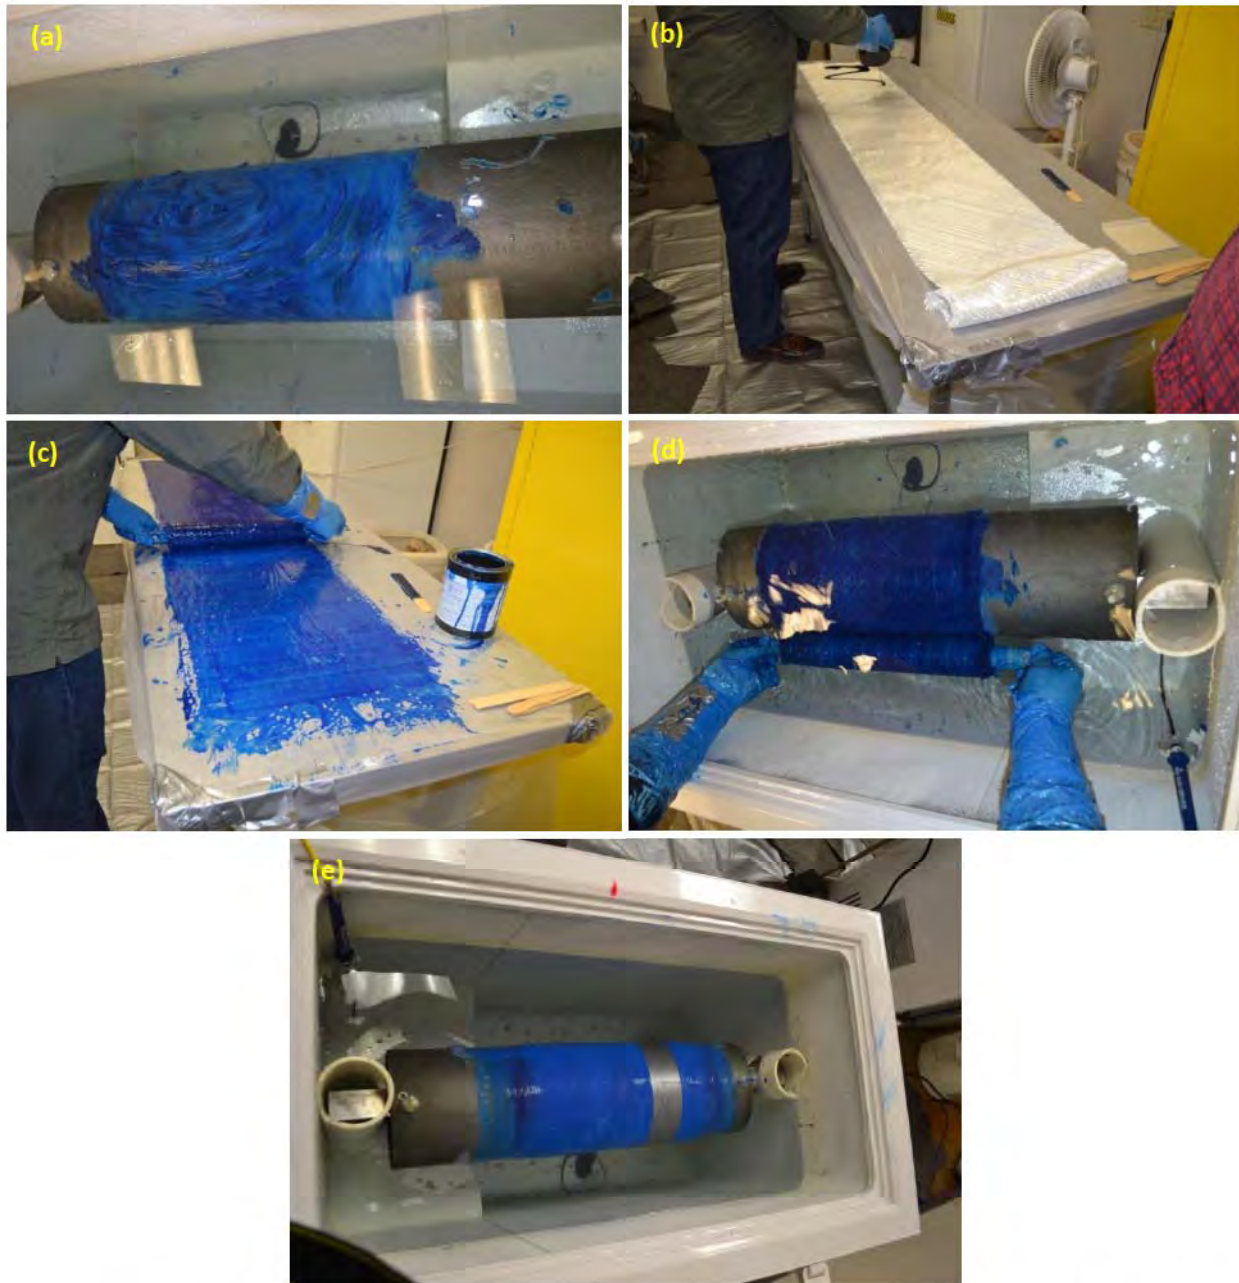
Figure 6: Photographs showing application of laboratory epoxy repair wrap: (a) epoxy applied to bare steel; (b) and (c) fabric impregnated with two-part epoxy; (d) fiber mesh repair wrapped around pipe in four layers; and (e) stricture banding applied over repair.

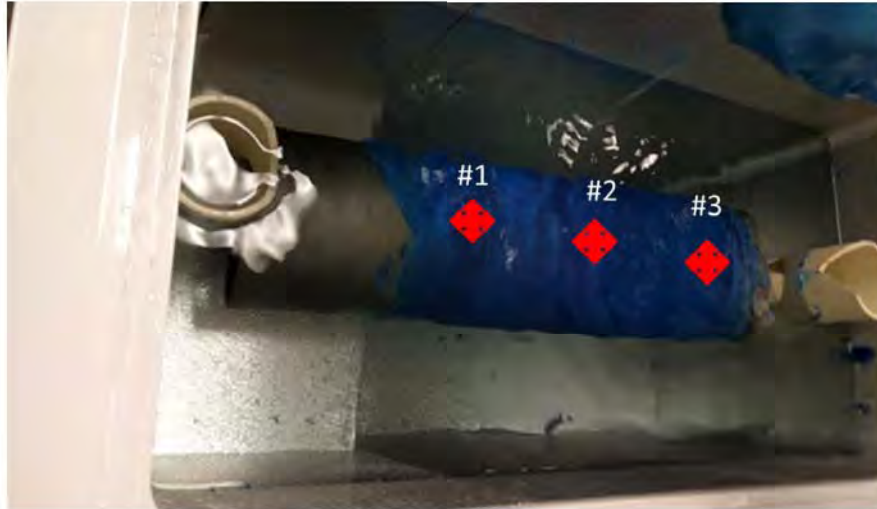
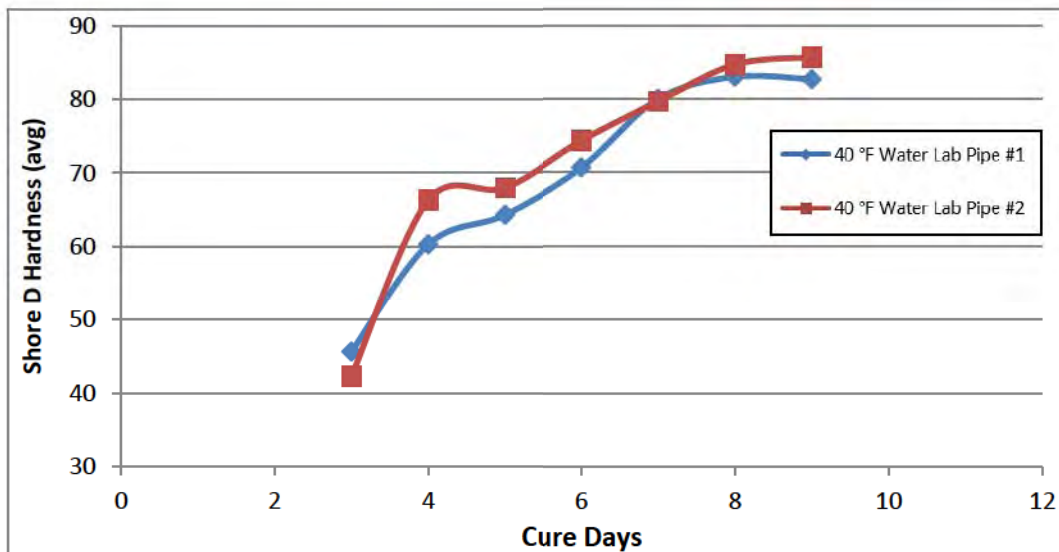
Figure 7: (a) Photograph showing locations of coating hardness measurements and (b) graph of coating hardness results during curing at 40°F.

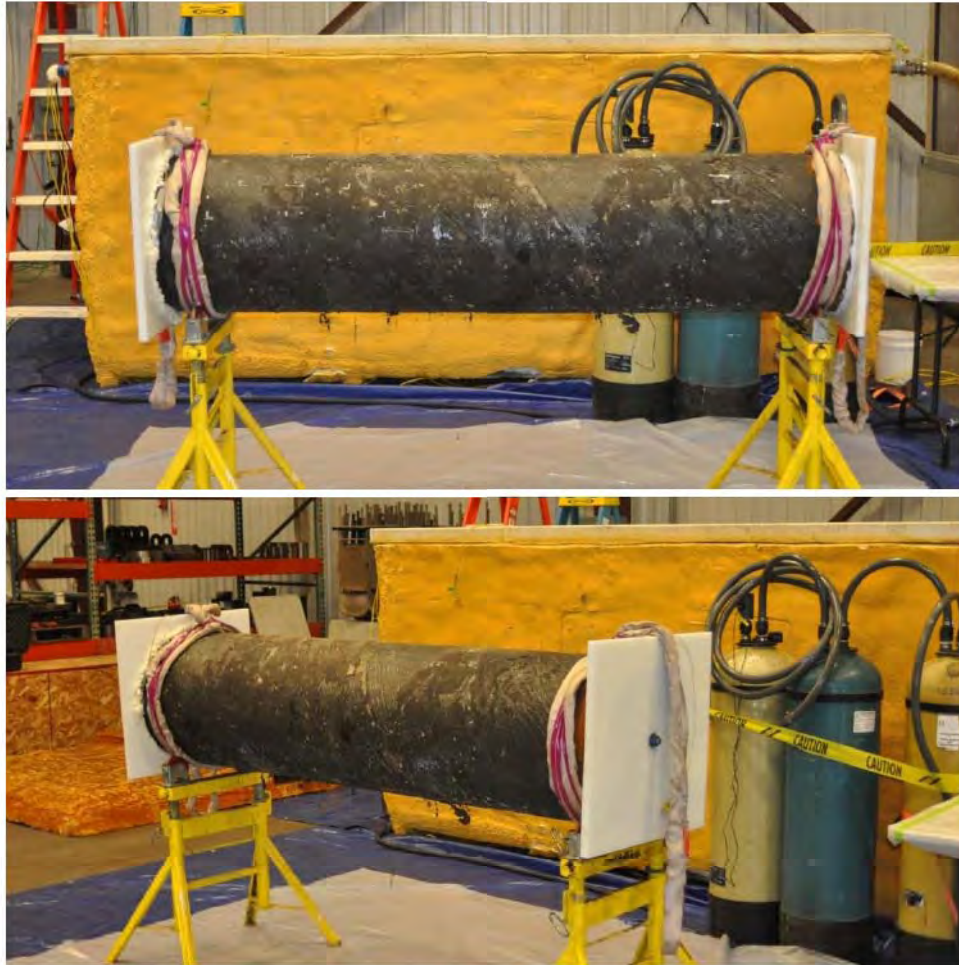
Figure 8: Photographs showing 20" diameter pipe used for full-scale testing of epoxy repair material. Note insulated yellow water tank shown in background.

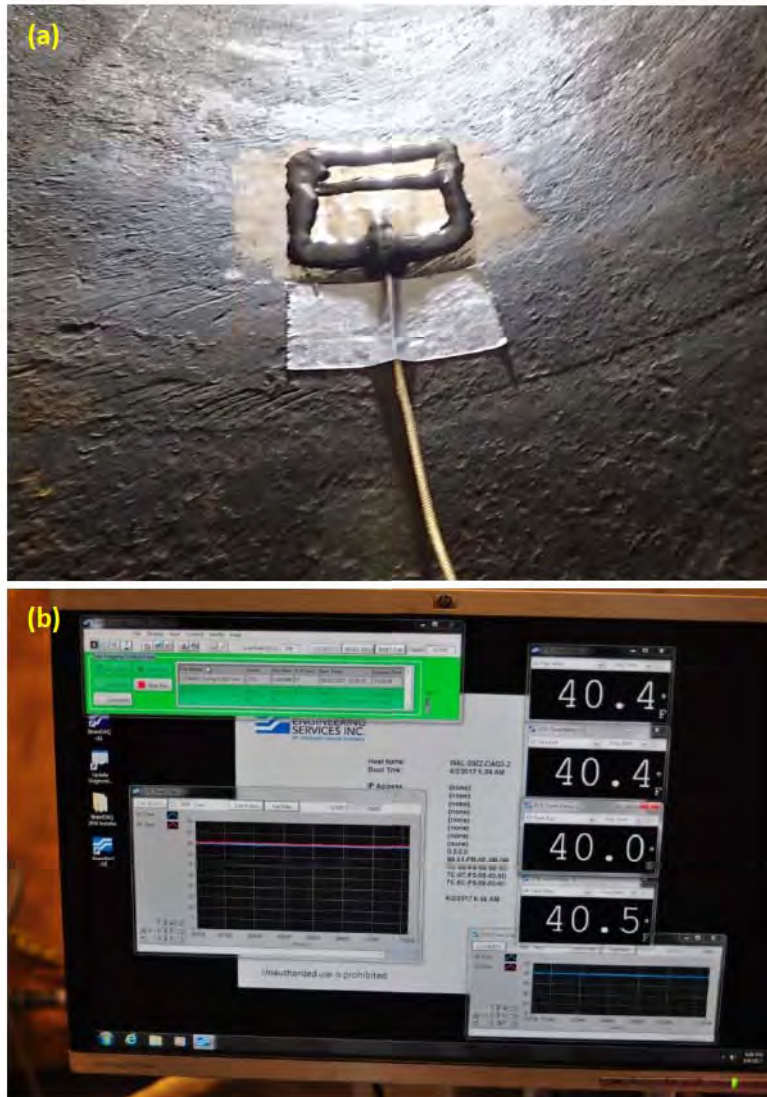
Figure 9: Photograph showing (a) thermocouple attached to inside surface of pipe and (b) temperature readout for water tank and pipe.

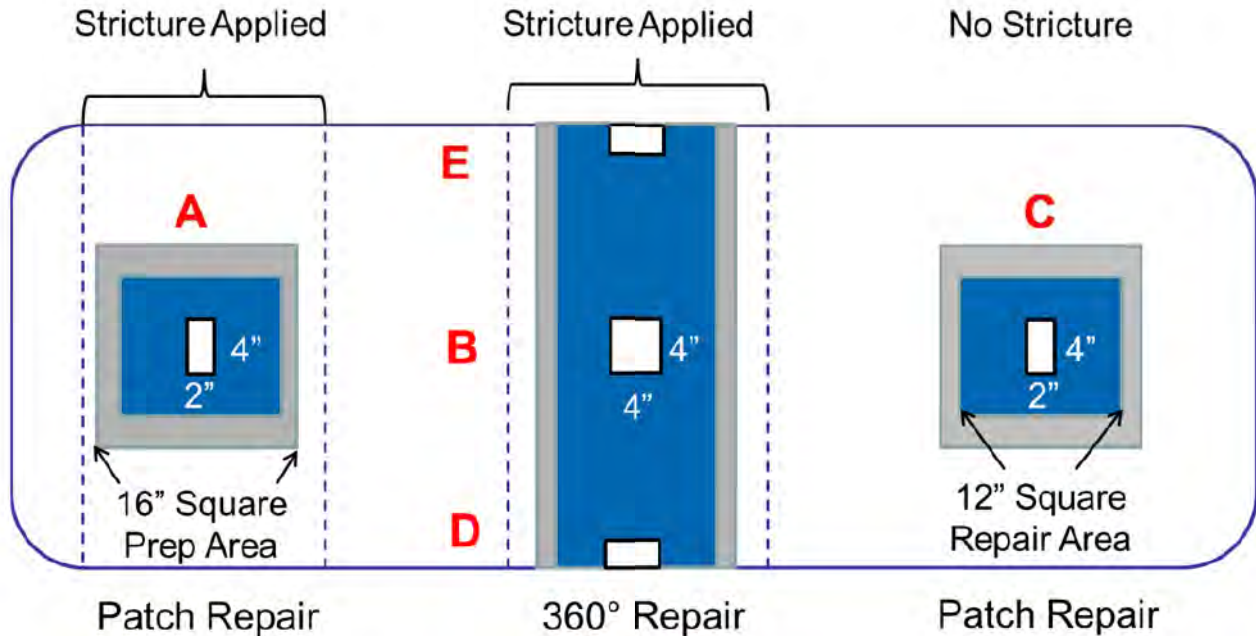
Figure 10: Schematic showing repair locations on 20" diameter full-scale pipe. Table 1 summarizes details of each repair location. (Note: Gray- and blue-shaded areas represent prepared and repaired areas, respectively. Plan view, not to scale.)

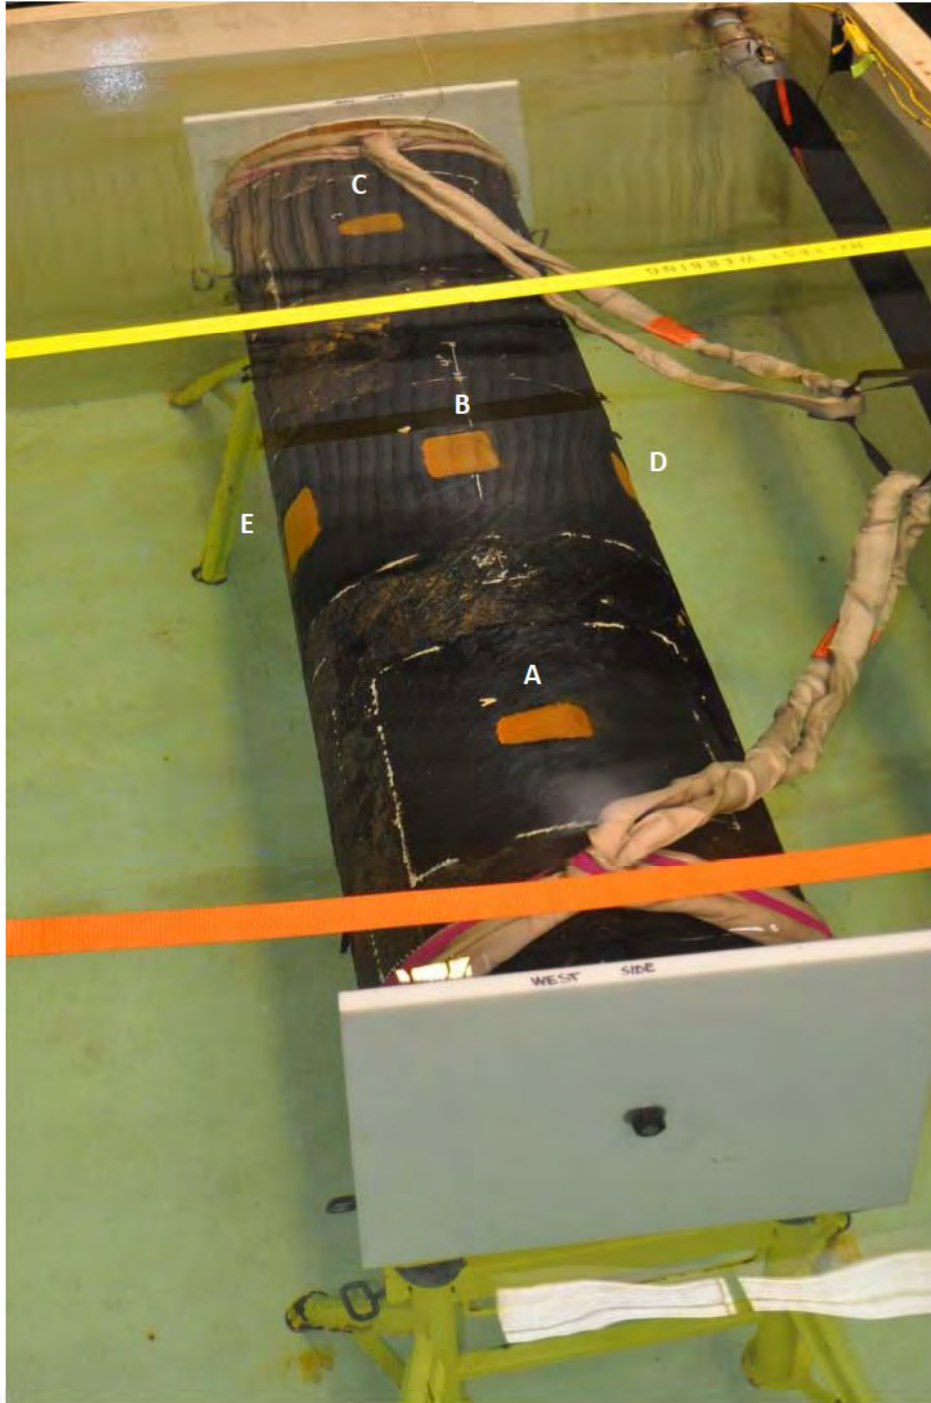
Figure 11: Photograph showing 20" pipe in 40°F water prior to application of epoxy repairs. Repair areas are labeled per Table 1 and Figure 10. Flash rust on exposed areas was removed prior to repair.

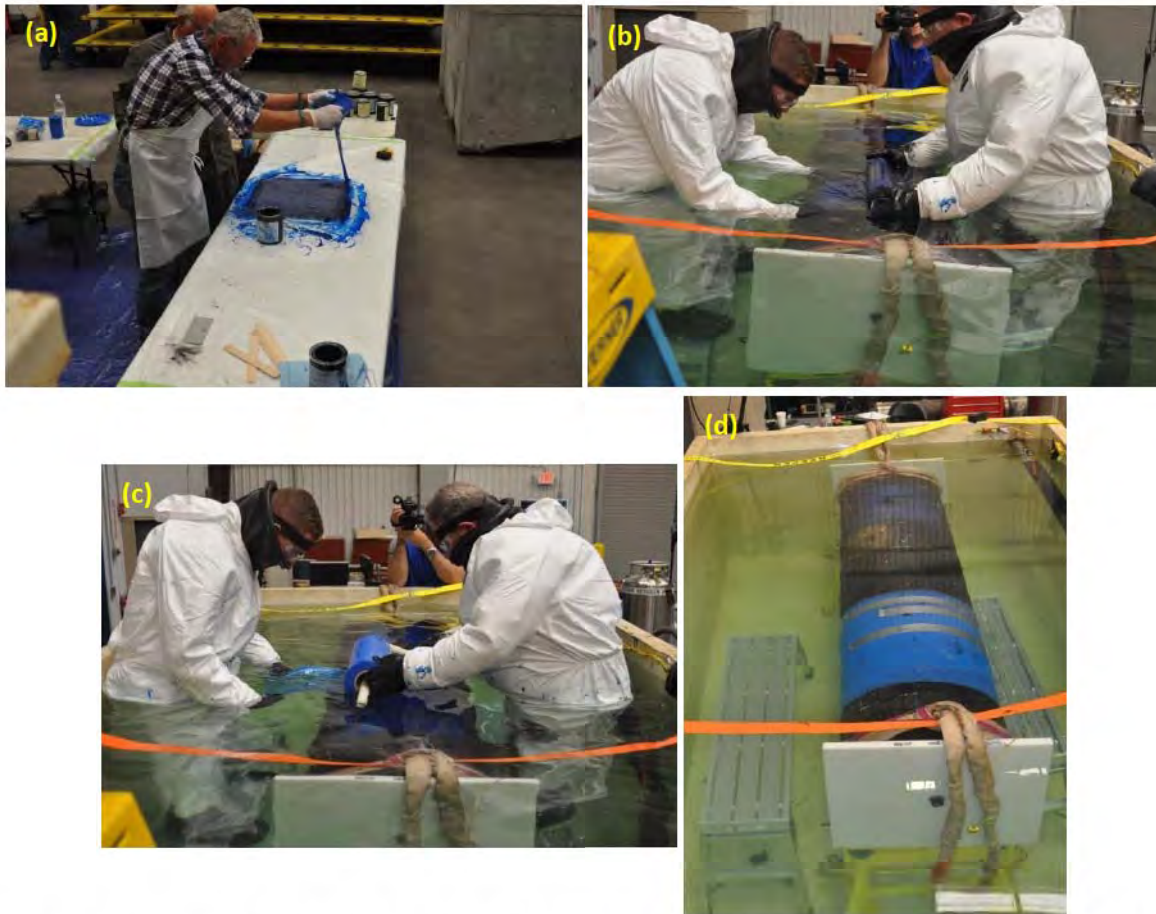
Figure 12: Application of patch repair at Area “A.” Photographs show (a) impregnation of 12” x 12” fabric with epoxy; (b) application of repair on pipe in water tank; (c) wrapping repair with stricture; and (d) completed repair.

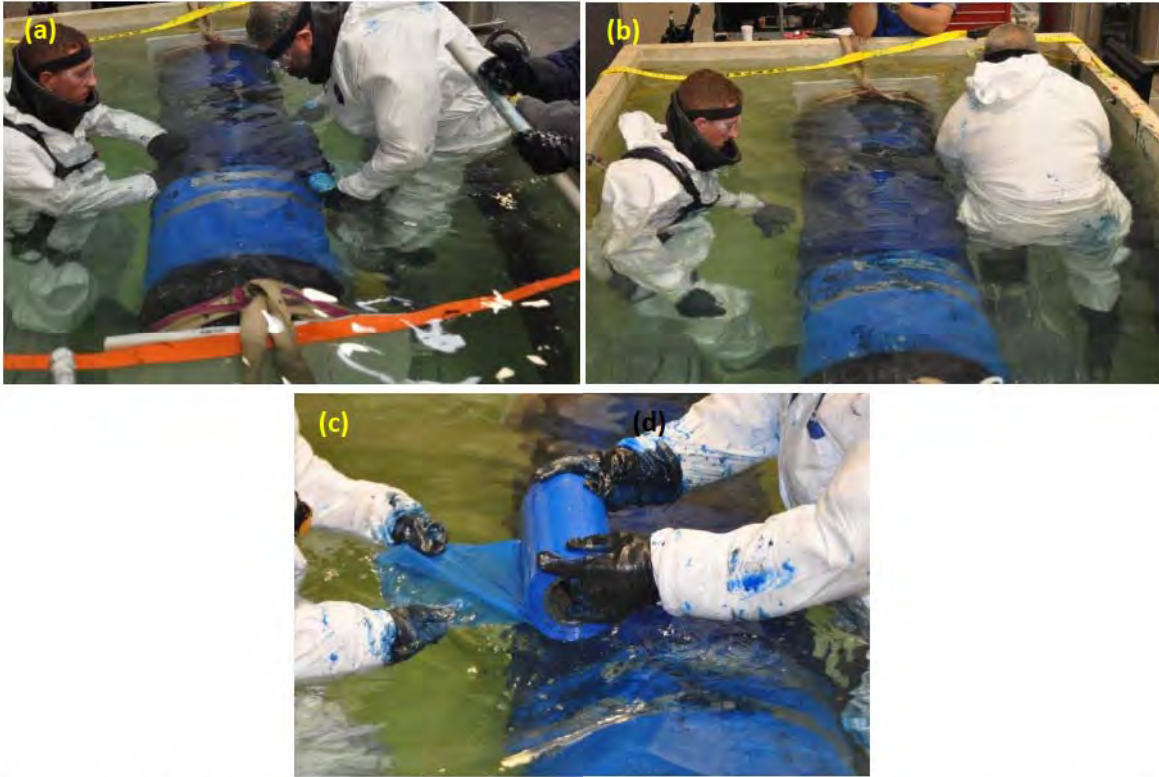
Figure 13: Application of full circumferential repair at Areas “B,” “D,” and “E.” Photographs (a) and (b) show application of impregnated fabric around the circumference of pipe; (c) shows application of stricture.

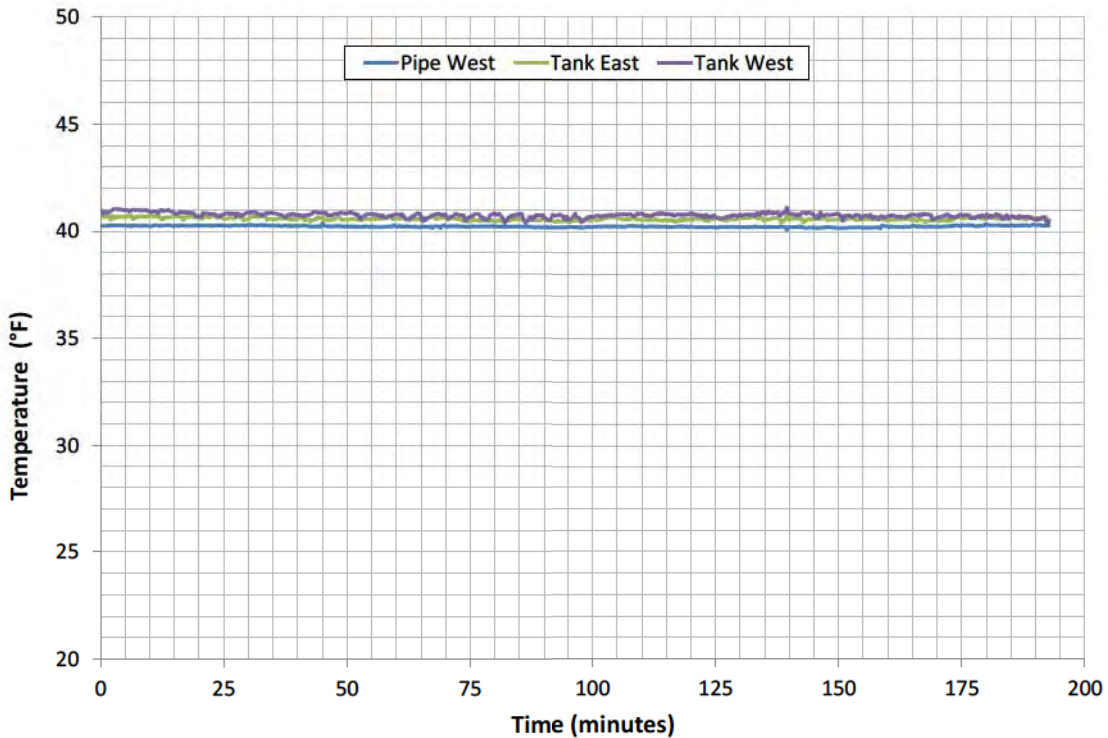
Figure 14: Graph of temperature data during application of full circumferential repair at Areas “B,” “D,” and “E” (see Figure 13). Water temperature remained near 40°F during installation of all repairs.

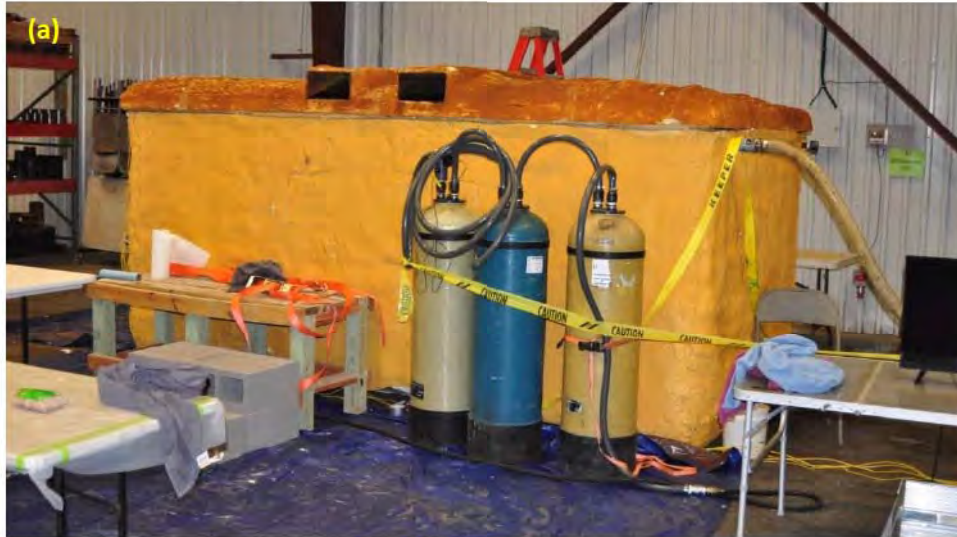
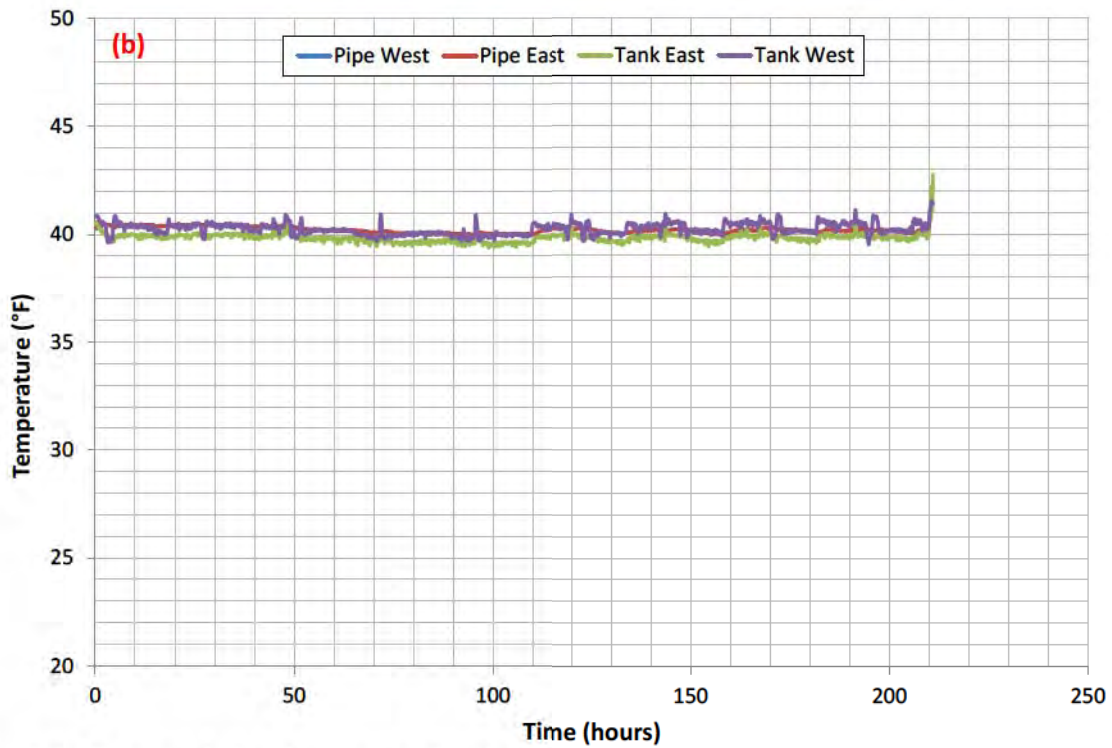
Figure 15: (a) Photograph showing water tank and (b) graph of water-bath temperature during curing period of full-scale repairs.
