Coating Repairs Work Plan Line 5 Dual Pipelines

United States v. Enbridge Energy et al Case 1:16 –cv-914

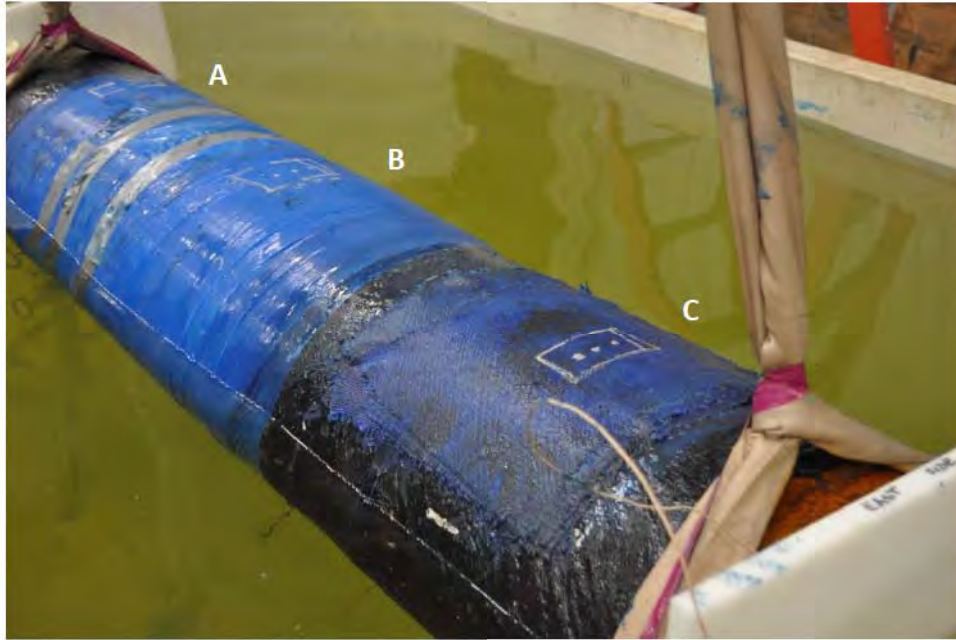
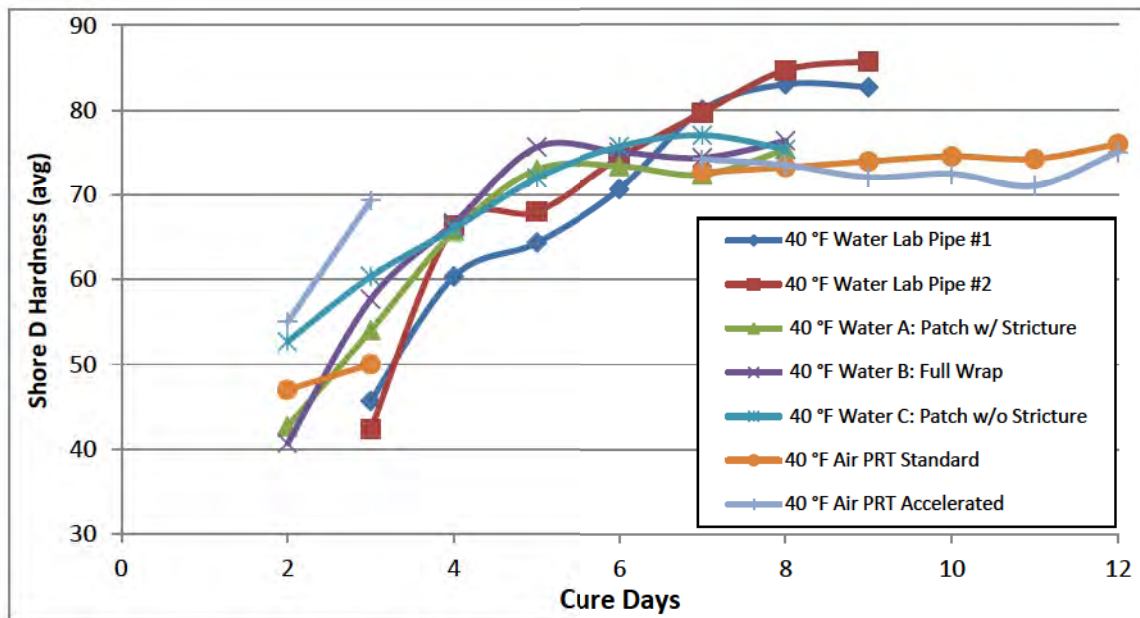
Figure 16: (a) Photograph showing 20” pipe lifted from water tank to allow durometer hardness testing. Areas “A,” “B,” and “C” were tested every 24 hours after an initial waiting period of 48 hours. (b) Graph of Shore D Hardness as a function of cure time.

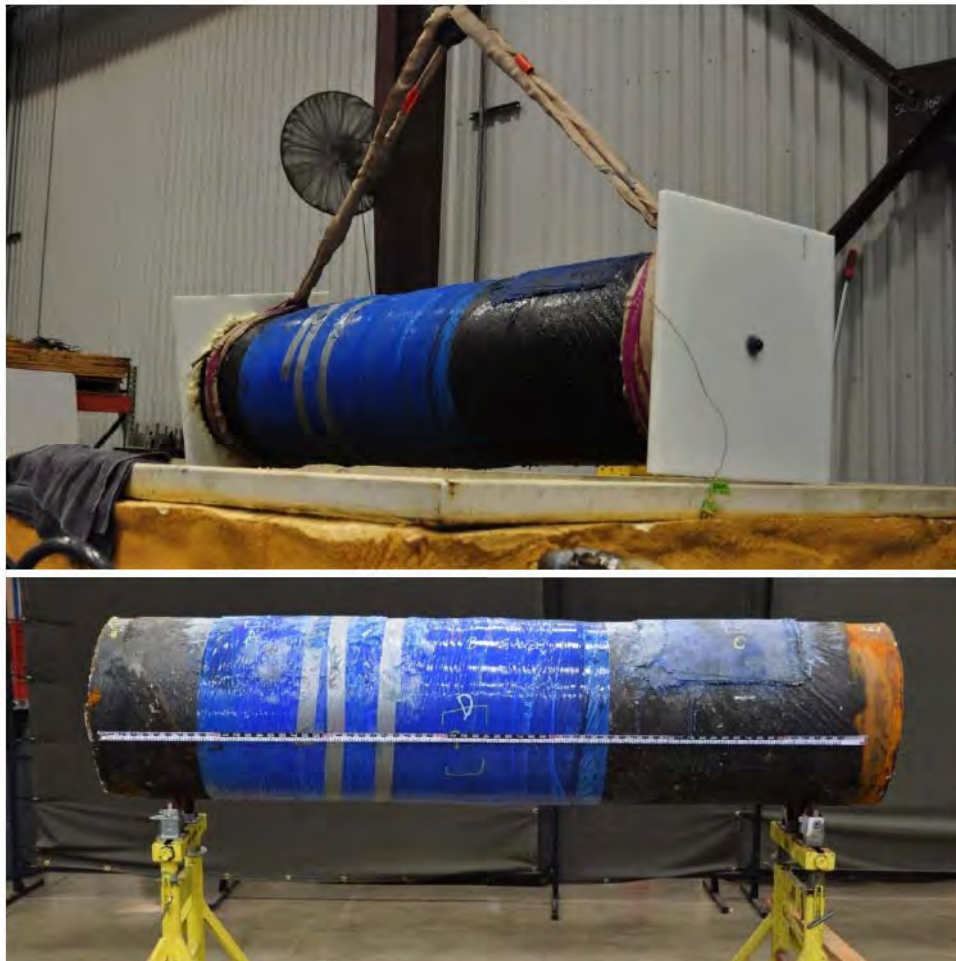
Figure 17: (a) Photograph of 20” pipe sample after removal from water bath; (b) photograph showing stricture still applied to Areas “A” and “B/D/E.” Area “C” (patch repair with no stricture) is on right end. Numbered scale divisions are 0.1 feet.

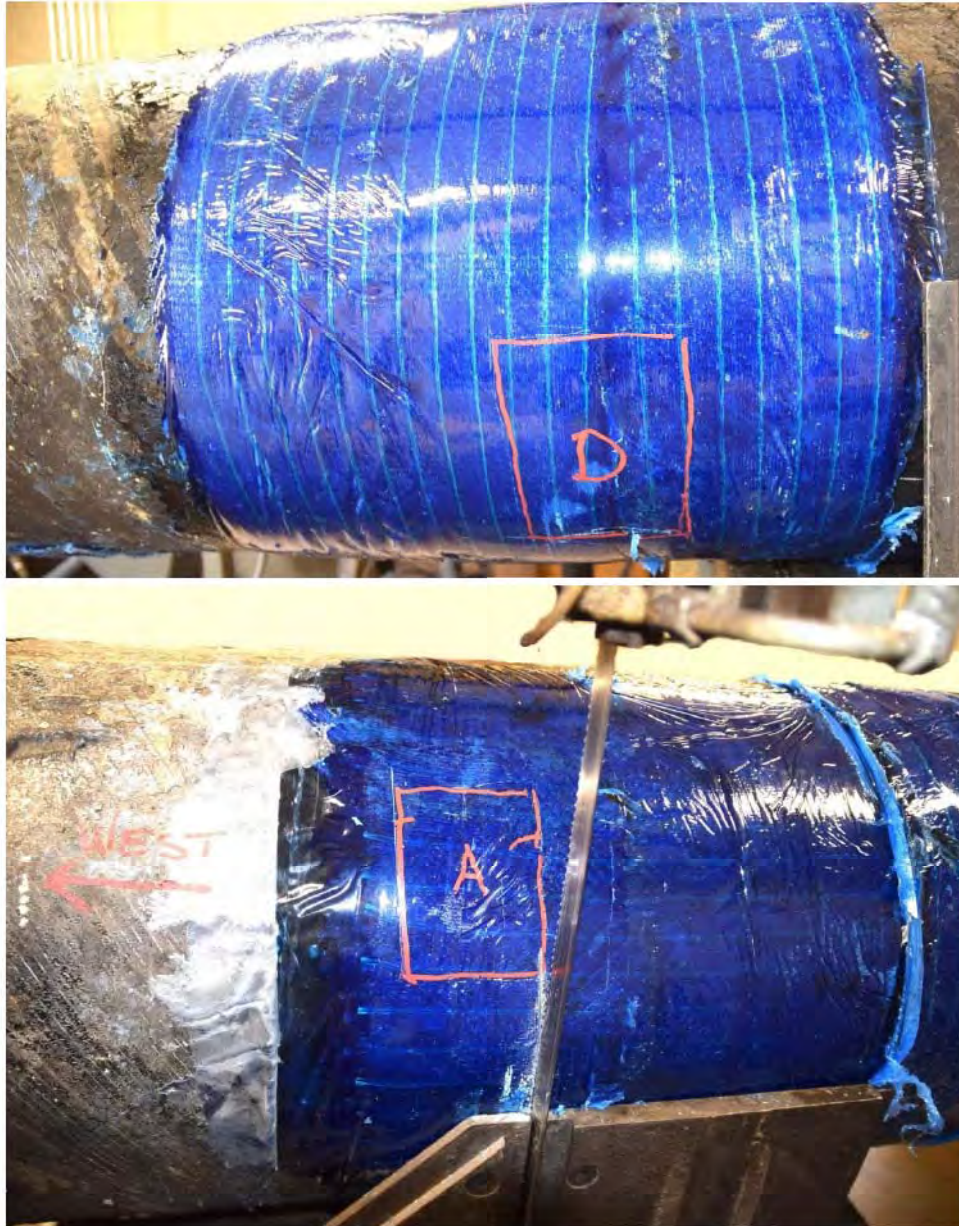
Figure 18: Full circumferential repair (Areas “B/D/E”) is shown in upper photograph after stricture was removed. Patch repair Area “A” is shown in lower photograph after stricture was removed.

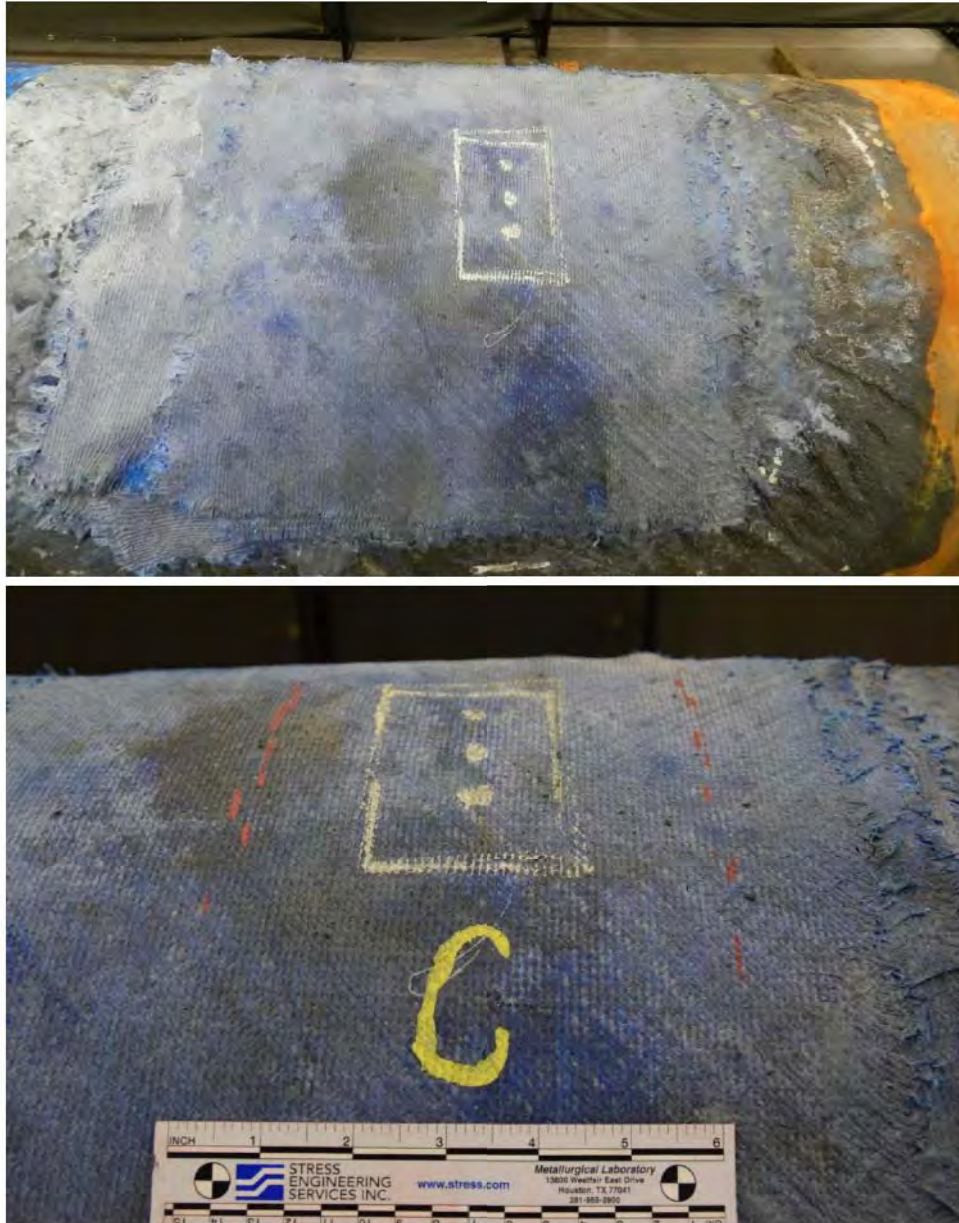
Figure 19: Photographs showing patch repair at Area “C” where no stricture was applied.

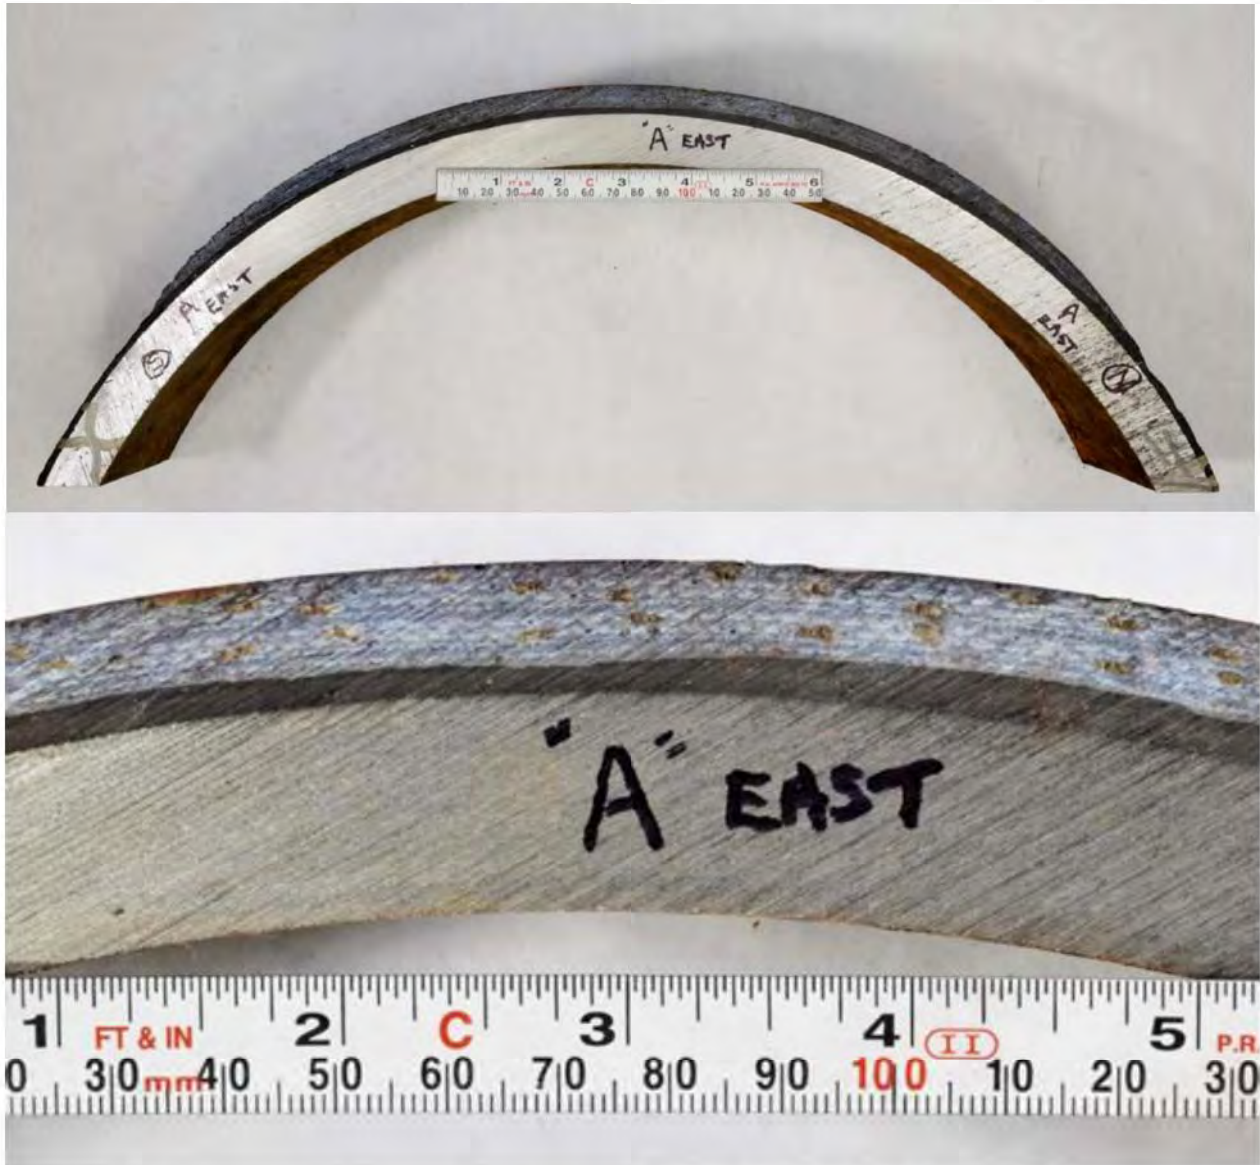
Figure 20: Photographs of rough cut cross-section through repair Area “A” (a patch repair with stricture banding).

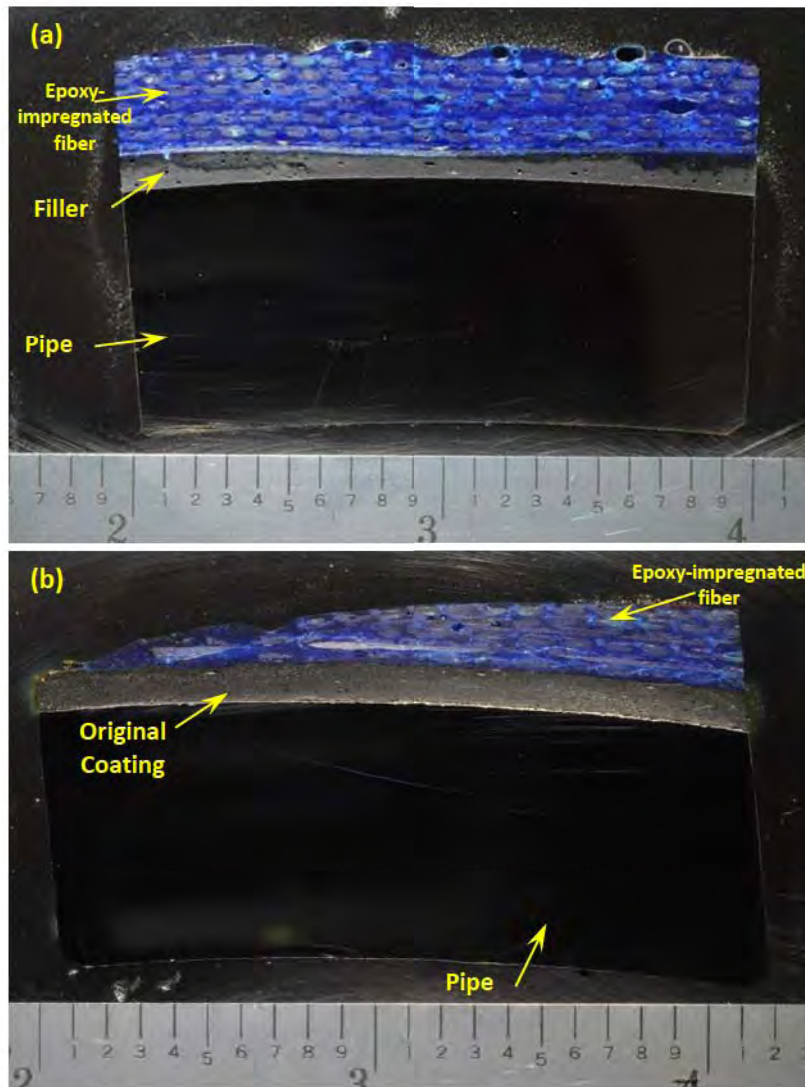
Figure 21: Metallographic cross-sections through repair Area “A.” Section in upper photograph was removed through center of repair where original coating was completely removed down to bare metal. Lower photograph shows edge of repair where fiber wrap covers original coating.

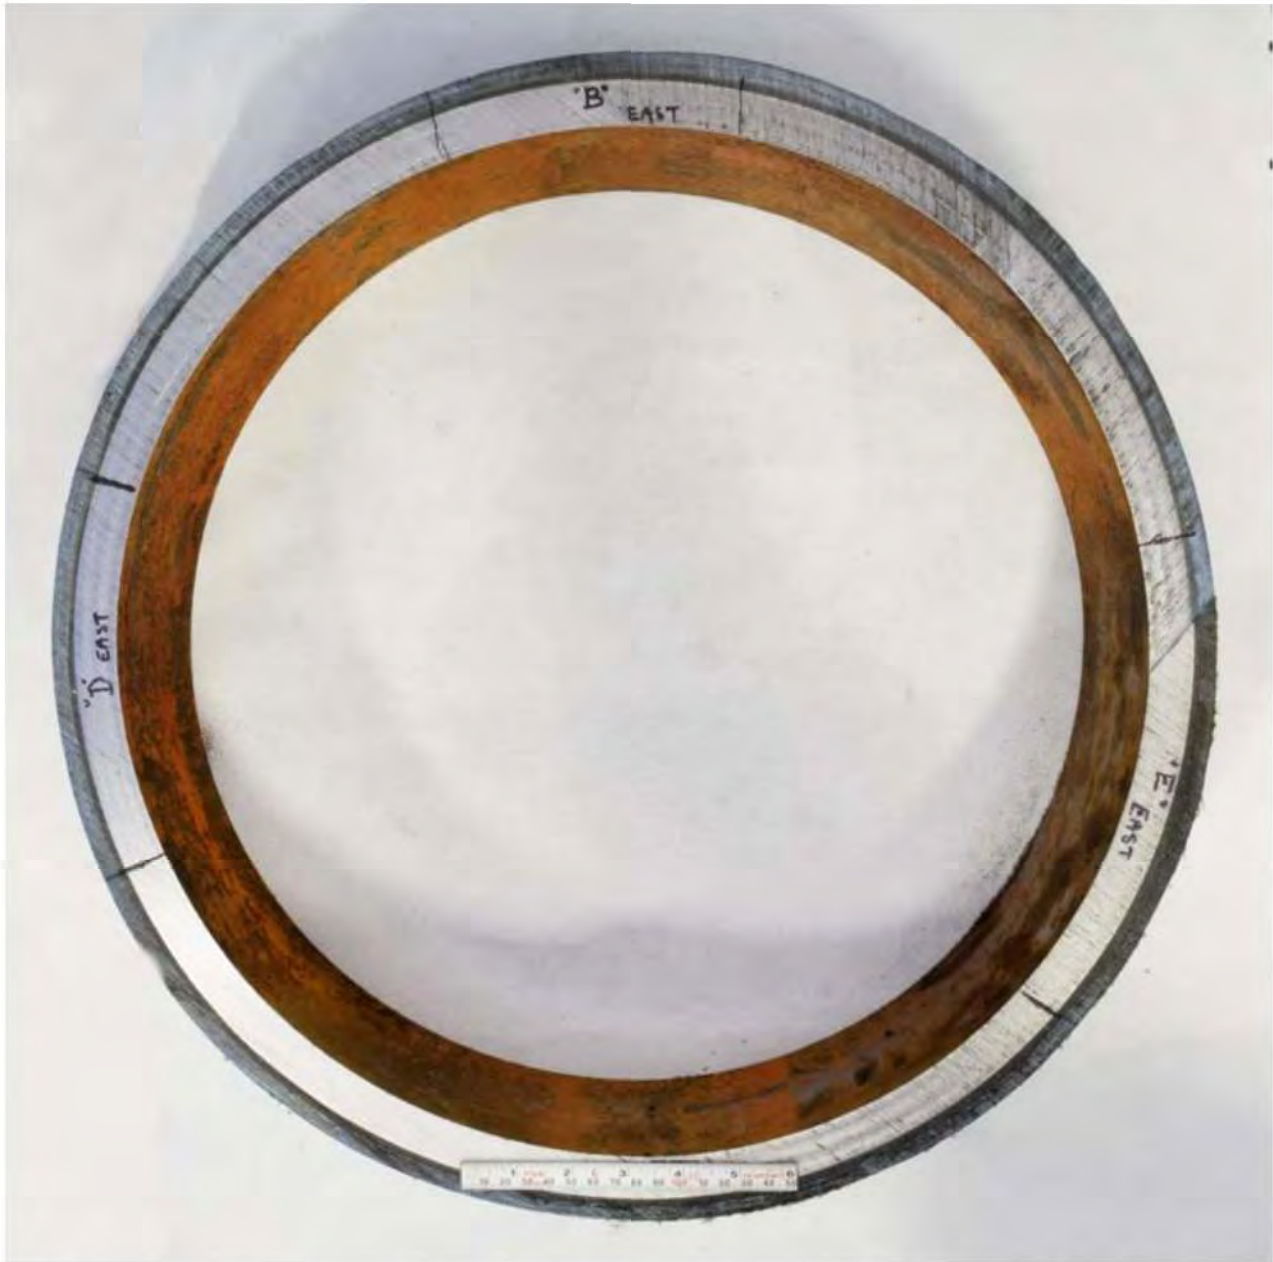
Figure 22: Photograph of cross-sectional ring cut from center of 20" pipe sample containing repair Areas "B/D/E."

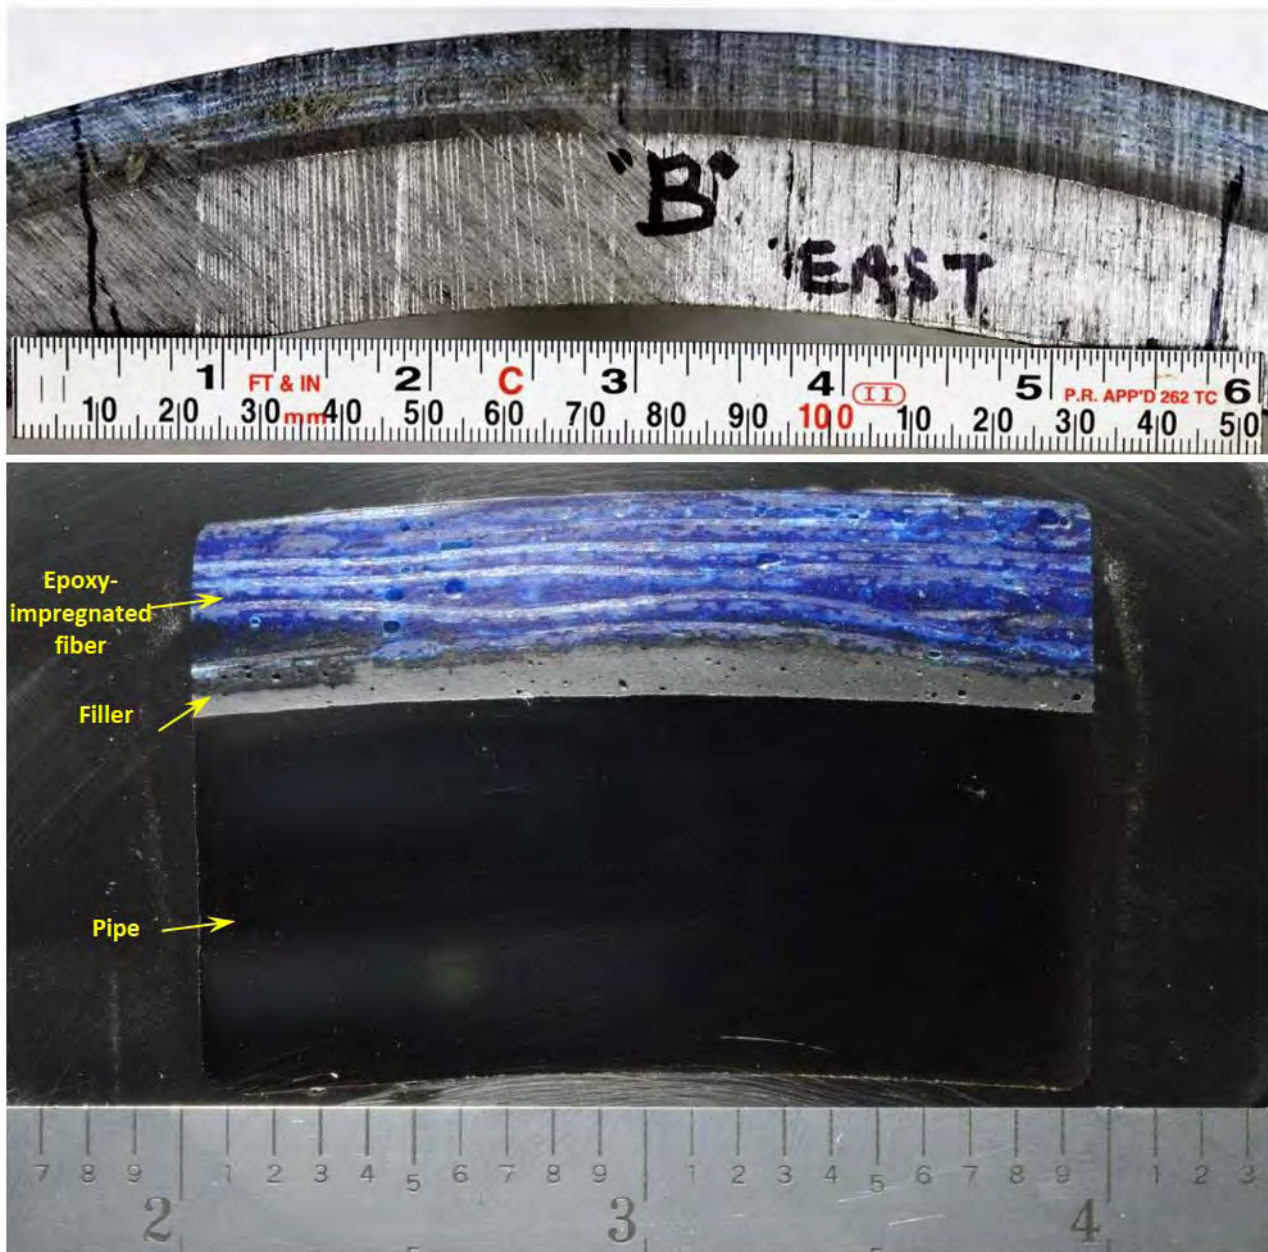
Figure 23: Metallographic cross-section of repair Area "B" located at top of pipe. A full 360° wrap and stricture was used in this repair.

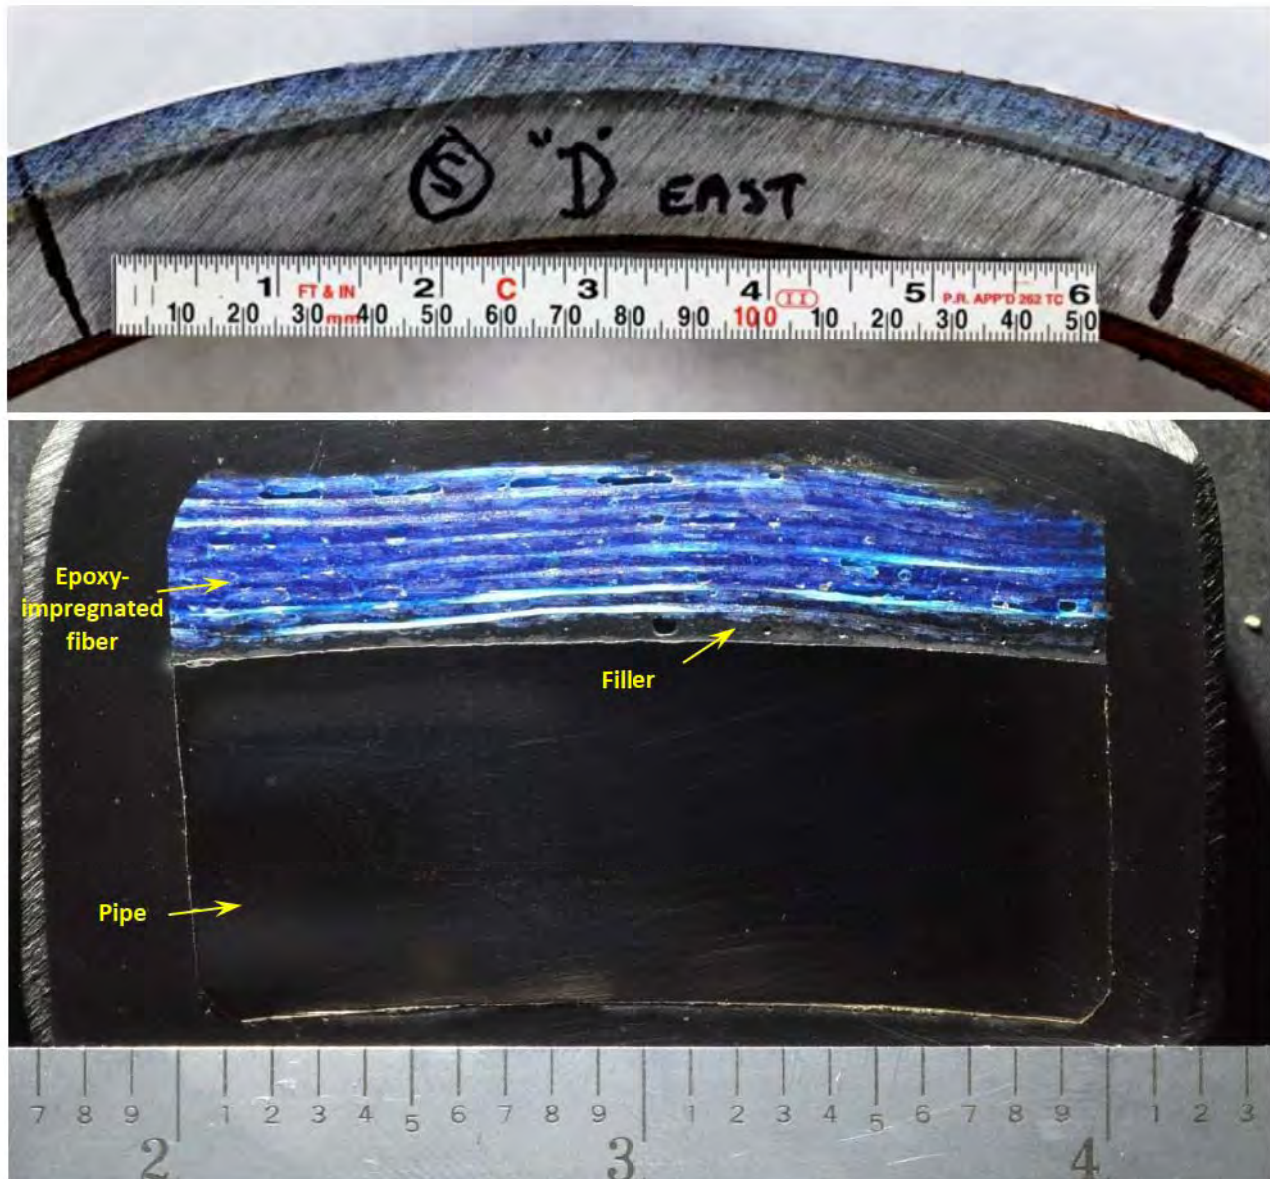
Figure 24: Metallographic cross-section of repair Area "D" located on south side (90°) of pipe. A full 360° wrap and stricture was used in this repair.

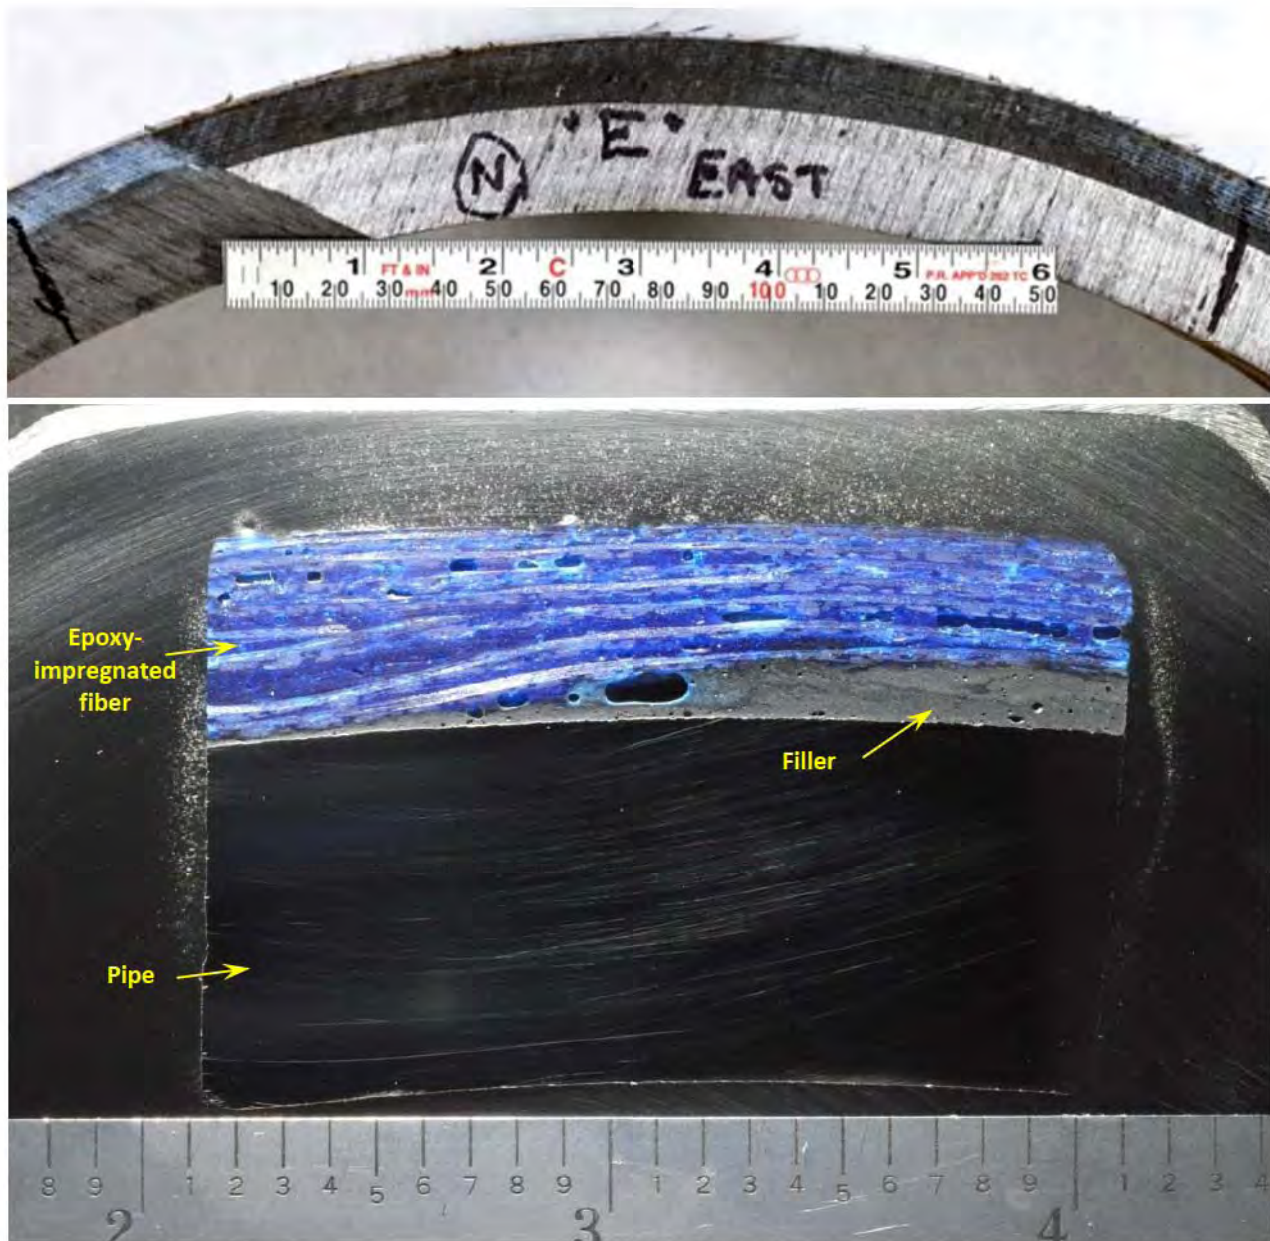
Figure 25: Metallographic cross-section of repair Area “E” located on north side (270°) of pipe. A full 360° wrap and stricture was used in this repair. (Reduction in thickness of filler material at left side of section is due to this section’s being taken near edge of repair.)

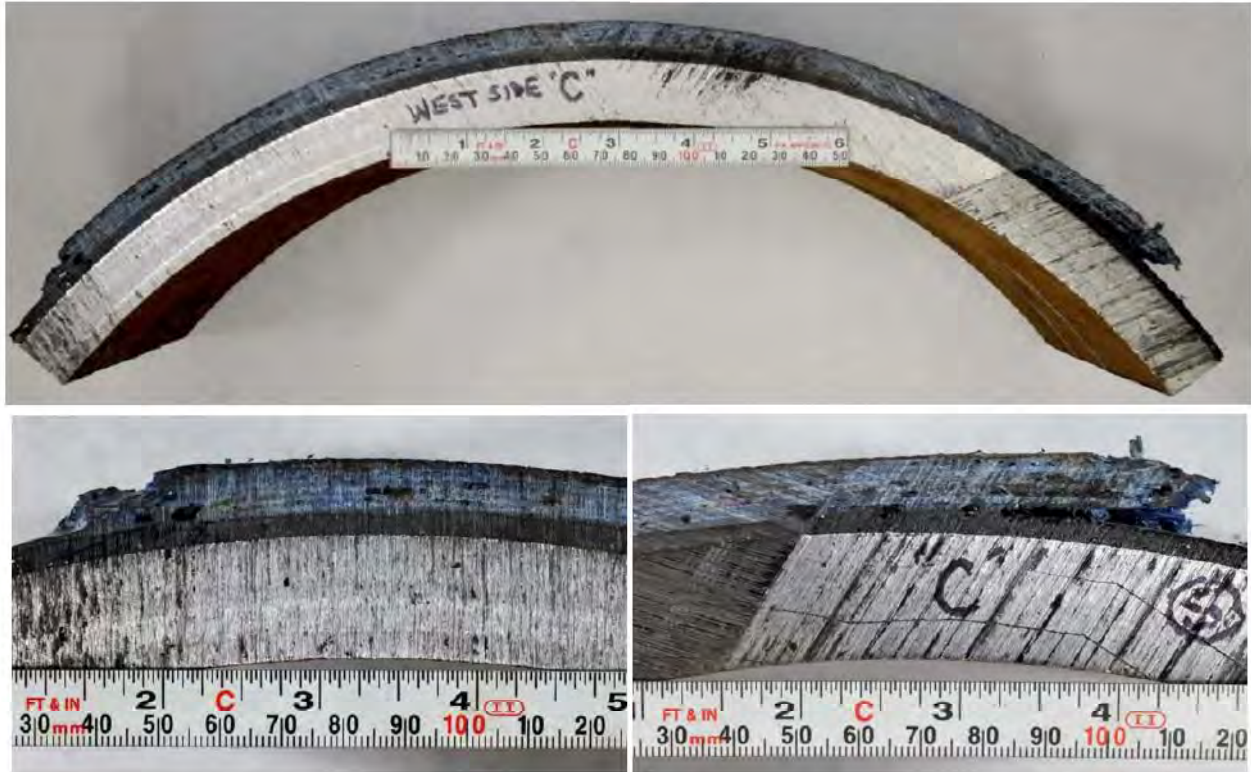
Figure 26: Rough cut cross-section through repair Area “C,” a patch repair where no stricture banding was used. While center of repair was well adhered to pipe wall, perimeter of patch was disbonded from pipe.

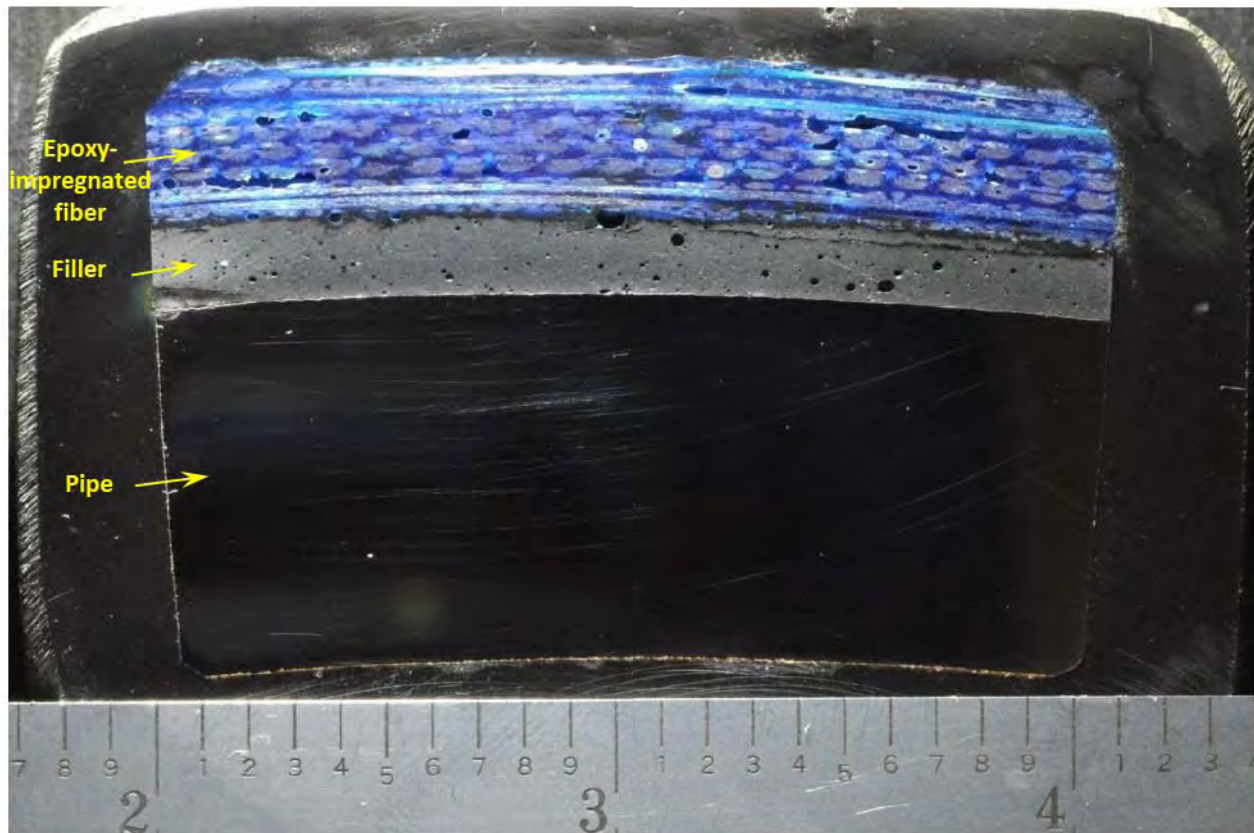
Figure 27: Metallographic cross-section through repair Area “C,” a patch repair where no stricture banding was used.

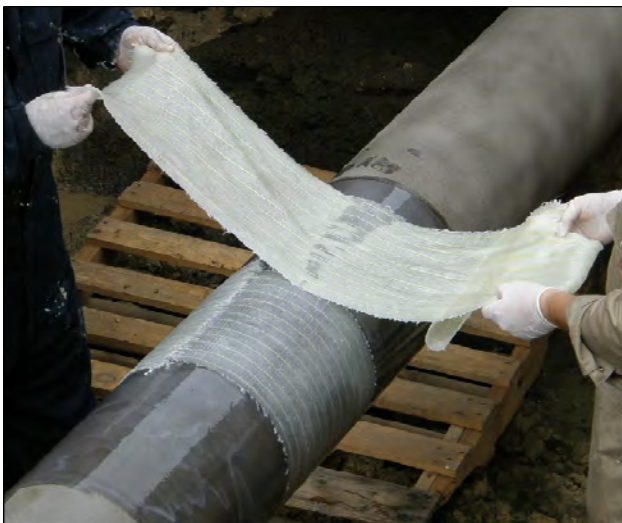
- Corrosion Remediation
- Structural Reinforcement
- Leak Containment
- Abrasion Protection

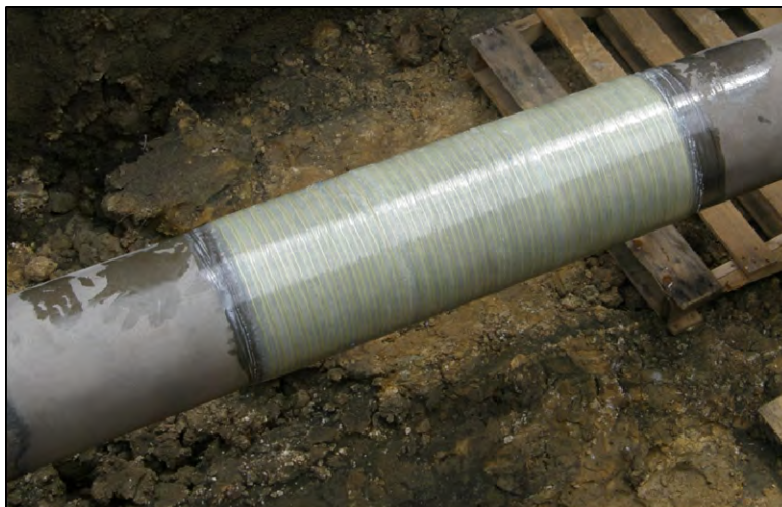
An ISO 9001:2008 Certified Manufacturer
