Coating Repair Form for L5 Straits of Mackinac
---	---

General Information

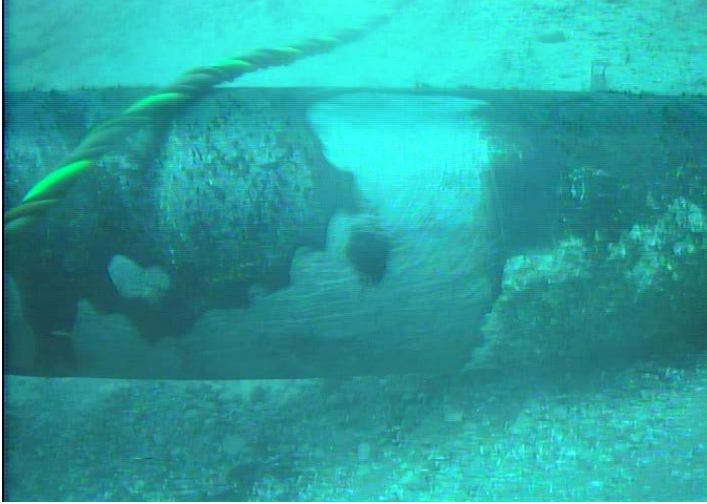
Date:	10/06/18	Frame (HH:MM:SS)	01:22:19
-------	----------	---------------------	----------

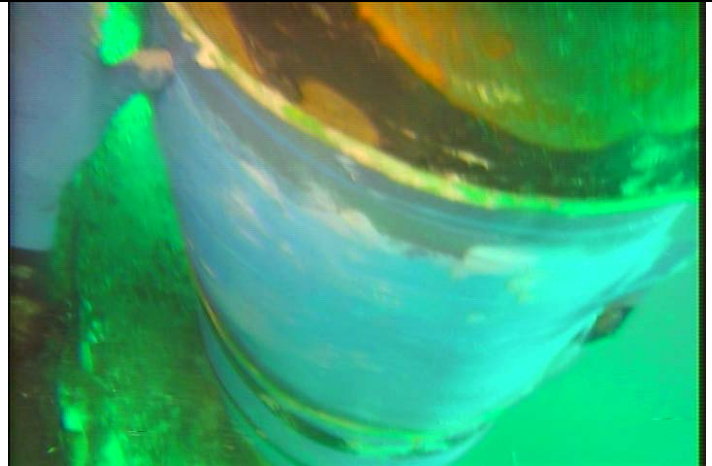
Date:		Frame (HH:MM:SS)	
-------	--	---------------------	--

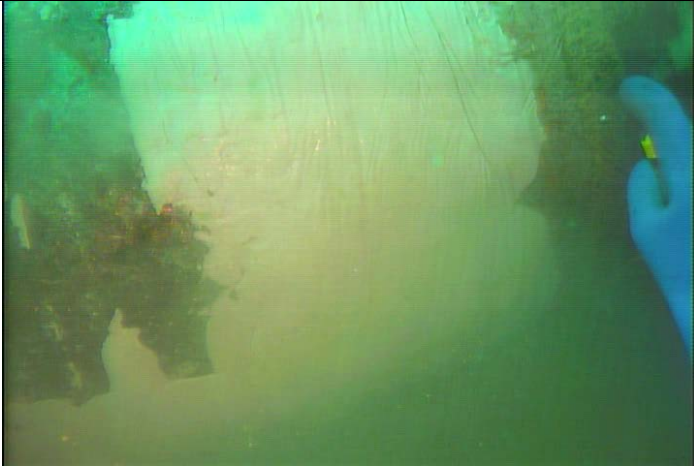
Date:	02/07/18	Frame (HH:MM:SS)	01:01:29	Date:	DD/MM/YY	Frame (HH:MM:SS)	
-------	----------	------------------	----------	-------	----------	------------------	--

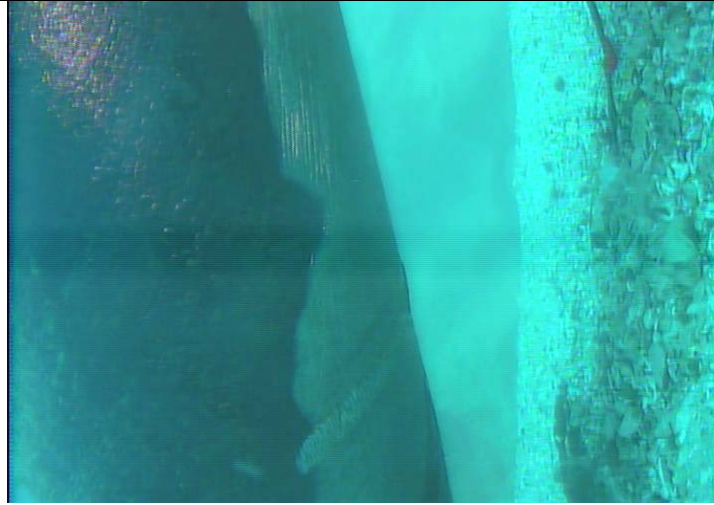
Surface of the pipe after epoxy filler application
Repair Area # 2.

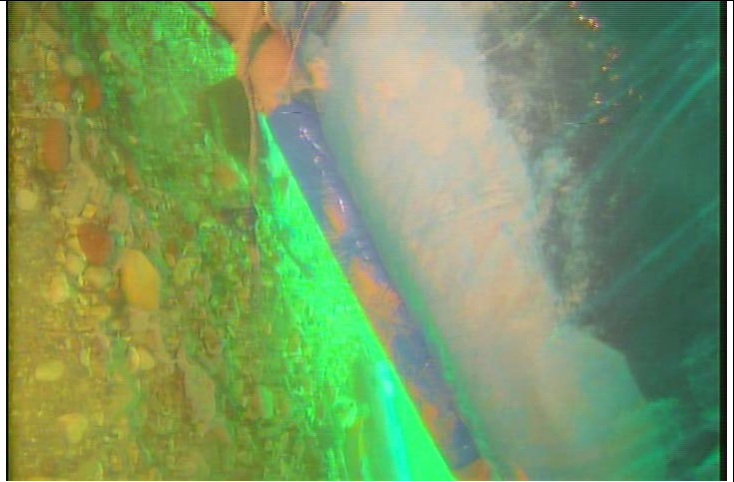
Date:	10/06/18	Frame (HH:MM:SS)	00:22:16
-------	----------	------------------	----------

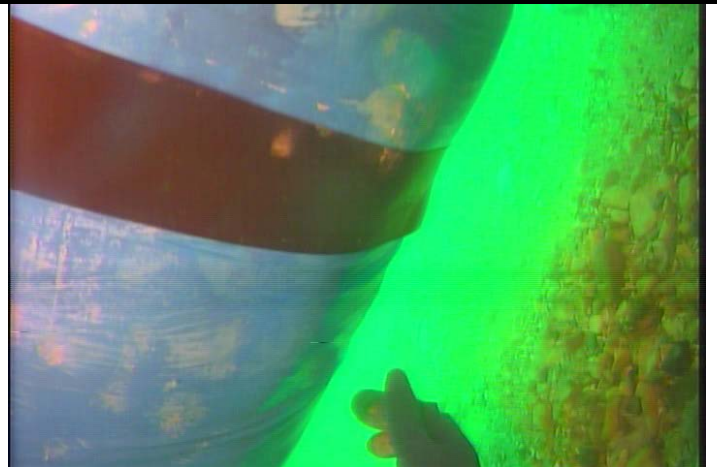
Date:		Frame (HH:MM:SS)	
-------	--	------------------	--

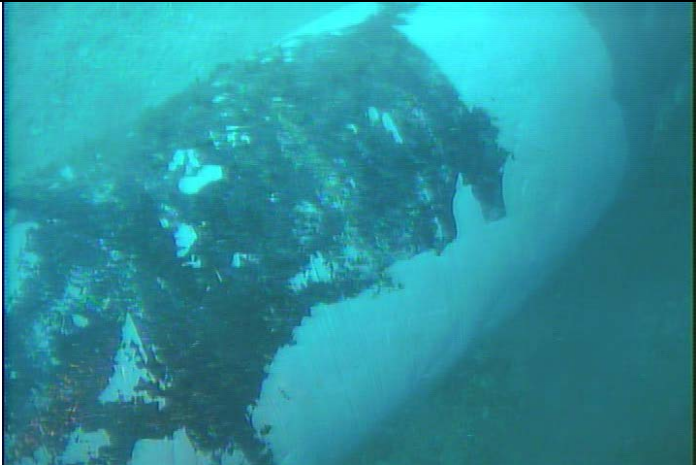
Date:	02/07/18	Frame (HH:MM:SS)	01:05:09	Date:	DD/MM/YY	Frame (HH:MM:SS)

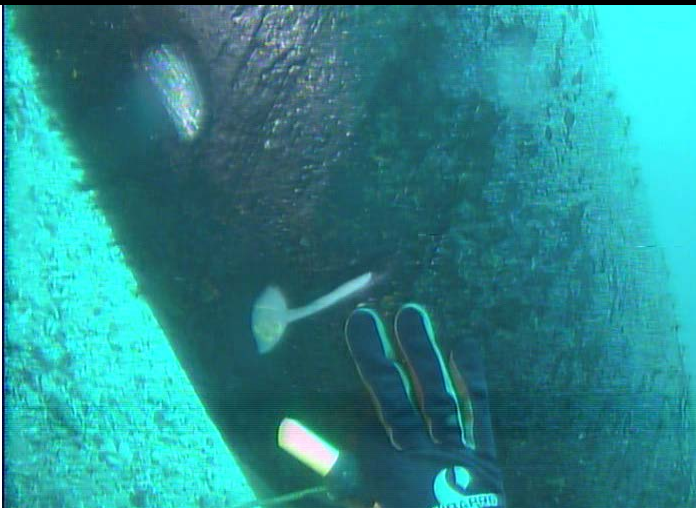
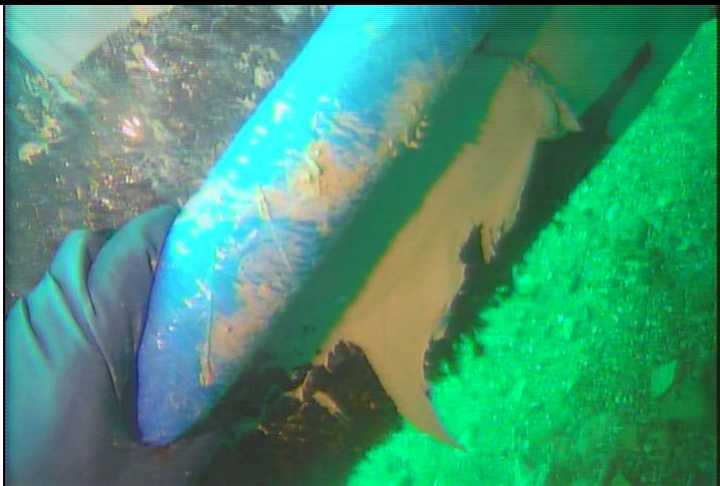
Date:	10/06/18	Frame (HH:MM:SS)	00:57:00	Date:	28/06/18	Frame (HH:MM:SS)	00:12:28

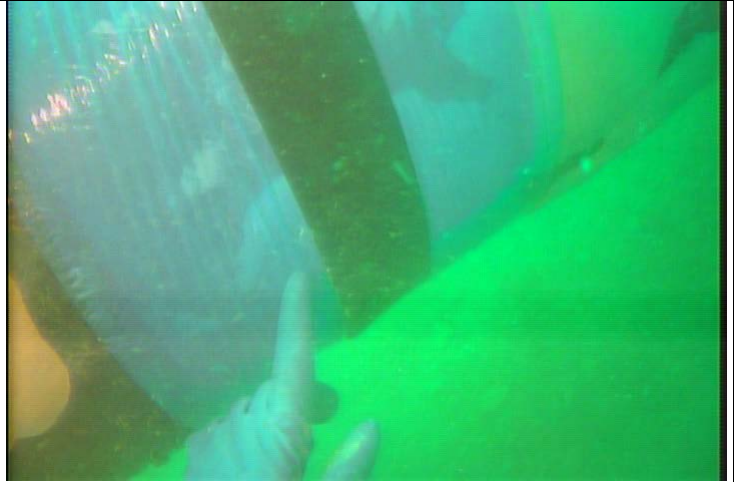
Date:		Frame (HH:MM:SS)		Date:	28/06/2018	Frame (HH:MM:SS)	00:18:58
-------	--	---------------------	--	-------	------------	---------------------	----------

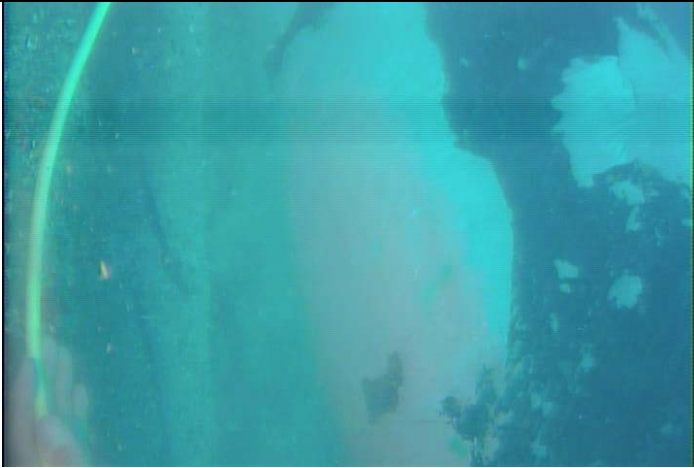
Date:	02/07/18	Frame (HH:MM:SS)	01:08:41	Date:	DD/MM/YY	Frame (HH:MM:SS)	
-------	----------	---------------------	----------	-------	----------	---------------------	--

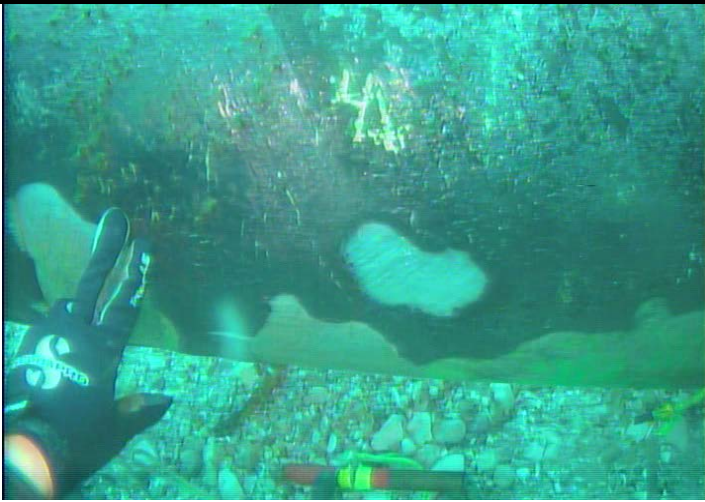
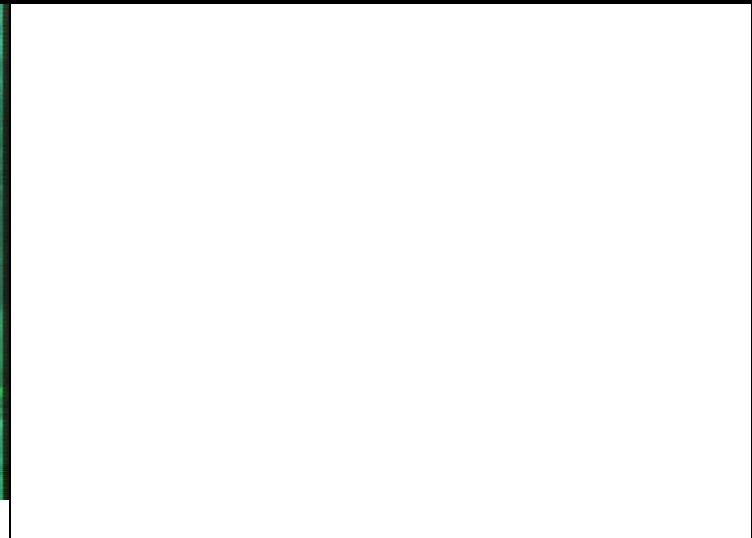
Date:	10/06/18	Frame (HH:MM:SS)	01:01:55
-------	----------	---------------------	----------

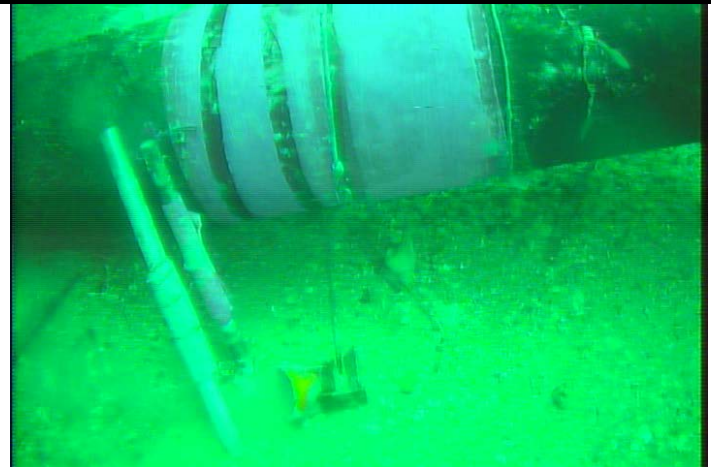
Date:		Frame (HH:MM:SS)	
-------	--	---------------------	--

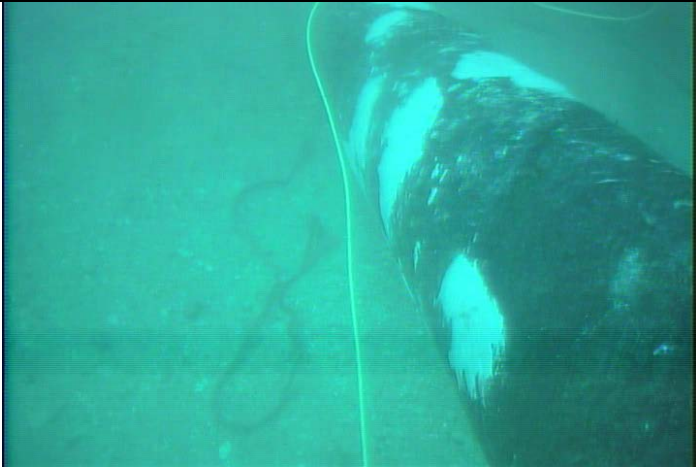
Date:	02/0718	Frame (HH:MM:SS)	01:07:30	Date:	DD/MM/YY	Frame (HH:MM:SS)	
-------	---------	---------------------	----------	-------	----------	---------------------	--

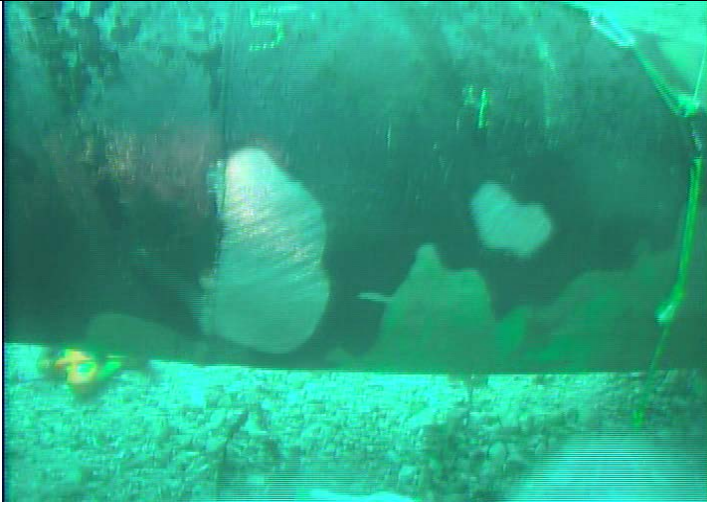
Surface of the pipe after epoxy filler application
Repair Area # 5.

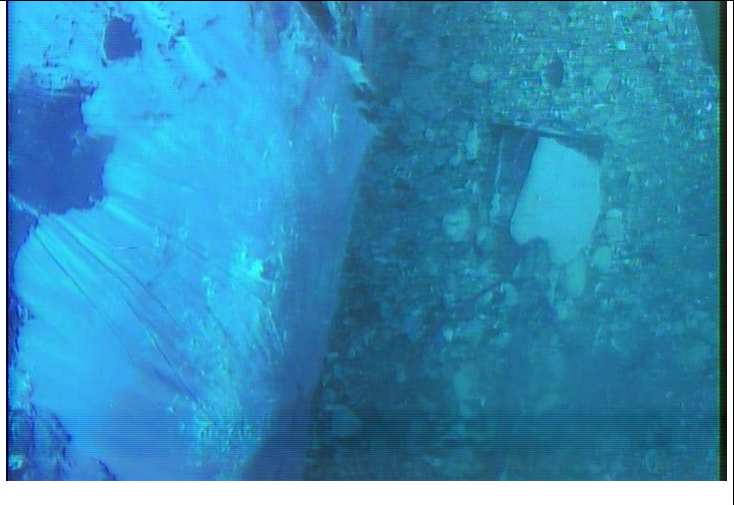
Date:	10/06/18	Frame (HH:MM:SS)	01:14:46
-------	----------	------------------	----------

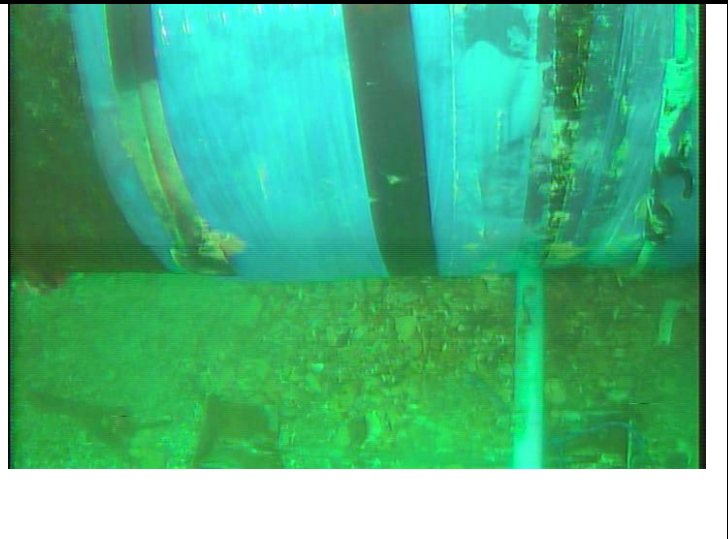
Date:		Frame (HH:MM:SS)	
-------	--	------------------	--

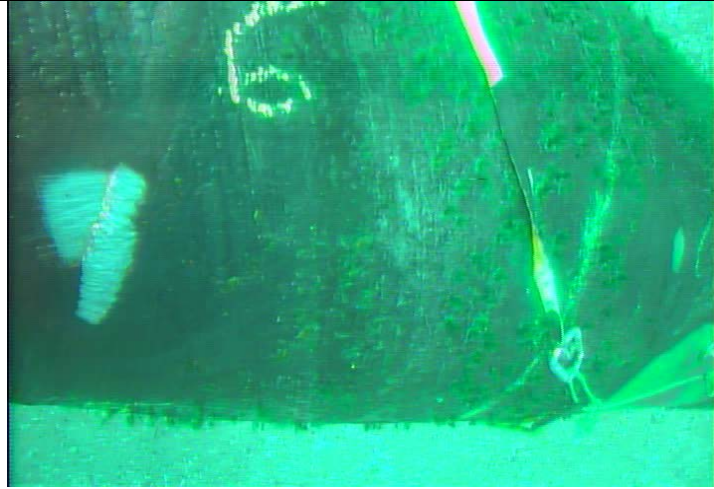
Surface of the pipe after epoxy filler
application Repair Area # 6.

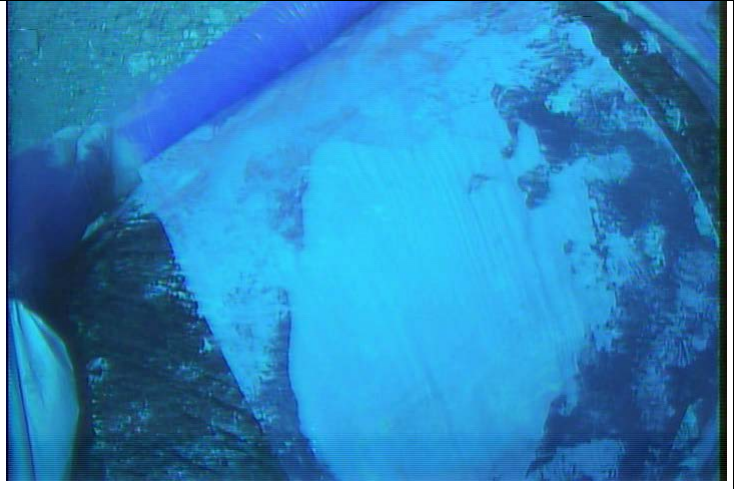
Date:	10/06/18	Frame (HH:MM:SS)	01:17:56
-------	----------	---------------------	----------

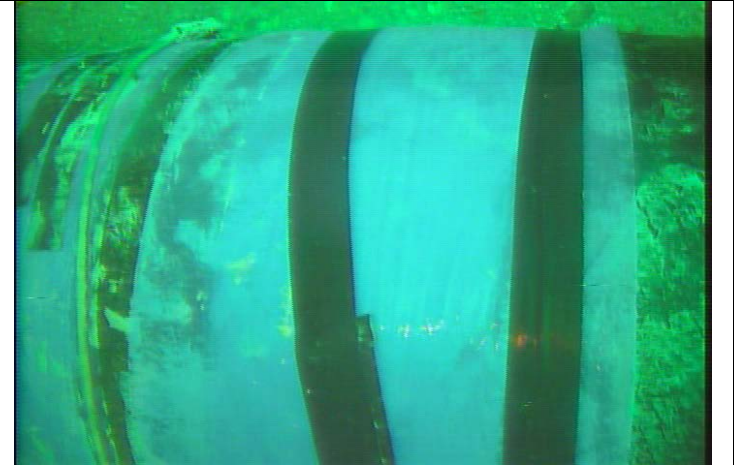
Date:		Frame (HH:MM:SS)	
-------	--	---------------------	--

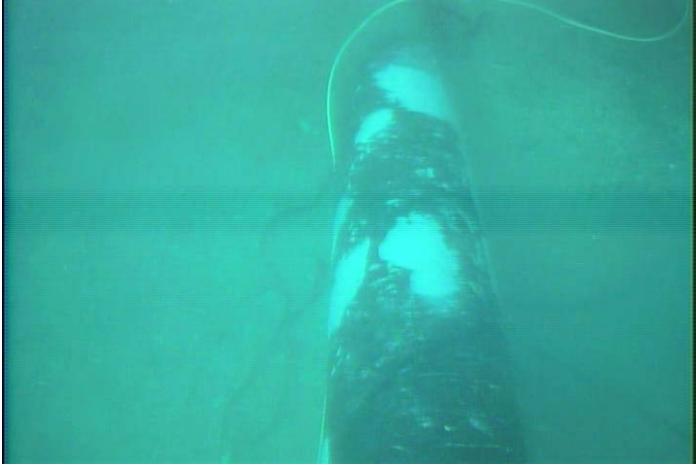
Date:	02/07/18	Frame (HH:MM:SS)	01:07:30	Date:	DD/MM/YY	Frame (HH:MM:SS)	
-------	----------	---------------------	----------	-------	----------	---------------------	--

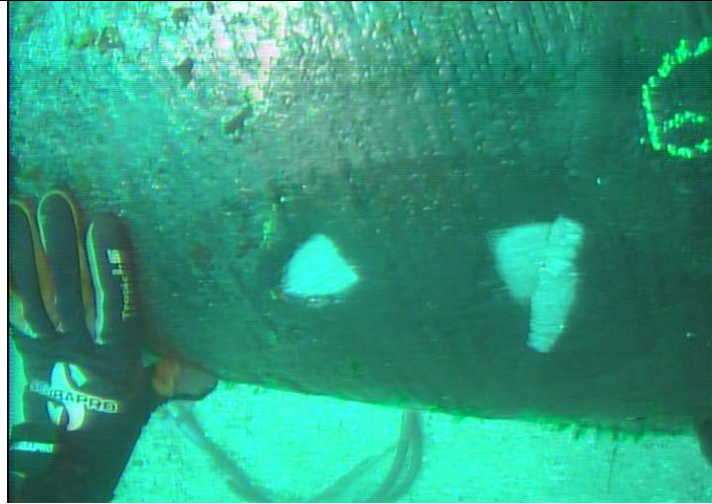
Surface of the pipe after epoxy filler
application Repair Area # 7.

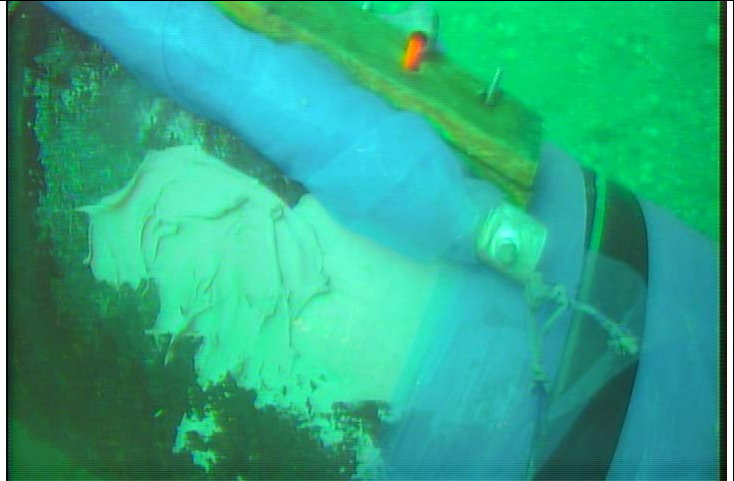
Date:	10/06/18	Frame (HH:MM:SS)	01:21:38
-------	----------	---------------------	----------

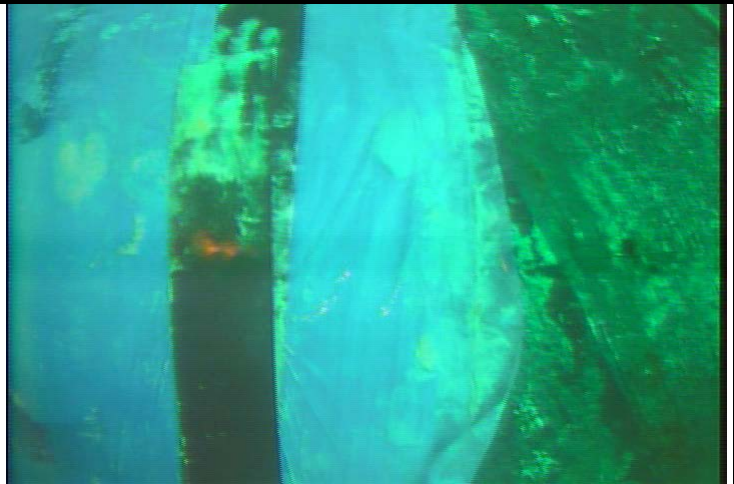
Date:		Frame (HH:MM:SS)	
-------	--	---------------------	--

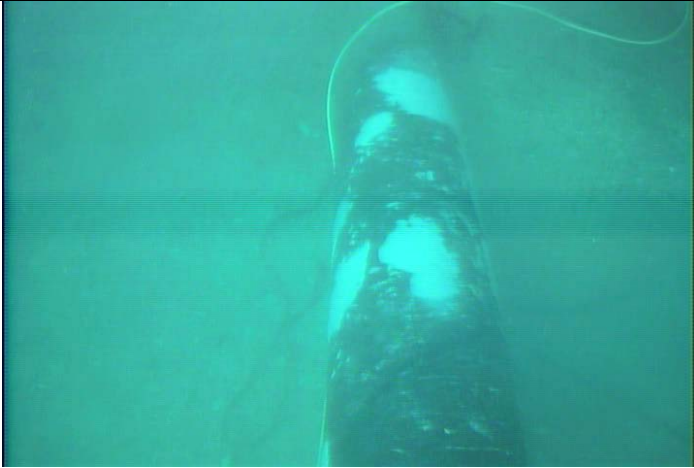
Date:	02/07/18	Frame (HH:MM:SS)	01:07:59	Date:	DD/MM/YY	Frame (HH:MM:SS)	
-------	----------	---------------------	----------	-------	----------	---------------------	--

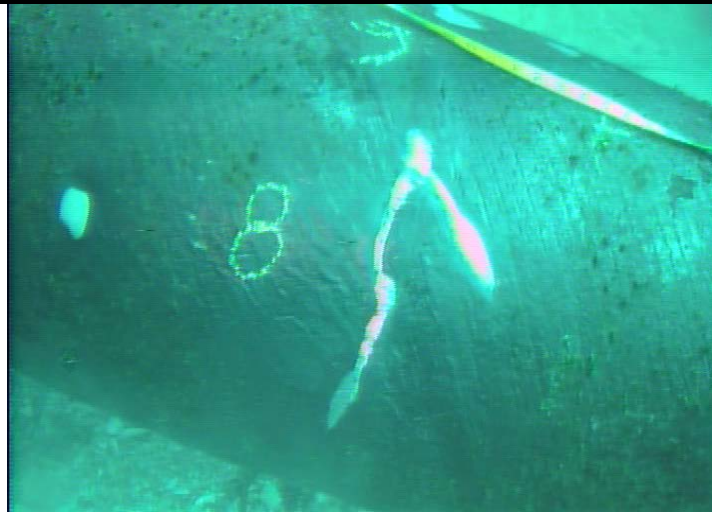
Surface of the pipe after epoxy filler application
Repair Area # 8.

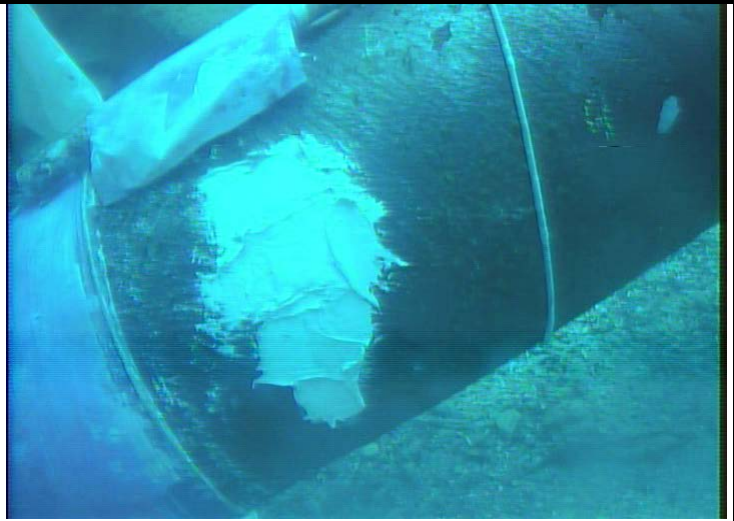
Date:	10/06/18	Frame (HH:MM:SS)	01:25:47
-------	----------	------------------	----------

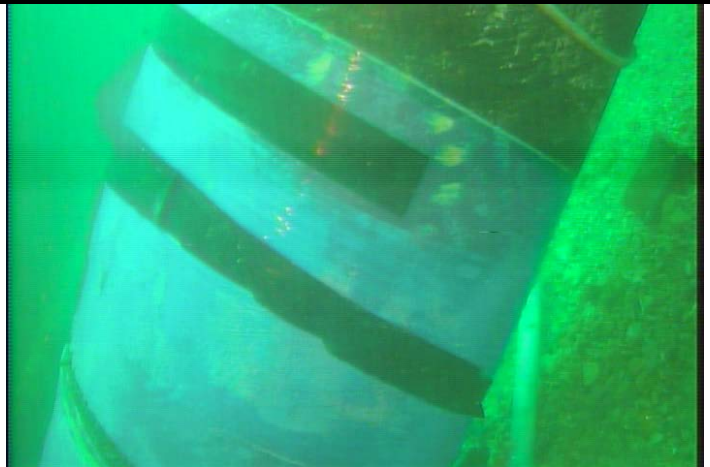
Date:		Frame (HH:MM:SS)	
-------	--	------------------	--

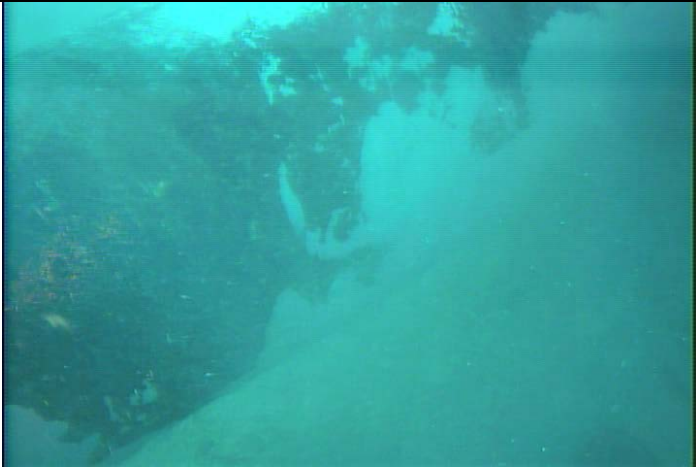
Date:	02/07/18	Frame (HH:MM:SS)	01:07:01	Date:	DD/MM/YY	Frame (HH:MM:SS)	
-------	----------	---------------------	----------	-------	----------	---------------------	--

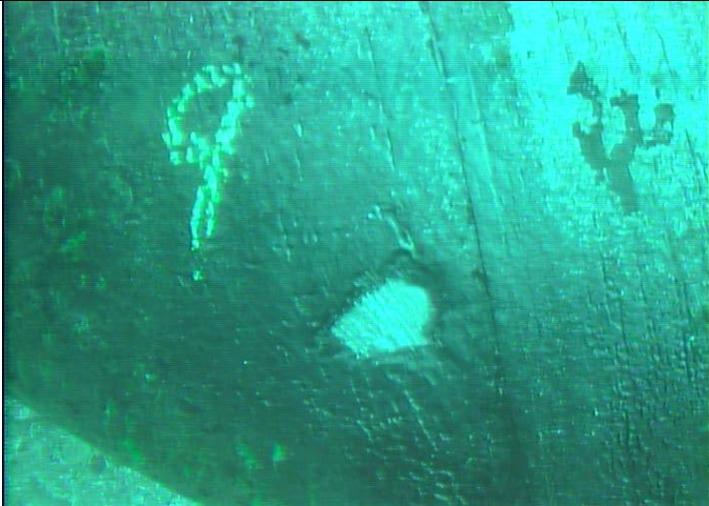
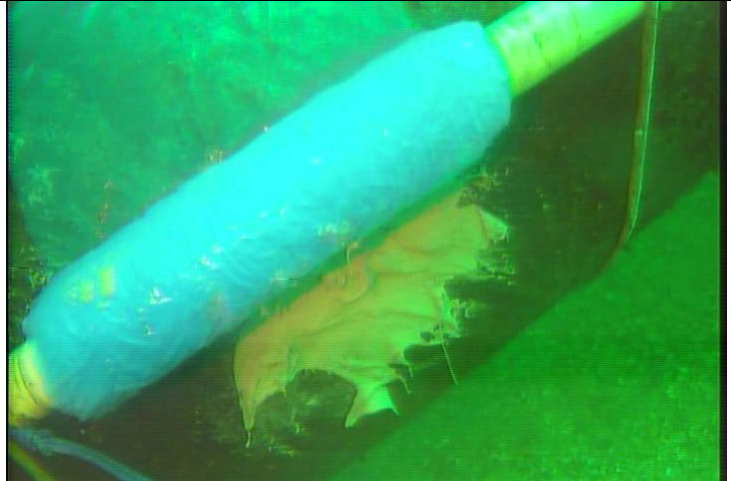
Date:	10/06/18	Frame (HH:MM:SS)	01:28:08
-------	----------	------------------	----------

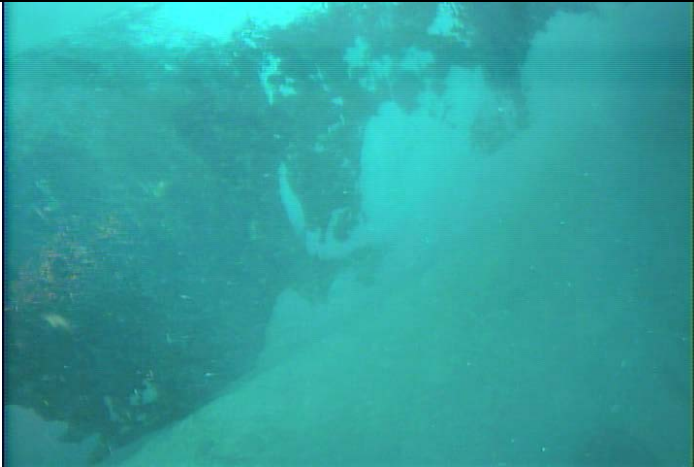
Date:	02/07/18	Frame (HH:MM:SS)	01:07:30	Date:	DD/MM/YY	Frame (HH:MM:SS)	
-------	----------	---------------------	----------	-------	----------	---------------------	--

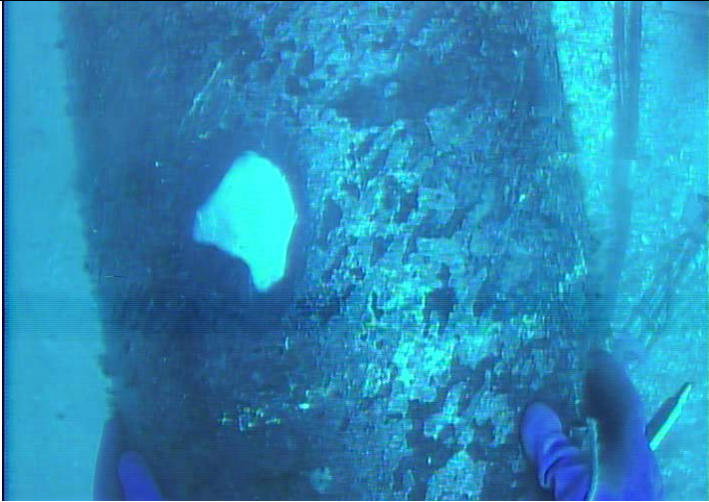
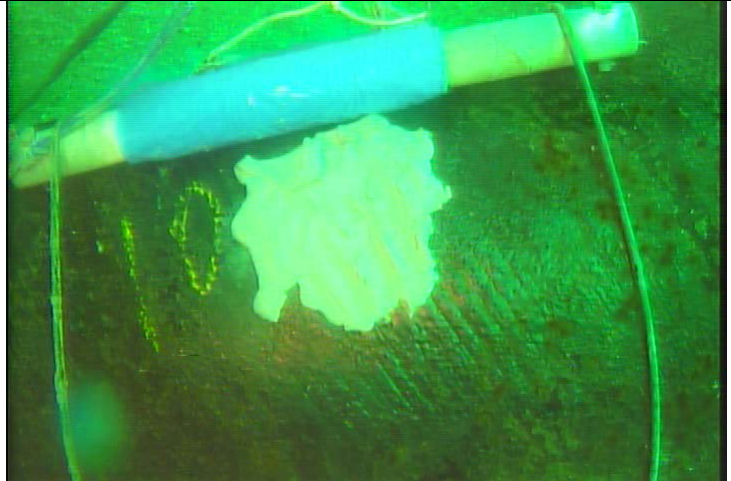
Date:	10/06/18	Frame (HH:MM:SS)	00:19:00
-------	----------	------------------	----------

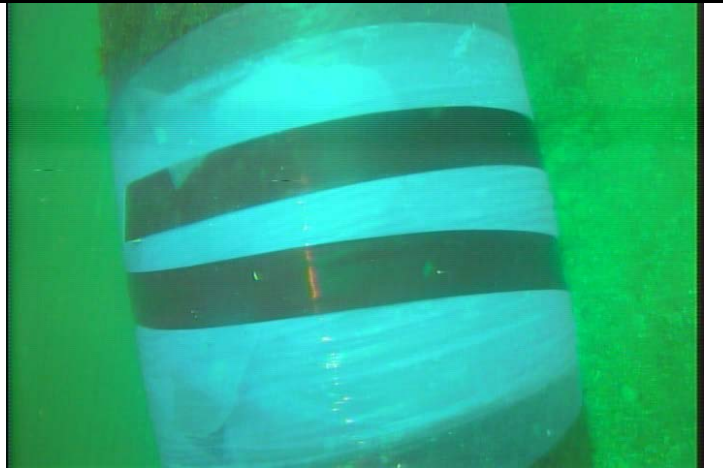
Date:		Frame (HH:MM:SS)	
-------	--	------------------	--

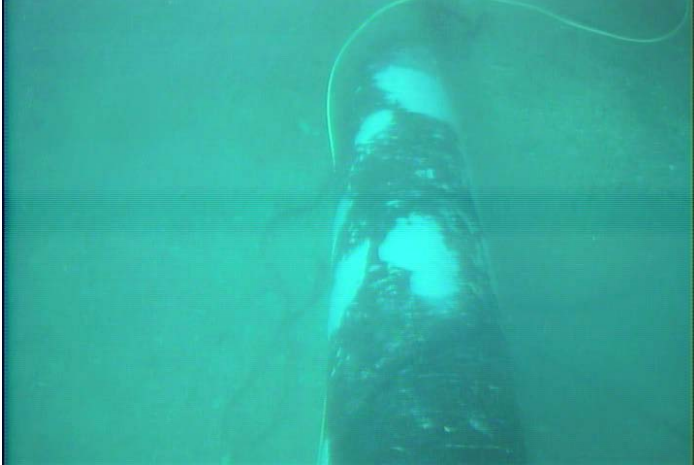
Date:	02/07/18	Frame (HH:MM:SS)	01:07:30	Date:	DD/MM/YY	Frame (HH:MM:SS)	
-------	----------	------------------	----------	-------	----------	------------------	--

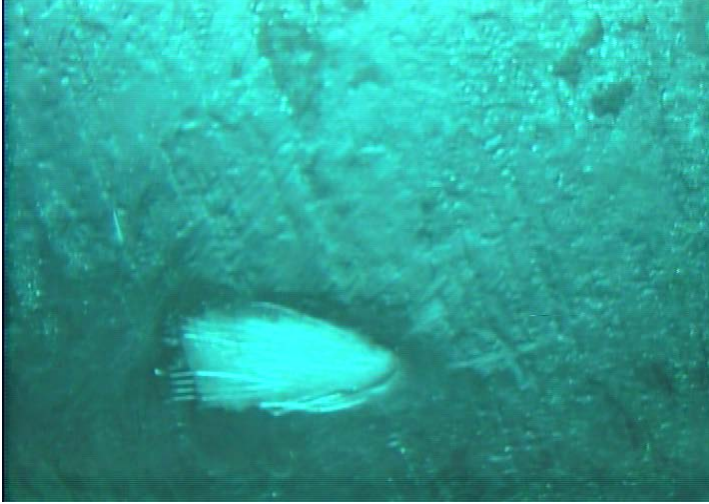
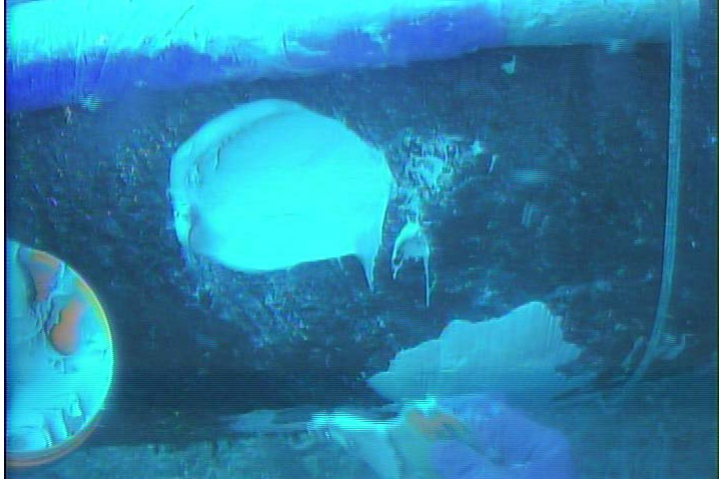
Date:	10/06/18	Frame (HH:MM:SS)	01:33:53	Date:	28/06/18	Frame (HH:MM:SS)	00:10:52

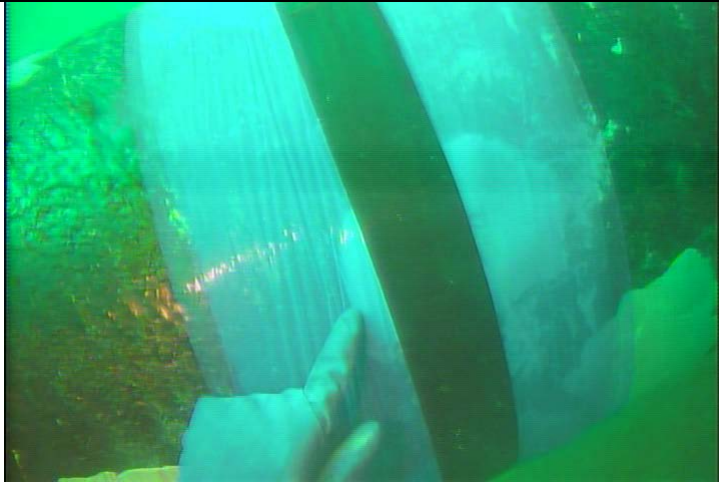
Date:		Frame (HH:MM:SS)		Date:	28/06/18	Frame (HH:MM:SS)	00:18:48

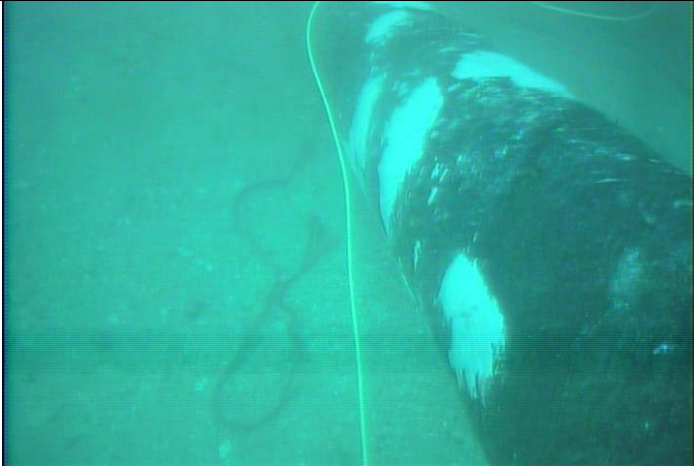
Date:	02/07/18	Frame (HH:MM:SS)	01:07:59	Date:	DD/MM/YY	Frame (HH:MM:SS)	
-------	----------	------------------	----------	-------	----------	------------------	--

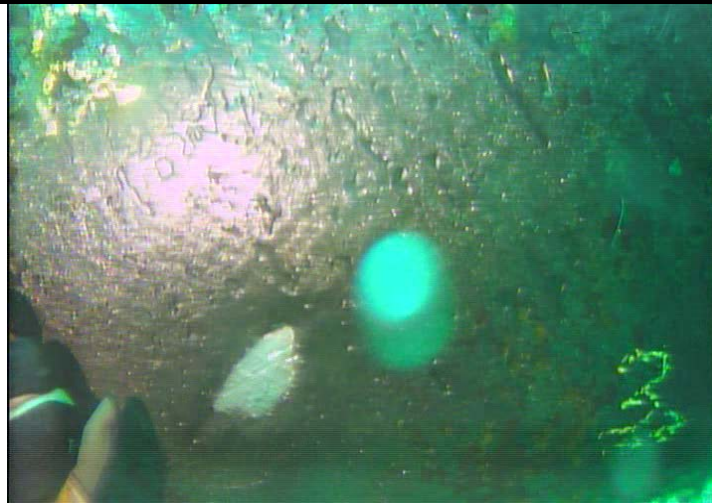
Surface of the pipe after epoxy filler application
Repair Area # 12.

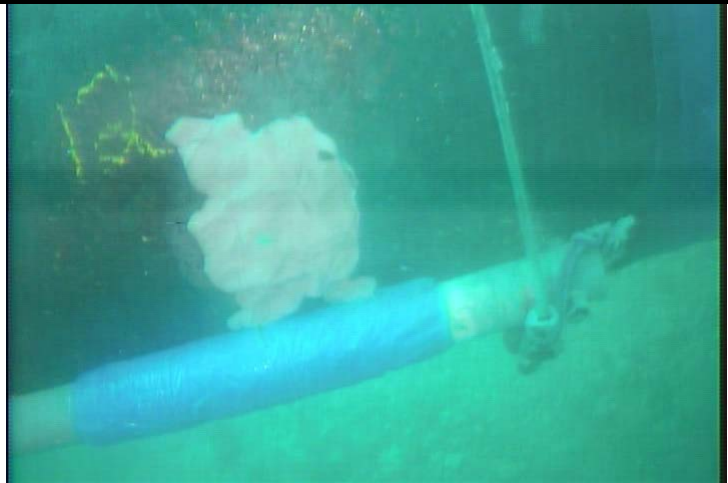
Date:	10/06/18	Frame (HH:MM:SS)	01:36:22
-------	----------	---------------------	----------

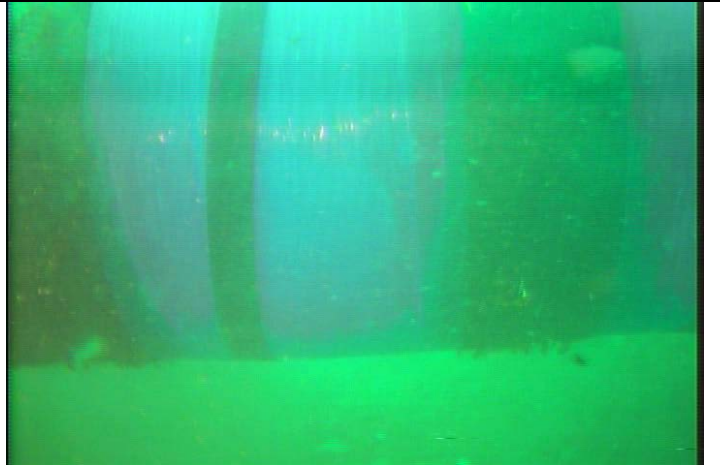
Date:		Frame (HH:MM:SS)	
-------	--	---------------------	--

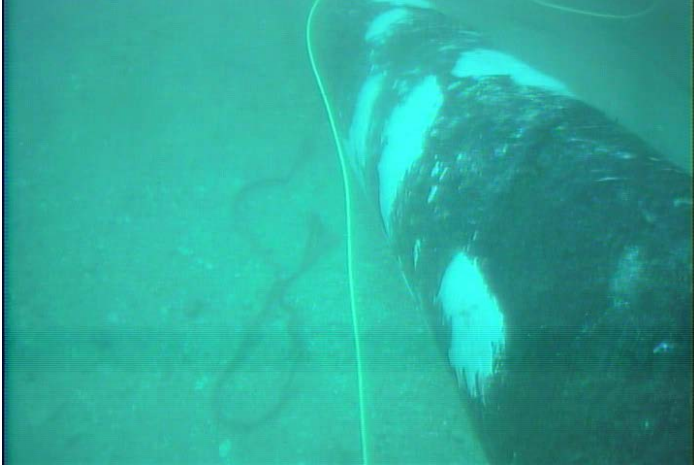
Date:	02/07/18	Frame (HH:MM:SS)	01:07:59	Date:	DD/MM/YY	Frame (HH:MM:SS)	
-------	----------	------------------	----------	-------	----------	------------------	--

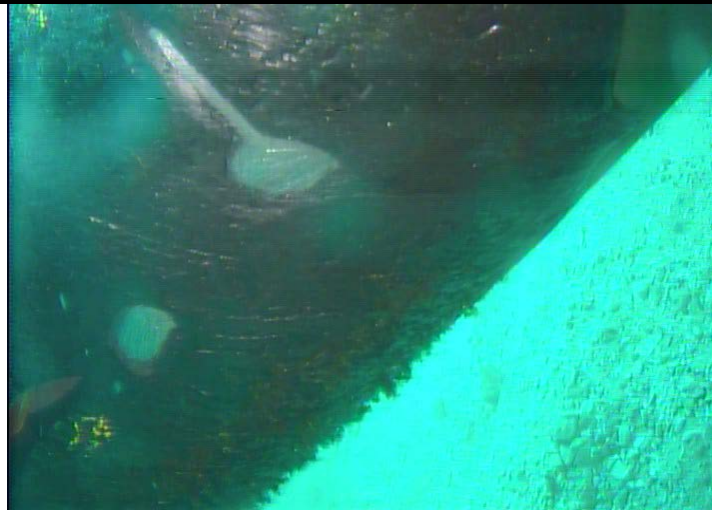
Surface of the pipe after epoxy filler application
Repair Area # 13.

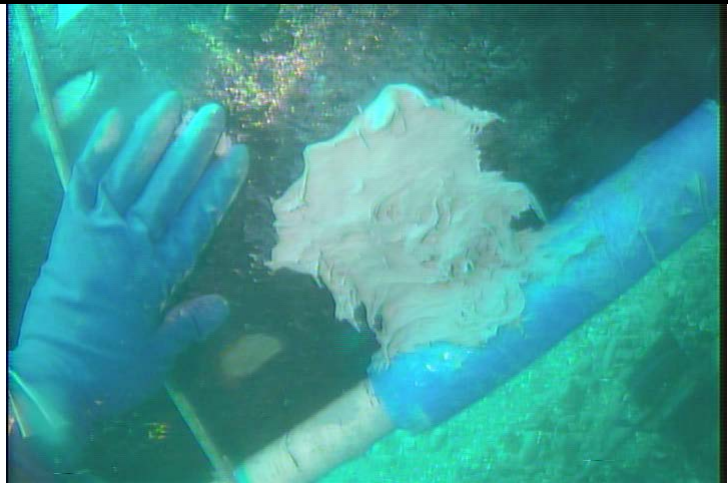
Date:	10/06/18	Frame (HH:MM:SS)	01:42:10
-------	----------	---------------------	----------

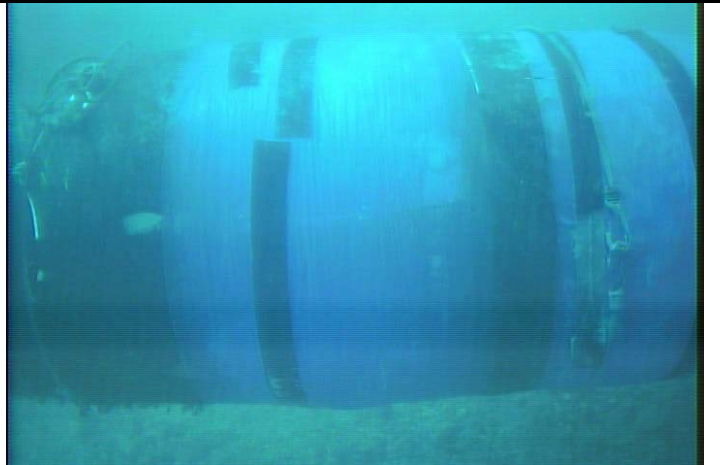
Date:		Frame (HH:MM:SS)	
-------	--	---------------------	--

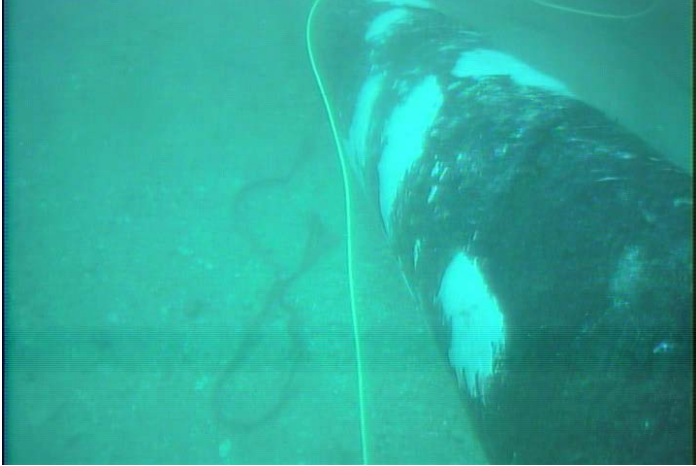
Date:	02/07/18	Frame (HH:MM:SS)	01:07:59	Date:	DD/MM/YY	Frame (HH:MM:SS)	
-------	----------	---------------------	----------	-------	----------	---------------------	--

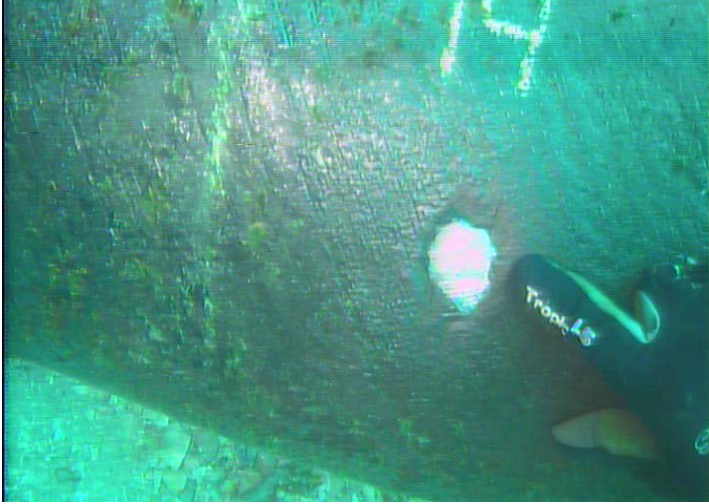
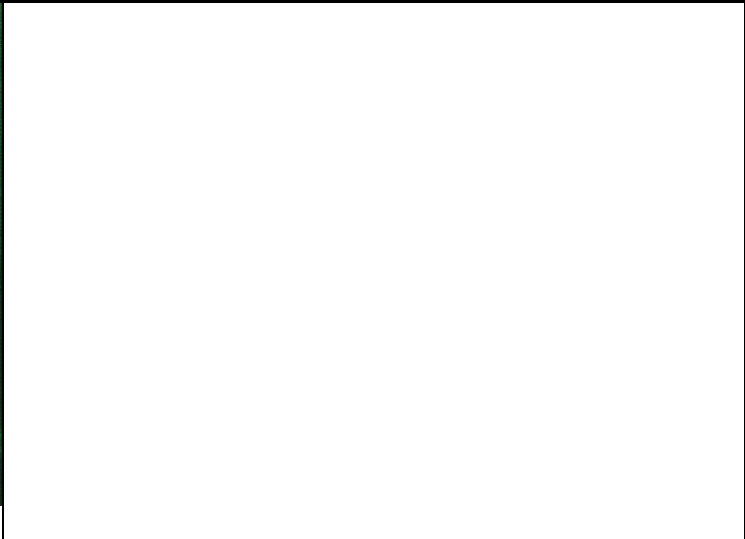
Date:	10/06/18	Frame (HH:MM:SS)	01:44:55	Date:		Frame (HH:MM:SS)

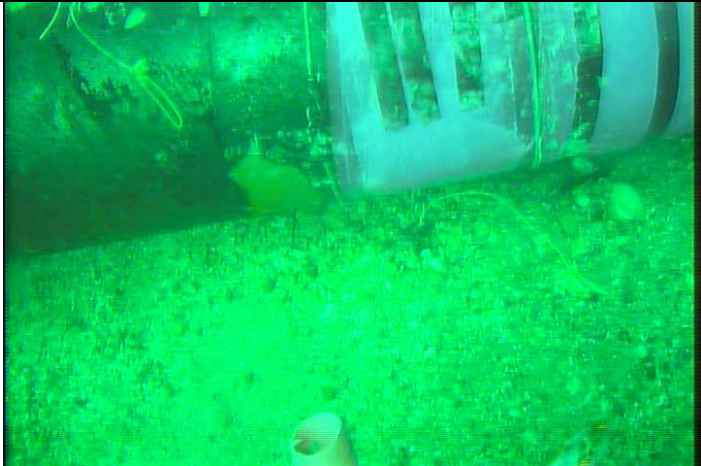
Date:		Frame (HH:MM:SS)		Date:	11/06/18	Frame (HH:MM:SS)	01:02:45

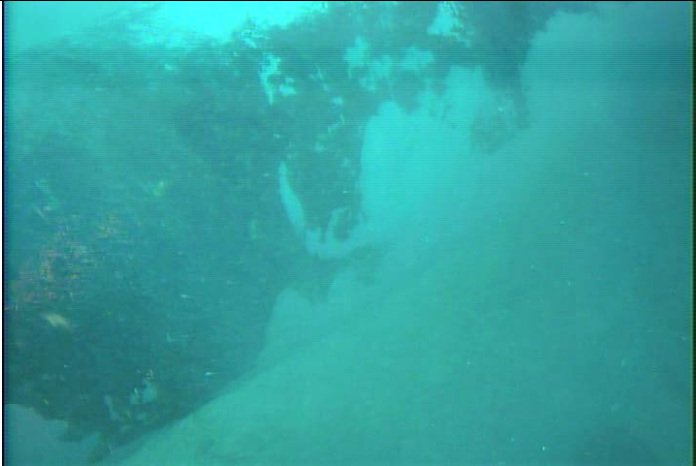
Date:	02/07/18	Frame (HH:MM:SS)	01:07:01	Date:	DD/MM/YY	Frame (HH:MM:SS)	
-------	----------	------------------	----------	-------	----------	------------------	--

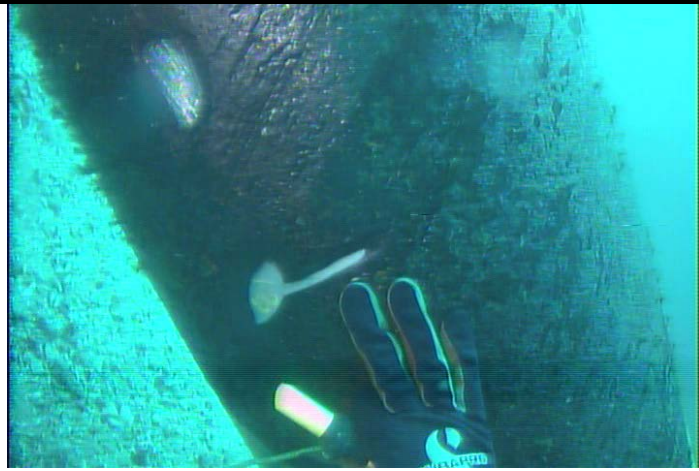
Surface of the pipe after epoxy filler application
Repair Area # 15.

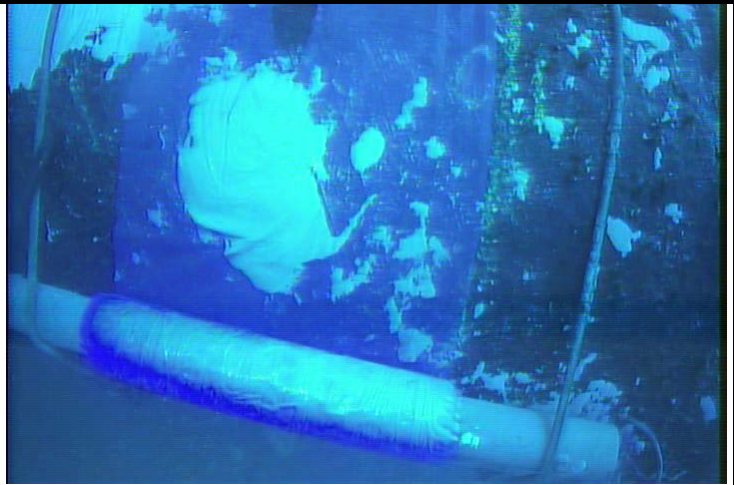
Date:	10/06/18	Frame (HH:MM:SS)	00:17:51
-------	----------	------------------	----------

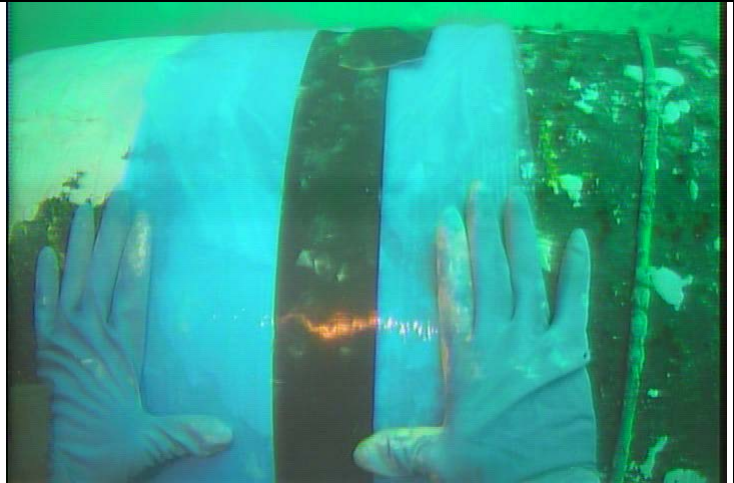
Date:		Frame (HH:MM:SS)	
-------	--	------------------	--

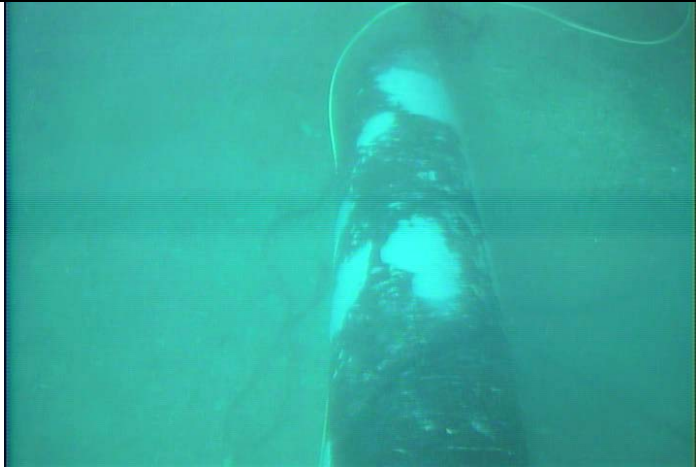
Date:	02/07/18	Frame (HH:MM:SS)	01:07:30	Date:	DD/MM/YY	Frame (HH:MM:SS)	
-------	----------	------------------	----------	-------	----------	------------------	--

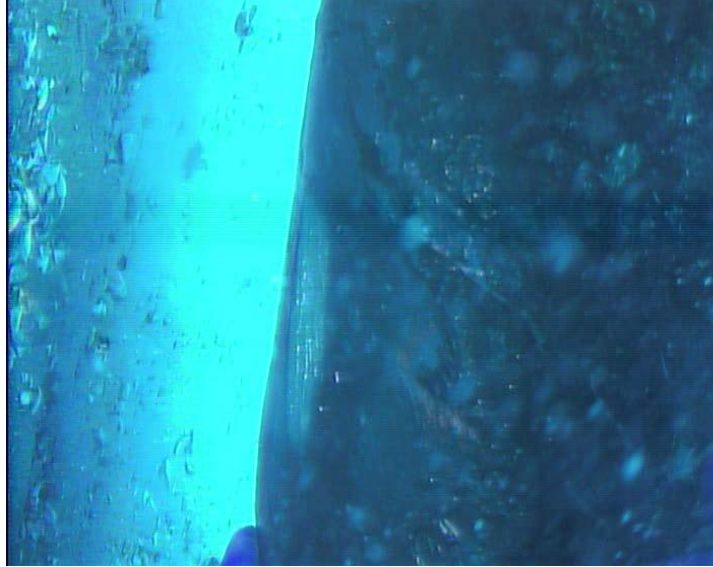
Surface of the pipe after epoxy filler application
Feature 1.

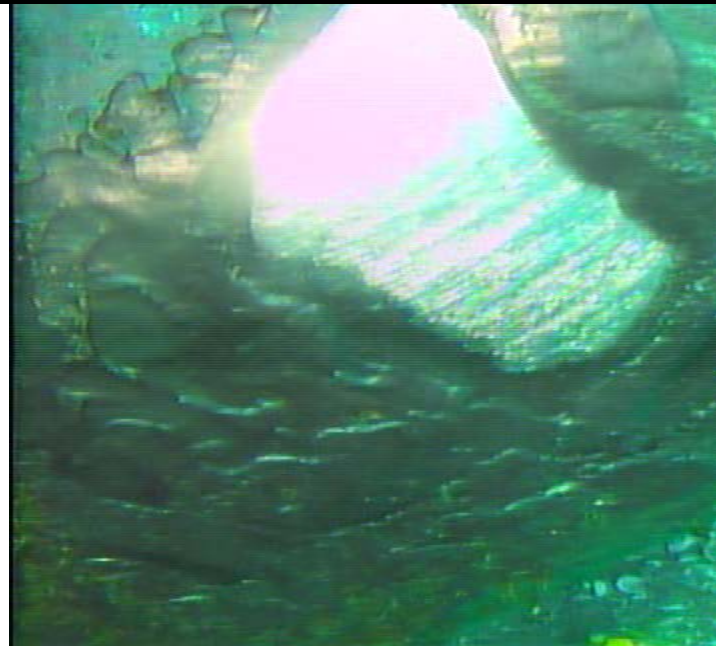
Surface of the pipe after epoxy filler
application Feature 2.

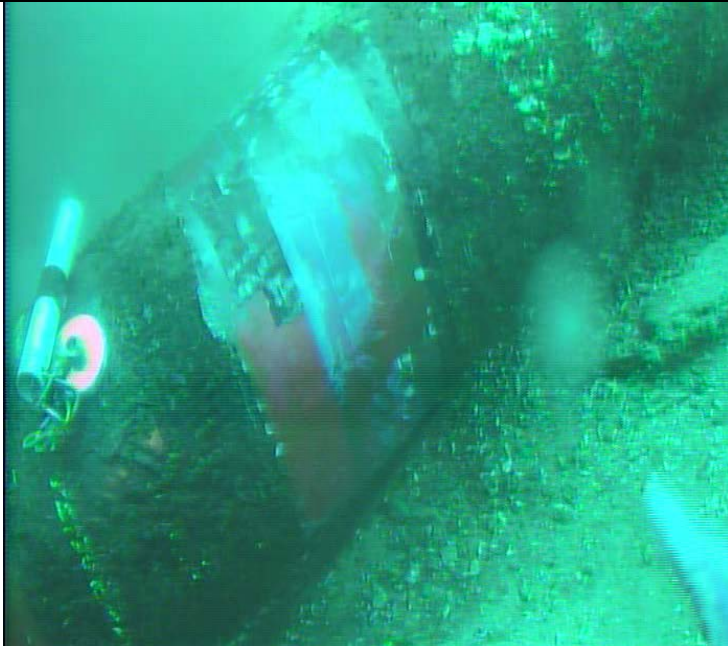
Date:		Frame (HH:MM:SS)		Date:	6/6/18	Frame (HH:MM:SS)	01:32:00
