Drainage Master Plan

*Prepared for:
Town of Tisbury, Massachusetts*

January 2018

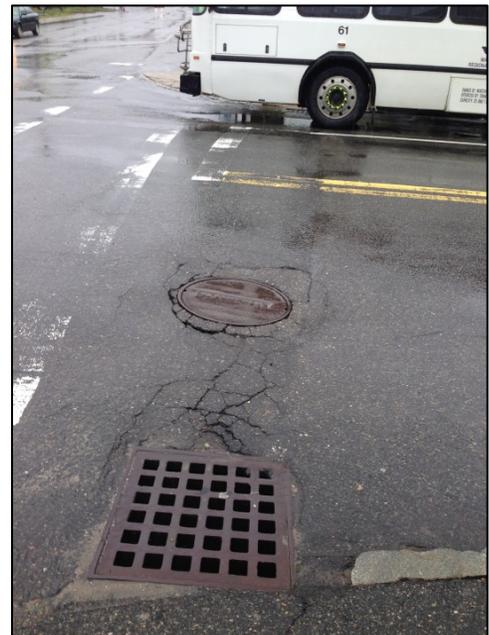
Undermined Structures at Intersection

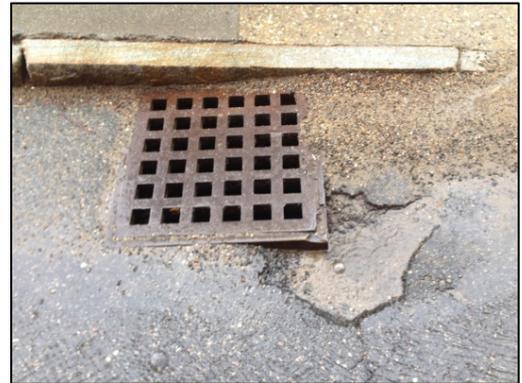
Sediment Buildup at Catch Basin

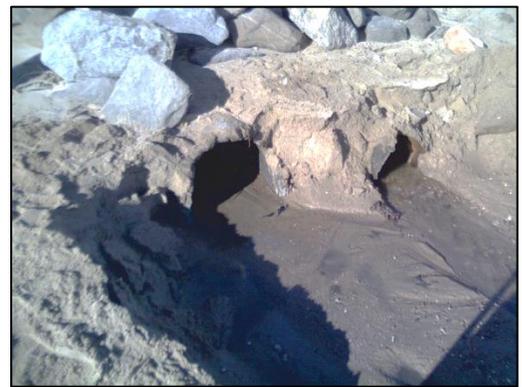
Two Outfalls Uncovered on Beach

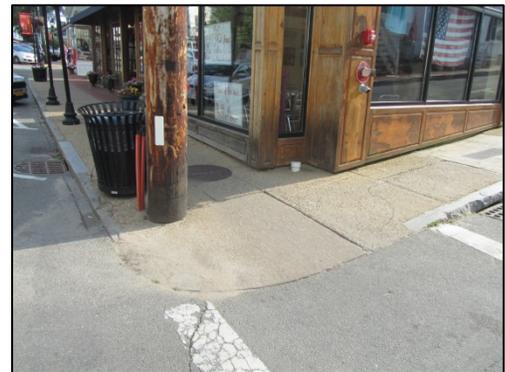
Center St / Main Street Sediment

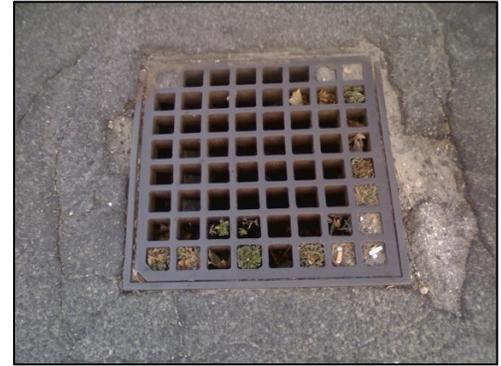
Clogged Catch Basin 195 – Union St

- Model stormwater runoff
 - Evaluate upstream controls (leaching chambers and catch basins, swales, etc.)
 - Include tide impacts
 - Coordinate with / include upstream areas of concern to address entire catchment area
- Data Collection
 - Detailed survey at Main St and Union Street to Water Street (minimum)
 - Boings and/or test pits at infiltration locations
 - Clean and inspect pipelines to determine condition and size
- Design
 - Maximize upstream infiltration and/or redirection
 - Coordinate with Main Street and Water Street improvements or reconfiguration
 - Coordinate with Steamship Authority as needed

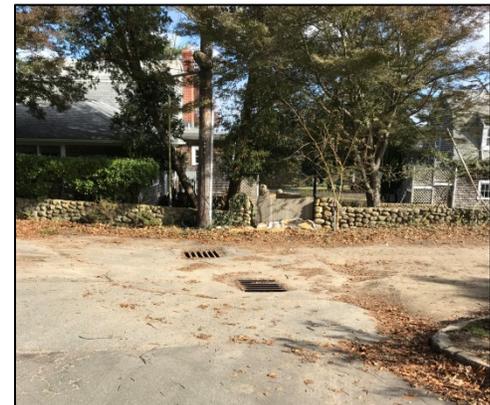
Delano Road at Villa Drive

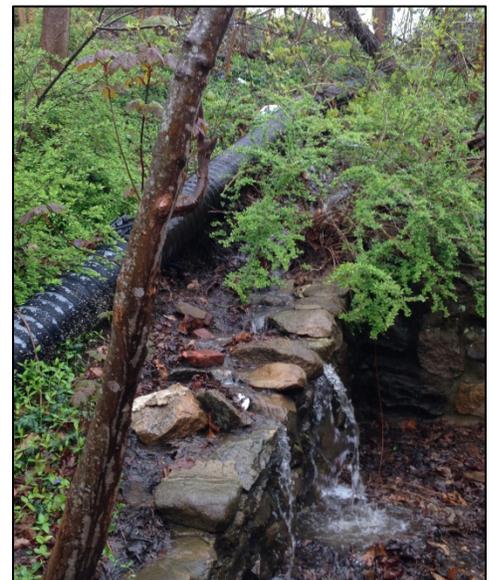
Leaking CMP pipe at Causeway Rd

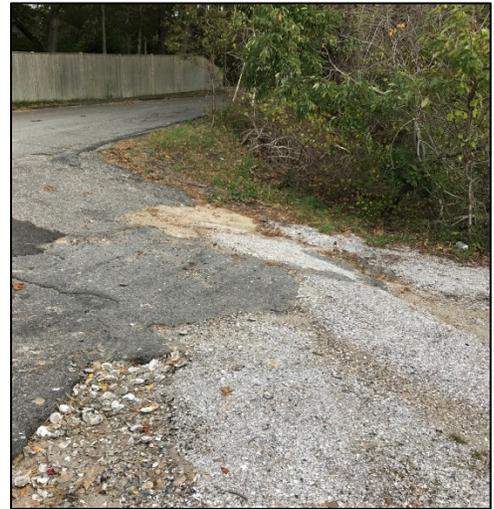
Washout at Landing – East Side

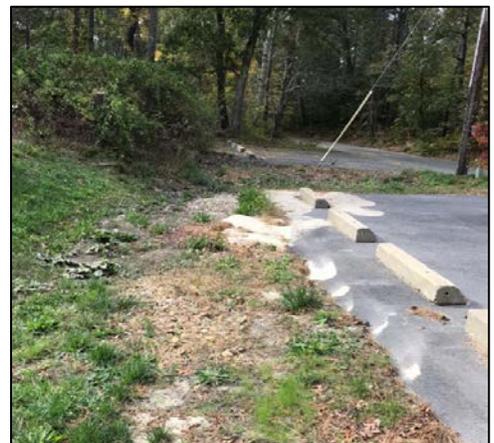
Sediment beyond BMP at Tennis Courts

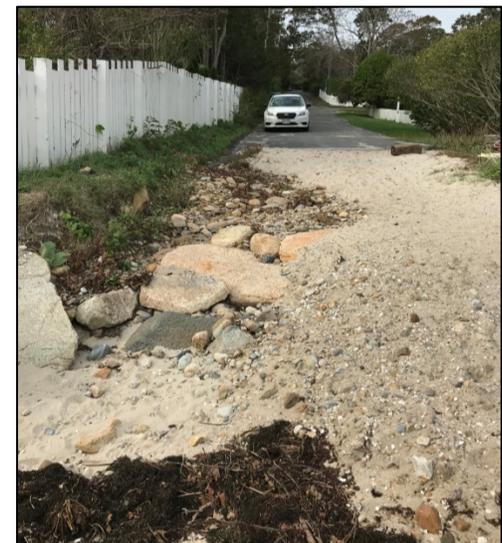
Erosion at Beach

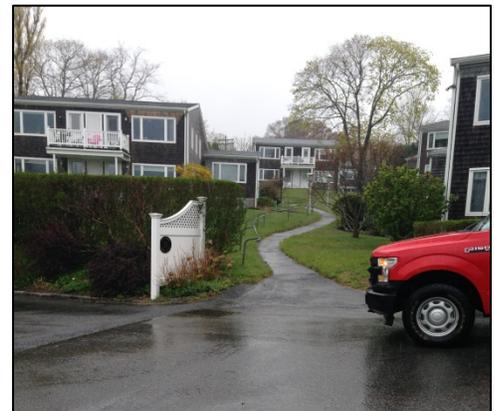
Havenside Drainage at Crocker Ave
