Subject: August 22, 2019 Reconnaissance Inspection Report for ArcelorMittal Burns Harbor

**CWA RECONNAISSANCE INSPECTION REPORT  
U.S. ENVIRONMENTAL PROTECTION AGENCY (EPA), REGION 5**

**Facility:** ArcelorMittal Burns Harbor, LLC  
250 West U.S. Highway 12  
Burns Harbor, IN 46304

**Date of Inspection:** August 22, 2019

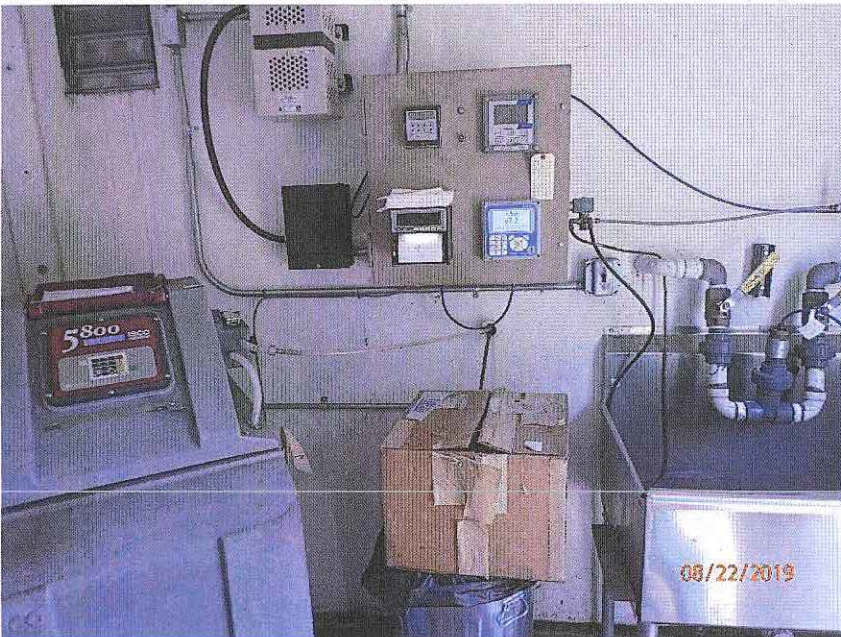
11: P8220011

Total residual chlorine is not analyzed within the required holding time. This was stated by Ms. Kirk when EPA questioned how long it took to transport a sample from the remote sampling location to their lab. 40 CFR 136.3 requires analysis within 15 minutes. Chlorine in aqueous solution is not stable, and the chlorine content of samples or solutions, particularly weak solutions, will decrease rapidly.

ArcelorMittal collects a grab sample for oil and grease by pumping effluent through plastic tubing to the collection jar. EPA Method 1664 Rev. A includes the following statement, "The high probability that extractable matter may adhere to sampling equipment and result in measurements that are biased low precludes the collection of composite samples for determination of oil and grease. Therefore, samples must be collected as grab samples." Drawing a sample through 30 feet of tubing may result in

measurements that are biased low.

Description: Sampling equipment inside Monitoring Station 011.

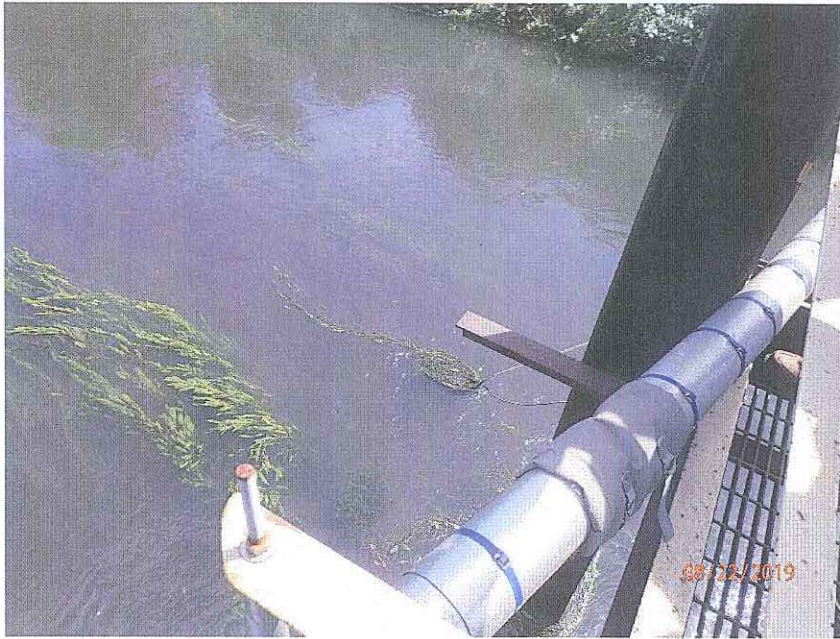
12: P8220012

Description: The end of the intake tube for Monitoring Station 011 has weeds caught on it.

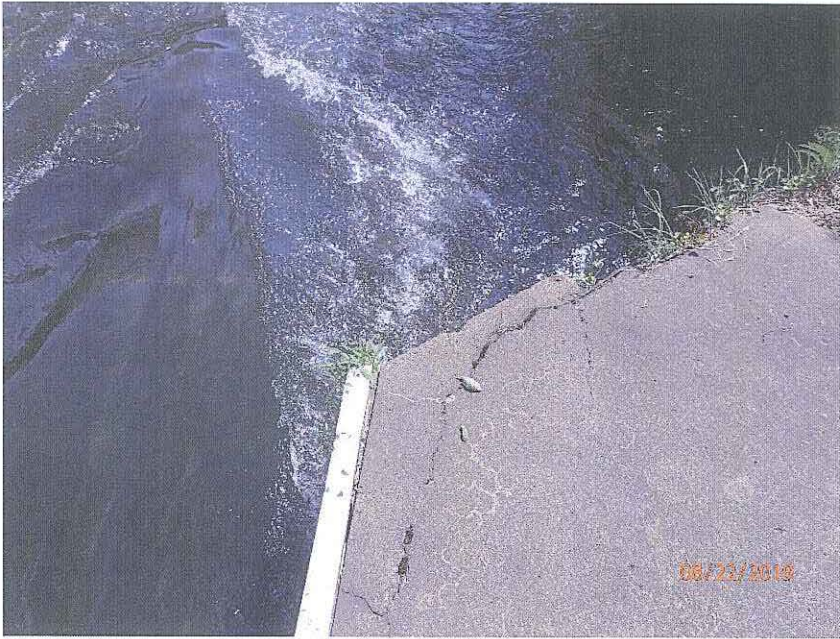
16: P8220016

Description: Small dead fish on the concrete by the weirs.

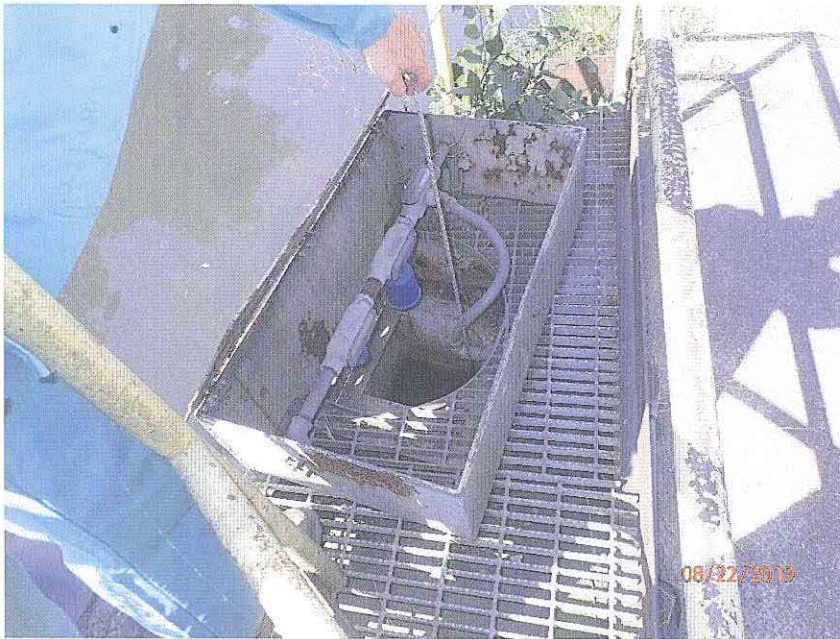
17: P8220017

Effluent flows through two parallel 7-foot Parshall flumes. Head is only measured at the south flume, and total flow is assumed to be twice the flow rate through the south flume.

Description: Parshall flume meter at the weirs for Outfall 001.

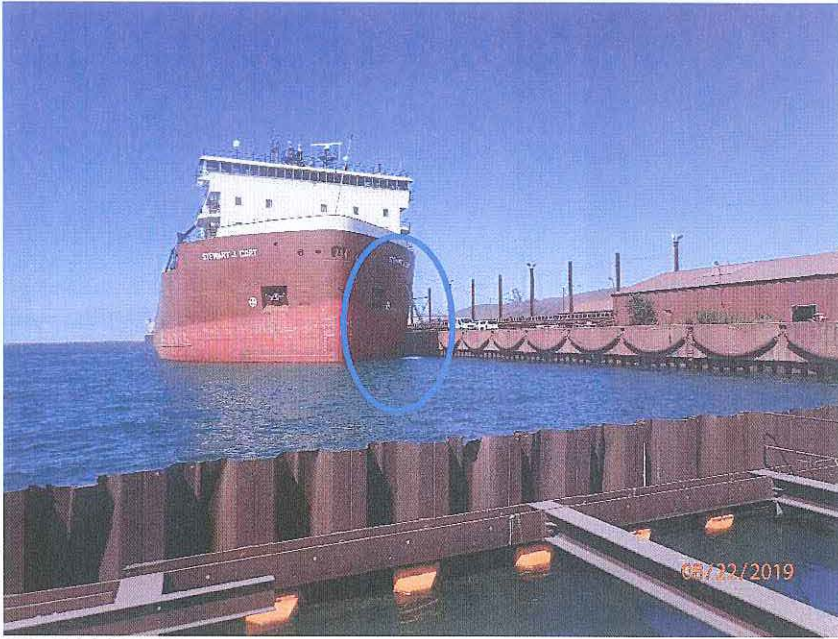
20: P8220020

Description: One of the ships docked in the harbor with bilge water from the ship being discharged into the harbor. Blue circle denotes bilge water coming from ship. Note the piles of iron ore and other raw materials behind the ship.

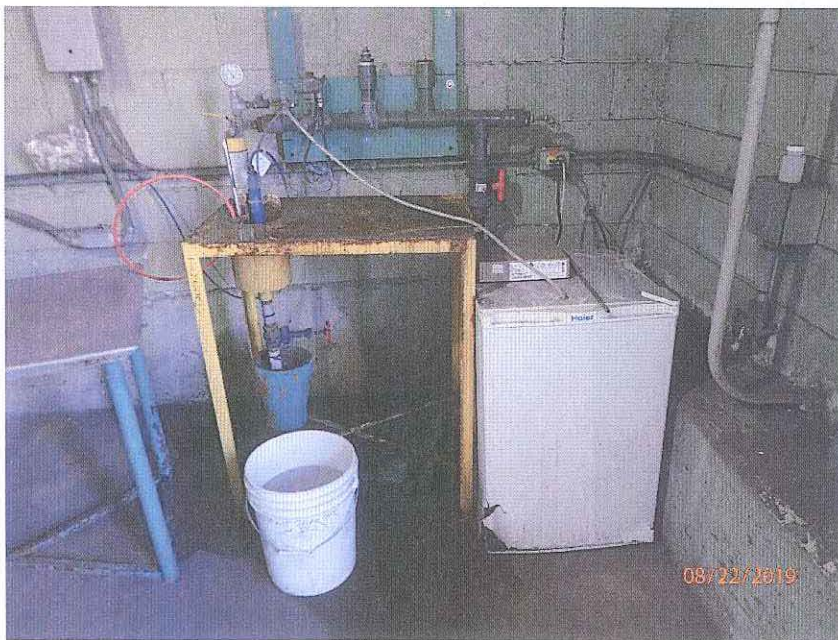
21: P8220021

ArcelorMittal collects a grab sample for oil and grease by pumping effluent through an undetermined length of plastic tubing to the collection jar. EPA Method 1664 Rev. A includes the following statement, "The high probability that extractable matter may adhere to sampling equipment and result in measurements that are biased low precludes the collection of composite samples for determination of oil and grease. Therefore, samples must be collected as grab samples." Drawing a sample through tubing may result in measurements that are biased low. In addition, their sampling location is in a pipe about 100 feet upstream of the discharge to the harbor. The sampling location does not allow the sampler to note whether a sheen is present at the outfall.

Description: Sampling equipment for Outfall 002. Temperature in the sample fridge was 5 °C.

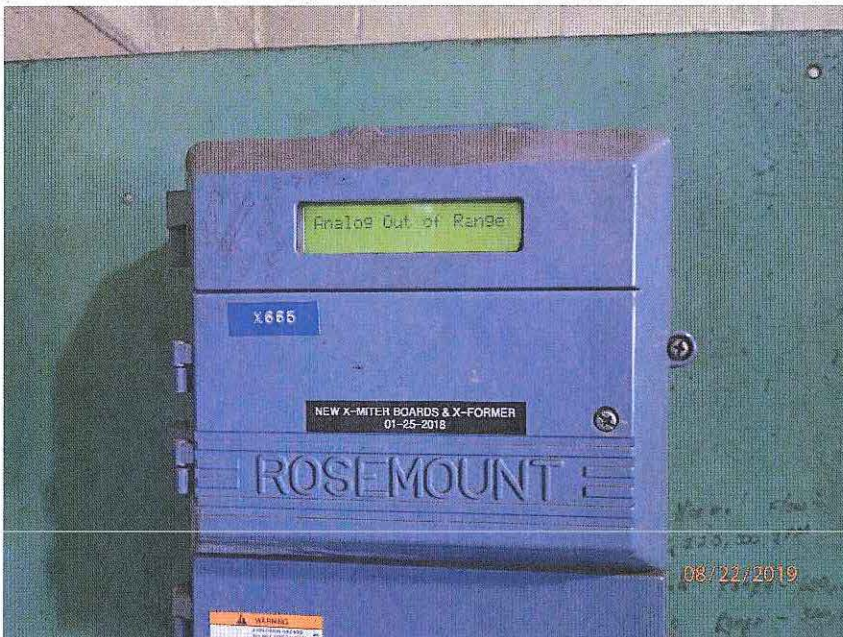
23: P8220023

The readout on the ultrasonic flow gauge showed "out of range". When EPA asked Ms. Kirk about this, she stated flow was being calculated from the combined input of multiple sources, because the gauge was not working.

Description: Flow meter for Outfall 002 is out of range according to flow panel in sample house.

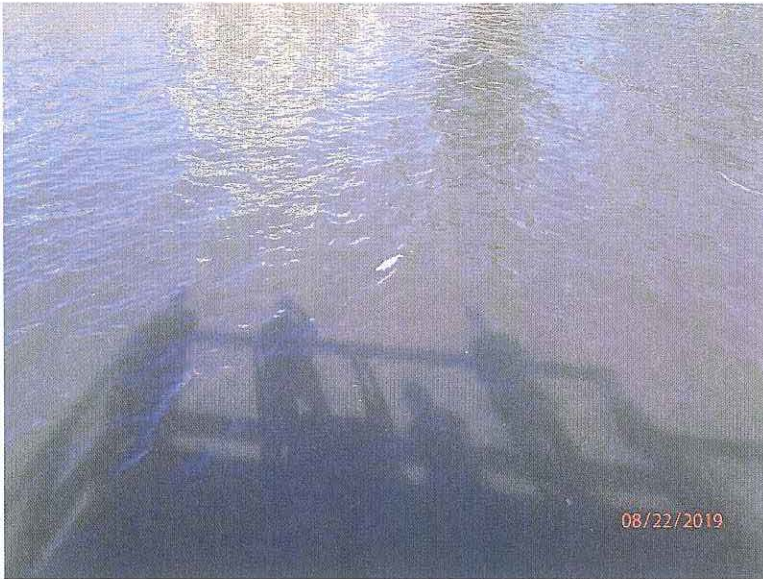
24: P8220024

Mr. Ream, the IDEM inspector, received a call to inspect the East Arm of the Little Calumet River to observe any dead fish. EPA accompanied IDEM to the river. We saw a dead fish (see Photo 24) and a Beach Closure notice (see Photo 25) at the Portage Lakefront river walk.

Description: Dead fish in the Portage Burns Waterway.

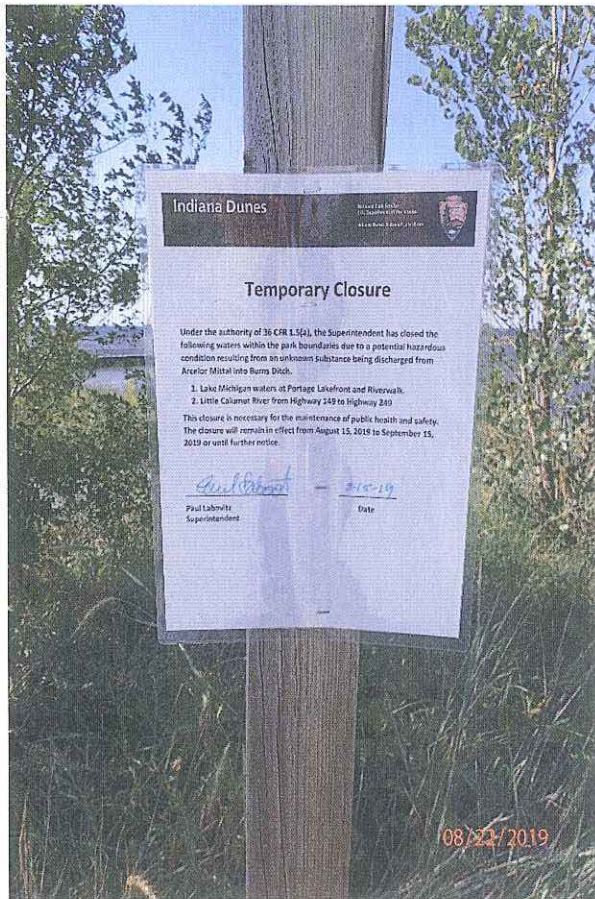
25: P8220025

Description: Temporary Closure sign at the Indiana Dunes.
