Subject: August 12, 2020 Inspection Report for ArcelorMittal Burns Harbor, NPDES Permit Number IN0000175

**CWA COMPLIANCE EVALUATION INSPECTION REPORT  
U.S. ENVIRONMENTAL PROTECTION AGENCY, REGION 5**

ArcelorMittal Burns Harbor, LLC  
250 US-12  
Burns Harbor, Indiana 46304  
Porter County  
41.625, -87.117

IN0000175

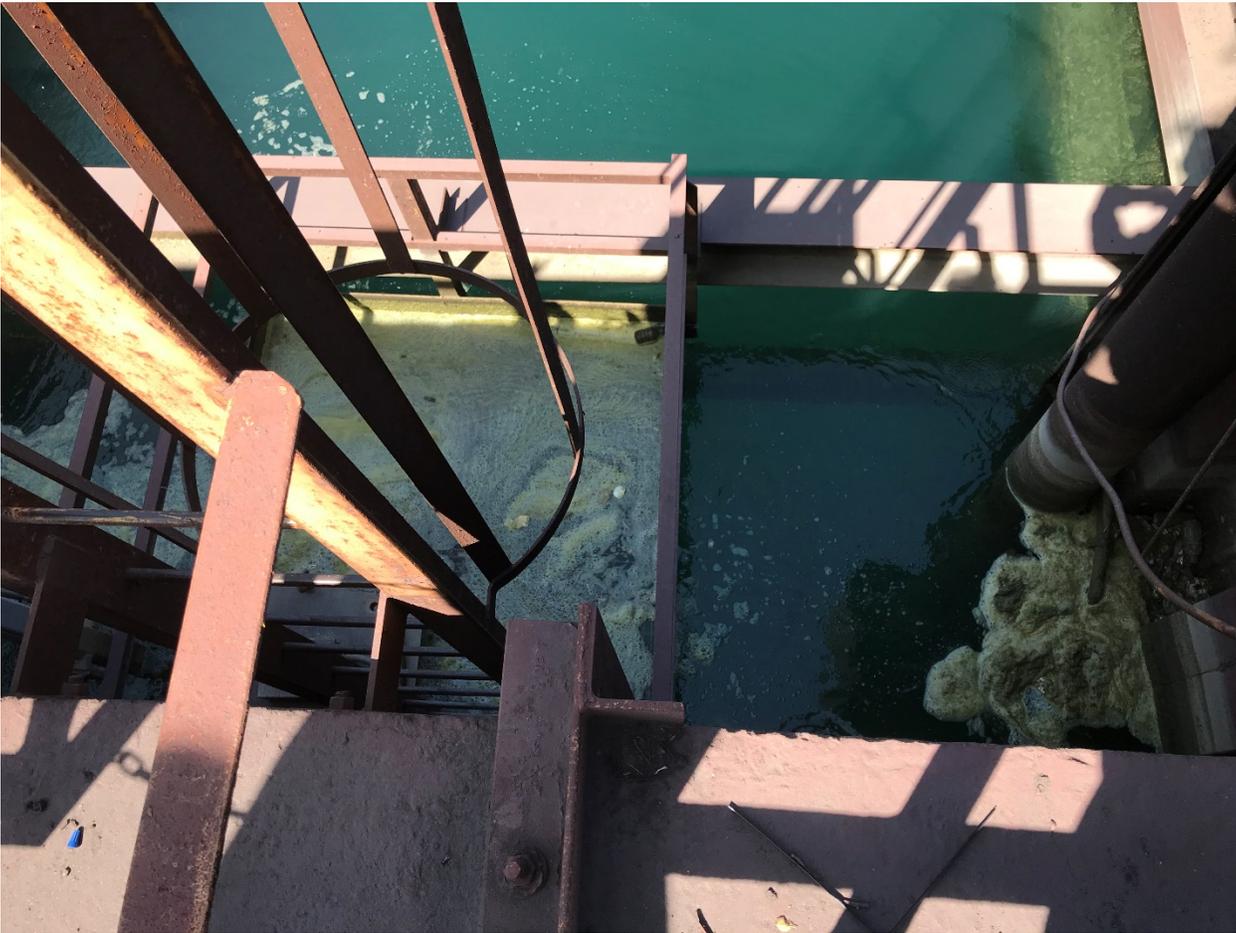
1: IMG\_0826 (Photo was rotated 90°)

Description: Looking down into the Outfall 002 channel at a small amount of foam. Outfall 002 discharges to Burns Harbor approximately 5' below the water level at this end of the channel.

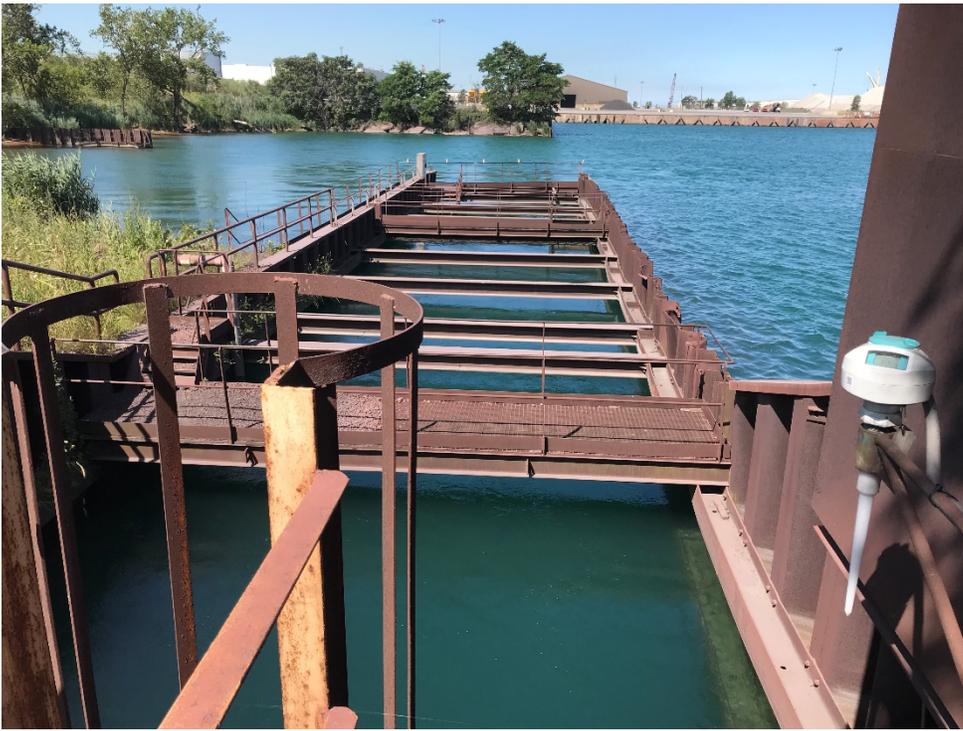
2: IMG\_0827

Description: The Outfall 002 Channel to Burns Harbor. Outfall 002 discharges to Burns Harbor approximately 5' below the water level at the near end of the channel.

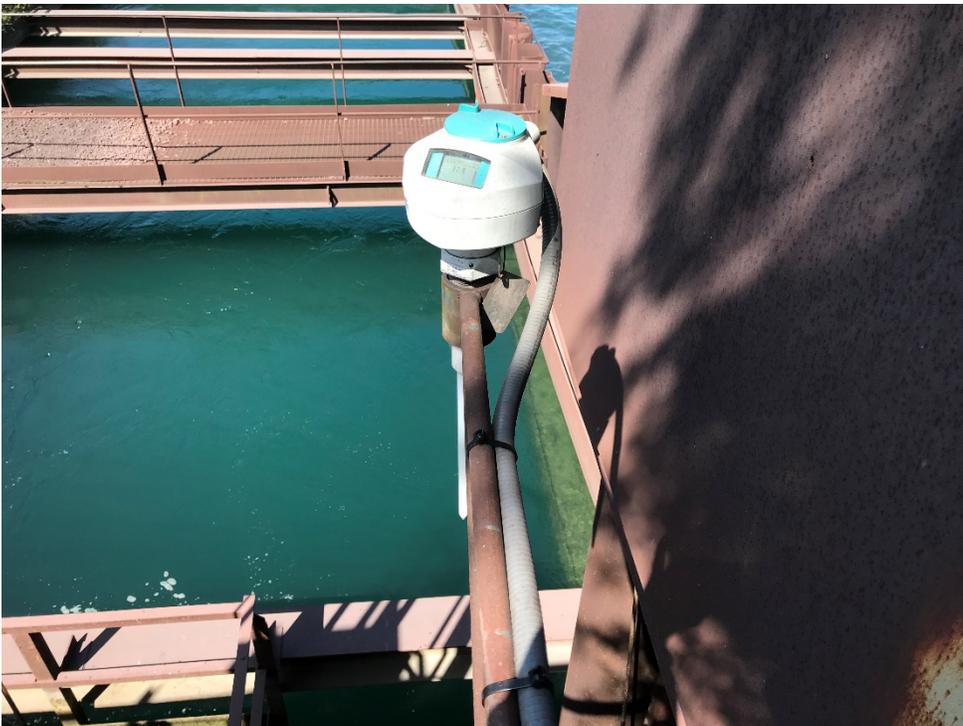
3: IMG\_0828

Description: Probe measures the depth to the surface of the water, used by shipping activities.

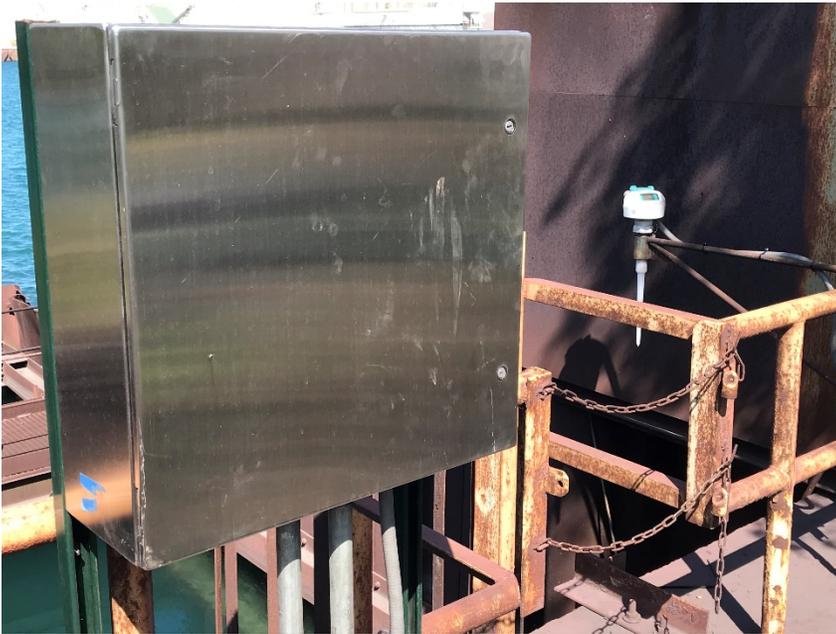
4: IMG\_0829

After observing Outfall 002, EPA and IDEM inspectors were still unclear as to the actions taken by AMBH and requested a call with AMBH representatives to clarify what was observed on August 12, 2020 by Outfall 002. On August 19, 2020, Mr. Ream and Ms. Rogers spoke with Ms. Swanson and Mr. Mathias on the phone. During the conversation, the inspectors learned that the high Lake Michigan water levels were getting into the housing for the electronics for the Outfall 002 flow meter. This housing was previously slightly above water level, but as the lake level rose, it was now submerged. Although the housing was supposed to be water-tight, water did get in and caused shorting of the electronics. The electronics have been moved to ground level.

Description: Silver box contains the electronics for the flow meter for Outfall 002. The electronics were previously at water level, but since the lake level has risen, the electronics needed to be moved to prevent outages.

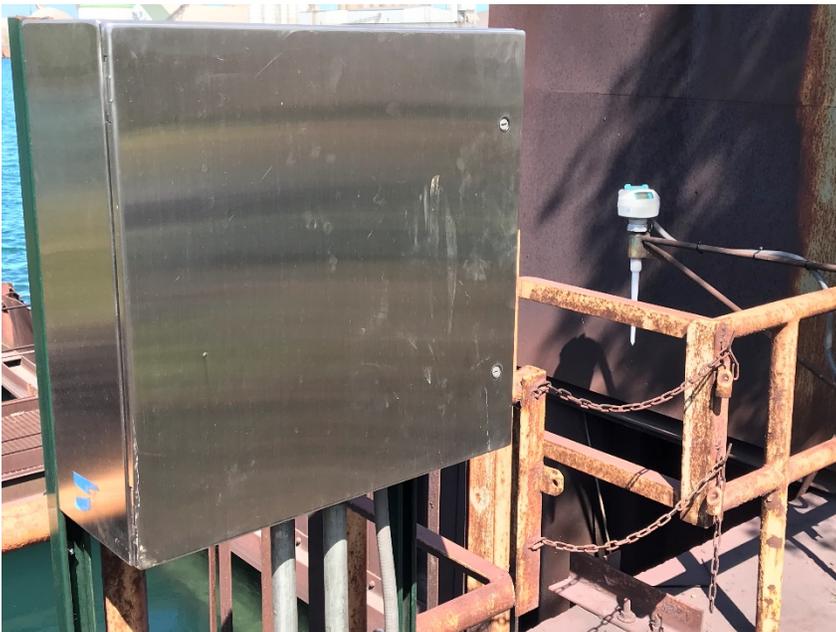
5: IMG\_0830

Description: Duplicate photo as IMG\_0829.

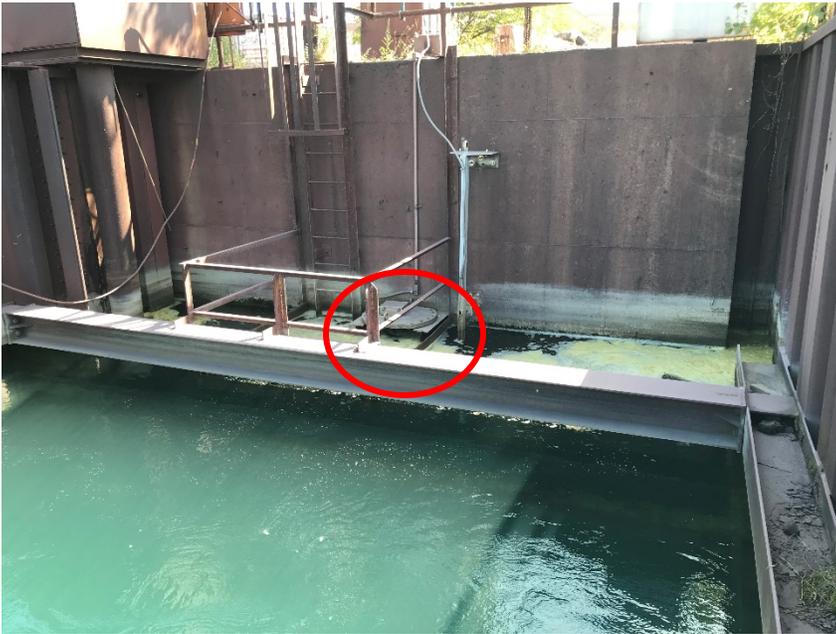
6: IMG\_0831

Description: Looking back at the head wall of the Outfall 002 Channel. Electronics for the flow meter were previously in a housing at lake level - identified by a red circle in photo. They have now been moved up to ground level.

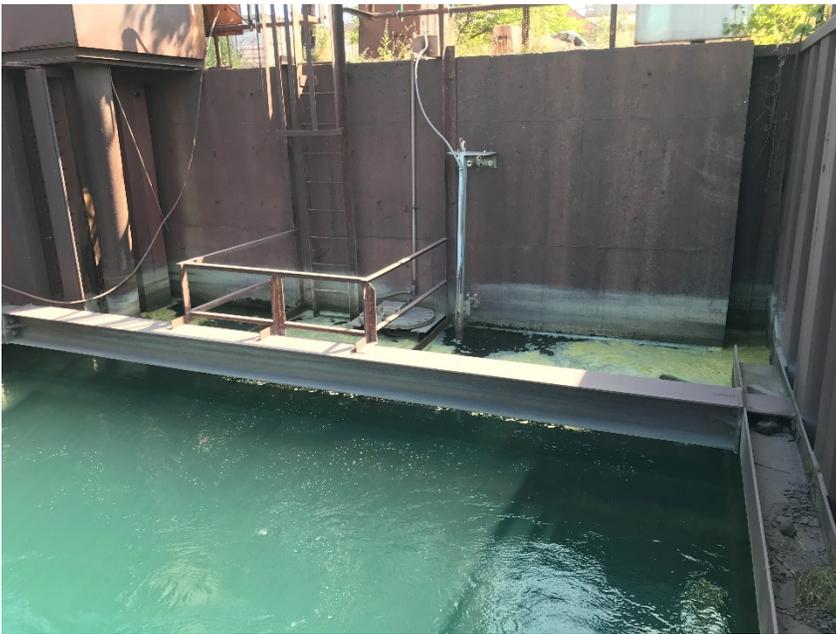
7: IMG\_0832

Description: Duplicate photo as IMG\_0831.
