Subject: October 26, 2020 Inspection Report for ArcelorMittal Burns Harbor,  
NPDES Permit Number IN0000175

**CWA COMPLIANCE EVALUATION INSPECTION REPORT  
U.S. ENVIRONMENTAL PROTECTION AGENCY, REGION 5**

ArcelorMittal Burns Harbor, LLC  
250 US-12  
Burns Harbor, Indiana 46304  
Porter County  
41.625, -87.117

October 26, 2020

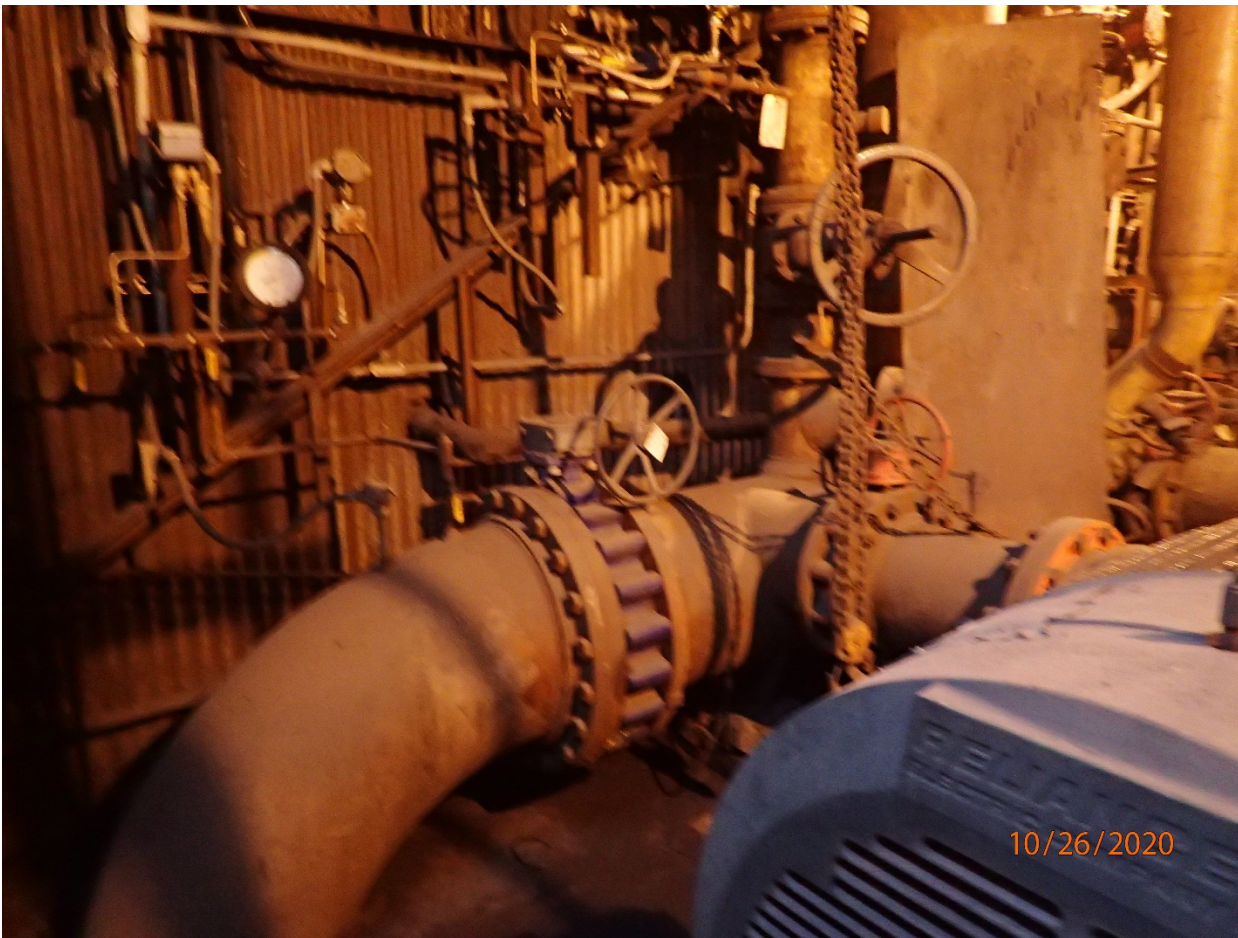
1: PA260001

Description: Shut off valve for Blast Furnace Recycle System.

Location: D Furnace Pump House.

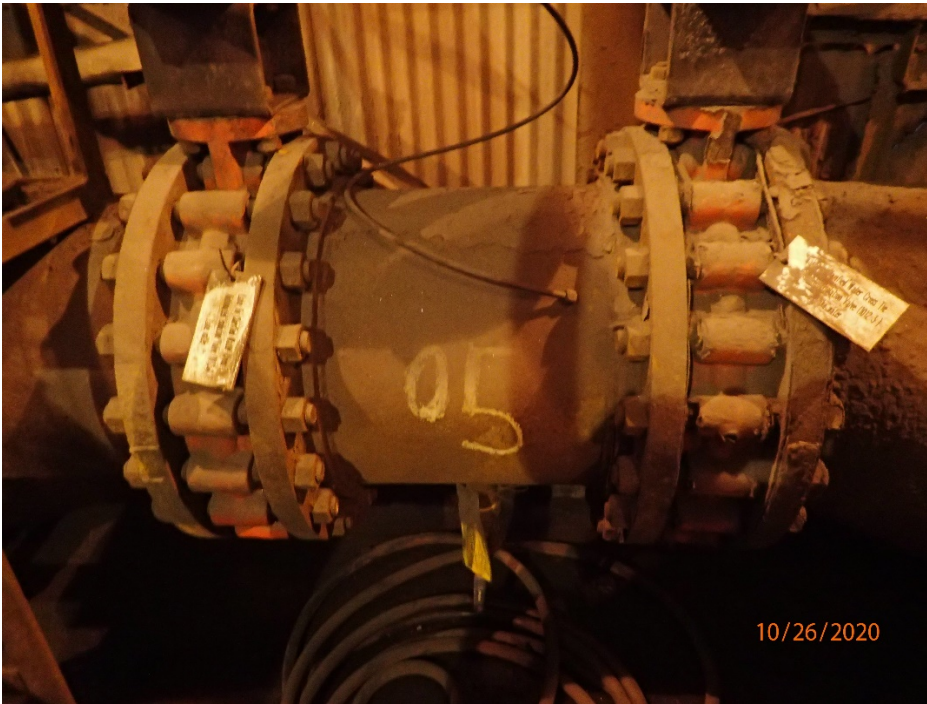
2: PA260002

It was explained that the BFRS water pressure is approximately 80 psi while the Lake Water System is at approximately 60 psi. Since there is an approximately 20 psi pressure differential, the BFRS water has the potential to comingle with the Lake Water System and flow to Outfall 002. There are no flow gauges to know how much BFRS water discharged to Outfall 002. AMBH personnel stated that the lake water flow is 20,000 GPM and they used that knowledge, along with the time that the valves were improperly open to estimate the amount of BFRS water that discharged on June 15, 2020, but they could not explain their calculation.

There are also no alarms to indicate that the BFRS and Lake Water System were connected in a way that could cause a discharge to Outfall 002.

Description: Isolation Valves for Blast Furnace Recycle Sytem and Lake Water System on either side of an open empty portion of piping with a Bleed Valve below.

Location: D Furnace Pump House.

Since the bypass event on June 15, 2020, AMBH has identified that better training is needed for the operators of the valves to prevent future discharges.

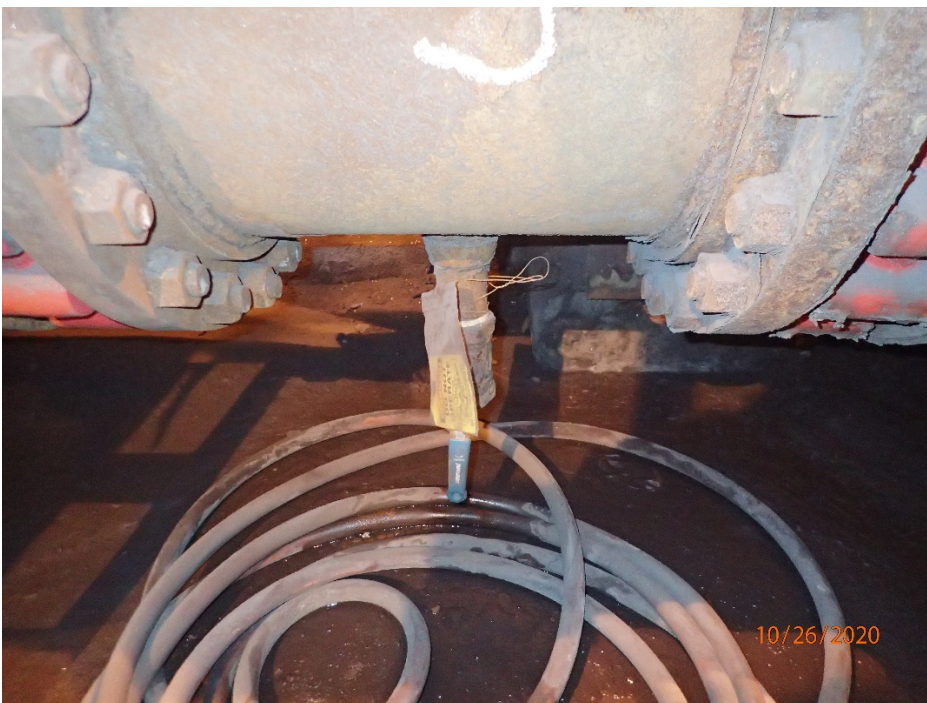
3: PA260003

Description: Bleed Valve below the empty pipe between the two isolation valves. The Bleed Valve is always open when the isolation valves are closed, and any water from it would indicate a failure of one or both of the isolation valves. Flow from the Bleed Valve would flow along the floor to a floor drain which goes to the Quick Dump Sump.

Location: D Furnace Pump House.

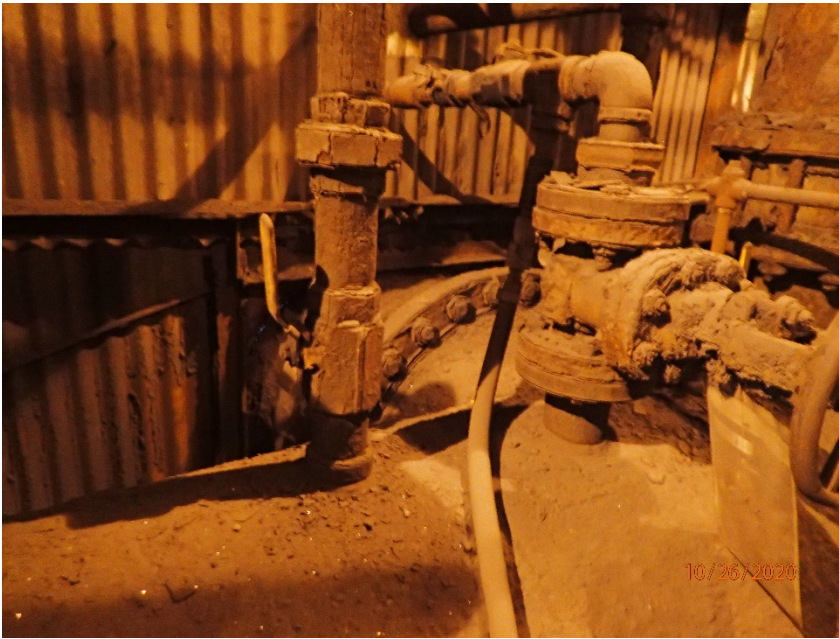
4: PA260004

Description: Lake Water Intake pipe (through wall). Lake water flows at approximately 20,000 gpm through this pipe.

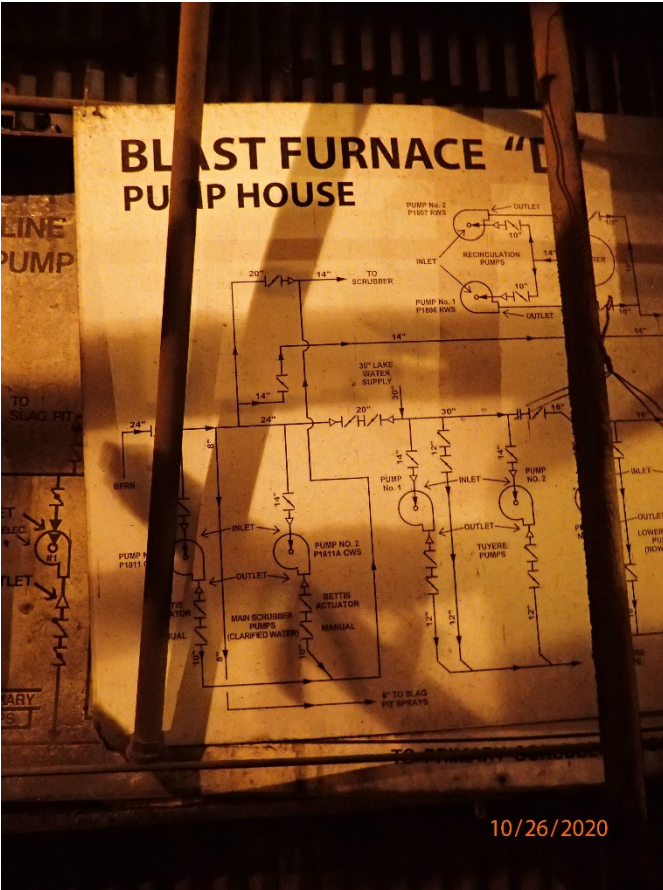
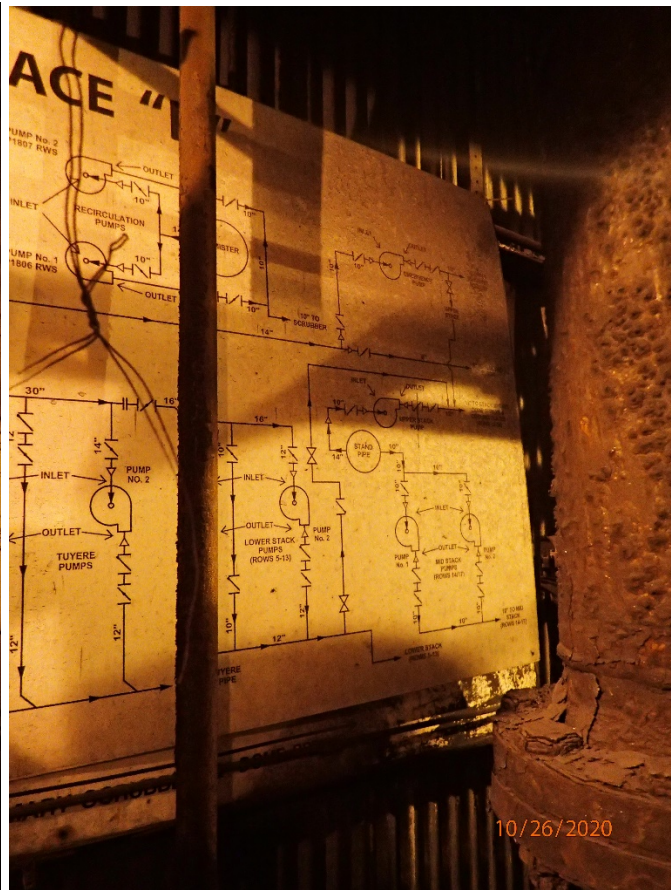
5: PA260005

Description: Left half of diagram on wall behind piping.

Description: Right half of diagram on wall behind piping.

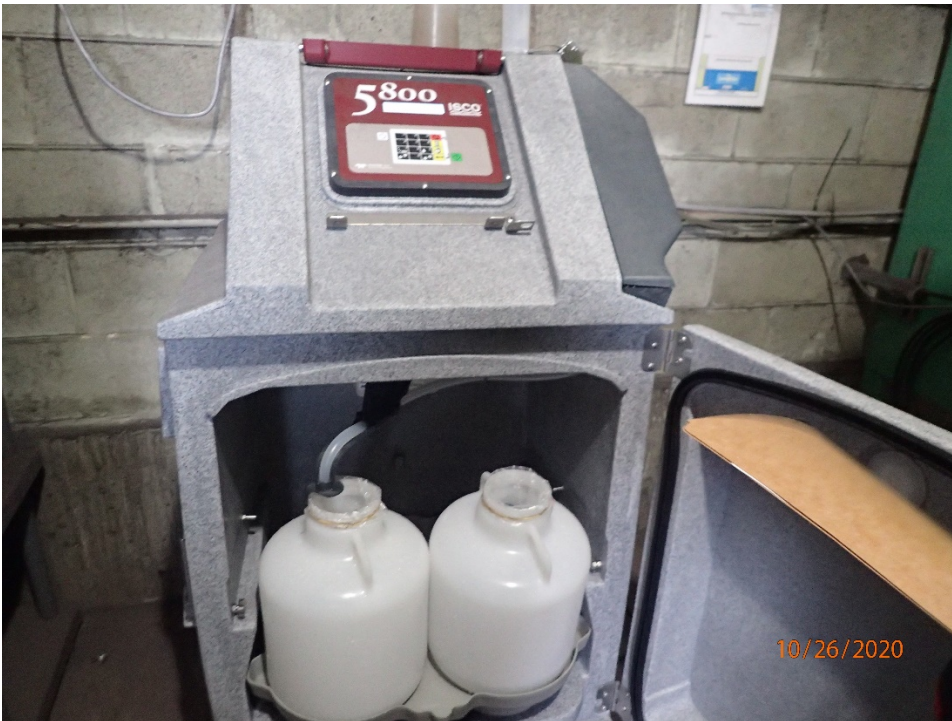
7: PA260007

Description: Inside the auto sampler for samples at Outfall 002.

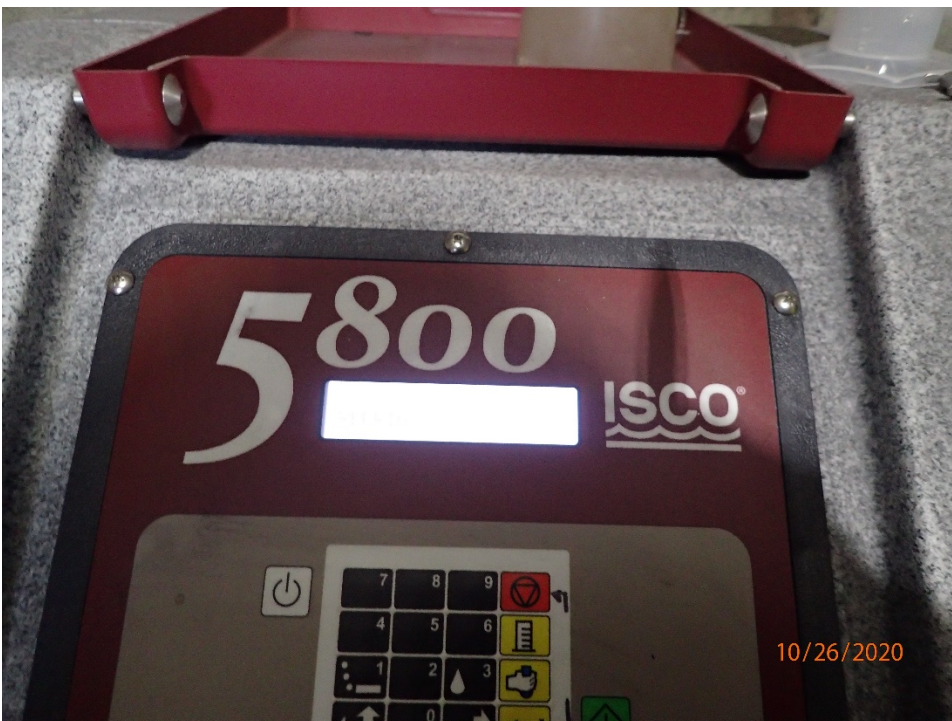
8: PA260008

Description: Display reading didn't photograph, but the temperature of the inside of the sampler is displayed on the outside panel.

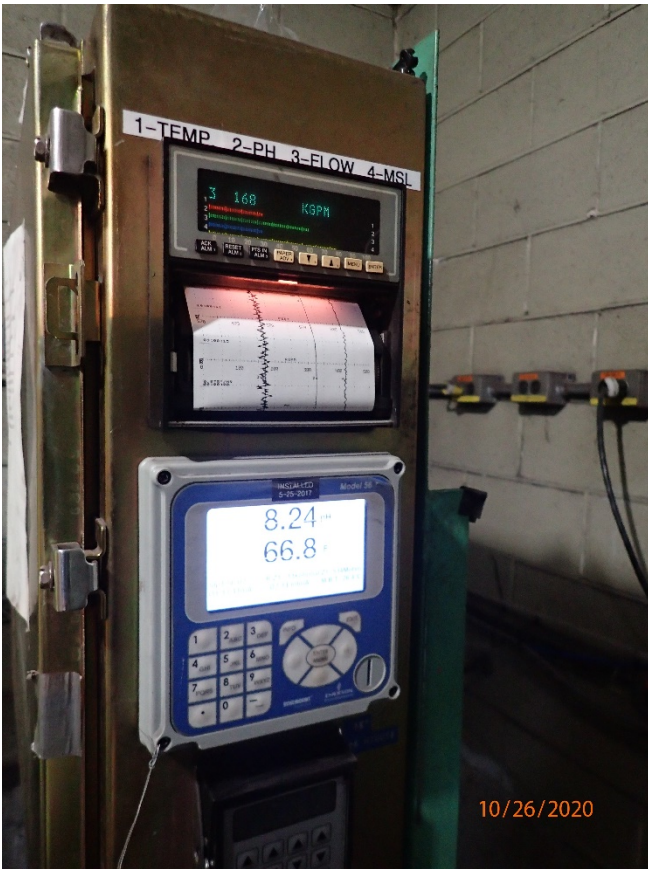
9: PA260009

Description: Flow meter inside for Outfall 002 is inside the Sample Building. Flow on the meter was at 168,000 GPM.

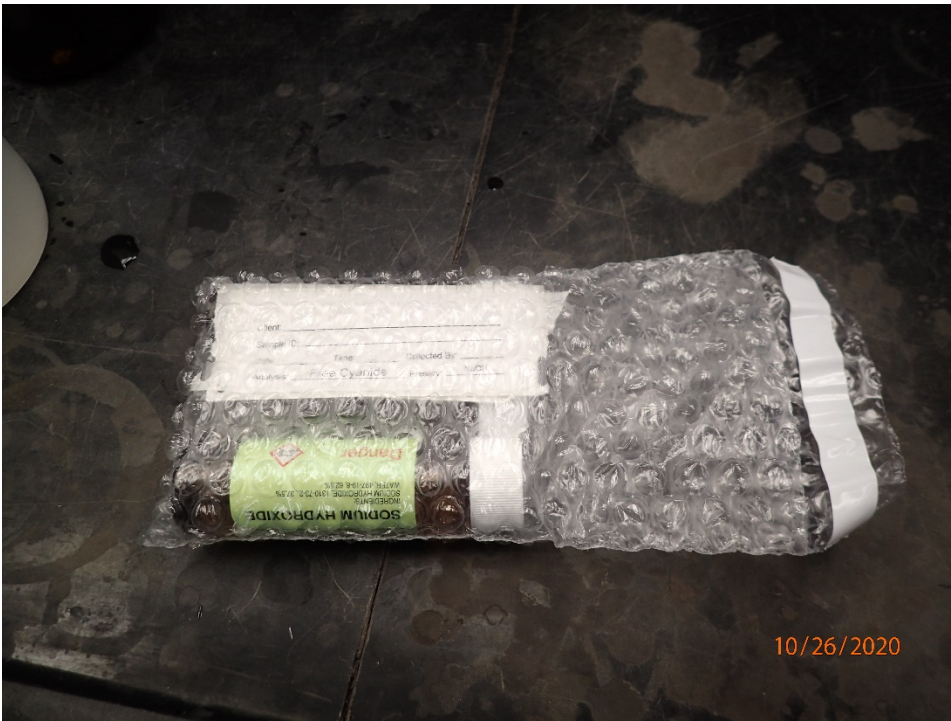
11: PA260011

Description: Sample package for composite sample which is sent to Microbac Lab.

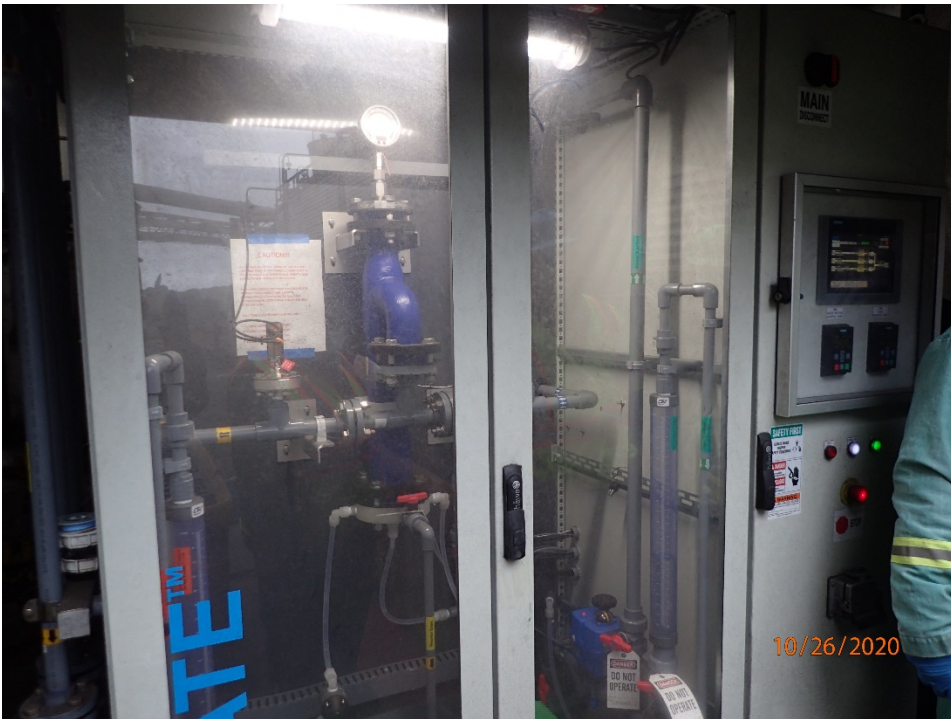
12: PA260012

Description: Chlorine Dioxide Generator creates Chlorine Dioxide on site.

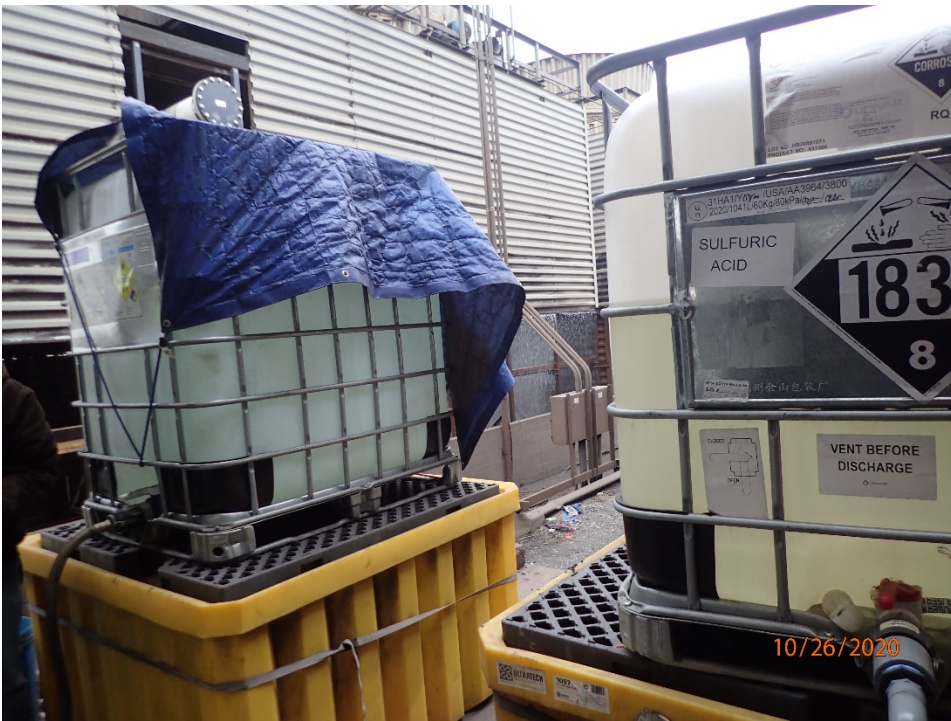
13: PA260013

Description: Chemicals used to create chlorine dioxide are stored outside in totes. Chemicals are sodium chlorate and sulfuric acid.

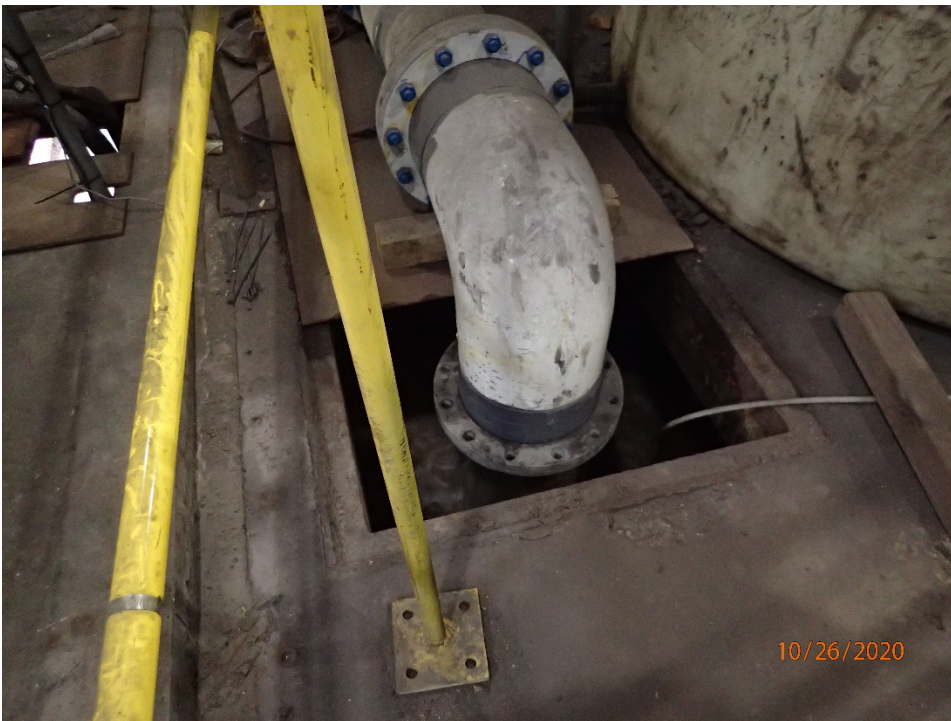
14: PA260014

Description: Chlorine dioxide is fed into Cell 6 at the Cyanide Destruct System.

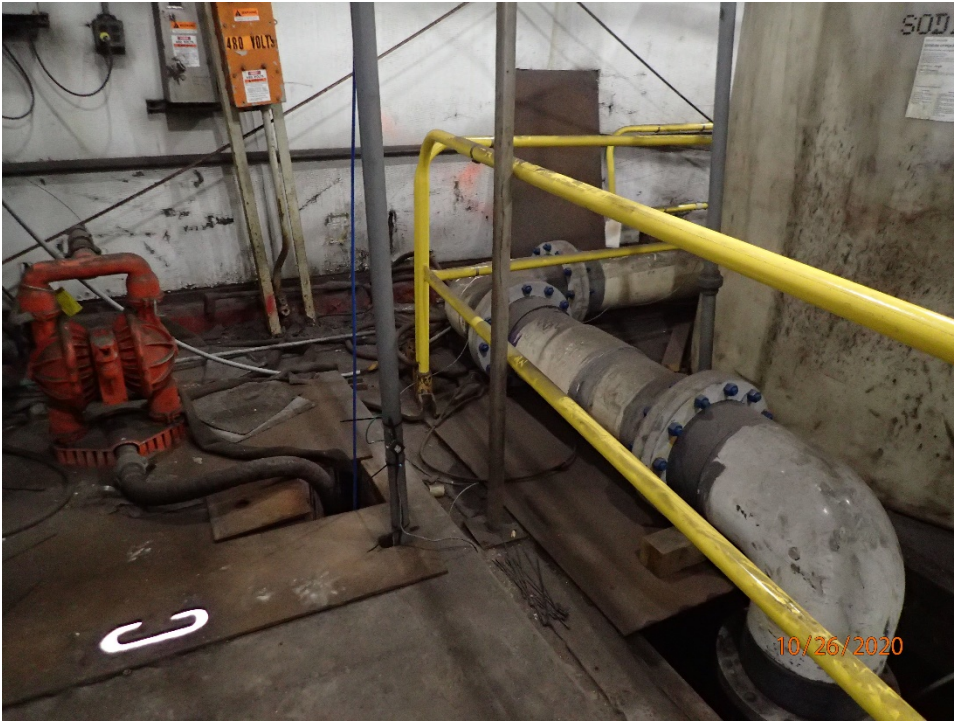
15: PA260015

Description: White pipe is coming from the cooling tower outside the building that is being used to strip ammonia from the blowdown flow.

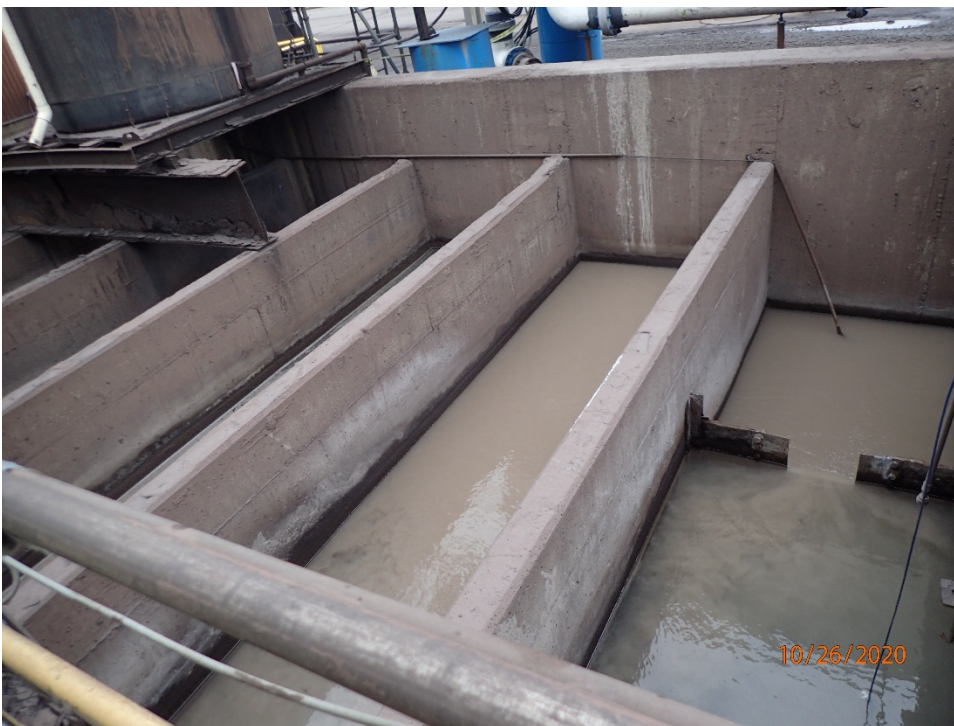
16: PA260016

Description: Cell 4 of the Cyanide Destruct System. There is a plume in the water that indicates a reaction of the chemicals in the water.

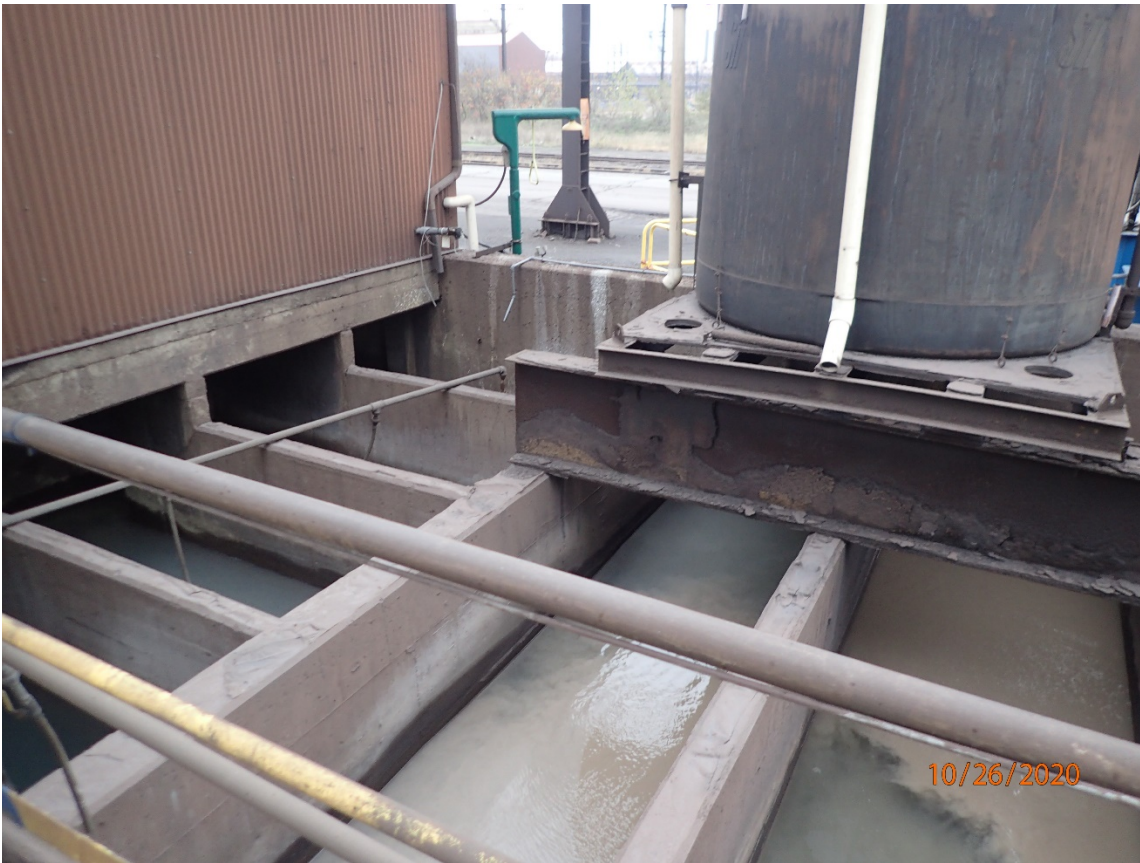
17: PA260017

Description: Cell 5 of the Cyanide Destruct System is on the left side of the photo and Cell 4 is on the right.

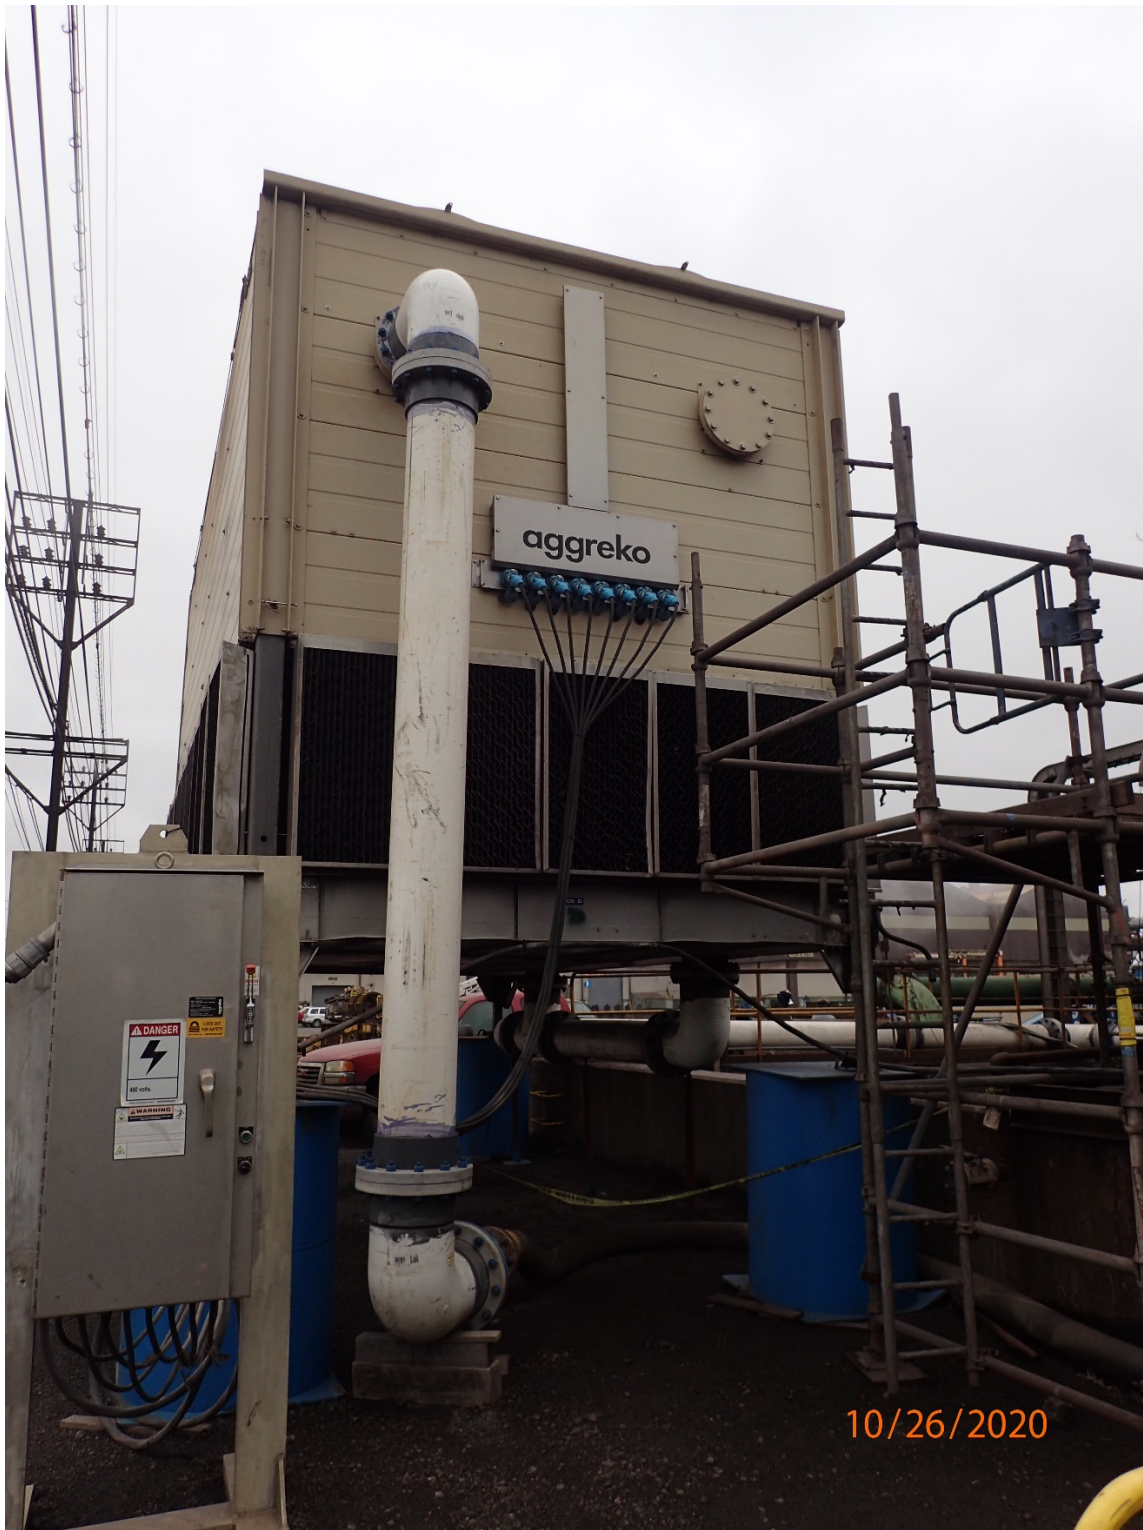
18: PA260018

Description: pH of the Blast Furnace Blowdown is raised to 10 s.u. and then lifted to the top of the cooling tower for ammonia stripping. Cooling tower was rented and installed to investigate a way to reduce ammonia from the blowdown from the Blast Furnace Recycle System.

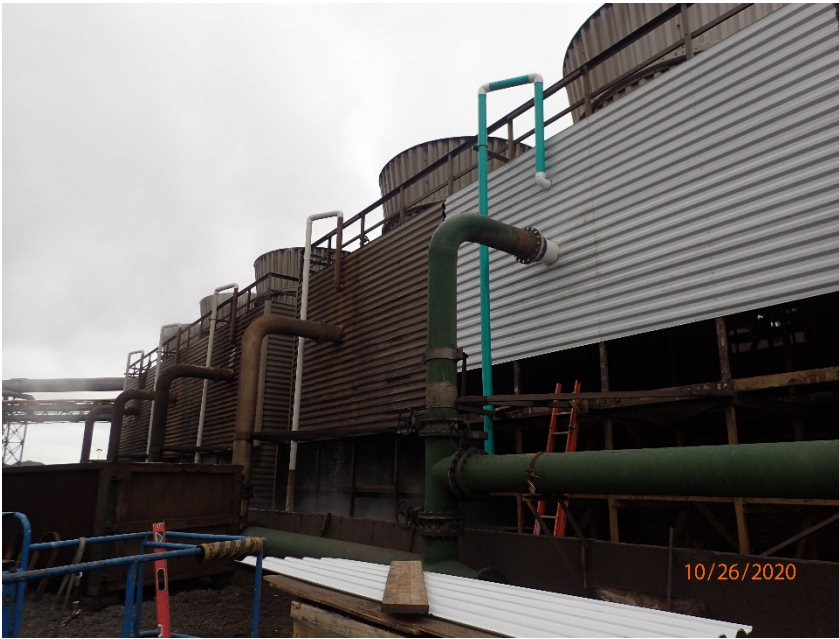
19: PA260019

While the inspection team was at the Cyanide Destruct System, EPA and IDEM observed one of the cooling towers for the BFRS was partially open and AMBH personnel described how the facility was repairing and replacing the cooling towers one at a time. Over the years, the slats of fill inside the cooling towers have become clogged from the

TSS in the recirculation water and the weight of the clogged slats has caused the inside slats to collapse. Once repaired and replaced, the cooling tower will not have fill inside anymore, but will utilize a spray nozzle to spray the water in a fine spray to cool it.

Description: Cooling Towers for the Blast Furnaces are being overhauled one at a time. The insides of the cooling towers have collapsed from the weight of the particles on the fill media inside.

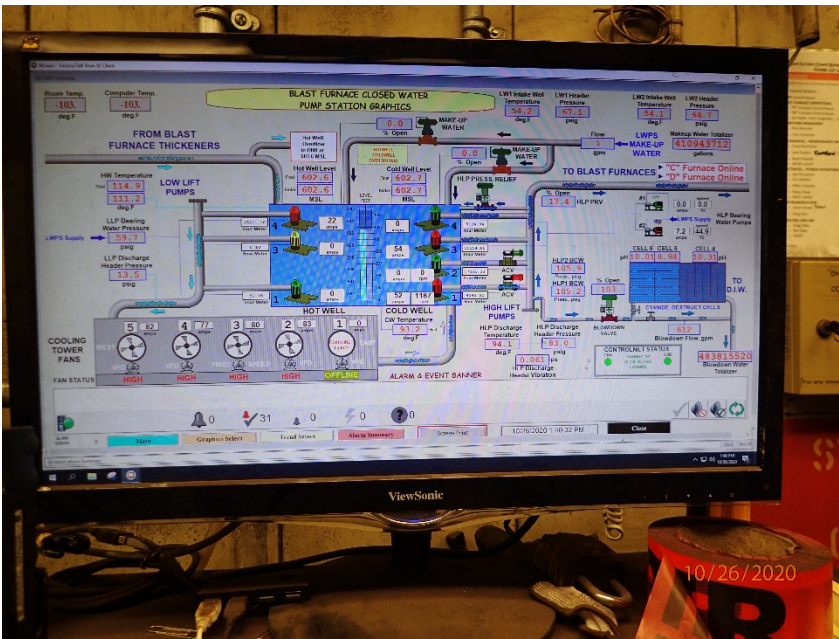
20: PA260020

Description: Blast Furnace Closed Water Pump Station Graphics Screen.
