# ***Section 17 Projects: Old Church Rock Mine and Downwind Structures***

Presenter: Eugene Esplain

**Navajo Superfund Program - Site Assessment**

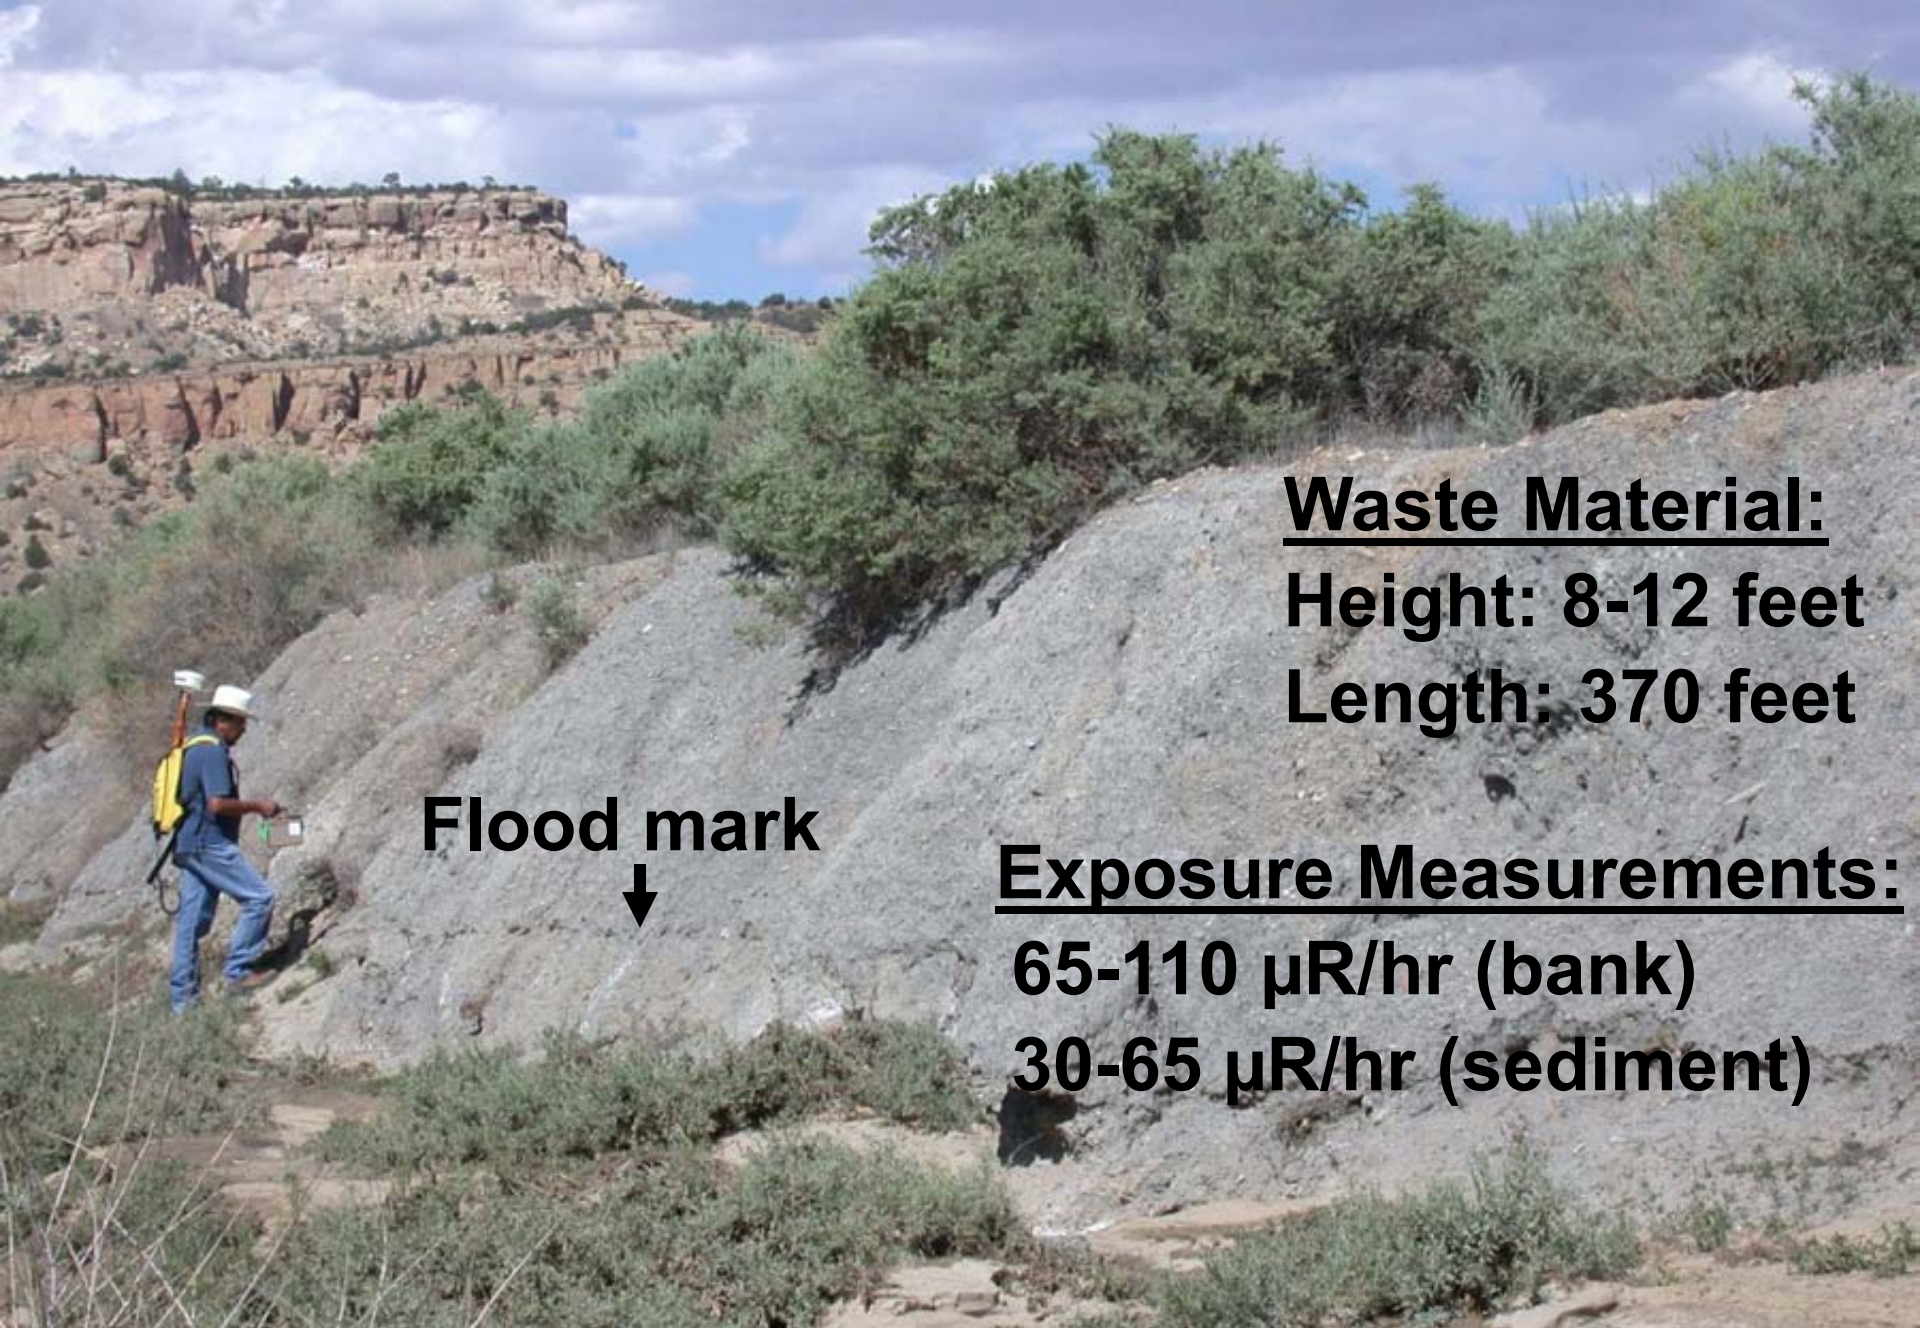
# August 2, 2006

**Waste Material:**  
**Height: 8-12 feet**  
**Length: 370 feet**

**Exposure Measurements:**  
**65-110  $\mu\text{R/hr}$  (bank)**  
**30-65  $\mu\text{R/hr}$  (sediment)**

**Background=12-15 microRoentgens per hour ( $\mu\text{R/hr}$ )**

**White Waste Material in Bank  
(Stratum: 3' thick & 30' length)**

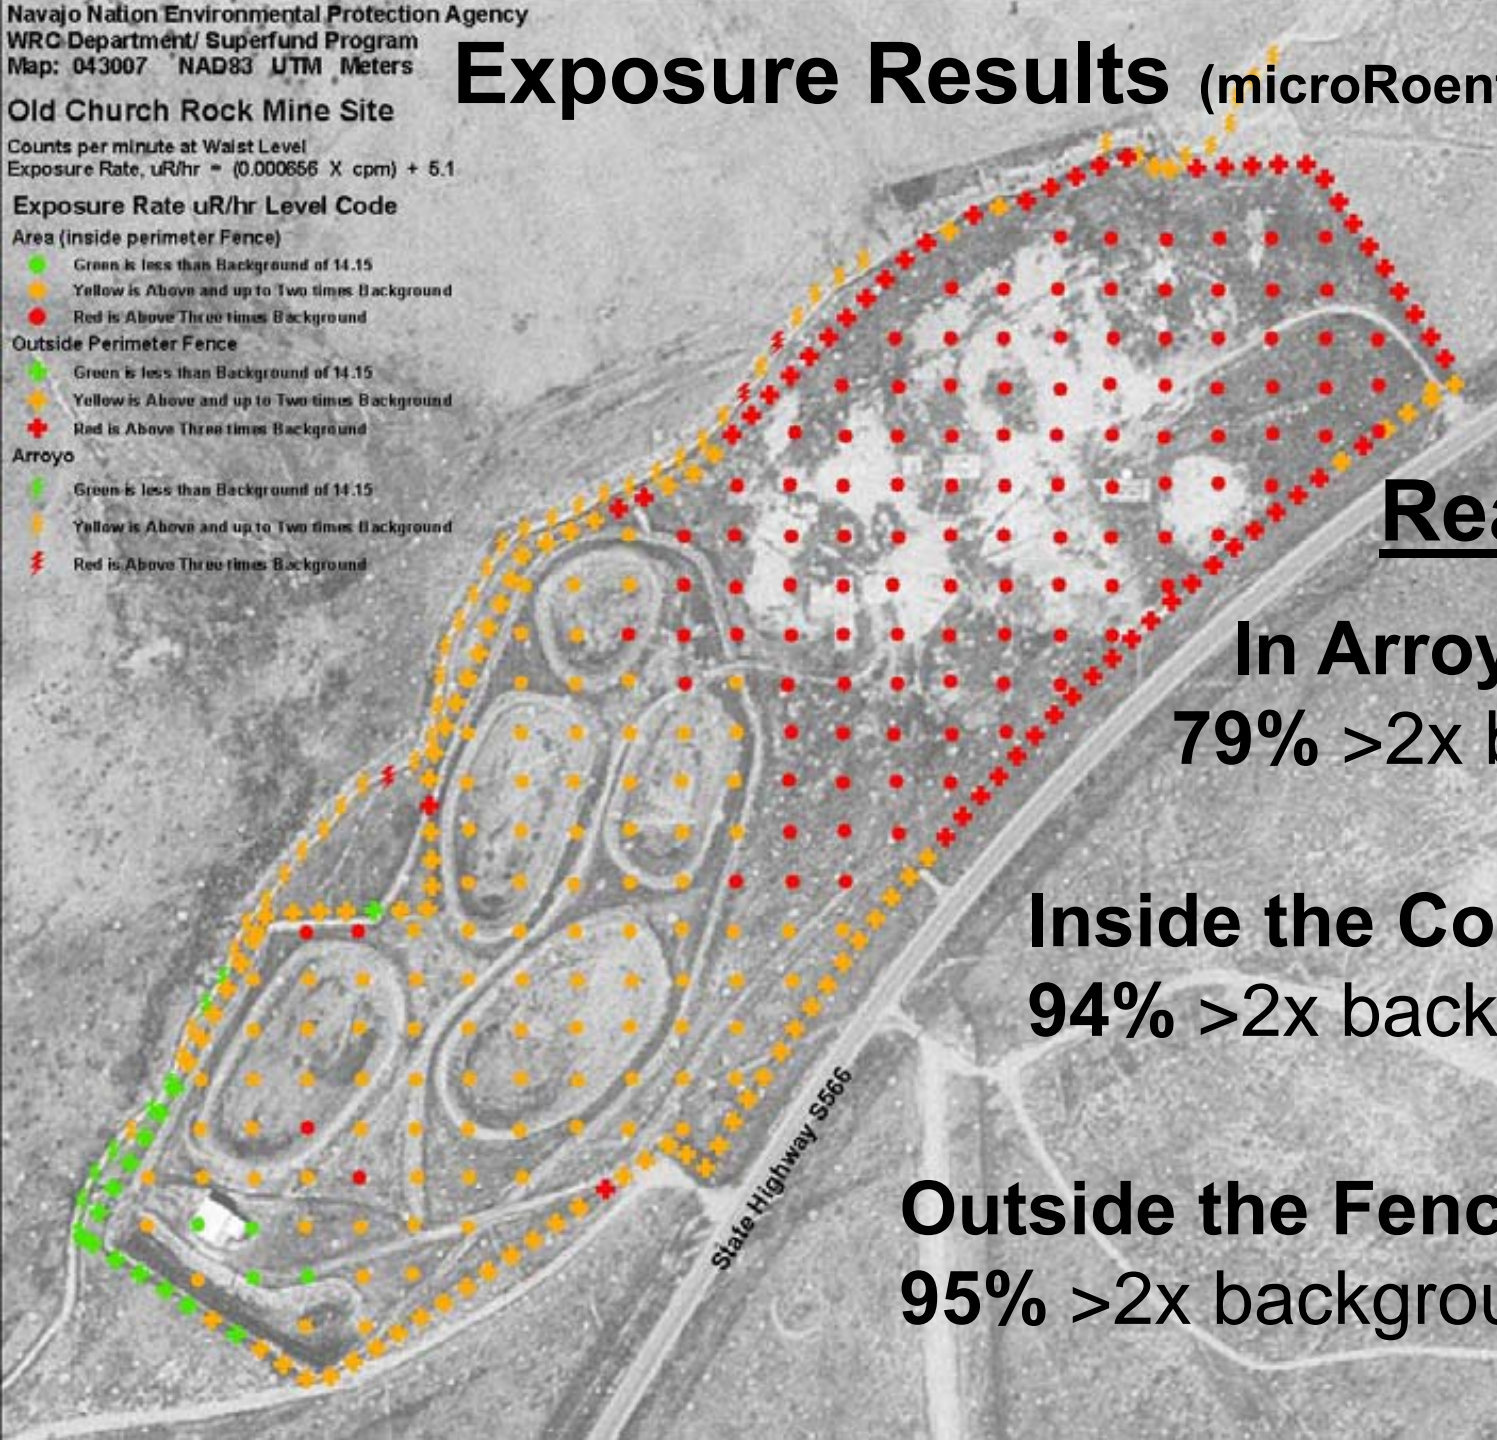
# Exposure Results (microRoentgens per hour)

## Readings:

**In Arroyo**

**79% >2x background**

**Inside the Compound**

**94% >2x background**

**Outside the Fence Line**

**95% >2x background**

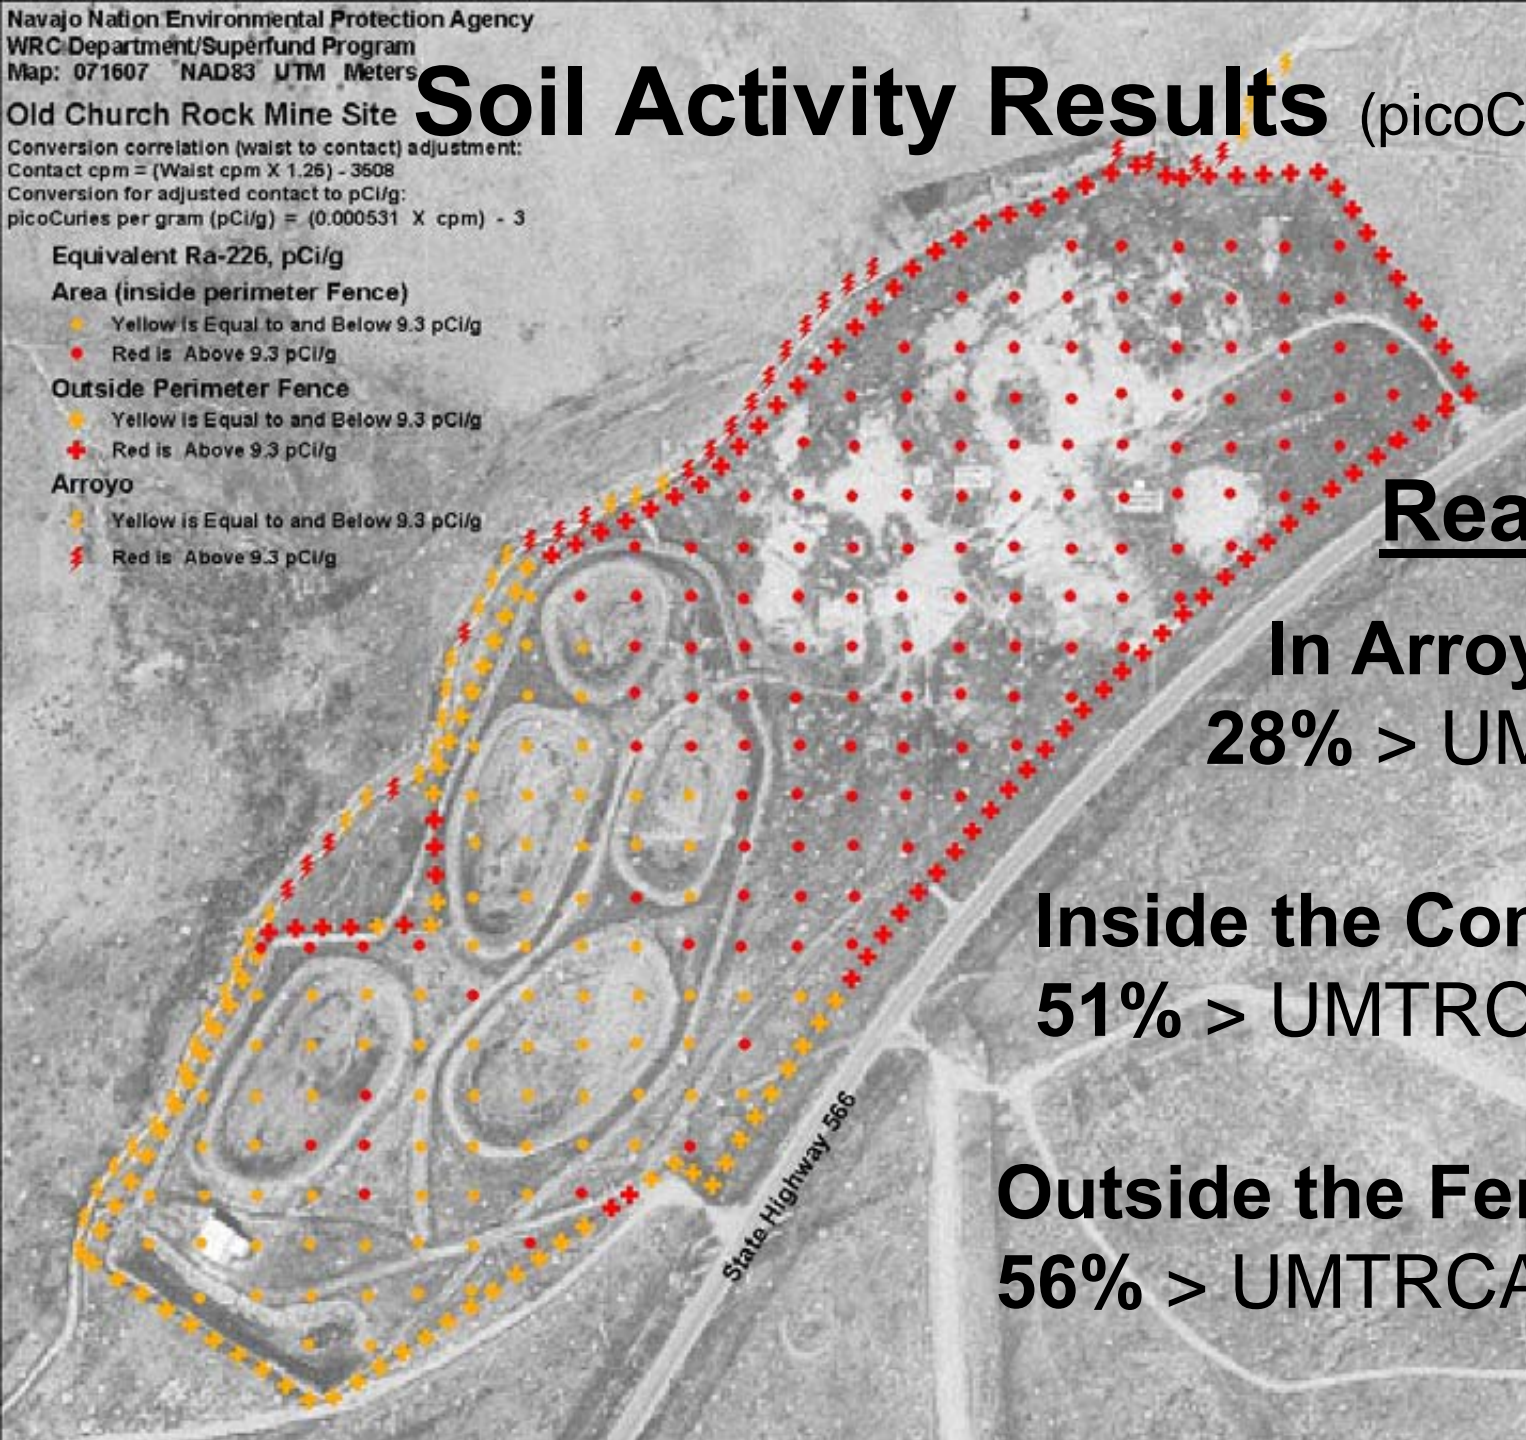
# Soil Activity Results (picoCurie per gram)

## Readings:

**In Arroyo**

**28% > UMTRCA std.**

**Inside the Compound**

**51% > UMTRCA standard**

**Outside the Fence Line**

**56% > UMTRCA standard**

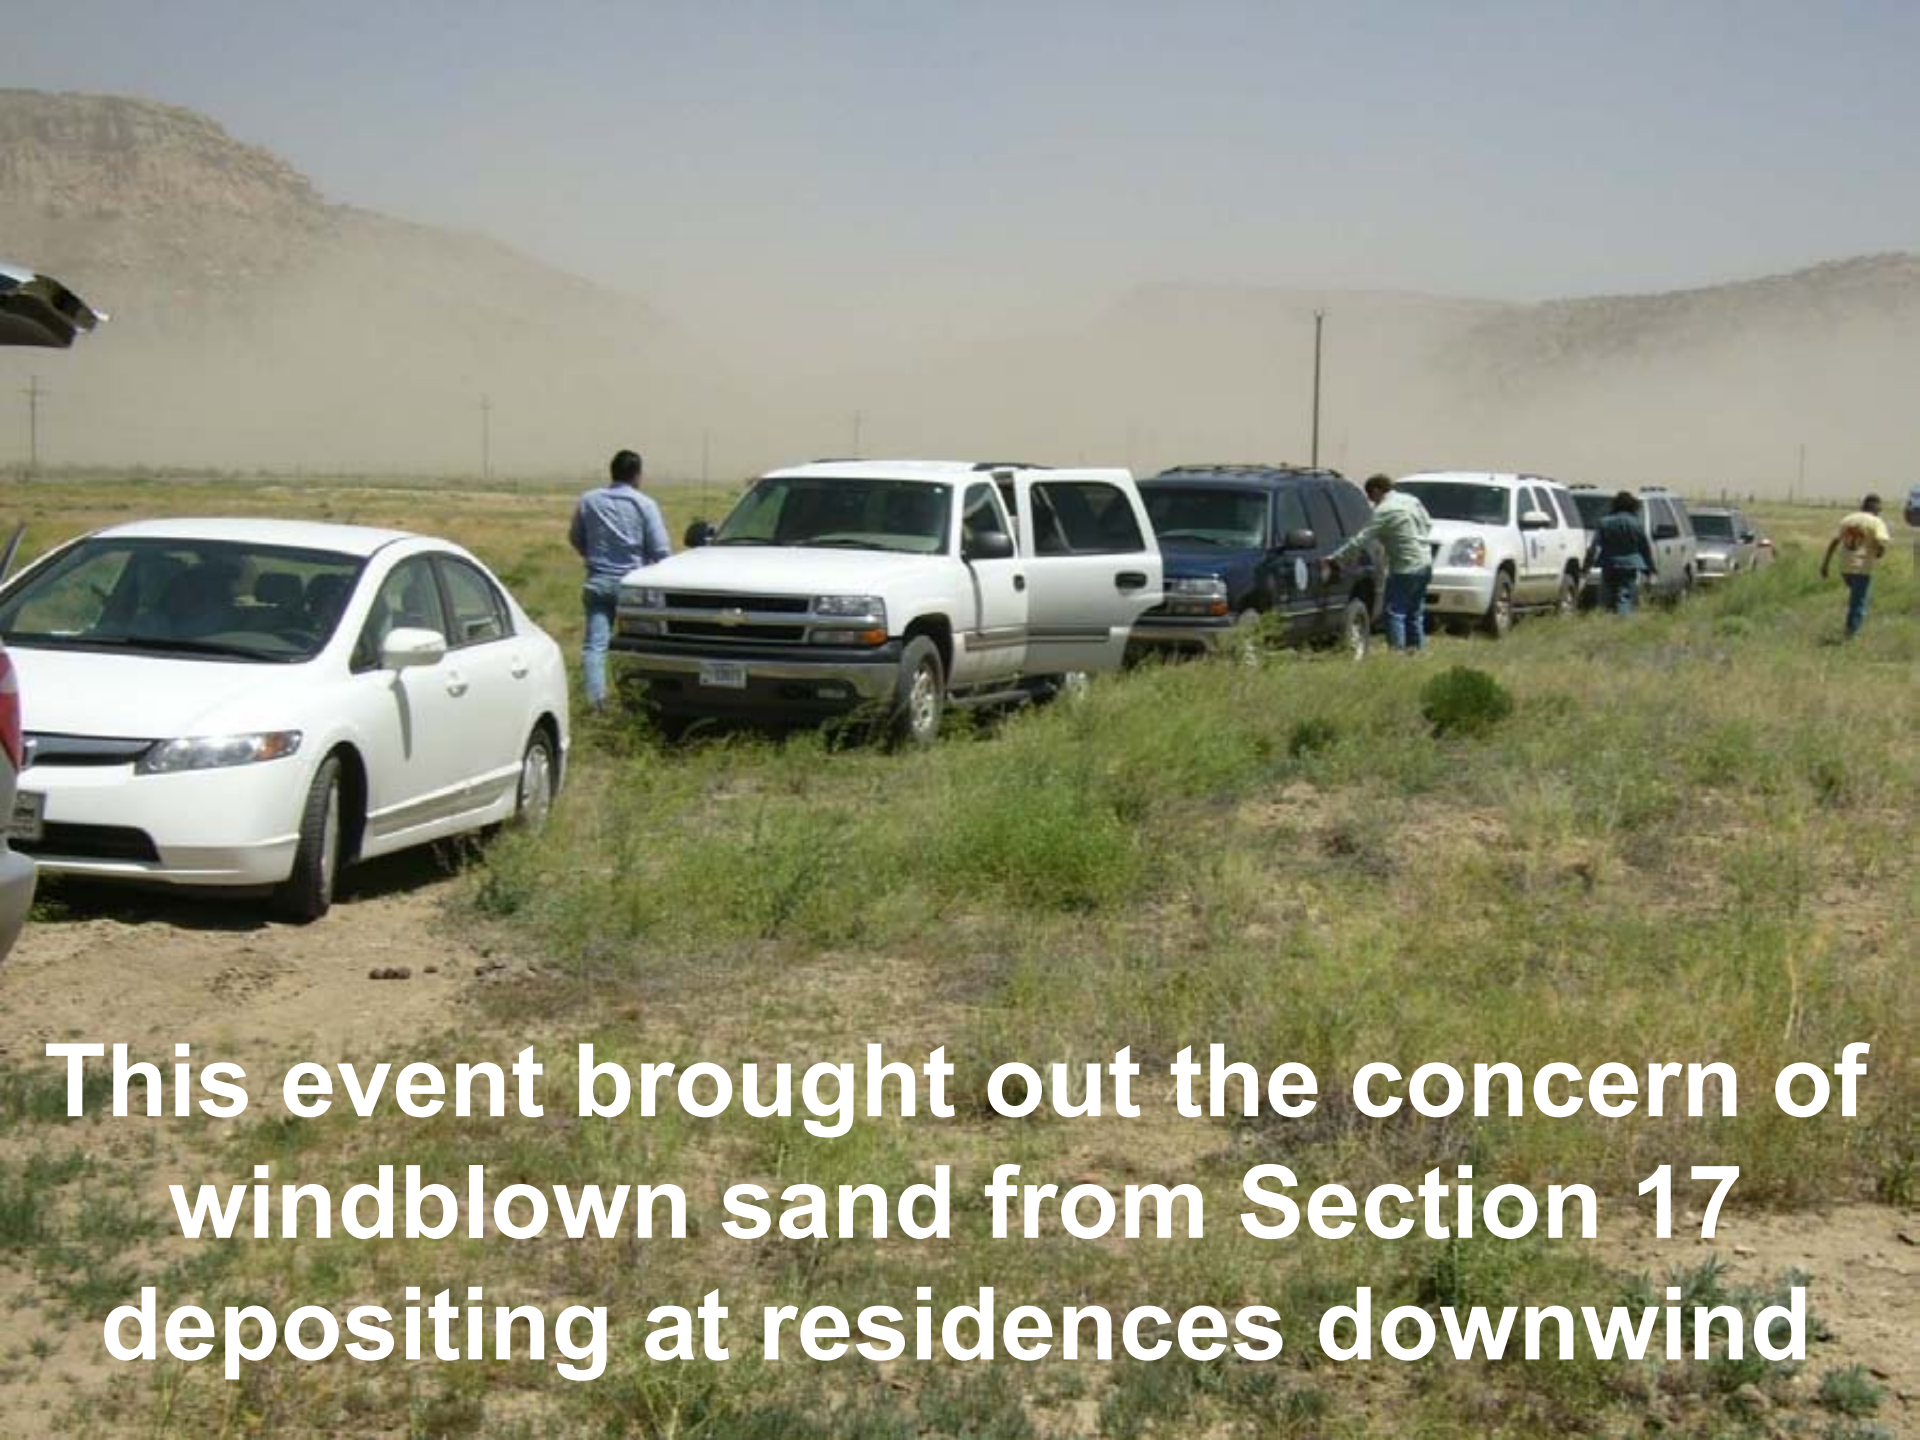
**This event brought out the concern of  
windblown sand from Section 17  
depositing at residences downwind**
