Navajo Abandoned Uranium Mine Site Screen Report

NE Churchrock Quivira Mines (No. 1)

Navajo AUM Eastern Region

May 2009

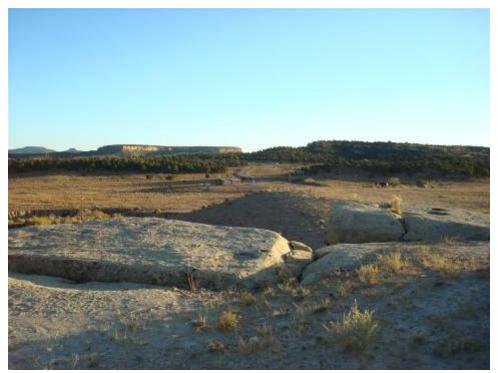
Photo 1: NE Churchrock Quivira Mines (No.1) site, towards the south

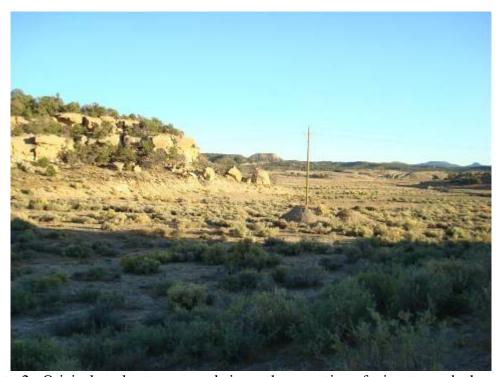
Photo 2: Original grade at power pole in northern portion of mine, towards the north

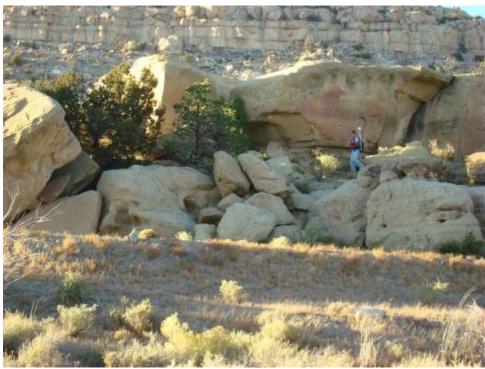
Photo 3: Survey of western mine boundary, towards the north

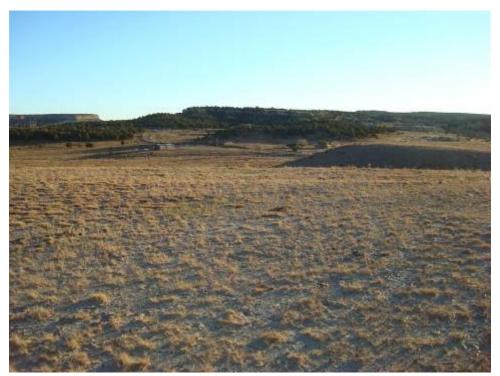
Photo 4: Southern portion of mine and residence located to the south

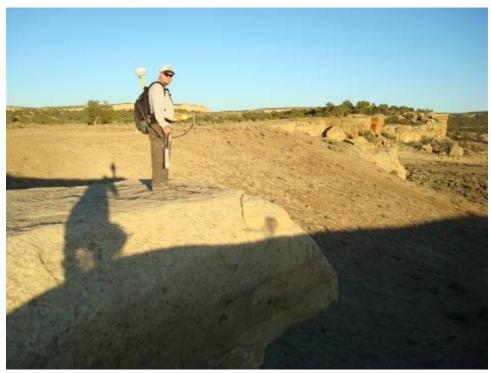
Photo 5: Survey of central portion of mine towards the east

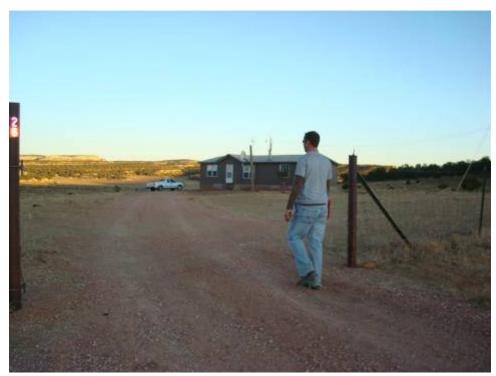
Photo 6: Nearest residence located south of the mine.

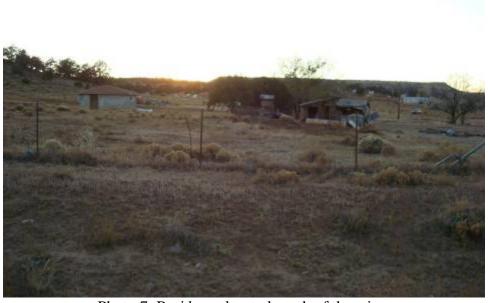
Photo 7: Residence located south of the mine.

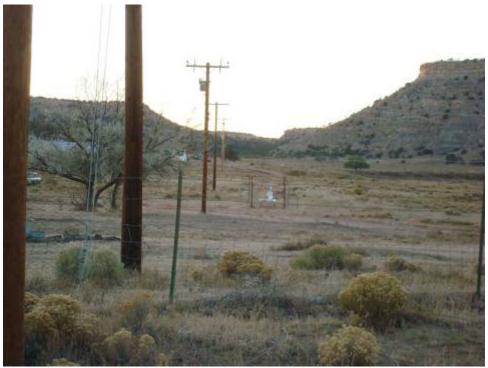
Photo 8: Well located between residences and mine.

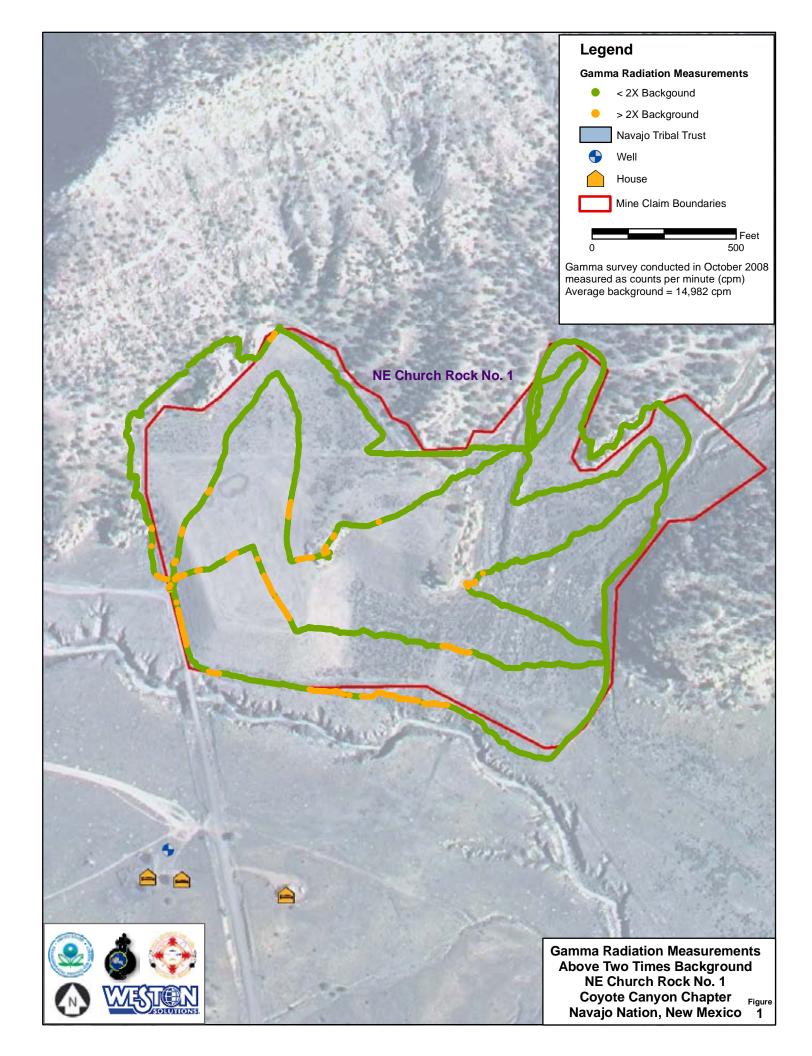
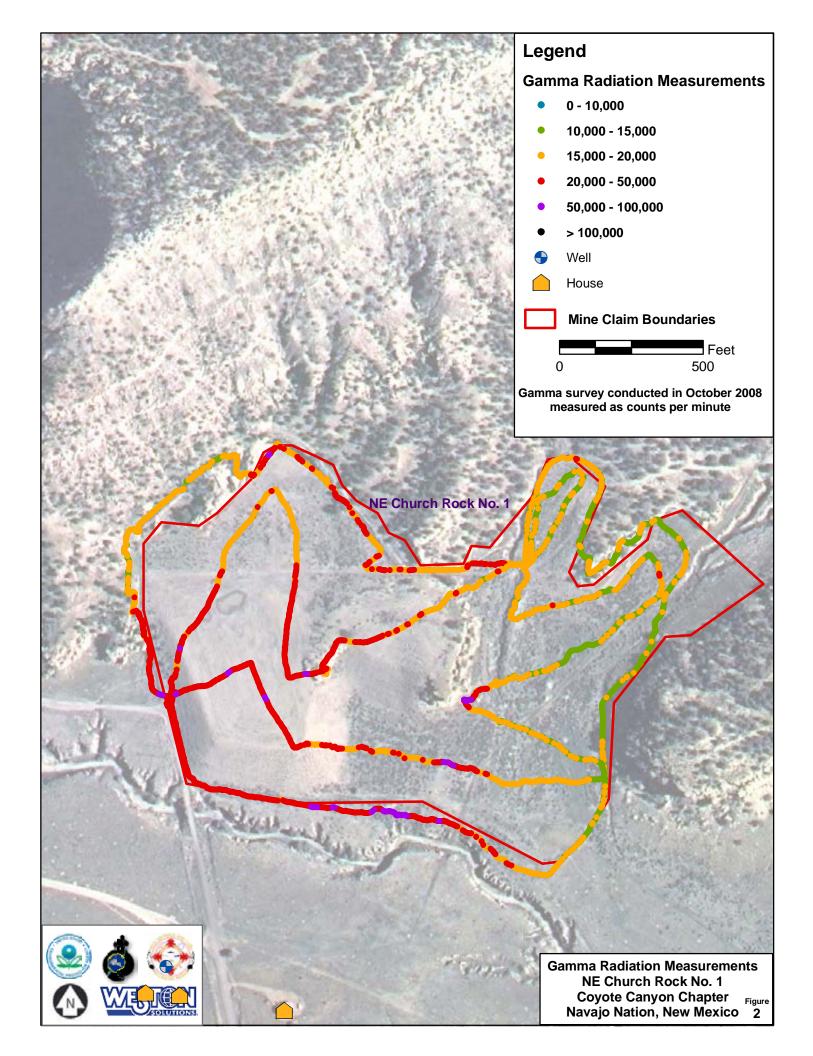
A total of 5,278 gamma radiation measurements were collected from mine sites, ranging from 10,249 cpm to 79,431 cpm. The measurements are represented in Figures 1 and 2.
