## **Appendix D**

### **Construction Program Site Visit Reports**

### **Thomes Creek Bridge Project Site Visit Date: 10/13/2009**

**Caltrans MS4 (SWRCB Order No. 99-06-DWQ)**  
**Thomes Creek Bridge Project**  
**Caltrans District 2**

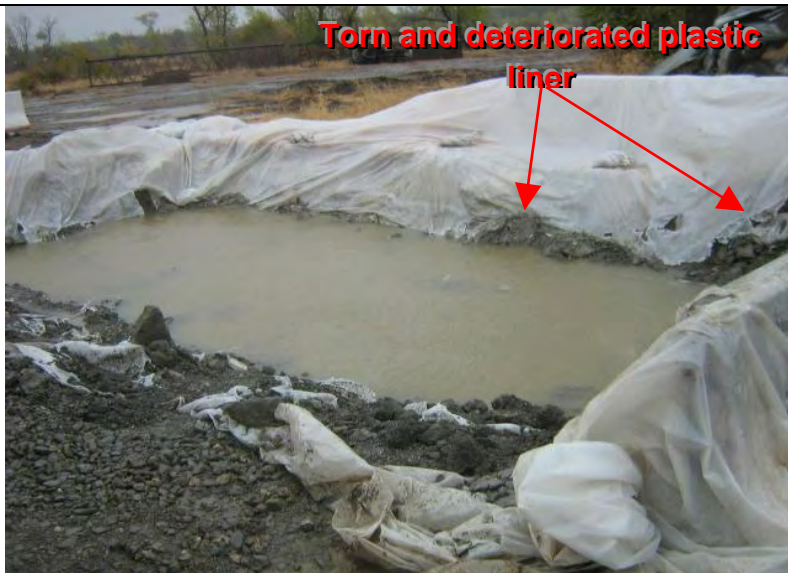
Photograph 1 – Concrete washout unmaintained (e.g., torn and deteriorated plastic liner)

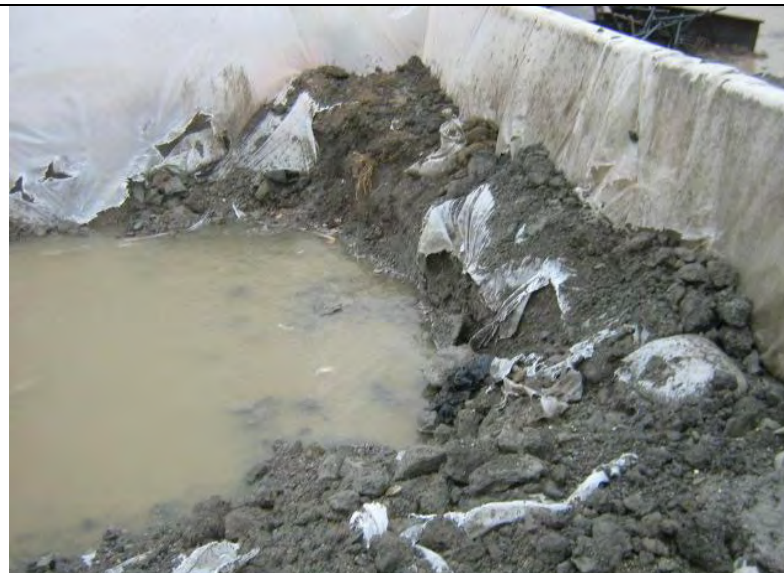
Photograph 2 – Close-up view of unmaintained (e.g., torn and deteriorated) concrete washout plastic liner

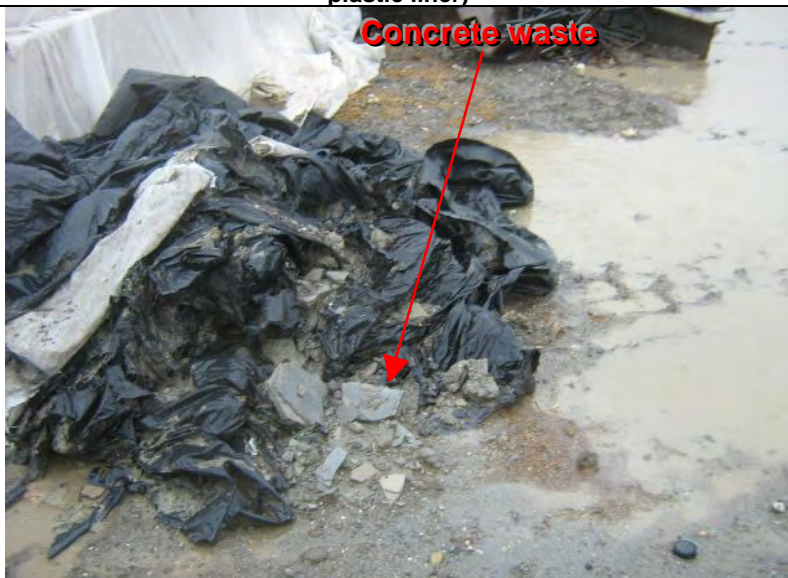
Photograph 3 – Concrete waste on the ground surface directly adjacent to the concrete washout

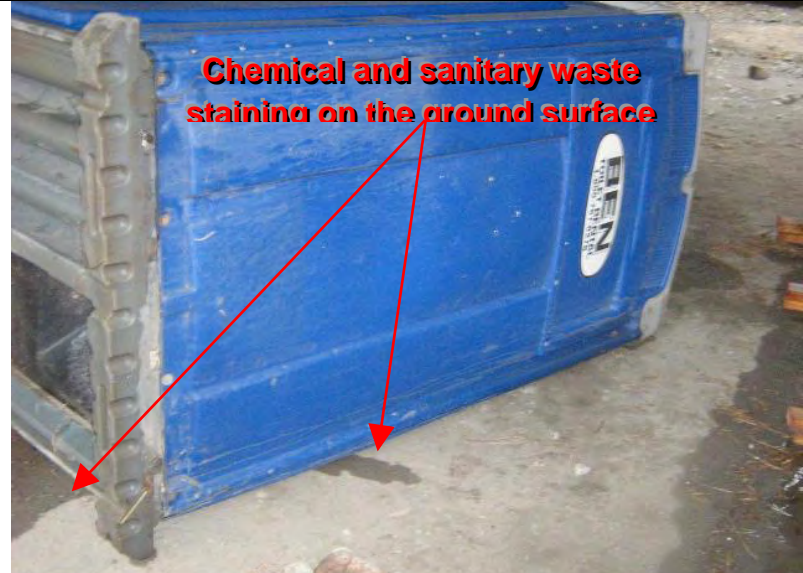
Photograph 14 – Visible chemical and sanitary waste staining on the ground surface

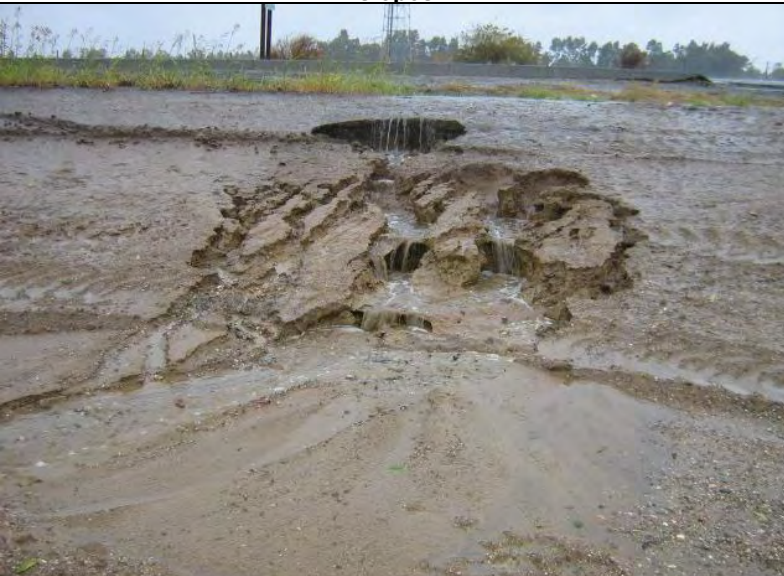
**Photograph 3 – Sediment basin embankment slope erosion (e.g., gulley formation) and failure**

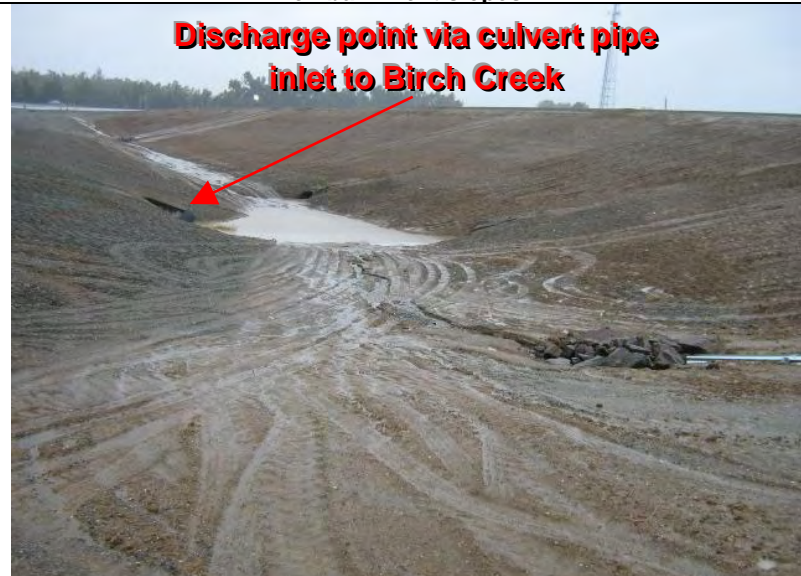
**Photograph 4 – Adequate BMPs had not been implemented to prevent the discharge of sediment to the culvert inlet/drainage pipe leading to Birch Cr.**

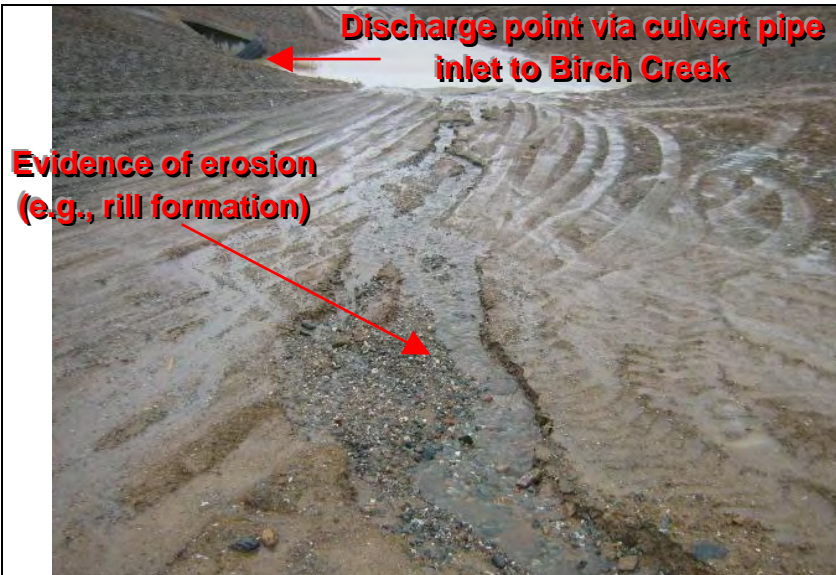
Photograph 5— Close-up of area in Photograph 4 depicting erosion (e.g., rill formation) and inadequate BMPs located adjacent to discharge point

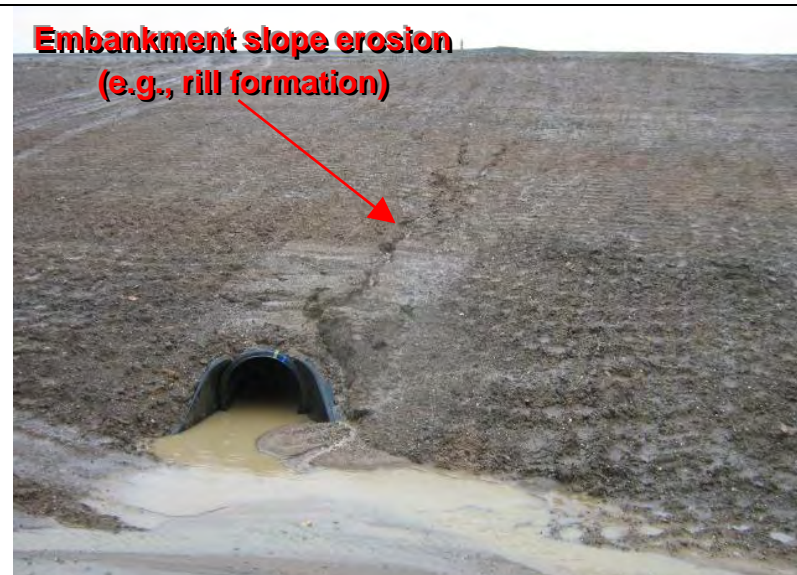
Photograph 6 – Embankment slope erosion (e.g., rill formation)

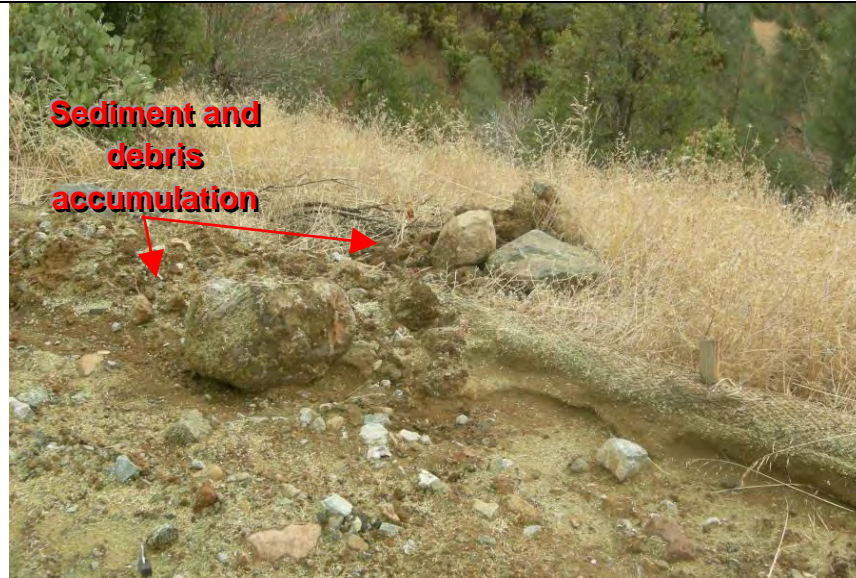
Photograph 1 – Perimeter control failure at the former staging area

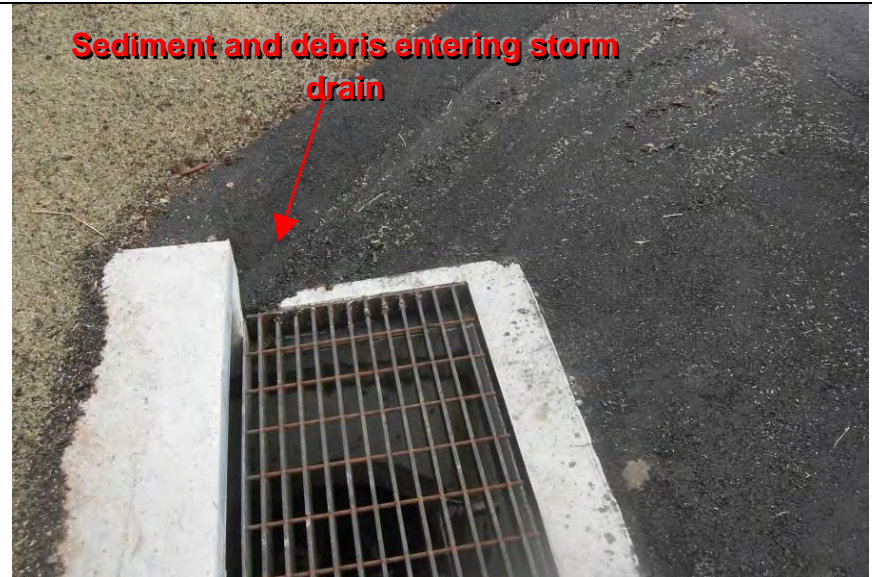
Photograph 4 – Storm drain located on the west side of Highway 299

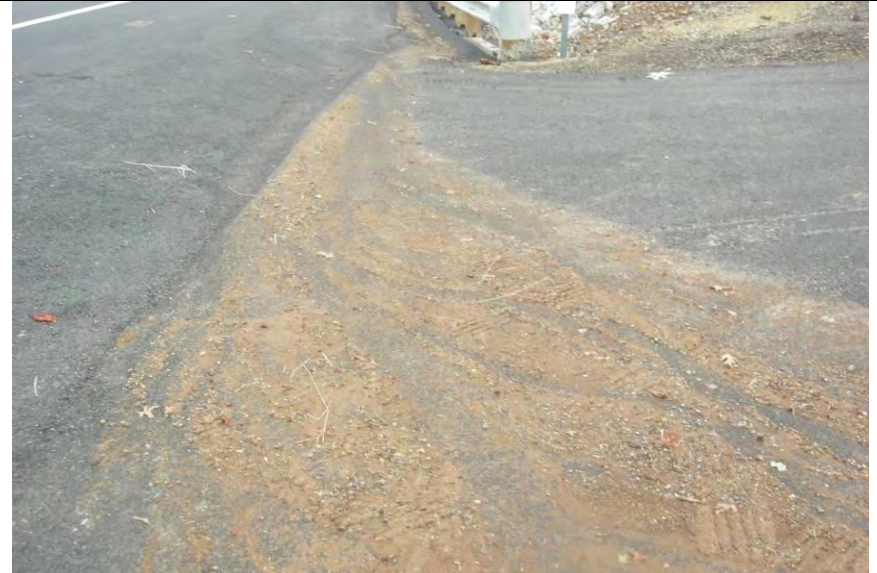
In addition, BMPs were not adequately implemented on the disturbed slope along the south side of the sound wall to prevent sediment discharge (see Photographs 5 and 6). Furthermore, sediment accumulation was observed along the flow path of a rock lined drainage swale leading to a down-gradient drainage pipe (see Photographs 7 and 8). The straw wattles utilized at the down-gradient drainage pipe inlet were not adequately maintained.

Photograph 6 – Sediment discharge along the highway from Photograph 5

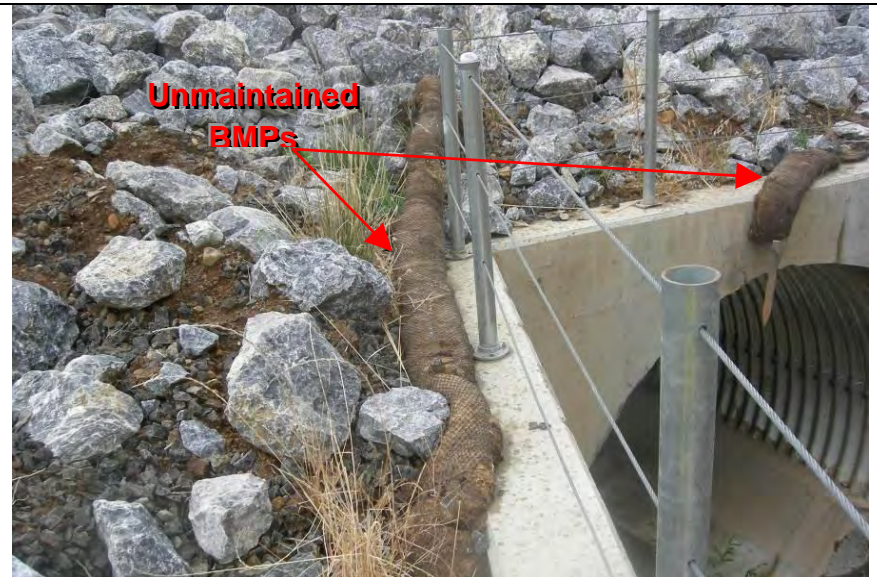
Photograph 8 – Inadequate straw wattle BMP maintenance at drainage pipe inlet

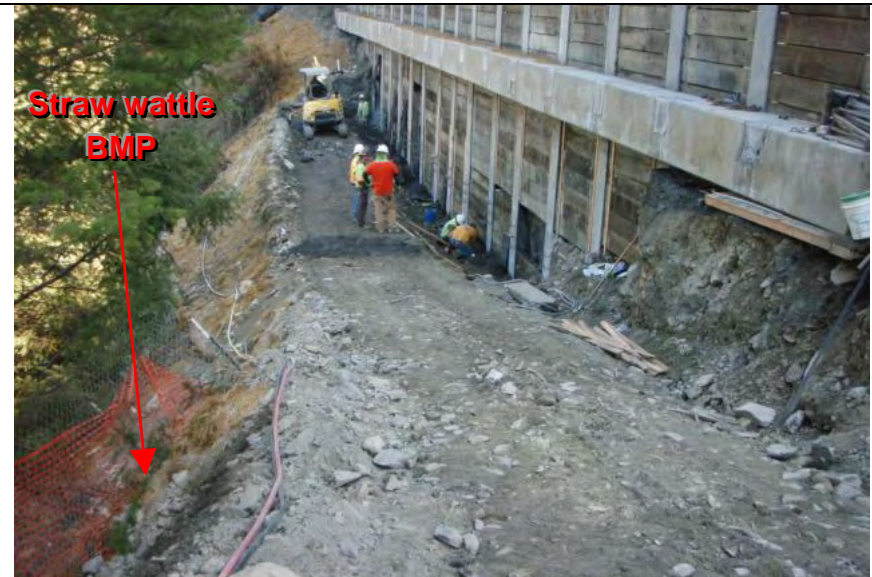
Photograph 2 – Example of straw wattle BMP implemented down-gradient of disturbance and retaining wall construction

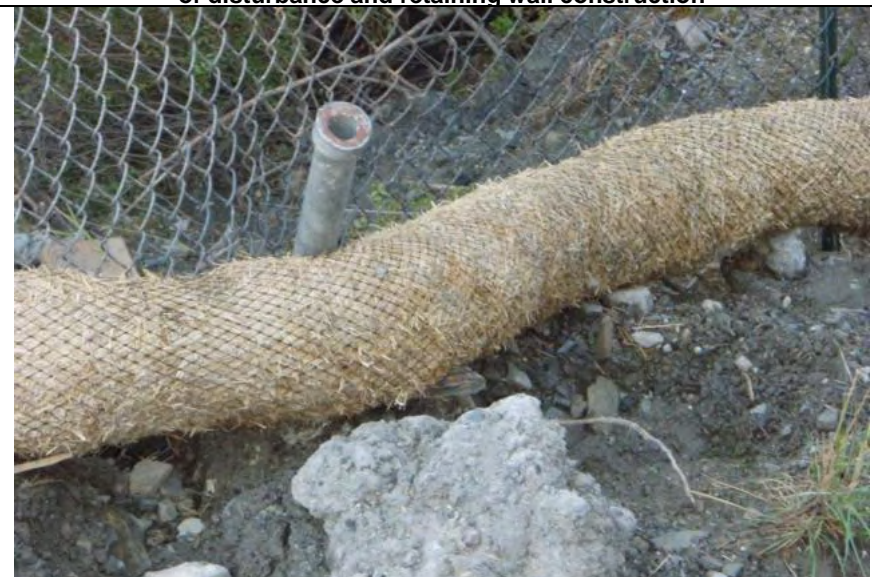
Photograph 4 – Close-up view of fiber roll not entrenched or staked into the ground

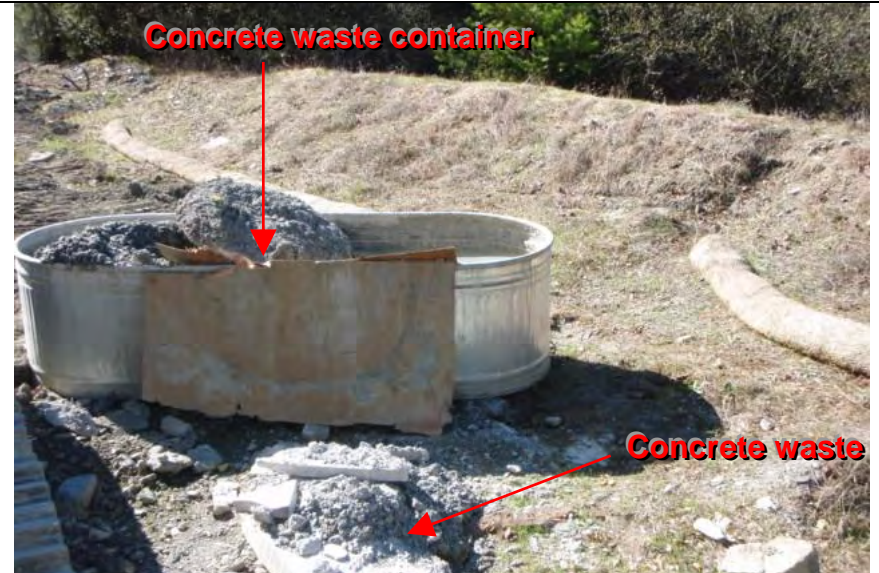
Photograph 10— Concrete waste and container in staging area (Note: Straw wattle BMP not staked or entrenched into ground)

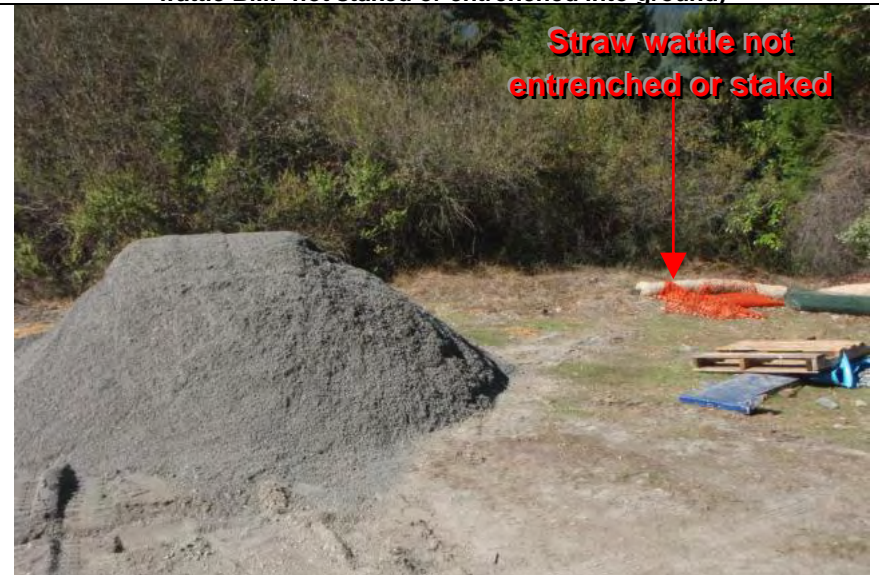
Photograph 12— Stockpile in staging area without BMPs for containment or coverage

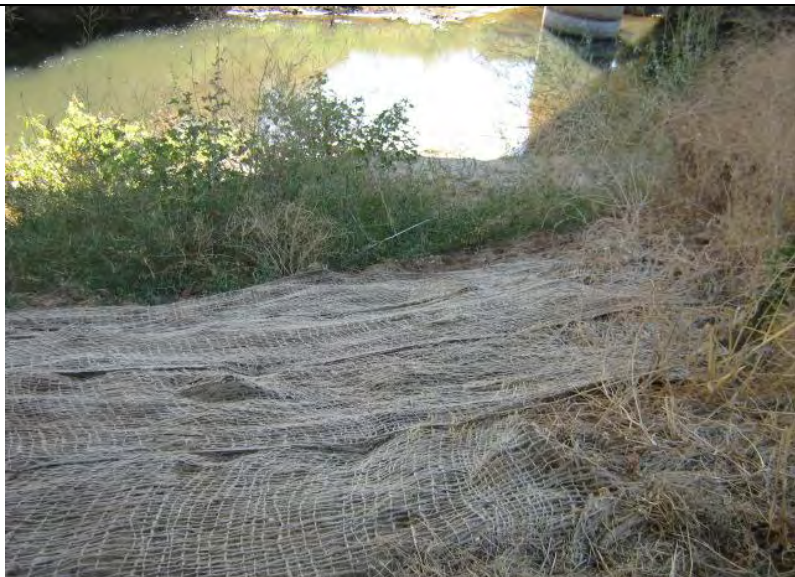
**Photograph 1 – Erosion control blanket not properly installed (e.g., improper overlap – not shingled downgradient) adj. to Bear River at top.**

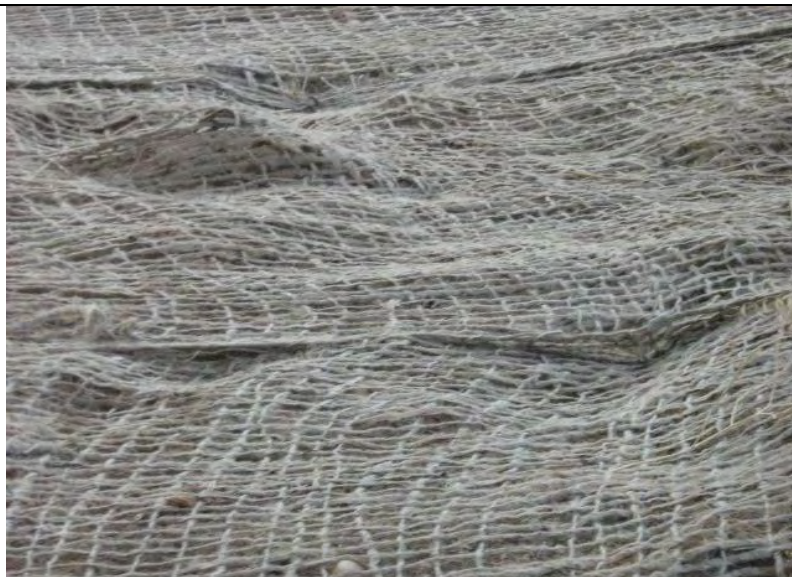
**Photograph 2 – Close-up of Photograph 1 looking down-gradient.**

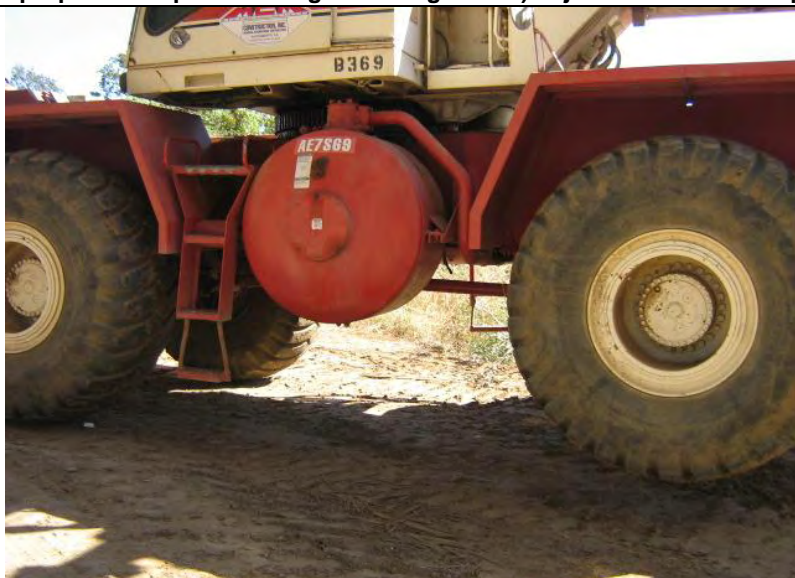
**Photograph 3 – Equipment with petroleum product leaking onto ground surface (see Photograph 4 for close-up view).**

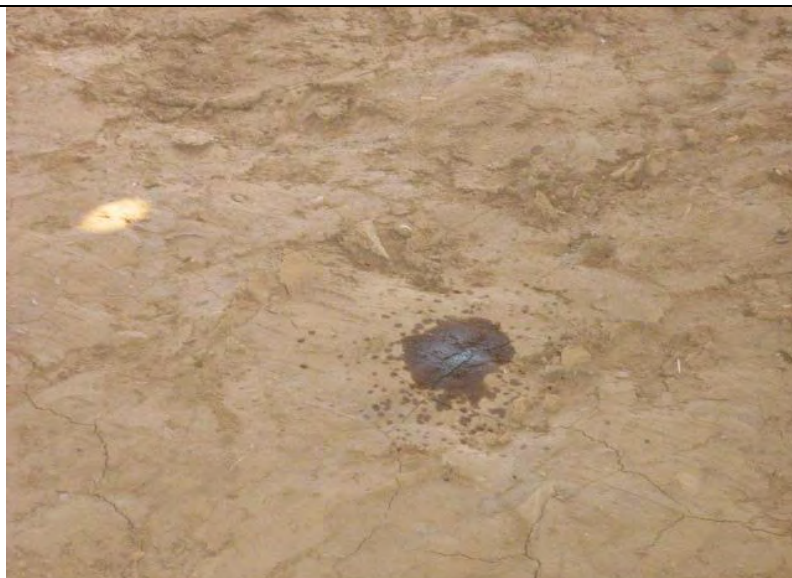
**Photograph 4 – Close-up view of petroleum product on ground surface**

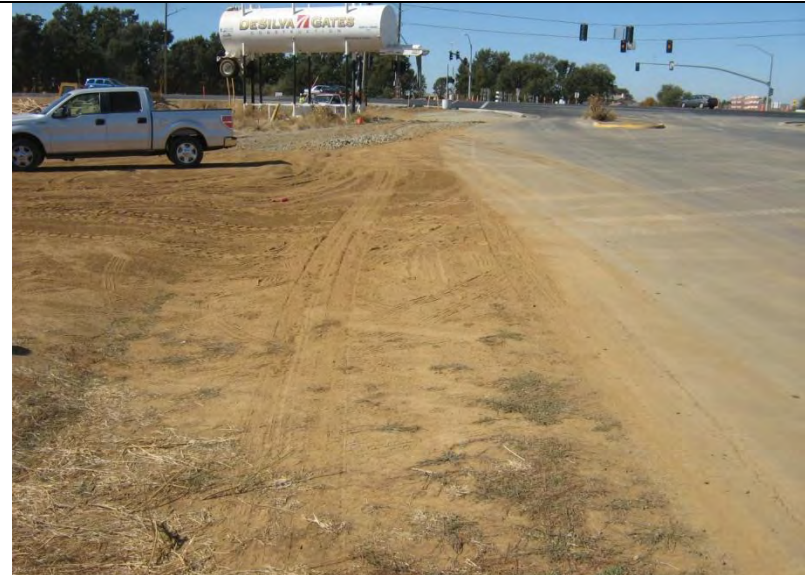
**Photograph 12 – Tracking control BMPs not implemented for disturbed area of contractor parking. Observed sediment transport to roadway**

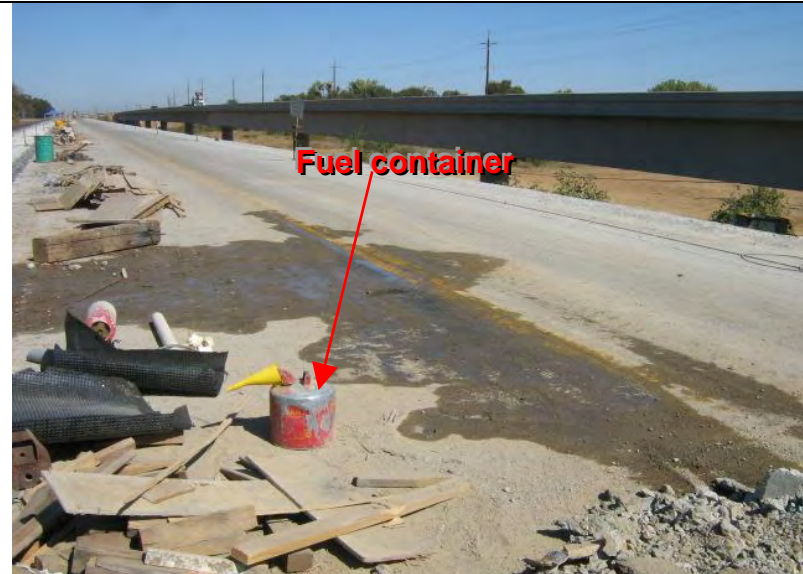
Photograph 18 – Inadequate materials handling and storage

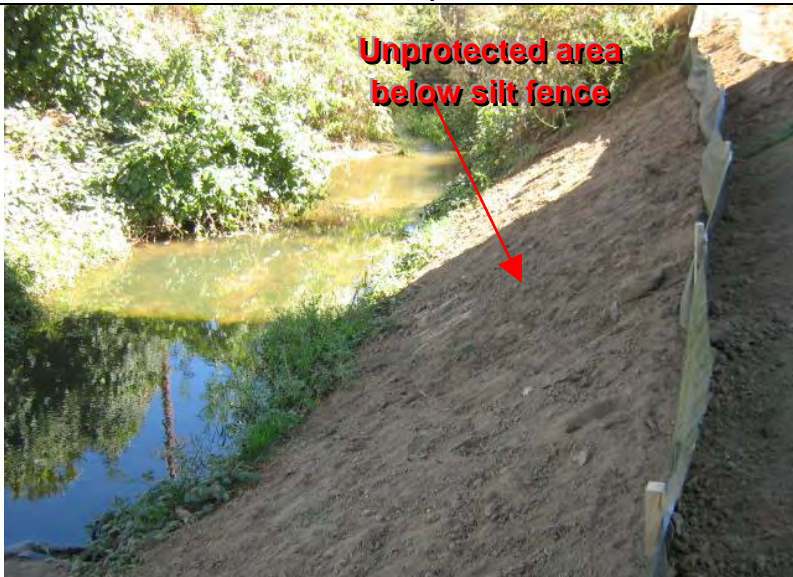
Photograph 19 – Unstabilized slope area adjacent to Yankee Slough

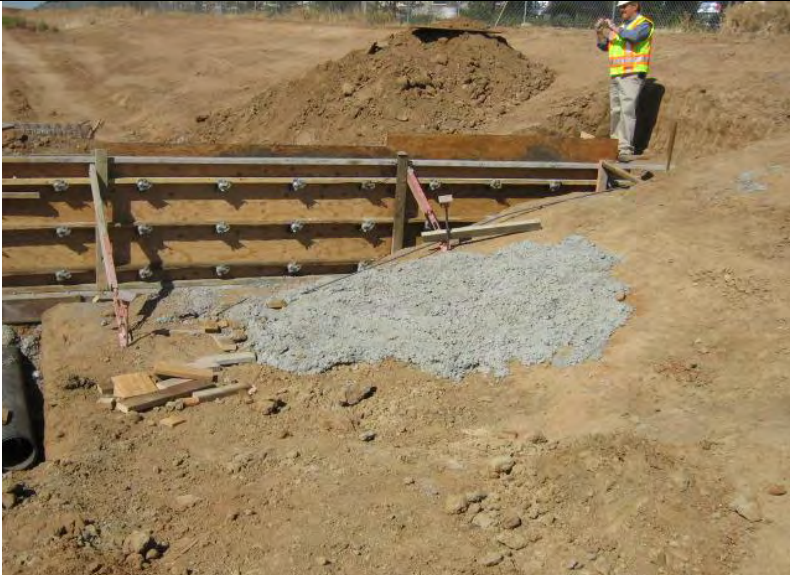
Photograph 1 – Improper concrete waste disposal practices

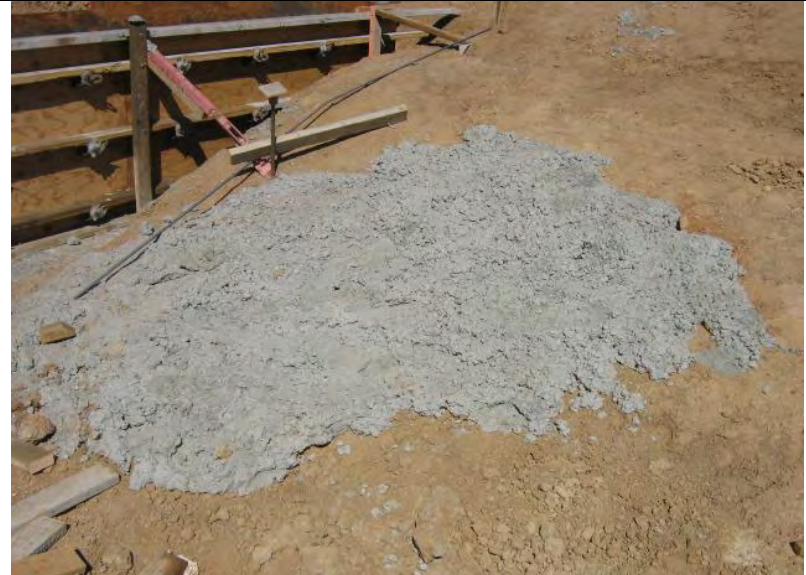
Photograph 2 – Close-up of Photograph 1

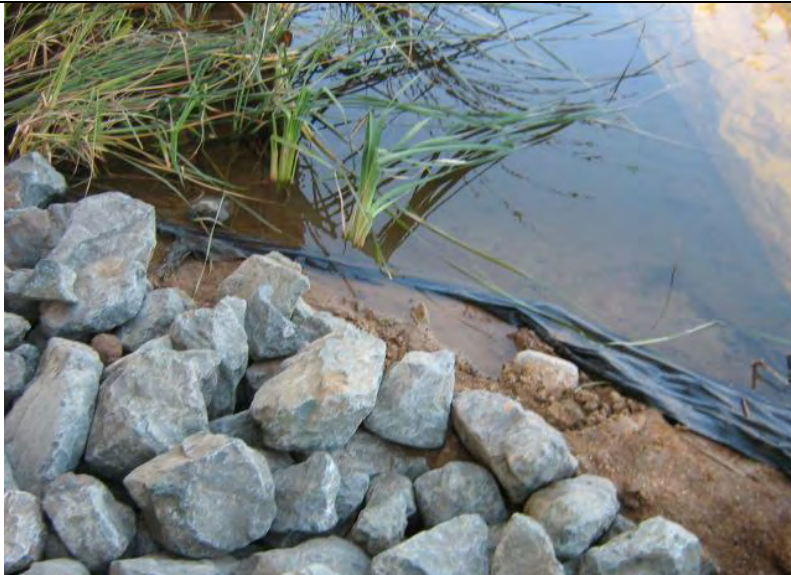
**Photograph 7 – Badly deteriorated silt fence BMP located in/adjacent to North Ingram Slough**

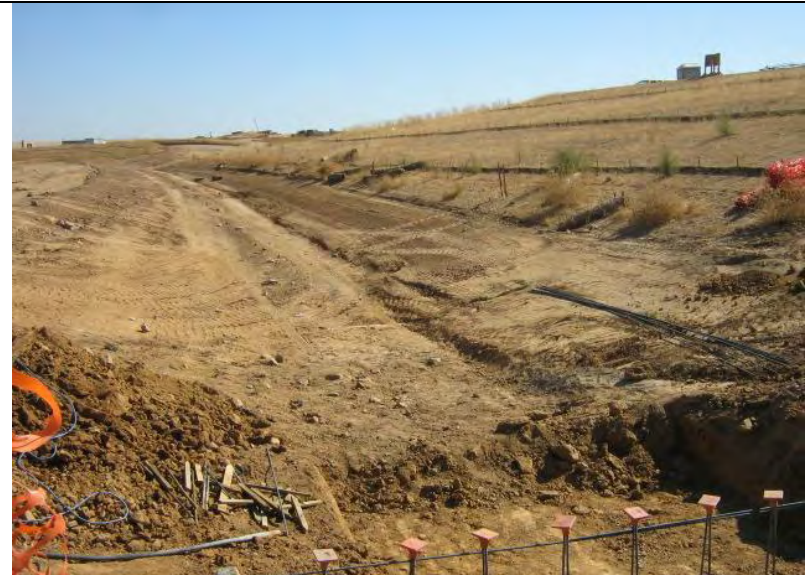
**Photograph 8 – Disturbed conveyance channel with no slope run-on BMPs or erosion and sediment control BMPs near the S. Ingram Slough.**

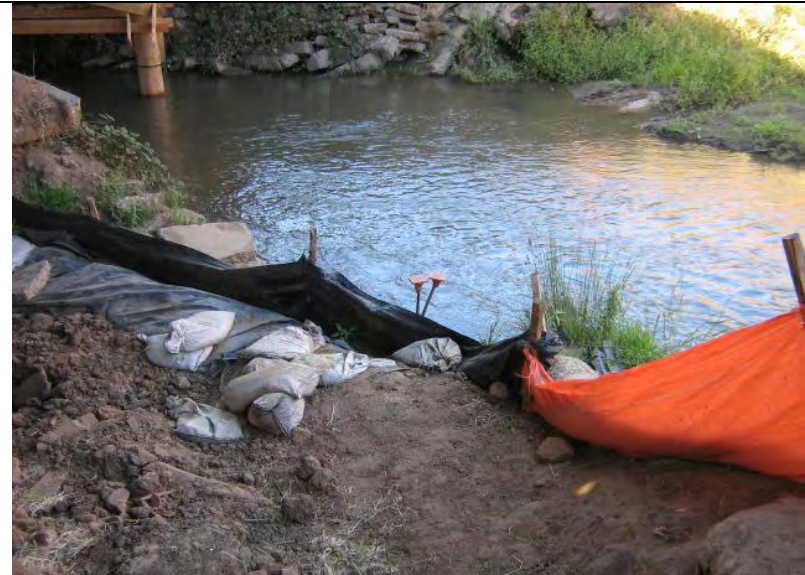
**Photograph 12 – Silt Fence BMP not adequately maintained (e.g., down in areas; deteriorated) adjacent to Auburn Ravine**

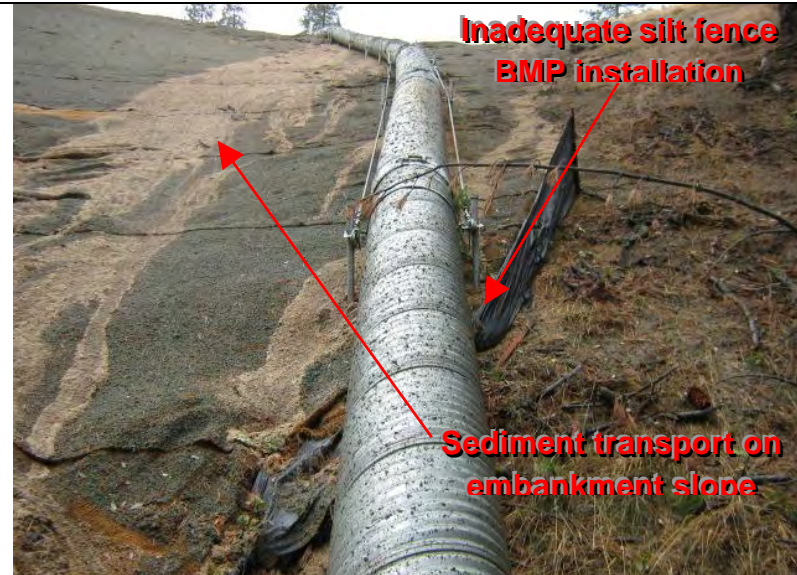
Photograph 14 – Evidence of sediment transport on the embankment slope of the field constructed sediment basin No. 2. Inadequate silt fence BMP installation under culvert pipe

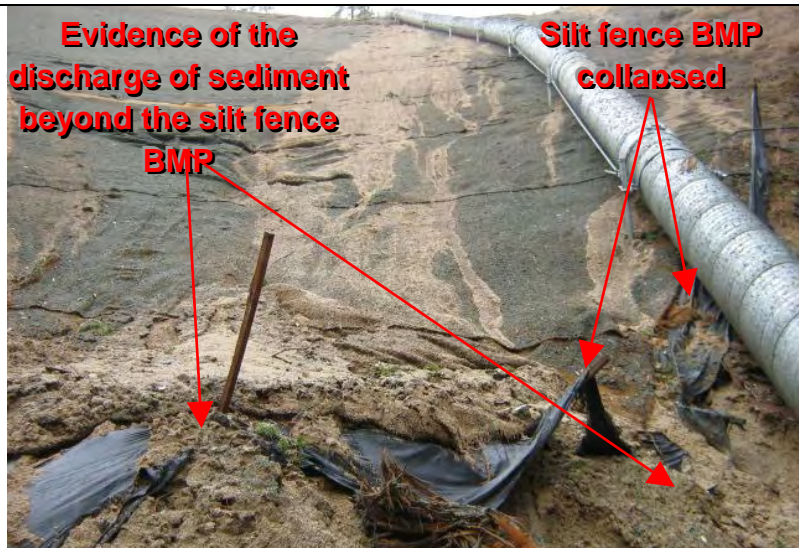
Photograph 15—SF BMPs were not adequately maintained (e.g., collapsed in areas) to prevent the discharge of sediment to the unnamed tributary.

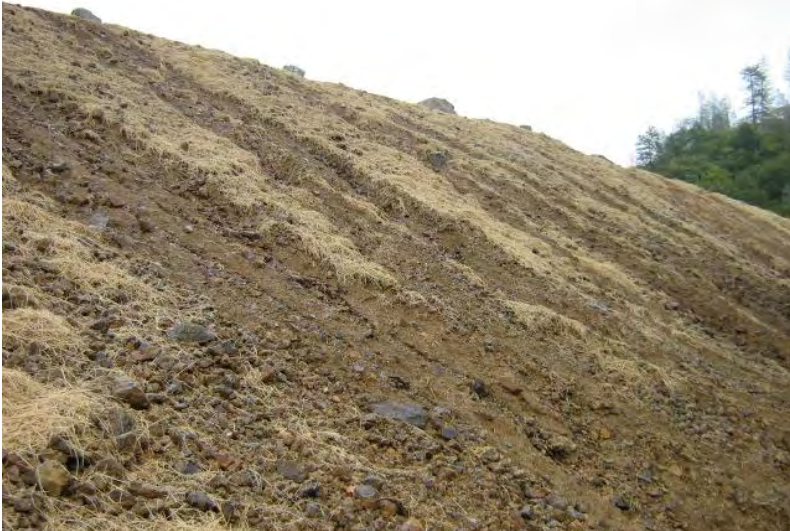
Photograph 1 – Evidence of erosion and slope failure on disturbed slope areas draining to Crystal Creek on the south side of State Highway 299

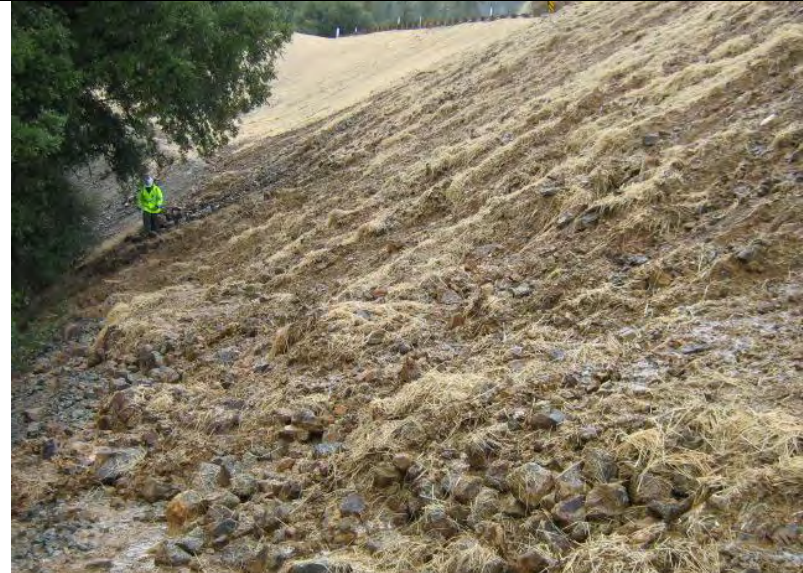
Photograph 2 – Evidence of erosion and slope failure on disturbed slope areas draining to Crystal Creek on the south side of State Highway 299

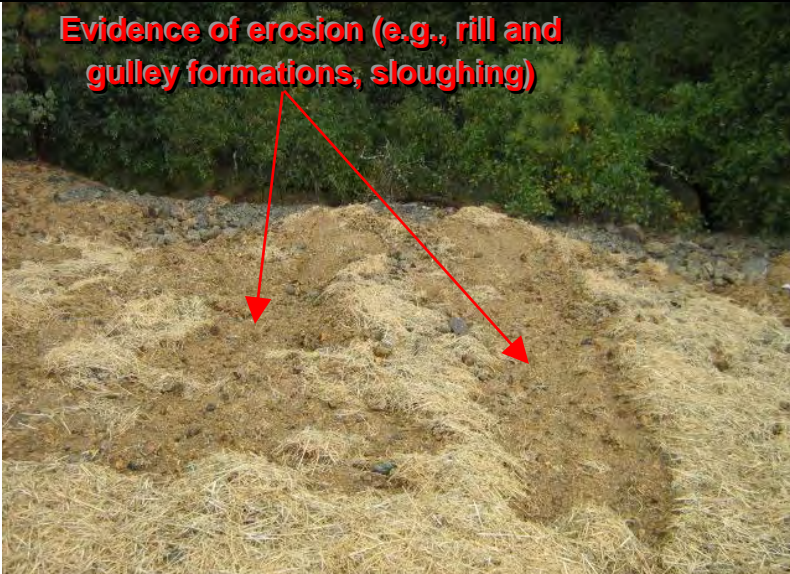
Photograph 3 – Evidence of erosion (e.g., rill and gully formation) and sediment transport from the disturbed slope failure

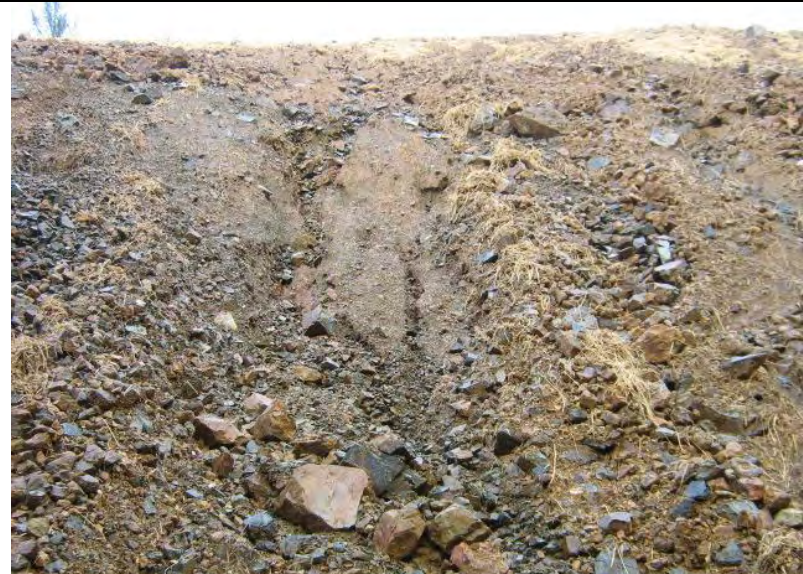
Photograph 4 – Visible evidence of erosion (e.g., rill and gully formation) on the disturbed slope area draining to Crystal Creek

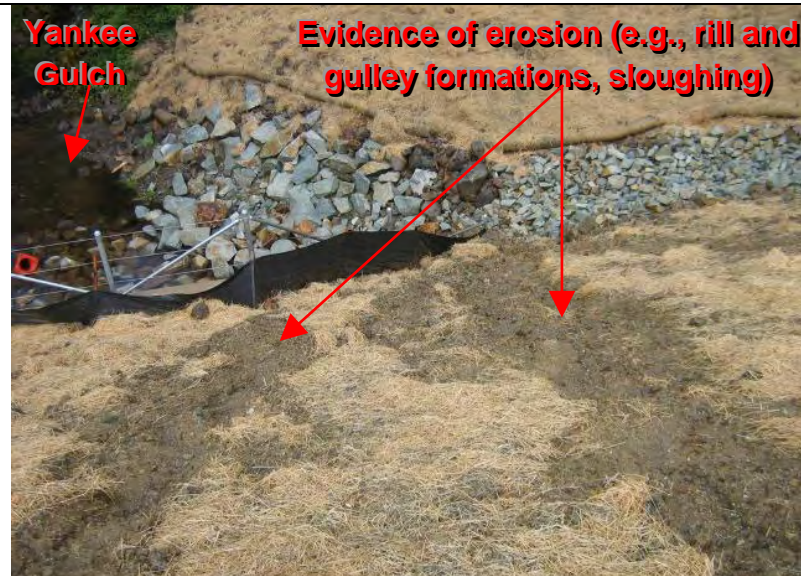
Photograph 8 – Evidence of erosion (e.g., rill and gully formation) and sediment transport from the disturbed slope failure

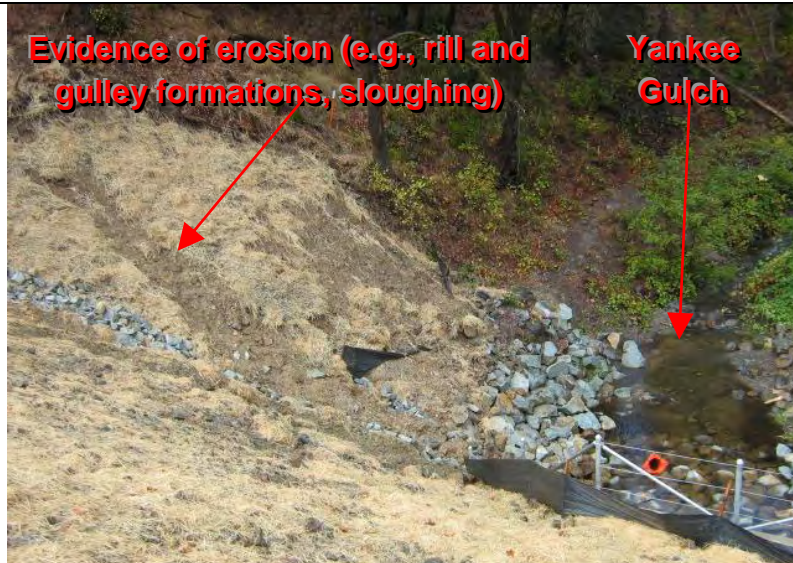
Photograph 9— Evidence of erosion (e.g., rill and gulley formation) and sediment transport from the disturbed slope failure

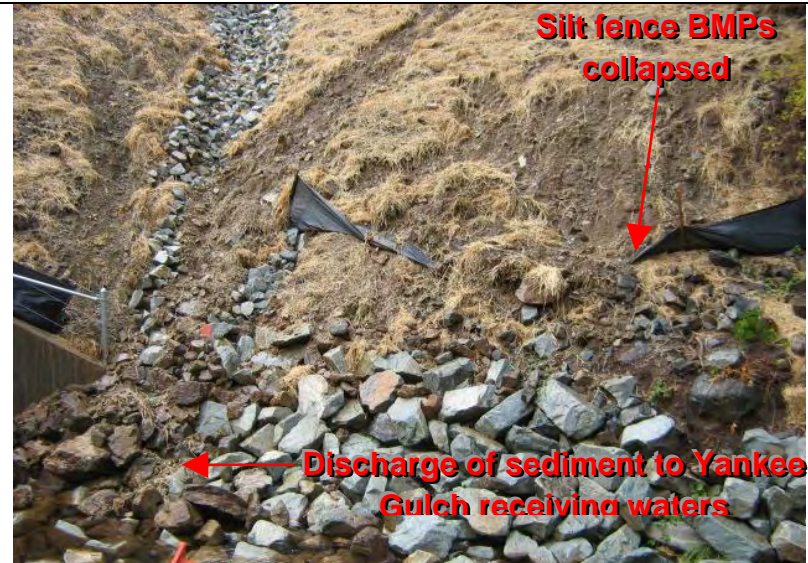
Photograph 10 – Silt fence BMPs collapsed in areas and evidence of the discharge of sediment to Yankee Gulch

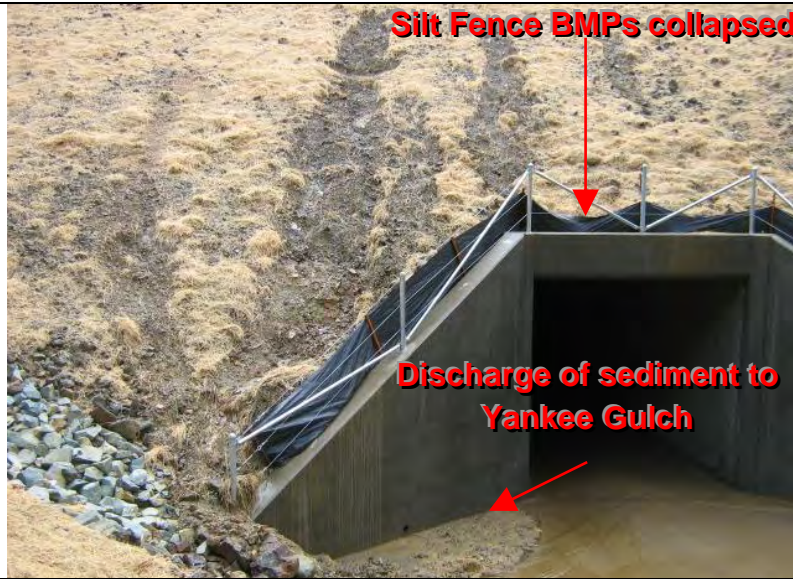
Photograph 11—Visible evidence of slope failure and the discharge of sediment to Yankee Gulch receiving water

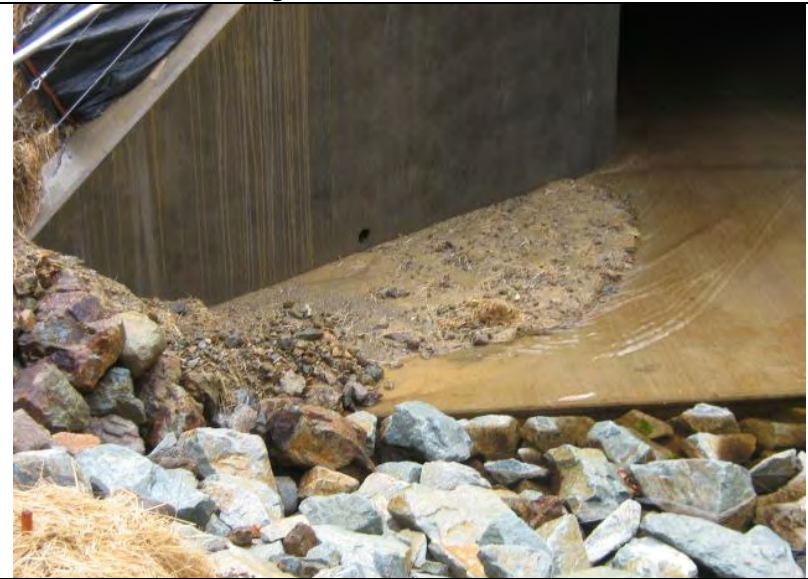
Photograph 12 – Close-up view of Photograph 11 depicting the discharge of sediment and sediment accumulation in Yankee Gulch

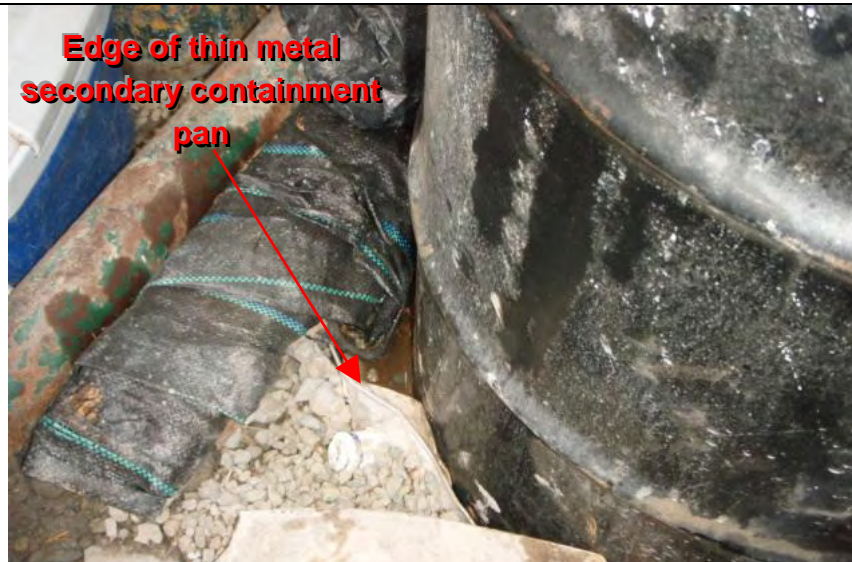
Photograph 9— Close-up view of damaged secondary containment pan underneath 55-gallon drum

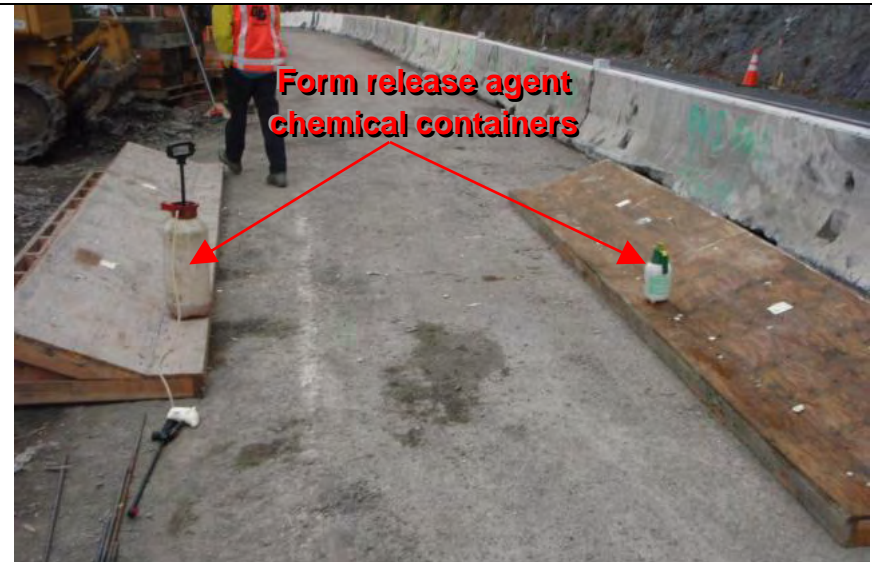
Photograph 10— Chemical sprayers not within secondary containment

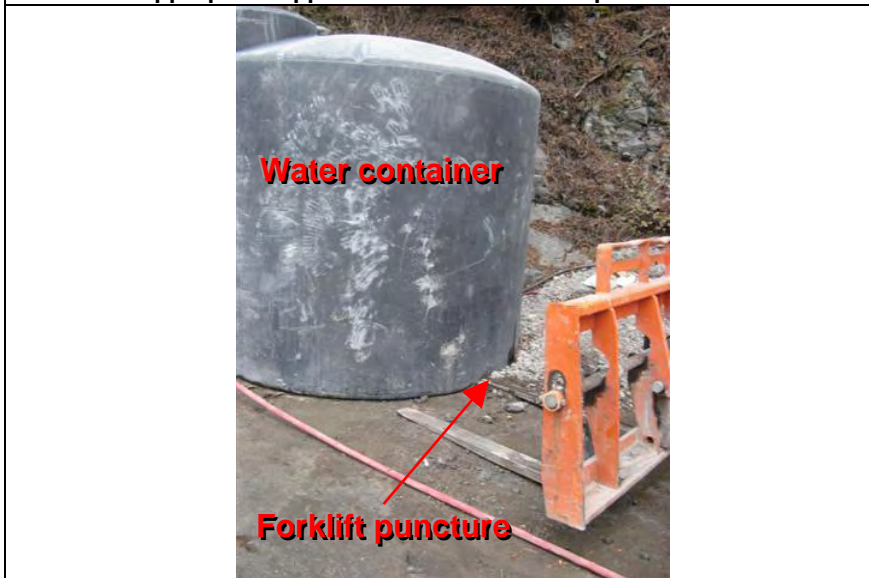
The EPA Audit Team observed that a water storage tank (approximately 1,000-gallon capacity) located up-gradient had been punctured by a forklift and was leaking (see Photographs 15 and 16). Water was observed slowly flowing underneath the straw wattle BMPs that been placed on the impervious roadway surface adjacent to K-rail barriers near the southern end of the construction project (see Photograph 17). The straw wattle BMPs had been installed prior to the puncture incident. Water had flowed underneath the straw wattles and jersey barriers and was observed on the adjacent roadway (see Photograph 18).

Photograph 15— View of forklift that had punctured the water container

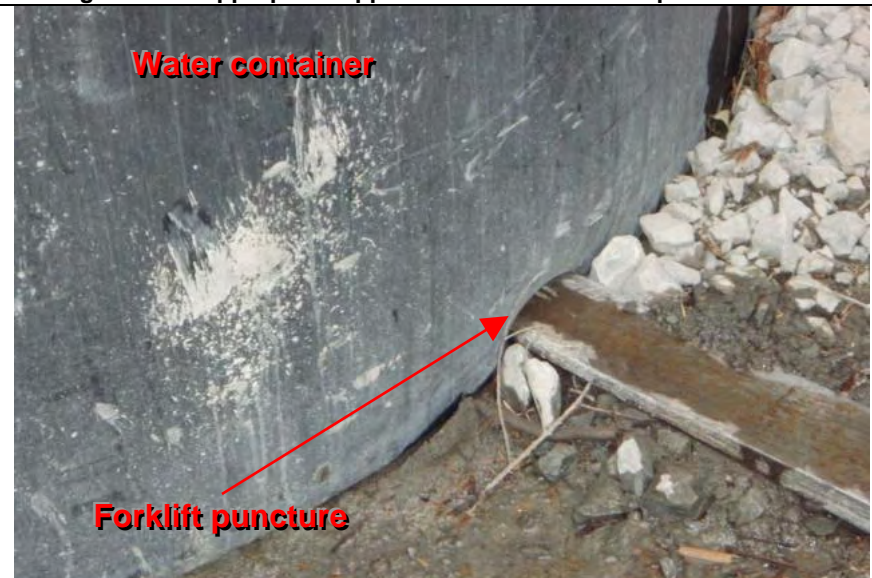
Photograph 16— Close-up view of puncture in water container

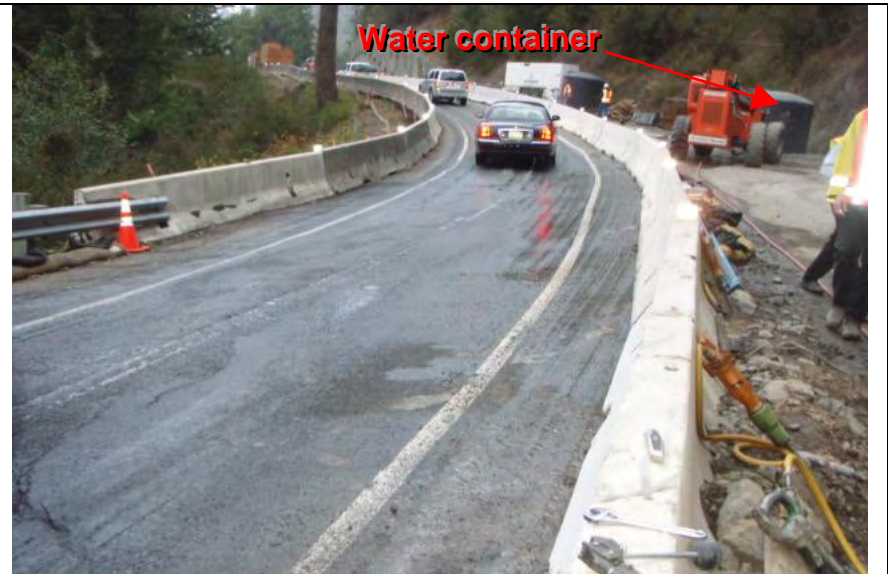
Photograph 18— View up-gradient to water container (Note: Wetness on roadway surface down-gradient of water container)

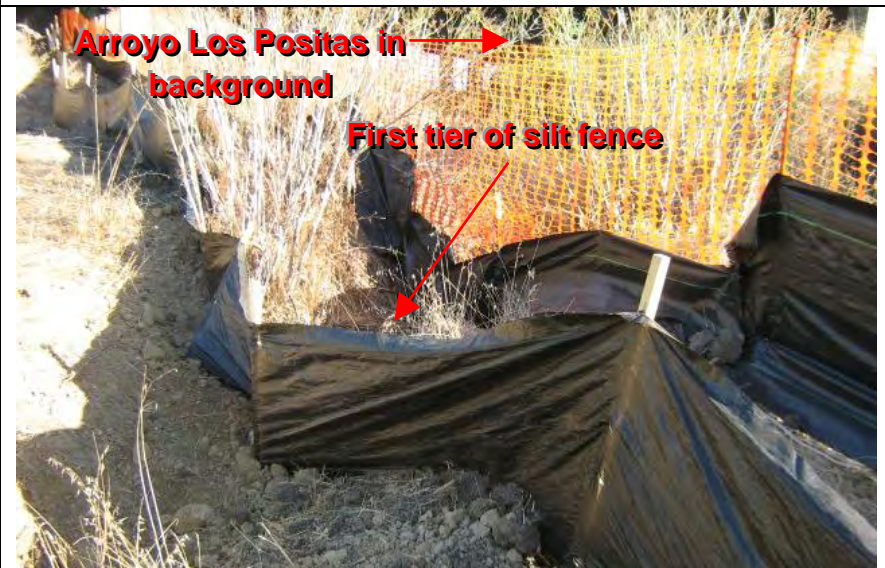
In an area located upstream of the constructed diversion near the entrance to the construction access road, a silt fence BMP was improperly installed in a drainage depression leading to Arroyo Los Positas and had partially collapsed. Although two tiers of silt fence had been installed for BMP redundancy, both tiers were in need of maintenance and the first tier of silt fence had failed (see Photographs 4 and 5). As a result, there was a potential for the discharge of sediment to Arroyo Los Positas.

Photograph 4 – Silt fence BMP installed in a drainage depression
