## **Appendix D**

### **Construction Program Site Visit Reports**

### **Thomes Creek Bridge Project Site Visit Date: 10/13/2009**

**Caltrans MS4 (SWRCB Order No. 99-06-DWQ)**  
**Thomes Creek Bridge Project**  
**Caltrans District 2**

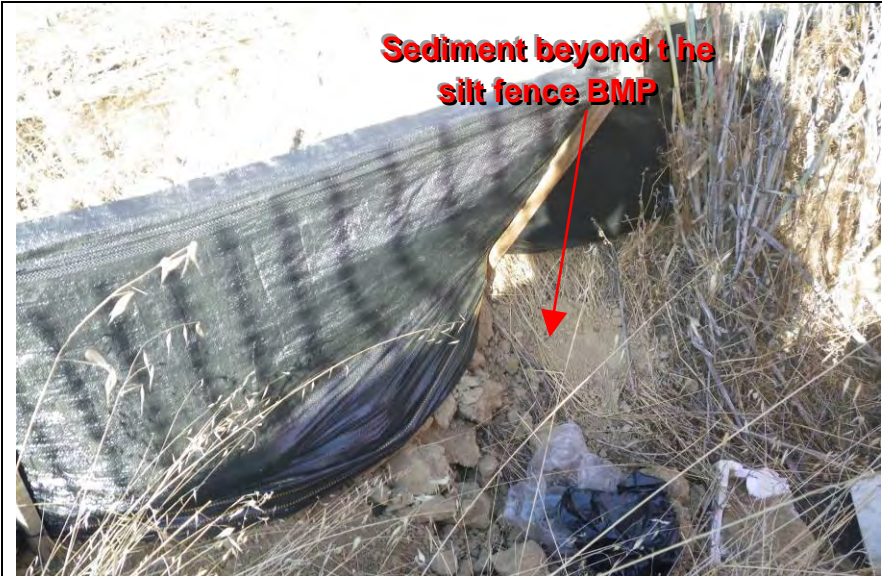
Photograph 5— Failure of first tier of silt fence shown in Photograph 4

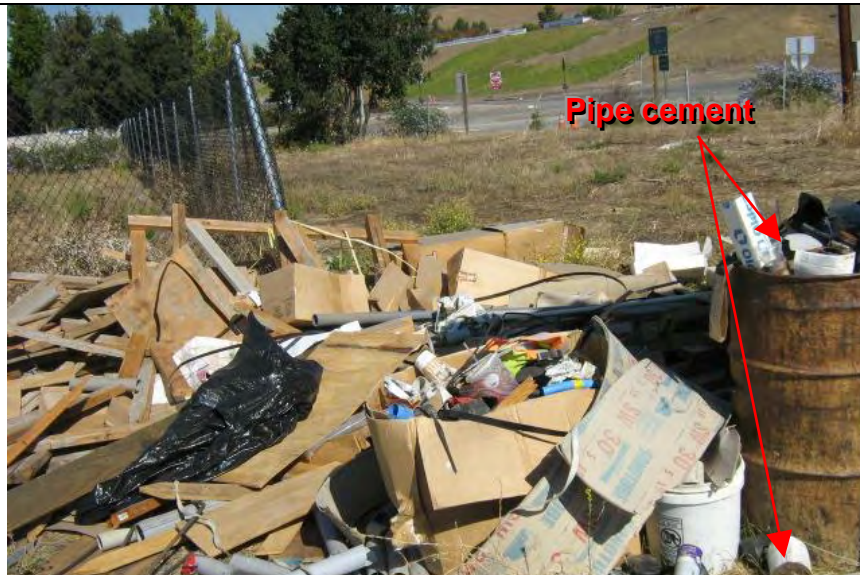
Photograph 1 – Construction wastes and chemicals improperly disposed

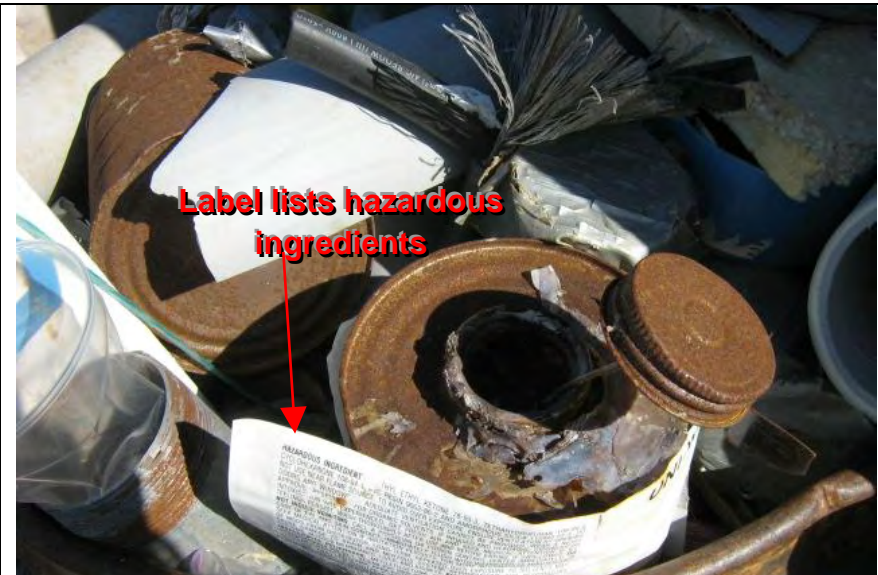
Photograph 2 – Close-up view showing open containers of pipe cement

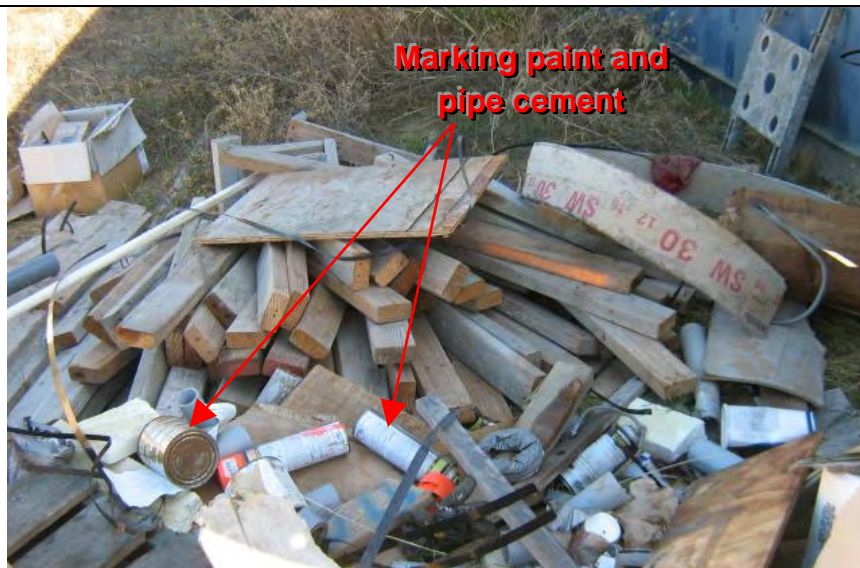
Photograph 3 – Construction wastes and chemicals improperly disposed

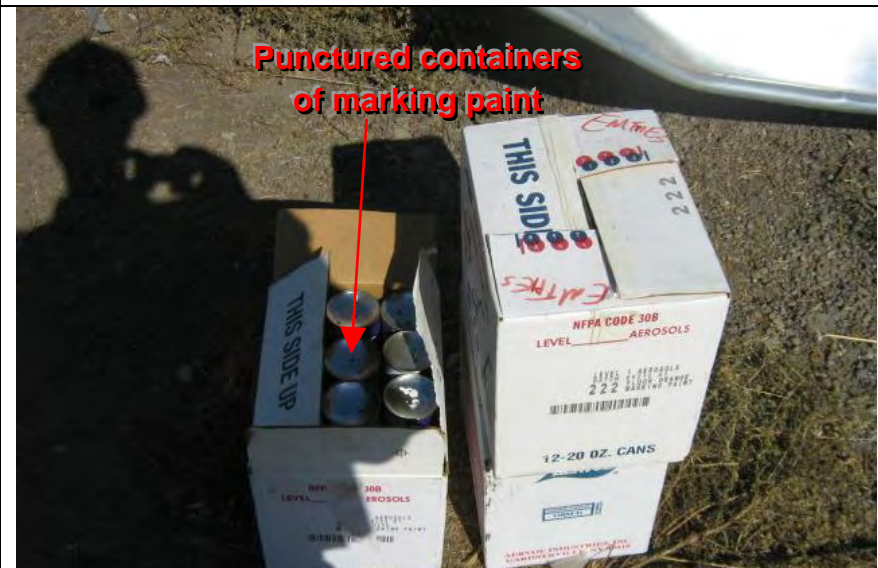
Photograph 4 – Construction wastes and chemicals improperly disposed

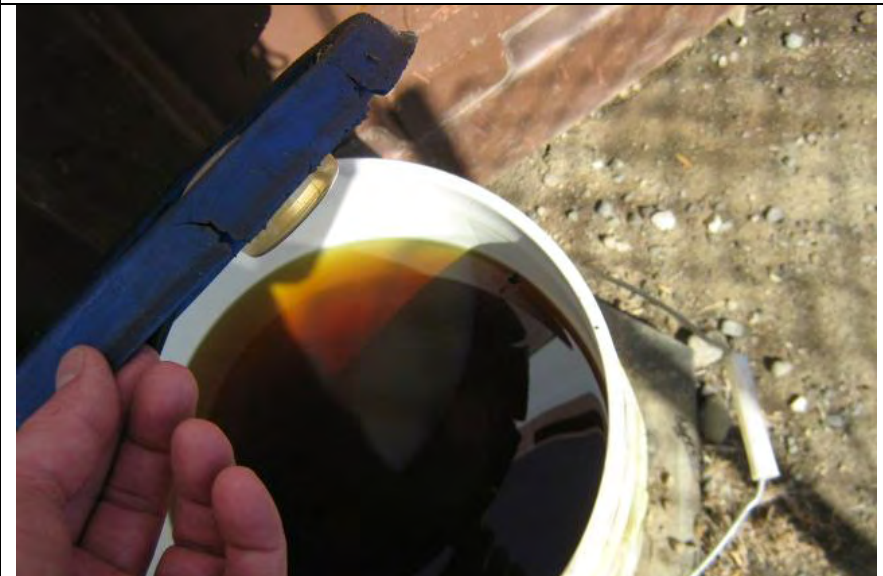
Photograph 8 – Petroleum product without secondary containment

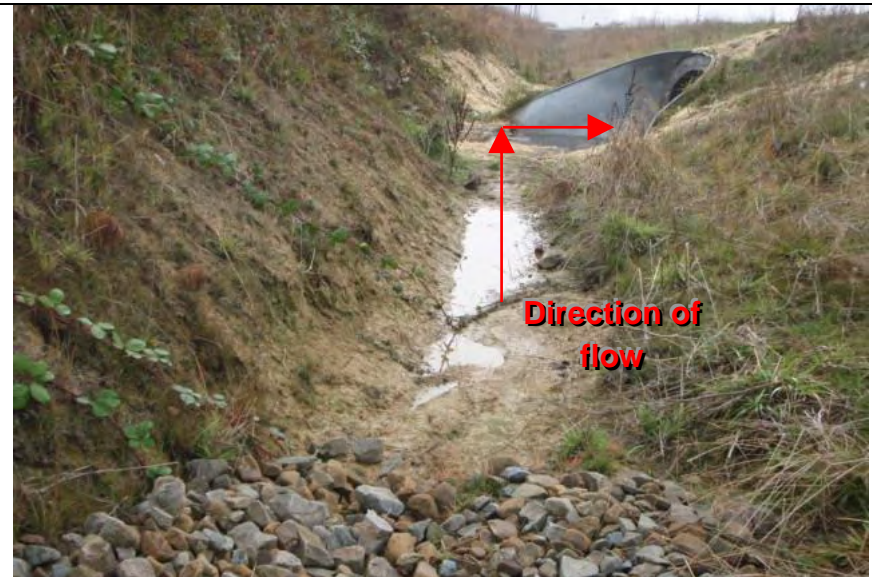
Photograph 2 – Closer view of disturbed drainage ditch and culvert inlet

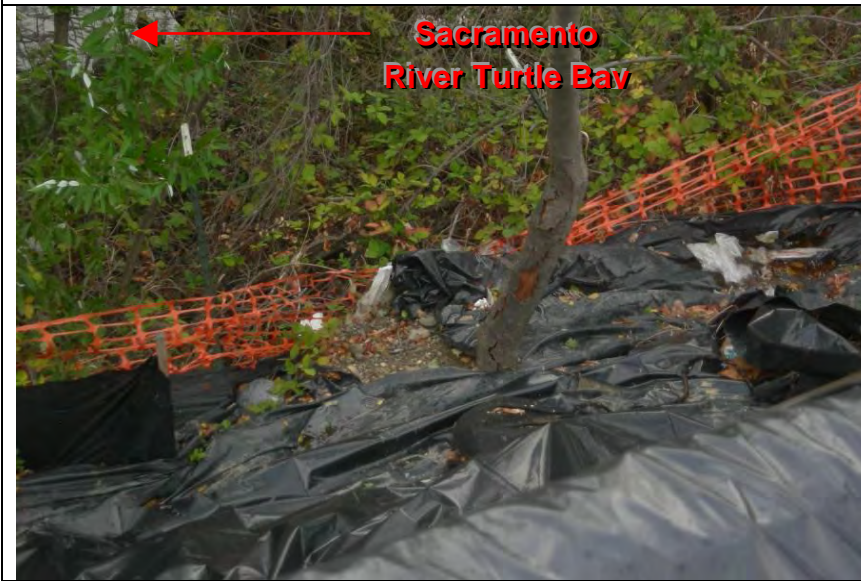
In an area along the northern portion of Interstate 5 and east of the Auditorium Drive Bridge, a perimeter control silt fence located at the toe of the slope had failed (see Photographs 2 and 3). As a result, there was potential for the discharge of sediment offsite into the Sacramento River Turtle Bay Park (see Photograph 3).

Photograph 3 – View of deteriorated slope stabilization BMP and collapsed silt fence in Photograph 2

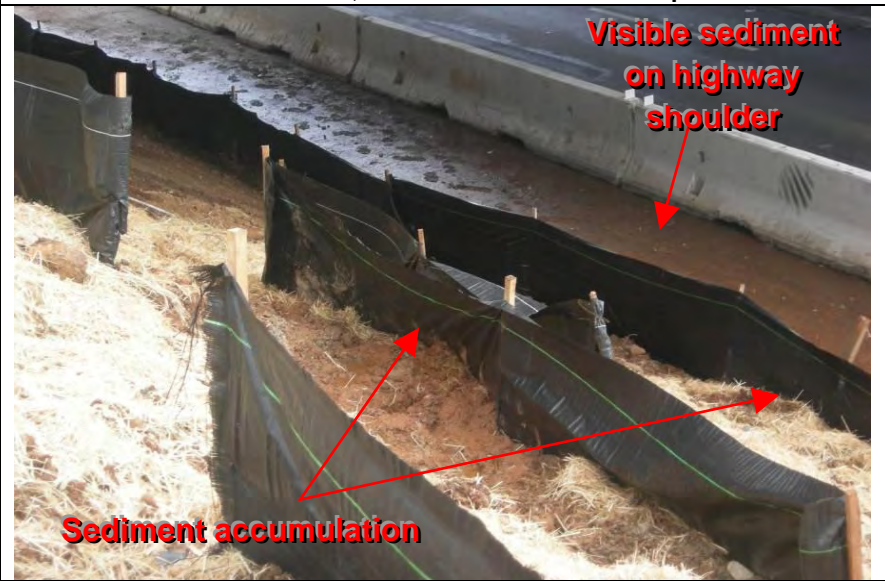
Adequate BMPs were not implemented for disturbed areas associated with the disturbed slope area under the Auditorium Drive Bridge overpass replacement and construction. Specifically, silt fence BMPs had accumulated sediment to approximately half the exposed silt fence height in several areas (see Photograph 4). Although three tiers of silt fence had been installed for BMP redundancy, the tiers were in need of maintenance (see Photograph 4), and sediment was visible beyond the BMPs on the highway shoulder.

Photograph 4 – Silt fence on the north side of I-5, view facing south-southeast

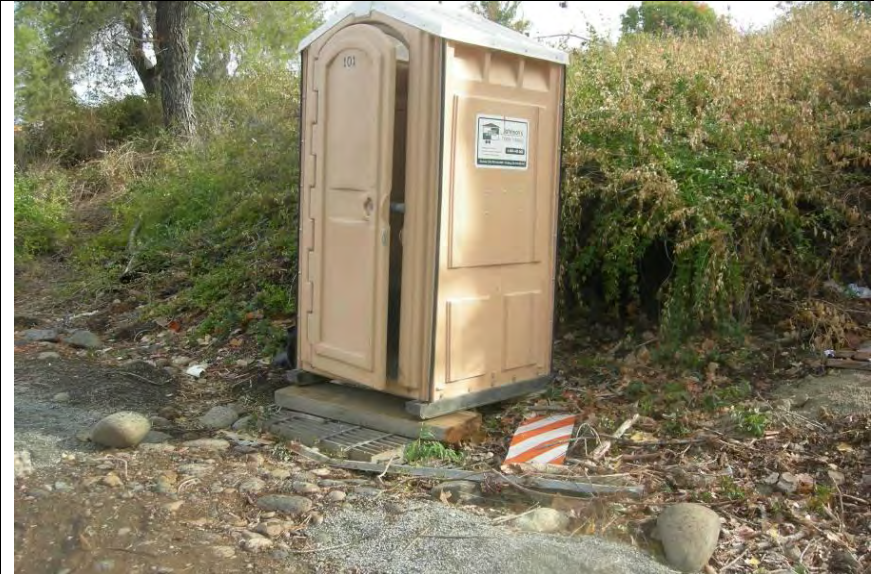
**Photograph 6 – View of unsecured portable toilet**

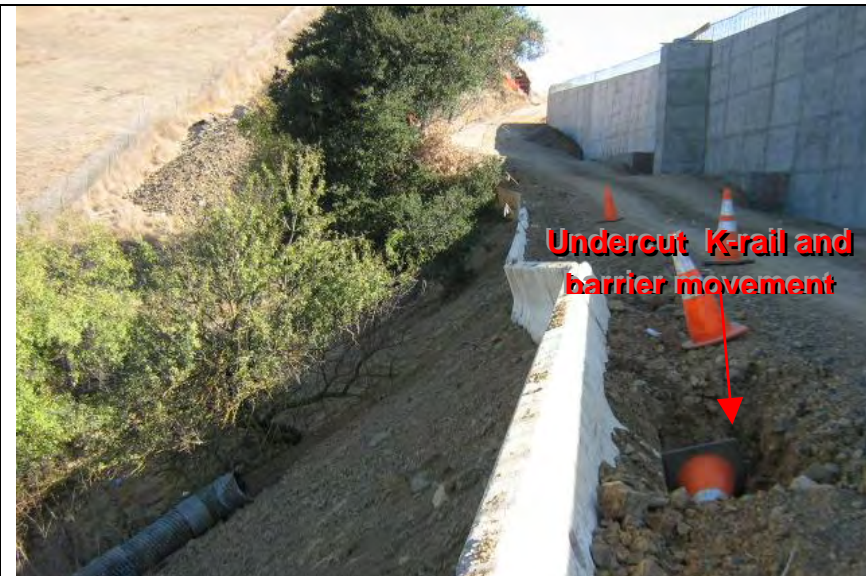
Photograph 2 – Failed fill slope along access road

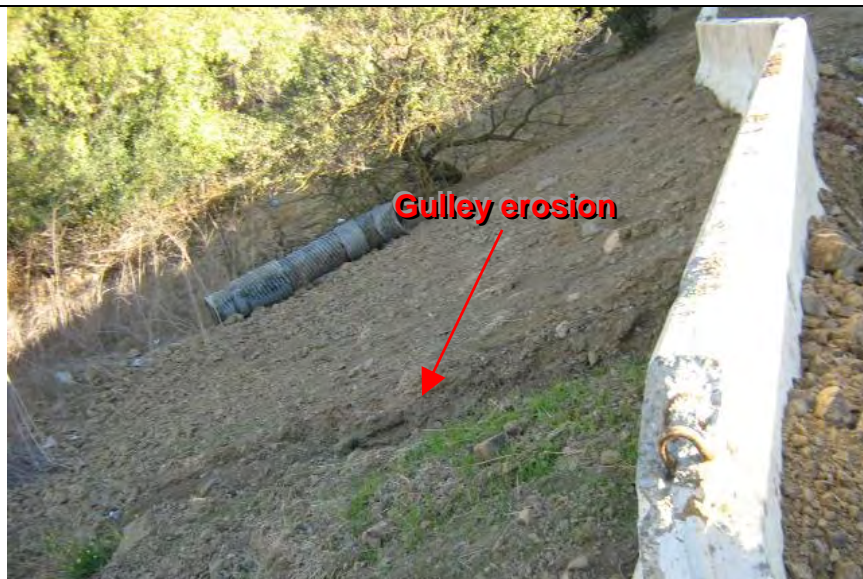
Photograph 3 – Slope erosion below undercut K-rail shown in Photograph 2

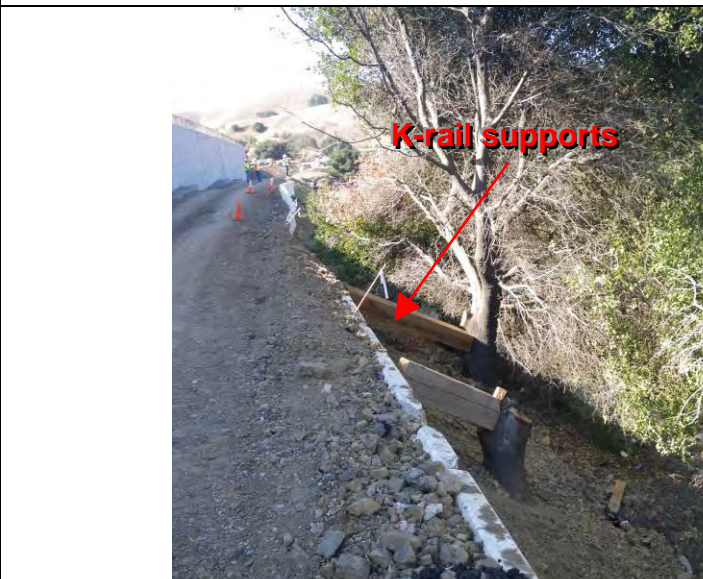
Photograph 4 – Failed area along access road

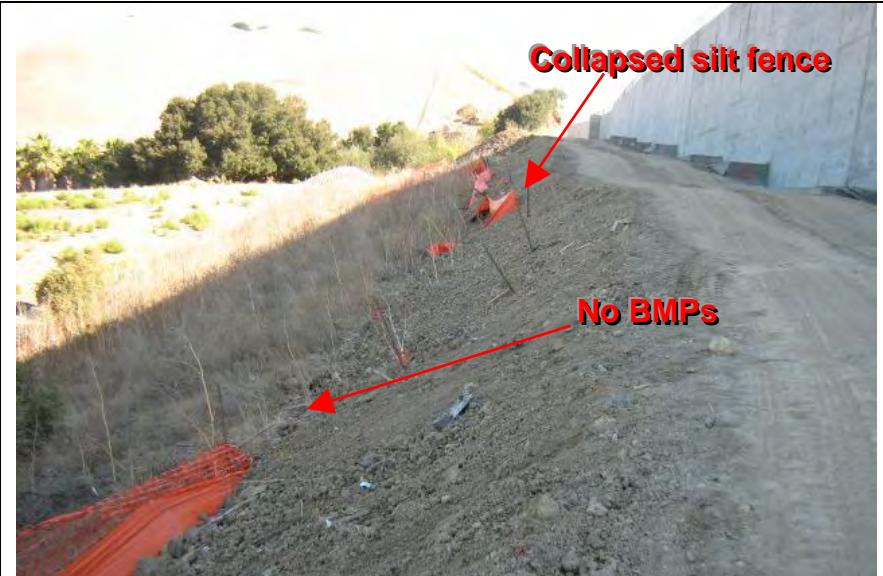
Appendix D of the Caltrans SWMP, Section 4.5.1, Temporary Sediment Control, states “repair undercut silt fences...repair or replace split, torn, slumping or weathered fabric.” The EPA Audit Team observed areas along the access road fill slope where the silt fence BMP had not been adequately inspected and maintained and several lengths of silt fence had collapsed (see Photographs 6 and 7).

Photograph 6 – Fill slope along access road without BMPs

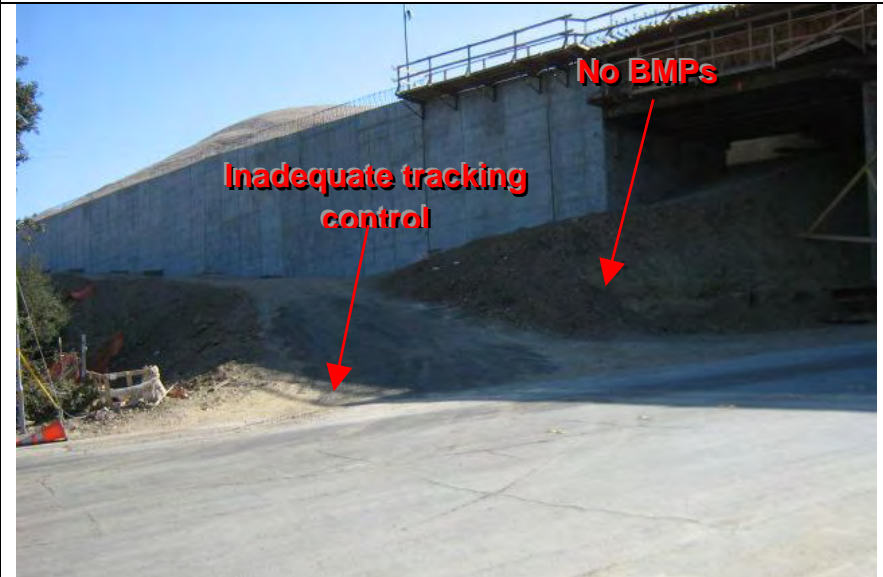
Photograph 8 – View of fill slope along access road without BMPs and vehicle tracking control pad

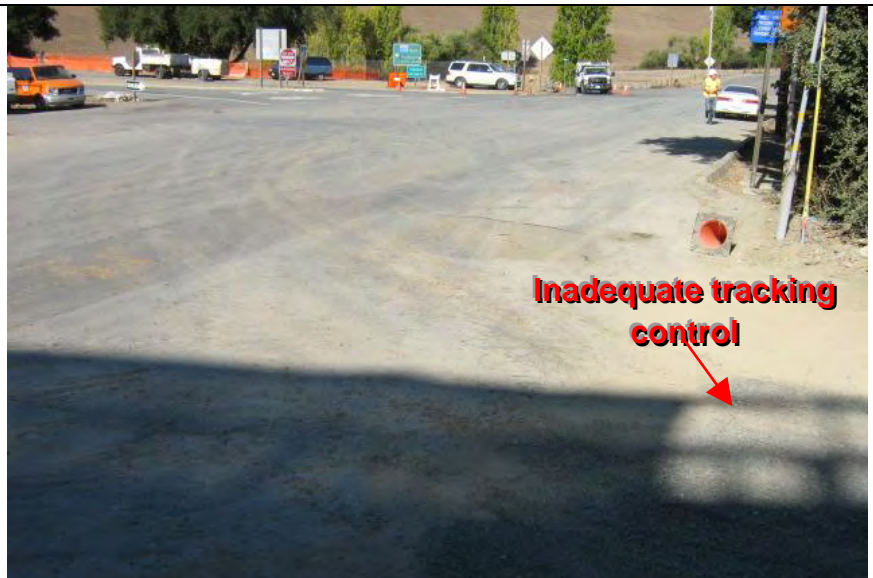
Photograph 9— Sediment conveyed onto roadway
