## **Appendix E**

### **Maintenance Program Site Visit Reports**

**Site Visit No. 16**

**Caltrans MS4 (SWRCB Order No. 99-06-DWQ)**  
**Willow Creek Highway Maintenance Facility**  
**Caltrans District 1**

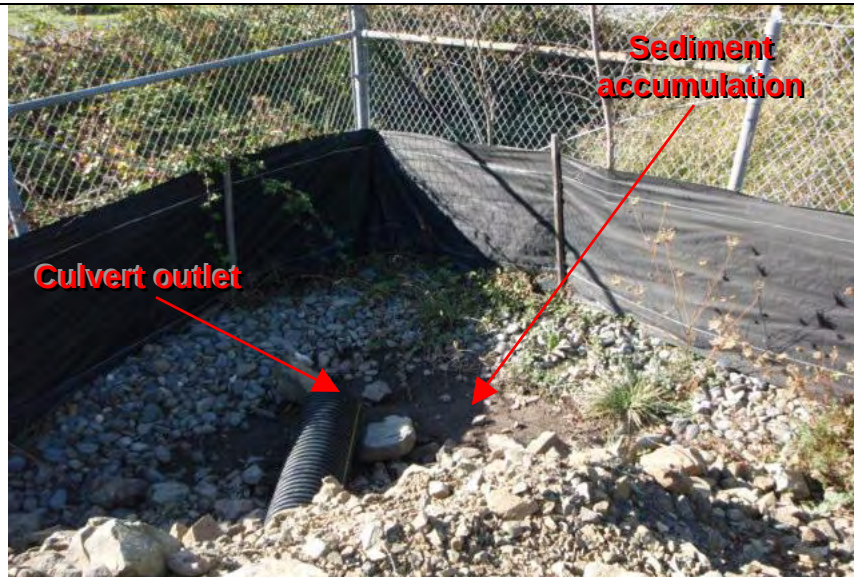
Provision I.3.b of the Permit requires Caltrans to provide appropriate site-specific BMPs for all maintenance facilities. As explained by the Highway Maintenance Supervisor, most of the storm water runoff at the facility flows to the northwest corner of the facility either by overland flow or through a culvert inlet and pipe (see [Photographs 1, 2 and 3](#)). He added that storm water runoff does not generally discharge off-site from this location to the adjacent PG&E facility but rather ponds and remains as standing water until it infiltrates into the ground or evaporates. Nonetheless, evidence of sediment discharged to the northwest corner of the facility was observed (see [Photograph 3](#)). Furthermore, a silt fence BMP had been installed in the concentrated flow pathway of the culvert outlet, was not entrenched into the ground, and had been installed backwards (see [Photographs 3 and 4](#)).

Photograph 3 – Culvert outlet to northwest corner of facility (Note: Silt fence BMP installed backwards)

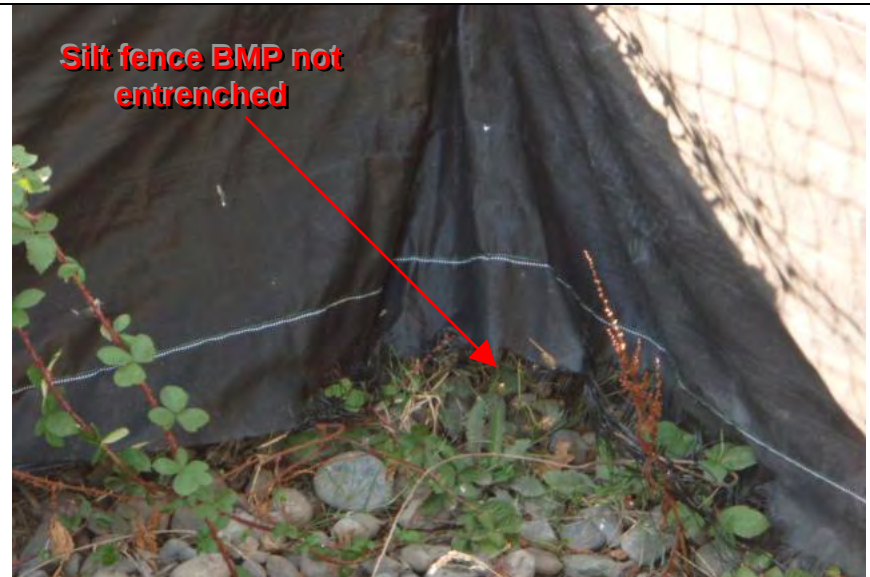
Photograph 4 – Closer view of silt fence BMP shown in Photograph 3

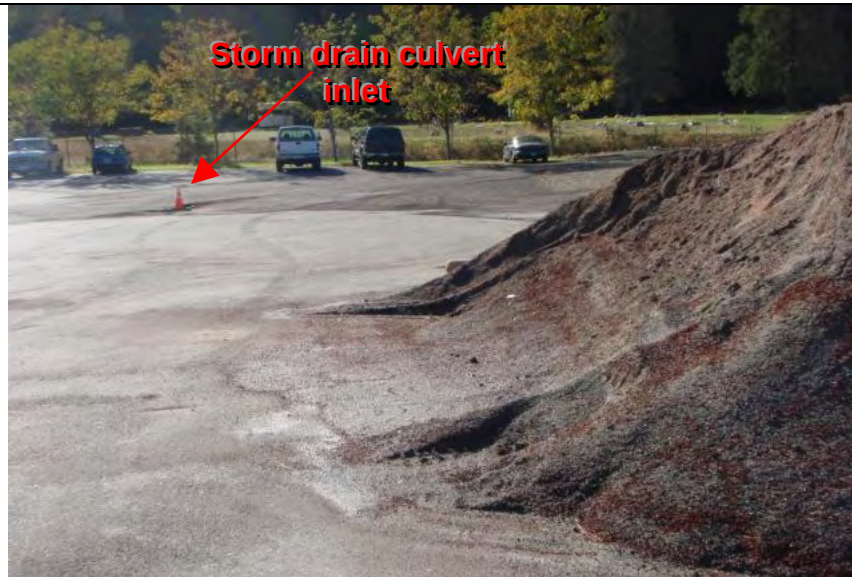
In addition, a stockpile of roadway abrasives was stored up-gradient of the storm drain culvert inlet in an uncovered area, and on the impervious ground surface (see [Photograph 5](#)). Straw wattle BMPs had been placed around the stockpile on the downslope side; however, the straw wattles were improperly installed on the impervious surface of the facility, and therefore were not properly entrenched in the ground to retain the stockpiled materials (see [Photograph 6](#)). Furthermore, what appeared to be a salt residue was observed around the stockpile which indicated that the stockpile itself contained salt, or the straw wattles had previously been used for the containment of a salt-bearing product (see [Photograph 7](#)). As a result, there was a potential for the discharge of stockpiled materials to the storm drain culvert inlet and subsequently off-site. Although placed under cover, a second stockpile containing salt also had a straw wattle BMP improperly installed on the impervious ground surface (see [Photographs 8 and 9](#)). Straw wattle BMPs are not intended to control salt products or other pollutants that will dissolve upon contact with water. As a result, adequate BMPs were not implemented for stockpile management.

Photograph 5— Stockpile of sand and ash mixture up-gradient of inlet

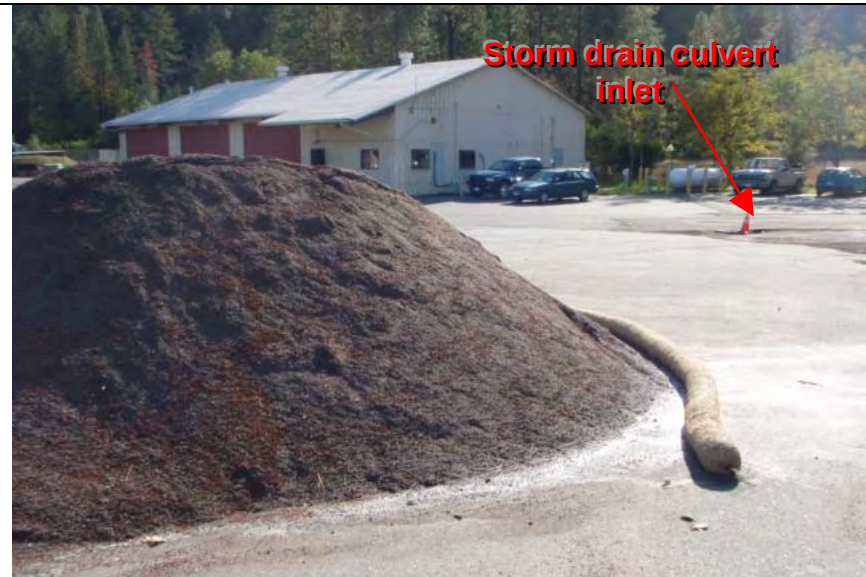
Photograph 6 – Inappropriate application of straw wattle BMP

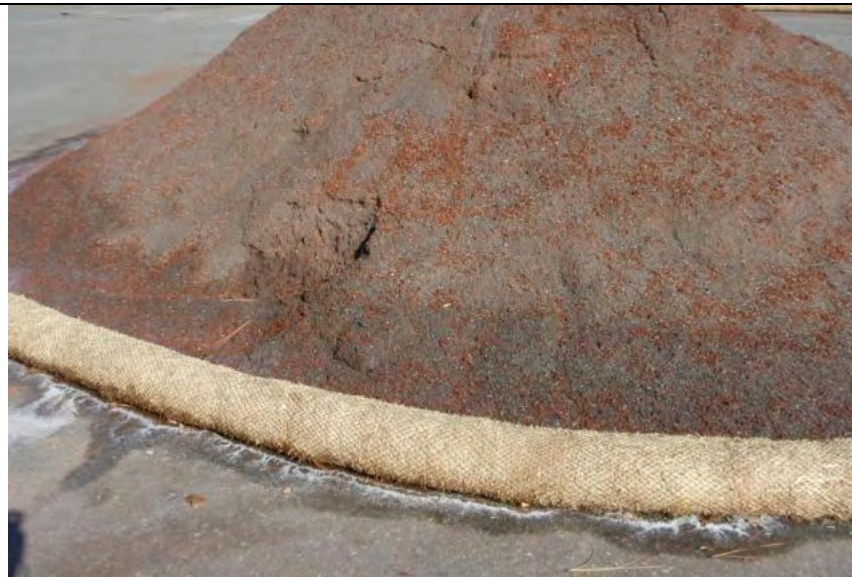
Photograph 7— Closer view of straw wattle BMP around stockpile  
(Note: Apparent salt residue)

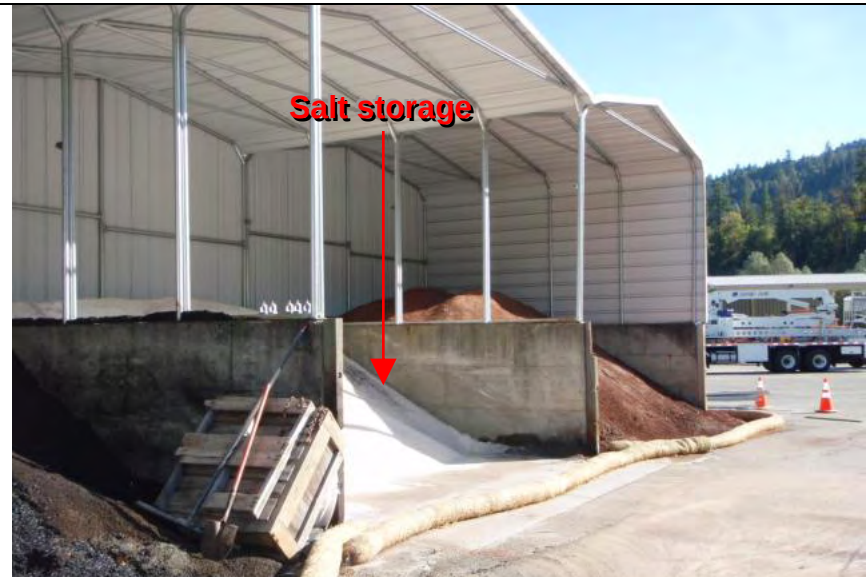
Photograph 8 – Inappropriate application of straw wattle BMP

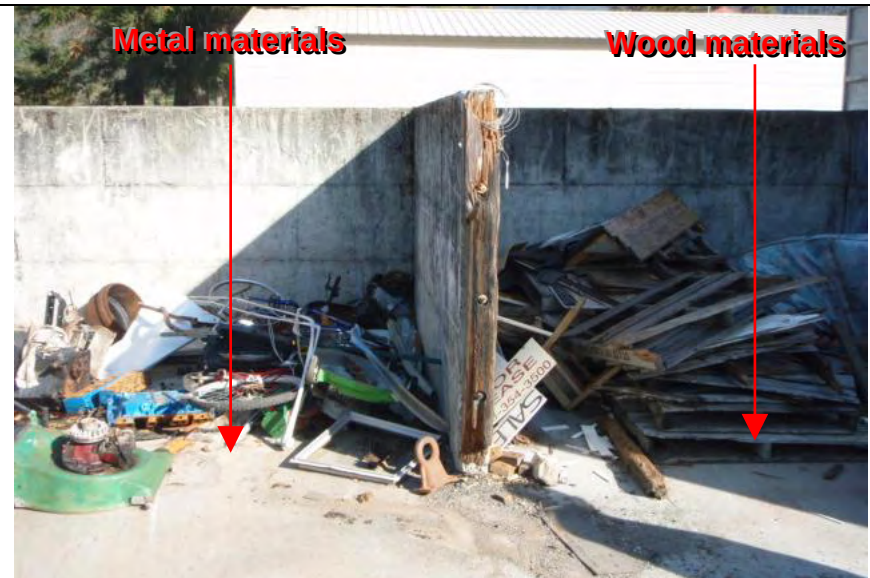
The facility has a dedicated area for storage of materials picked up from the highway system by maintenance crews. The area is segregated to provide an area for wood-based materials and another area for metal-based materials (see [Photograph 10](#)). According to the Highway Maintenance Supervisor, an engine block from an automobile had been deposited in the metal-bearing materials storage area earlier on day of the inspection (see [Photograph 11](#)). It appeared that the engine block still contained automotive fluids or petroleum products that had leaked onto the impervious ground surface in the storage area (see [Photograph 11](#)). The storage area is not covered and does not have a berm for containment. As a result, there was a potential for the contribution of pollutants to storm water runoff and the subsequent discharge of pollutants off-site.

Photograph 10 – Storage area for materials picked up from the highways  
(Note: Area is uncovered and not bermed)

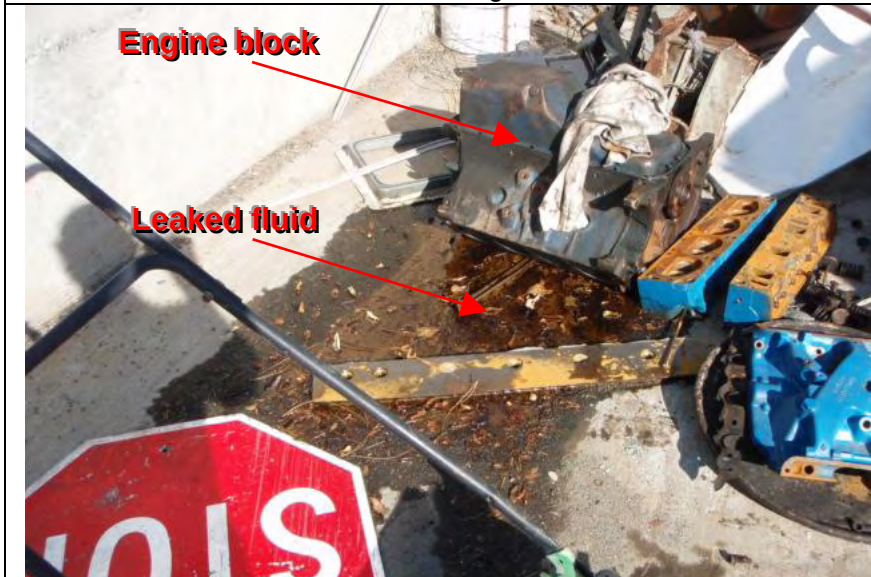
Photograph 11— Engine block stored in metal material storage area  
(Note: Fluid on impervious ground surface)

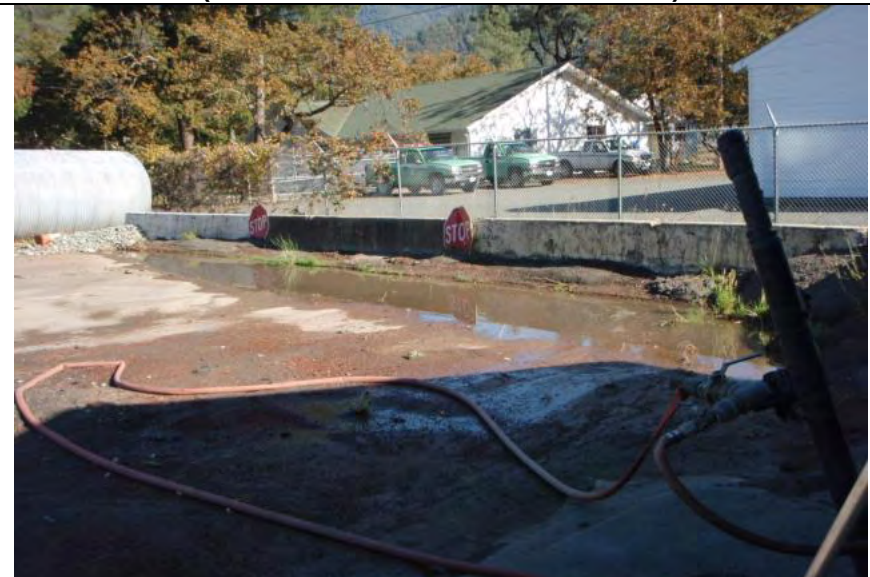
Although the facility is equipped with a designated and covered vehicle and equipment wash rack, a bermed area toward the southern end of the facility is used for truck bed washing (see [Photograph 12](#)). An area of wet soil was observed on the backside of the bermed area adjacent to a drainage ditch that flows off-site to the south (see [Photographs 13 and 14](#)). As a result, there was a potential for the discharge of pollutants to the drainage ditch, a component of the Caltrans MS4, and subsequently off-site. Appendix D of the Caltrans SWMP, Section 2.15.1, Vehicle and Equipment Cleaning, states “when possible, truck beds should be cleaned using dry cleanup technique (sweep up or shovel out).”

Photograph 12 – Bermed area used for truck bed washing

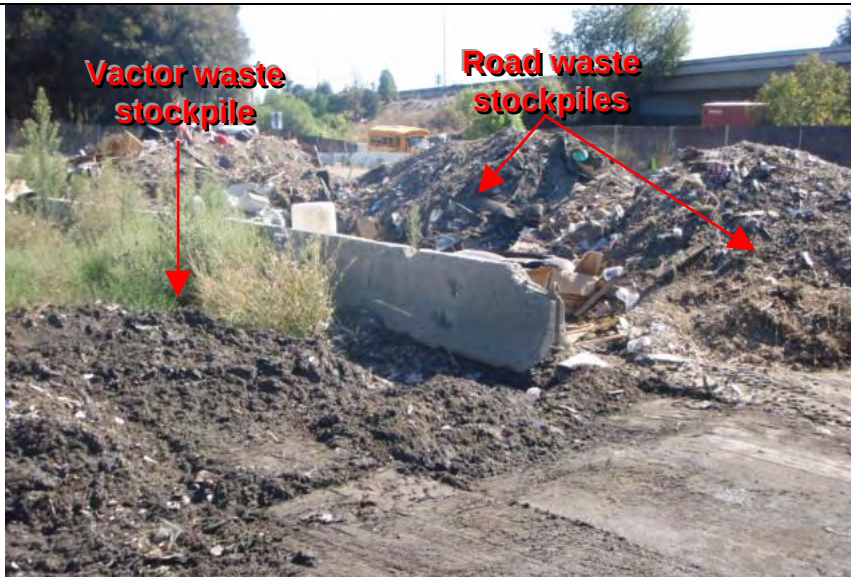
Furthermore, coverage and containment BMPs had not been implemented for the sweeper and roadway waste stockpiles and there was a potential for the contribution of pollutants to storm water runoff ([see Photographs 1, 3, and 4](#)). Due to the lack of coverage and containment BMPs, fugitive trash and other debris was not maintained as part of the original stockpile and had been strewn across the site ([see Photographs 4 and 5](#)). A Caltrans roadway maintenance supervisor from the San Leandro Maintenance Yard stated that the debris deposited at the waste storage site is generally stored for about 90 days before a contracted hauling company removes the material and disposes of it at a nearby landfill. A Caltrans staff member explained that BMPs had not yet been implemented at the site because at the time of the audit it was prior to the October 15<sup>th</sup> start of the rainy season. He added that straw wattles would be placed around the waste stockpiles on the ground surface in accordance with the stockpile management techniques outlined in the Caltrans Stormwater Quality Handbook – Maintenance Staff Guide. The EPA Audit Team noted that BMPs were not stored at the facility for implementation in the event of precipitation prior to October 15<sup>th</sup>.

Photograph 3 – Lack of BMPs for containment or coverage of road waste stockpiles

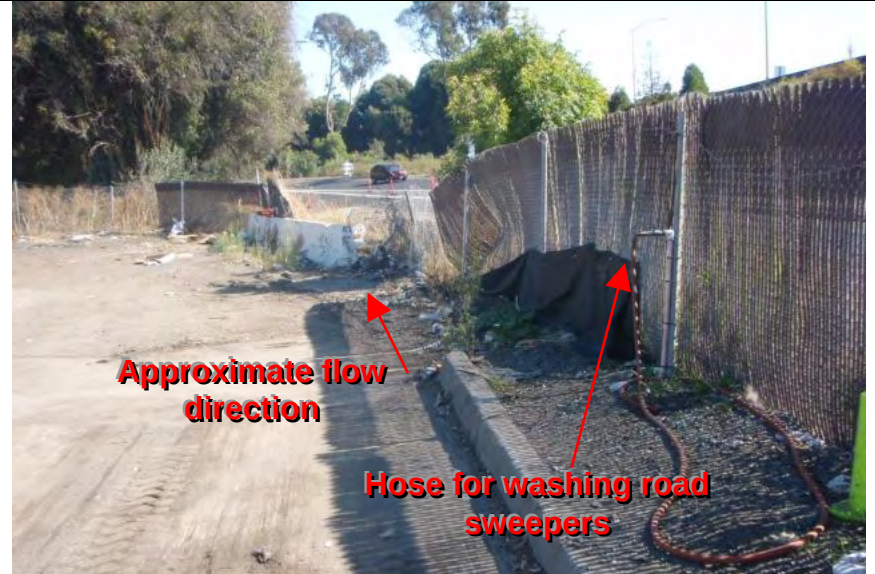
Despite the availability of a designated wash area at the nearby San Leandro Maintenance Yard, a road sweeper pre-washing area was observed along the fenceline of the facility. The pre-washing area is not equipped to properly capture, treat, re-use, or dispose of vehicle wash water and associated pollutants ([see Photographs 6 and 7](#)). As explained by a Caltrans roadway maintenance supervisor from the San Leandro Maintenance Yard, road sweepers are hosed off at the Washington Temporary Storage Site at the end of a working day before they return to the San Leandro Maintenance Yard to be cleaned in the facility’s dedicated wash area. The maintenance supervisor added that this practice is performed to remove large waste from the sweeper before it is in the wash area, so the trough drain at the maintenance yard does not fill up as quickly. It was

Photograph 6 – Location of road sweeper pre-washing area

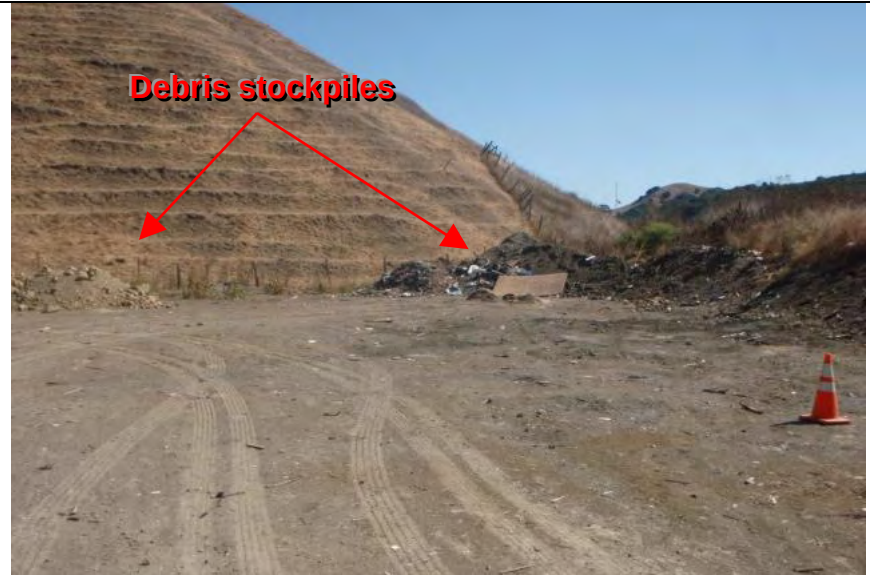
Additionally, coverage and containment BMPs had not been implemented for a sweeper and roadway waste stockpile at the Schaefer Ranch Waste Storage site and there was a potential for the contribution of pollutants to storm water runoff (see Photographs 3, 4, and 5). Specifically, the EPA Audit Team observed a culvert in the northwestern part of the site which a Caltrans staff member stated is connected to Caltrans’ storm water conveyance system (see Photograph 6). An unmaintained, collapsed silt fence BMP was observed up-gradient of the culvert inlet (see Photograph 7). A Caltrans staff member explained that perimeter control BMPs had not yet been implemented for the stockpile because at the time of the audit it was prior to the October 15<sup>th</sup> start of the rainy season. He added that straw wattles would be placed around the debris pile on the ground surface in accordance with the stockpile management techniques outlined in the Caltrans Stormwater Quality Handbook – Maintenance Staff Guide.

Photograph 2 –Lack of BMPs for containment or coverage of stockpiles

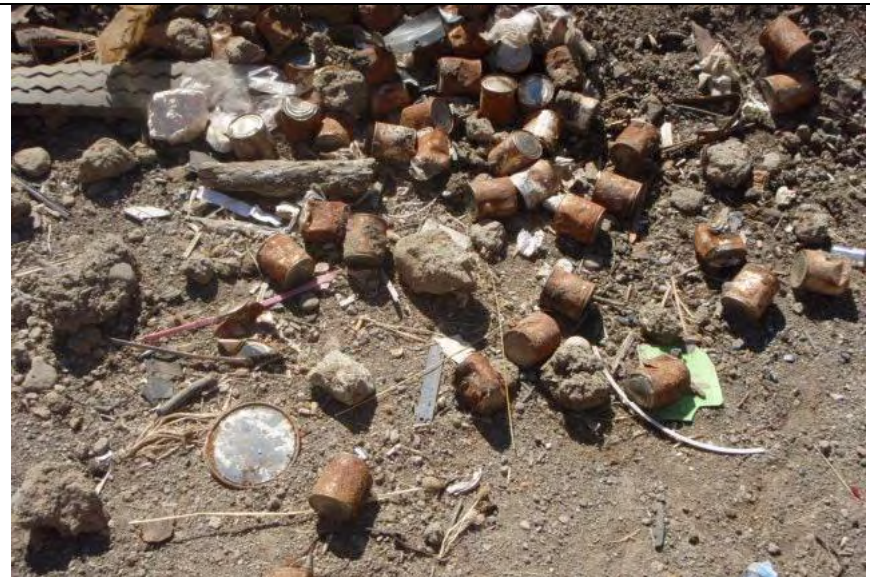
Photograph 4 – Close-up view of debris in stockpile pictured in Photograph 3. The metal cans appeared to contain a liquid milk substance.

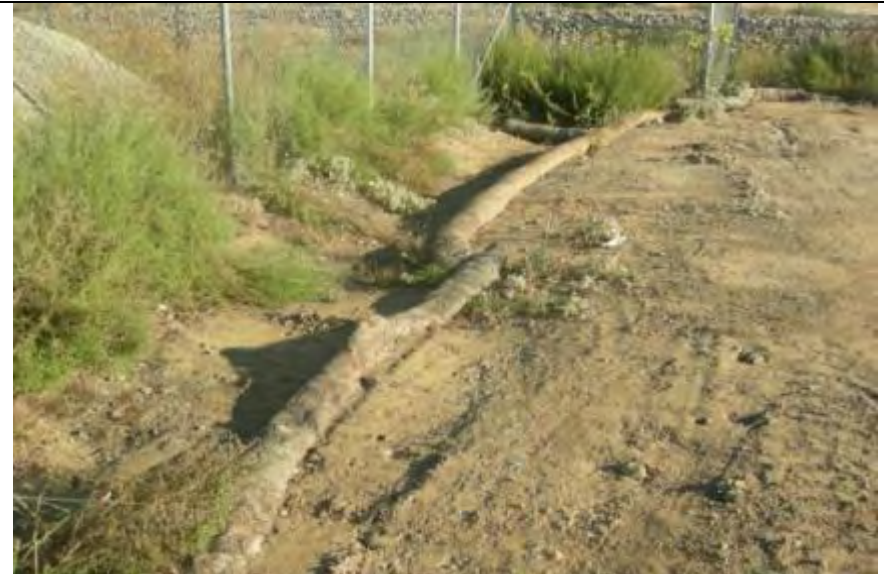
Photograph 2 – View of straw wattle BMPs, not adequately installed

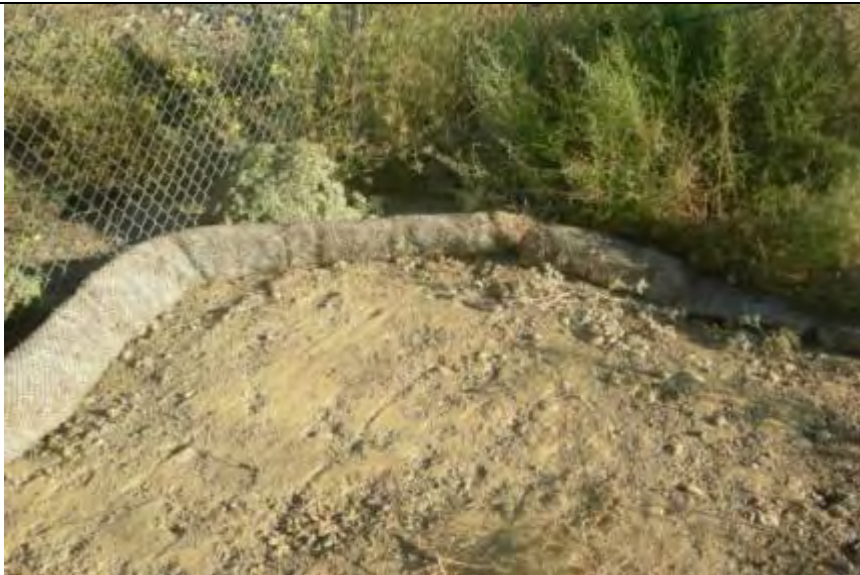
Photograph 3 – Close up view of straw wattle installation shown in Photograph 2

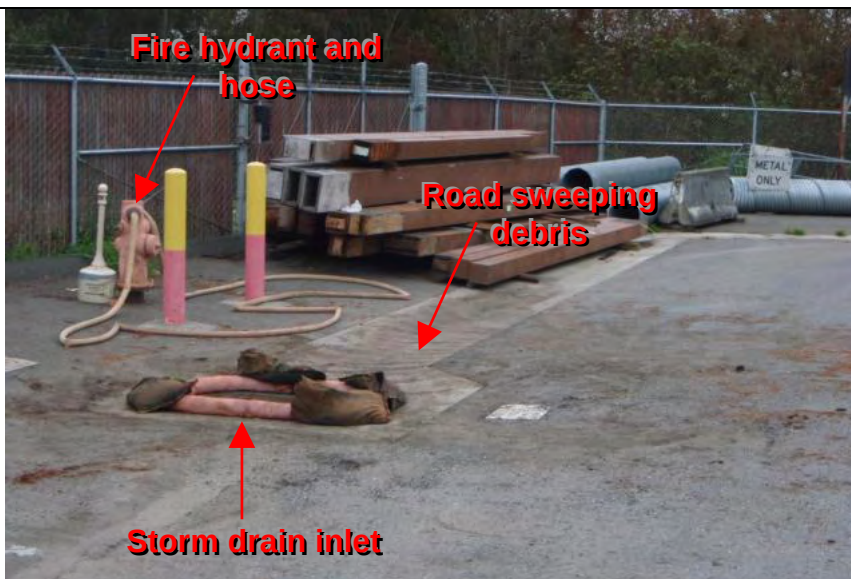
Although storm drain inlets at the facility were equipped with filters, evidence of pollutant accumulation was observed within one of the storm drain inlets near the road sweeper washing area (see Photograph 7), which indicated that an unknown quantity of sweeper wash water had been discharged to the MS4. The discharge location of the storm drain inlets associated with the road sweeper washing area was unclear. Prohibition A.7 of the Permit states “wastes or wastewater from road sweeping vehicles or from other maintenance or construction activities shall not be discharged to any surface waters or to any storm drain leading to surface water bodies.”

Photograph 3 – Area in northwest corner of facility used for road sweeper washing. (Note: Pollutant accumulation around storm drain inlet)

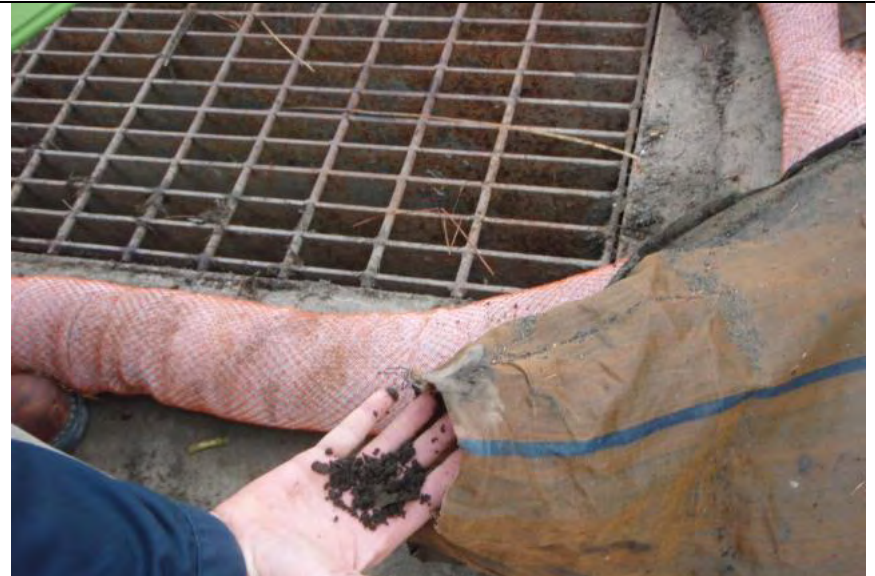
Filter fabric had been installed in one of the adjacent storm drain inlets and absorbent booms had been placed around the other inlet (see Photographs 4 and 5). However, the BMPs implemented for inlet protection were not properly maintained and significant pollutant accumulation was observed around the inlets. Furthermore, sand bags containing debris had been used for weights on top of the absorbent booms placed around one of the storm drain inlets, and several of the bags were no longer securely closed (see Photograph 6).

Photograph 6 – View of debris contained in bags used for securing absorbent booms

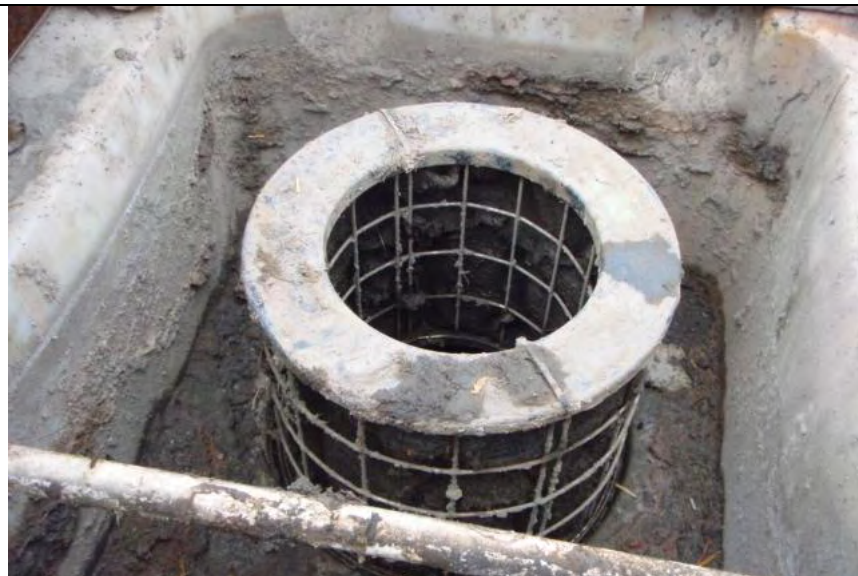
Additional storm drain inlet filters at the facility (see Photograph 8) did not appear to have been recently cleaned or maintained and debris accumulation was observed in the filter units and inlets (see Photograph 9). It was not clear when maintenance had been last performed on the filters.

Photograph 9— Closer view of filter shown in Photograph 8.  
(Note: Pollutant accumulation within filter and inlet)

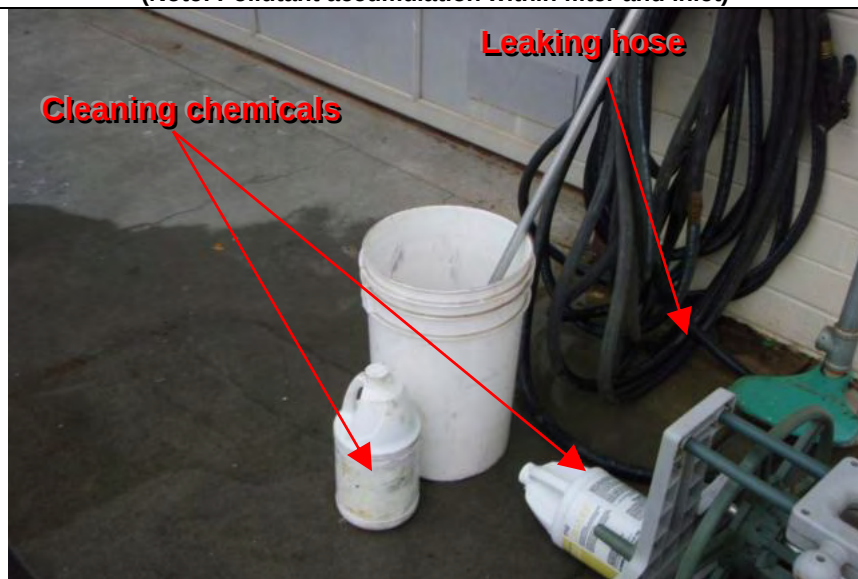
Two containers of a cleaning agent were improperly stored adjacent to a concrete drainage swale and leaking hose along the eastern side of the facility (see Photograph 11). The containers were not stored within secondary containment, and as a result, there was a potential for the contribution of wash water and pollutants to storm water runoff, and subsequently to a down-gradient storm drain inlet (see Photograph 12).

Photograph 11— Cleaning/washing chemicals stored on impervious ground surface adjacent to leaking hose

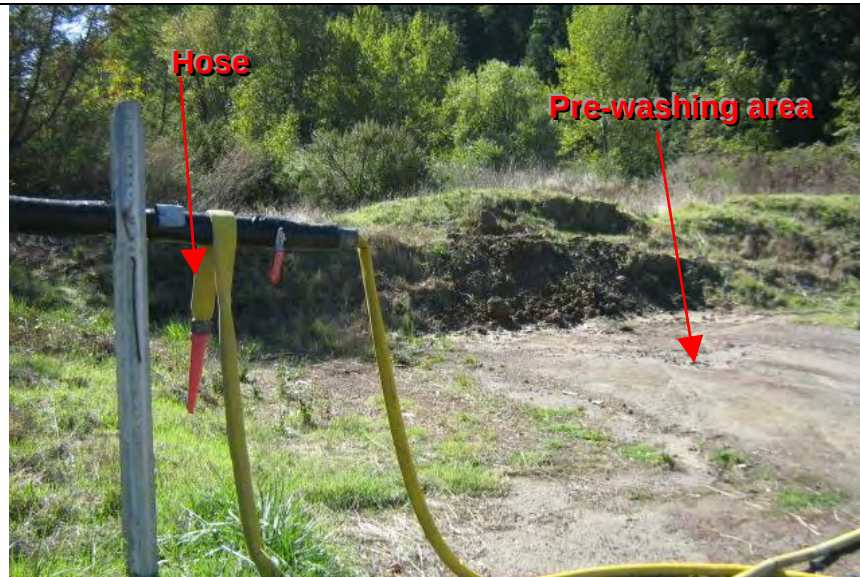
Despite the availability of the designated wash rack, a vehicle pre-washing area was observed in the lower yard (see Photograph 5). The lower yard is located west of the main office and maintenance facility, in much closer proximity to the South Fork Eel River. The pre-washing area is not equipped to properly capture, treat, re-use, or dispose of vehicle wash water and associated pollutants. Additionally, a berm installed down-gradient of the vehicle pre-washing area showed signs of standing water and had been damaged (see Photographs 6 and 7).

Photograph 5— Vehicle pre-washing area in the lower yard

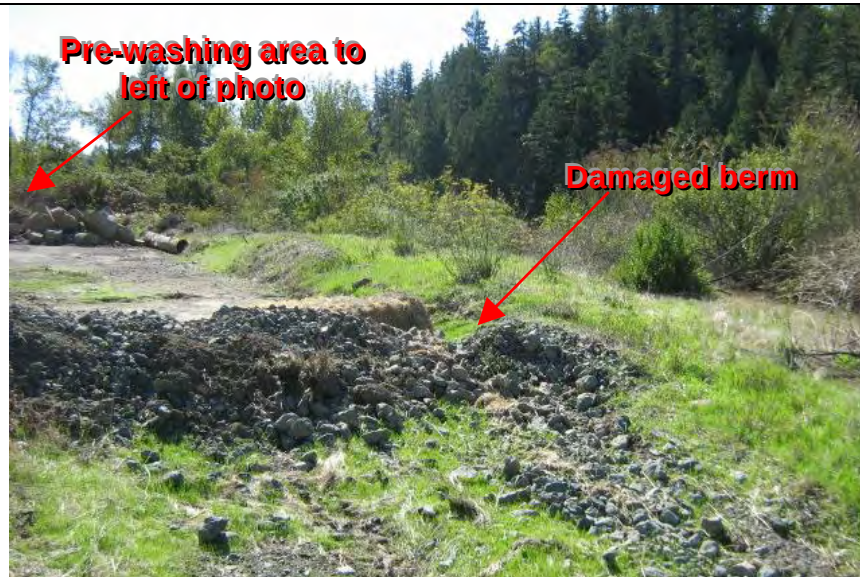
Photograph 7— Damaged berm shown in Photograph 6

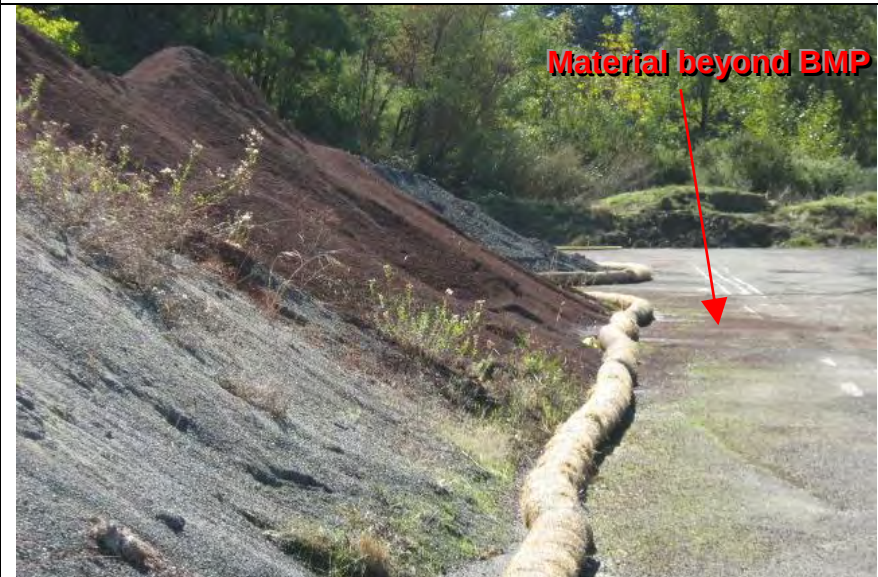
In addition, straw wattle BMPs used for stockpile management were improperly installed on impervious surfaces throughout the facility and were not properly entrenched in the ground to retain the stockpiled materials (see Photographs 8 and 9). Although located under cover, a second stockpile area containing salt also had a straw wattle BMP improperly installed on an impervious surface (see Photograph 9). Furthermore, straw wattle BMPs are not intended to control salt products or other pollutants that will dissolve upon contact with water. As a result, adequate BMPs were not implemented for stockpile management.

Photograph 8 – Inappropriate application of wattles on impervious surface

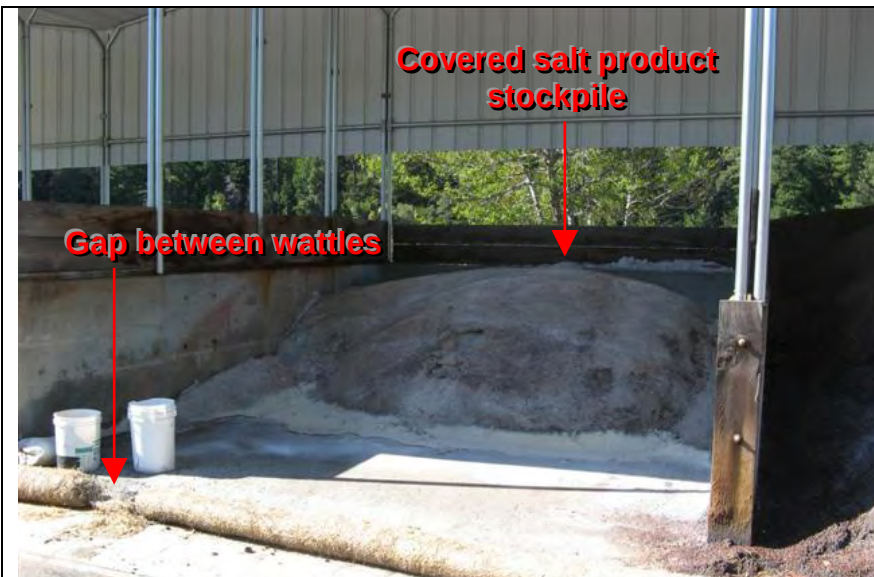
Photograph 9— Inappropriate application of wattles

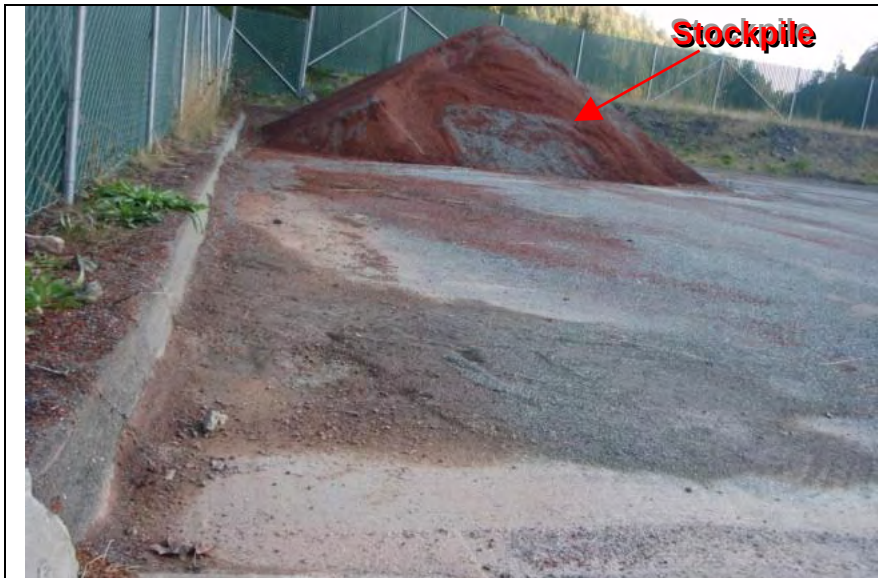
Photograph 1 – Stockpile without BMPs for coverage or containment

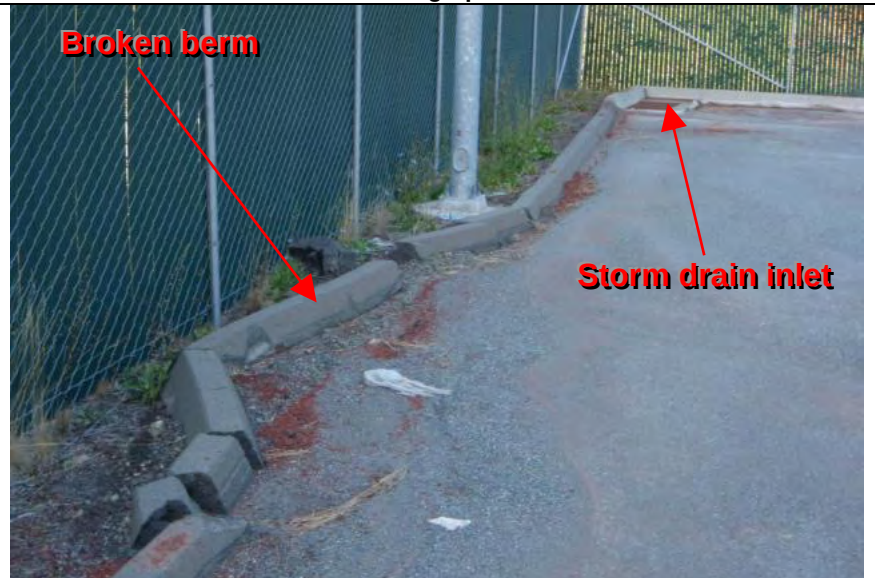
In addition, a 10 to 20 foot section of the berm along the northern perimeter of the site was not intact and accumulated roadway abrasives were observed adjacent to the failed berm (see Photograph 4). Roadway abrasives were also observed on the impervious ground surface in other various areas at the facility and beyond the perimeter fenceline (see Photographs 5, 6 and 7). As a result, there was a discharge of pollutants beyond the bermed perimeter, and the potential for subsequent off-site discharge.

Photograph 4 – Broken berm along northern perimeter of facility  
(Note: Accumulation of roadway abrasives adjacent to berm)

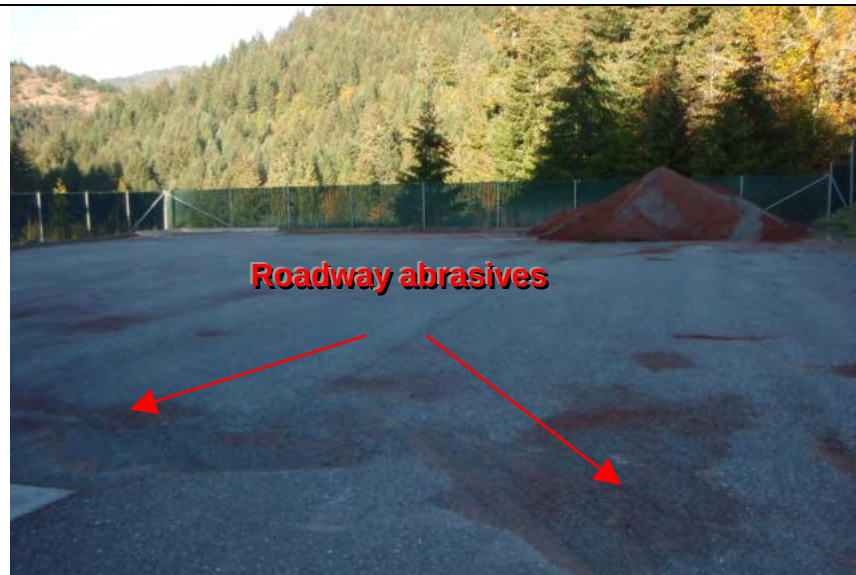
Photograph 5— Roadway abrasives on impervious ground surface

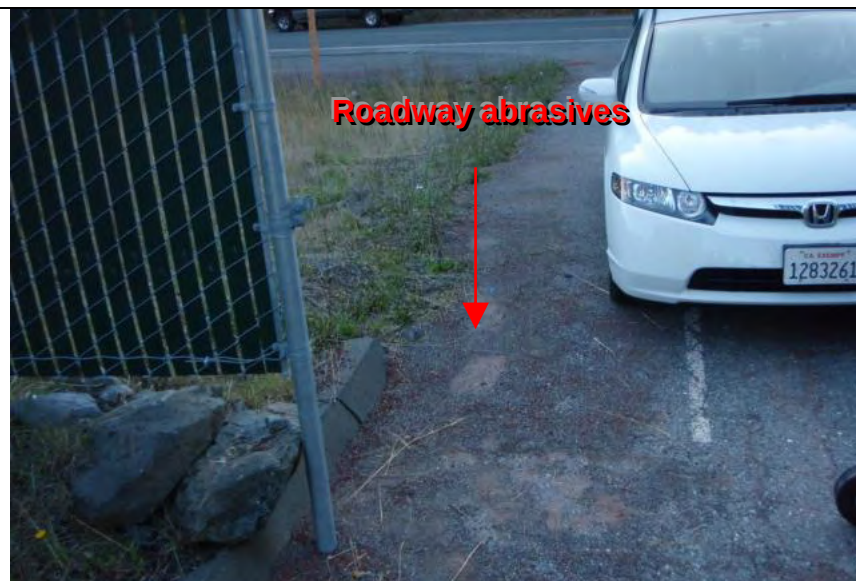
Photograph 7— Roadway abrasives outside facility entrance

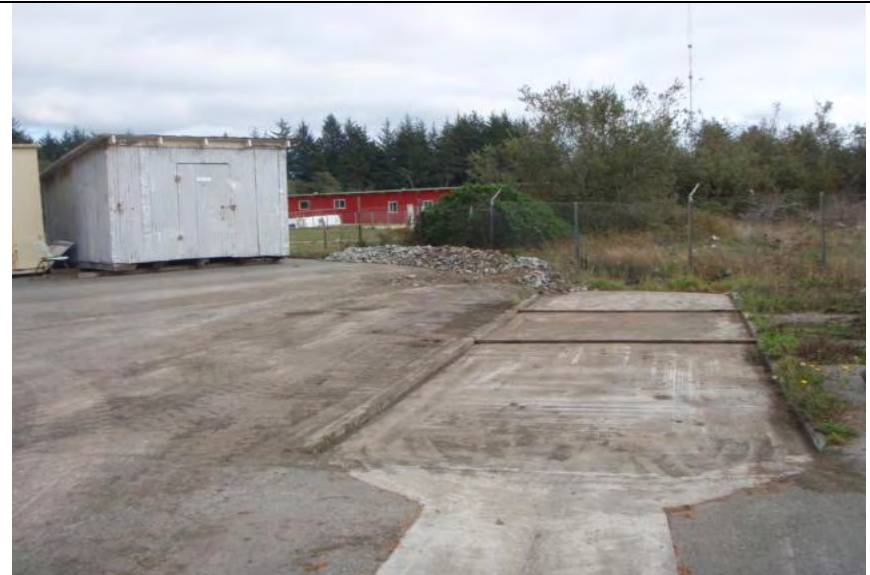
In addition, a significant amount of sediment accumulation was observed on the impervious ground surface near the southeast corner of the facility (see Photographs 6 and 7). As explained by the Highway Maintenance Supervisor, the area was used as a temporary stockpile location for washout material from front loaders and dump trucks. Whether the equipment washout operation was conducted with dry or wet processes was unclear. Appendix D of the Caltrans SWMP, Section 2.15.1, Vehicle and Equipment Cleaning, states “when possible, truck beds should be cleaned using dry cleanup technique (sweep up or shovel out).” It should also be noted that the stockpile area was located directly in the flow pathway of the surface drainage system at the facility (see Photograph 8). As a result, there was a potential for the discharge of sediment and other pollutants to the drainage ditch along the southern edge of the facility (see Photograph 9).

Photograph 6 – Area used for stockpiling washout material  
(Note: Sediment accumulation on impervious ground surface)

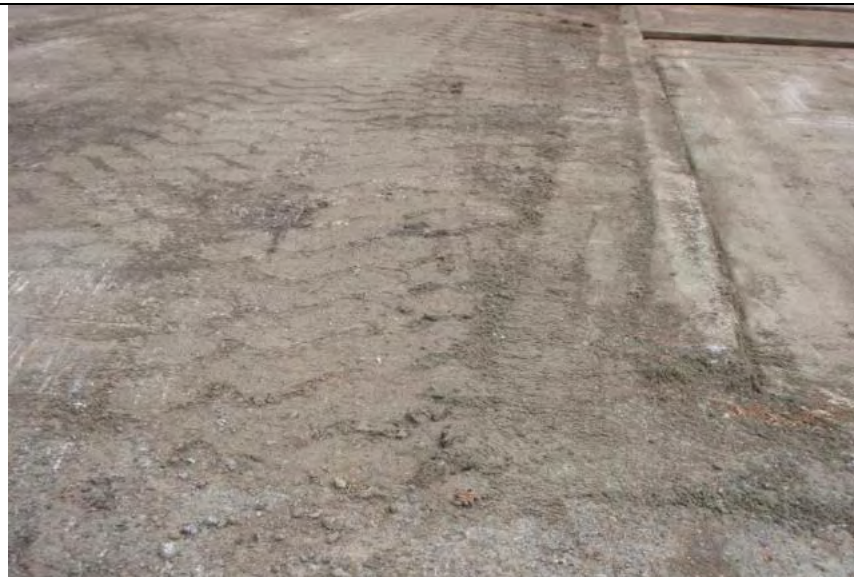
Photograph 7— Closer view of sediment accumulation on impervious  
ground surface

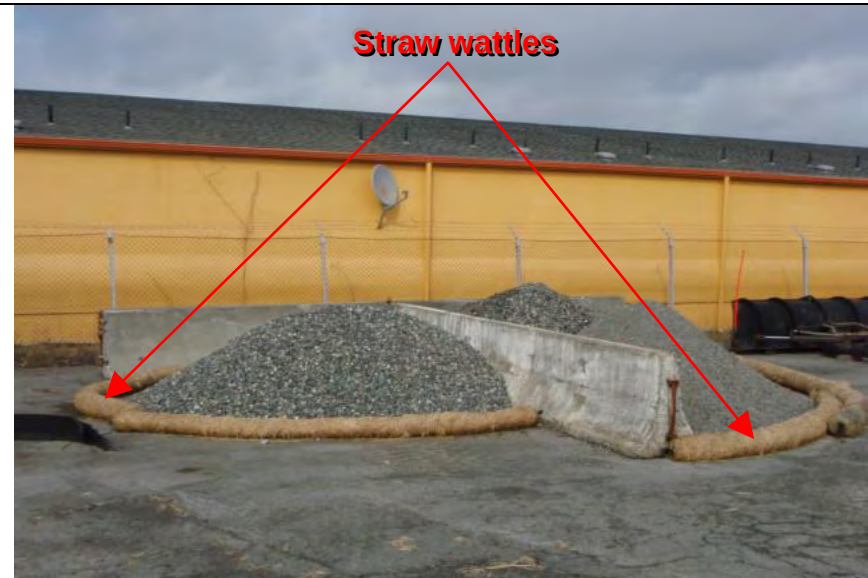
In addition, straw wattle BMPs used for stockpile management were improperly installed on impervious surfaces at the facility, and therefore were not properly entrenched in the ground to retain the stockpiled materials (see Photograph 10).

Photograph 10 – Inappropriate application of wattles on impervious surface

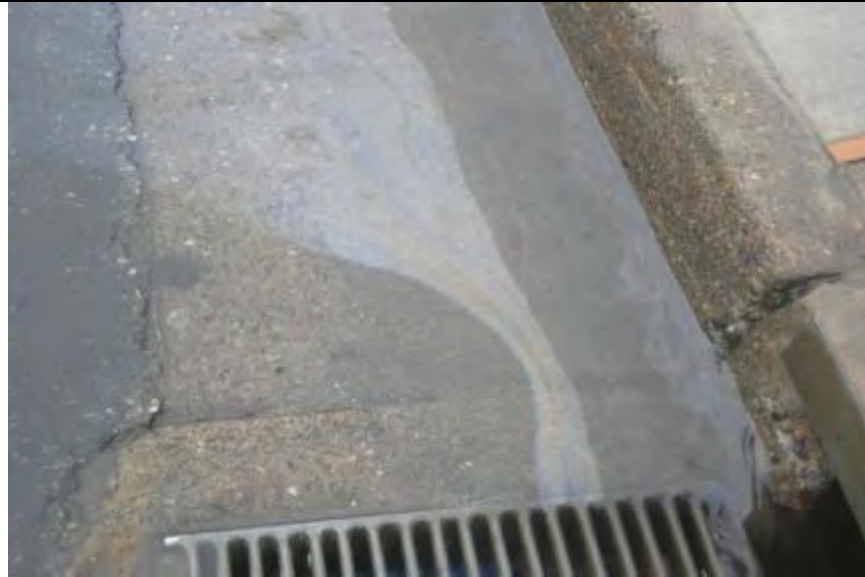
Provision I.3.b of the Permit requires Caltrans to provide appropriate site-specific BMPs for all maintenance facilities. A visible sheen was observed flowing into the storm drain located along the curb and gutter line of the northern portion of the rest area (see Photographs 1 and 2). The Caltrans Maintenance representative stated that an oil water separator BMP had been installed at this location because it drained directly into Shasta Lake. However, site plans or maintenance activity schedules were not produced to confirm that the treatment BMP was installed at this location.

Photograph 1 – Visible sheen entering storm drain

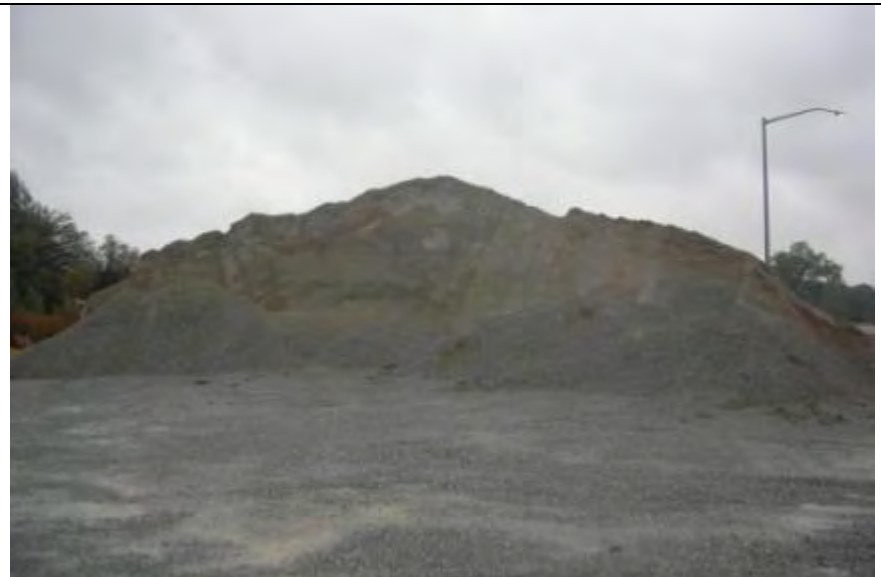
Photograph 2 – Lack of BMPs to contain stockpiled materials
