**UNITED STATES ENVIRONMENTAL PROTECTION AGENCY**  
**REGION IX**  
**75 Hawthorne Street**  
**San Francisco, CA 94105**

**WASTE MANAGEMENT DIVISION**  
**RCRA ENFORCEMENT OFFICE**

Purpose: RCRA Investigation

Facility: Chemical Waste Management, Inc.

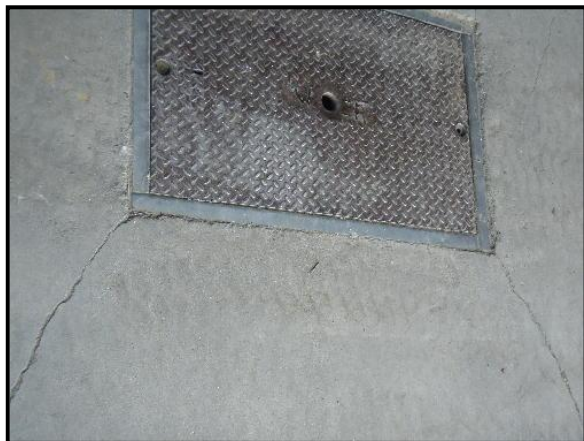
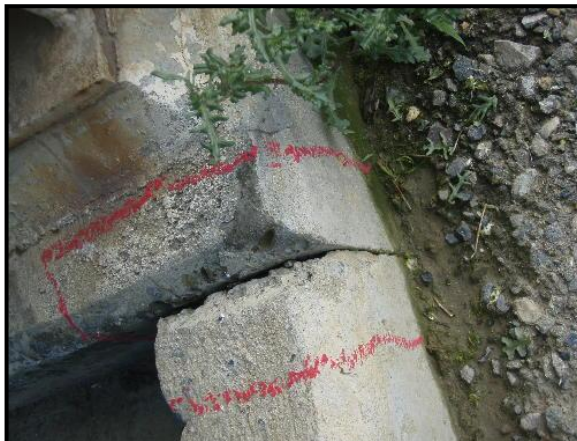
The base of the unit consists of a concrete pad underlain by a high density polyethylene (HDPE) liner. The pad is equipped with an HDPE-lined sump. The inspectors noted some cracks in the concrete flooring and in the berm which runs along the perimeter of the DSU (see photographs below).

EPA's review of the DSU's as-built diagram verified that the secondary containment capacity calculations were based on the footprint of each cell and not the perimeter of the DSU where the cracks in the above photographs were observed.

EPA observed that cracks located within the secondary containment area were repaired.

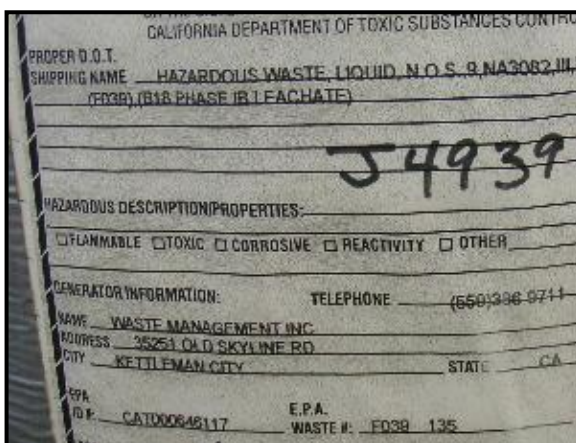
In A-Cell the inspectors observed eleven 55-gallon containers of leachate (F039) collected from the hazardous waste storage tank at P-16. CWM failed to check the appropriate box for the particular hazardous properties of the waste (i.e. toxic) on the labels (see example, photograph to the right).

This issue was corrected during the investigation.

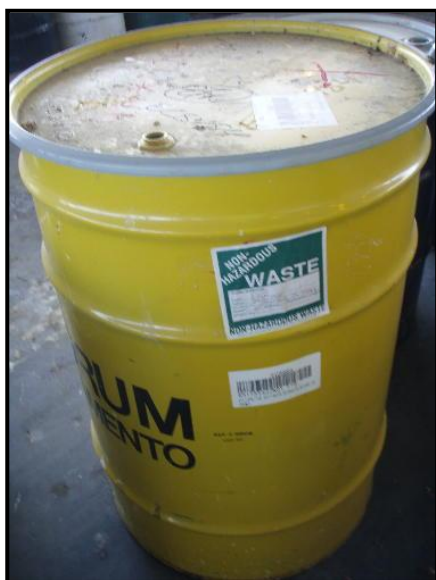
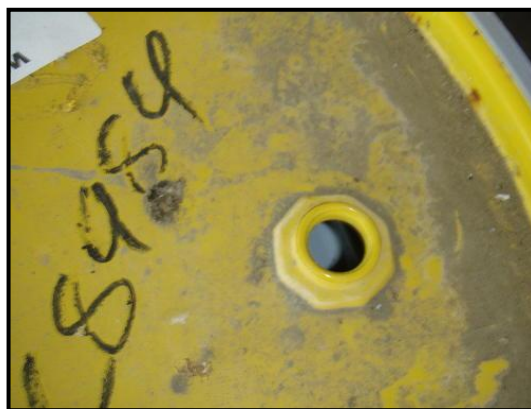
In B-Cell the inspectors noted one 55-gallon container filled with non-RCRA oily water that had an open bung (see photographs below). The facility representatives replaced the missing bung while the inspectors were there.

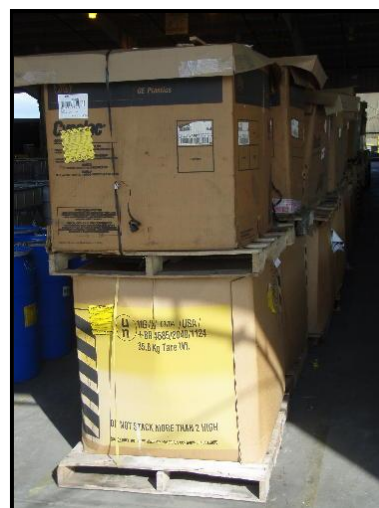
In C-Cell the inspectors noted that cardboard one-cubic card boxes were being stacked two high with a pallet underneath and between the boxes (see photograph to the right). CWM's Hazardous Waste Facility Permit allows for containers to be stacked to 72 inches in total container height, not including any pallet between the stacked containers. It appeared that the containers were right at the height limit so the inspectors cautioned CWM to ensure that none of their containers were stacked too high.

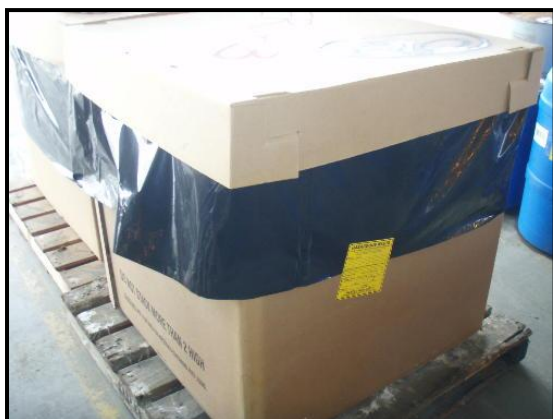
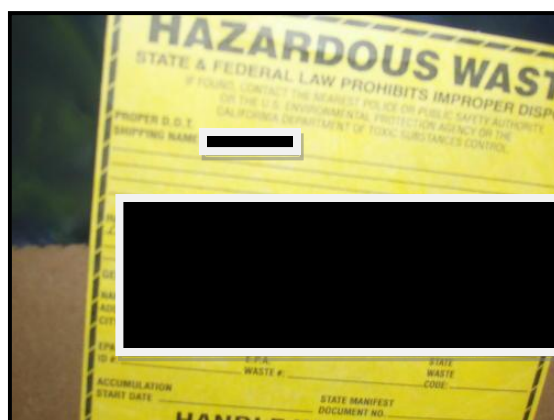
The inspectors noted a couple of dented containers in the F-Cell area although neither appeared to be leaking. The inspectors also found two cardboard cubic yard boxes filled with used aerosol cans (see photographs below). The generator's hazardous waste labels described the contents as "flammable aerosol cans-spent (Universal Waste)". It was unclear to the inspectors whether the aerosol cans were to be shipped off as hazardous waste or universal waste. According to facility representatives, CWM accepts universal waste, repackages it (if appropriate), and then sends it off to Veolia Environmental Services for recycling. When the inspectors returned to the DSU the following day they noted that the hazardous waste label had been removed and a new label affixed that described the contents as universal waste flammable aerosol cans.

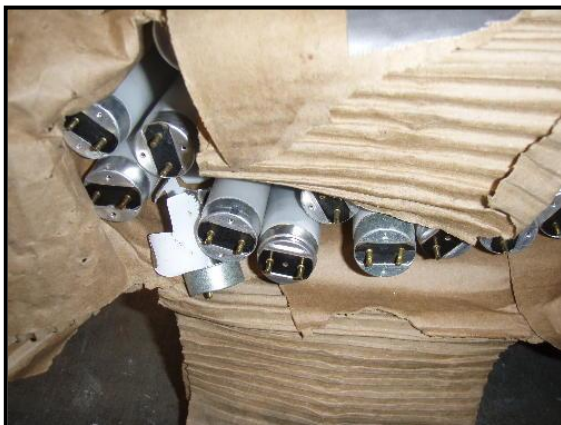
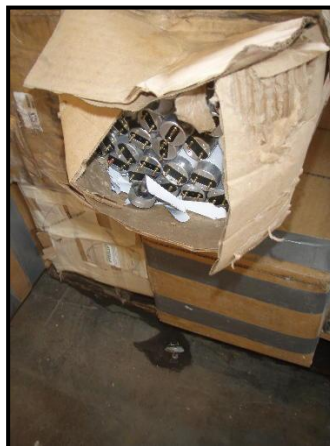
The inspectors found two containers of universal waste lamps that were left open (see photographs below). A lamp in one of the containers was broken and a small amount of liquid (rainwater which collected on the container from the recent rain) and glass were observed on the floor underneath the container (see photograph below on the right). The containers also were not marked with the words "universal waste – lamps" as required.

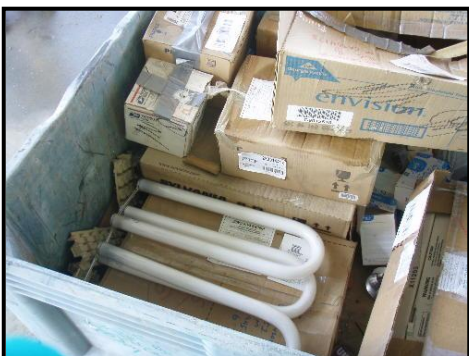
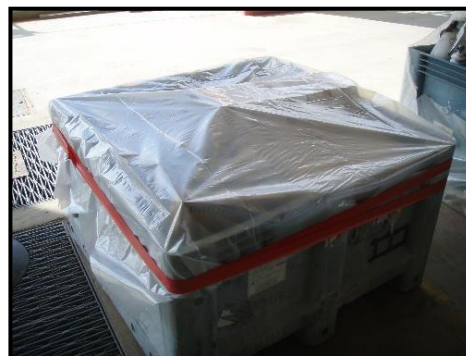
The inspectors also noted an open tote container filled with miscellaneous universal waste lamps in this area. Several of the lamps were not in an enclosed container as required (see photograph below on the left). When the inspectors returned to the DSU on the third day of the investigation they noted that facility representatives had corrected the potential violation and that all lamps were fully enclosed in cardboard boxes and that the tote container had been covered with plastic (see photograph below on the right).

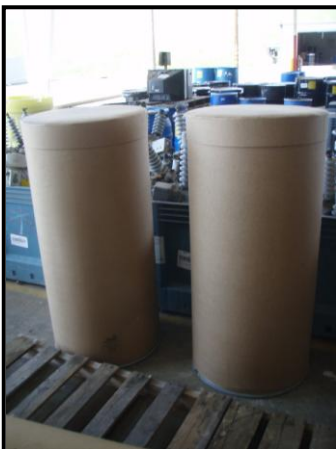
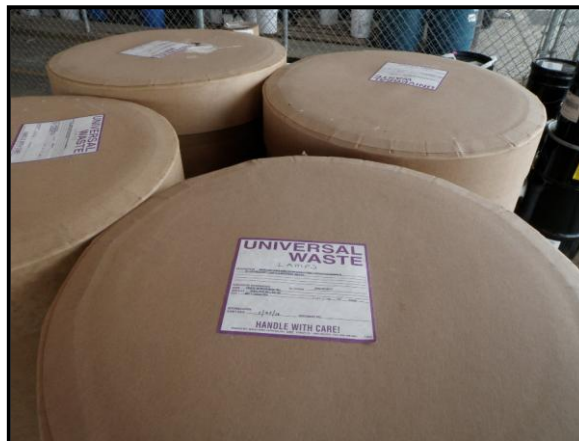
On the third day of the investigation, the inspectors observed two containers of universal waste lamps which were being filled, but were not labeled as required (see photograph below on the left). When the inspectors returned to the DSU the following day this issue had been resolved (see photograph below on the right).

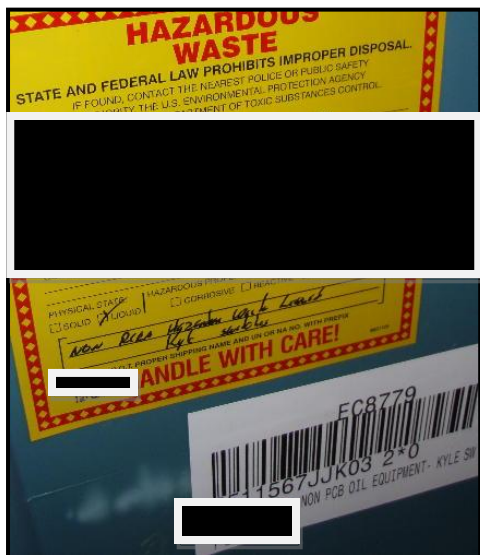
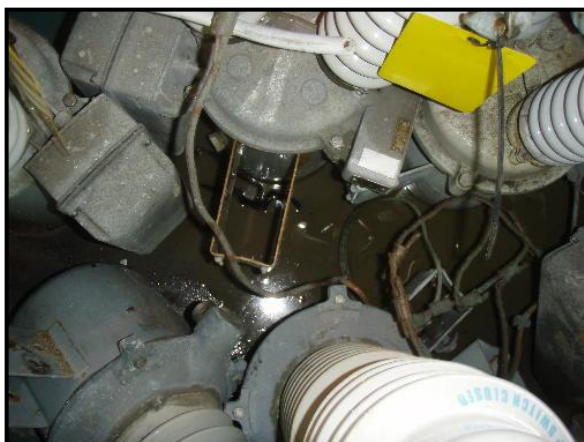
In another row in the G-Cell area, the inspectors observed several open bulk containers of electrical equipment which were filled with non-RCRA hazardous waste oil (see photographs below). Several of the containers had liquid in the bottom and oily sheens on the equipment indicating possible equipment leaks (see photograph below on the right).

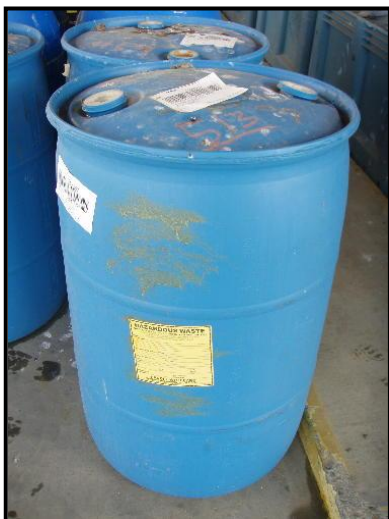
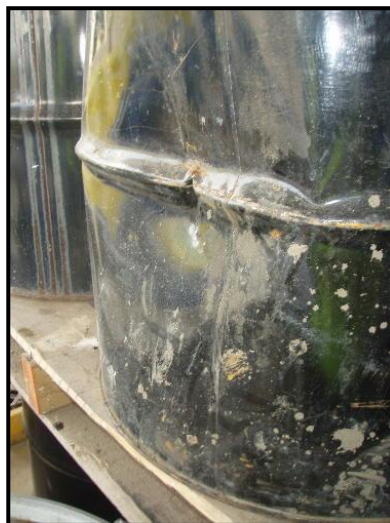
The inspectors observed a slightly bulging 55-gallon container of acid lab waste (see photograph below on the left) as well as a couple dented drums (see photograph below on the right) in the H-Cell area. No leaks were detected.

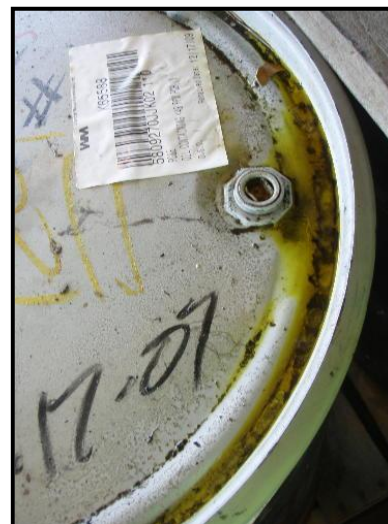
The inspectors also observed a 55-gallon drum of non-RCRA hazardous waste (used oil) which had a small amount of yellowish liquid on the top of the drum cover (see photograph to the right). When the inspectors returned to the DSU on the third day of the investigation the facility representatives pointed out that they had cleaned up and properly disposed of the small amount of used oil liquid which had accumulated on top of the drum.

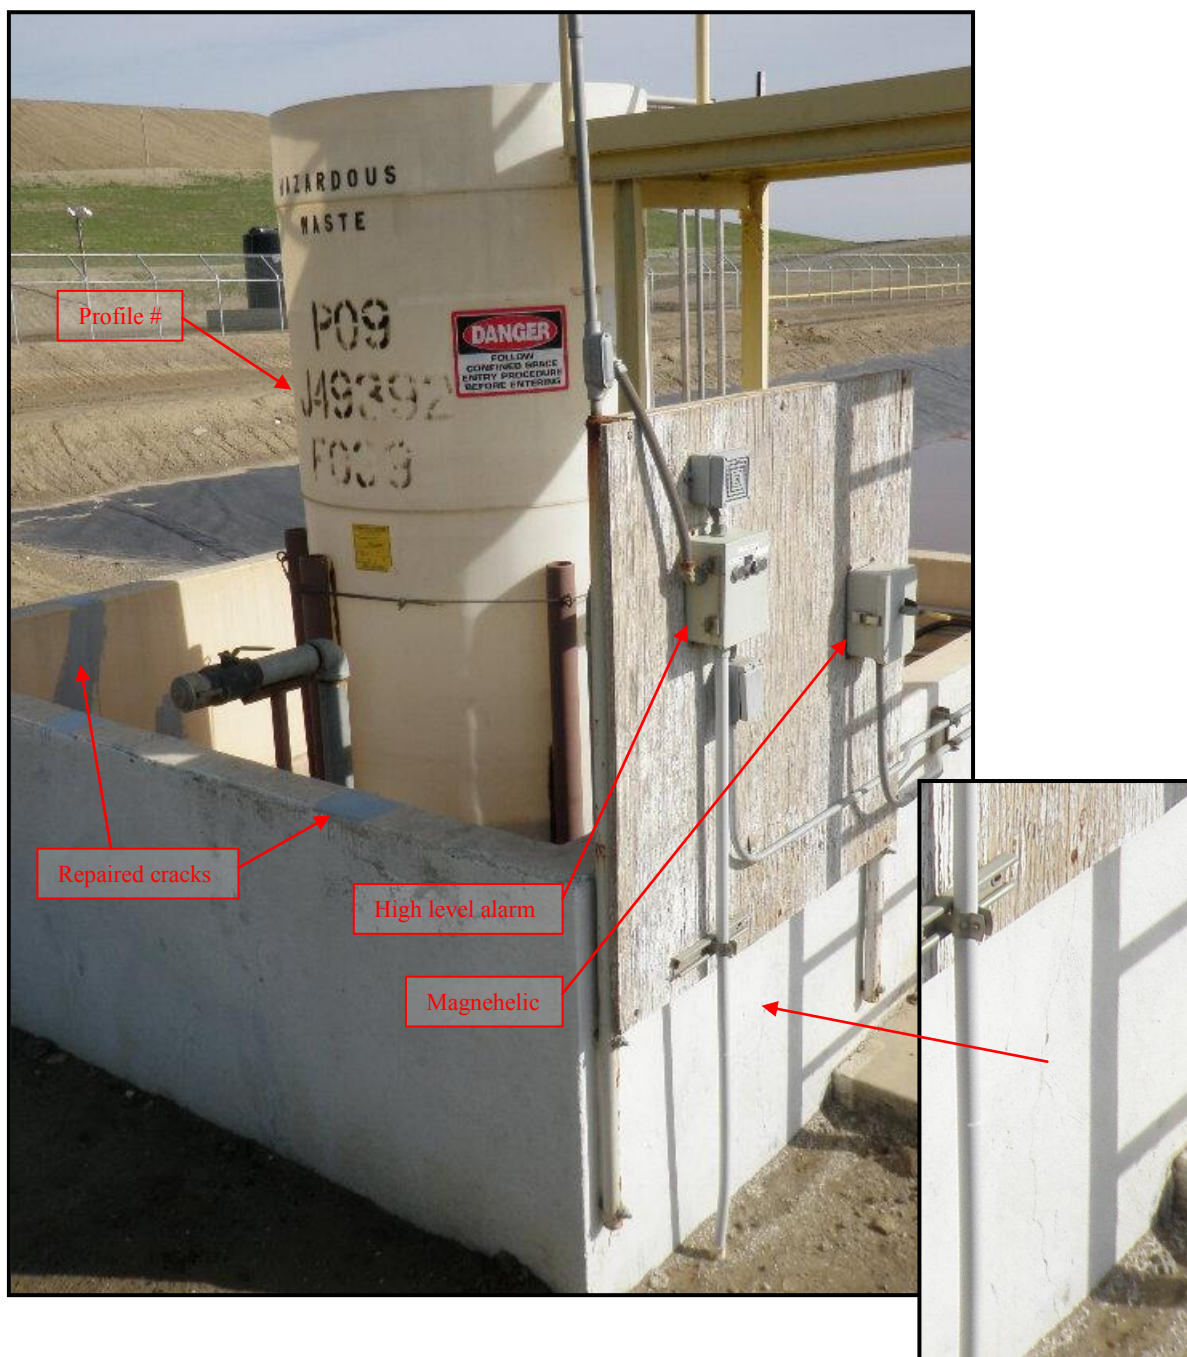
The inspectors noted cracks on the outside wall of the secondary containment system (see cropped and enlarged inset). The inspectors also noted that the cracks on the inside walls and floor of the secondary containment system were repaired.

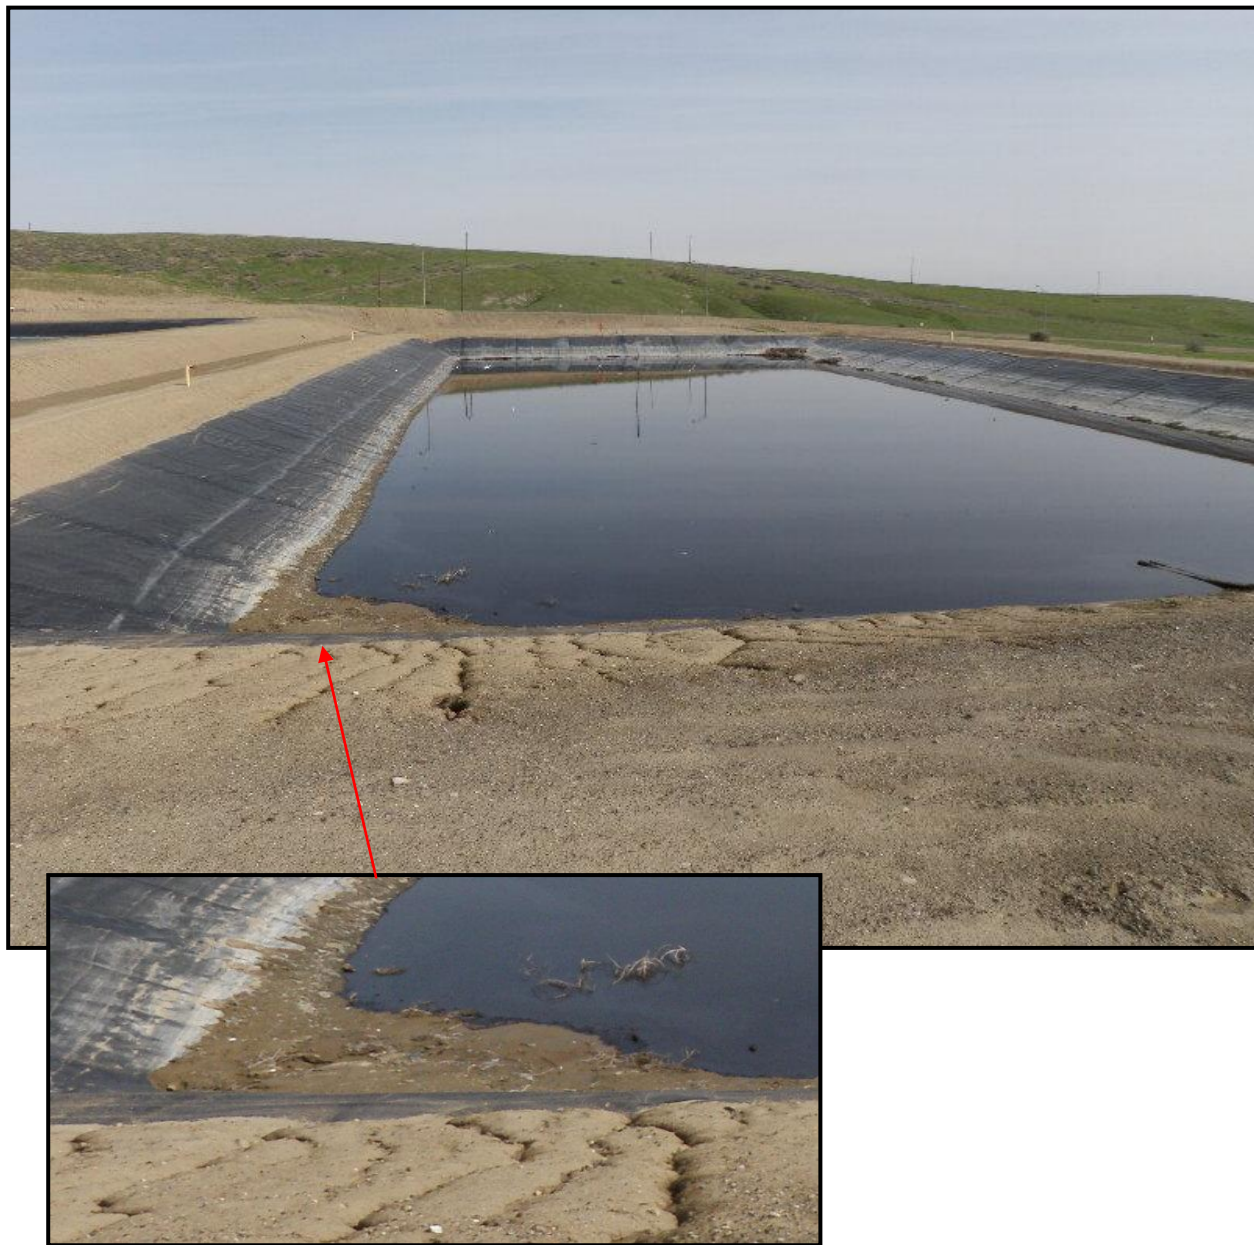
The inspectors observed an accumulation of unknown material along the waterline of P-14 (see photograph above - facing east). The cropped and enlarged inset photograph shows a close-up of some of the unknown material. Note: The P-14 leachate collection tank is located off-camera to the right.

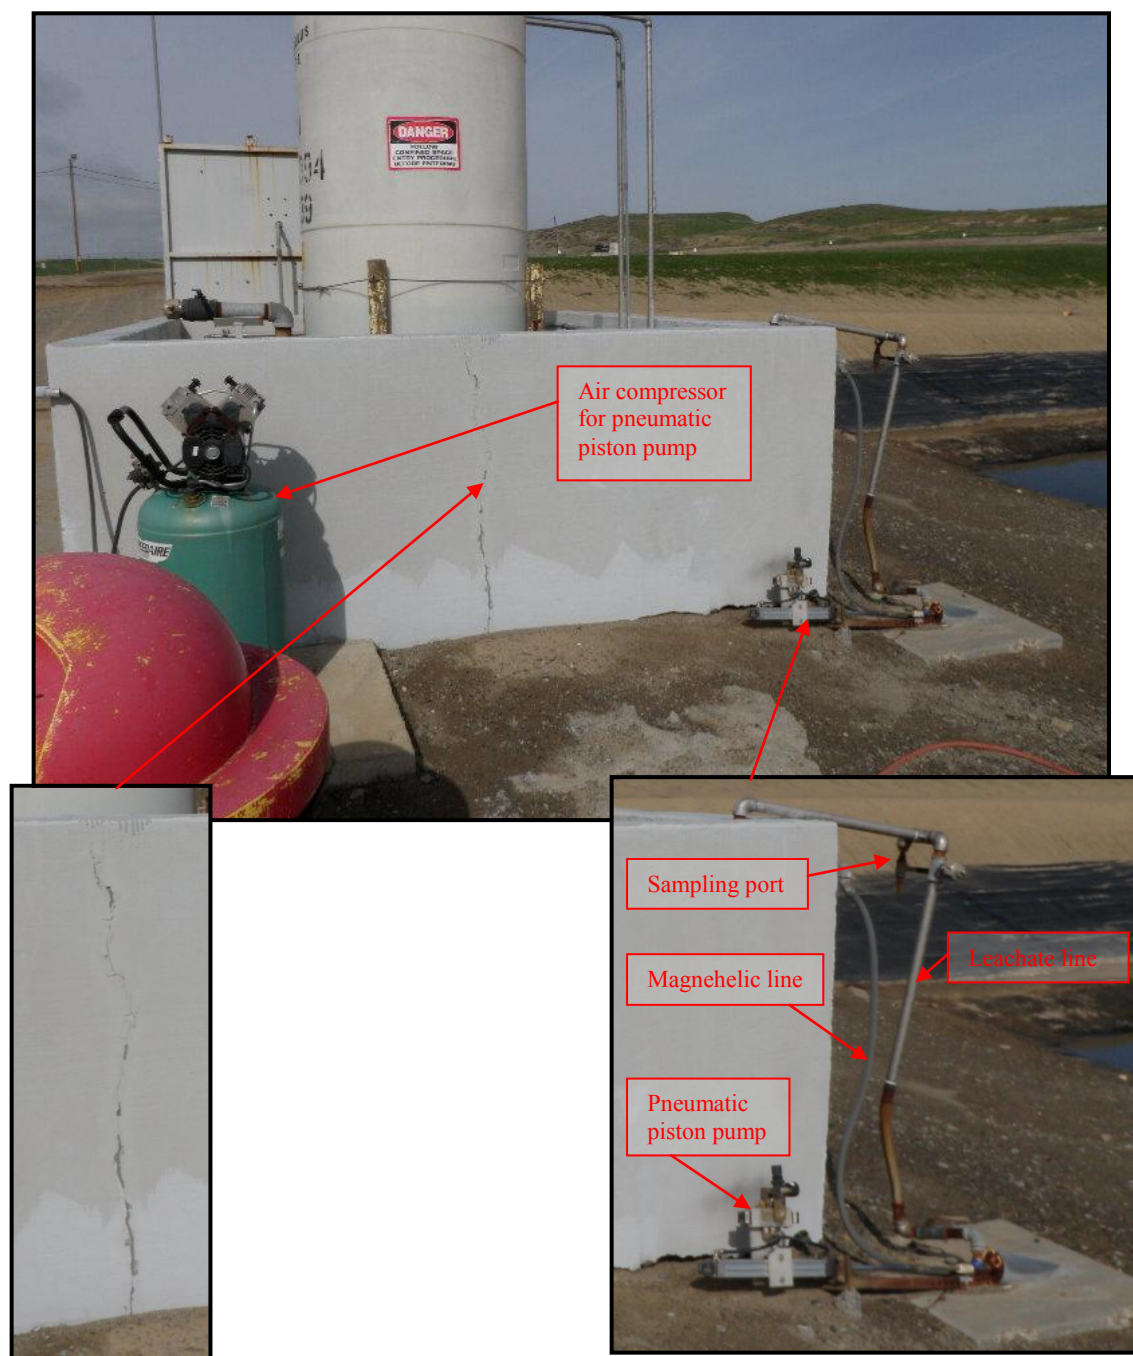
The inspectors noted cracks along the outside portion of the secondary containment system for the P-14 leachate collection tank (facing north; see cropped and enlarged inset on the left). As noted on the previous page, the cracks inside the secondary containment system were repaired.

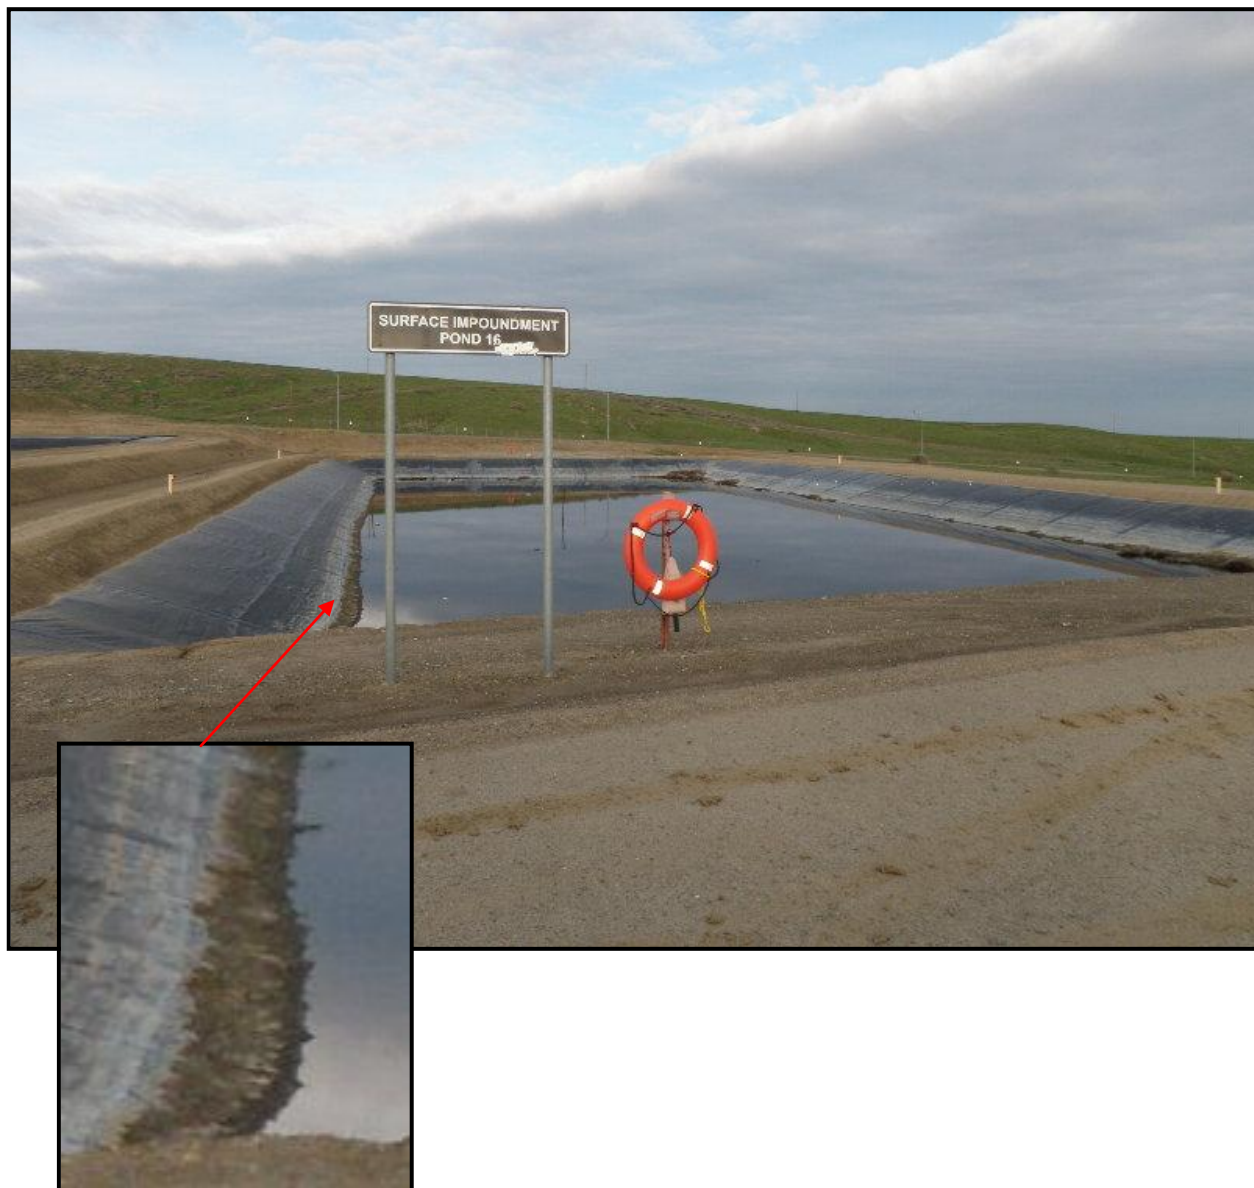
The inspectors observed an accumulation of unknown material along the waterline of P-16 (see photograph above - facing east). The cropped and enlarged inset photograph shows a close-up of some of the unknown material. Note: The P-16 leachate collection tank is located off-camera to the right.

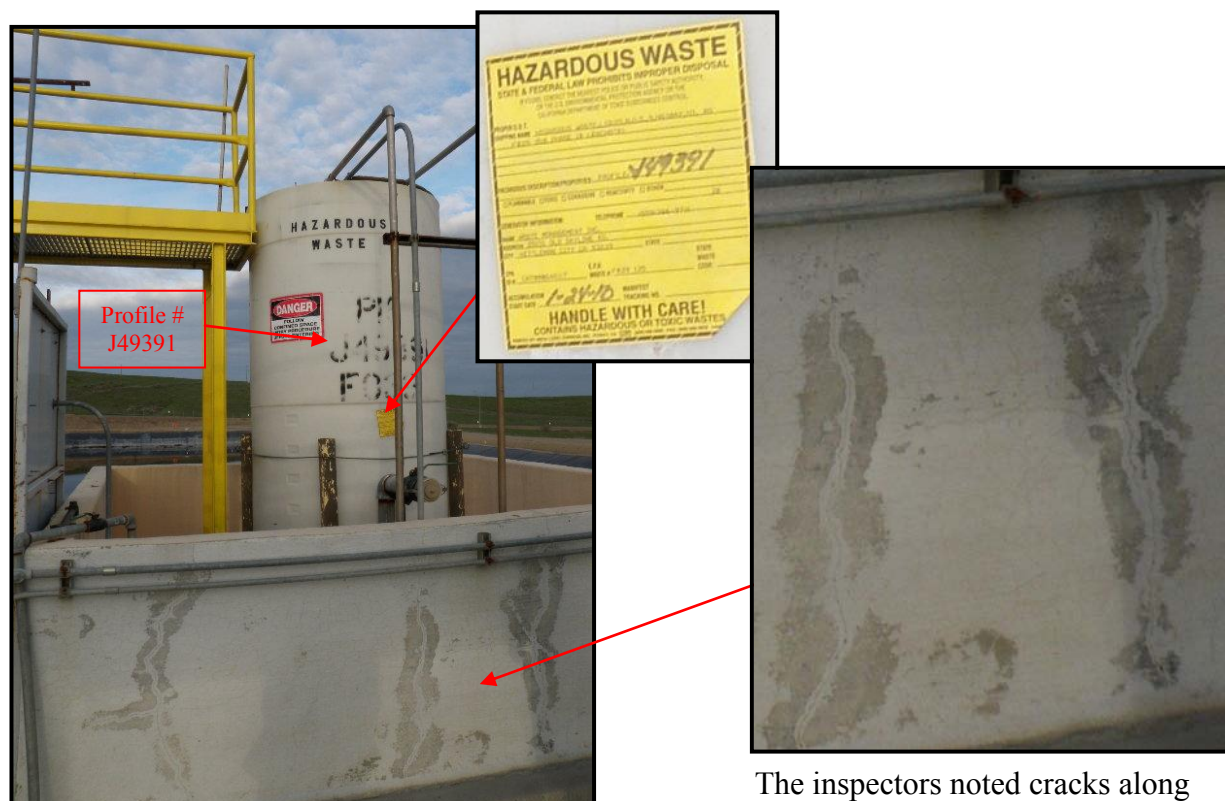
The inspectors noted cracks along the outside portion of the secondary containment system for the P-16 leachate collection tank (facing east; cropped and enlarged).

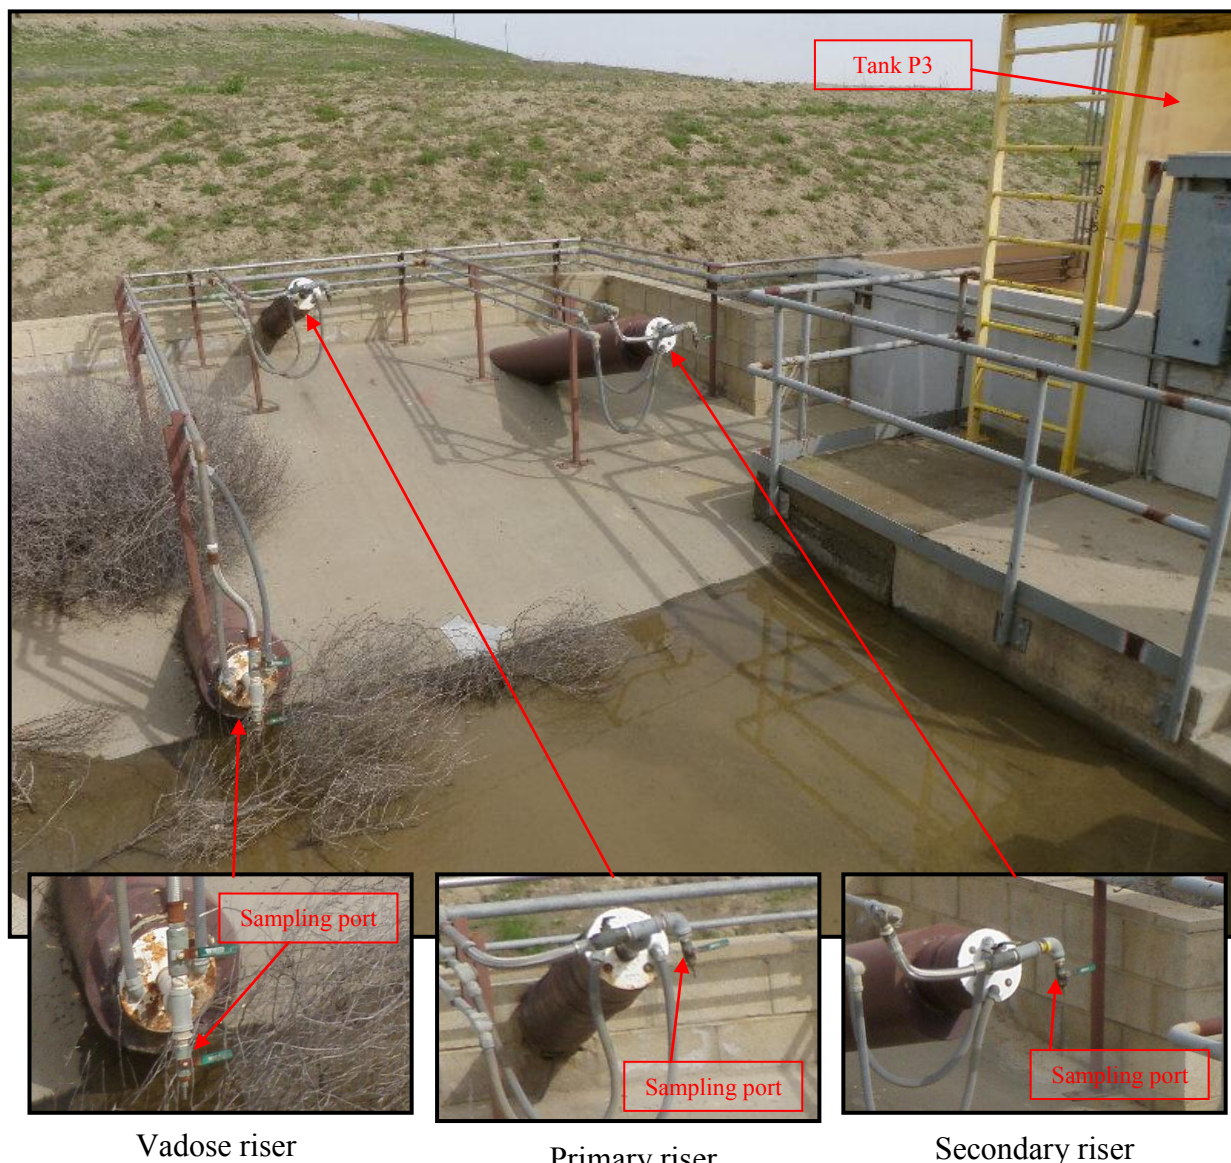
The inspectors noted that this area contained rainwater from the previous night's rain. This rainwater will be pumped into the adjacent tank.

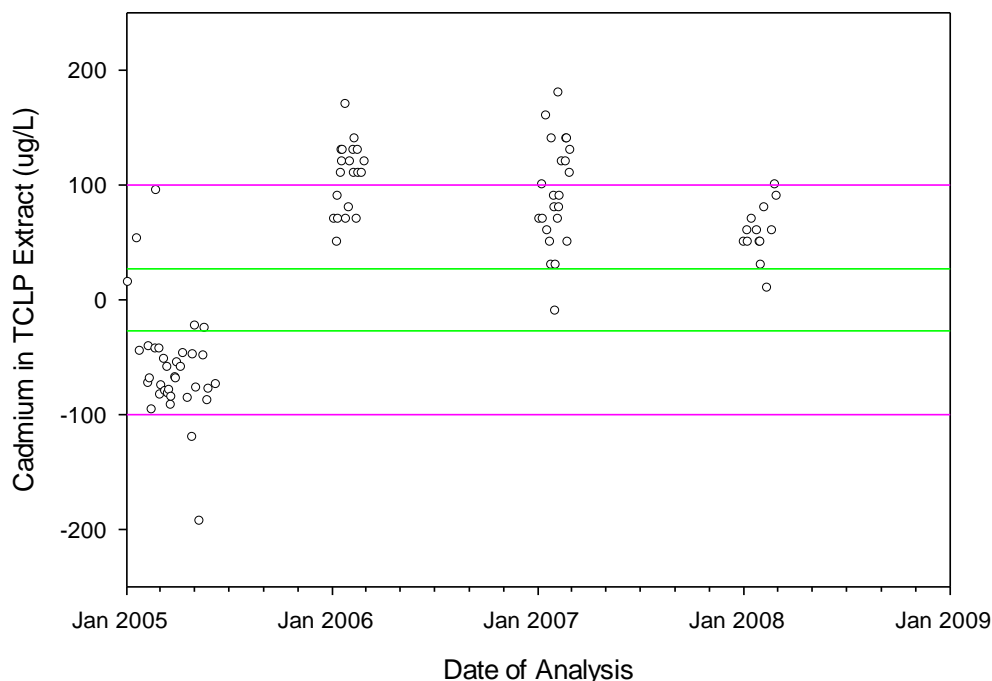
### Results for Zero Concentration Cadmium in Quality Control Sample ICS 1

Additionally, the table below summarizes CWM's own internal review of the acceptability of the ICV, ICS 1, and ICS 2 results. As previously described, failure of any of these critical quality control samples indicates that the data is not acceptable and corrective action must be taken. There were no correctives actions in response to any of the CWM self-identified failures. All of the associated sample data for TCLP extracts of hazardous waste were used to make waste management decisions for land disposal.
