SEWAGE COLLECTION SYSTEM INSPECTION FORM

City of Emeryville

Inspection Date: April 6, 2009

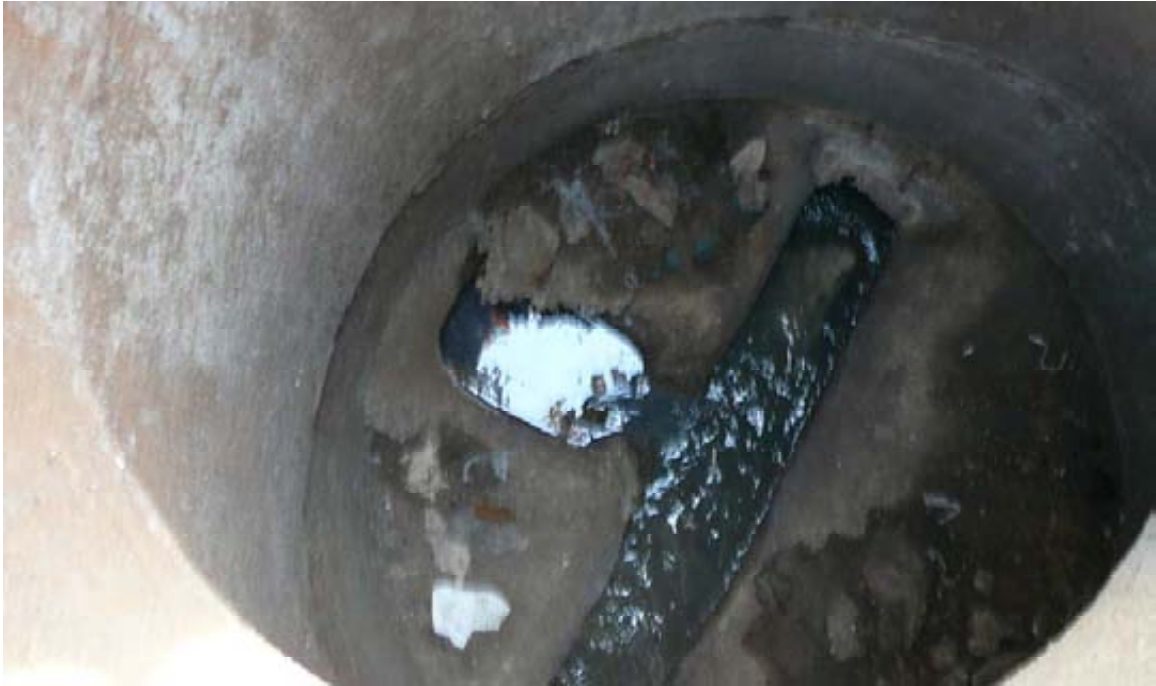
City staff noted that their hydraulic model indicates that the main where the 2/15/09 spill occurred may be undersized. This spill occurred during a rainfall event. The City plans to replace this main. The inspection team visited this spill site (Photos 7 and 8). The inspection team also visited the location of the spill on 11/16/07 (Photos 5 and 6).

Emeryville Photo 5: Manhole outside 1400 65th Street, where grease blockage occurred.

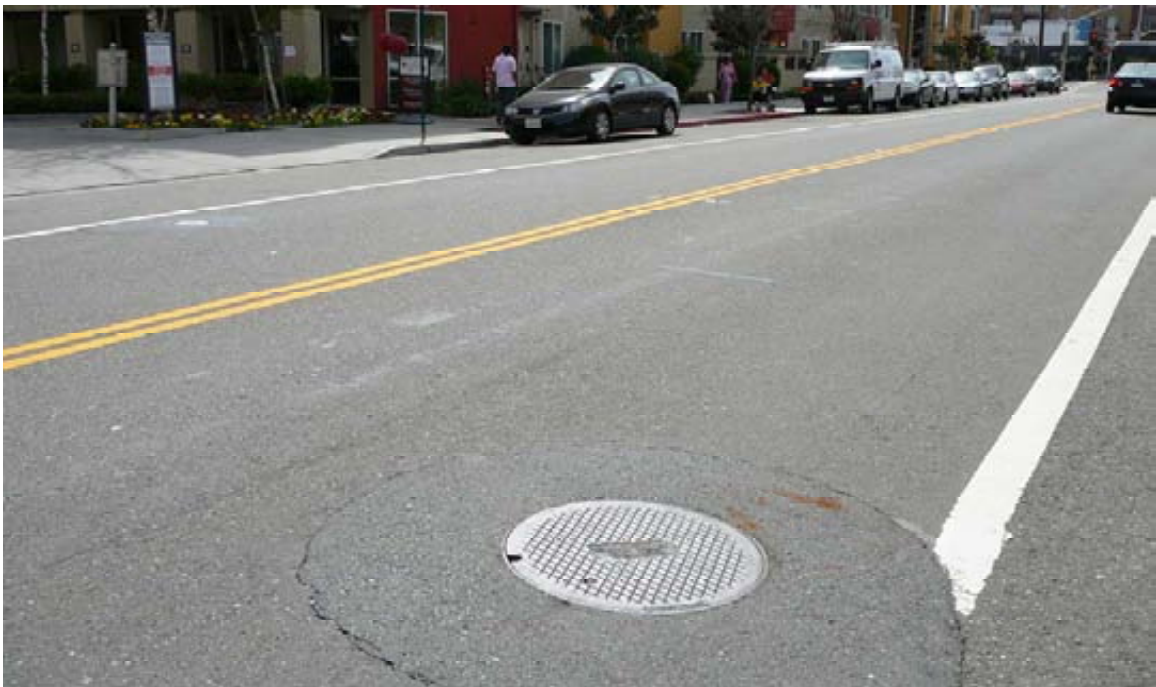
Emeryville Photo 6: 1400 65th Street - manhole cover showing pickhole that wastewater came out of.

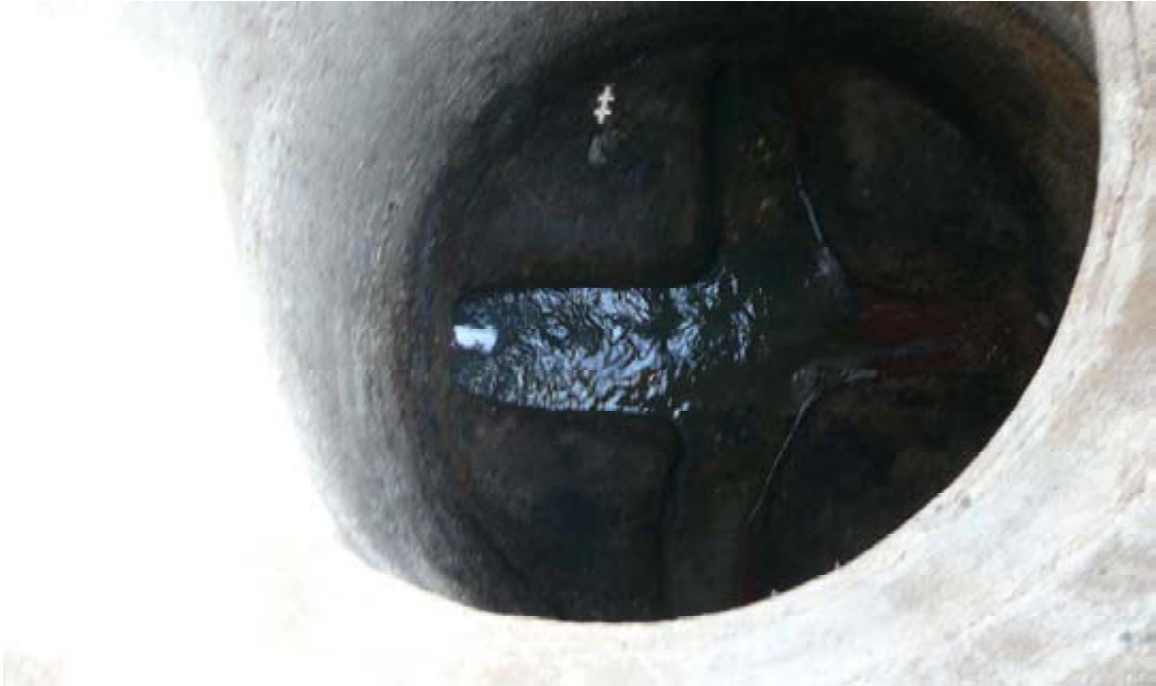
The area at 63rd and Vallejo where there have been blockages due to debris thought to be coming from Oakland is not on the hotspot schedule. The debris contained beer cans, so there is also concern that a cross connection might be involved. City staff did not contact Oakland about this issue.

Emeryville Photo 7: Manhole that overflowed at 63rd Street due to debris. Oakland flow enters from left.
