Leak Detection & Repair

Blue Print to Water Resource Management

COMMONWEALTH UTILITIES CORPORATION WATER DIVISION

Leak Detection and Repair Phase II

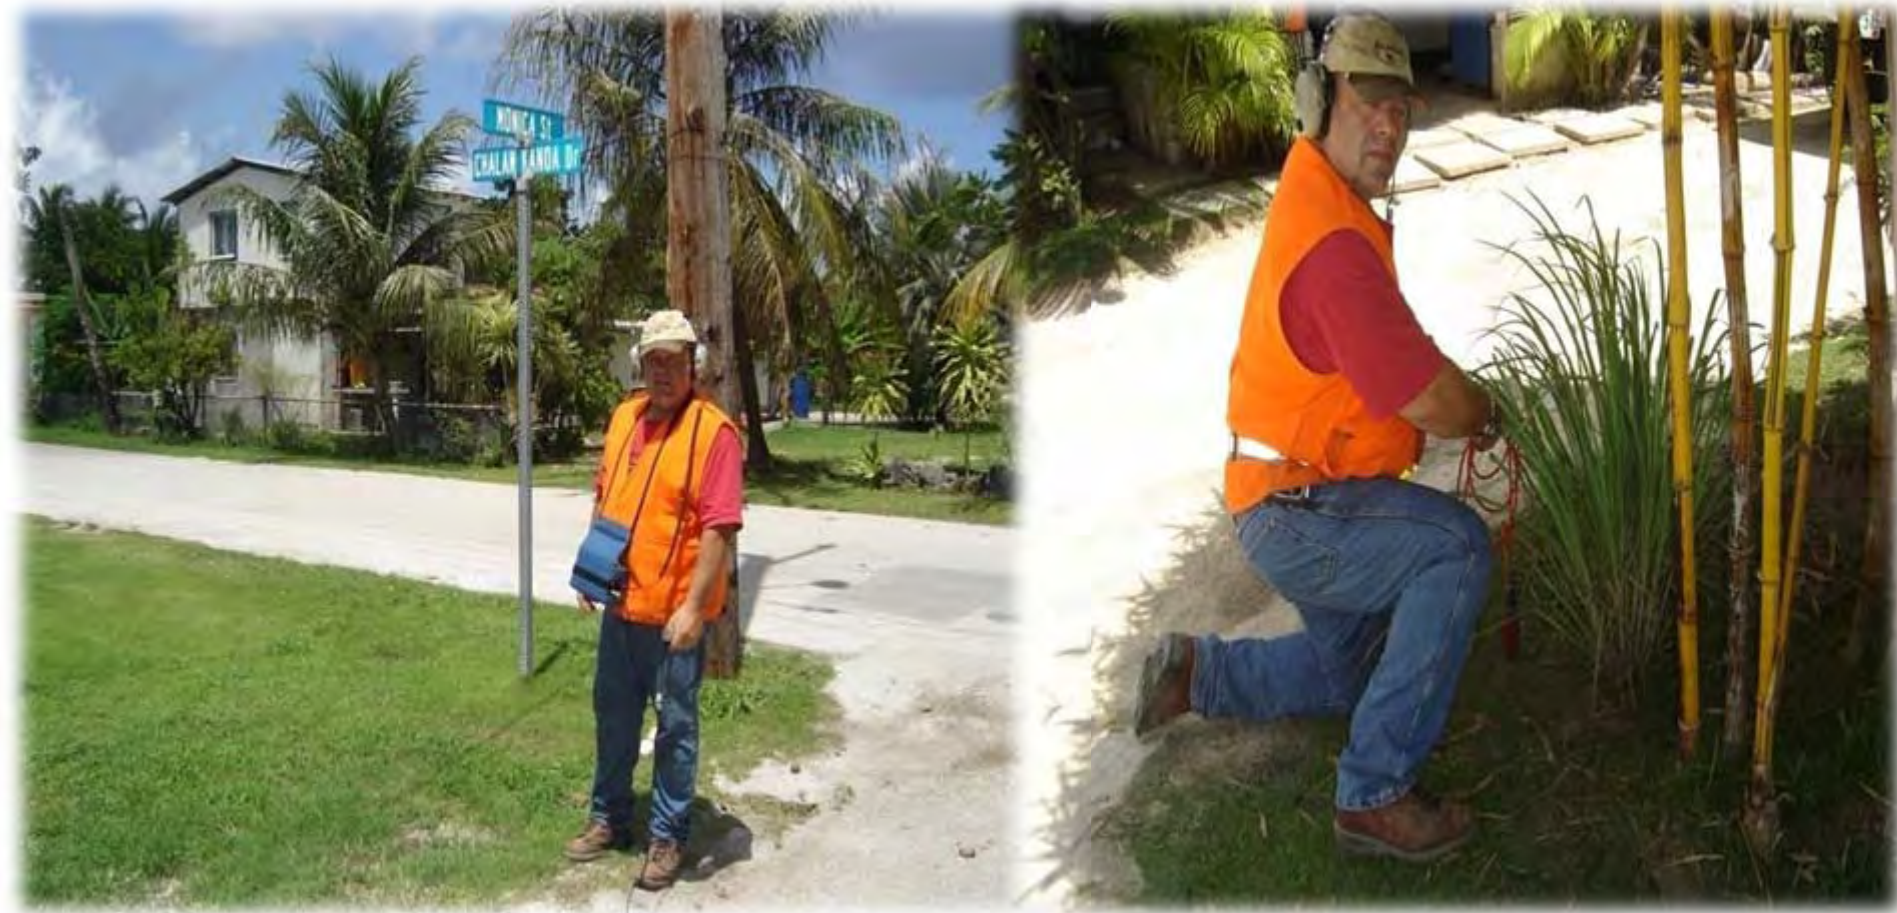
Chalan Kanoa

Leak Detection and Survey (Point to Point)

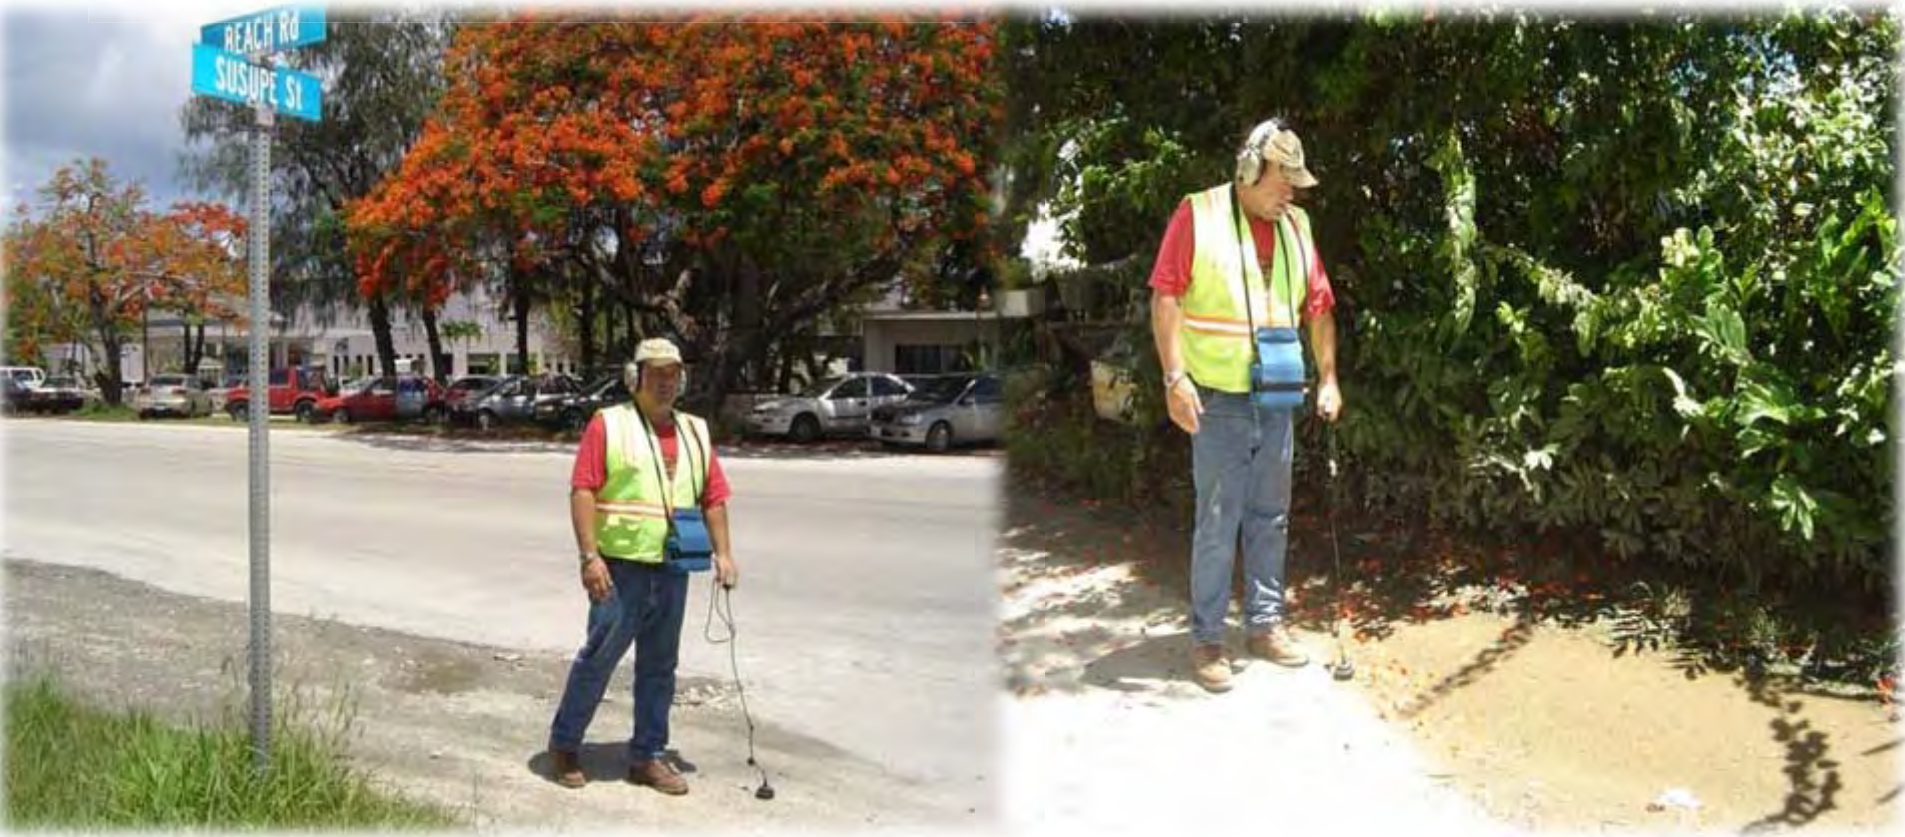
Susupe

Leak Detection and Survey (Ground Microphone)

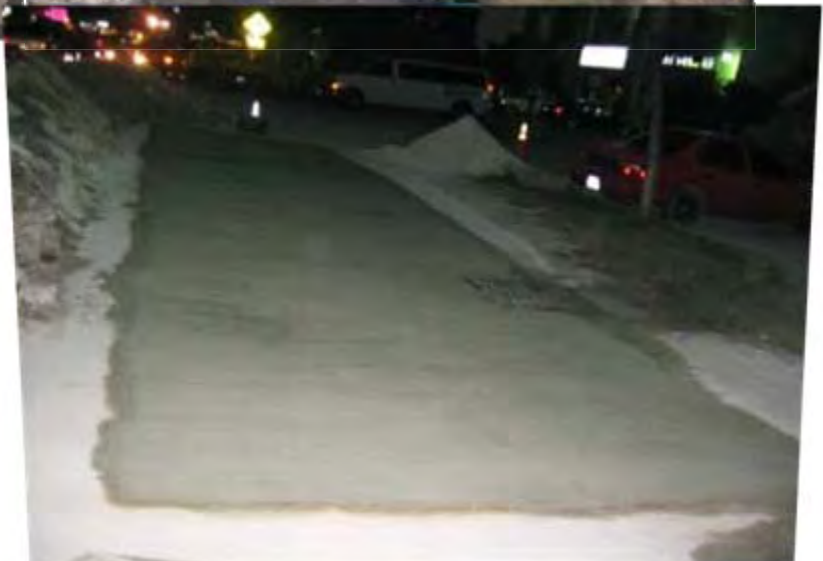
Chalan Kanoa

Leak Repair – 12" Ø PVC

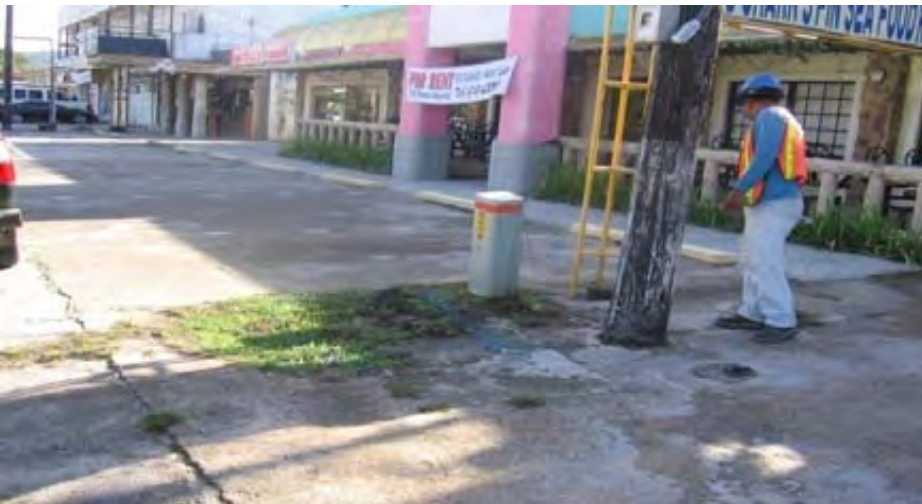
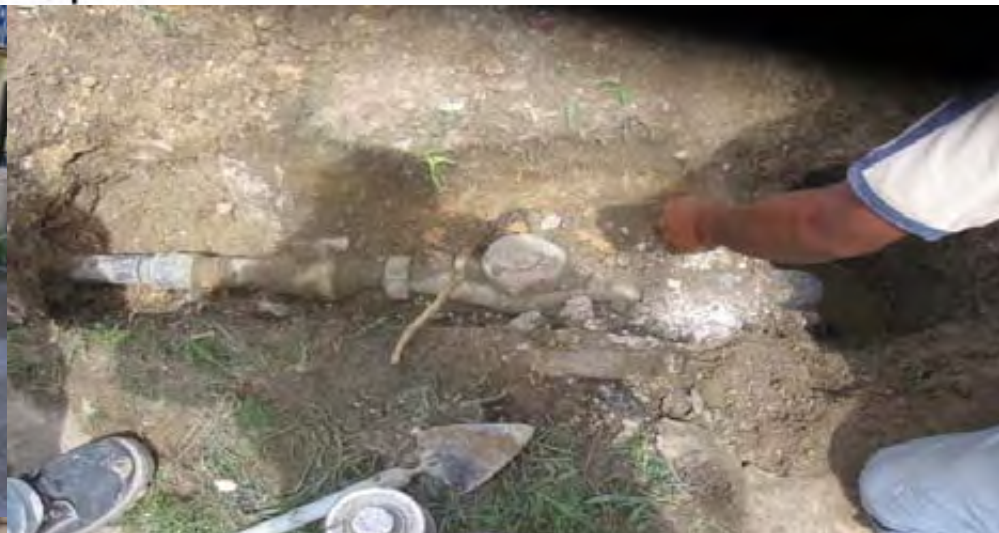
Susupe

Leak Repair –2" x 1-1/4" dia PVC

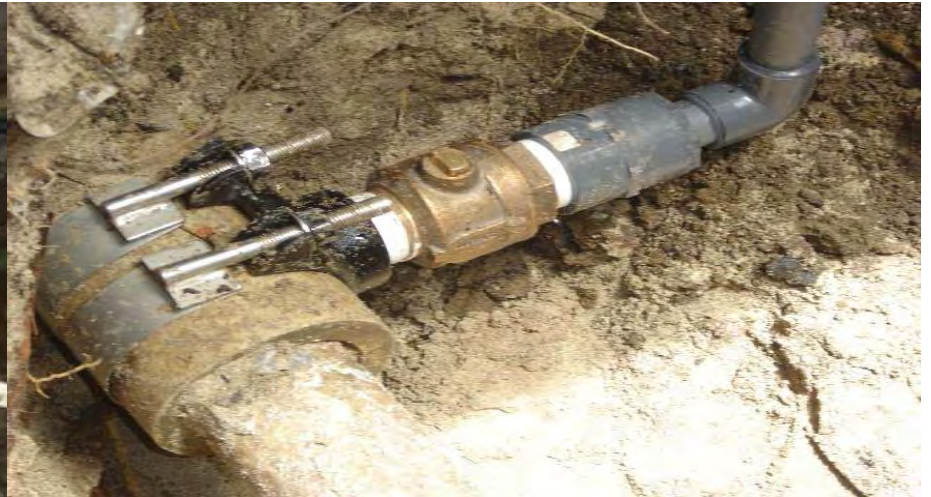
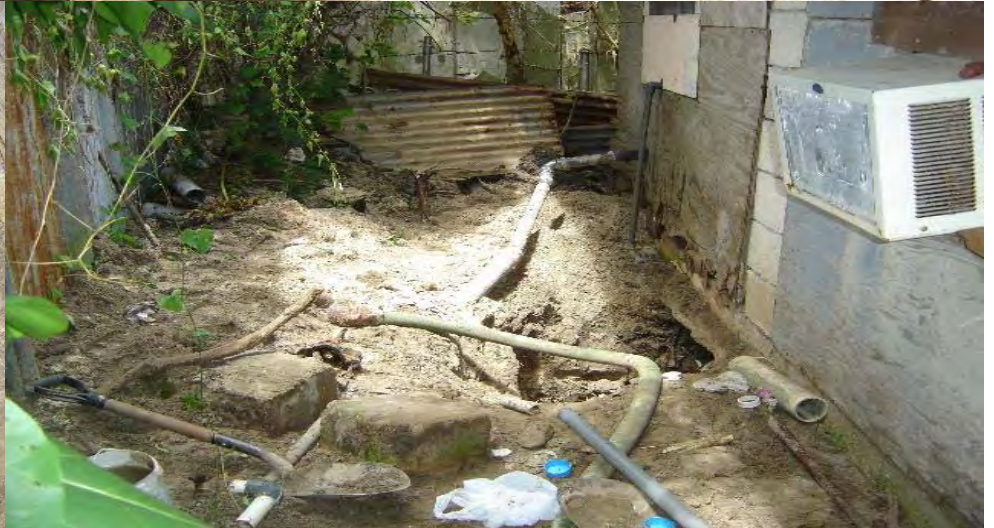
Leak Repair –6" x 2" Service Saddle and 2" Corporation Stop
San Antonio

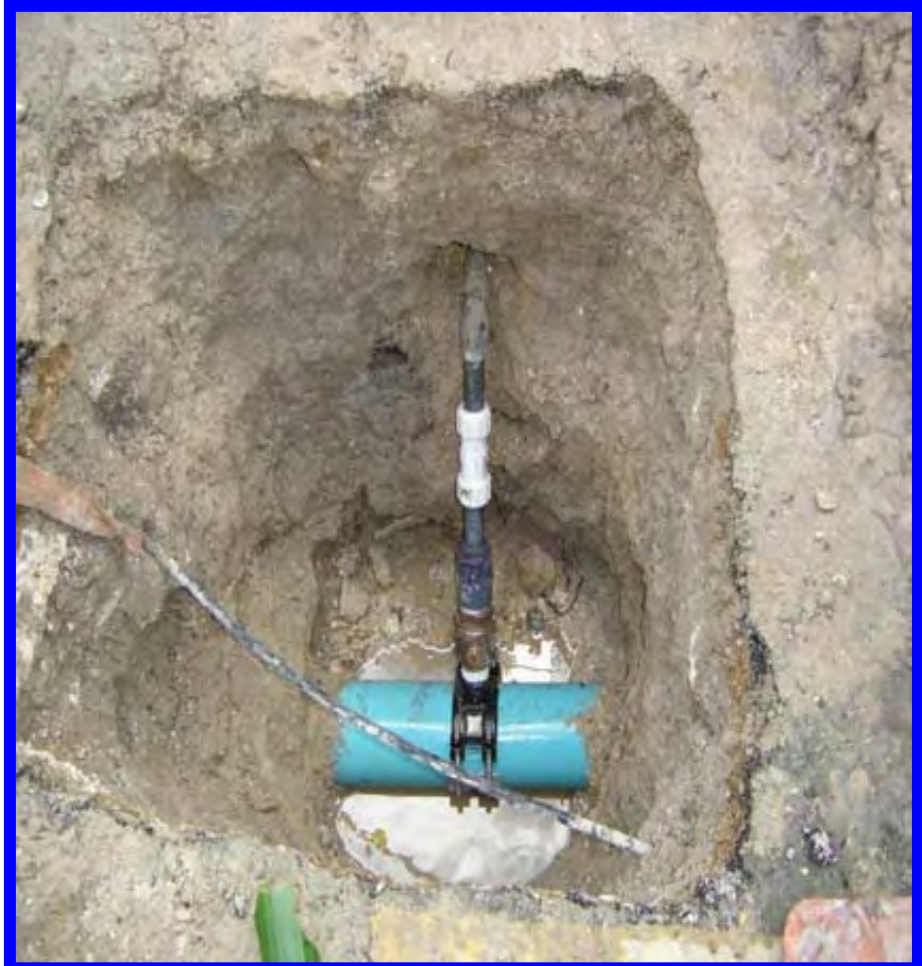
Leak Repair –6" x 2" Service Saddle and 2" Corporation Stop
Chalan Kanoa

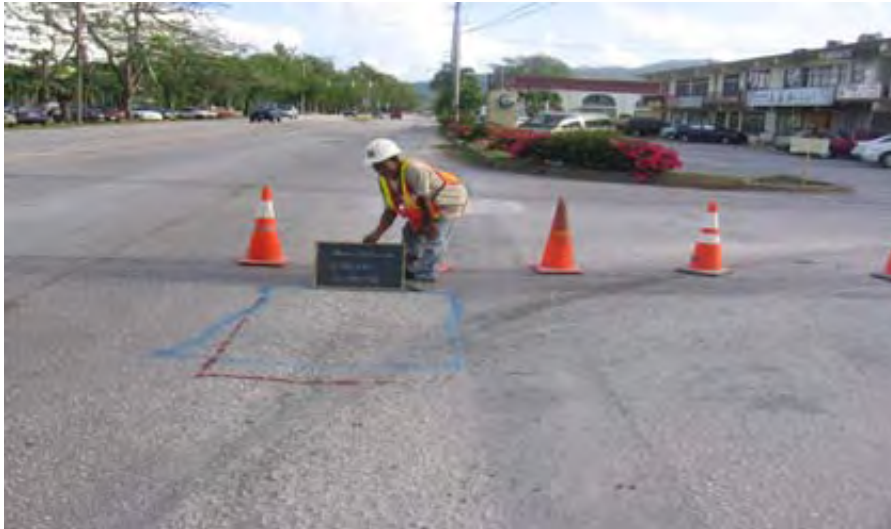
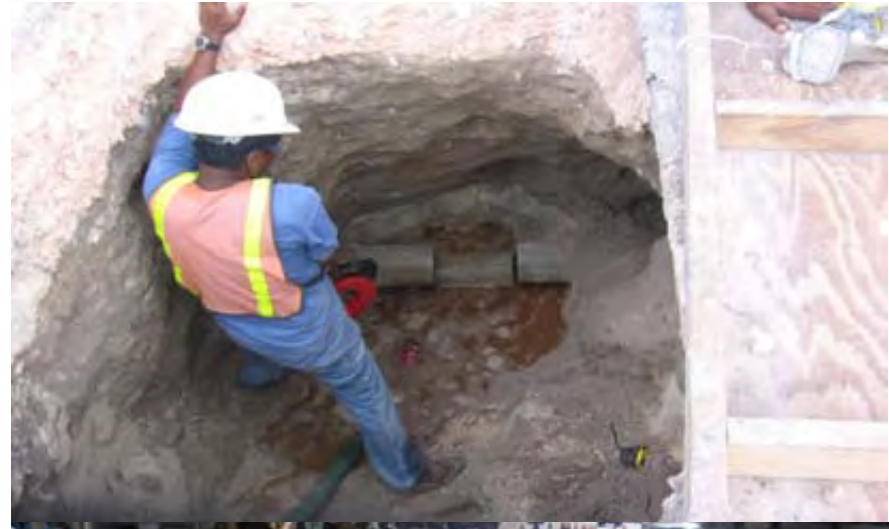
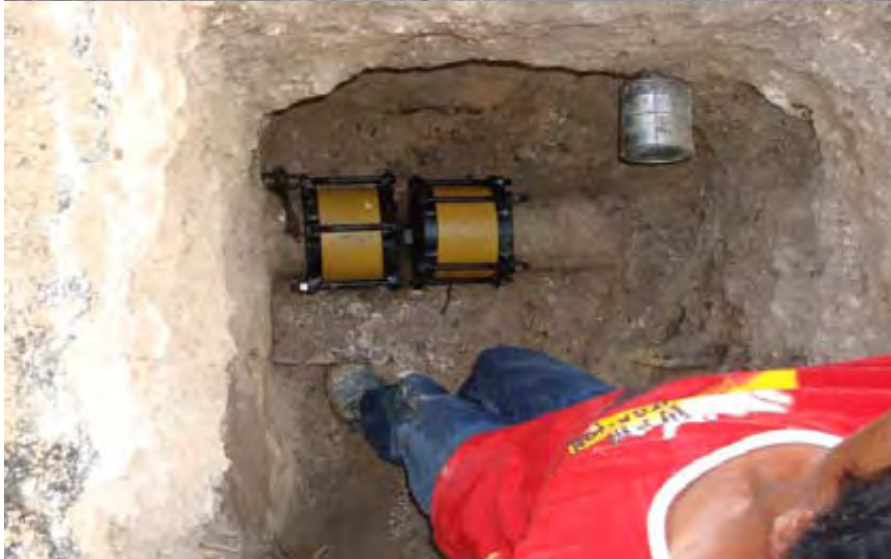
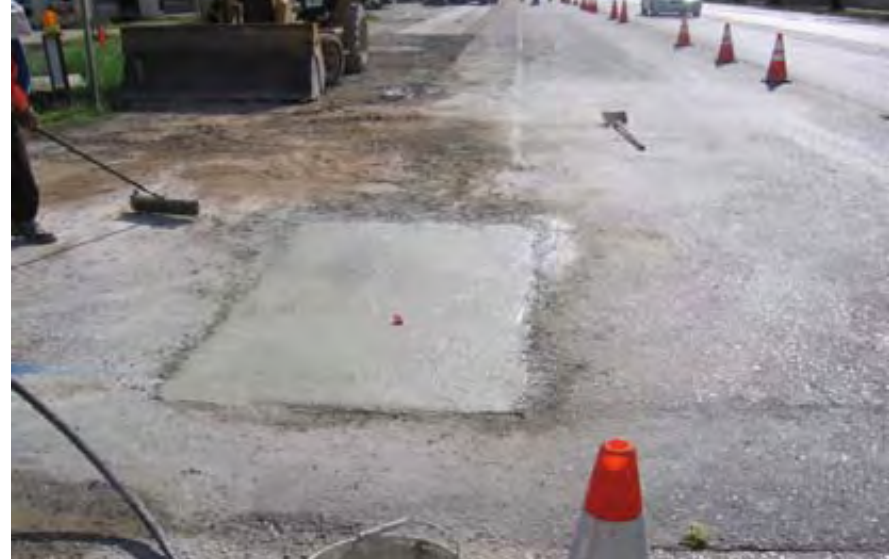
Susupe

Cut & Cap –6" ACP

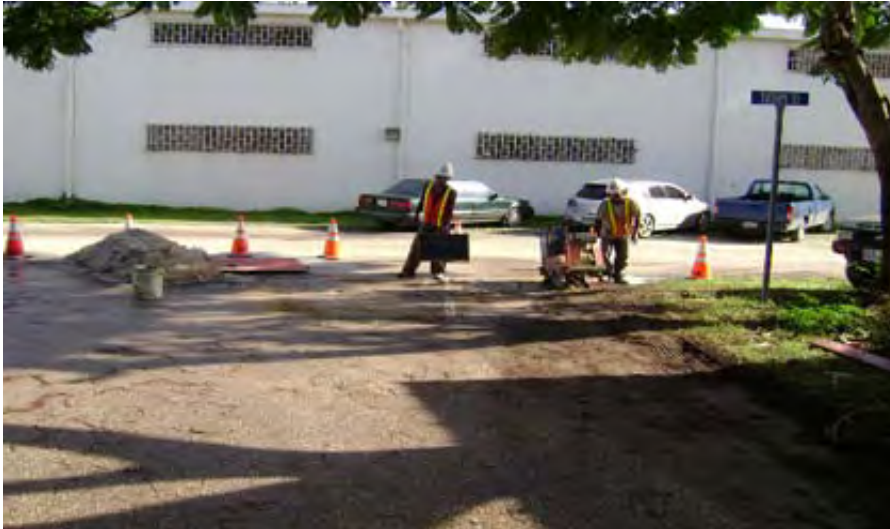
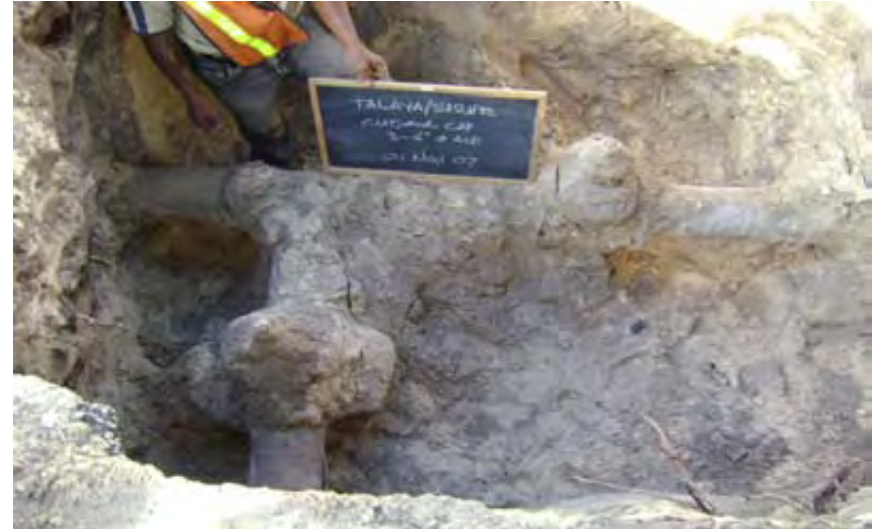
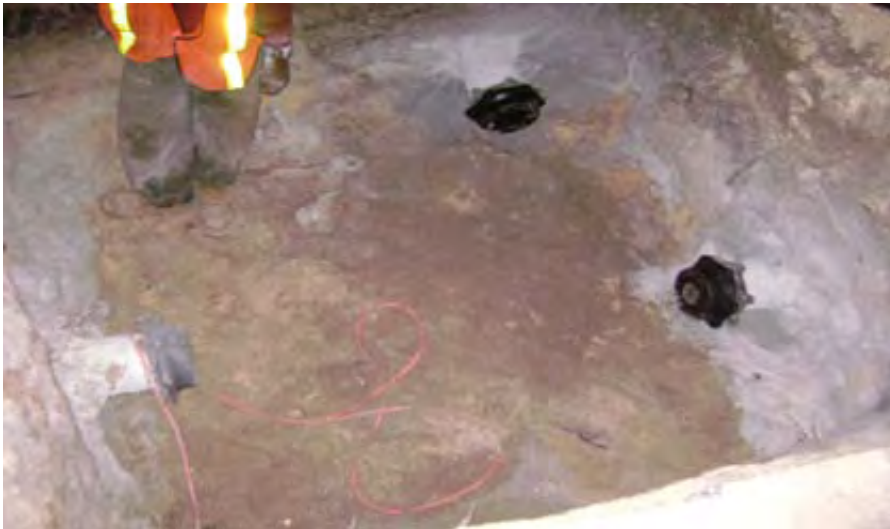
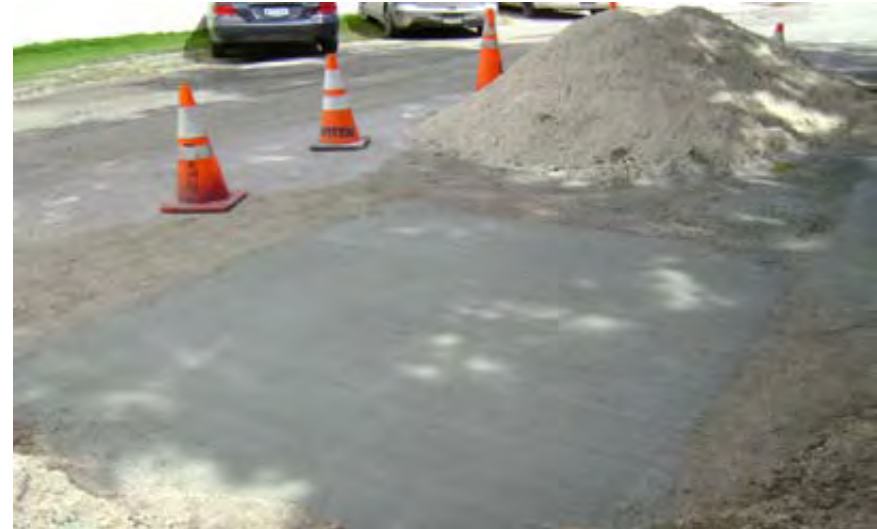
Susupe

Cut & Cap 6" ACP

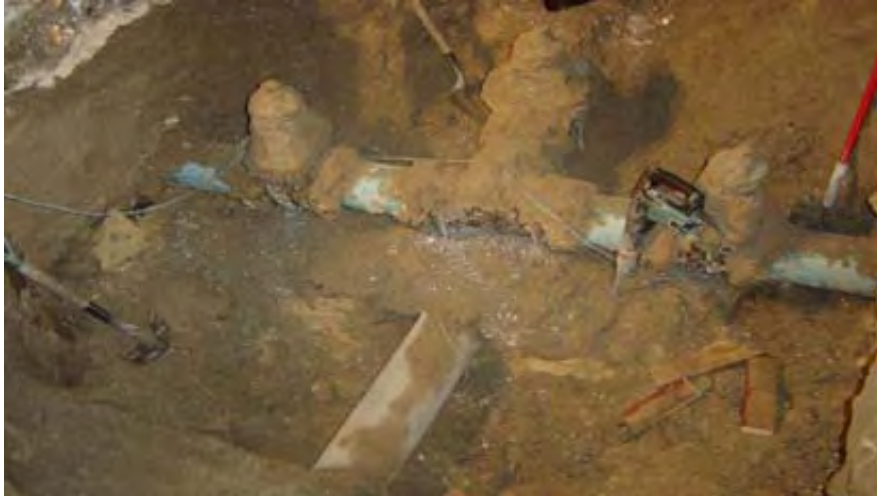
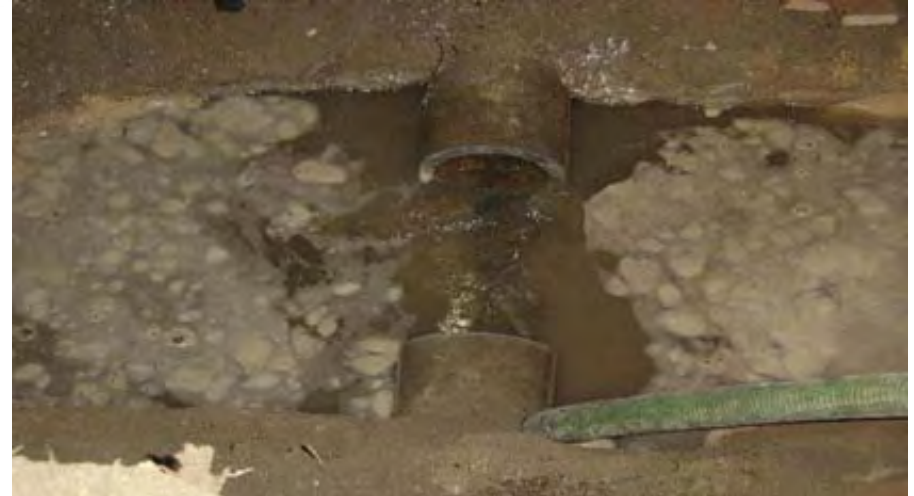
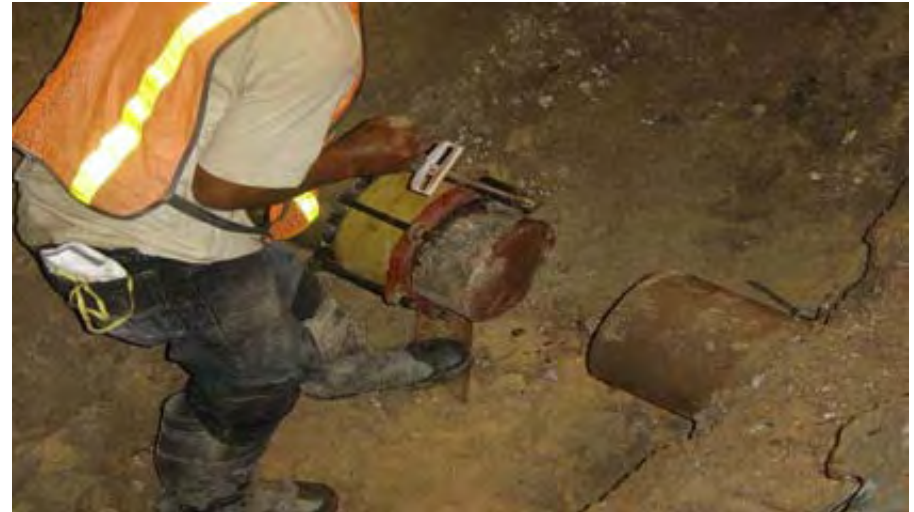
Chalan Kanoa

Cut & Cap – Undocumented Lines

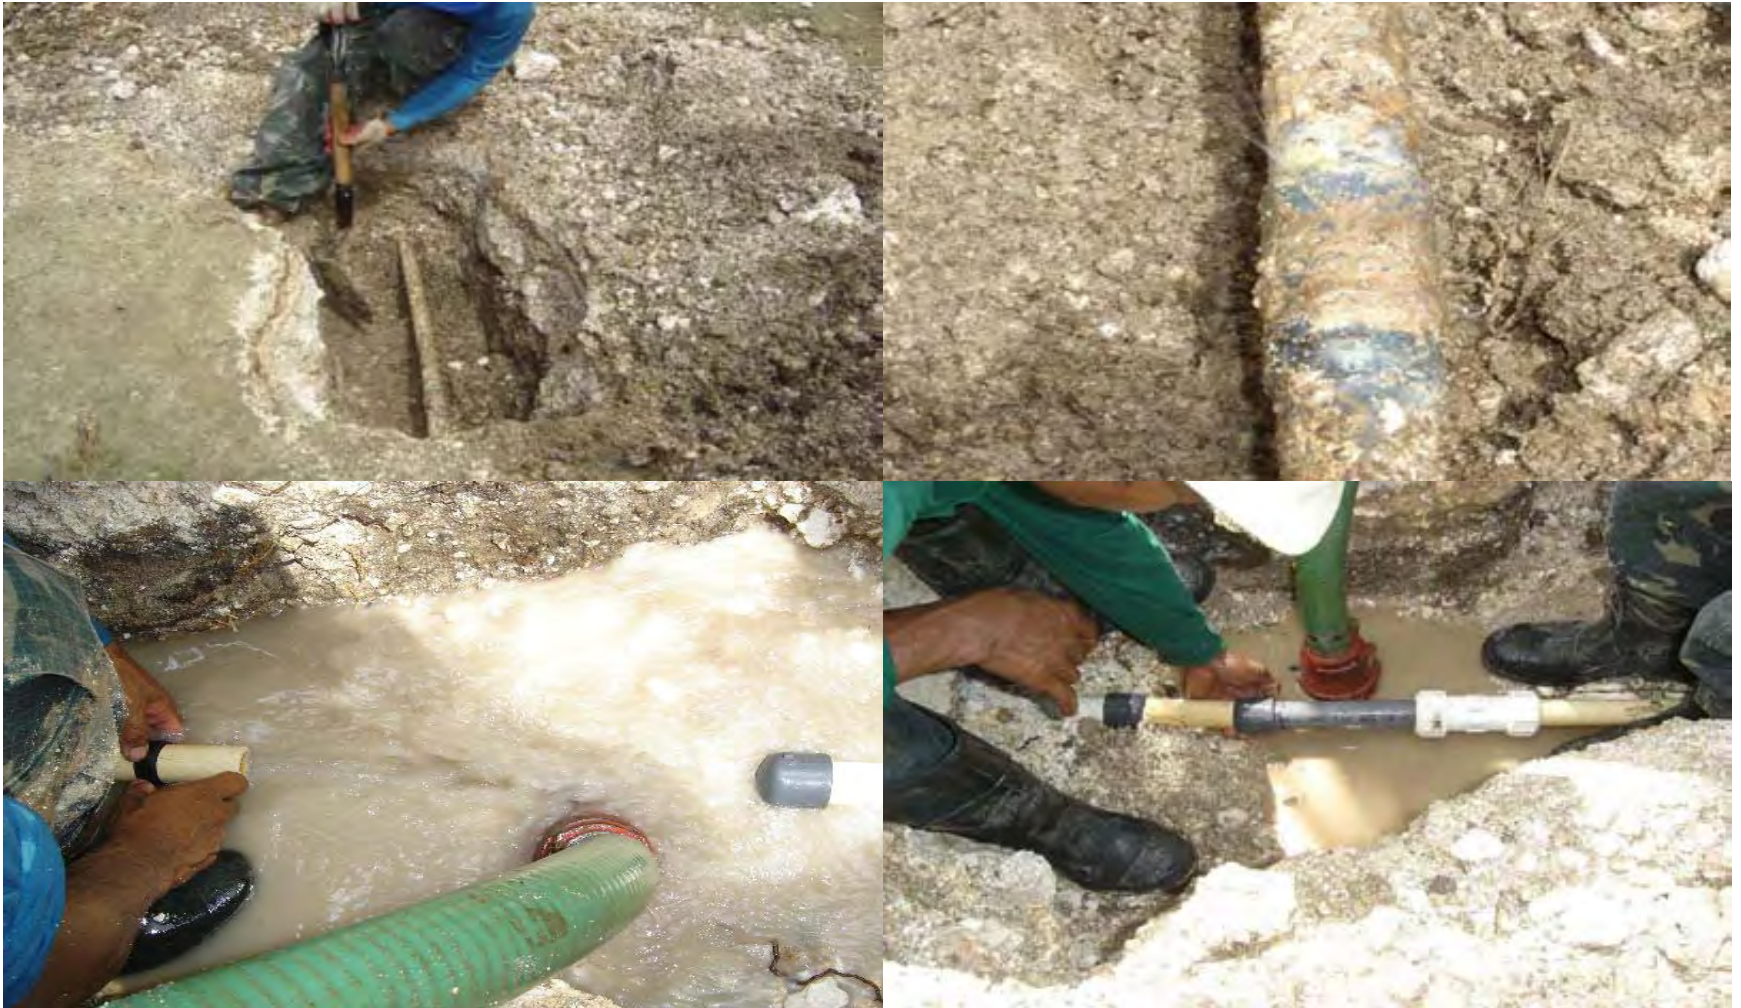
Cut & Cap – Undocumented Lines
San Antonio, Across from PIC

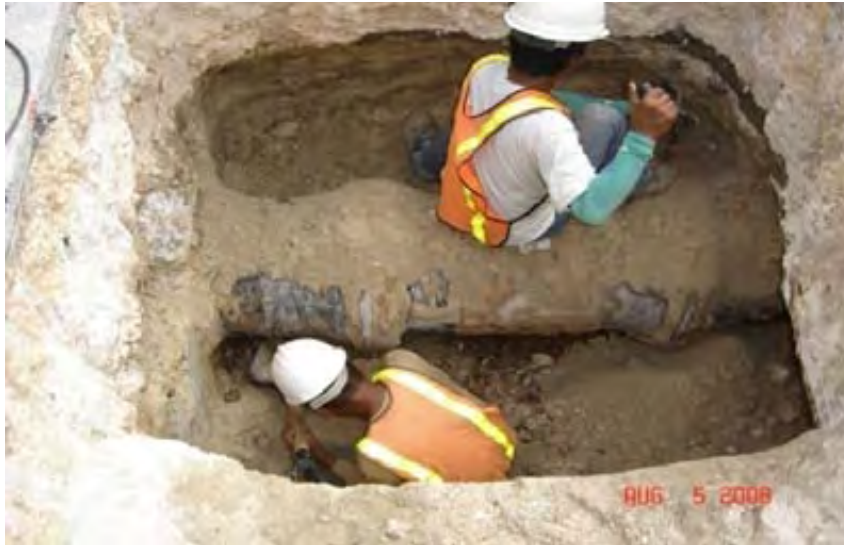
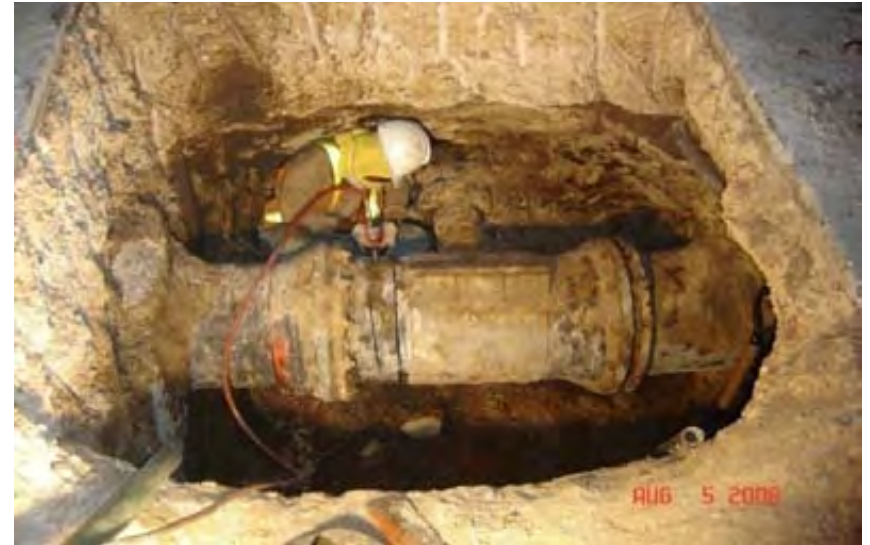
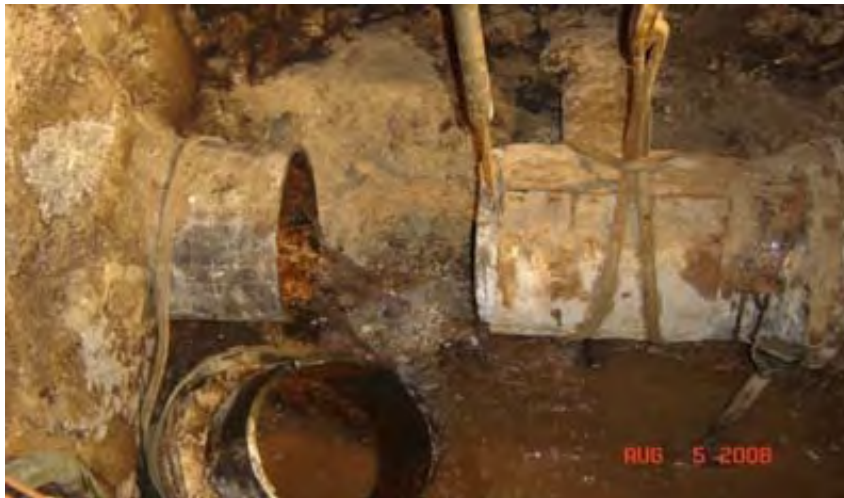
Butterfly Valve Installation—18" Ø Butterfly Valve
As Perdido

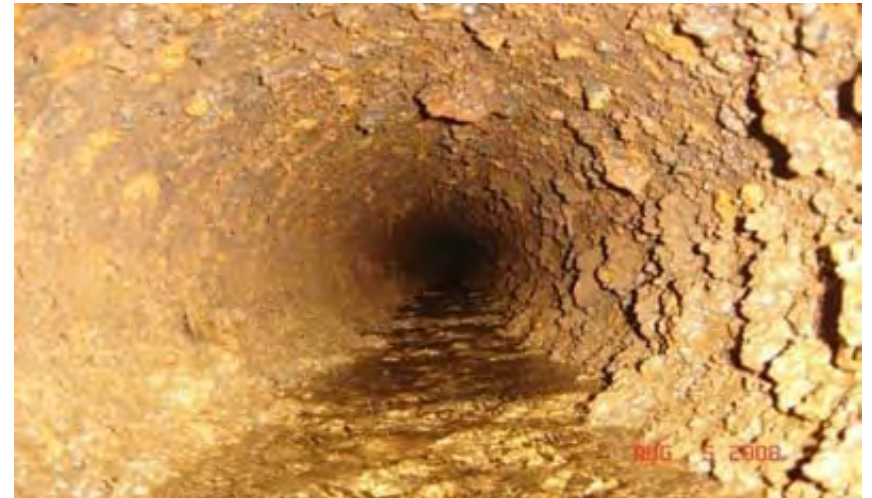
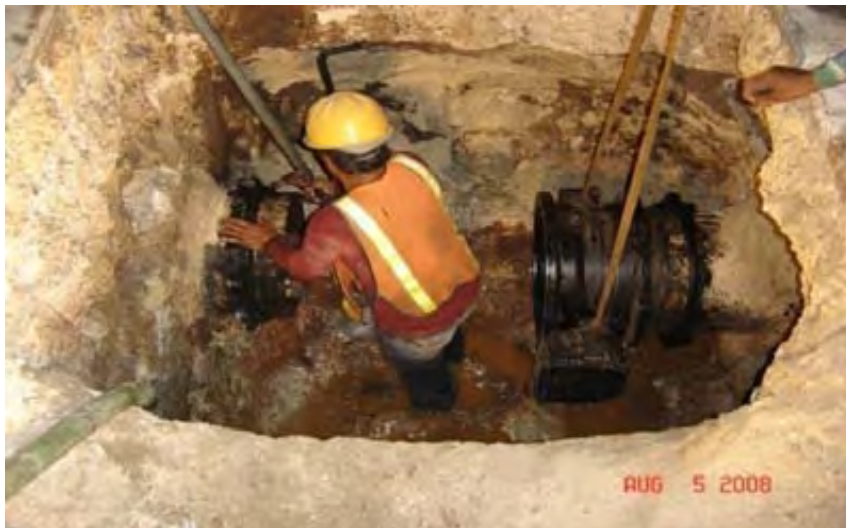
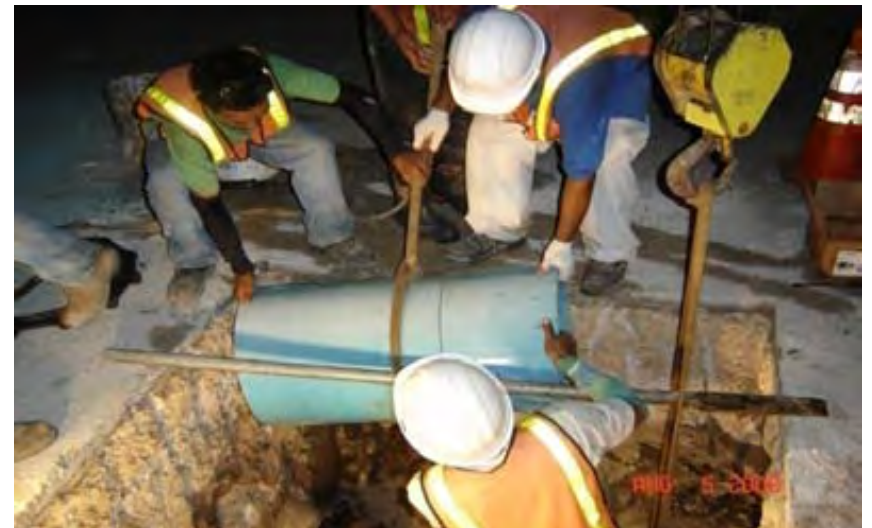
Butterfly Valve Installation—18" Ø Butterfly Valve
As Perdido

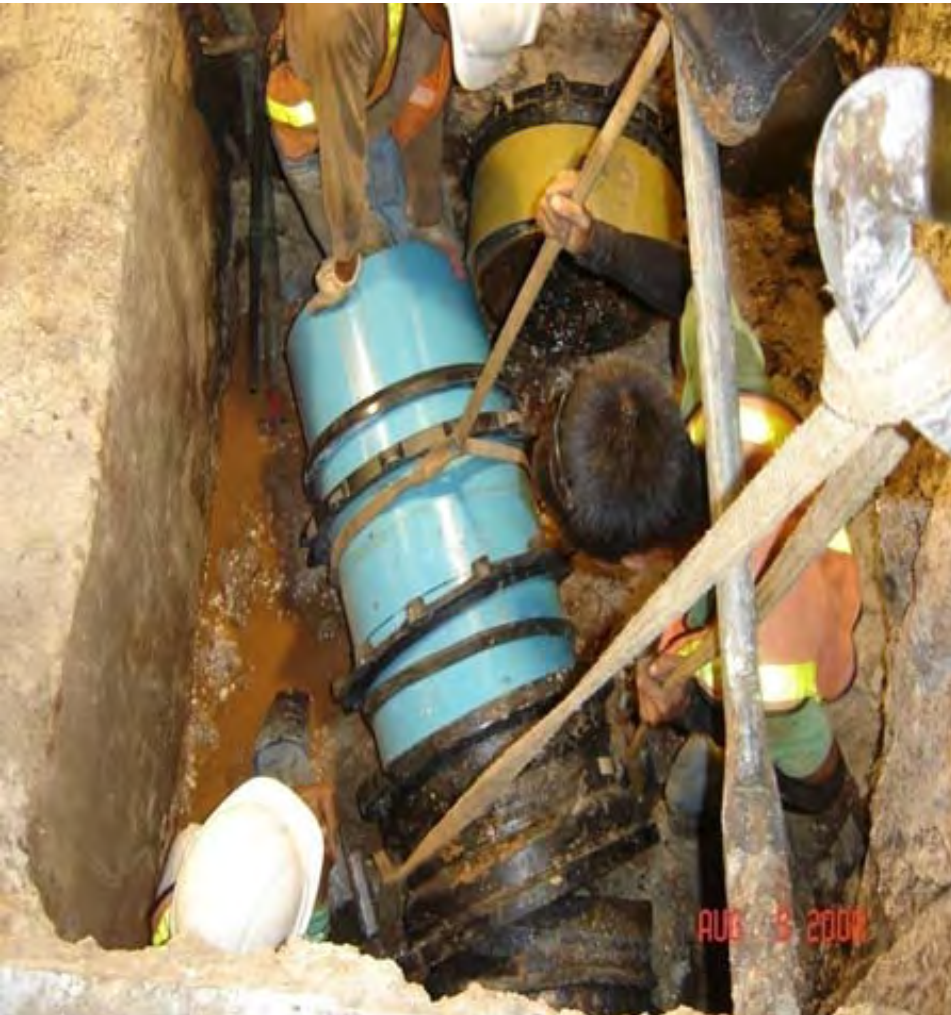
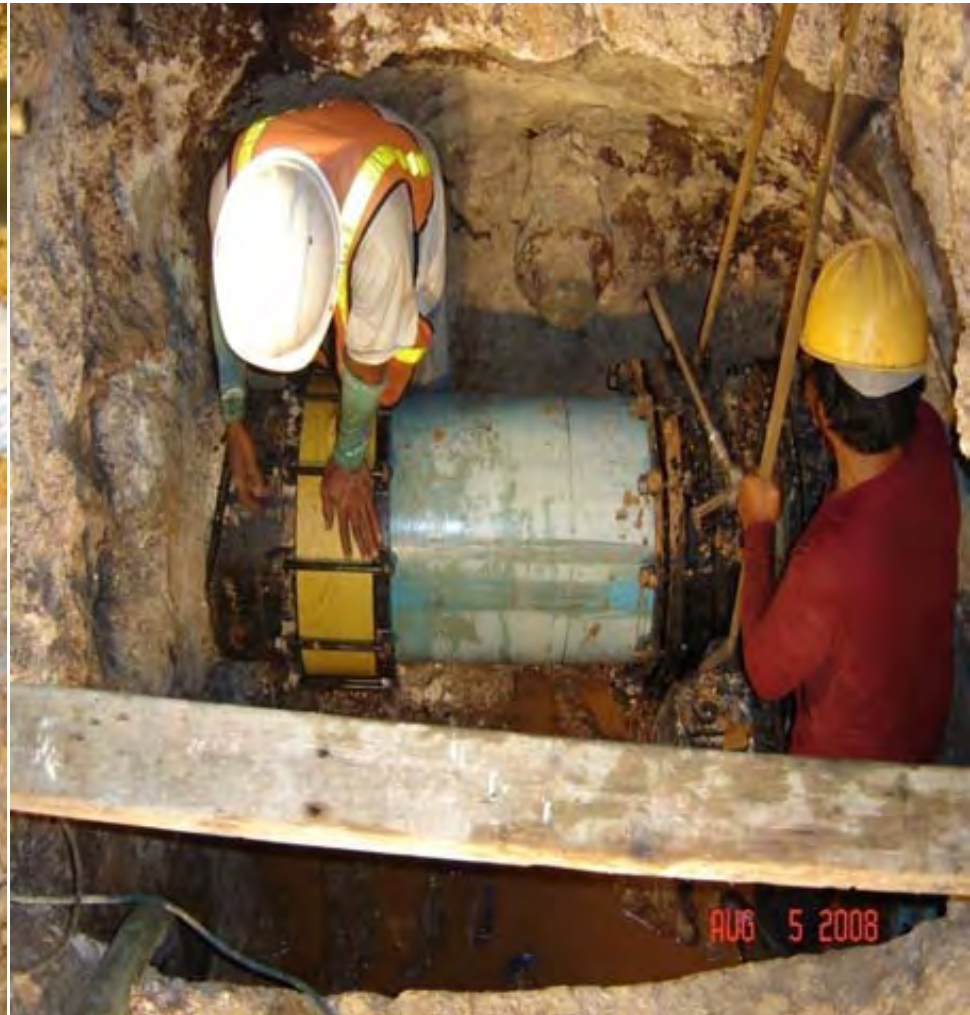
Butterfly Valve Installation—18" Ø Butterfly Valve
As Perdido

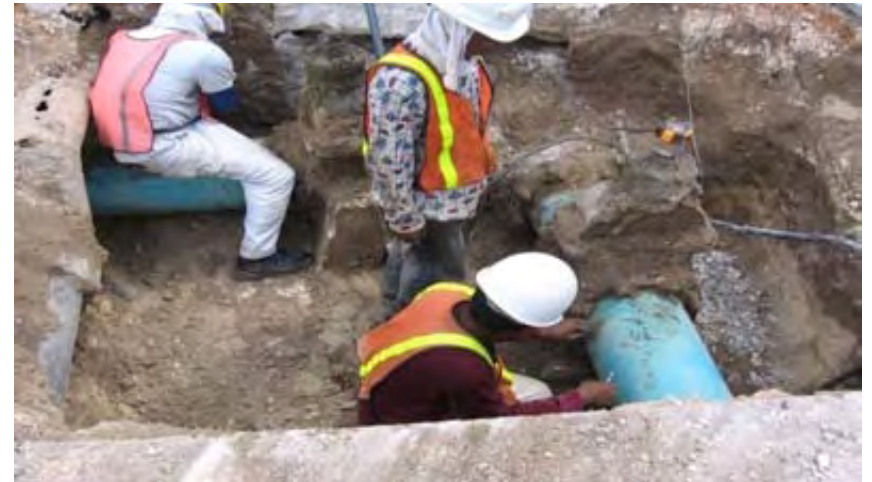
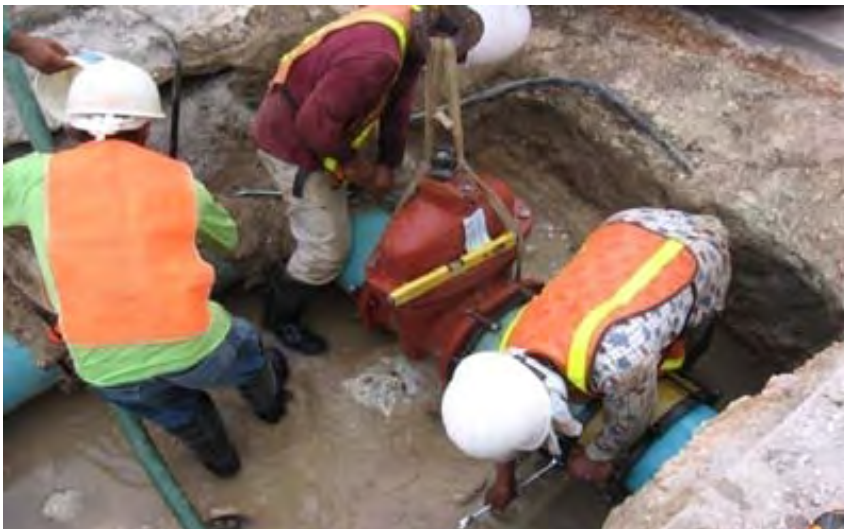
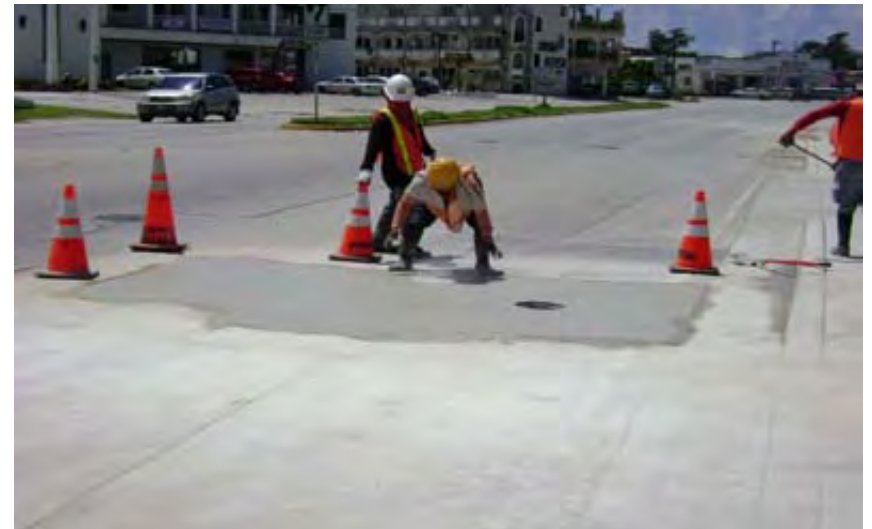
Gate Valve Replacement –12" Ø Gate Valve
As Perdido

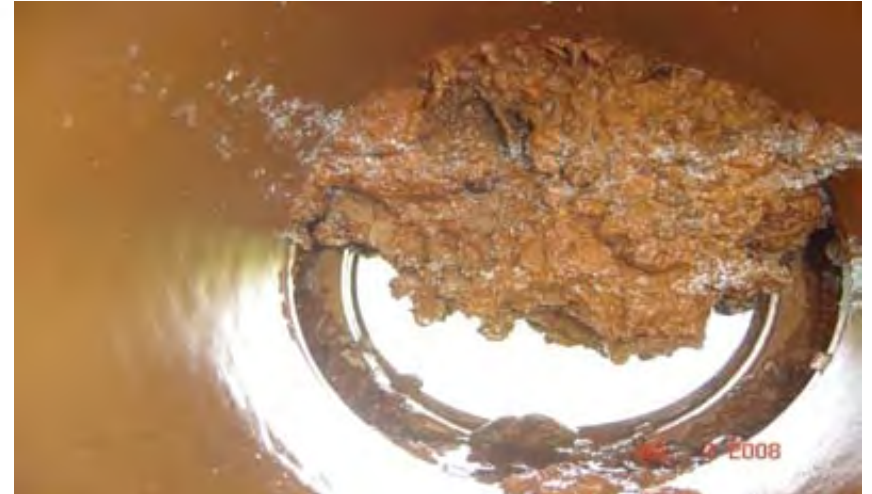
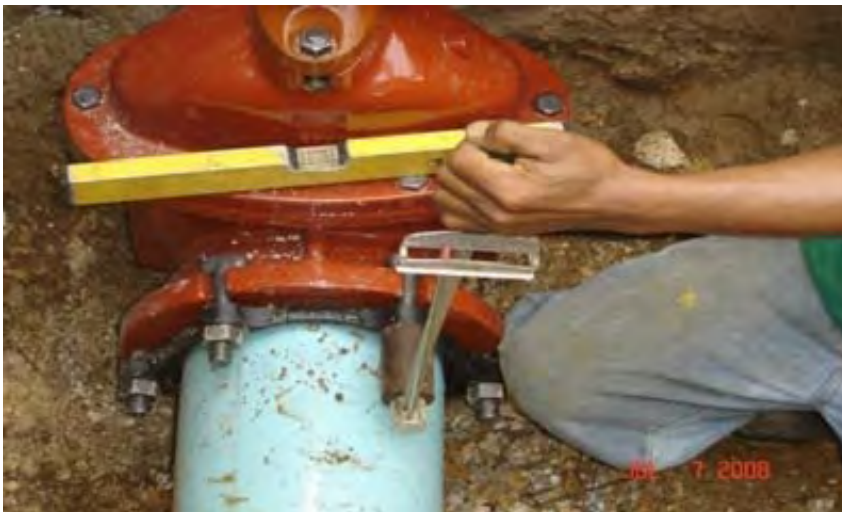
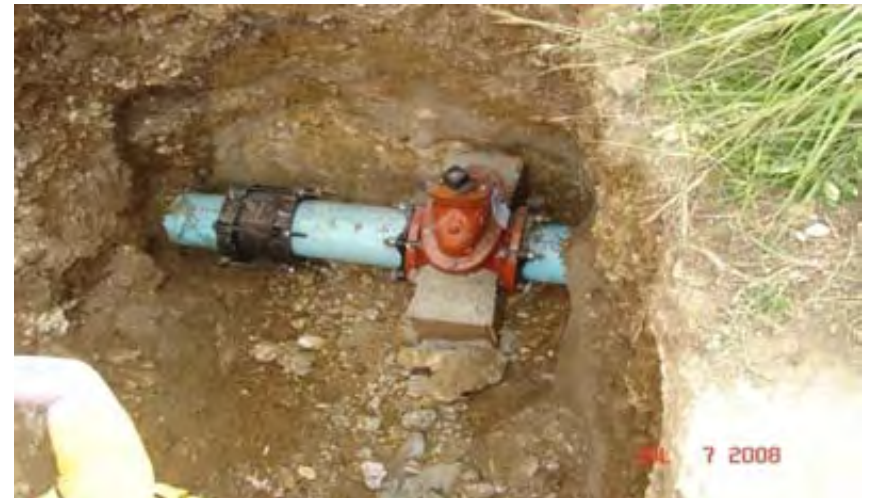
Gate Valve Replacement—8" Ø Gate Valve
Koblerville

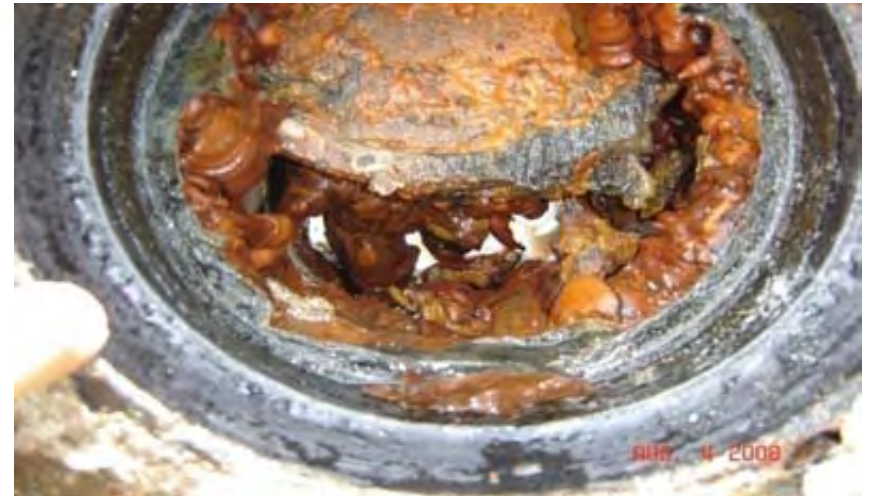
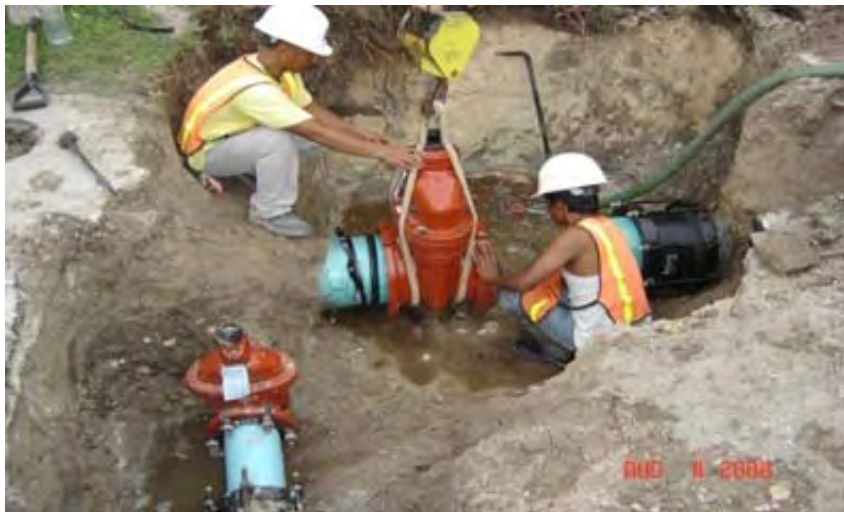
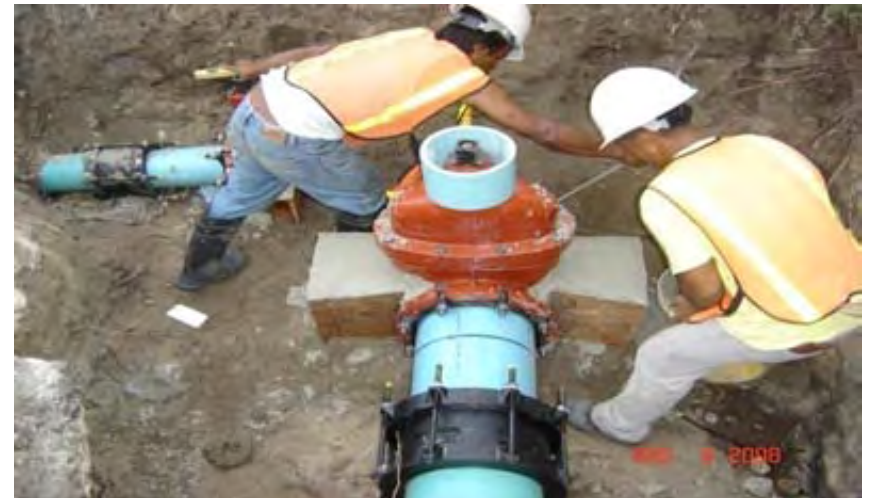
San Antonio

Gate Valve Replacement –6" and 12" Ø Gate Valve

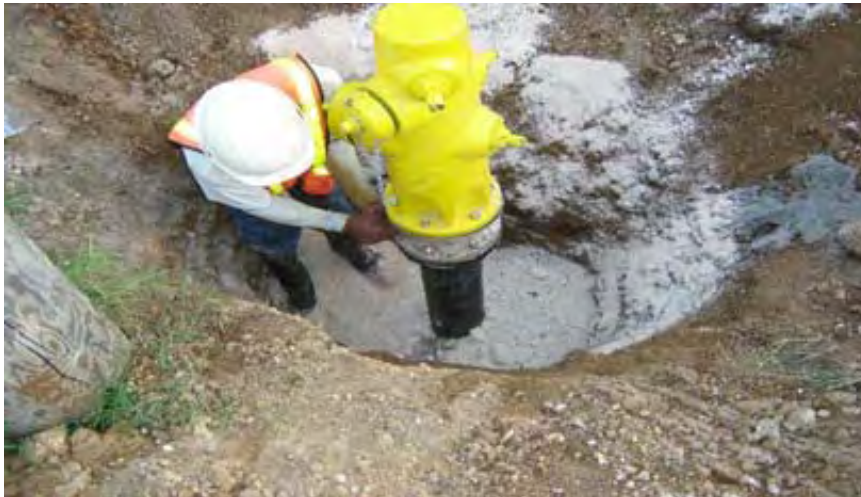
Replacement of Fire Hydrant & Assemblies
Koblerville
