Leak Detection & Repair

Blue Print to Water Resource Management

COMMONWEALTH UTILITIES CORPORATION WATER DIVISION

Leak Detection and Repair Phase II

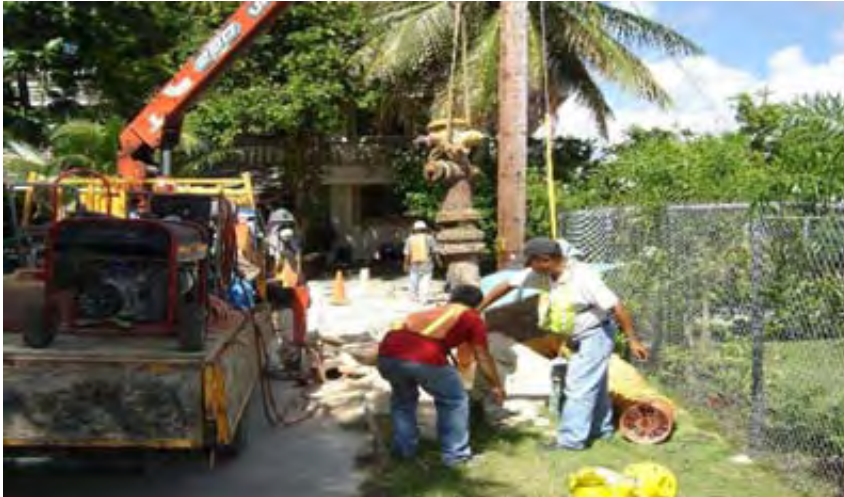
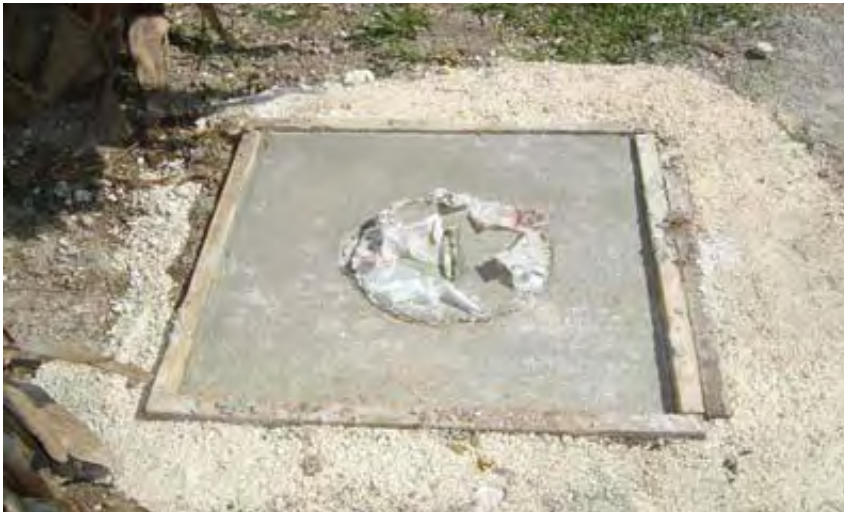
San Antonio

Replacement of Fire Hydrant & Assemblies

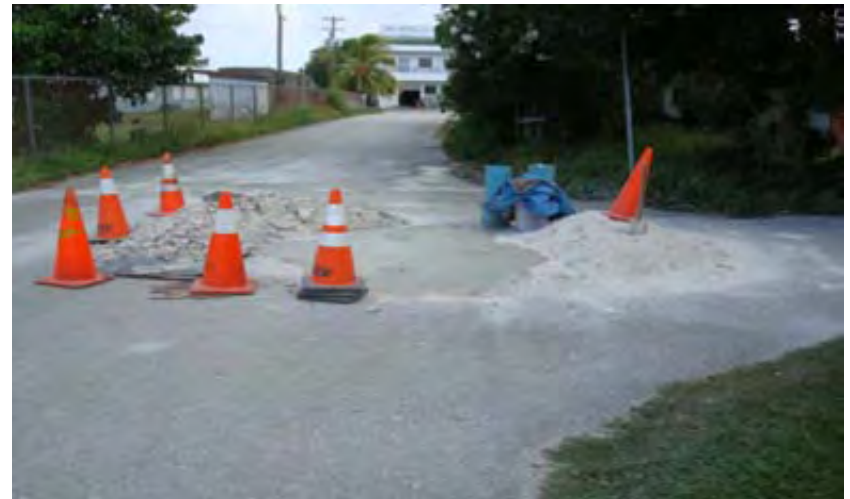
Valve Box Raising
Chalan Kanoa

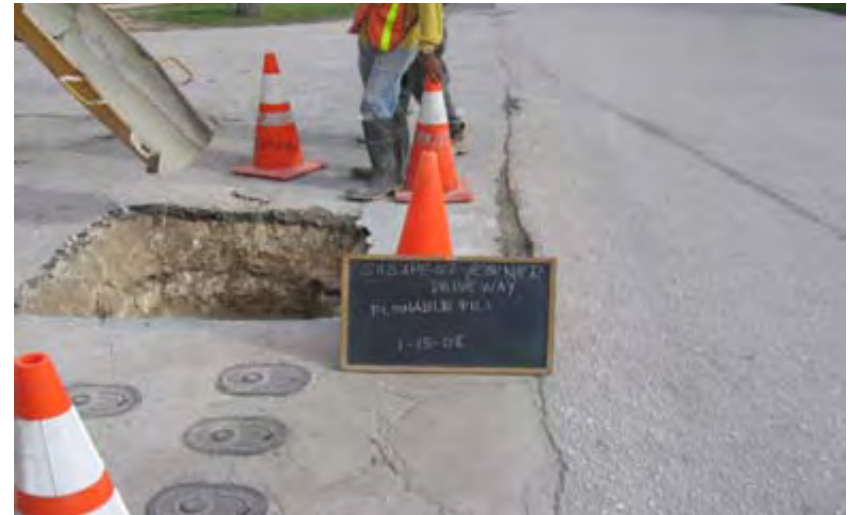
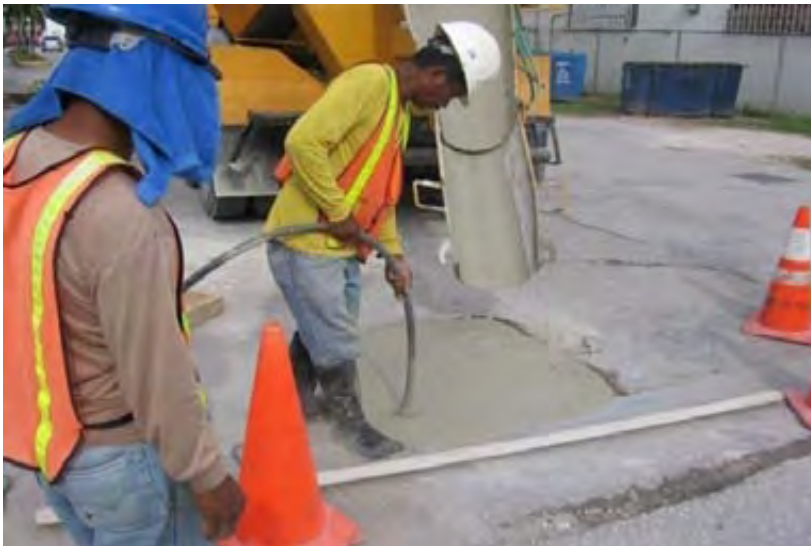
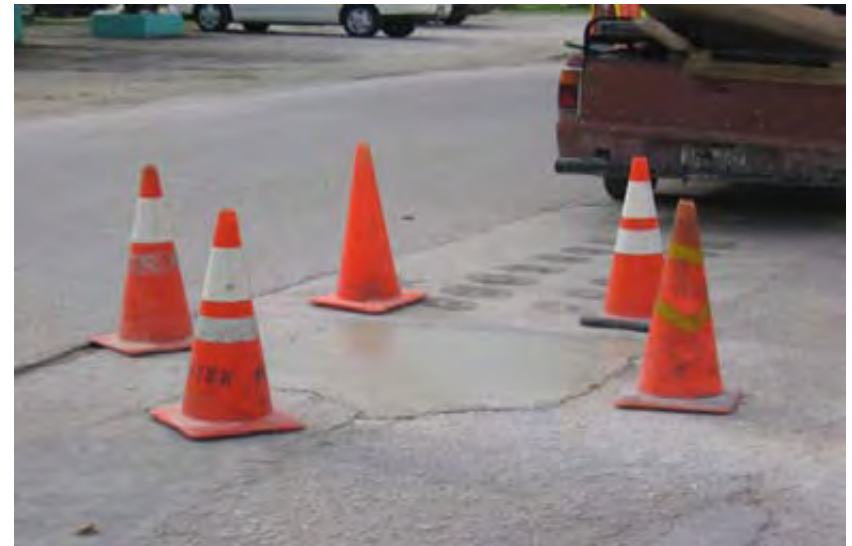
Potholing
Susupe

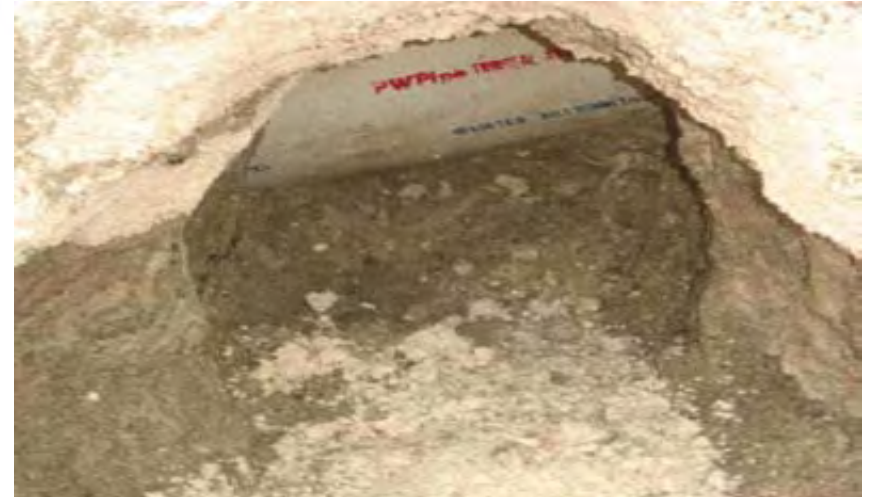
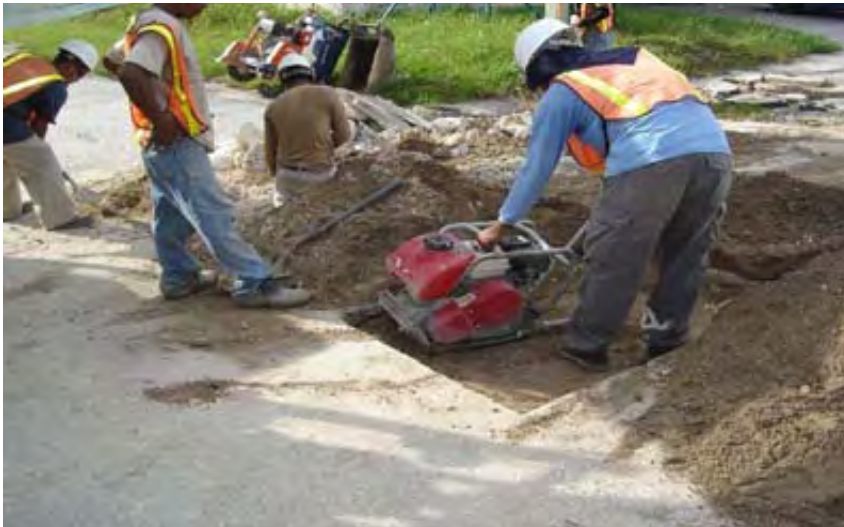
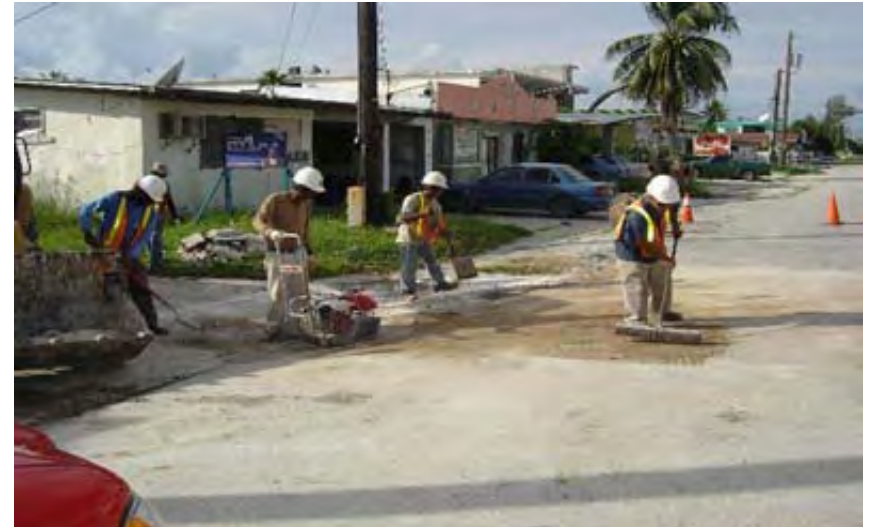
Potholing
San Antonio

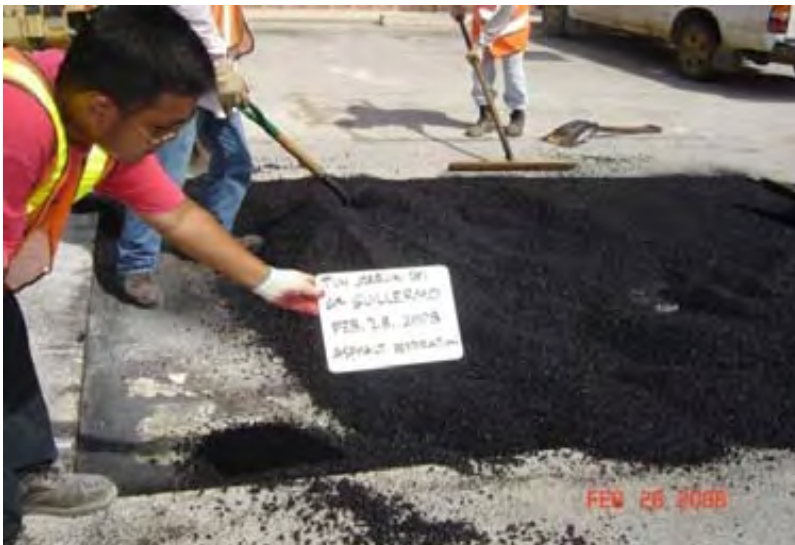
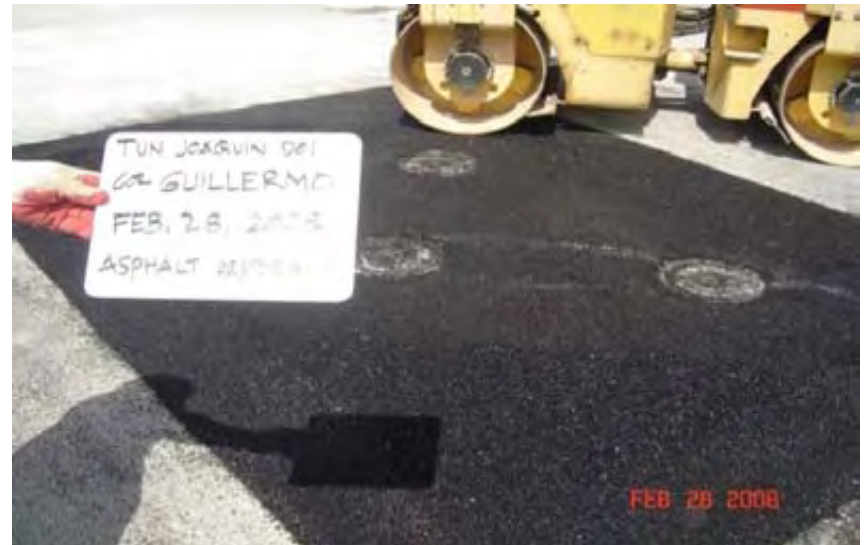
Asphalt Restoration
Chalan Kanoa

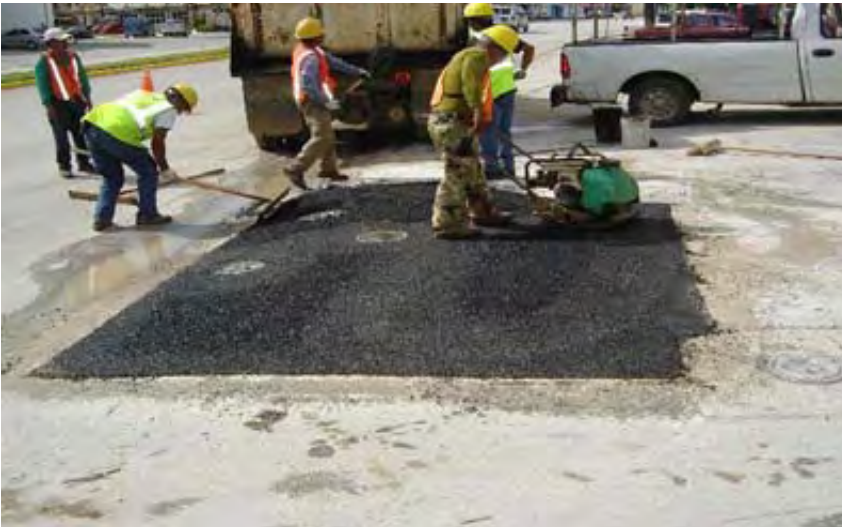
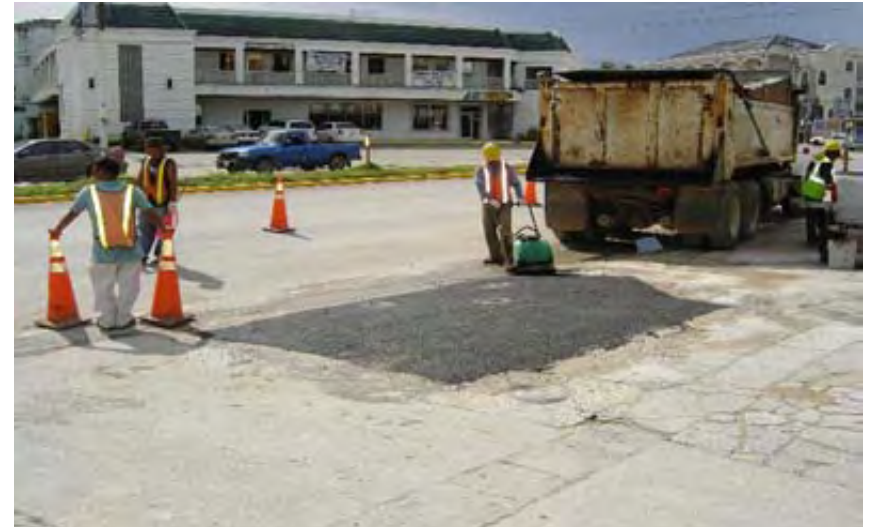
Chalan Piao

Asphalt Restoration

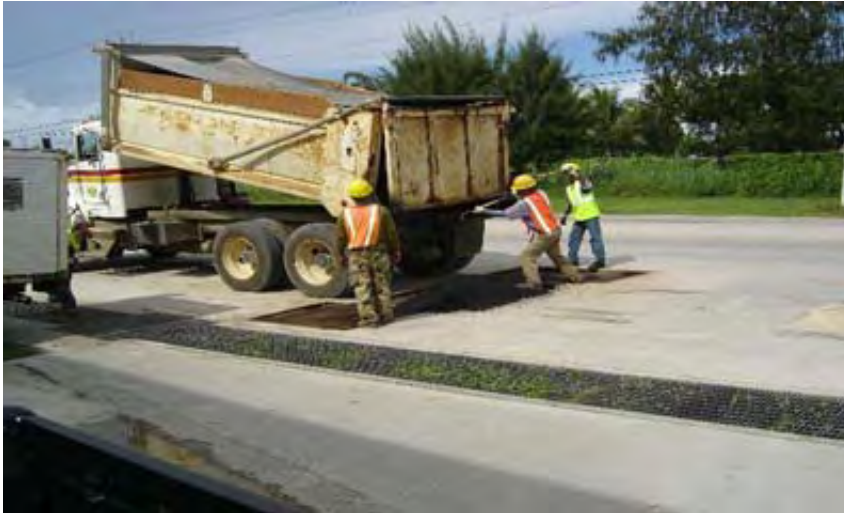
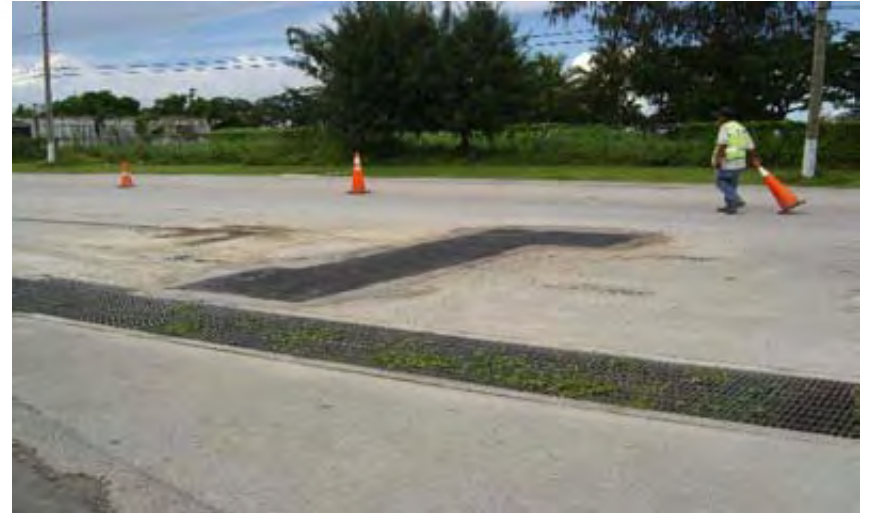
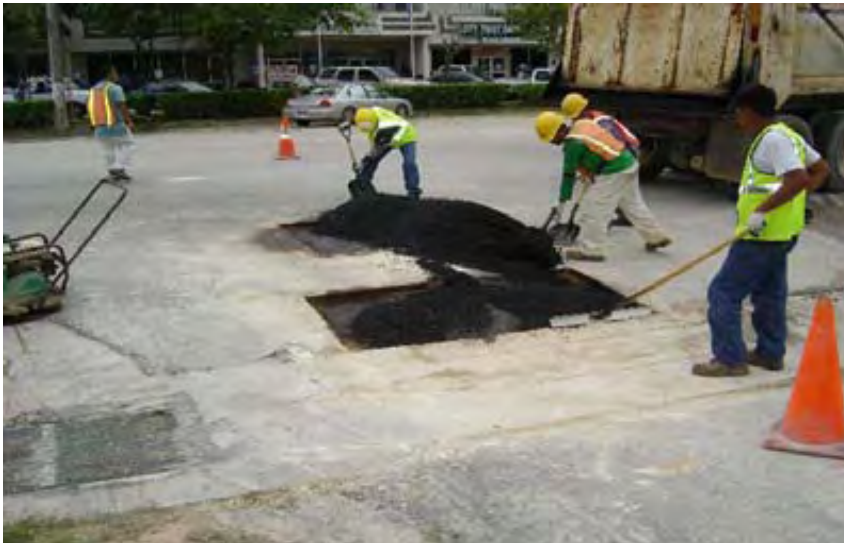
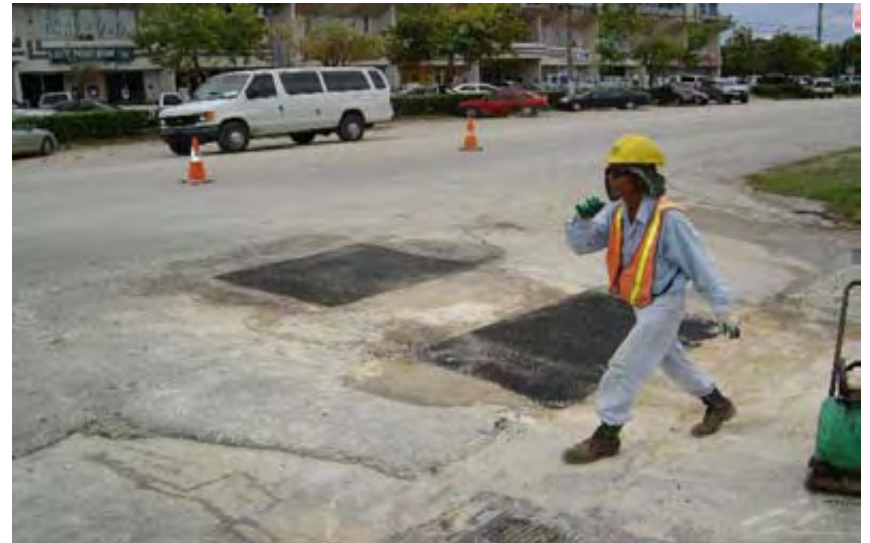
Asphalt Restoration
San Antonio

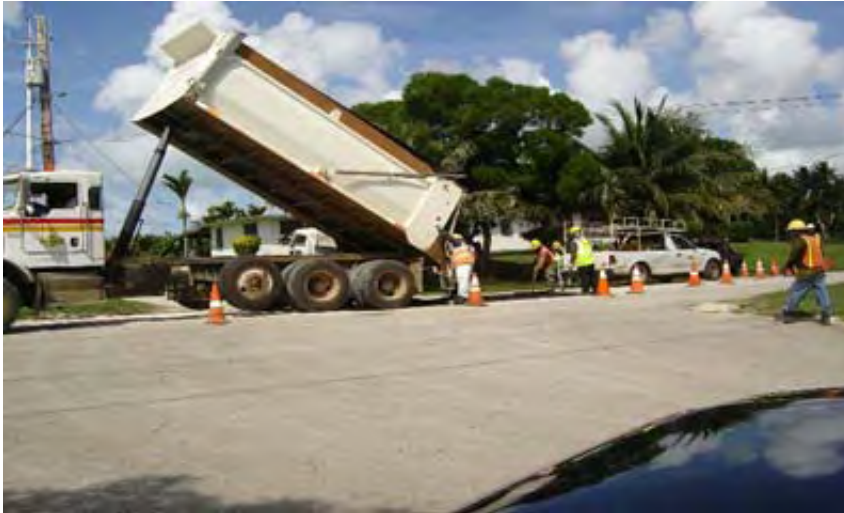
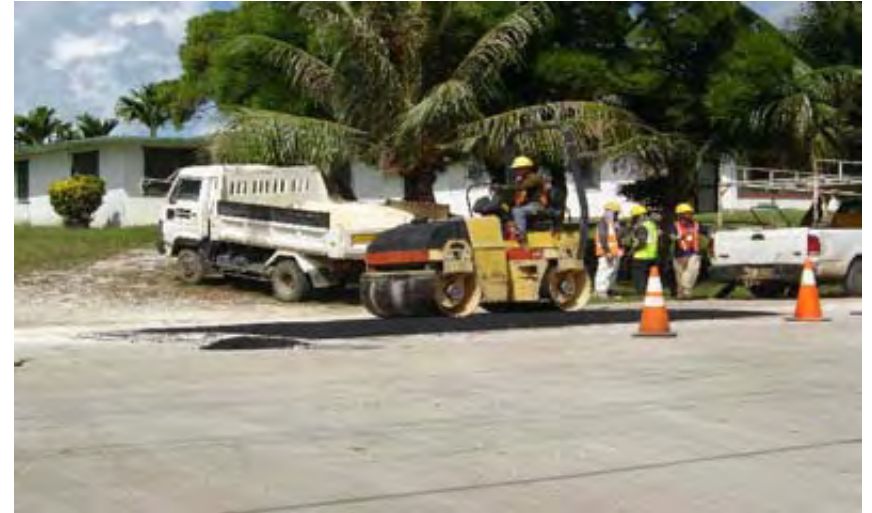
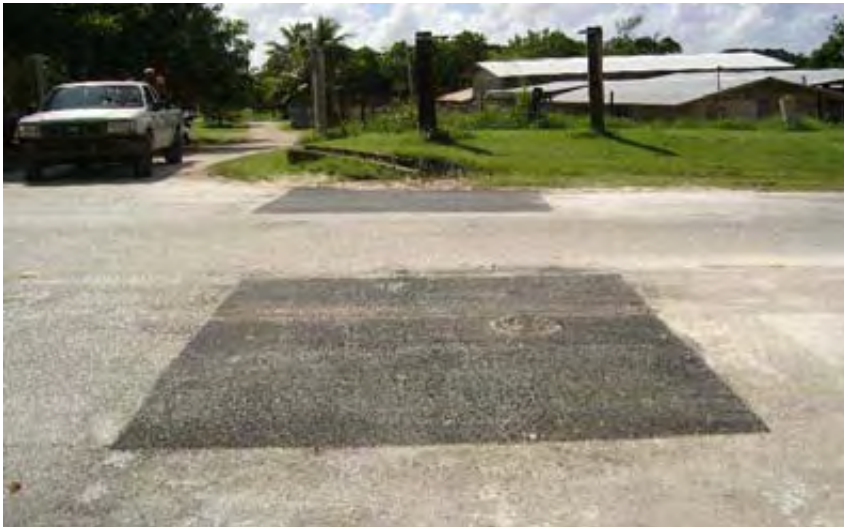
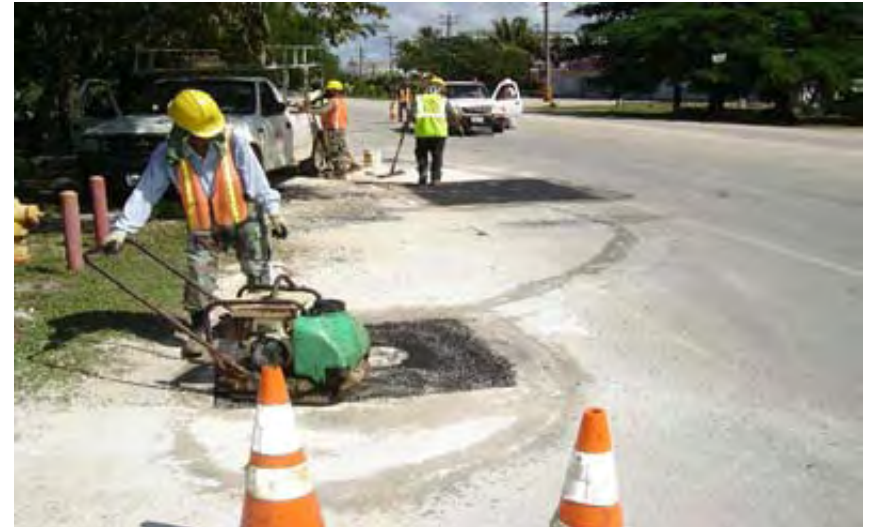
Asphalt Restoration
