Appendix B PHOTOGRAPH LOG

City of Mesa, AZ - Municipal Separate Storm Sewer System (MS4)
(Permit No. AZS000004) Photograph Log
Evaluated by: Scott Coulson (PG Environmental, LLC)

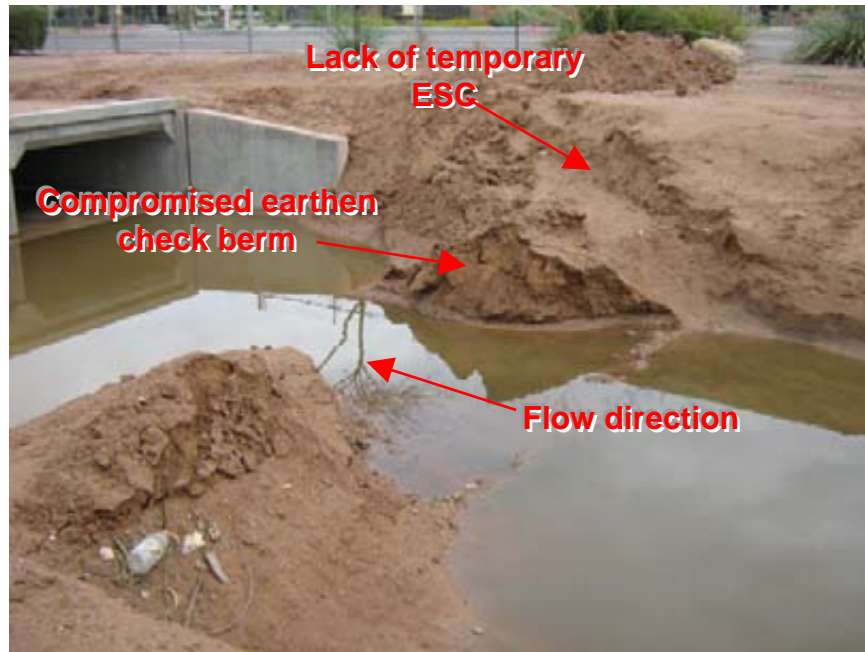
Photograph 3: Mountain View Village Center
Earthen check berm consisting of unconsolidated fill had been placed within the drainage channel and was compromised by a recent flow event

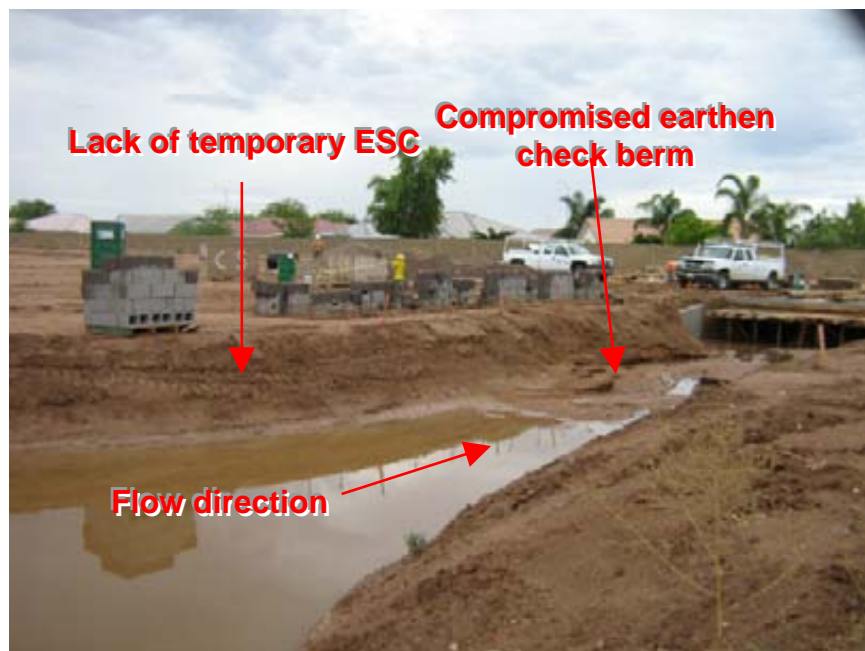
Photograph 4: Mountain View Village Center
Lack of temporary ESC between the large expanse of disturbed construction site area and the flowing drainage channel

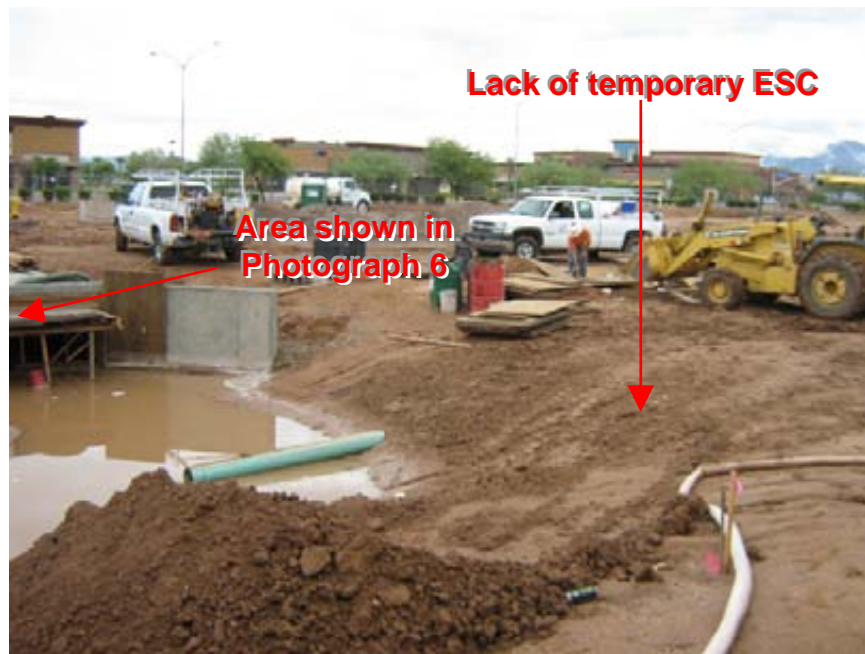
Photograph 5: Mountain View Village Center
Lack of temporary ESC between the large expanse of disturbed construction site area and the flowing drainage channel

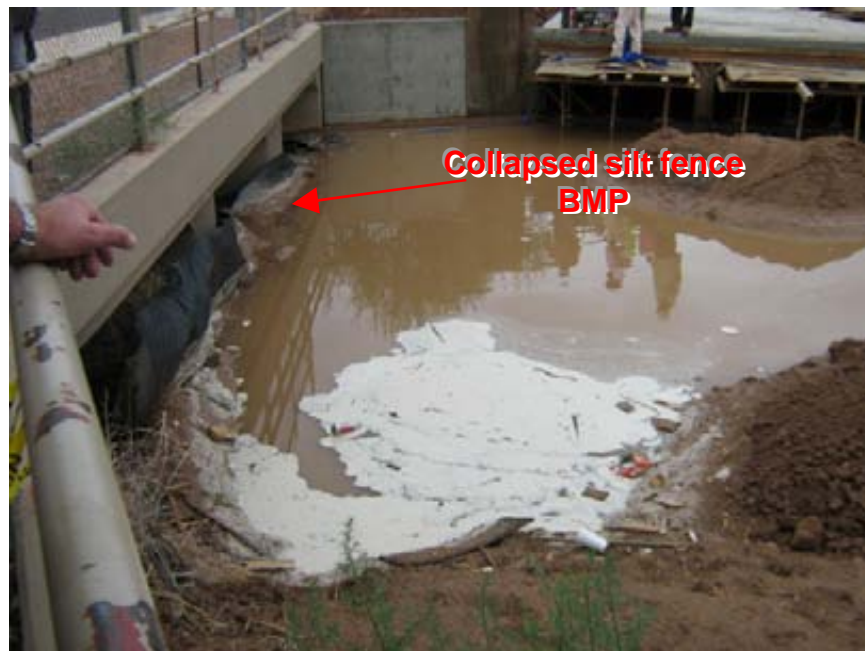
Photograph 6: Mountain View Village Center
Collapsed silt fence BMP installed within the concentrated flow of the drainage channel prior to exiting the site

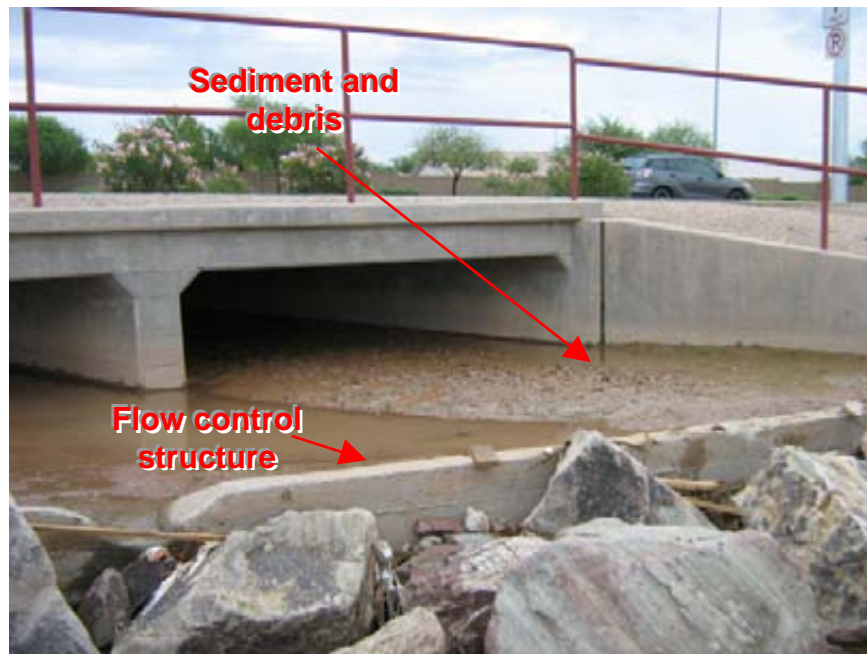
Photograph 9: Mountain View Village Center
View of sediment deposition on the opposite side of the failed
silt fence shown in Photograph 6

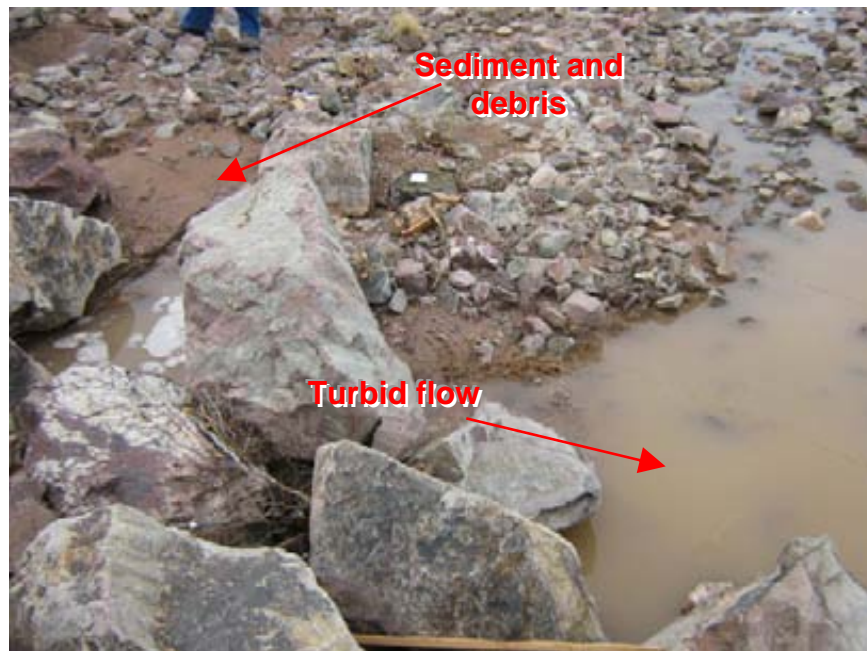
Photograph 10: Mountain View Village Center
Sediment, debris, and turbid flow were observed in the drainage channel
below the flow control structure shown in Photograph 9

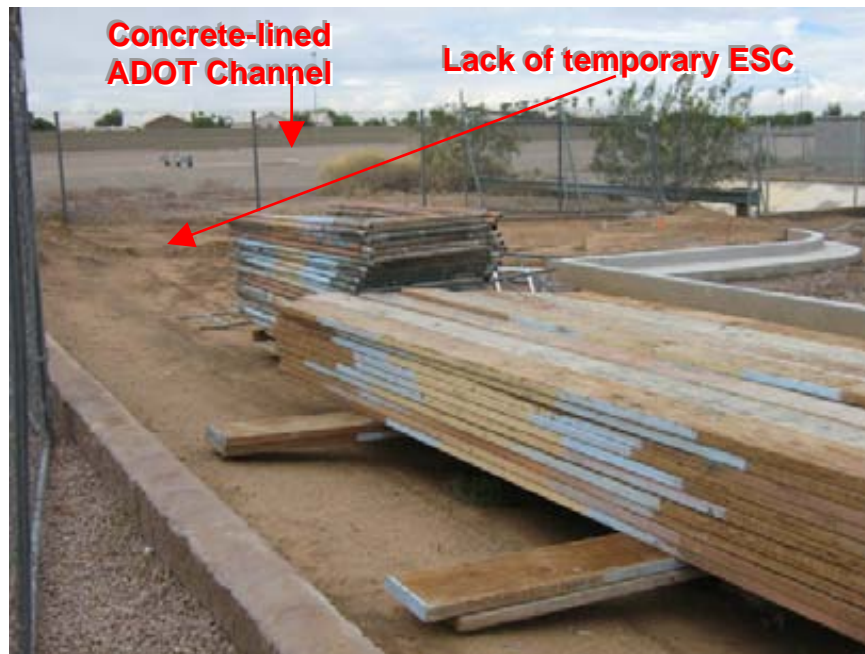
Photograph 11: Superstition Springs Commerce Center
View showing proximity of site to the ADOT Channel and lack of BMPs

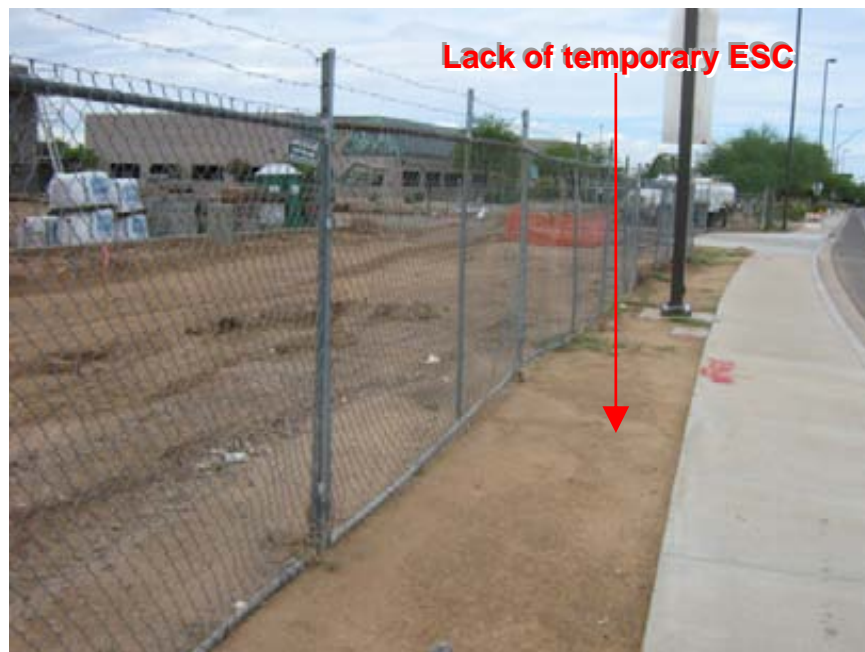
Photograph 12: Superstition Springs Commerce Center
BMPs were not implemented as perimeter control along Hampton Avenue, between the disturbed area and the offsite curb and gutter flowline

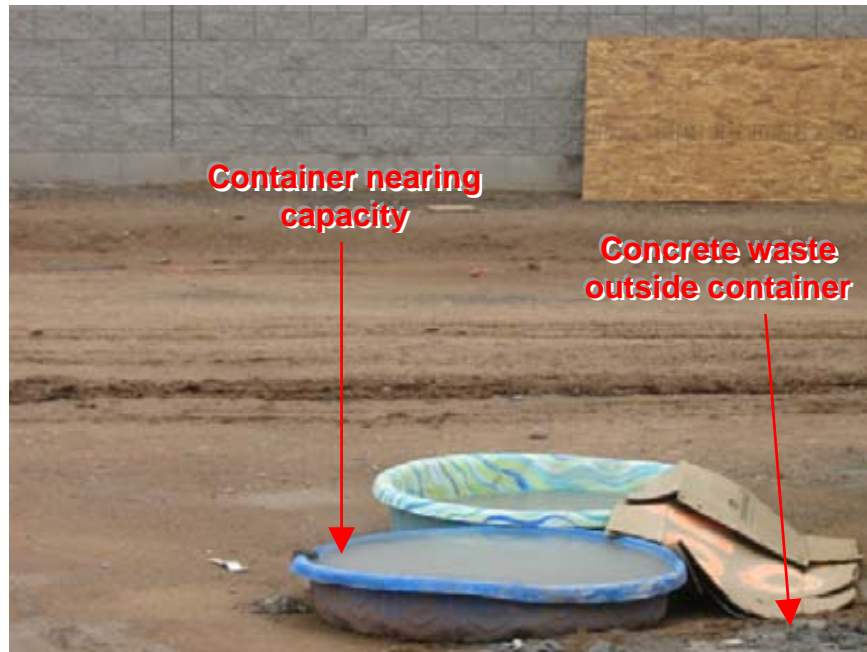
Photograph 13: Superstition Springs Commerce Center
Concrete waste was observed outside the containers and one of the two containers was nearing capacity

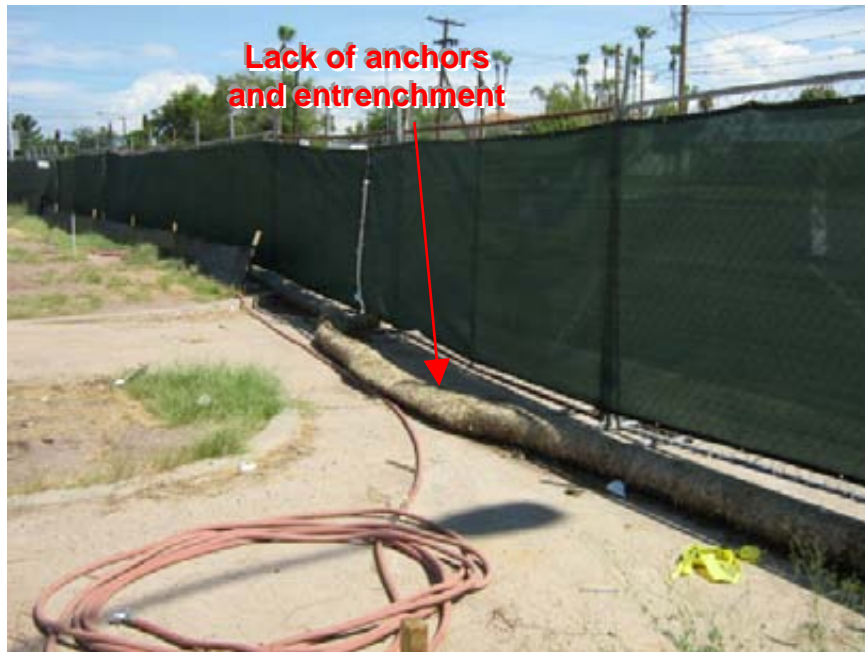
Photograph 15: Mesa Municipal Court

Straw wattles were installed on an impervious surface, and therefore were not properly entrenched or anchored to create an adequate seal

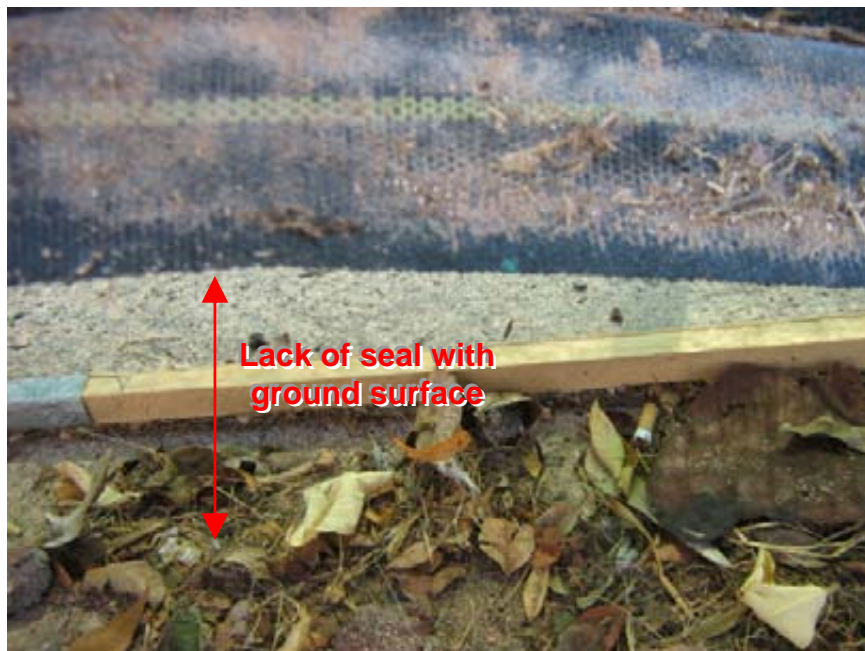
Photograph 16: Mesa Municipal Court

Sections of the silt fence along the southern perimeter were not maintained with adequate entrenchment

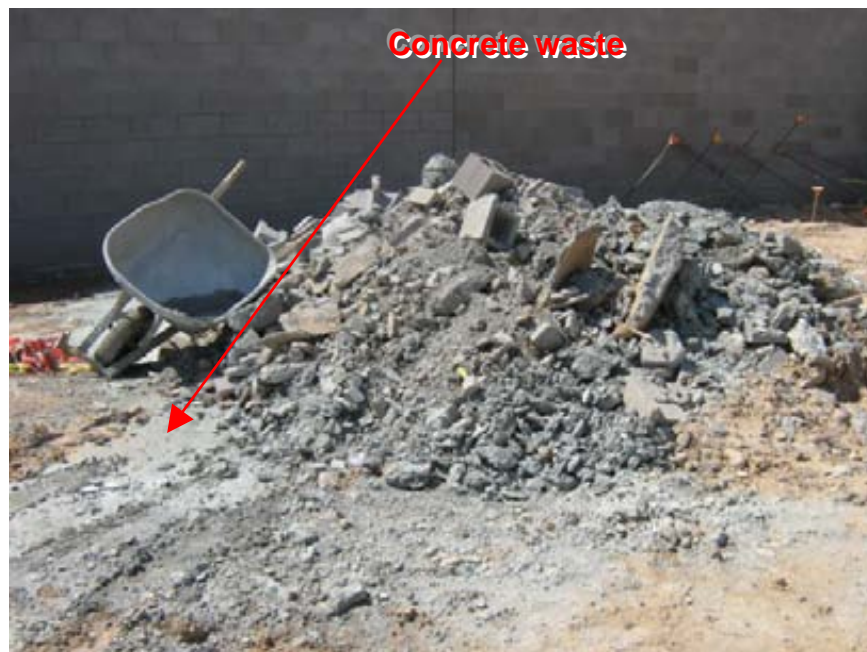
Photograph 18: Mesa Municipal Court
Close-up view of concrete waste shown in background of Photograph 17

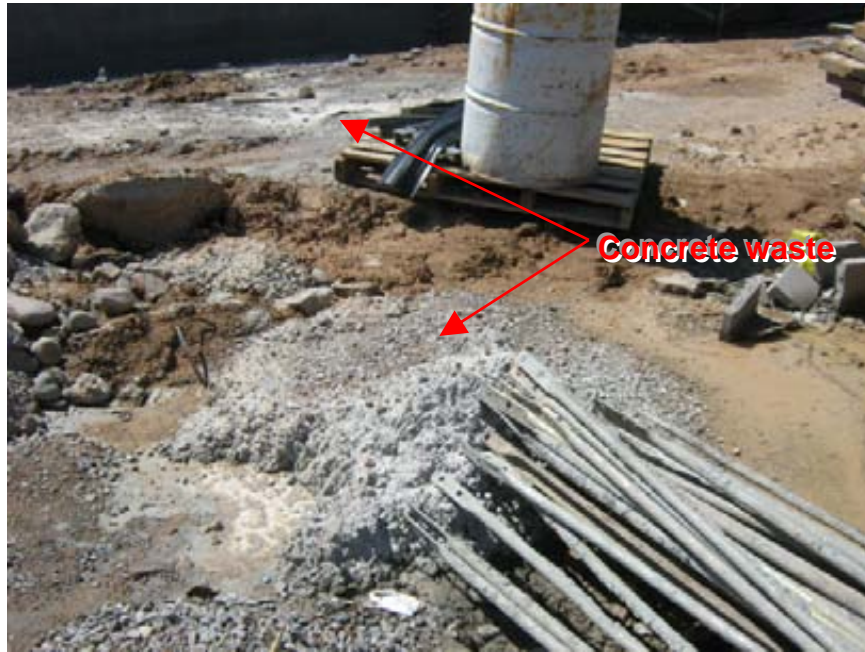
Photograph 19: Mesa Municipal Court
View of uncontrolled concrete waste
