Transmittal of "Port of Stockton Municipal Separate Storm Sewer Audit

Report"

On March 18-20, 2008, representatives from EPA Region 9, the Regional Water Quality Control Board, Central Valley Region, and EPA contractors (PG Environmental, LLC) conducted a compliance audit of the Port of Stockton's implementation of its Municipal Separate Storm Sewer System (MS4) stormwater management program required by the NPDES permit issued by the Regional Board (NPDES Permit No. CAS0084077). File reviews, interviews of program staff, field verification of program activities, and compliance inspections of Port tenant facilities were conducted. I appreciate the excellent cooperation that our audit team received from your staff throughout this effort.

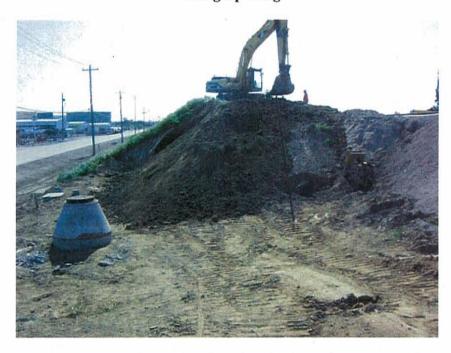
Photograph 1: An actively disturbed slope located adjacent to a drainage ditch along Navy Drive and southeast of the construction site entrance.

Section C.7.a.ii of the Order requires that Port inspections of construction sites ensure that sediments generated at a project site are retained on-site and that erosion from slopes and channels is controlled by implementing an effective combination of erosion and sediment control BMPs. It was observed during the audit that BMPs were not implemented to prevent the discharge of sediment from an actively disturbed slope adjacent to a drainage channel along Navy Drive and southeast of the construction site entrance (Photograph 1). BMPs were not implemented between the slope and the adjacent drainage channel or in the disturbed drainage channel itself, and the surfaces of the slope and channel were not stabilized (Photograph 2). As a result, there was a potential for the discharge of sediment from the disturbed slope and drainage channel leading to the South Ditch and East Complex Retention Basin. In addition, BMPs had not been implemented between a large expanse of disturbed soils, a number of uncontrolled soil stockpiles, and the adjacent drainage swale (Photographs 3 and 4). Evidence of erosion, including rill formation on the slope of the drainage swale (Photograph 4), was observed. The Port Construction Site Inspector explained that the drainage swale that encompasses the site discharges through a storm drain outfall into the drainage channel along Navy Drive (Photograph 5), leading to the South Ditch, East Complex Retention Basin, and ultimately the San Joaquin River. BMPs must be installed, inspected, and maintained to prevent the discharge of sediment from the aforementioned disturbed areas of the site to the drainage channel along Navy Drive. Moreover, the Port must ensure that sediments generated at the Pacific Ethanol project site are retained on-site and that erosion from slopes and channels is controlled by implementing an effective combination of erosion and sediment control BMPs.

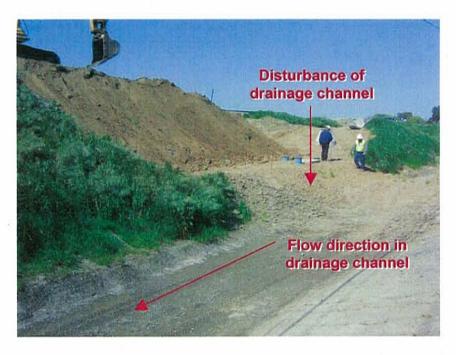
Photograph 2: BMPs were not implemented between the slope and the adjacent drainage channel or in the disturbed drainage channel itself, and the surface of the slope was not stabilized.

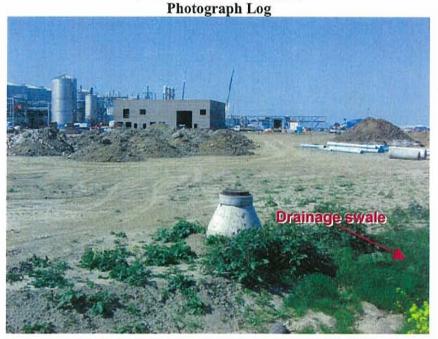
Photograph 3: BMPs were not implemented between a large expanse of disturbed soils, a number of uncontrolled soil stockpiles, and the adjacent drainage swale.

Section C.7.a.ii of the Order requires that Port inspections of construction sites ensure that sediments generated at a project site are retained on-site and that erosion from slopes and channels is controlled by implementing an effective combination of erosion and sediment control BMPs. It was observed during the audit that BMPs had not been implemented to prevent the discharge of sediment from a disturbed area surrounding a new railway crossing spanning an unnamed waterway north of the construction site entrance off Humphreys Drive (Photograph 6). No BMPs were present between the disturbed areas surrounding the railway crossing and the adjacent waterway (Photograph 7). Nor were run-on control BMPs implemented between the disturbed area on the southwest side of the railway crossing and the adjacent waterway (Photograph 8). Port personnel explained that the railway crossing and culverts had been installed approximately two weeks before the audit, and that the unnamed waterway flows southwest and is tributary to Burns Cutoff. BMPs must be installed, inspected, and maintained to prevent the discharge of sediment from the disturbed areas surrounding the new railway crossing to the unnamed waterway that is tributary to Burns Cutoff. Moreover, the Port must ensure that sediments generated at the Central California Traction project site are retained on-site using adequate source control and structural BMPs.

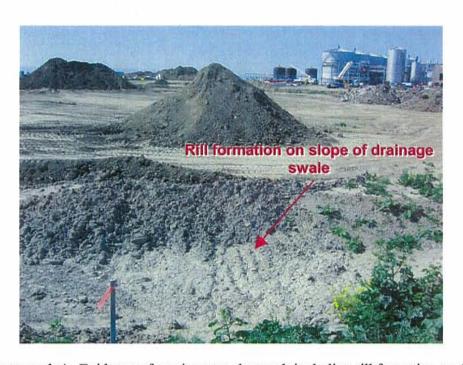
Photograph 4: Evidence of erosion was observed; including rill formation on the slope of the drainage swale.

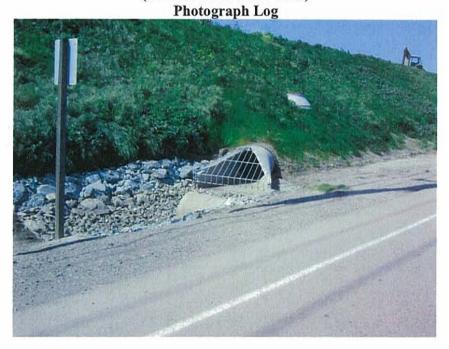
Photograph 5: Pacific Ethanol storm drain outfall into the drainage channel along Navy Drive.

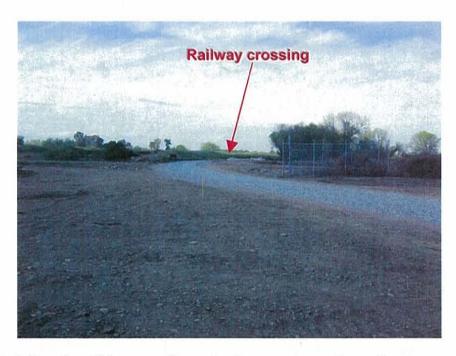
Photograph 6: Location of the new railway crossing spanning a unnamed waterway north of the construction site entrance off Humphreys Drive.

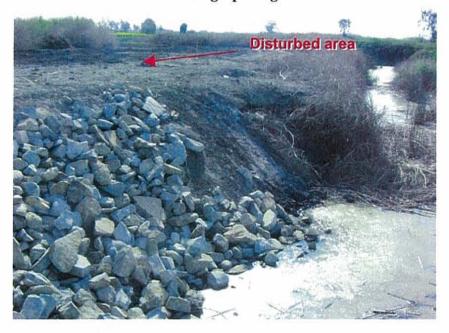
Photograph 7: BMPs were not implemented between the disturbed area on the northeast side of the railway crossing and the adjacent unnamed waterway.

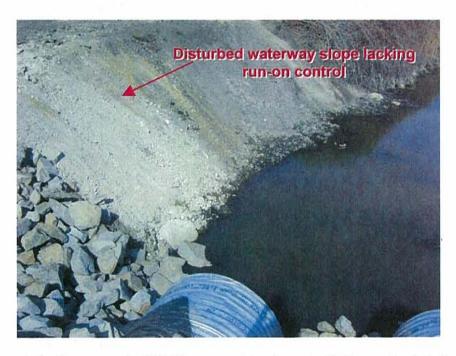
Photograph 8: Run-on control BMPs were not implemented between the disturbed area on the southwest side of the railway crossing and the adjacent unnamed waterway.

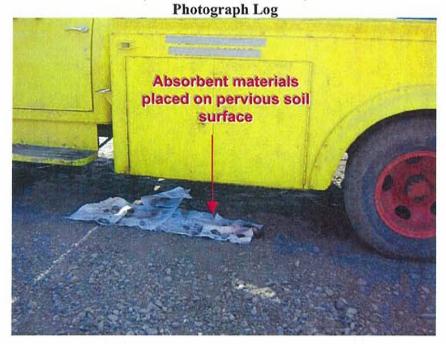
Photograph 9: A mobile fueling truck was actively leaking diesel fuel, and the source of the leak had not been addressed.

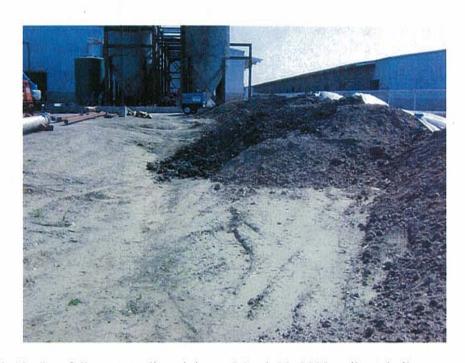
Snedeker Ave.) on March 19, 2008, the Port inspector noted soil stockpiles improperly placed in a drainage pathway and without down-gradient BMPs. In a follow-up audit activity on March 20, 2008, it was noted that these issues had not been corrected (Photograph 10). As a result, the Port exhibited a lack of adequate private construction oversight to prevent the contribution of pollutants to storm water from the aforementioned locations. These outstanding issues and Finding 2.4.2 were considered collectively in making this determination. The Port must correct the outstanding issues and Finding 2.4.2 through prompt and effective enforcement of its tenant agreements. Furthermore, it is strongly recommended that the Port develop and implement an Enforcement Response Plan (ERP) to establish clear direction and procedures for enforcement based on Port inspections of construction and industrial sites and other compliance activities.

Photograph 10: In a follow-up audit activity on March 20, 2008, soil stockpiles were still located in a drainage pathway and temporary perimeter controls had not been installed.

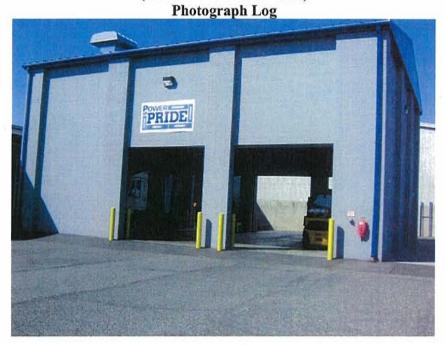
Photograph 11: View of Lowe's Distribution Center equipment maintenance shop.

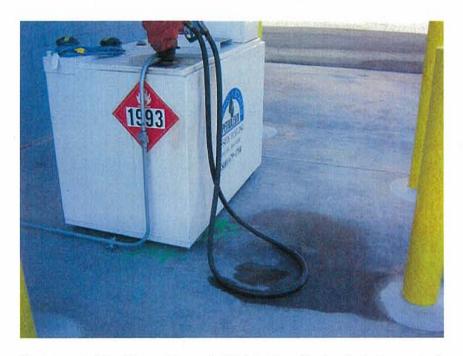
Photograph 12: View of Lowe's Distribution Center fuel storage tank located adjacent to the maintenance shop.

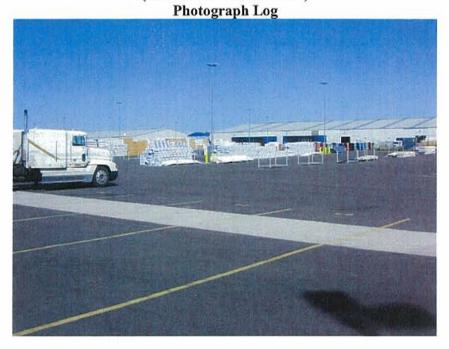
impervious parking improvements (<u>Photographs 13 and 14</u>). As a result, this project likely qualifies as a Priority Development Project under both the commercial and parking lot categories. Based on Port records provided during the audit, the Lowe's HIW, Inc., lease approval date (September 5, 2006) and construction start date occurred after the February 17, 2006, DSP compliance date (<u>Exhibit 4</u>) and therefore should have been reviewed and conditioned for compliance with the Development Standards.

Photograph 13: Impervious parking improvements at the Lowe's Distribution Center (looking north).

Furthermore, the Port must ensure that all current and future Priority Development Projects are reviewed for DSP applicability and that subsequent project plans are adequately conditioned and implemented for compliance with the Development Standards. This will become increasingly imperative because of the anticipated redevelopment of the West Complex.

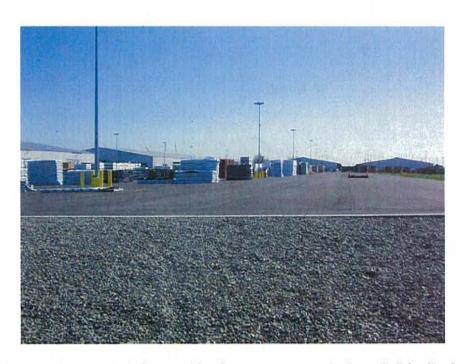
Photograph 14: Impervious parking improvements at the Lowe's Distribution Center (looking east).

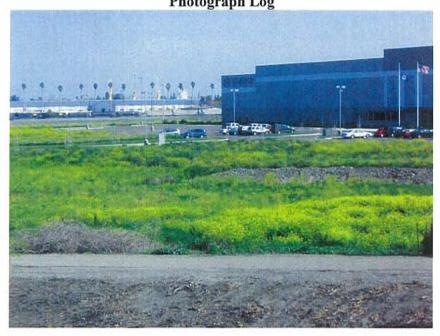
Photograph 15: Newly constructed warehouse structure and impervious parking improvements at the Ferguson Distribution Center (looking east).

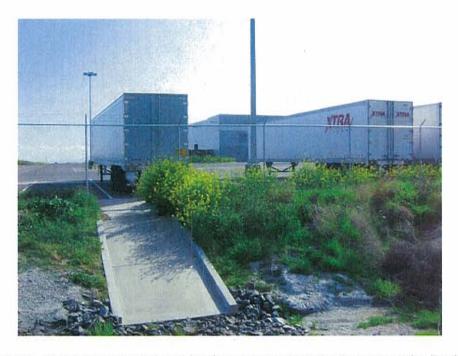
Photograph 16: Newly constructed parking improvements at the Ferguson Distribution Center (looking south).
