# Underground Assessment Of The Standard Mine Superfund Site Gunnison County, Colorado

Colorado Division of Reclamation, Mining & Safety  
1313 Sherman Street, Suite 215  
Denver, CO 80203

December, 2007

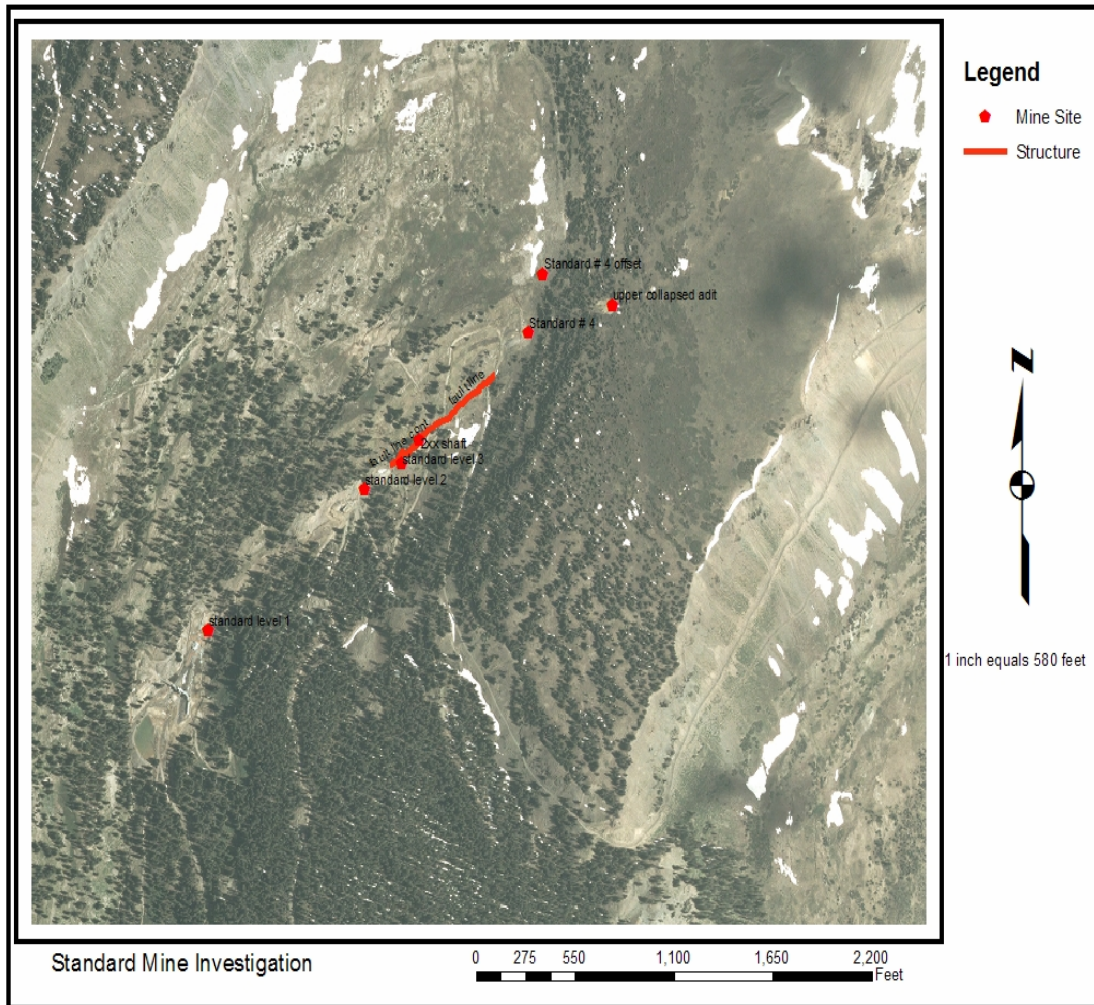
*Figure 5. Aerial Photograph of Standard Mine Vicinity with Mine Entries and Visible Fault Trace Depicted.*

Parts of the fault trace can be followed and mapped on the ground surface (Figure 5). The fault extends up the hillside above Level 5 to waste piles associated with a collapsed abandoned mine adit. Within Level 5, the fault trace was observed to be less distinct than what was observed at the ground surface overlying this drift. This raises the question of whether Level 5 workings follow the same fault structure as that observed on surface.

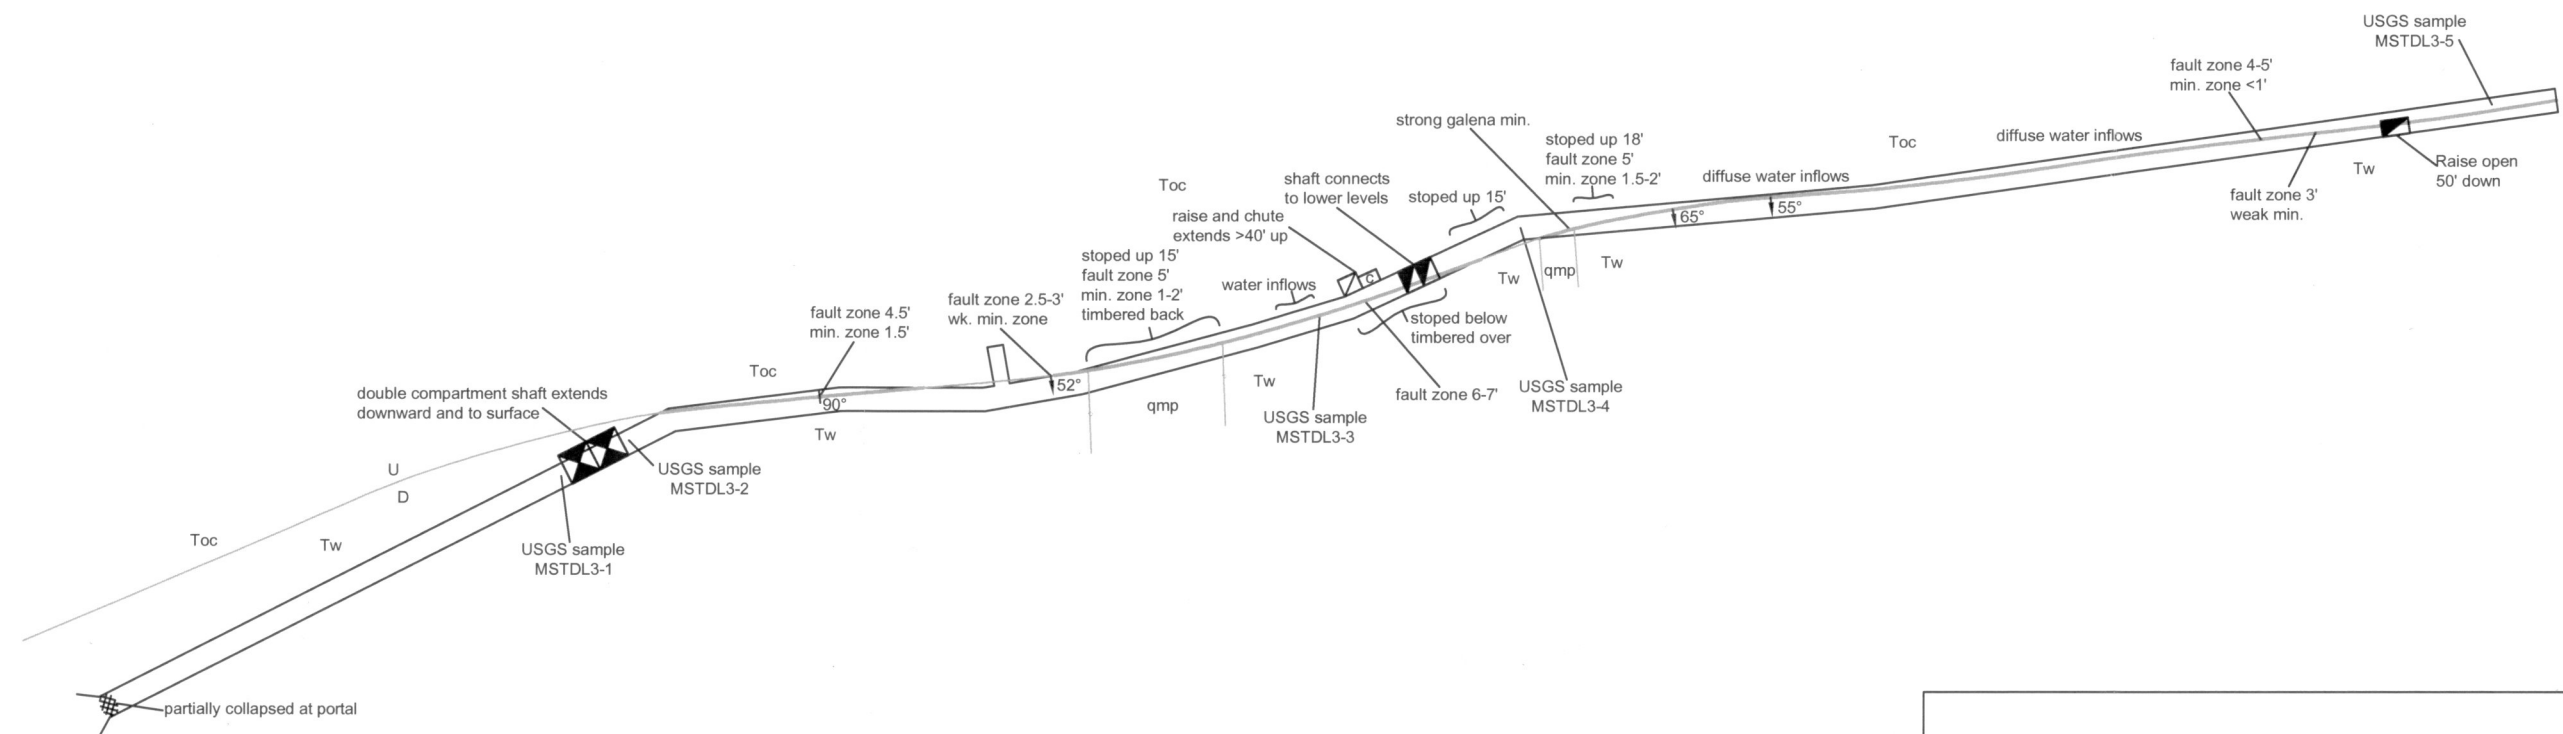
PLATE 1

Reconnaissance moved next to the Level 3 portal following abandonment of Level 1 exploration. This level is open and readily accessible via an open collapse immediately beyond the original portal. The ground above the drift just beyond the portal appears to have collapsed, blocking the original portal entry. Erosion, or potentially people with shovels, breached through the collapsed debris at a timber set beyond the original mine entrance, allowing entry to the workings. Once inside, the drift is open and relatively free of blockages. Water enters the drift at many areas on this level along the mineralized vein it follows. The vein structure appears to act as a conduit for groundwater movement downward into the mine workings. The water intercepted on this level flows down raises to Level 2 below. Following the initial reconnaissance, Level 3 was mapped in detail (Plate 1).

Moving inward beyond the head of this raise on Level 3, overhand stoping on the vein was observed in several locations. Ore was mined from the vein in the back to a height of 15 to 18 feet above the drift, over a vein width of 1.5 to 2 feet.

A fourth raise was encountered 610 feet in from the portal near the end of the drift workings on Level 3. Figure 4 indicates that this raise passes down only to Level 2. The head of the raise is collared on the south (right) side of the drift, and is inclined from the horizontal approximately 60° to follow the vein structure. It contains rotting ladders in very poor condition. The raise is not timbered and is in satisfactory condition; however access into Level 2 from this connection is prevented by a large rock jammed near the foot of the raise just above Level 2.

Water was observed to enter the Level 3 drift from numerous locations, all associated with the footwall (north) side of the fault system. Although much less significant inflow was observed at Level 5, it too was observed to enter from within the fault zone, or along the footwall side of the fault. No inflow from the hanging wall was observed on either Level 3 or 5.

Water quality results also indicate that after the fault-controlled water enters the mine workings, it becomes substantially more degraded upon contact with the exposed ore body and mineralized materials. A sample collected on Level 3 downstream from the fault seep sample locations had a metals concentration approximately seven times higher than that of the seep water inflow itself. This data suggests that water moving along the floor of the drift workings and through accumulated broken ore and mineralized waste material quickly leaches metals, further diminishing the quality of the water as it moves through the mine. The ready leaching of metals from mineralized waste material is supported by sampling of the water seeping from mine waste dumps at the site. Surface water quality data from the Levels 2 and 5 waste dumps showed water moving through the material quickly picks up very high metals concentrations. The movement of water downward from Level 3, through Level 2 and sublevels to Level 1, all through ore-laden stopes and ore passes, could account for the much higher metals concentrations observed in the Level 1 discharge. Exploration of Level 2 in conjunction with water sampling could potentially confirm that water moving from Level 3 to Level 2 becomes more degraded.

The increase in metals concentrations between Levels 3 and 1 could be reduced by controlling water pathways between the levels. Hydrologic barriers could be constructed in Level 3 to prevent the downward movement of water to the levels below. Placement of concrete or grout linings or aprons along the floor in Level 3 would reduce water infiltration and contact with mineralized material. A drain could be installed within the Level 3 floor lining to divert water out of the level before it can move downwards into the lower workings in the vein. Water thus diverted out of Level 3 is expected to have better quality than if it were allowed to continue through the workings to Level 1. This approach would also reduce the flow at Level 1 potentially resulting in opportunities for alternative treatment strategies.

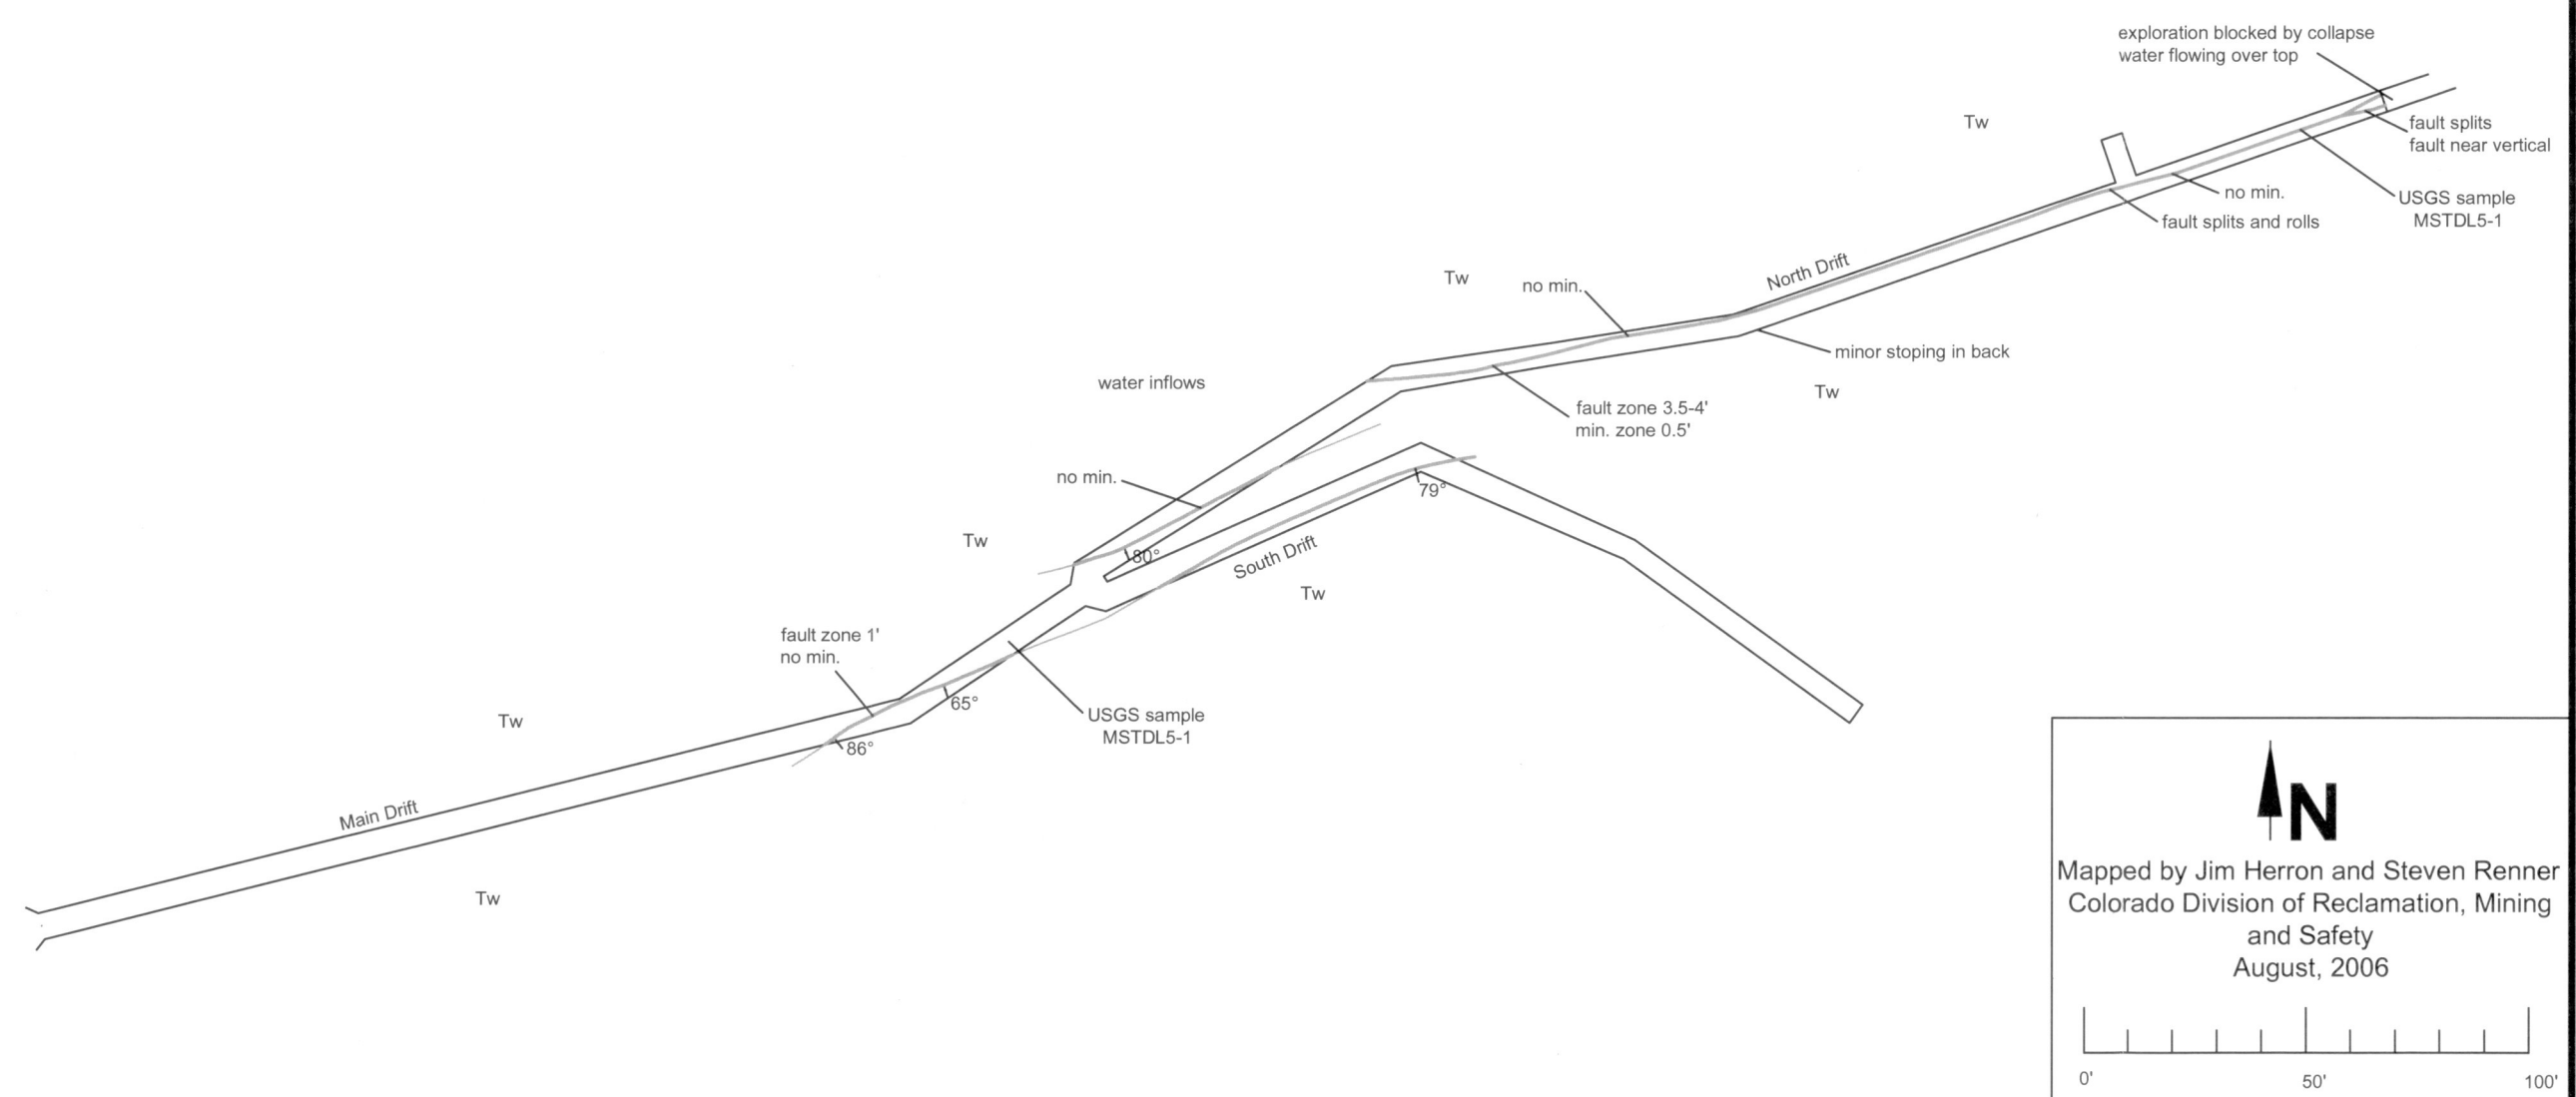
# LEVEL 5 STANDARD MINE

As with Level 3, Level 5 appears to generally follow the strike of the Micawber vein in upper Elk Basin. Water accumulates on the floor of the drift, with high water marks noted at approximately three feet above the floor. Few notable inflows were observed, thus, it is assumed that water within the drift can be attributed to diffuse seepage of seasonal precipitation from the surface. The drift runs fairly straight for approximately 250 feet, where it then branches into right (south) and left (north) headings (see Plate 2).

The north drift generally follows the strike of the Micawber fault-vein structure, turning slightly north of strike for the first 250 feet of this branch. The structure is un-mineralized, consisting of a barren fault that is somewhat difficult to trace in locations, and it rolls flatter (decrease in dip), and splits. The fault structure is not as well defined as was observed in Level 3, leading to the slight meanders noted in the workings. At approximately 300 feet in from the branch on this level, the north drift is blocked by a substantial collapse. The collapse acts as a dam, as a small quantity of water flows into Level 5 from near the top of the collapse material.

The first 80 feet of the south drift on Level 5 generally follows the same northeast strike as the main drift before the branch point. A discontinuous fault trace is present in the back and ribs along this section of the south drift to a point where it turns abruptly southeast. The workings continue southeast in barren ground with no evidence of a fault or vein structure, ending approximately 200 feet beyond the branch point on the main drift entry. A 6-inch to 10-inch wide un-mineralized fault re-appears at the face of the heading. No evidence of water inflow was observed in the south drift.

At Level 5, a maximum discharge of three gallons per minute was observed from the portal, with no more than two to three gallons per minute observed discharging from all measured interior sample points (Manning, et al., 2007).

Up Slope Diversion – The Micawber vein has been observed to extend well up slope of Level 5. Observations indicate that the fault-vein structure is the major source of water entering the mine workings. The Level 5 workings might be used as a “horizontal well” to intercept water produced from the fault structure up slope of that elevation. A system to move intercepted water out of this level quickly could be developed in order to minimize residence time and the potential to infiltrate into the fault structure in the floor of the drift workings. The diverted water would be treated if necessary and released via a diversion that would route water well away from the associated mine dump and the fault structure down slope.
