**UNITED STATES ENVIRONMENTAL PROTECTION AGENCY  
REGION IX  
75 Hawthorne Street  
San Francisco, CA 94105**

Purpose: RCRA Compliance Evaluation Inspection

Facility: Siemens Water Technologies Corporation

Date of Investigation: June 22, 2009

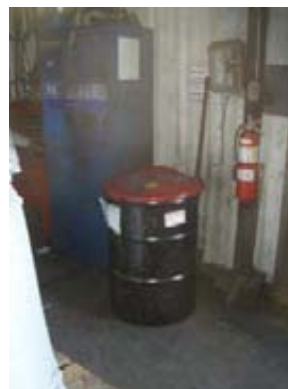
In addition to the containers of spent carbon from off-site facilities pending regeneration, the inspectors observed one 55-gallon satellite accumulation container for warehouse debris, dated 6/12/09, in this area (see photograph to the right). No potential violations were noted.

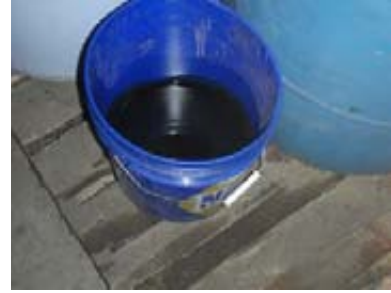
- One 5-gallon container of used oil (approximately 1/5 full) that was not labeled as used oil. This container was added to the properly labeled 55-gallon used oil container during the inspection.

Findings: The inspectors observed one 5-gallon container of used oil that was not marked as required.

Facility Response: This issue was corrected during the inspection.

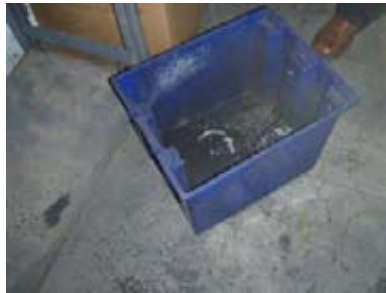
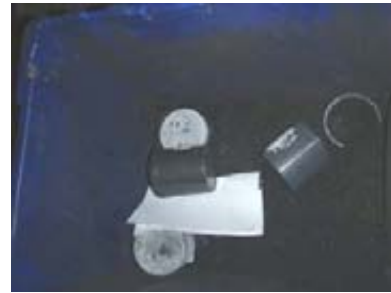
- Two open and unlabeled 5-gallon containers containing carbon from carbon samples (see photographs to the right). The carbon from these containers was properly managed during the inspection.

Findings: The inspectors observed two containers of spent carbon samples that were open at the time of the inspection.

Findings: The inspectors observed two containers of spent carbon samples that were not labeled at the time of the inspection.

Facility Response: This issue was corrected during the inspection.

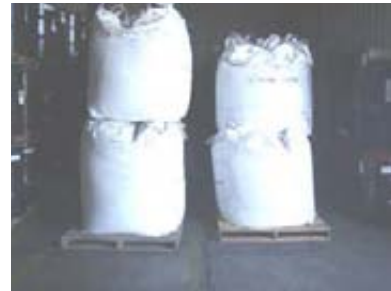
The inspectors noted that the aisle space between two of the rows in the warehouse was small (i.e., smaller than the aisle space distance marked on the floor between the other aisles (see photograph to the right). During the record review it was confirmed that the contents in these two rows were non-RCRA wastes. The inspectors recommended that Siemens maintain the same aisle space between all rows in the warehouse. No potential violations were noted.

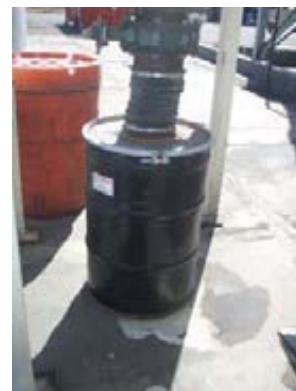
The container attached to the unit was dated March 24, 2009 (see photograph to the right). No potential violations were noted.

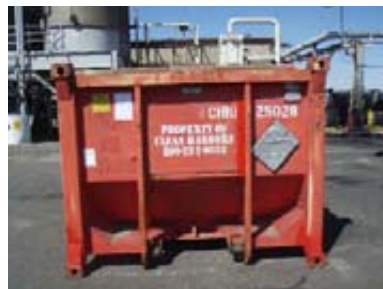
The 20-cubic yard roll-off bin was dated June 12, 2009 (see photograph to the right). No potential violations were noted.

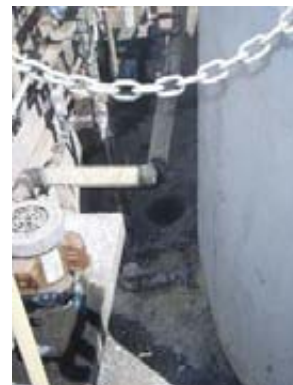
The inspectors observed some caustic residue from the product tank underneath one of the pipes (see photograph to the right). The inspectors informed the facility representative that this caustic should be cleaned up.

Findings: The inspectors observed dried caustic waste underneath a pipe next to the caustic product tank.

Subsequent to the inspection, the facility representatives provided photographs showing that this issue was resolved.

Facility Response: This area was cleaned up subsequent to the inspection.
