Second Five-Year Review Report

Smelertown Superfund Site Operable Units 1 and 2

Chaffee County,
Colorado

September 2010

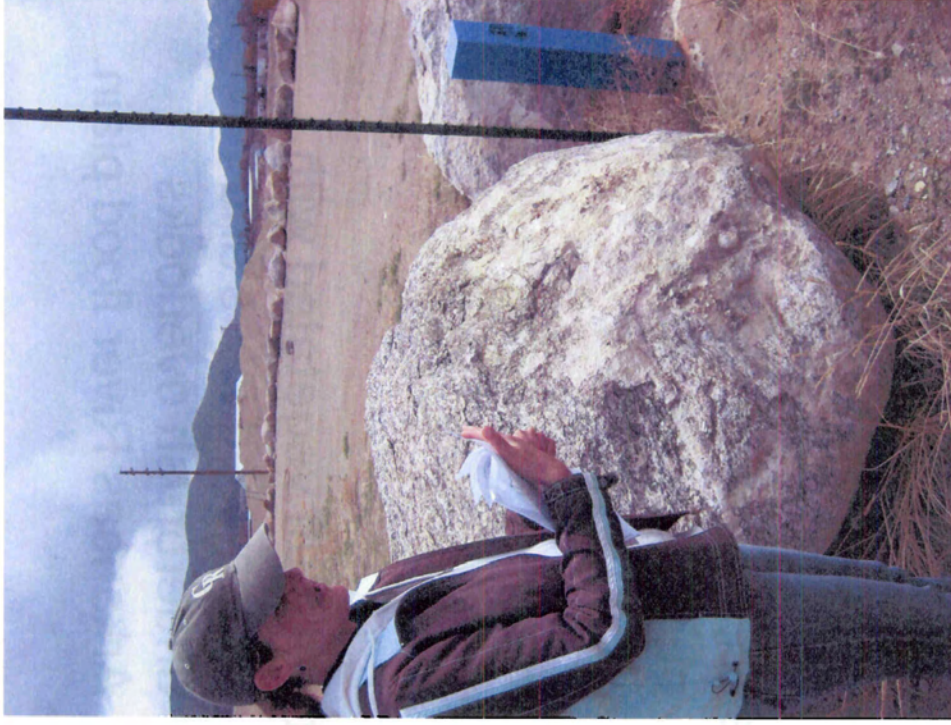
- Site visit coordinated with the inspection of the site's 17 monitoring wells.
- Monitoring wells are well marked and protected from damage by the heavy earth moving machinery.

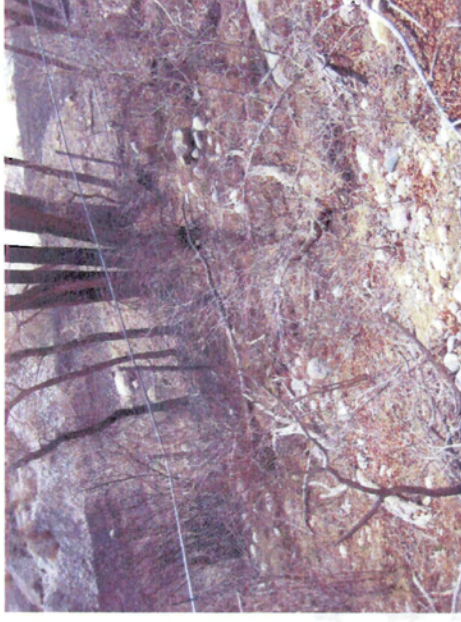
The fence around Spring No. 5 had been constructed and the gate was locked and in satisfactory condition. No flow of water or DNAPL, and no creosote odor were observed within the fenced area during the field inspection.

Fenced off seep area, restricts public from possible DNAPL exposure.

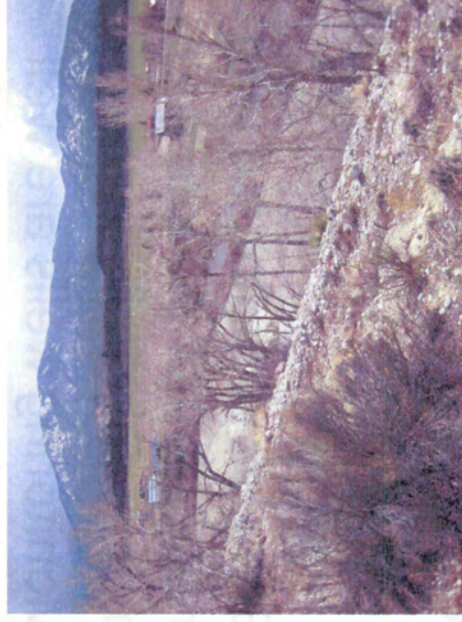
Steep bluff vegetated with cottonwood trees and underbrush overlooks Arkansas River flood plain.

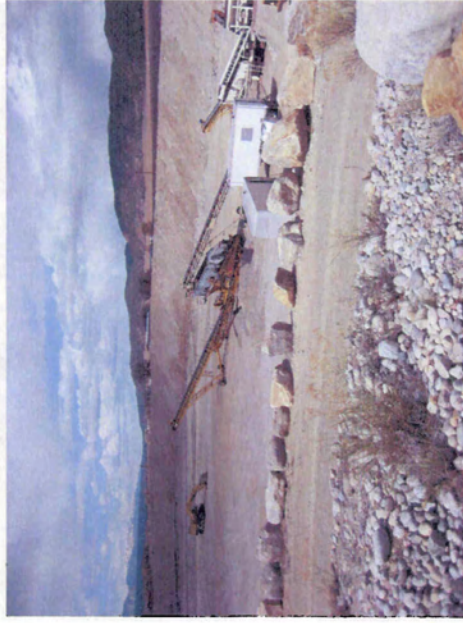
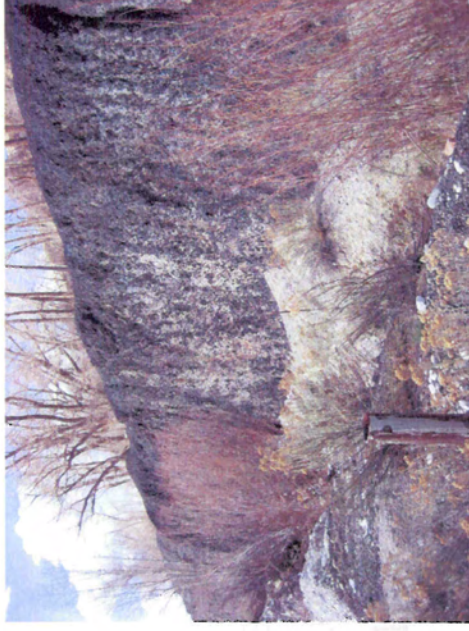
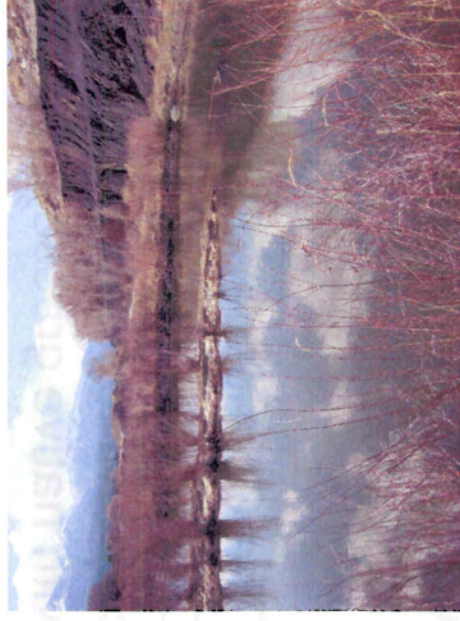
- Top left: Gravel operation near OU2
- Top right: Slag deposits along the Arkansas River
- Bottom right: Ponds adjacent to the Arkansas

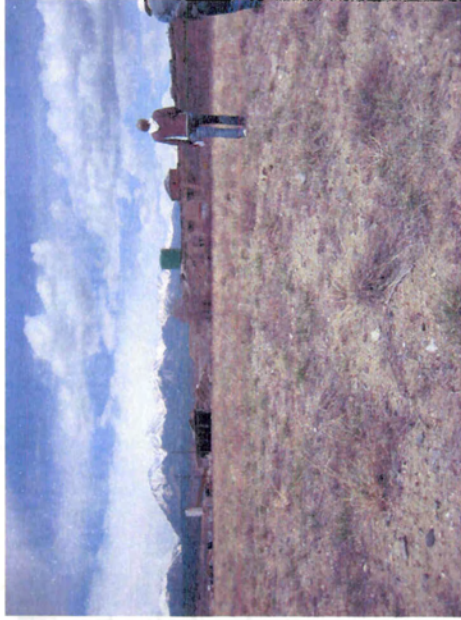
1. The cover system associated with the WCA remains in satisfactory condition and therefore prevents human exposure to consolidated wastes. Vegetative cover density is similar to nearby offsite non-irrigated properties. No erosion, animal burrows or differential settling were noted during the inspection.
2. The Butala and Teck LLC property perimeter fences are in satisfactory condition, and serve to control access to the WCA.
3. Institutional controls prohibiting residential use and restricting drilling, excavation, or re-contouring of the cap has been implemented, and compliance with the controls was confirmed during the site visit on April 20-21, 2010.
4. Groundwater monitoring has been conducted at the required frequency, for the required chemicals.

- The Consolidation Area at OU1 has been capped with clay and top soil and vegetated with native grasses.

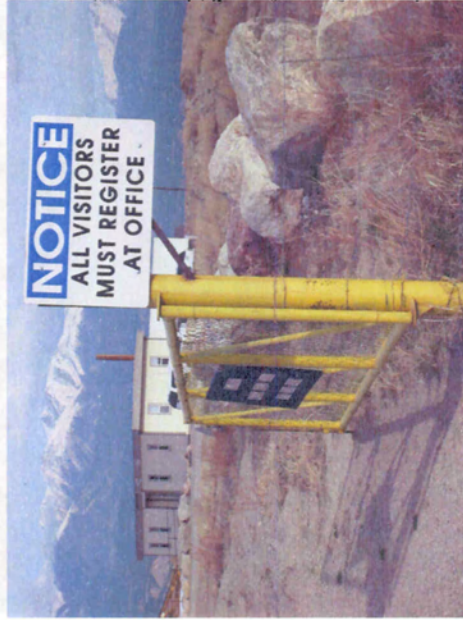
All physical remediation elements have been constructed. The perimeter Butala and Teck LLC property fences are in generally good condition and capable of restricting access to the entire property, including the WCA. The WCA is constructed and capped, and the vegetation density on the cap appeared similar to offsite non-irrigated properties. No erosion, rilling or exposure of contaminated materials was observed. Drainage swales around the WCA were in good condition. All required monitoring wells have been installed and appeared in satisfactory condition.

- The Superfund site has restricted access and is gated and fenced.
